**Flood Control Project Maintenance
Levee Inspections**

Maintenance Issue Types Only, Levee Inspection Report By Mile - Spring 2023

Reclamation District No. 0017 Mossdale

Waterway	Bank	Unit Miles	Inspection Start/End	Inspector
Unit No. 01 French Camp Slough	Left	1.76	05/05/2023 05/05/2023	Alberto De Leon

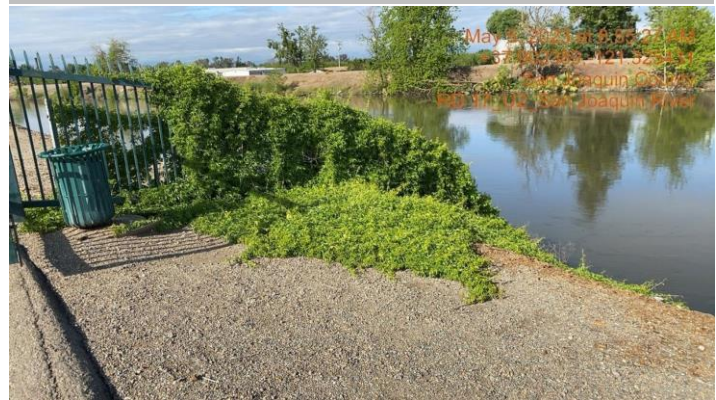
Photo 1 of 1 : SP_2023_RD0017_304_12_20230511_00042.jpg

LM Start	1.09	Rating **	M	Issue No.	12
LM End	1.09	Issue Type +	Ma	Location *	WS
Category	Earthen Levee			GPS Latitude/Longitude	
				Start	End
Item	Vegetation			37.902282°	37.902282°
				-121.325493°	-121.325493°
DWR ID	DWR_RD0017_02_s_2023_12				
Comment Code					
V2 : Remove the wild growth and woody vegetation other than native grasses from the levee slopes.					
Inspector Comment

View of ivy covering waterside slope. Spring 2023

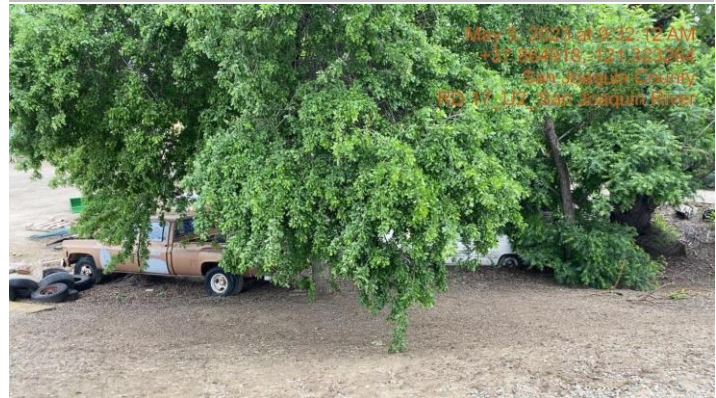
Photo 1 of 1 : SP_2023_RD0017_304_15_20230511_00045.jpg

LM Start	4.04	Rating **	M	Issue No.	15
LM End	4.04	Issue Type +	Ma	Location *	LS
Category	Earthen Levee			GPS Latitude/Longitude	
				Start	End
Item	Trim / Thin Trees			37.864908°	37.864908°
				-121.323251°	-121.323251°
DWR ID	DWR_RD0017_02_s_2023_15				
Comment Code					
T1 : Trim and thin trees to at least five feet above ground level to allow visibility of the ground and room to flood fight.					
Inspector Comment

View of untrimmed tree along the landside slope. Spring 2023

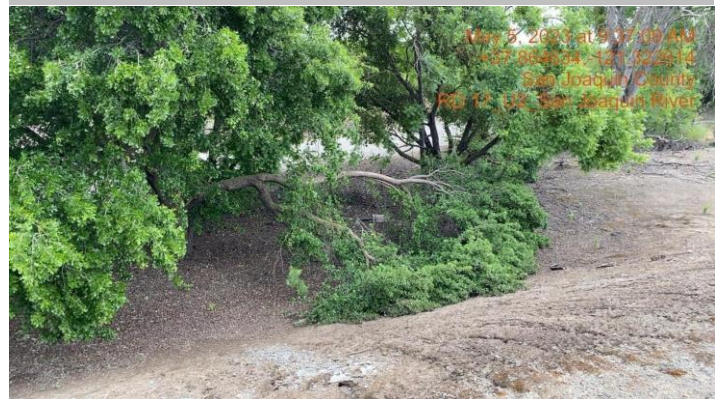
Photo 1 of 1 : SP_2023_RD0017_304_16_20230511_00046.jpg

LM Start	4.08	Rating **	U	Issue No.	16
LM End	4.08	Issue Type +	Ma	Location *	LS
Category	Earthen Levee			GPS Latitude/Longitude	
				Start	End
Item	Trim / Thin Trees			37.864613°	37.864613°
				-121.322513°	-121.322513°
DWR ID	DWR_RD0017_02_s_2023_16				
Comment Code					
T2 : Tree or limb.					
Inspector Comment

View of large broken tree branch along the landside slope. Spring 2023

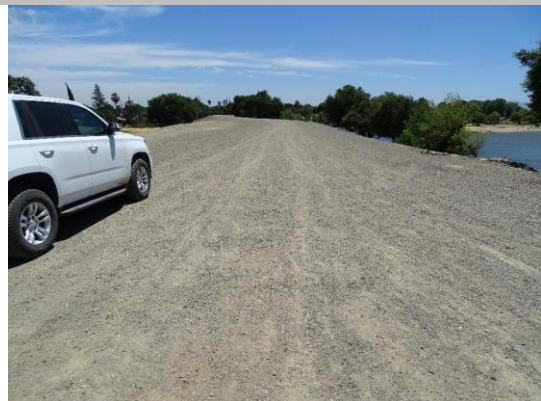
Photo 1 of 3 : UCIP_SP_2023_67818_100030.jpg

Comment Code					
Inspector Comment					
DS_ID:809					
FS_ID:67818					
EP_NO: N/A					
Repair Type: Non-Urgent					
EVAL Issue:					
Crossing Status: Found					
UCIP Comments: 06/07/2021 Record remains Non-Urgent. Crossing appears abandoned. (D.Sanoski - DWR UCIP)					
02/04/2010 No information was obtained from desk study. This crossing was found during field visit. Need to contact owner to obtain additional details about crossing (installation date and permit) and status. (O.Magana - DWR UCIP)					
FIELD_STRUCT_DESC: [Reclamation District No. 17 Drainage Plant] 18-inch drainage pipe of unknown material through the levee, 5.8 feet below the crown. Gate valve and siphon breaker on the waterside (WS) slope. Flap gate on the WS end. One CM cutoff wall. Pump on the landside (LS). (18-inch pipe Installed by USACE in 1961 -- no permit found). [Additional Reference(s): DWR Levee Log, 1981 (HLM 13.34). USACE San Joaquin O&M Manual, Unit 002, May 1963, Revised 29 December 2016, (HLM 13.36), listed as 18-inch pipe].

Top of Levee: view of crown.
