**Flood Control Project Maintenance
Levee Inspections**

Maintenance Issue Types Only, Levee Inspection Report By Mile - Spring 2024

Reclamation District No. 0017 Mossdale

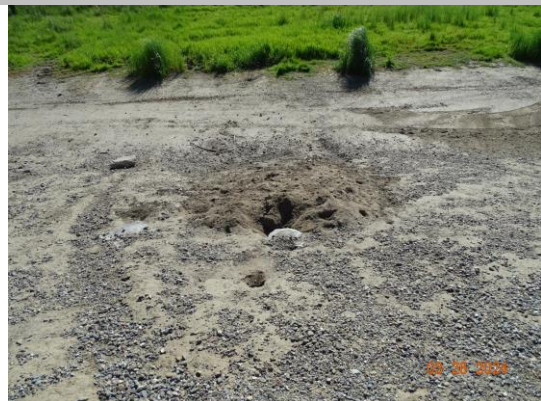
Photo 1 of 1 : SP_2024_RD0017_304_17_20240327_00045.jpg

LM Start	2.49	Rating **	U	Issue No.	17
LM End	2.49	Issue Type +	Ma	Location *	LS
Category	Earthen Levee			GPS Latitude/Longitude	
				Start	End
Item	Animal Control			37.883365°	37.883365°
				-121.331208°	-121.331208°
DWR ID	DWR_RD0017_02_s_2024_17				
Comment Code					
A3 : No rodents visible, but rodent burrows visible; need to backfill and compact or grout burrows.					
Inspector Comment

View of large animal burrow along the landside slope. Spring 2024

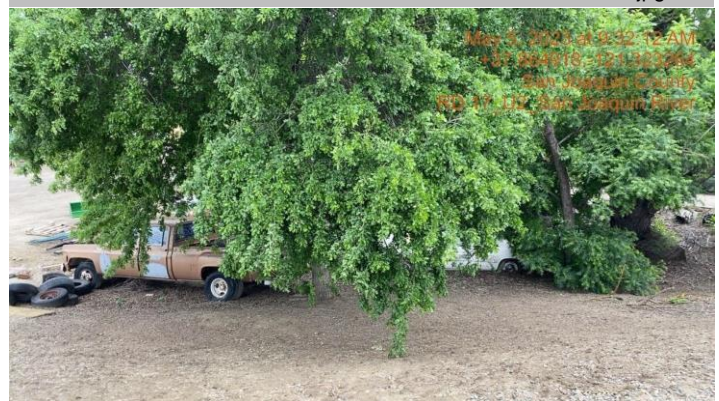
Photo 1 of 1 : SP_2024_RD0017_304_15_20240214_00002.jpg

LM Start	4.04	Rating **	M	Issue No.	15
LM End	4.04	Issue Type +	Ma	Location *	LS
Category	Earthen Levee			GPS Latitude/Longitude	
				Start	End
Item	Trim / Thin Trees			37.864908°	37.864908°
				-121.323251°	-121.323251°
DWR ID	DWR_RD0017_02_s_2023_15				
Comment Code					
T1 : Trim and thin trees to at least five feet above ground level to allow visibility of the ground and room to flood fight.					
Inspector Comment

View of untrimmed tree along the landside slope. Spring 2023

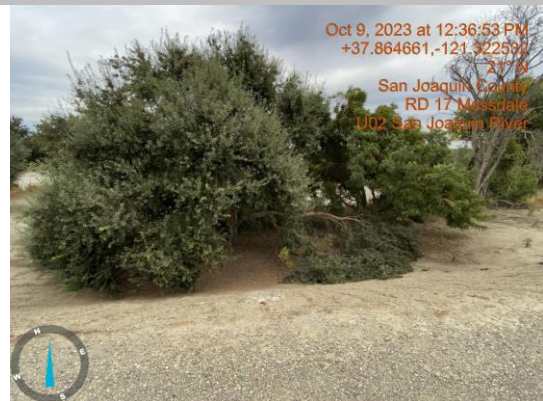
Photo 1 of 1 : SP_2024_RD0017_304_16_20240214_00003.jpg

LM Start	4.08	Rating **	M	Issue No.	16
LM End	4.08	Issue Type +	Ma	Location *	LS
Category	Earthen Levee			GPS Latitude/Longitude	
				Start	End
Item	Trim / Thin Trees			37.864613°	37.864613°
				-121.322513°	-121.322513°
DWR ID	DWR_RD0017_02_s_2023_16				
Comment Code					
T2 : Tree or limb.					
Inspector Comment

View of large broken tree branch along the landside slope. Fall 2023

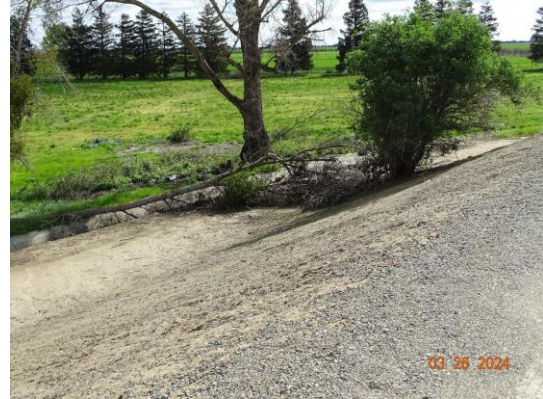
Photo 1 of 1 : SP_2024_RD0017_304_34_20240327_00048.jpg

LM Start	6.51	Rating **	U	Issue No.	34
LM End	6.51	Issue Type +	Ma	Location *	LS
Category	Earthen Levee			GPS Latitude/Longitude	
				Start	End
Item	Trim / Thin Trees			37.841739°	37.841739°
				-121.315990°	-121.315990°
DWR ID	DWR_RD0017_02_s_2024_34				
Comment Code					
T2 : Tree or limb.					
Inspector Comment

View of a downed tree along the landside easement. Spring 2024

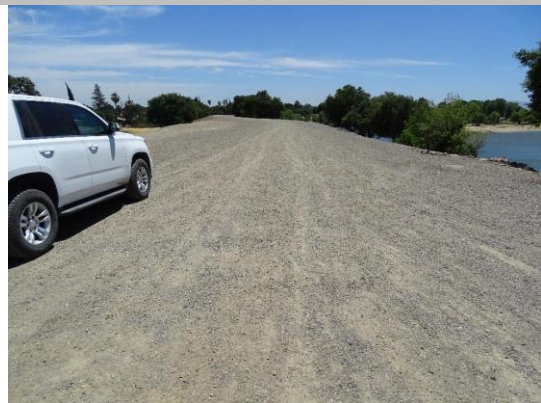
Photo 1 of 3 : UCIP_SP_2024_67818_100030.jpg

Comment Code					
Inspector Comment					
DS_ID:809					
FS_ID:67818					
EP_NO: N/A					
Repair Type: Non-Urgent					
EVAL Issue:					
Crossing Status: Found					
UCIP Comments: 06/07/2021 Record remains Non-Urgent. Crossing appears abandoned. (D.Sanoski - DWR UCIP)					
02/04/2010 No information was obtained from desk study. This crossing was found during field visit. Need to contact owner to obtain additional details about crossing (installation date and permit) and status. (O.Magana - DWR UCIP)					
FIELD_STRUCT_DESC: [Reclamation District No. 17 Drainage Plant] 18-inch drainage pipe of unknown material through the levee, 5.8 feet below the crown. Gate valve and siphon breaker on the waterside (WS) slope. Flap gate on the WS end. One CM cutoff wall. Pump on the landside (LS). (18-inch pipe Installed by USACE in 1961 -- no permit found). [Additional Reference(s): DWR Levee Log, 1981 (HLM 13.34). USACE San Joaquin O&M Manual, Unit 002, May 1963, Revised 29 December 2016, (HLM 13.36), listed as 18-inch pipe].

Top of Levee: view of crown.

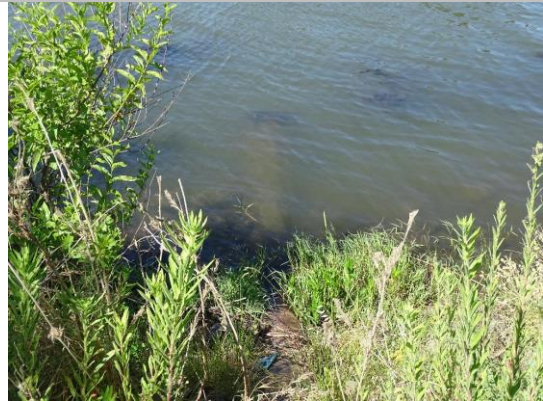
Photo 2 of 3 : UCIP_SP_2024_67818_100052.jpg

Water-Side: view of pipe in water at toe.

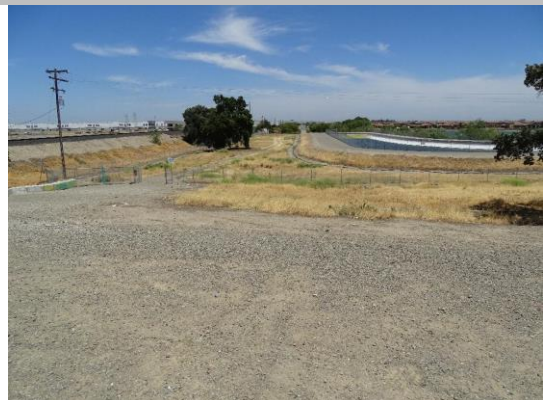
Photo 3 of 3 : UCIP_SP_2024_67818_100031.jpg

Land-Side: view of slope.
