**Flood Control Project Maintenance
Levee Inspections**
LMA District Cover Sheet
Spring 2009 Levee Inspection Results

Reclamation District No. 0017

Levee Inspection Report By Mile - Spring 2009

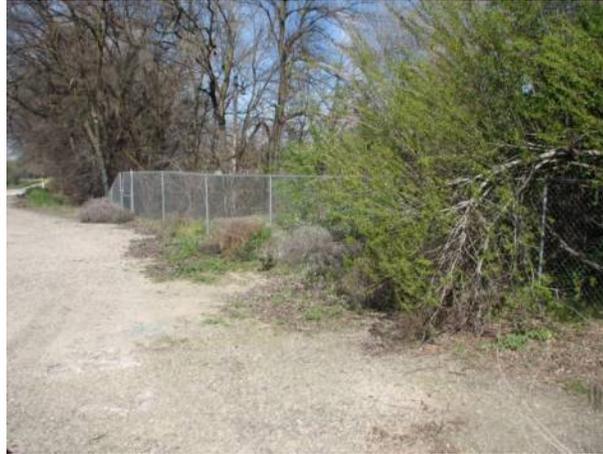
Levee Mile Report Line	1
Start Levee Mile	0.00
End Levee Mile	0.02
Location	Water Side
Category	Earthen Levee
Item	Encroachments
Fence on landside shoulder from LM 0.00 to 0.02

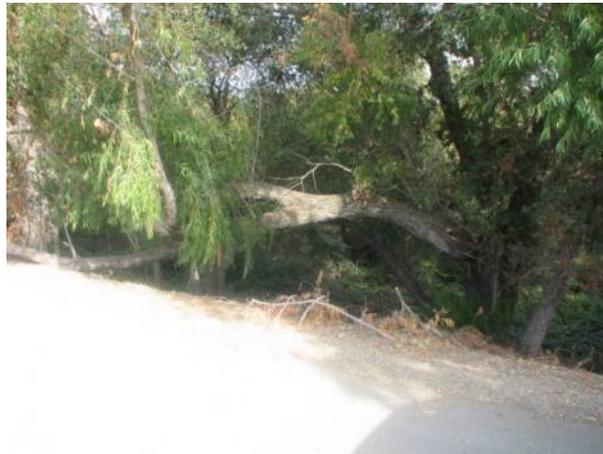
6	0.19	0.19	Earthen Levee	Encroachments	WS	M	Tree or limb Inspector Comments: Down tree limb laying on waterside slope.	37.913254 ° -121.293366 °	37.913254 ° -121.293366 °	Y	10
7	0.31	0.31	Earthen Levee	Animal Control	LS	M	No rodents visible, but rodent burrows visible; need to backfill and compact or grout borrows.	37.913448 ° -121.295492 °	37.913448 ° -121.295492 °		13
8	0.48	0.51	Earthen Levee	Encroachments	WS	M	Prunings	37.912770 ° -121.298426 °	37.912853 ° -121.298865 °		11
9	0.57	0.57	Earthen Levee	Encroachments	LS	M	Prunings	37.913288 ° -121.299812 °	37.913288 ° -121.299812 °		6
10	0.88	0.97	Earthen Levee	Animal Control	WS	M	No rodents visible, but rodent burrows visible; need to backfill and compact or grout borrows.	37.915093 ° -121.304609 °	37.915237 ° -121.306245 °		12
11	1.19	1.19	Earthen Levee	Trim / Thin Trees	WS	M	Trim trees to at least five feet above ground level.	37.915875 ° -121.309795 °	37.915875 ° -121.309795 °		7

Levee Mile Report Line	6
Start Levee Mile	0.19
End Levee Mile	0.19
Location	Water Side
Category	Earthen Levee
Item	Encroachments
Down tree branch on waterside slope

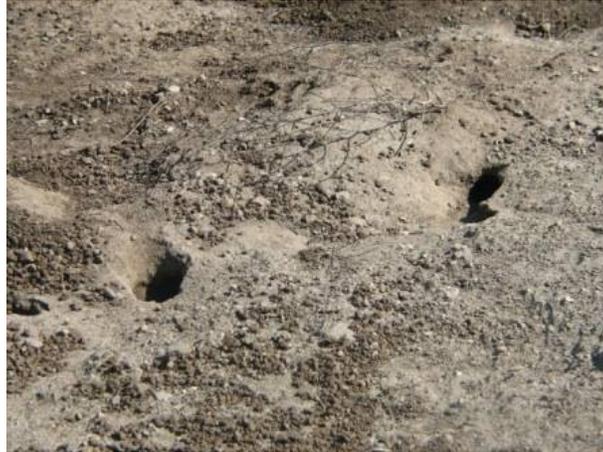
Levee Mile Report Line	2
Start Levee Mile	2.19
End Levee Mile	2.23
Location	Land Side
Category	Earthen Levee
Item	Animal Control
Squirrel borrows on landside slope heavy infestation from LM 2.19 to 2.60

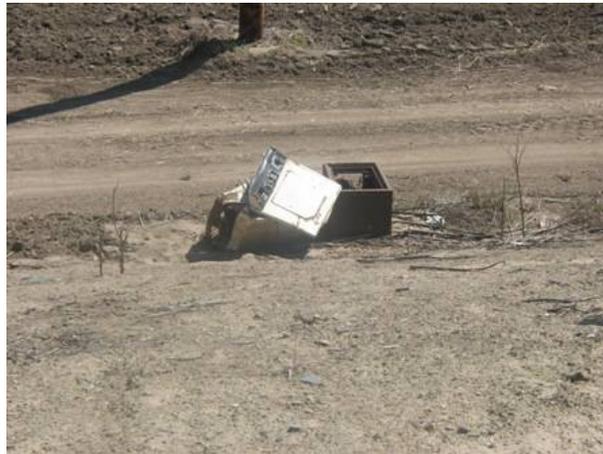
Levee Mile Report Line	3
Start Levee Mile	2.76
End Levee Mile	2.76
Location	Land Side
Category	Earthen Levee
Item	Encroachments
Garbage at landside toe.

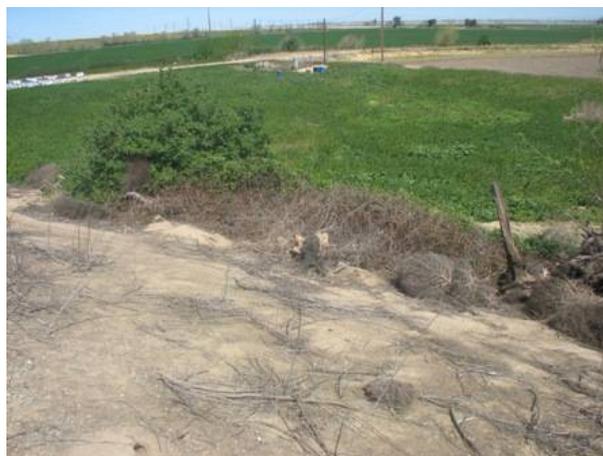
Levee Mile Report Line	7
Start Levee Mile	3.31
End Levee Mile	3.31
Location	Land Side
Category	Earthen Levee
Item	Vegetation
Overgrown of dead berryvines at landside toe.

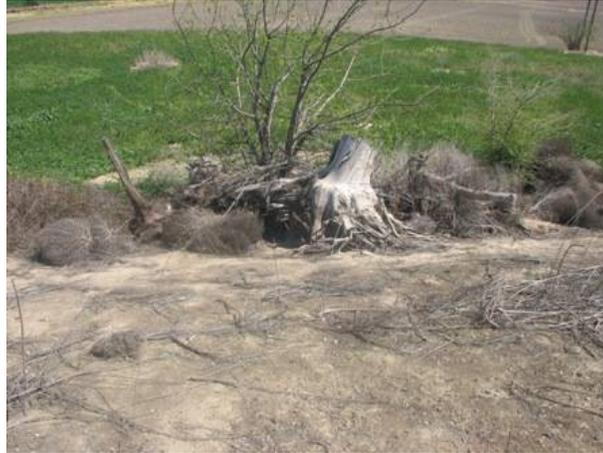
Levee Mile Report Line	8
Start Levee Mile	3.31
End Levee Mile	3.31
Location	Land Side
Category	Earthen Levee
Item	Encroachments
Tree stump and limbs at landside toe.

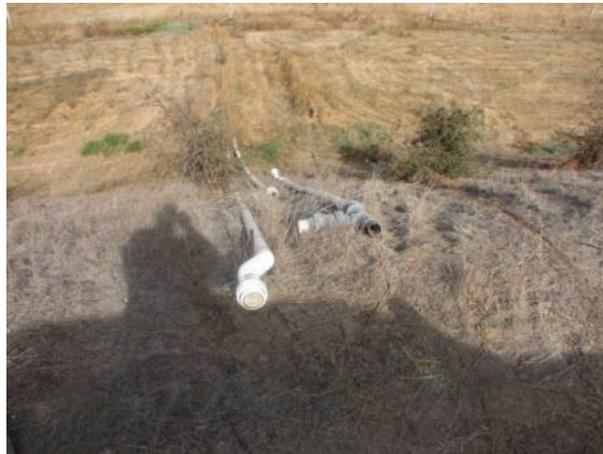
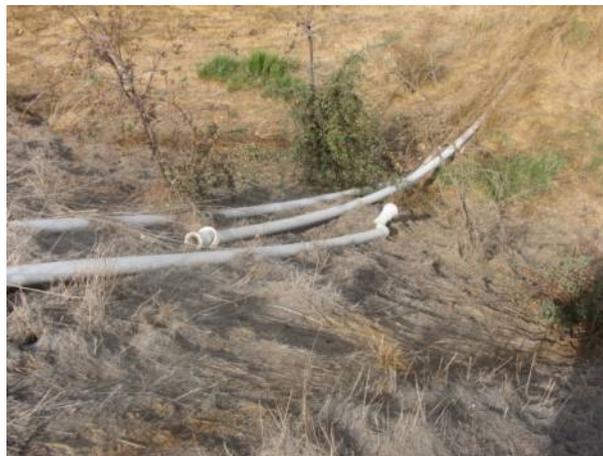
16	4.21	4.21	Earthen Levee	Encroachments	LS	M	Pipe Inspector Comments: Non-permitted 3-4 inch PVC pipes on landside slope.	37.864097 °	37.864097 °	Y	47
								-121.321352 °	-121.321352 °

Levee Mile Report Line	16
Start Levee Mile	4.21
End Levee Mile	4.21
Location	Land Side
Category	Earthen Levee
Item	Encroachments
Looking eastward at abandoned PVC pipes on landward slope.

Levee Mile Report Line	16
Start Levee Mile	4.21
End Levee Mile	4.21
Location	Land Side
Category	Earthen Levee
Item	Encroachments
Looking northward at abandoned PVC pipes on landward slope.

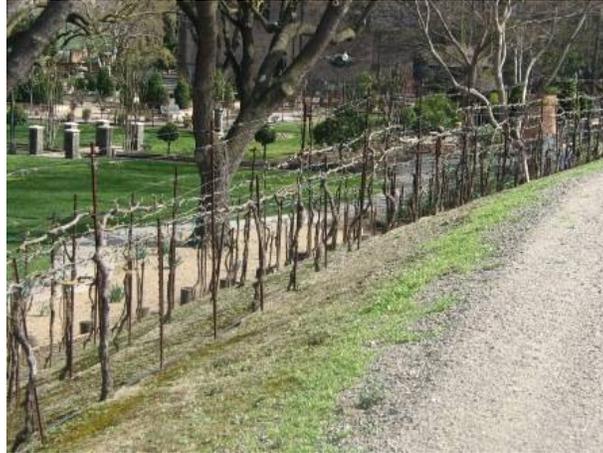
Levee Mile Report Line	18
Start Levee Mile	4.28
End Levee Mile	4.32
Location	Land Side
Category	Earthen Levee
Item	Encroachments
Grape vines on landside slope from LM 4.28 to 4.32

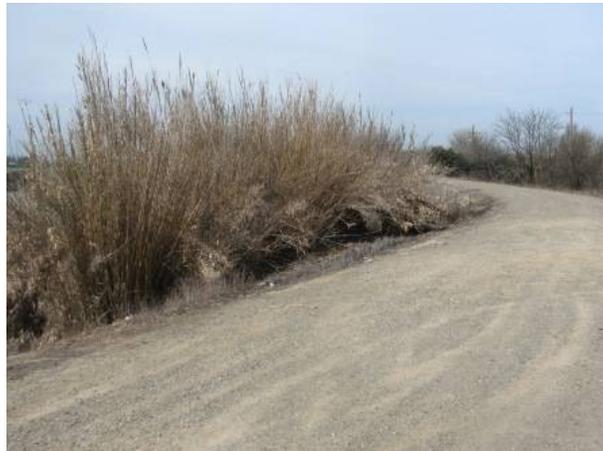
23	4.58	4.60	Earthen Levee	Vegetation	WS	U	Remove the wild growth other than native grasses from the levee slopes. Inspector Comments: Remove dead bamboo.	37.860395 ° -121.317962 °	37.860170 ° -121.317622 °	Y	15
24	4.67	4.69	Earthen Levee	Trim / Thin Trees	LS	C	Trim trees to at least five feet above ground level.	37.859165 ° -121.317288 °	37.858918 ° -121.317348 °		51
25	5.01	5.01	Earthen Levee	Trim / Thin Trees	LS	M	Trim trees to at least five feet above ground level.	37.855163 ° -121.319817 °	37.855163 ° -121.319817 °		16
26	5.45	5.45	Earthen Levee	Animal Control	LS	M	Exterminate rodents and backfill and compact or grout burrows.	37.851576 ° -121.321798 °	37.851576 ° -121.321798 °		52
27	5.55	5.55	Earthen Levee	Encroachments	WS	M	Tree or limb Inspector Comments: Cut and remove broken tree limb from levee slope.	37.850507 ° -121.320432 °	37.850507 ° -121.320432 °	Y	17
28	5.58	5.58	Earthen Levee	Animal Control	LS	M	No rodents visible, but rodent burrows visible; need to backfill and compact or grout borrows.	37.850118 ° -121.320188 °	37.850118 ° -121.320188 °		76

Levee Mile Report Line	23
Start Levee Mile	4.58
End Levee Mile	4.60
Location	Water Side
Category	Earthen Levee
Item	Vegetation
Dead bamboo on waterside slope at LM 4.58 (Remove dead bambo)

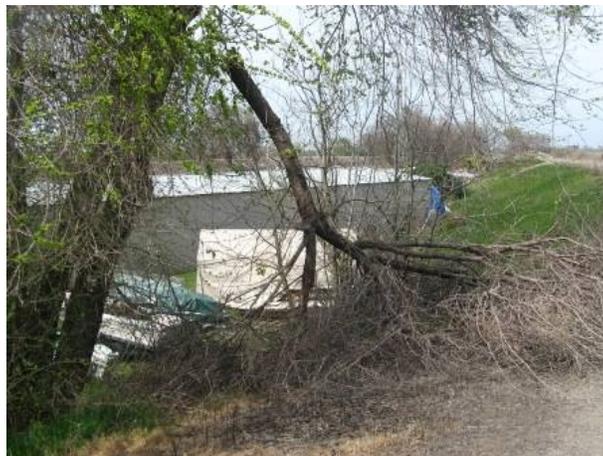
Levee Mile Report Line	27
Start Levee Mile	5.55
End Levee Mile	5.55
Location	Water Side
Category	Earthen Levee
Item	Encroachments
Broken tree limb at LM 5.55

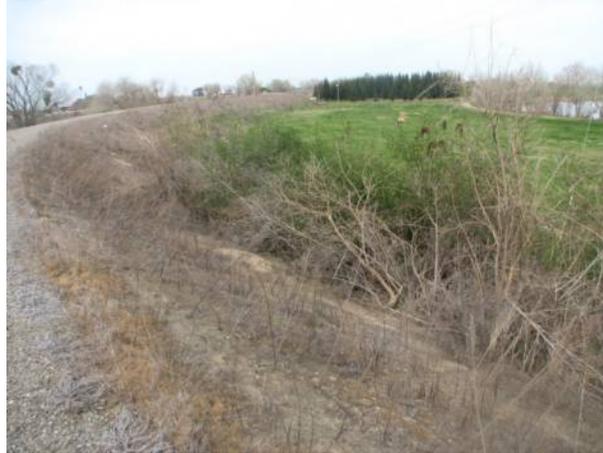
Levee Mile Report Line	38
Start Levee Mile	6.35
End Levee Mile	6.36
Location	Land Side
Category	Earthen Levee
Item	Vegetation
Elderberry blocking view of waterside toe from LM 6.35 to 6.36

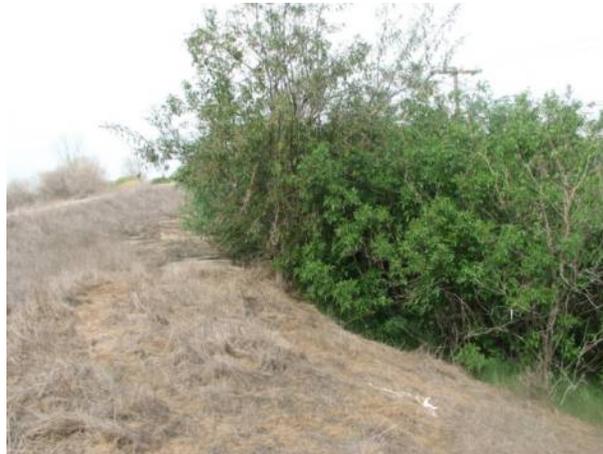
45	7.67	7.69	Earthen Levee	Vegetation	LS	M	Remove the wild growth other than native grasses from the levee slopes.	37.828095 ° -121.309945 °	37.827920 ° -121.309847 °	Y	25
46	7.75	7.75	Earthen Levee	Trim / Thin Trees	LS	C	Trim trees to at least five feet above ground level.	37.827038 ° -121.309375 °	37.827038 ° -121.309375 °		62
47	7.77	7.77	Earthen Levee	Trim / Thin Trees	LS	C	Trim trees to at least five feet above ground level.	37.826741 ° -121.309703 °	37.826741 ° -121.309703 °		63
48	8.02	8.02	Earthen Levee	Trim / Thin Trees	WS	M	Trim trees to at least five feet above ground level.	37.823928 ° -121.310788 °	37.823928 ° -121.310788 °		26
49	8.16	8.16	Earthen Levee	Animal Control	LS	M	Exterminate rodents and backfill and compact or grout burrows.	37.824588 ° -121.312998 °	37.824588 ° -121.312998 °		79

Levee Mile Report Line	45
Start Levee Mile	7.67
End Levee Mile	7.69
Location	Land Side
Category	Earthen Levee
Item	Vegetation
Elderberry blocking view of landside slope and toe from LM 7.67 to 7.69

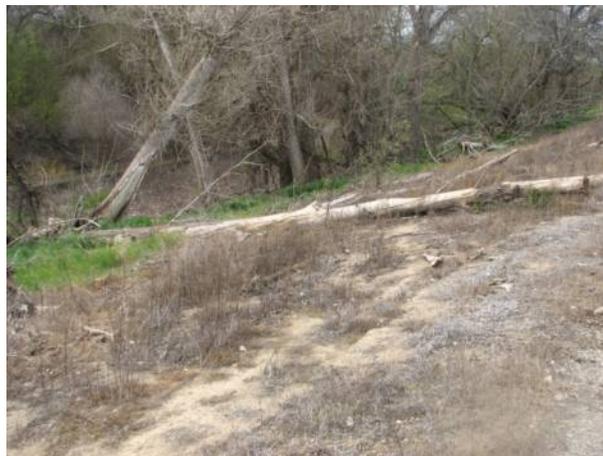
Levee Mile Report Line	60
Start Levee Mile	11.90
End Levee Mile	11.90
Location	Water Side
Category	Earthen Levee
Item	Encroachments
Tree limbs on waterwater slope at LM 11.90

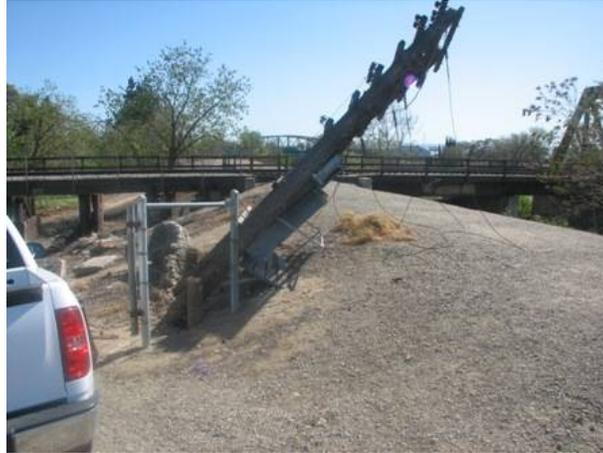
61	12.29	12.29	Earthen Levee	Trim / Thin Trees	LS	M	Trim trees to at least five feet above ground level.	37.793823 ° -121.305991 °	37.793823 ° -121.305991 °		71
62	12.71	12.71	Earthen Levee	Encroachments	WS	M	Poles	37.787908 ° -121.307120 °	37.787908 ° -121.307120 °	Y	82
63	12.76	12.76	Earthen Levee	Trim / Thin Trees	LS	M	Trim and thin trees to allow visibility of the ground and room to flood fight.	37.787188 ° -121.307062 °	37.787188 ° -121.307062 °		83
64	13.45	13.45	Earthen Levee	Trim / Thin Trees	WS	M	Trim trees to at least five feet above ground level.	37.779355 ° -121.299948 °	37.779355 ° -121.299948 °		33
65	13.62	13.62	Earthen Levee	Trim / Thin Trees	LS	M	Trim trees to at least five feet above ground level.	37.777212 ° -121.298555 °	37.777212 ° -121.298555 °		34
66	13.66	13.66	Earthen Levee	Encroachments	LS	PO	Landscaping	37.776618 ° -121.298610 °	37.776618 ° -121.298610 °	Y	35

Levee Mile Report Line	62
Start Levee Mile	12.71
End Levee Mile	12.71
Location	Water Side
Category	Earthen Levee
Item	Encroachments
Old broken power pole on waterside slope.

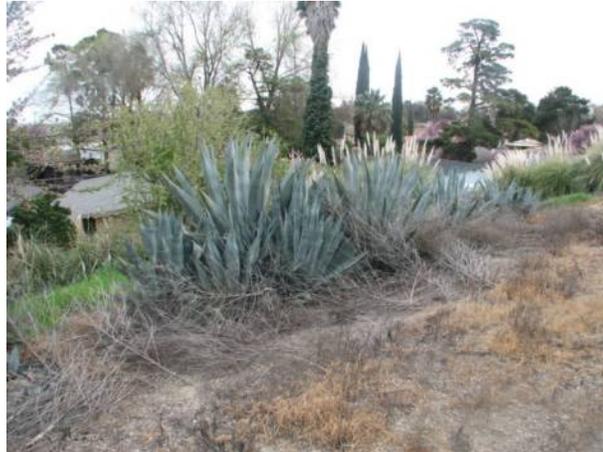
Levee Mile Report Line	66
Start Levee Mile	13.66
End Levee Mile	13.66
Location	Land Side
Category	Earthen Levee
Item	Encroachments
Catus (Landscaping) on landside slope blocking view at LM 13.66
