**Flood Control Project Maintenance
Levee Inspections**

Fall 2014 Levee Maintenance Deficiency Summary Report

Sacramento River Basin

Reclamation District No. 0070 Meridian

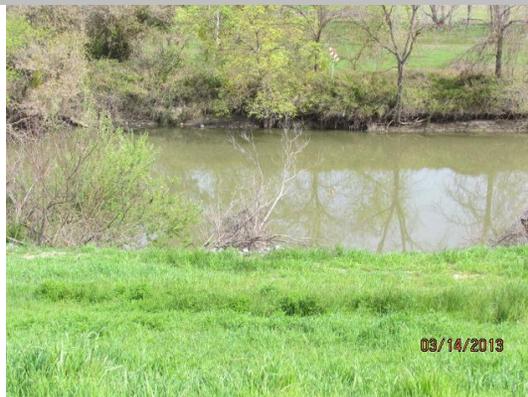
Photo 1 of 1 : FA_2014_RD0070_29_11_20141013_00005.jpg

LM Start	0.48	Rating **	M	Issue No.	11
LM End	0.48	Issue Type +	Ma	Location *	WS
Category	Earthen Levee		GPS Latitude/Longitude		
			Start	End	
Item	Erosion / Bank Caving		39.141909 °	39.141909 °	
			-121.840141 °	-121.840141 °	
DWR ID	DWR_RD0070_01_s_2013_11				
Action/Comments					
Note and monitor erosion site.

View of the erosion along the waterside toe.

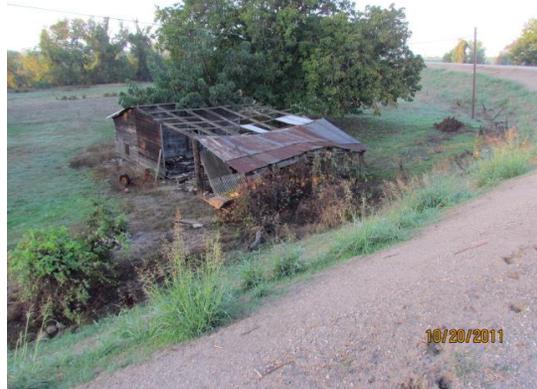
Photo 1 of 1 : FA_2014_RD0070_29_1_20141013_00001.jpg

LM Start	0.95	Rating **	M	Issue No.	1
LM End	0.95	Issue Type +	En	Location *	LS
Category	Earthen Levee		GPS Latitude/Longitude		
			Start	End	
Item	Encroachments		39.146211 °	39.146211 °	
			-121.844551 °	-121.844551 °	
DWR ID	DWR_RD0070_01_s_2012_1				
Action/Comments					
Building

View of the building along the L/S toe.

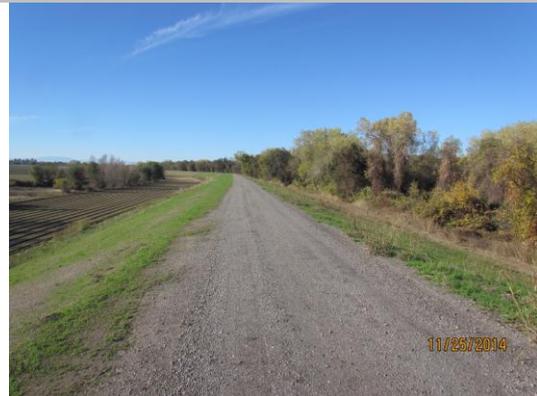
Photo 1 of 1 : FA_2014_RD0070_29_34_20141126_00031.jpg

LM Start	2.19	Rating **	A	Issue No.	34
LM End	2.19	Issue Type +	Ma	Location *	LS
Category	Earthen Levee		GPS Latitude/Longitude		
			Start	End	
Item	Vegetation		39.153608 °	39.153608 °	
			-121.861802 °	-121.861802 °	
DWR ID	DWR_RD0070_01_f_2014_34				
Action/Comments					
Control annual grass and weeds on the levee slopes and easements.

View of the controlled vegetation on both slopes.

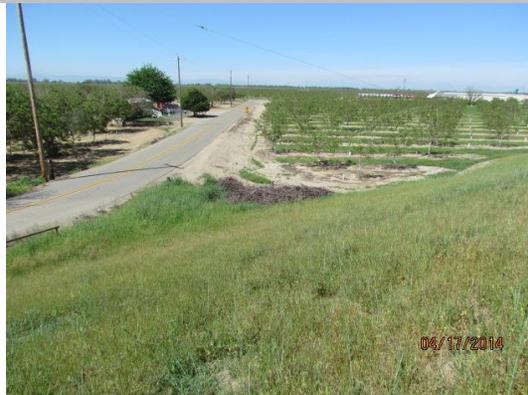
Photo 1 of 1 : FA_2014_RD0070_29_357_20141013_00007.jpg

LM Start	4.71	Rating **	M	Issue No.	357
LM End	4.71	Issue Type +	En	Location *	LS
Category	Earthen Levee		GPS Latitude/Longitude		
			Start	End	
Item	Encroachments		39.168037 °	39.168037 °	
			-121.899854 °	-121.899854 °	
DWR ID	DWR_RD0070_01_s_2014_357				
Action/Comments					
Prunings

View of the prunings at the landside toe.

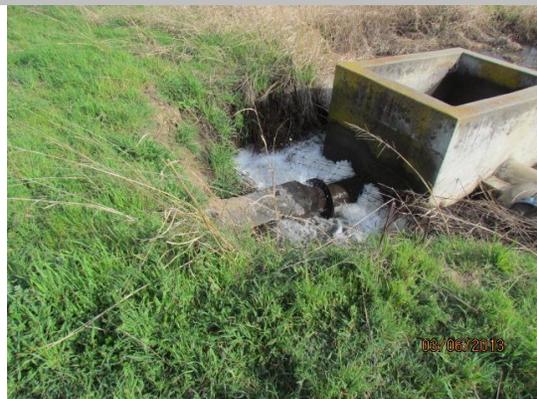
Photo 1 of 1 : FA_2014_RD0070_29_10_20141013_00004.jpg

LM Start	7.61	Rating **	A/W	Issue No.	10
LM End	7.61	Issue Type +	En	Location *	LS
Category	Earthen Levee		GPS Latitude/Longitude		
			Start	End	
Item	Encroachments		39.196703 °	39.196703 °	
			-121.929372 °	-121.929372 °	
DWR ID	DWR_RD0070_01_s_2013_10				
Action/Comments					
Pipe Inspector Comments: Repair leaking pipe on L/S & W/S

View of the erosion caused by the leaky pipe.

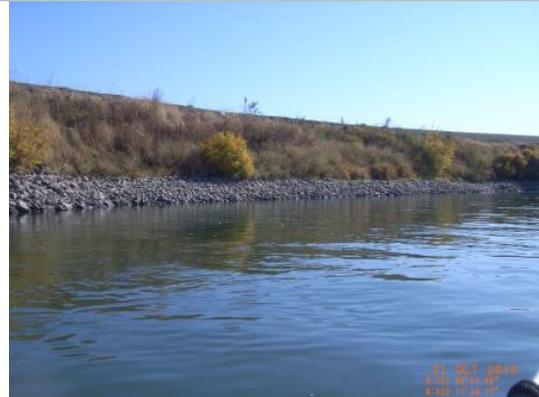
Photo 1 of 1 : FA_2014_RD0070_30_16_20141013_00014.jpg

LM Start	0.08	Rating **	M	Issue No.	16
LM End	0.17	Issue Type +	Ma	Location *	WS
Category	Supplemental			GPS Latitude/Longitude	
				Start	End
Item	USACE Erosion Survey			39.193219 °	39.190038 °
				-121.935783 °	-121.934199 °
DWR ID	DWR_RD0070_02_f_2014_16				
Action/Comments					
Inspector Comments: 1997 - Loss of cobble revetment in levee section. 2004 - New fresh erosion in a short section of the downstream end. 2010 - New deposition on cobbles. 2013: No observed changes. [2013 Site ID: SAC_138-1_L]

USACE 2013 Photo #1

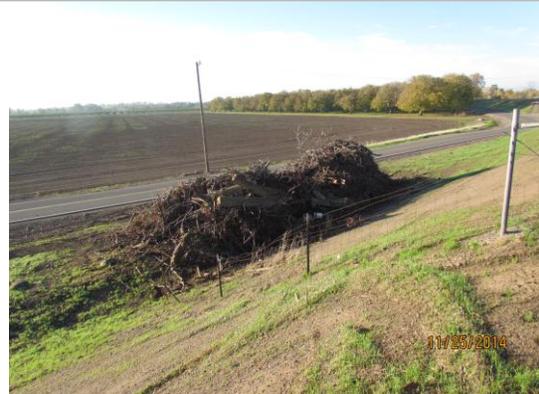
Photo 1 of 1 : FA_2014_RD0070_30_67_20141126_00055.jpg

LM Start	0.65	Rating **	M	Issue No.	67
LM End	0.65	Issue Type +	En	Location *	LS
Category	Earthen Levee		GPS Latitude/Longitude		
			Start	End	
Item	Encroachments		39.187498 °	39.187498 °	
			-121.938445 °	-121.938445 °	
DWR ID	DWR_RD0070_02_f_2014_67				
Action/Comments					
Prunings

View of the prunings along the landside toe.

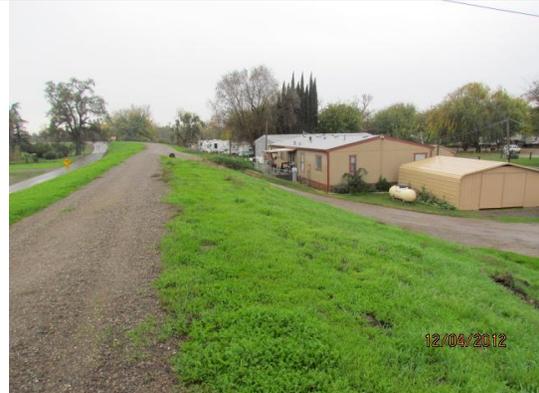
Photo 1 of 1 : FA_2014_RD0070_30_12_20141013_00009.jpg

LM Start	1.19	Rating **	M	Issue No.	12
LM End	1.19	Issue Type +	En	Location *	WS
Category	Earthen Levee			GPS Latitude/Longitude	
				Start	End
Item	Encroachments			39.181247 °	39.181247 °
				-121.943808 °	-121.943808 °
DWR ID	DWR_RD0070_02_f_2012_12				
Action/Comments					
Building

View of the buildings along the waterside toe of the levee.

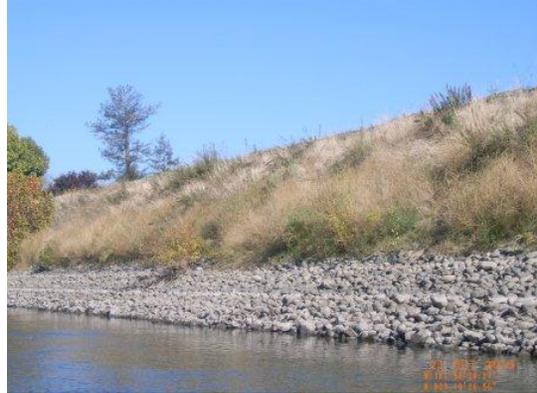
Photo 2 of 2 : FA_2014_RD0070_30_15_20141013_00013.jpg

LM Start	1.78	Rating **	M	Issue No.	15 (cont)
LM End	1.91	Issue Type +	Ma	Location *	WS
Category	Supplemental			GPS Latitude/Longitude	
				Start	End
Item	USACE Erosion Survey			39.173912 °	39.172344 °
				-121.938745 °	-121.937925 °
DWR ID	DWR_RD0070_02_f_2014_15				
Action/Comments					
Inspector Comments: 1997 - Toe erosion on a cobble revetment on the outside of a low receding bend. 2012 - Toe appears pretty stable with old cobbles. 2013: No observed changes. [2013 Site ID: SAC_136-6_L]

USACE 2013 Photo #2

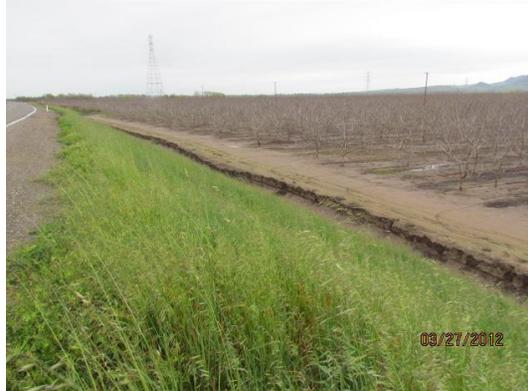
Photo 1 of 1 : FA_2014_RD0070_30_1_20141013_00001.jpg

LM Start	2.17	Rating **	M	Issue No.	1
LM End	2.35	Issue Type +	En	Location *	LS
Category	Earthen Levee			GPS Latitude/Longitude	
				Start	End
Item	Encroachments			39.168854 °	39.166503 °
				-121.936223 °	-121.935547 °
DWR ID	DWR_RD0070_02_s_2012_1				
Action/Comments					
Ditch

Agricultural ditch along the landside toe.

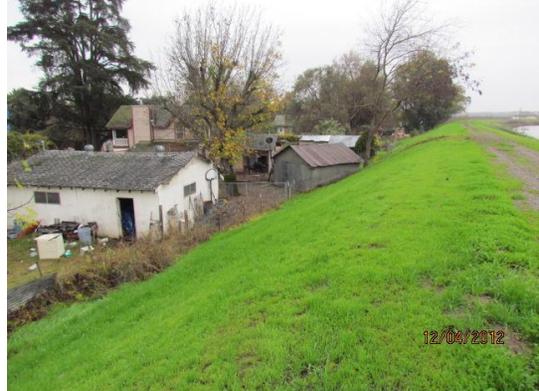
Photo 1 of 1 : FA_2014_RD0070_30_13_20141013_00010.jpg

LM Start	4.35	Rating **	M	Issue No.	13
LM End	4.35	Issue Type +	En	Location *	LS
Category	Earthen Levee		GPS Latitude/Longitude		
			Start	End	
Item	Encroachments		39.144233 °	39.144233 °	
			-121.917413 °	-121.917413 °	
DWR ID	DWR_RD0070_02_f_2012_13				
Action/Comments					
Building

View of the buildings along the landside toe of the levee.

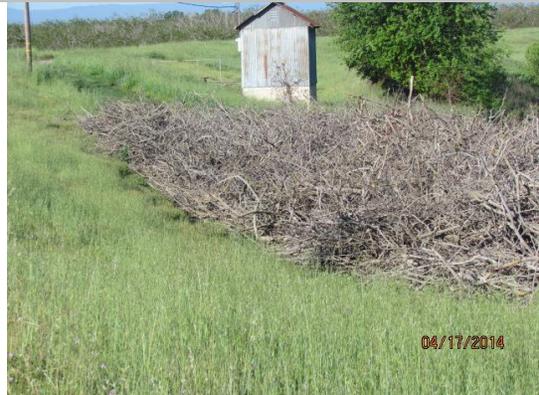
Photo 1 of 1 : FA_2014_RD0070_30_3_20141013_00004.jpg

LM Start	4.53	Rating **	M	Issue No.	3
LM End	4.57	Issue Type +	Ma	Location *	WS
Category	Earthen Levee		GPS Latitude/Longitude		
			Start	End	
Item	Encroachments		39.141707 °	39.141379 °	
			-121.918480 °	-121.918972 °	
DWR ID	DWR_RD0070_02_s_2012_3				
Action/Comments					
Prunings

View of the prunings along the waterside toe.

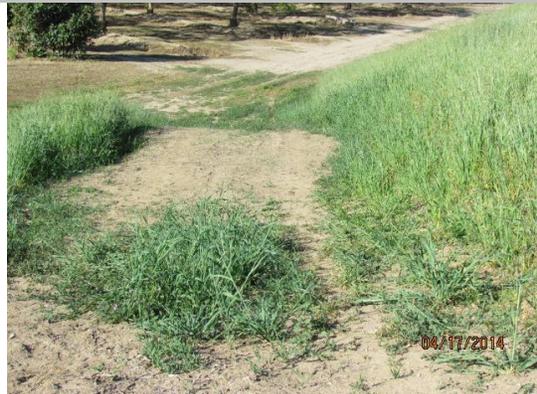
Photo 1 of 1 : FA_2014_RD0070_30_770_20141013_00023.jpg

LM Start	4.60	Rating **	M	Issue No.	770
LM End	4.60	Issue Type +	Ma	Location *	LS
Category	Earthen Levee		GPS Latitude/Longitude		
			Start	End	
Item	Erosion / Bank Caving		39.141155 °	39.141155 °	
			-121.919432 °	-121.919432 °	
DWR ID	DWR_RD0070_02_s_2014_770				
Action/Comments					
Schedule repair of erosion site prior to the next inspection.

View of the damaged ramp along the landside slope.

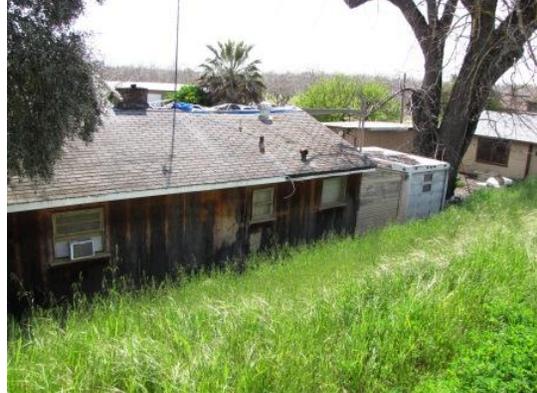
Photo 1 of 1 : FA_2014_RD0070_30_9_20141013_00006.jpg

LM Start	4.99	Rating **	U	Issue No.	9
LM End	5.02	Issue Type +	En	Location *	LS
Category	Earthen Levee		GPS Latitude/Longitude		
			Start	End	
Item	Encroachments		39.142008 °	39.142032 °	
			-121.926267 °	-121.926855 °	
DWR ID	DWR_RD0070_02_s_2012_9				
Action/Comments					
Building

View of the building along the toe.

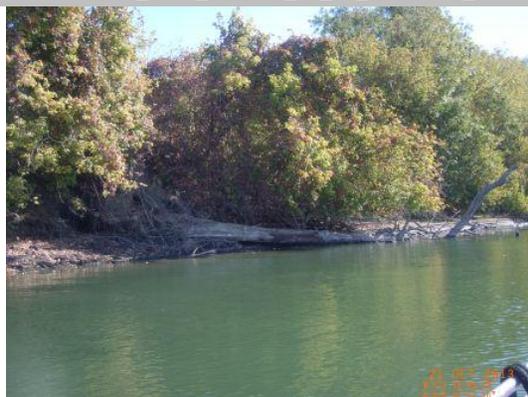
Photo 1 of 1 : FA_2014_RD0070_30_14_20141013_00011.jpg

LM Start	6.50	Rating **	M	Issue No.	14
LM End	6.60	Issue Type +	Ma	Location *	WS
Category	Supplemental		GPS Latitude/Longitude		
			Start	End	
Item	USACE Erosion Survey		39.132040 °	39.130900 °	
			-121.936521 °	-121.934690 °	
DWR ID	DWR_RD0070_02_f_2014_14				
Action/Comments					
Inspector Comments: 2005 - (known as 132) On inside of bend. Erosion of berm toe. Levee slope is steep. Erosion probably due to eddy scour off upstream cobble. 2009 - Groins may be a good option for repair. 2010 - Scour off the upstream rock, some new erosion. 2011 - Site extended downstream. 2012 - Minor new erosion since last year and new animal holes. 2012 - Minor new erosion since last year and new animal holes. 2013: New tree popout. [2013 Site ID: SAC_131-8_L]

USACE 2013 Photo #1

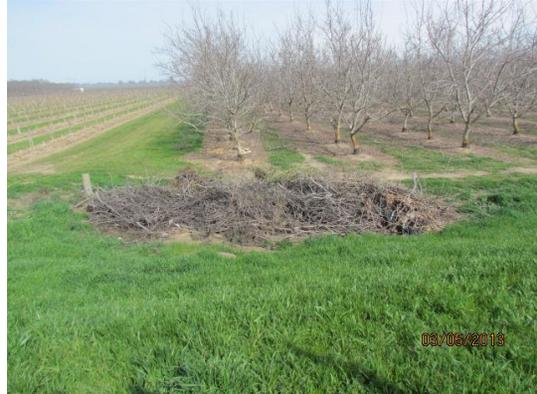
Photo 1 of 1 : FA_2014_RD0070_30_26_20141013_00016.jpg

LM Start	7.70	Rating **	M	Issue No.	26
LM End	7.70	Issue Type +	En	Location *	LS
Category	Earthen Levee		GPS Latitude/Longitude		
			Start	End	
Item	Encroachments		39.124493 °	39.124493 °	
			-121.917105 °	-121.917105 °	
DWR ID	DWR_RD0070_02_s_2013_26				
Action/Comments					
Prunings

View of the prunings along the landside slope.

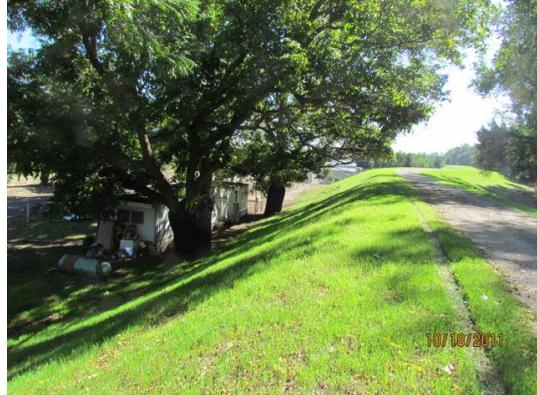
Photo 1 of 1 : FA_2014_RD0070_30_37_20141013_00020.jpg

LM Start	10.06	Rating **	M	Issue No.	37
LM End	10.06	Issue Type +	Ma	Location *	LS
Category	Earthen Levee		GPS Latitude/Longitude		
			Start	End	
Item	Encroachments		39.097769 °	39.097769 °	
			-121.896592 °	-121.896592 °	
DWR ID	DWR_RD0070_02_f_2012_37				
Action/Comments					
Prunings

View of rodent holes along the L/S slope.

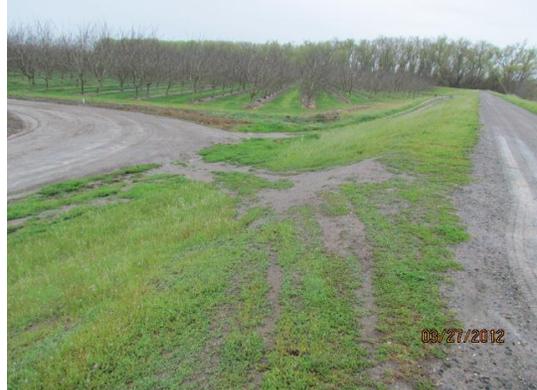
Photo 1 of 1 : FA_2014_RD0070_30_6_20141013_00005.jpg

LM Start	10.71	Rating **	M	Issue No.	6
LM End	10.71	Issue Type +	Ma	Location *	LS
Category	Earthen Levee		GPS Latitude/Longitude		
			Start	End	
Item	Slope Stability		39.090300 °	39.090300 °	
			-121.893102 °	-121.893102 °	
DWR ID	DWR_RD0070_02_s_2012_6				
Action/Comments					
Repair the levee slope damaged by vehicle traffic and prevent access where possible.

View of vehicle erosion along landside slope.

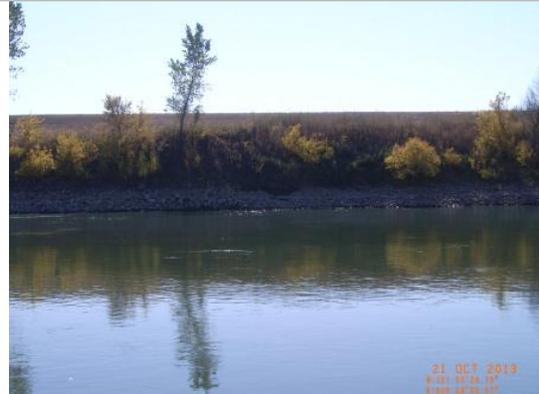
Photo 1 of 1 : FA_2014_RD0070_30_10_20141013_00007.jpg

LM Start	11.63	Rating **	M	Issue No.	10
LM End	11.68	Issue Type +	Ma	Location *	WS
Category	Supplemental		GPS Latitude/Longitude		
			Start	End	
Item	USACE Erosion Survey		39.080669 °	39.080621 °	
			-121.891164 °	-121.891564 °	
DWR ID	DWR_RD0070_02_f_2014_10				
Action/Comments					
Inspector Comments: 2005 - Site was repaired. 2009 - Site is at upstream end of the repair site. 2011 - Still minor erosion. 2012 - Site shortened to remove non-eroding section, minor erosion with failing cobbles. 2013: No observed changes. [2013 Site ID: SAC_125-8_L]

USACE 2013 Photo #1

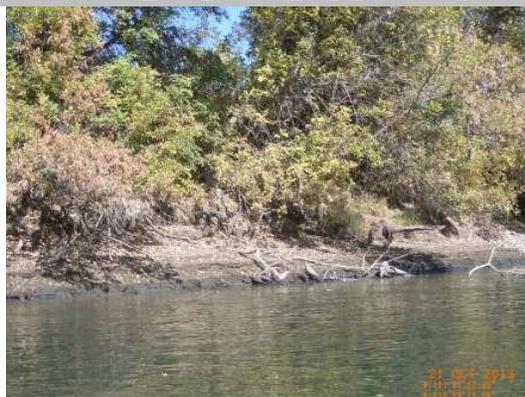
Photo 1 of 2 : FA_2014_RD0070_30_2_20141013_00002.jpg

LM Start	14.10	Rating **	M	Issue No.	2
LM End	14.28	Issue Type +	Ma	Location *	WS
Category	Supplemental		GPS Latitude/Longitude		
			Start	End	
Item	USACE Erosion Survey		39.069166 °	39.070105 °	
			-121.857995 °	-121.855929 °	
DWR ID	DWR_RD0070_02_f_2014_2				
Action/Comments					
Inspector Comments: 2006 - Erosion into the levee toe. Rock at upstream end has poor transition causing eddy scour. 2010 - Minor new erosion. 2011 - Some fresh erosion. 2012 - Additional slumping on the previously slumped bank, site extended downstream. 2013: No observed changes. [2013 Site ID: SAC_123-3_L]

USACE 2013 Photo #1

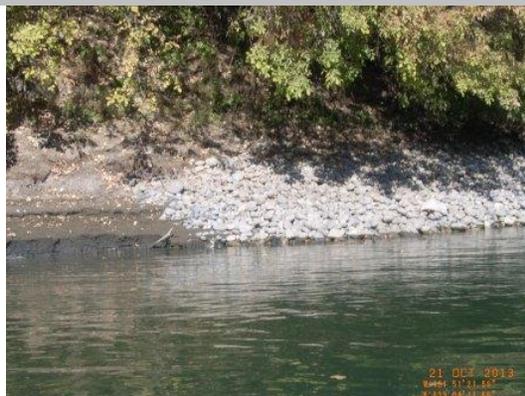
Photo 2 of 2 : FA_2014_RD0070_30_2_20141013_00003.jpg

LM Start	14.10	Rating **	M	Issue No.	2 (cont)
LM End	14.28	Issue Type +	Ma	Location *	WS

USACE 2013 Photo #2
