**Flood Control Project Maintenance  
Levee Inspections**

**Fall 2015 Levee Maintenance Deficiency Summary Report**

**Sacramento River Basin**

**Reclamation District No. 0070 Meridian**

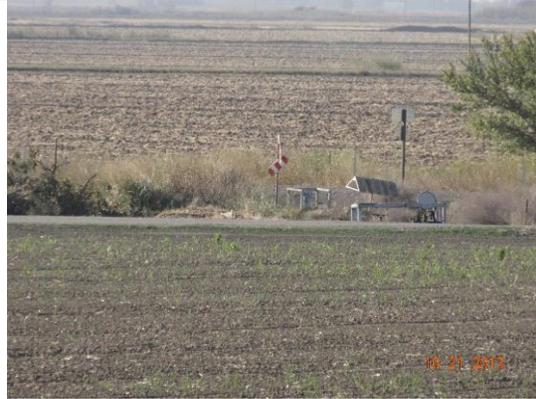
Photo 1 of 3 : UCIP\_FA\_2015\_2157.jpg

Inspector Comments: FS\_ID:23463  
 DS\_ID:21347  
 EP\_NO: 3804  
 FS\_HLM: 0.4376  
 Repair Type: Non-Urgent  
 Crossing Status: Indicator Found  
 UCIP Comments: Unable to confirm if the indicators that were found in the field correspond to this crossing. Will need to contact PG&E to confirm location of crossing. Photos will need to be updated if the photos attach do not correspond to this crossing. This crossing is referenced in the USACE Periodic Inspection as item USACE\_CESPK\_MRD1\_2012\_p\_0304 for 12 inch gas pipe. Coordinates between DWR UCIP and USACE PI are approximately 630 feet apart.  
 FIELD\_STRUCT\_DESC: 12-inch steel gas pipe through the levee, 3.6 feet below the crown. Concrete cutoff wall around pipe at center of levee. Marker sign on waterward shoulder. Rock revetment on waterward slope. (Permit No. 3804-1961)  
 FS Date: 10/21/2013

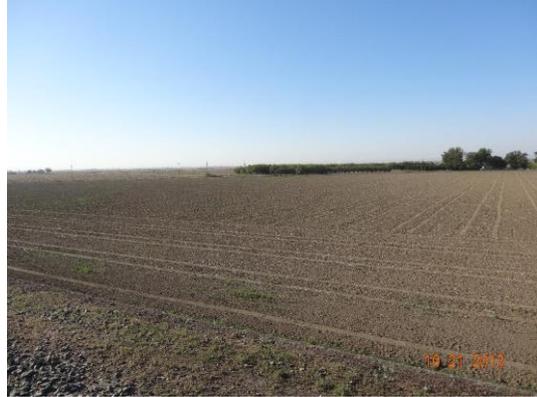
Photo 2 of 3 : UCIP\_FA\_2015\_2182.jpg

LM Start	0.42	Rating **	M	Issue No.	41 (cont)
LM End	0.42	Issue Type +	En	Location *	LS
Category	Supplemental			GPS Latitude/Longitude	
			Start	End	
Item	DWR UCIP Field Study			39.141519 °	39.141519 °
DWR ID				-121.839585 °	-121.839585 °
Action/Comments					
Inspector Comments: FS_ID:23463 DS_ID:21347 EP_NO: 3804 FS_HLM: 0.4376 Repair Type: Non-Urgent Crossing Status: Indicator Found UCIP Comments: Unable to confirm if the indicators that were found in the field correspond to this crossing. Will need to contact PG&E to confirm location of crossing. Photos will need to be updated if the photos attach do not correspond to this crossing. This crossing is referenced in the USACE Periodic Inspection as item USACE_CESPK_MRD1_2012_p_0304 for 12 inch gas pipe. Coordinates between DWR UCIP and USACE PI are approximately 630 feet apart. FIELD_STRUCT_DESC: 12-inch steel gas pipe through the levee, 3.6 feet below the crown. Concrete cutoff wall around pipe at center of levee. Marker sign on waterward shoulder. Rock revetment on waterward slope. (Permit No. 3804-1961) FS Date: 10/21/2013

View of landward side where gas line markers are visible approximately 900 feet from levee.

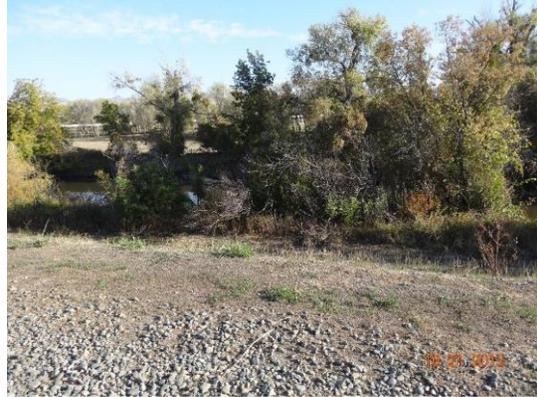
Photo 3 of 3 : UCIP\_FA\_2015\_2183.jpg

View of waterward side--no markers visible.

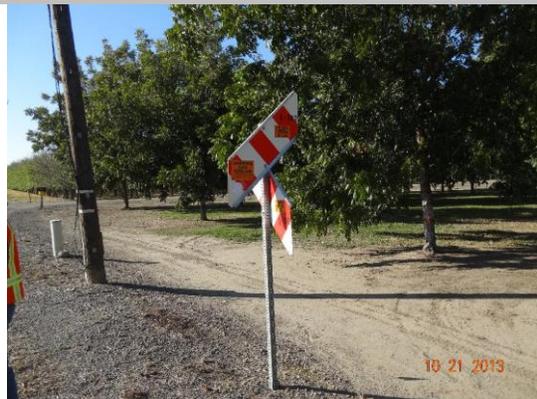
Photo 1 of 3 : UCIP\_FA\_2015\_2326.jpg

LM Start	<b>0.55</b>	Rating **	M	Issue No.	<b>43</b>
LM End	<b>0.55</b>	Issue Type +	En	Location *	WS
Category	Supplemental			GPS Latitude/Longitude	
				Start	End
Item	DWR UCIP Field Study			39.142565 °	39.142565 °
				-121.841600 °	-121.841600 °
DWR ID					
Action/Comments					
Inspector Comments: FS_ID:23384 DS_ID:21415 EP_NO: 15936 FS_HLM: 0.58 Repair Type: Non-Urgent Crossing Status: Indicator Found UCIP Comments: No markers visible on levee slope or levee toe to indicate line crosses levee. Need to contact PG&E to confirm location through levee. Also need to confirm the emergency contact person for this crossing. FIELD_STRUCT_DESC: 8-inch steel pipe through the levee, 2.5 feet below the crown. Gas line markers on the landward side. (Permit No. 15936-2005) FS Date: 10/21/2013

View of markers on the west side of S. Tarke Road.

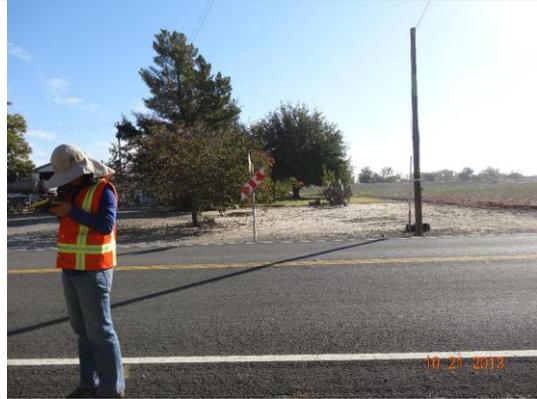
Photo 3 of 3 : UCIP\_FA\_2015\_2328.jpg

View of markers on the east side of S. Tarke Road.

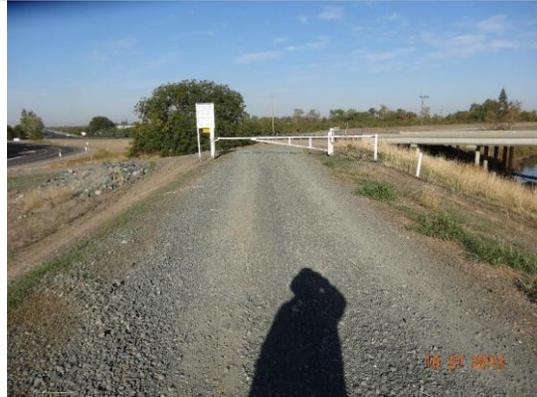
Photo 1 of 3 : UCIP\_FA\_2015\_2158.jpg

Item	DWR UCIP Field Study			39.142682 °	39.142682 °
				-121.841913 °	-121.841913 °
DWR ID					
Action/Comments					
Inspector Comments: FS_ID:23503 DS_ID:21351 EP_NO: 3686 FS_HLM: 0.6 Repair Type: Non-Urgent Crossing Status: Found UCIP Comments: Dense vegetation limits the inspector's visibility to identify signs of pipe failure (leaks) along the waterward slope. Recommend removing vegetation along pipe alignment to conduct proper inspection of structure and appurtenances. Unable to find the gate valve on landward side. Walkway on waterward side in bad shape. This crossing is referenced in the USACE Periodic Inspection as item USACE_CESPK_MRD1_2012_p_0300 for 18 inch pipe. Pipe on LS is 10 inch not 18 inch. SEE UCIP DS_ID 21350 for details pertaining to 18 inch pipe. FIELD_STRUCT_DESC: 10-inch pipe and electrical conduit through the levee, 14.8 and 1.0 feet below the crown, respectively. Gate valve on landward end--not found during 10/21/13 pipe inventory. Pump on pile structure in stream. Walkway to slide gate on waterward end. Rock revetment on waterward slope. Pump and concrete support piers at waterward toe installed under Permit No. 3686 (1963). Service pole with meter and control panel at landward toe. FS Date: 10/21/2013

View of levee crown looking downstream.

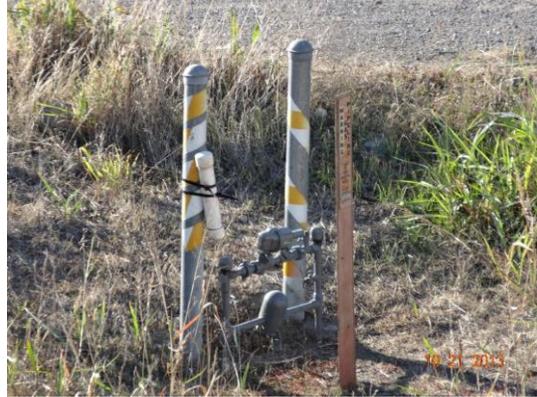
Photo 1 of 3 : UCIP\_FA\_2015\_2184.jpg

Item	DWR UCIP Field Study			39.143380 °	39.143380 °
				-121.842606 °	-121.842606 °
DWR ID					
Action/Comments					
Inspector Comments: FS_ID:23467 DS_ID:21354 EP_NO: 14802 FS_HLM: 0.67 Repair Type: Non-Urgent Crossing Status: Indicator Found UCIP Comments: Need to contact owner to determine status of crossing. Need date of last inspection and confirmation that crossing is still in operable condition. Markers found about 159 feet upstream of coordinates at the crossing of the ramp and S. Tarke Road (39.142684, -121.842685). FIELD_STRUCT_DESC: 4-inch steel gas pipe through the levee, 2.5 feet below the crown. Aluminum pipe marker on landward slope. (Permit No. 14802-1987) Contact emergency information for Pacific Gas & Electric Company 1-800-344-4749? 4742? or 1-916-742-3251. FS Date: 10/21/2013

Close-up of the additional appurtenances for gas line located landward side.

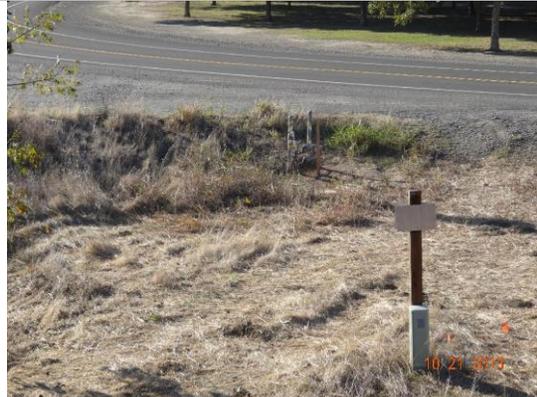
Photo 2 of 3 : UCIP\_FA\_2015\_2185.jpg

Additional appurtenances for gas line located at landward side near S. Tarke Rd.

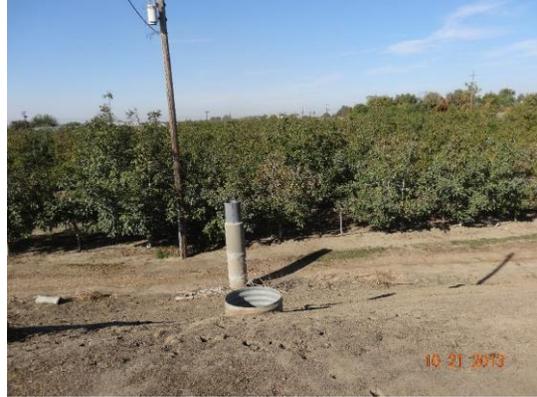
Photo 2 of 3 : UCIP\_FA\_2015\_2141.jpg

LM Start	0.70	Rating **	M	Issue No.	47 (cont)
LM End	0.70	Issue Type +	En	Location *	WS
Category	Supplemental			GPS Latitude/Longitude	
				Start	End
Item	DWR UCIP Field Study			39.144369 °	39.144369 °
				-121.842778 °	-121.842778 °
DWR ID					
Action/Comments					
Inspector Comments: FS_ID:23526 DS_ID:21355 EP_NO: 9961 FS_HLM: 0.745 Repair Type: Non-Urgent Crossing Status: Found UCIP Comments: Dense burrow activity present on both waterward side and landward side. Recommend addressing burrow activity at this location. Also recommend having owner clear vegetation blocking access along walkway. This crossing is referenced in the USACE Periodic Inspection as item USACE_CESPK_MRD1_2012_p_290. FIELD_STRUCT_DESC: 10-inch (not 12-inch as noted in desk study) steel pipe through the levee, 5.4 feet below the crown. Siphon breaker in CM pipe riser on landward slope. 24-inch concrete standpipe at landward toe. Walkway to pump on pile structure in stream. This pipe was retained under ABO No. 9961 (1974). FS Date: 10/21/2013

View of standpipe and CMP riser located on landward side.

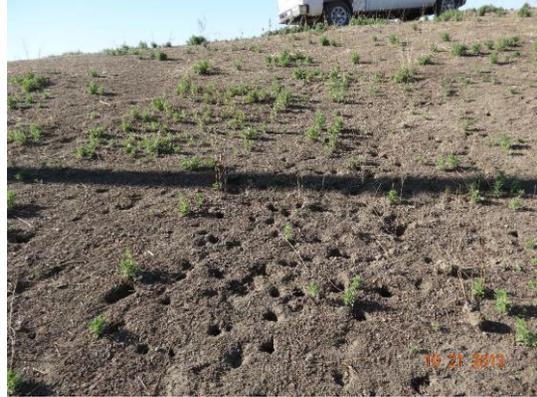
Photo 1 of 3 : UCIP\_FA\_2015\_2199.jpg

Inspector Comments: FS\_ID:23508  
 DS\_ID:21336  
 EP\_NO: N/A  
 FS\_HLM: 1.889  
 Repair Type: Non-Urgent  
 Crossing Status: Found  
 UCIP Comments: Need to find owner to determine if crossing is still in use. If crossing is no longer in use owner will need to coordinate with DWR inspector and CVFPB to remove according to Title 23 requirements. Evidence of high burrow activity on waterward side recommend addressing issue. This crossing is referenced as USACE\_CESPK\_MRD1\_2012\_p\_0230 in the USACE's PI report for no USACE recommendation letter available -- correction pipe is 12-inch not 16-inch.  
 FIELD\_STRUCT\_DESC: 12-inch pipe through the levee, 4.0 feet below the crown. Siphon breaker on the landward slope. Concrete distribution box (7 ft by 9 ft) at landward toe. Service pole on waterward slope. Pump on concrete sump on waterward slope. Overhead power line crosses levee at location. This pipe was retained under ABO No. 9948 (1974) issued to Edward E. and Doris M. Nall. Permit No. 613 issued in May 29, 1934 is for 12 inch pipe issued to Waldo Nall.

Dense burrow activity found on waterward slope.

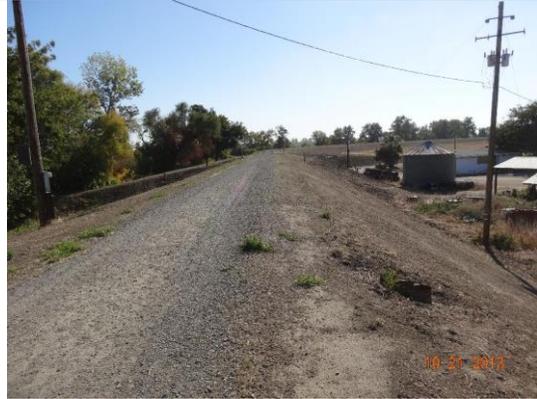
Photo 3 of 3 : UCIP\_FA\_2015\_2201.jpg

LM Start	1.83	Rating **	M	Issue No.	48 (cont)
LM End	1.83	Issue Type +	En	Location *	WS
Category	Supplemental			GPS Latitude/Longitude	
				Start	End
Item	DWR UCIP Field Study			39.151786 °	39.151786 °
				-121.856875 °	-121.856875 °
DWR ID					
Action/Comments					
Inspector Comments: FS_ID:23508 DS_ID:21336 EP_NO: N/A FS_HLM: 1.889 Repair Type: Non-Urgent Crossing Status: Found UCIP Comments: Need to find owner to determine if crossing is still in use. If crossing is no longer in use owner will need to coordinate with DWR inspector and CVFPB to remove according to Title 23 requirements. Evidence of high burrow activity on waterward side recommend addressing issue. This crossing is referenced as USACE_CESPK_MRD1_2012_p_0230 in the USACE's PI report for no USACE recommendation letter available -- correction pipe is 12-inch not 16-inch. FIELD_STRUCT_DESC: 12-inch pipe through the levee, 4.0 feet below the crown. Siphon breaker on the landward slope. Concrete distribution box (7 ft by 9 ft) at landward toe. Service pole on waterward slope. Pump on concrete sump on waterward slope. Overhead power line crosses levee at location. This pipe was retained under ABO No. 9948 (1974) issued to Edward E. and Doris M. Nall. Permit No. 613 issued in May 29, 1934 is for 12 inch pipe issued to Waldo Nall. FS Date: 10/21/2013

View of levee crown looking upstream from crossing.

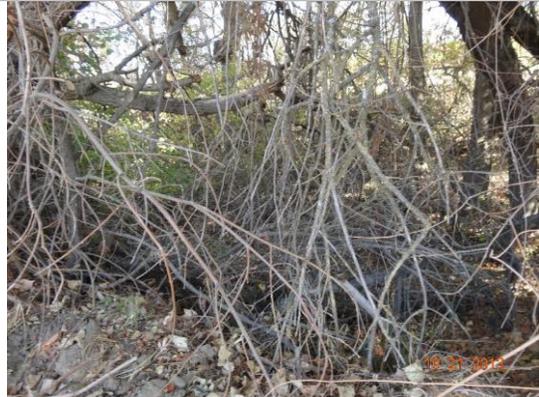
Photo 2 of 3 : UCIP\_FA\_2015\_2180.jpg

Waterward side covered by vegetation.

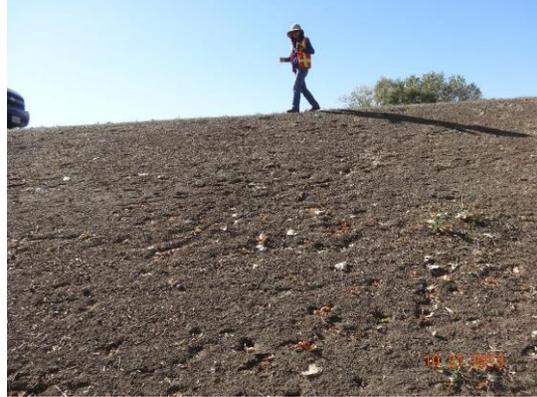
Photo 3 of 3 : UCIP\_FA\_2015\_2181.jpg

View of waterward slope.

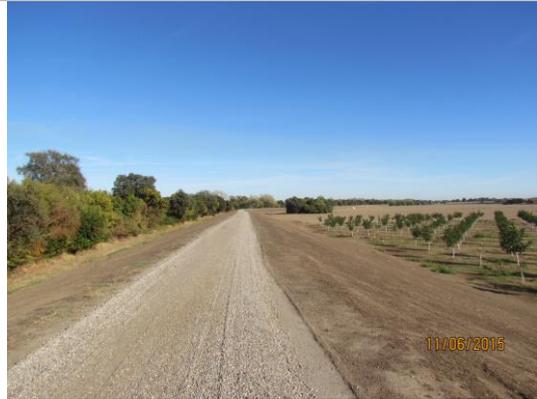
Photo 1 of 1 : FA\_2015\_RD0070\_29\_39\_20151109\_00034.jpg

LM Start	<b>3.14</b>	Rating **	A	Issue No.	<b>39</b>
LM End	<b>3.14</b>	Issue Type +	Ma	Location *	LS
Category	Earthen Levee			GPS Latitude/Longitude	
				Start	End
Item	Vegetation			39.158018 °	39.158018 °
				-121.878985 °	-121.878985 °
DWR ID	DWR_RD0070_01_f_2015_39				
Action/Comments					
Control annual grass and weeds on the levee slopes and easements. Inspector Comments: The district burned and dragged both slopes.

View of the no vegetation on both slopes.

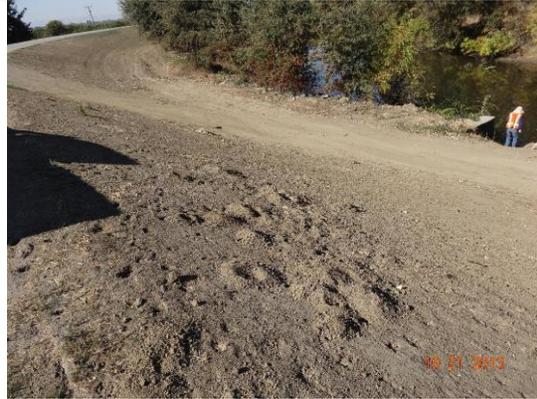
Photo 1 of 3 : UCIP\_FA\_2015\_2169.jpg

Item	DWR UCIP Field Study			39.156437 °	39.156437 °
				-121.882519 °	-121.882519 °
DWR ID					
Action/Comments					
Inspector Comments: FS_ID:23506 DS_ID:21361 EP_NO: 9944 FS_HLM: 3.43 Repair Type: Non-Urgent Crossing Status: Found UCIP Comments: Burrow activity present on levee slopes. Multiple pipes found on landward side--are these pipes part of original crossing? This crossing is referenced in the USACE Periodic Inspection as item USACE_CESPK_MRD1_2012_p_0291--no USACE recommendation letter available. FIELD_STRUCT_DESC: 18-inch steel pipe through the levee, 21.5 feet below the crown. Gate valve on the waterward end. Discharges into concrete box on the landward side. Rock revetment on waterward slope. This pipe was retained under ABO No. 9944 (1974). FS Date: 10/21/2013

Recent burrow activity soil months next to holes.

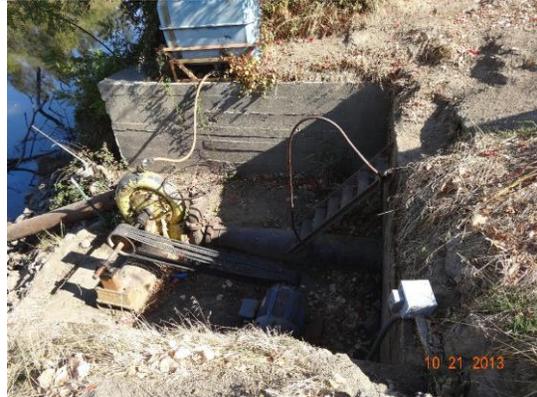
Photo 3 of 3 : UCIP\_FA\_2015\_2198.jpg

U shaped concrete box located on waterward side contains pump, motor, stairs, and pipe.

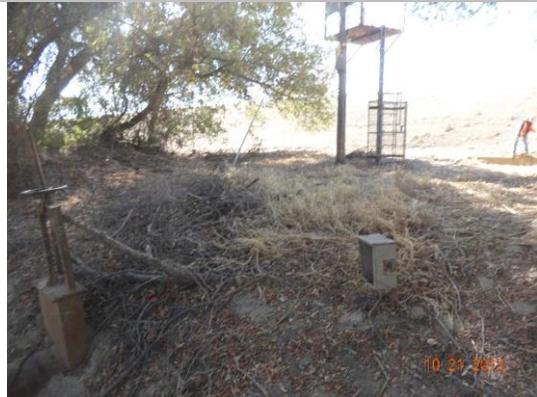
Photo 1 of 3 : UCIP\_FA\_2015\_2209.jpg

View of appurtenances located on waterward side.

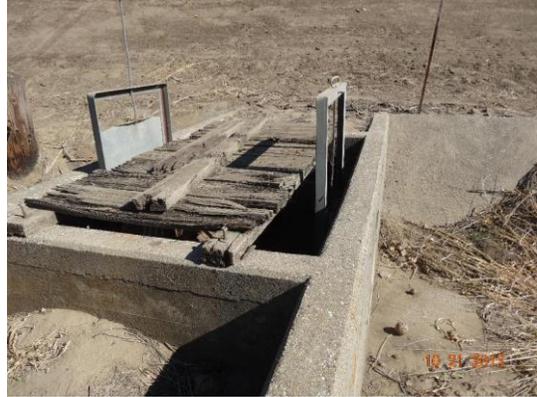
Photo 3 of 3 : UCIP\_FA\_2015\_0685.jpg

Concrete distribution box located at landward toe.

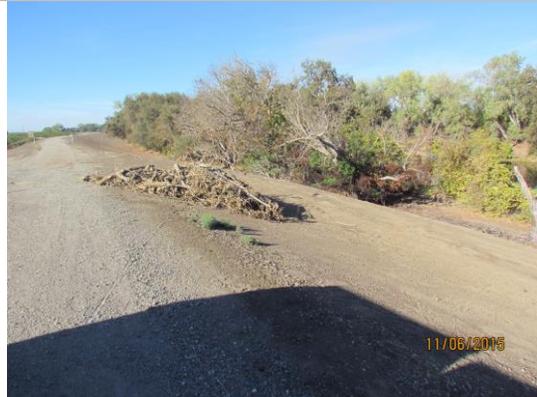
Photo 1 of 1 : FA\_2015\_RD0070\_29\_38\_20151109\_00038.jpg

View of the prunings along the waterside slope.

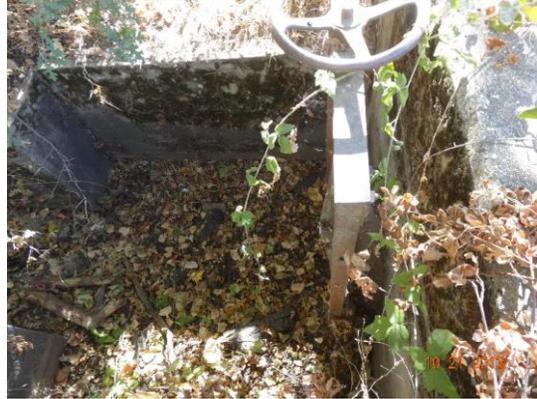
Photo 2 of 3 : UCIP\_FA\_2015\_0690.jpg

View of slide gate on waterward side.

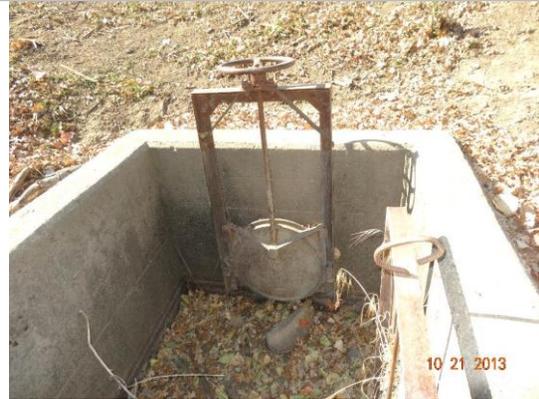
Photo 1 of 3 : UCIP\_FA\_2015\_0564.jpg

Screw gate located inside concrete distribution box located on waterward side.

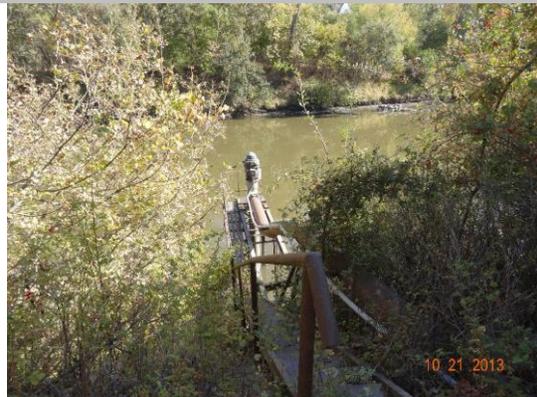
Photo 1 of 3 : UCIP\_FA\_2015\_0565.jpg

View of waterward side--pump, pipe, and walkway.

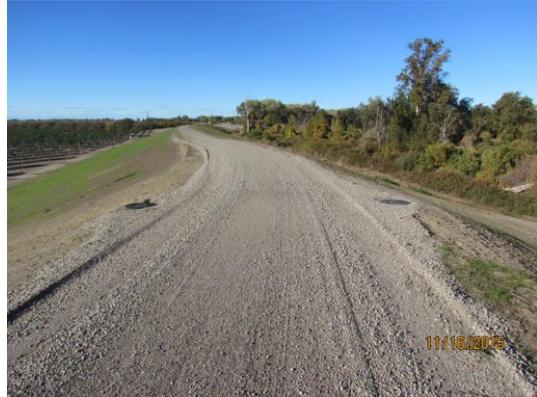
Photo 1 of 1 : FA\_2015\_RD0070\_29\_40\_20151119\_00045.jpg

View where new 16-inch diameter steel irrigation pipe was replaced.

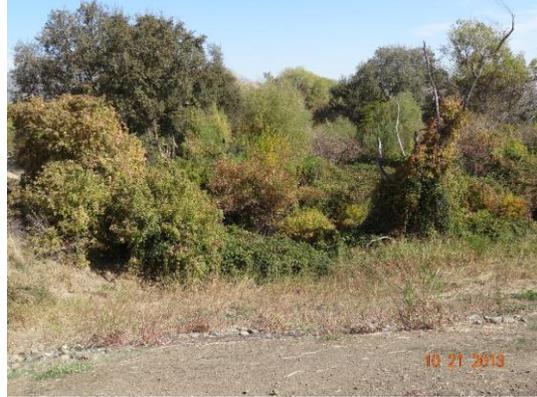
Photo 1 of 3 : UCIP\_FA\_2015\_0552.jpg

View of waterward side.

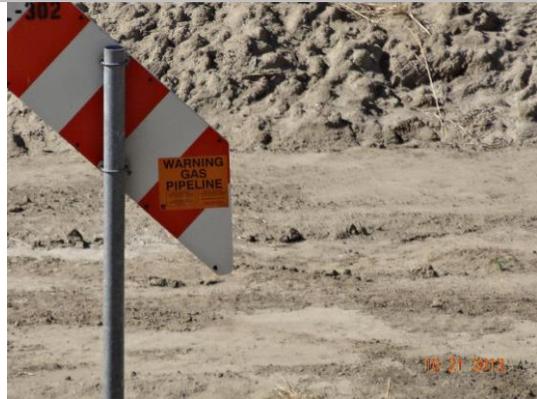
Photo 2 of 3 : UCIP\_FA\_2015\_0553.jpg

Pipeline marker on landward side.

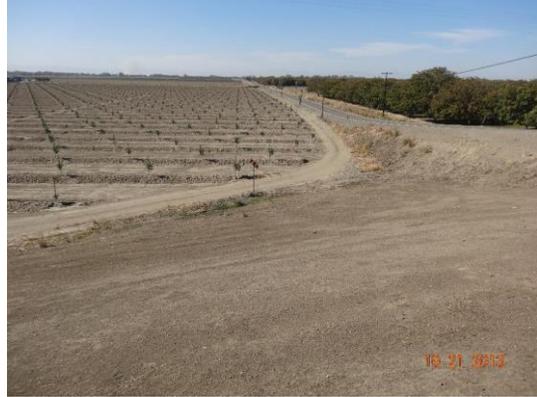
Photo 3 of 3 : UCIP\_FA\_2015\_0554.jpg

View of landward side.

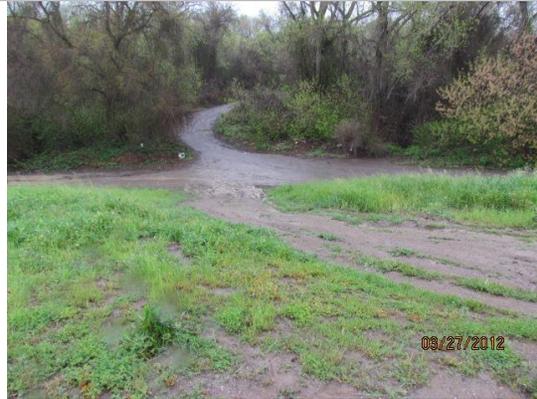
Photo 1 of 2 : FA\_2015\_RD0070\_29\_6\_20150910\_00002.jpg

View of vehicle erosion along the waterside slope.

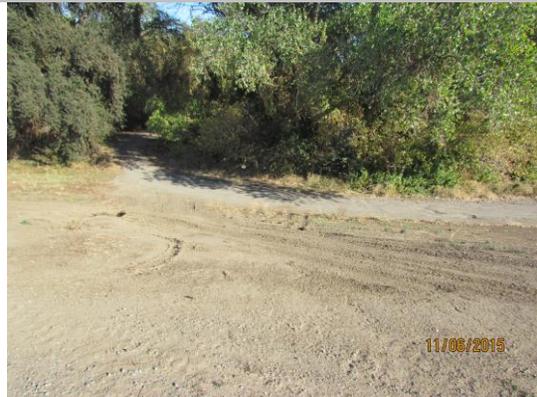
Photo 2 of 2 : FA\_2015\_RD0070\_29\_6\_20151109\_00043.jpg

View of the vehicle erosion along the waterside slope.

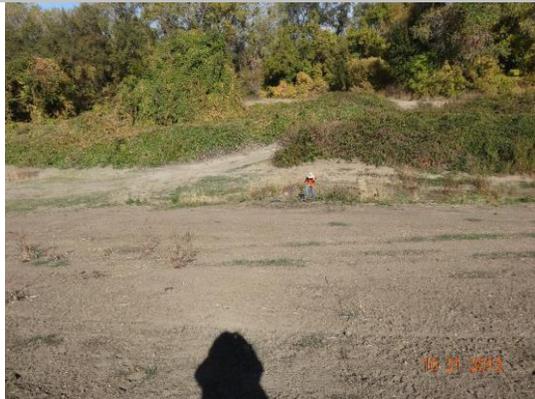
Photo 2 of 3 : UCIP\_FA\_2015\_2344.jpg

View of waterward side.

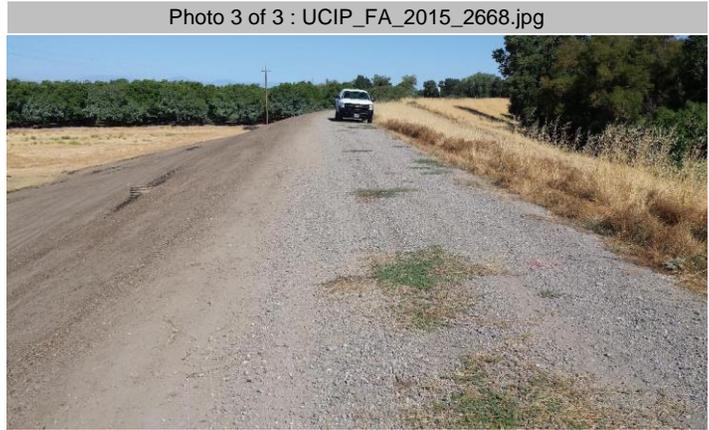
Overview of levee crown at crossing. No change from last inspection.

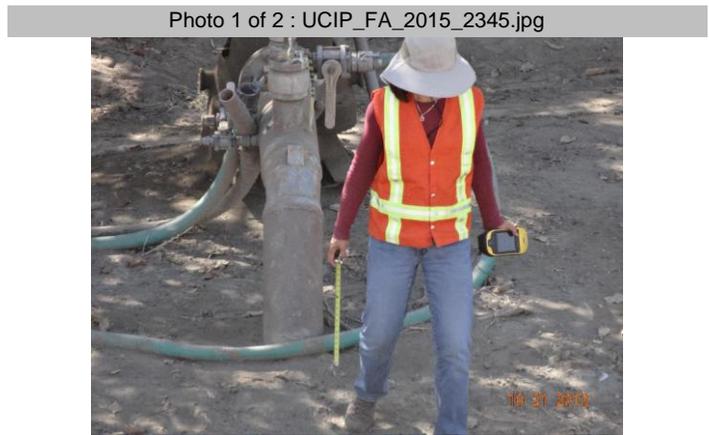
LM Start	<b>6.74</b>	Rating **	M	Issue No.	<b>59</b>
LM End	<b>6.74</b>	Issue Type +	En	Location *	WS
Category	Supplemental			GPS Latitude/Longitude	
				Start	End
Item	DWR UCIP Field Study			39.194042 °	39.194042 °
				-121.916630 °	-121.916630 °
DWR ID					
Action/Comments					
Inspector Comments: FS_ID:23523 DS_ID:21342 EP_NO: N/A FS_HLM: 6.82 Repair Type: Non-Urgent Crossing Status: Indicator Found UCIP Comments: Unable to determine if this is an irrigation pipe or groundwater pipe. This crossing is referenced in the USACE Periodic Inspection as item USACE_CESPK_MRD1_2012_p_0062--no permit available. FIELD_STRUCT_DESC: 8-inch (not 12-inch as found in desk study) pipe through the levee. Pump and service pole at landward toe. FS Date: 10/21/2013

Pump system and pipe on landward side.

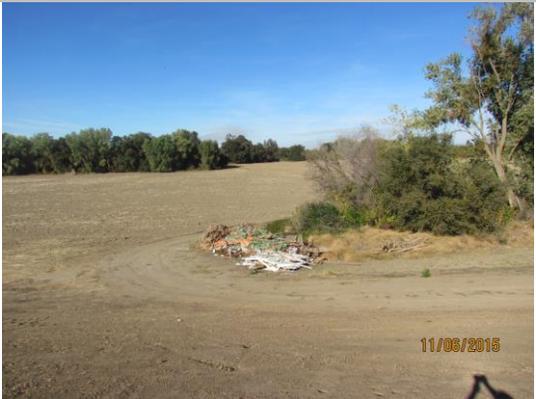
Photo 1 of 1 : FA\_2015\_RD0070\_29\_37\_20151109\_00041.jpg

View of the garbage and material along the waterside toe.

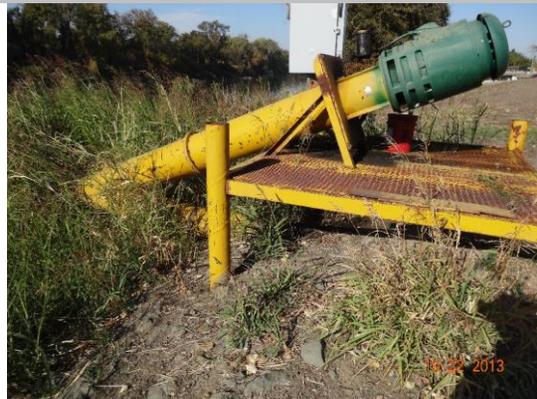
Photo 1 of 3 : UCIP\_FA\_2015\_2656.jpg

View of pump on waterward side.

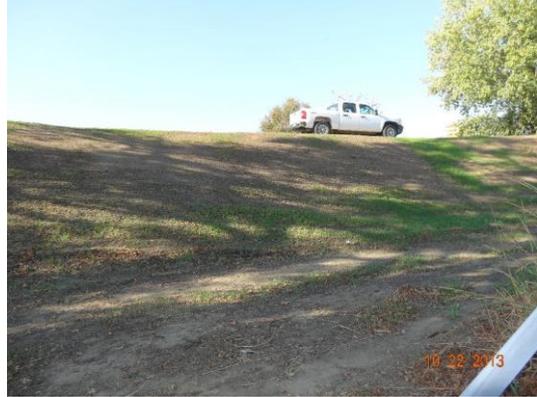
Photo 3 of 3 : UCIP\_FA\_2015\_2658.jpg

View of levee slope on landward side.

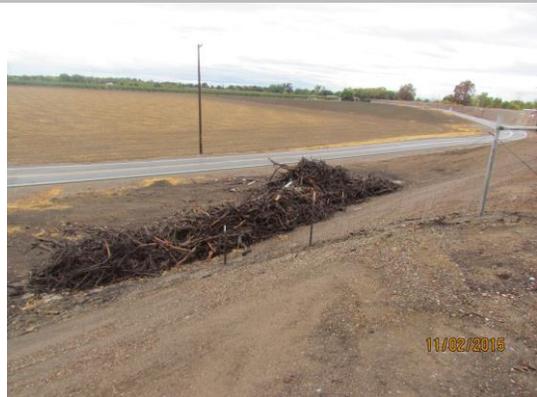
Photo 1 of 1 : FA\_2015\_RD0070\_30\_67\_20151116\_00051.jpg

View of the prunings along the landside toe.

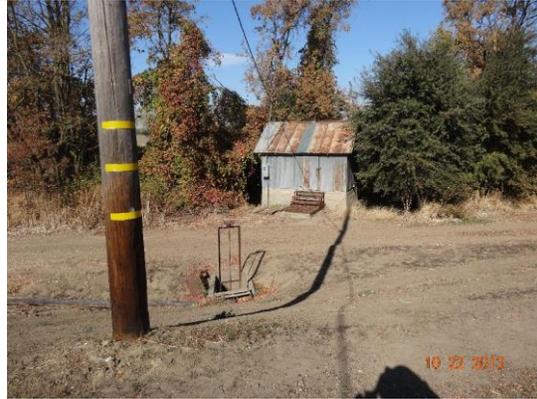
Photo 1 of 3 : UCIP\_FA\_2015\_2856.jpg

View of waterward side--appurtenances present pump house, concrete distribution box, screw gate, and power pole.

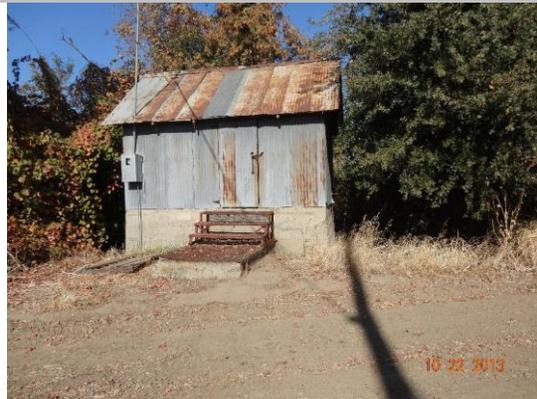
Photo 2 of 3 : UCIP\_FA\_2015\_2857.jpg

Pump station on waterward side.

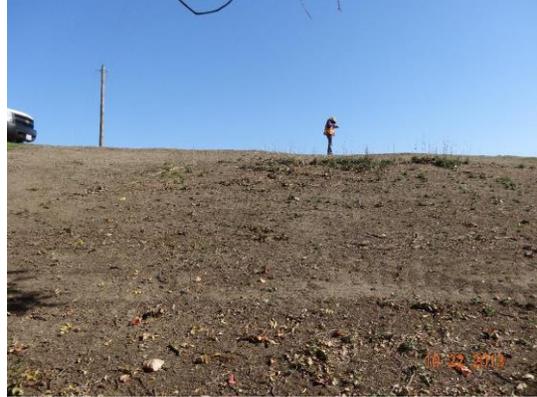
Photo 1 of 3 : UCIP\_FA\_2015\_2473.jpg

View of waterward slope.

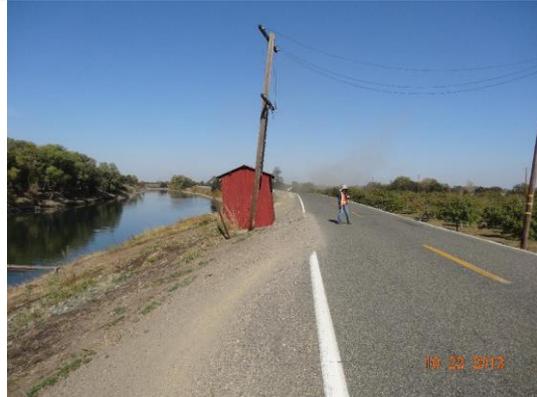
Photo 1 of 3 : UCIP\_FA\_2015\_2242.jpg

View of levee crown and waterward side.

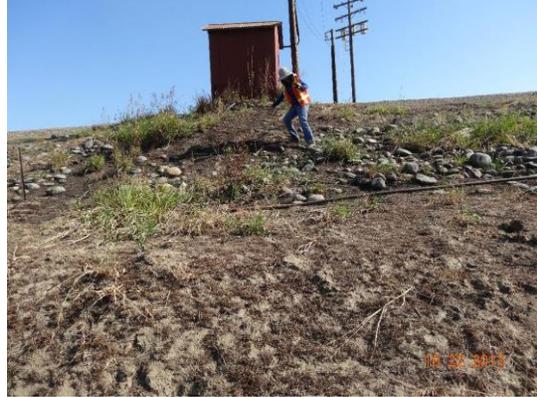
Photo 3 of 3 : UCIP\_FA\_2015\_2244.jpg

View of slope on waterward side.

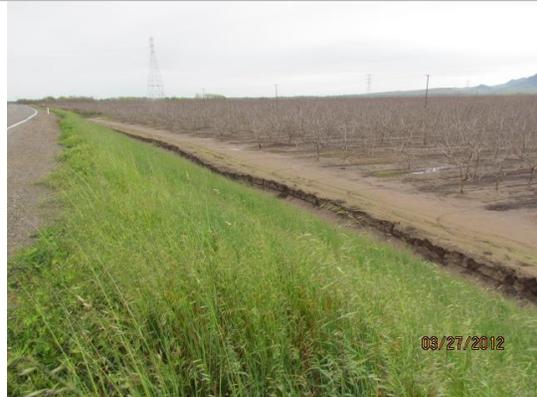
Photo 1 of 1 : FA\_2015\_RD0070\_30\_1\_20150910\_00001.jpg

Agricultural ditch along the landside toe.

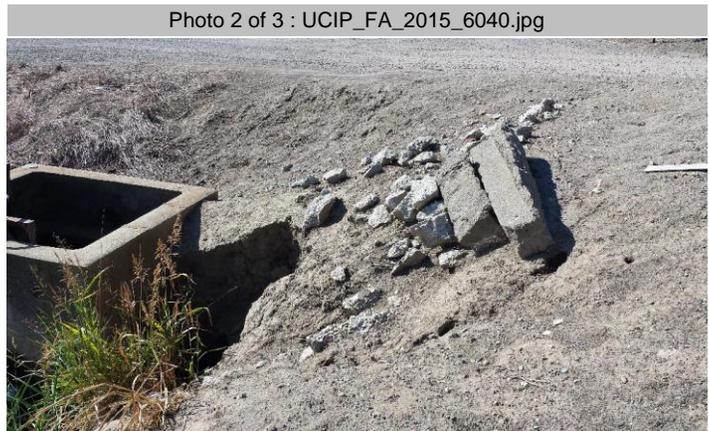
Item	DWR UCIP Field Study			39.166298 °	39.166298 °
DWR ID				-121.935570 °	-121.935570 °
Action/Comments					
Inspector Comments: FS_ID:46407 DS_ID:21367 EP_NO: 1158 FS_HLM: 2.354 Repair Type: Urgent Crossing Status: Found UCIP Comments: Pipe was running during site visit. Scour hole located at landward side (LS) toe is still present. New signs of stress on slope are visible on LS near concrete box. On the waterward side (WS) 2 leaks are present. The first leak is located at the pipe joint near the WS toe, the joint connection is leaking significantly. The second potential leak is near the pipe daylight on WS. Unable to confirm cause of leak but downstream seepage is present along pipe alignment. Seepage indicates that pipe may be leaking and causing internal erosion and void along pipe alignment. Recommend LMA superintendent notify owner to stop using crossing to avoid further damage to levee. Owner will need to coordinate with DWR Inspector and CVFPB to address leaky pipe per Title 23 requirements. FIELD_STRUCT_DESC: 18-inch steel pipe through the levee, 4.1 feet below the crown. Pump in pumphouse on waterward shoulder on concrete stand. Pipe discharges into concrete box at landward toe. Walkway to pumphouse on waterward side. (Permit No. 1158-1946) FS Date: 07/28/2015

Slope failure signs present along landward side above concrete box.

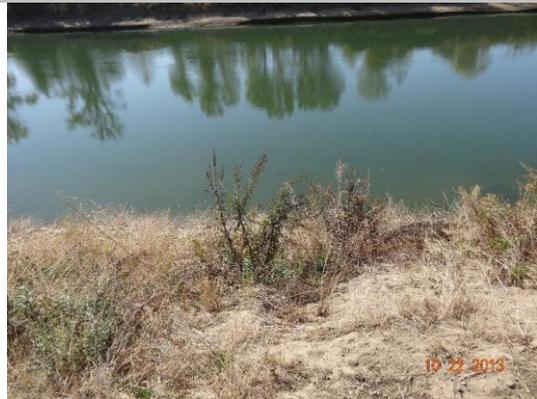
Photo 2 of 3 : UCIP\_FA\_2015\_2249.jpg

Dense vegetation on the waterward edge.

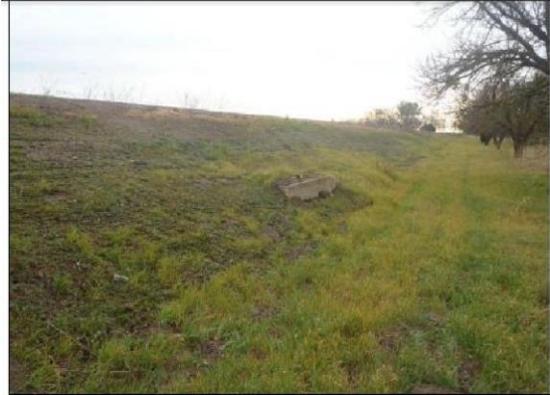
Photo 2 of 2 : UCIP\_FA\_2015\_0593.jpg

View of landward side--photo is from USACE PI Report draft final issue USACE\_CESPK\_MRD2\_2012\_p\_0197.

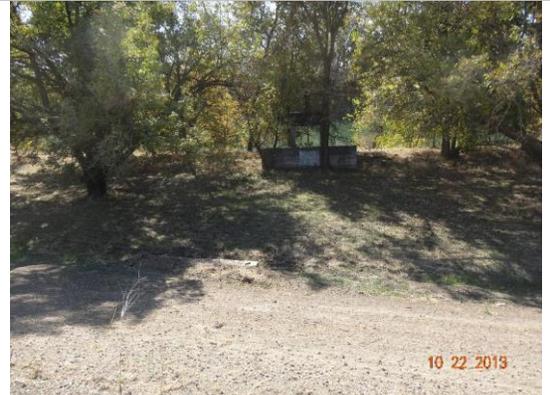
Photo 1 of 2 : UCIP\_FA\_2015\_2757.jpg

View of concrete headwall and screw gate on waterward side.

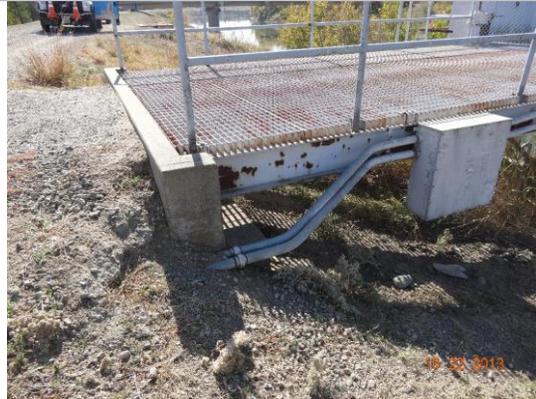
Photo 1 of 1 : UCIP\_FA\_2015\_2759.jpg

Conduits through levee along walkway.

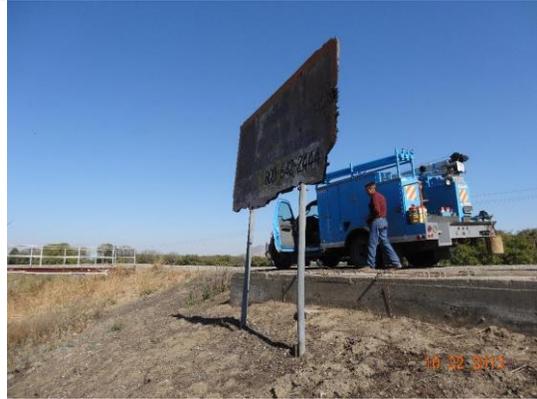
Photo 3 of 3 : UCIP\_FA\_2015\_2766.jpg

Gas line sign located on waterward side--sign in bad shape.

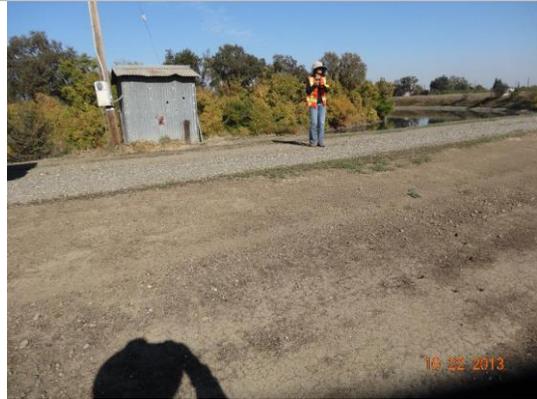
Photo 1 of 3 : UCIP\_FA\_2015\_2767.jpg

View of levee crown and pump house photo taken from landward side.

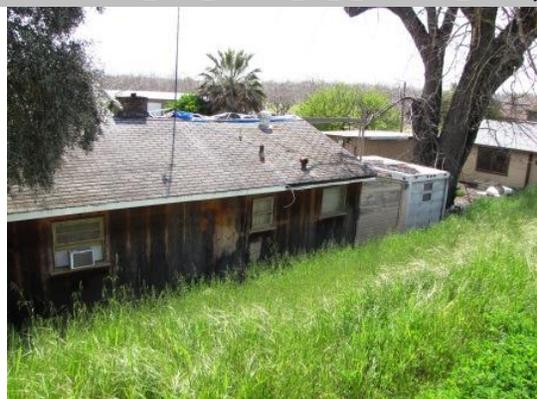
Photo 1 of 1 : FA\_2015\_RD0070\_30\_9\_20150910\_00006.jpg

View of the building along the toe.

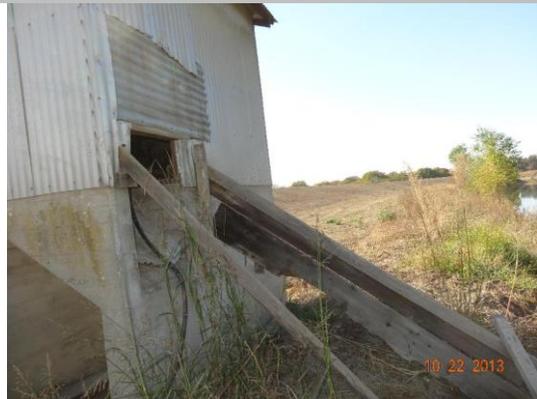
Photo 1 of 3 : UCIP\_FA\_2015\_0580.jpg

No pipe exists the pump house on waterward side.

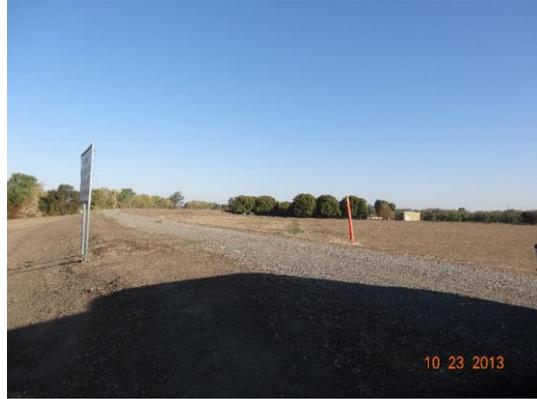
Photo 3 of 3 : UCIP\_FA\_2015\_0583.jpg

Markers visible on both levee shoulders.

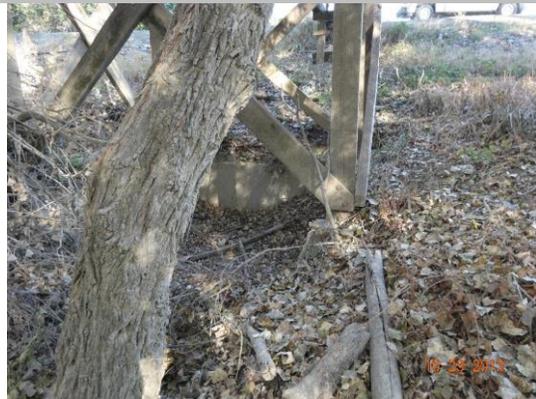
Photo 1 of 3 : UCIP\_FA\_2015\_0584.jpg

Concrete headwall located on waterward side.

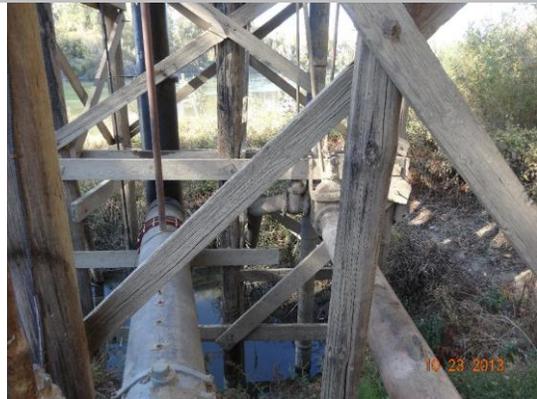
Photo 2 of 3 : UCIP\_FA\_2015\_2666.jpg

View of 16-inch pipe and 24-inch pipe located on waterward side.

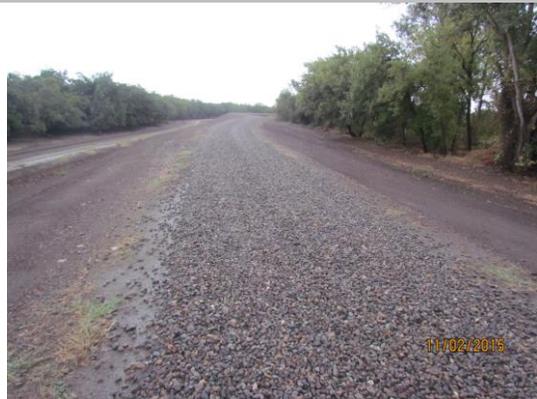
Photo 1 of 1 : FA\_2015\_RD0070\_30\_70\_20151116\_00058.jpg

View of the new gravel on the crown roadway.

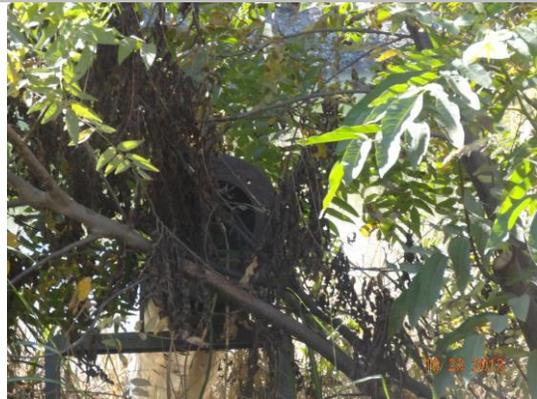
Photo 4 of 4 : UCIP\_FA\_2015\_2817.jpg

Pipe section exposed unable to determine if it is still in use.

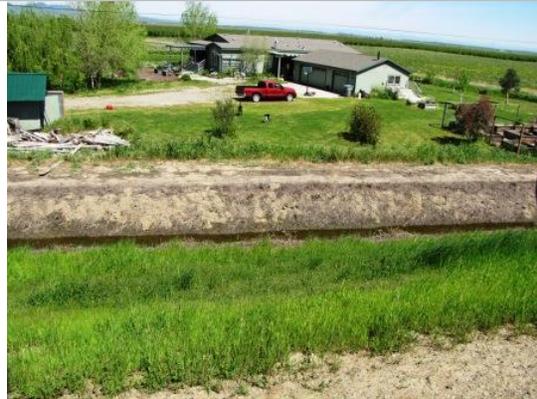
Photo 1 of 1 : FA\_2015\_RD0070\_30\_33\_20150910\_00018.jpg

View of the Ag ditch along the L/S toe.

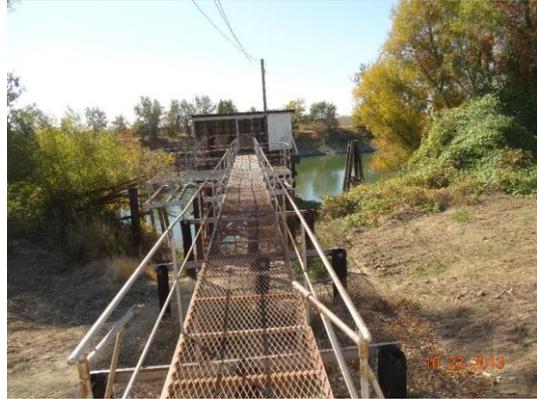
Photo 1 of 3 : UCIP\_FA\_2015\_2901.jpg

Walkway and pump house on waterward side.

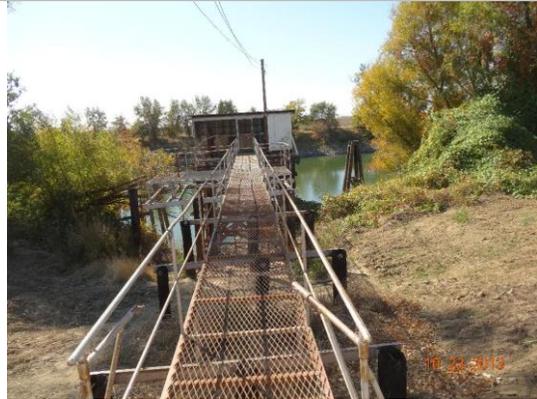
Photo 1 of 3 : UCIP\_FA\_2015\_2904.jpg

Walkway and Pump house located on waterward side.

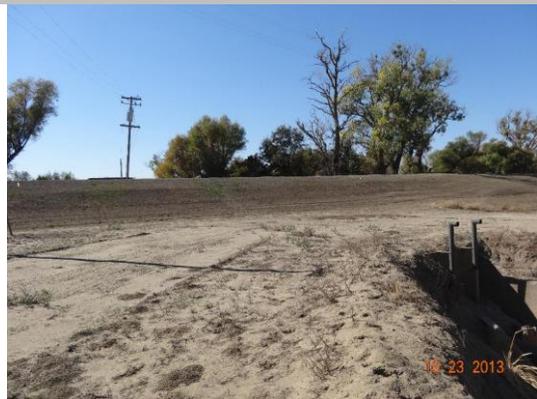
Photo 2 of 3 : UCIP\_FA\_2015\_2908.jpg

View of landward side photo taken from concrete headwall.
