**Flood Control Project Maintenance  
Levee Inspections**  
**LMA District Cover Sheet**  
**Spring 2014 Levee Inspection Results**

**Reclamation District No. 0070 Meridian**

Waterway		Bank	Unit Miles
Unit No. 01 Sutter Bypass		Right	8.00

**Levee Inspection Report By Mile - Spring 2014**

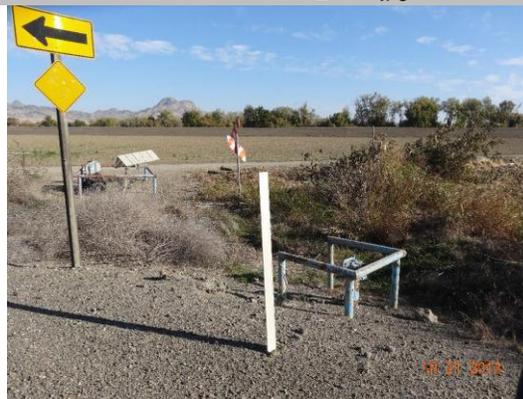
Photo 1 of 1 : UCIP\_3405.jpg

Item	DWR UCIP Field Study			39.141518 °	39.141518 °
				-121.839584 °	-121.839584 °
DWR ID	DWR_RD0070_01_s_2014_333				
Action/Comments					
Inspector Comments: FS_ID:23463 EP_NO: 3804 Repair Type: Crossing Status: UCIP Comments: Unable to confirm if the indicators that were found in the field correspond to this crossing. Will need to contact PG&E to confirm location of crossing. Photos will need to be updated if the photos attach do not correspond to this crossing. This crossing is referenced in the USACE Periodic Inspection as item USACE_CESPK_MRD1_2012_p_0304 for 12 inch gas pipe. Coordinates between DWR UCIP and USACE PI are approximately 630 feet apart. FIELD_STRUCT_DESC: 12-inch steel gas pipe through the levee, 3.6 feet below the crown. Concrete cutoff wall around pipe at center of levee. Marker sign on waterward shoulder. Rock revetment on waterward slope. (Permit No. 3804-1961) FS Date: 10/21/2013

View of pipeline marker photo taken from S. Tarke Road.

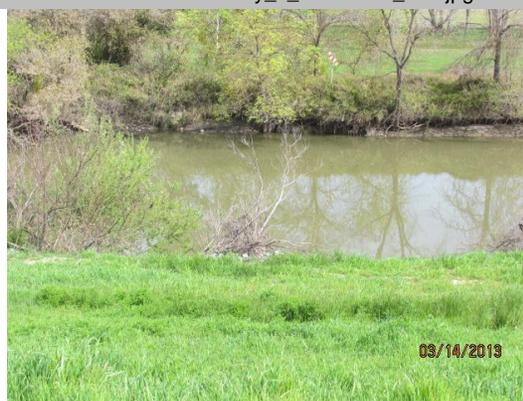
Photo 1 of 1 : rduffey\_s\_20140304\_799.jpg

LM Start	<b>0.48</b>	Rating **	M	Issue No.	<b>11</b>
LM End	<b>0.48</b>	Issue Type +	Ma	Location *	WS
Category	Earthen Levee			GPS Latitude/Longitude	
				Start	End
Item	Erosion / Bank Caving			39.141909 °	39.141909 °
				-121.840141 °	-121.840141 °
DWR ID	DWR_RD0070_01_s_2013_11				
Action/Comments					
Note and monitor erosion site.

View of the erosion along the waterside toe.

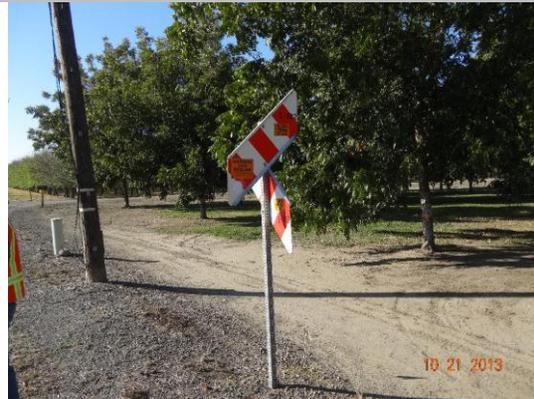
Photo 1 of 1 : UCIP\_3399.jpg

LM Start	<b>0.58</b>	Rating **	M	Issue No.	<b>335</b>
LM End	<b>0.58</b>	Issue Type +	En	Location *	WS
Category	Supplemental		GPS Latitude/Longitude		
			Start	End	
Item	DWR UCIP Field Study		39.142565 °	39.142565 °	
			-121.841600 °	-121.841600 °	
DWR ID	DWR_RD0070_01_s_2014_335				
Action/Comments					
Inspector Comments: FS_ID:23384 EP_NO: 15936 Repair Type: Crossing Status: UCIP Comments: No markers visible on levee slope or levee toe to indicate line crosses levee. Need to contact PG&E to confirm location through levee. Also need to confirm the emergency contact person for this crossing. FIELD_STRUCT_DESC: 8-inch steel pipe through the levee, 2.5 feet below the crown. Gas line markers on the landward side. (Permit No. 15936-2005) FS Date: 10/21/2013

View of markers on the west side of S. Tarke Road.

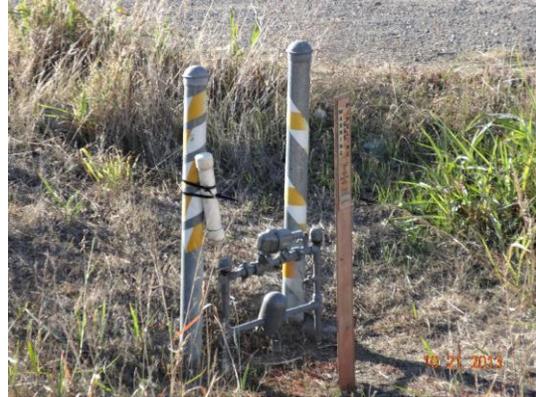
Photo 1 of 1 : UCIP\_3408.jpg

Item	DWR UCIP Field Study			39.143380 °	39.143380 °
				-121.842606 °	-121.842606 °
DWR ID	DWR_RD0070_01_s_2014_338				
Action/Comments					
Inspector Comments: FS_ID:23467					
EP_NO: 14802					
Repair Type:					
Crossing Status:					
UCIP Comments: Need to contact owner to determine status of crossing. Need date of last inspection and confirmation that crossing is still in operable condition. Markers found about 159 feet upstream of coordinates at the crossing of the ramp and S. Tarke Road (39.142684, -121.842685).					
FIELD_STRUCT_DESC: 4-inch steel gas pipe through the levee, 2.5 feet below the crown. Aluminum pipe marker on landward slope.					
(Permit No. 14802-1987) Contact emergency information for Pacific Gas & Electric Company 1-800-344-4749? 4742? or 1-916-742-3251.					
FS Date: 10/21/2013

Close-up of the additional appurtenances for gas line located landward side.

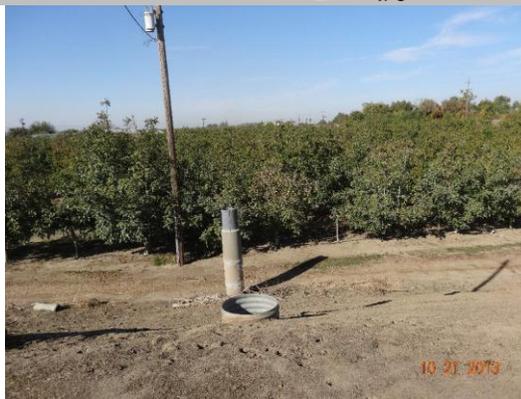
Photo 1 of 1 : UCIP\_3499.jpg

Item	DWR UCIP Field Study			39.144369 °	39.144369 °
				-121.842778 °	-121.842778 °
DWR ID	DWR_RD0070_01_s_2014_339				
Action/Comments					
Inspector Comments: FS_ID:23526 EP_NO: 9961 Repair Type: Crossing Status: UCIP Comments: Dense burrow activity present on both waterward side and landward side. Recommend addressing burrow activity at this location. Also recommend having owner clear vegetation blocking access along walkway. This crossing is referenced in the USACE Periodic Inspection as item USACE_CESPK_MRD1_2012_p_290. FIELD_STRUCT_DESC: 10-inch (not 12-inch as noted in desk study) steel pipe through the levee, 5.4 feet below the crown. Siphon breaker in CM pipe riser on landward slope. 24-inch concrete standpipe at landward toe. Walkway to pump on pile structure in stream. This pipe was retained under ABO No. 9961 (1974). FS Date: 10/21/2013

View of standpipe and CMP riser located on landward side.

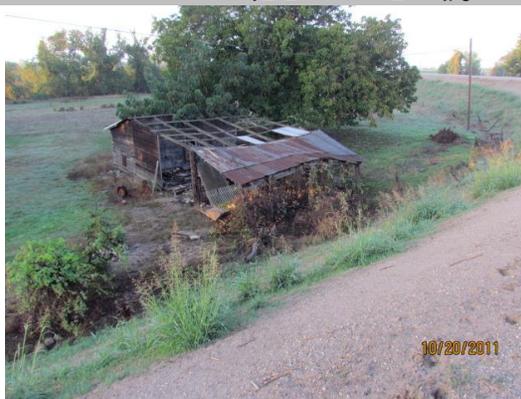
Photo 1 of 1 : rduffey\_s\_20140304\_795.jpg

LM Start	<b>0.95</b>	Rating **	M	Issue No.	<b>1</b>
LM End	<b>0.95</b>	Issue Type +	En	Location *	LS
Category	Earthen Levee			GPS Latitude/Longitude	
				Start	End
Item	Encroachments			39.146211 °	39.146211 °
				-121.844551 °	-121.844551 °
DWR ID	DWR_RD0070_01_s_2012_1				
Action/Comments					
Building

View of the building along the L/S toe.

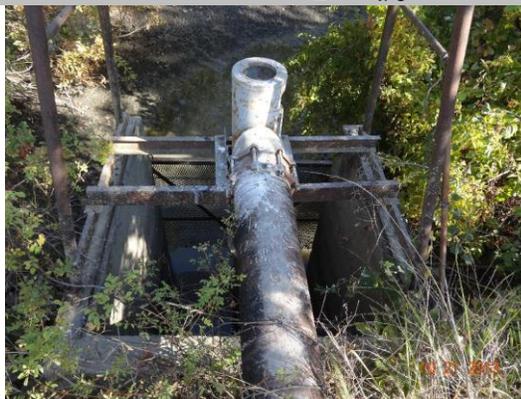
Photo 1 of 1 : UCIP\_3436.jpg

Item	DWR UCIP Field Study			39.151786 °	39.151786 °
				-121.856875 °	-121.856875 °
DWR ID	DWR_RD0070_01_s_2014_340				
Action/Comments					
Inspector Comments: FS_ID:23508 EP_NO: N/A Repair Type: Crossing Status: UCIP Comments: Need to find owner to determine if crossing is still in use. If crossing is no longer in use owner will need to coordinate with DWR inspector and CVFPB to remove according to Title 23 requirements. Evidence of high burrow activity on waterward side recommend addressing issue. This crossing is referenced as USACE_CESPK_MRD1_2012_p_0230 in the USACE's PI report for no USACE recommendation letter available -- correction pipe is 12-inch not 16-inch. FIELD_STRUCT_DESC: 12-inch pipe through the levee, 4.0 feet below the crown. Siphon breaker on the landward slope. Concrete distribution box (7 ft by 9 ft) at landward toe. Service pole on waterward slope. Pump on concrete sump on waterward slope. Overhead power line crosses levee at location. This pipe was retained under ABO No. 9948 (1974). FS Date: 10/21/2013

Pipe and concrete distribution box located on waterward side.

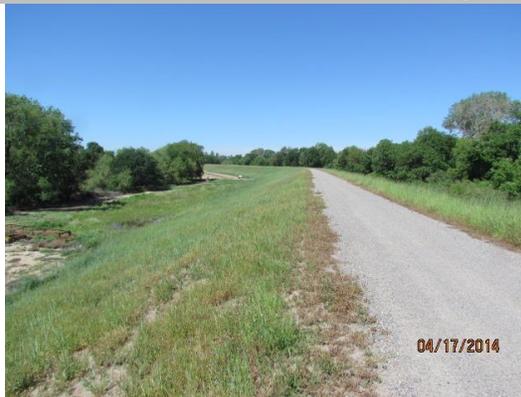
Photo 1 of 1 : rduffey\_s\_20140421\_187.jpg

LM Start	<b>2.86</b>	Rating **	A	Issue No.	<b>355</b>
LM End	<b>2.86</b>	Issue Type +	Ma	Location *	LS
Category	Earthen Levee			GPS Latitude/Longitude	
				Start	End
Item	Vegetation			39.158078 °	39.158078 °
				-121.872658 °	-121.872658 °
DWR ID	DWR_RD0070_01_s_2014_355				
Action/Comments					
Control annual grass and weeds on the levee slopes and easements.

View of the native grasses on both slopes.

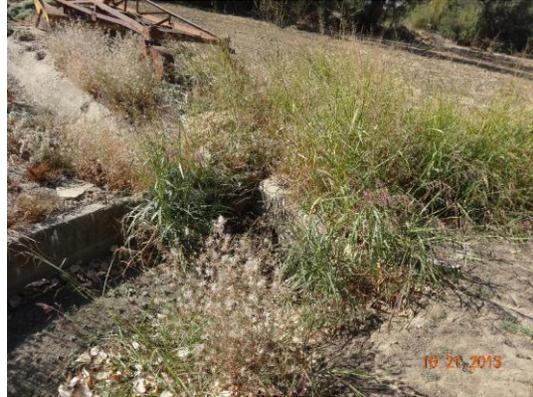
Photo 1 of 1 : UCIP\_3522.jpg

Item	DWR UCIP Field Study			39.158151 °	39.158151 °
				-121.873005 °	-121.873005 °
DWR ID	DWR_RD0070_01_s_2014_341				
Action/Comments					
Inspector Comments: FS_ID:23530 EP_NO: N/A Repair Type: Crossing Status: UCIP Comments: Unable to determine if crossing exists need to coordinate with LMA to determine if more information is available about crossing. This crossing is referenced in the USACE Periodic Inspection as item USACE_CESPK_MRD1_2012_p_0208 for concrete ditch lined within 15 feet of LS toe, no water present, and no USACE recommendation letter available. FIELD_STRUCT_DESC: 12-inch steel pipe through the levee. Cutoff wall around pipe at center of levee. Two slide gates, on each end of pipe. Pump on waterward side. Concrete distribution box on landward side. (USACE-1953). This entry matches the Drainage or Irrigation Structure referenced in O&M manual (Station 142+70). FS Date: 10/21/2013

Concrete structure located at the landward toe.

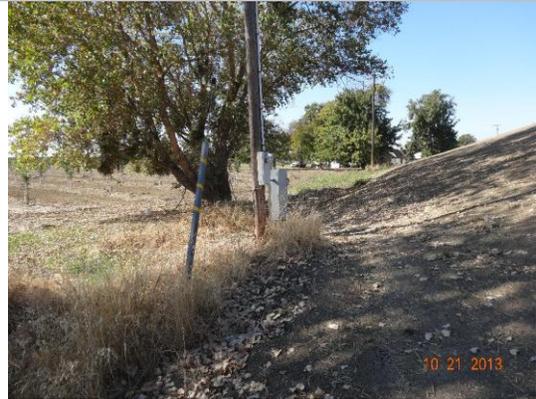
Photo 1 of 1 : UCIP\_3423.jpg

Item	DWR UCIP Field Study			39.156437 °	39.156437 °
				-121.882519 °	-121.882519 °
DWR ID	DWR_RD0070_01_s_2014_342				
<b>Action/Comments</b>					
Inspector Comments: FS_ID:23506 EP_NO: 9944 Repair Type: Crossing Status: UCIP Comments: Burrow activity present on levee slopes. Multiple pipes found on landward side--are these pipes part of original crossing? This crossing is referenced in the USACE Periodic Inspection as item USACE_CESPK_MRD1_2012_p_0291--no USACE recommendation letter available. FIELD_STRUCT_DESC: 18-inch steel pipe through the levee, 21.5 feet below the crown. Gate valve on the waterward end. Discharges into concrete box on the landward side. Rock revetment on waterward slope. This pipe was retained under ABO No. 9944 (1974). FS Date: 10/21/2013

Power pole located downstream from crossing on landward side.

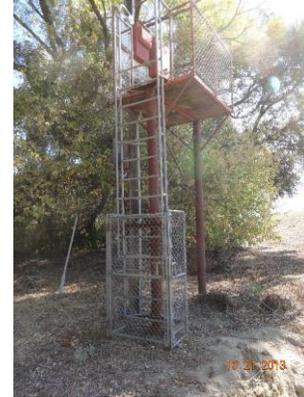
Photo 1 of 1 : UCIP\_3440.jpg

Item	DWR UCIP Field Study			39.157330 °	39.157330 °
				-121.887113 °	-121.887113 °
DWR ID	DWR_RD0070_01_s_2014_343				
Action/Comments					
Inspector Comments: FS_ID:23510 EP_NO: 9944 Repair Type: Crossing Status: UCIP Comments: No pump connection. Need to coordinate with owner to determine status of crossing. If crossing is no longer in use owner will need to contact the CVFPB to comply with Title 23. This crossing is referenced in the USACE Periodic Inspection as item USACE_CESPK_MRD1_2012_p_0183 no USACE recommendation letter available. FIELD_STRUCT_DESC: 18-inch pipe through the levee, 19.5 feet below the crown. Slide gate on waterward end. Pump on waterward side. Concrete distribution box on landward slope. (USACE-1953). This entry matches the Drainage or Irrigation Structure referenced in O&M manual (Station 180+50). This pipe was retained under ABO No. 9944 (1974). FS Date: 10/21/2013

Structure with access stairs located on waterward side.

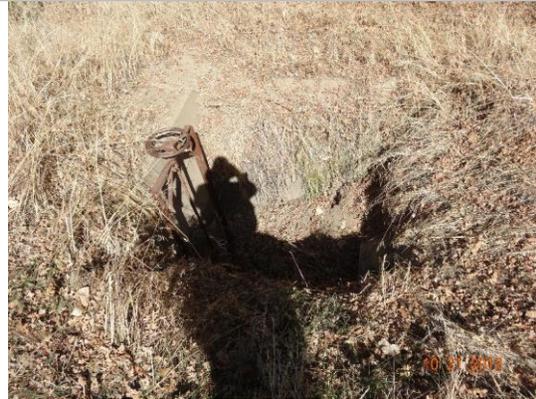
Photo 1 of 1 : UCIP\_3448.jpg

Item	DWR UCIP Field Study			39.166859 °	39.166859 °
				-121.898846 °	-121.898846 °
DWR ID	DWR_RD0070_01_s_2014_344				
Action/Comments					
Inspector Comments: FS_ID:23515 EP_NO: 9954 Repair Type: Crossing Status: UCIP Comments: Power pole down on waterward side. Need to coordinate with owner to determine status of crossing. If crossing is no longer in use owner will need to contact the CVFPB to comply with Title 23. This crossing is referenced in the USACE Periodic Inspection as item USACE_CESPK_MRD1_2012_p_0147. FIELD_STRUCT_DESC: 18-inch (not 24-inch as listed in desk study) steel pipe through the levee, 18.0 feet below the crown. Pipe crosses levee at a 45 degree angle. Slide gate in concrete box (5x5 foot) at waterward toe. Pump in pump house on the waterward side--no pump house found on waterward side. Discharge box at the landward toe. Power pole at the waterward toe. This pipe was retained under ABO No. 9954 (1974). FS Date: 10/21/2013

View of concrete box located on waterward side, photo 1 of 2.

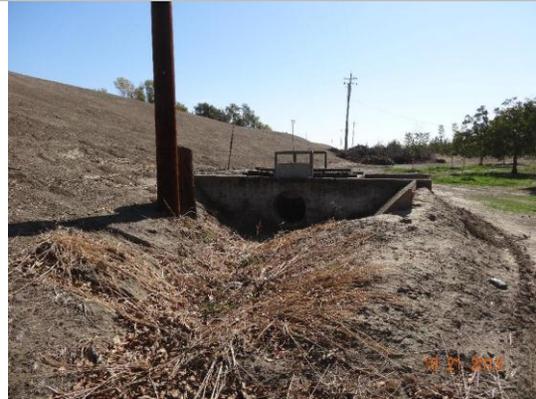
Photo 1 of 1 : UCIP\_3457.jpg

Item	DWR UCIP Field Study			39.167406 °	39.167406 °
				-121.899277 °	-121.899277 °
DWR ID	DWR_RD0070_01_s_2014_345				
Action/Comments					
Inspector Comments: FS_ID:23516 EP_NO: 9951 Repair Type: Crossing Status: UCIP Comments: Need to coordinate with owner to determine status of crossing. If crossing is no longer in use owner will need to contact the CVFPB to comply with Title 23. This crossing is referenced in the USACE Periodic Inspection as item USACE_CESPK_MRD1_2012_p_0144. FIELD_STRUCT_DESC: 10-inch steel pipe through the levee, 16.3 feet below the crown. Pipe crosses levee at a 45 degree angle. Siphon breaker in CM pipe riser on landward slope. Gate valve on waterward end. Discharges into concrete discharge box. This pipe was retained under ABO No. 9951 (1974). FS Date: 10/21/2013

Concrete distribution box located at landward toe.

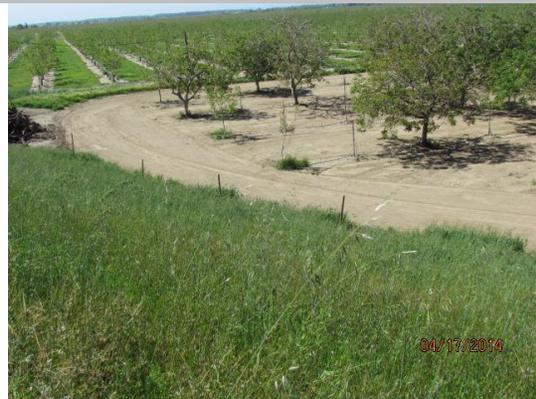
Photo 1 of 1 : rduffey\_s\_20140421\_188.jpg

LM Start	<b>4.67</b>	Rating **	U	Issue No.	<b>356</b>
LM End	<b>4.67</b>	Issue Type +	En	Location *	LS
Category	Earthen Levee			GPS Latitude/Longitude	
				Start	End
Item	Encroachments			39.167454 °	39.167454 °
				-121.899412 °	-121.899412 °
DWR ID	DWR_RD0070_01_s_2014_356				
Action/Comments					
Tree or limb

View of the new Walnut trees planted at the toe.

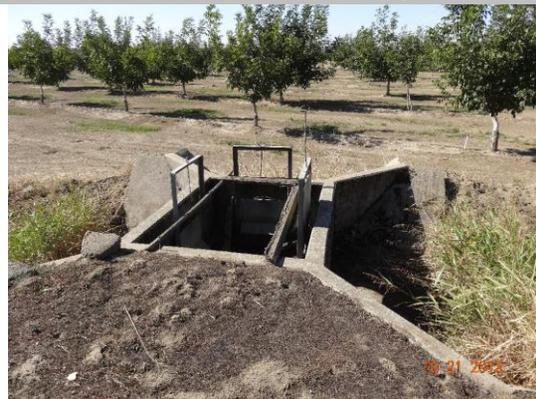
Photo 1 of 1 : UCIP\_3461.jpg

Item	DWR UCIP Field Study		39.168832 °	39.168832 °	
			-121.900436 °	-121.900436 °	
DWR ID	DWR_RD0070_01_s_2014_346				
Action/Comments					
Inspector Comments: FS_ID:23517 EP_NO: 9954 Repair Type: Crossing Status: UCIP Comments: Burrow activity present on waterward slope. Need to coordinate with owner to determine status of crossing. If crossing is no longer in use owner will need to contact the CVFPB to comply with Title 23. This crossing is referenced in the USACE Periodic Inspection as item USACE_CESPK_MRD1_2012_p_0134. FIELD_STRUCT_DESC: 24-inch CM pipe through the levee, 19.0 feet below the crown. Slide gate on the waterward. Concrete distribution box at landward toe. This pipe was retained under ABO No. 9954 (1974). FS Date: 10/21/2013

Concrete distribution box located on landward side, photo 1 of 3.

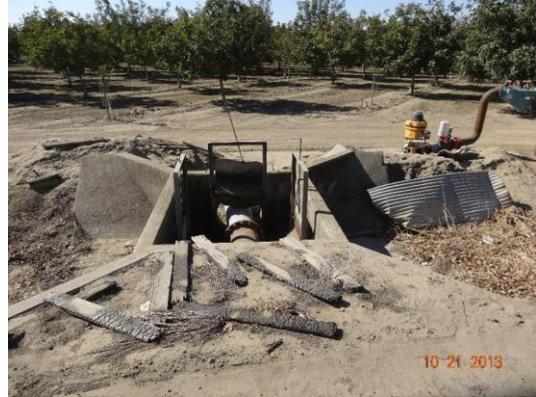
Photo 1 of 1 : UCIP\_3466.jpg

Item	DWR UCIP Field Study			39.172334 °	39.172334 °
				-121.902998 °	-121.902998 °
DWR ID	DWR_RD0070_01_s_2014_347				
Action/Comments					
Inspector Comments: FS_ID:23518 EP_NO: 9940 Repair Type: Crossing Status: UCIP Comments: No connection present--need to contact owner to determine if owner plans to use. If crossing is no longer in use owner will need to coordinate with DWR inspector and CVFPB to remove according to Title 23 requirements. Unable to determine if crossing is in use. This crossing is referenced in the USACE Periodic Inspection as item USACE_CESPK_MRD1_2012_p_0125. FIELD_STRUCT_DESC: 18-inch steel pipe through the levee, 19.0 feet below the crown. Cutoff wall around pipe at center of levee. Slide gate in concrete distribution box on landward side. Pump on waterward side. Discharges into concrete box on the landward side. (USACE-1953). This entry matches the Drainage or Irrigation Structure referenced in O&M manual (Station 251+30). This pipe was retained under ABO No. 9940 (1974). FS Date: 10/21/2013

Concrete distribution box located on landward side.

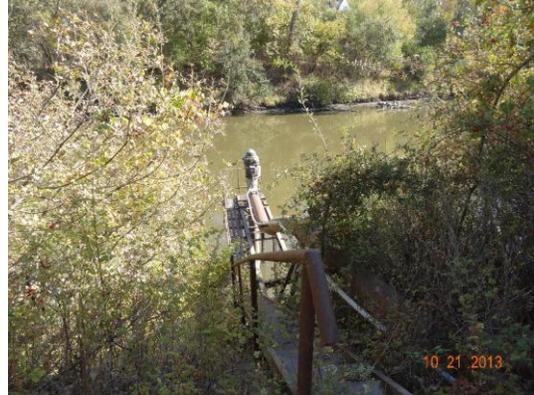
Photo 1 of 1 : UCIP\_3478.jpg

LM Start	<b>5.48</b>	Rating **	M	Issue No.	<b>348</b>
LM End	<b>5.48</b>	Issue Type +	En	Location *	LS
Category	Supplemental			GPS Latitude/Longitude	
				Start	End
Item	DWR UCIP Field Study			39.176780 °	39.176780 °
				-121.908025 °	-121.908025 °
DWR ID	DWR_RD0070_01_s_2014_348				
Action/Comments					
Inspector Comments: FS_ID:23519 EP_NO: 9957 Repair Type: Crossing Status: UCIP Comments: Burrow activity on slopes -- recommend addressing issue. This crossing is referenced in the USACE Periodic Inspection as item USACE_CESPK_MRD1_2012_p_0110. FIELD_STRUCT_DESC: 12-inch steel pipe through the levee, 5.5 feet below the crown. Siphon breaker in CM pipe riser on landward slope. Pump on waterward slope. Discharges into concrete box and service pole at landward toe. This pipe was retained under ABO No. 9957 (1975). FS Date: 10/21/2013

View of waterward side--pump, pipe, and walkway.

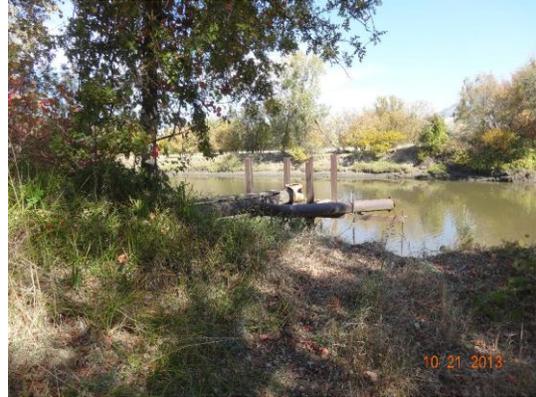
Photo 1 of 1 : UCIP\_3486.jpg

Item	DWR UCIP Field Study			39.184488 °	39.184488 °
				-121.909139 °	-121.909139 °
DWR ID	DWR_RD0070_01_s_2014_349				
Action/Comments					
Inspector Comments: FS_ID:23521 EP_NO: 9947 Repair Type: Crossing Status: UCIP Comments: Need to coordinate with owner to determine status of crossing. If crossing is no longer in use owner will need to contact the CVFPB to comply with Title 23. Recommend removing vegetation on landward side by concrete distribution box--dense vegetation limited the inspection of the structure. This crossing is referenced in the USACE Periodic Inspection as item USACE_CESPK_MRD1_2012_p_0094. FIELD_STRUCT_DESC: 14-inch steel pipe through the levee, 11.0 feet below the crown. Pump on pile structure on the waterward side. Concrete distribution box at the landward toe. Service pole on the waterward shoulder. This pipe was retained under ABO No. 9947 (1974). FS Date: 10/21/2013

Crossing through levee on waterward side.

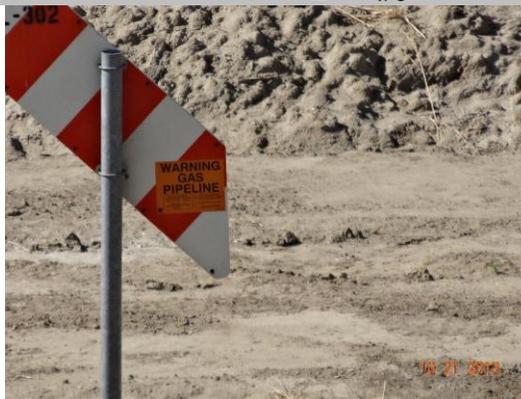
Photo 1 of 1 : UCIP\_3413.jpg

LM Start	<b>6.19</b>	Rating **	M	Issue No.	<b>350</b>
LM End	<b>6.19</b>	Issue Type +	En	Location *	LS
Category	Supplemental			GPS Latitude/Longitude	
				Start	End
Item	DWR UCIP Field Study			39.186652 °	39.186652 °
				-121.910548 °	-121.910548 °
DWR ID	DWR_RD0070_01_s_2014_350				
Action/Comments					
Inspector Comments: FS_ID:23479 EP_NO: 4867 Repair Type: Crossing Status: UCIP Comments: Utility marker contact information includes Contact prior to Excavation call 1-800-227-2600 or Emergency Contact 1-800-811-4111. Need to contact owner to determine status of crossing. Need date of last inspection and confirmation that crossing is still in operable condition. FIELD_STRUCT_DESC: 6.5-inch steel gas pipe through the levee, 4.0 feet below the crown. Concrete cutoff wall around pipe at center of levee. Rock revetment on waterward slope. (Permit No. 4867-1966) FS Date: 10/21/2013

Pipeline marker on landward side.

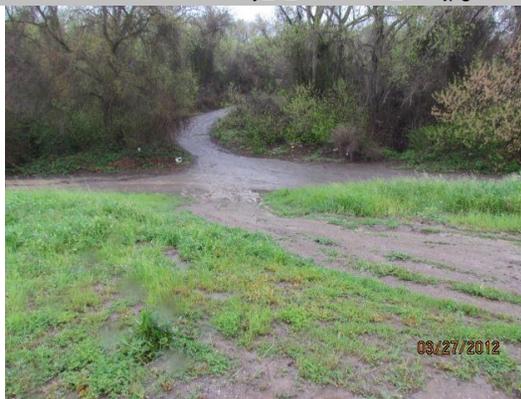
Photo 1 of 1 : rduffey\_s\_20140304\_796.jpg

LM Start	<b>6.25</b>	Rating **	M	Issue No.	<b>6</b>
LM End	<b>6.25</b>	Issue Type +	Ma	Location *	WS
Category	Earthen Levee			GPS Latitude/Longitude	
				Start	End
Item	Slope Stability			39.187481 °	39.187481 °
				-121.910852 °	-121.910852 °
DWR ID	DWR_RD0070_01_s_2012_6				
Action/Comments					
Repair the levee slope damaged by vehicle traffic and prevent access where possible.

View of vehicle erosion along the waterside slope.

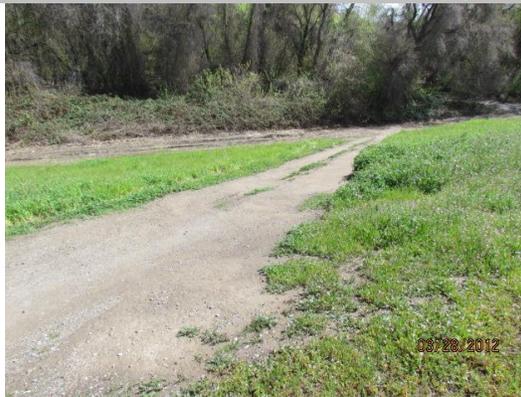
Photo 1 of 1 : rduffey\_s\_20140304\_797.jpg

LM Start	<b>6.28</b>	Rating **	M	Issue No.	<b>7</b>
LM End	<b>6.28</b>	Issue Type +	Ma	Location *	WS
Category	Earthen Levee			GPS Latitude/Longitude	
				Start	End
Item	Slope Stability			39.187895 °	39.187895 °
				-121.910976 °	-121.910976 °
DWR ID	DWR_RD0070_01_s_2012_7				
Action/Comments					
Repair the levee slope damaged by vehicle traffic and prevent access where possible.

View of vehicle erosion along the waterside slope.

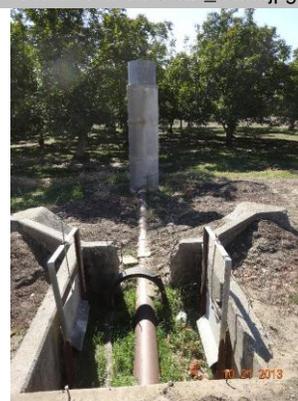
Photo 1 of 1 : UCIP\_3493.jpg

Item	DWR UCIP Field Study			39.192336 °	39.192336 °
				-121.914637 °	-121.914637 °
DWR ID	DWR_RD0070_01_s_2014_351				
Action/Comments					
Inspector Comments: FS_ID:23522 EP_NO: 9960 Repair Type: Crossing Status: UCIP Comments: Hole present on pipe on waterward side. This crossing was determined urgent due to hole on pipe-no signs leaks present on waterward or landward slopes. Unable to find if crossing is being used. Need to contact owner to determine crossing is still in use. If crossing is no longer in use owner will need to coordinate with DWR inspector and CVFPB to remove according to Title 23 requirements. Unable to determine if crossing is in use. This crossing is referenced in the USACE Periodic Inspection as item USACE_CESPK_MRD1_2012_p_0069. FIELD_STRUCT_DESC: 12-inch steel pipe through the levee, 6.2 feet below the crown. Siphon breaker in CM pipe riser on the landward slope. Service pole on the landward shoulder. Concrete distribution box at the landward toe. (USACE-1953). This entry matches the Drainage or Irrigation Structure referenced in O&M manual (Station 332+72). This pipe was retained under ABO No. 9960 (1974). FS Date: 10/21/2013

View of pipe located at landward toe.

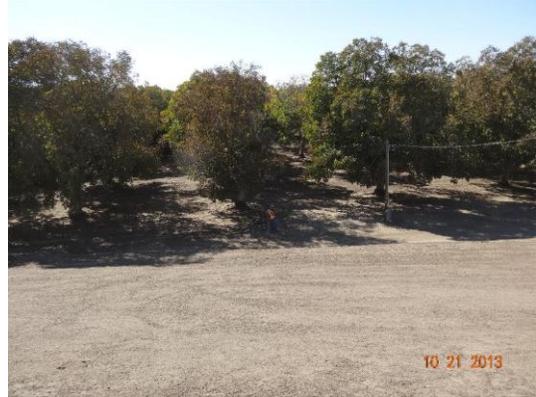
Photo 1 of 1 : UCIP\_3497.jpg

LM Start	<b>6.82</b>	Rating **	M	Issue No.	<b>352</b>
LM End	<b>6.82</b>	Issue Type +	En	Location *	WS
Category	Supplemental			GPS Latitude/Longitude	
				Start	End
Item	DWR UCIP Field Study			39.194042 °	39.194042 °
				-121.916630 °	-121.916630 °
DWR ID	DWR_RD0070_01_s_2014_352				
Action/Comments					
Inspector Comments: FS_ID:23523 EP_NO: N/A Repair Type: Crossing Status: UCIP Comments: Unable to determine if this is an irrigation pipe or groundwater pipe. This crossing is referenced in the USACE Periodic Inspection as item USACE_CESPK_MRD1_2012_p_0062--no permit available. FIELD_STRUCT_DESC: 8-inch (not 12-inch as found in desk study) pipe through the levee. Pump and service pole at landward toe. FS Date: 10/21/2013

View of landward side.

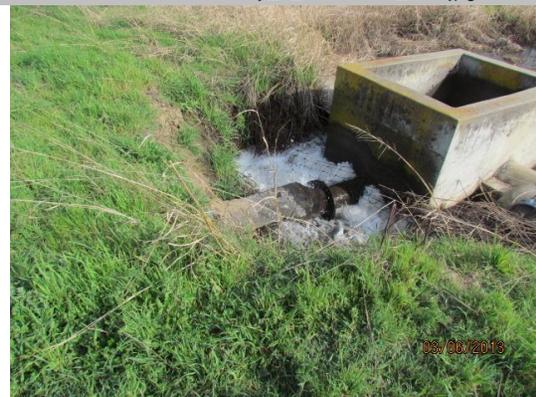
Photo 1 of 1 : ruffey\_s\_20140304\_798.jpg

View of the erosion caused by the leaky pipe.

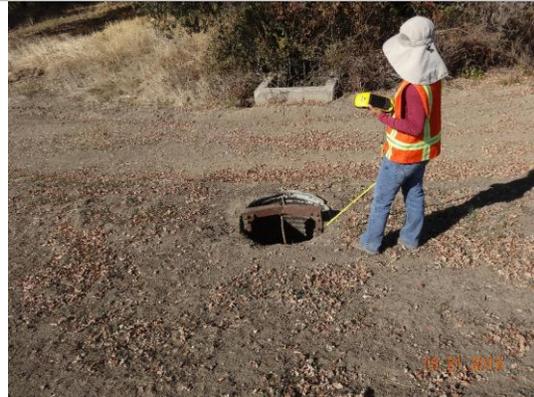
Photo 1 of 1 : UCIP\_3516.jpg

CMP riser with screw gate inside. Gate is missing the handle to close gate.

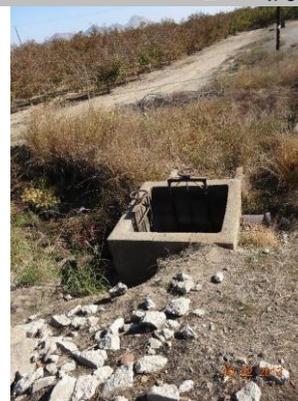
Photo 1 of 1 : UCIP\_3952.jpg

Concrete distribution box located on landward side--cavity collapse behind concrete box.

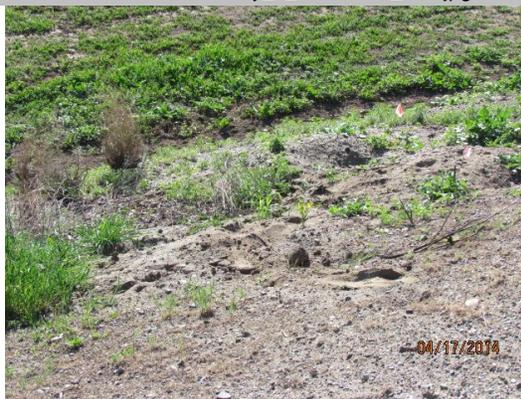
Photo 1 of 1 : rduffey\_s\_20140421\_180.jpg

View of the rodent activity along the landside slope.

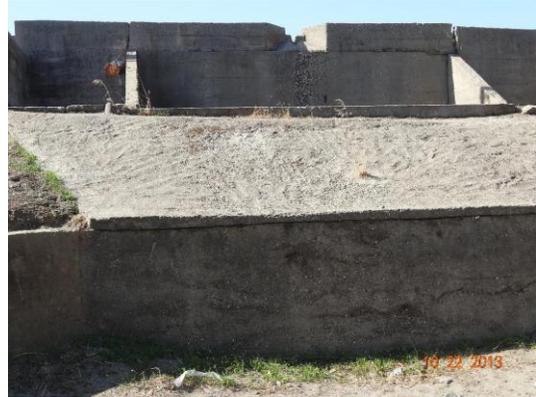
Photo 1 of 1 : UCIP\_3878.jpg

Concrete headwall located on landward side--no pipe. Only visible pipe is the pipe located at the far left (downstream end).

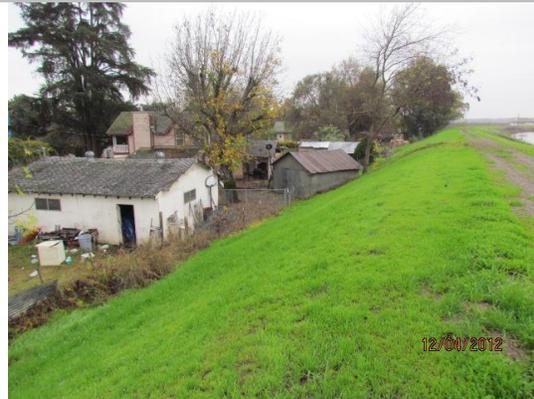
Photo 1 of 1 : rduffey\_s\_20140304\_284.jpg

View of the buildings along the landside toe of the levee.

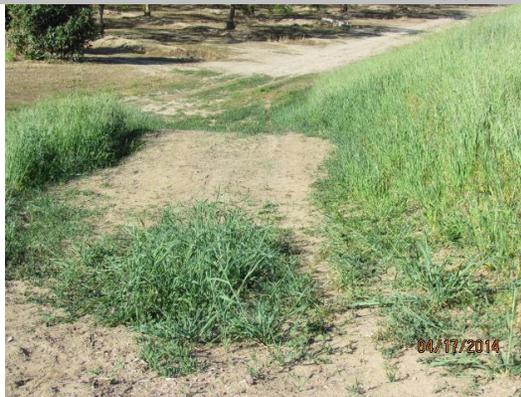
Photo 1 of 1 : rduffey\_s\_20140421\_182.jpg

View of the damaged ramp along the landside slope.

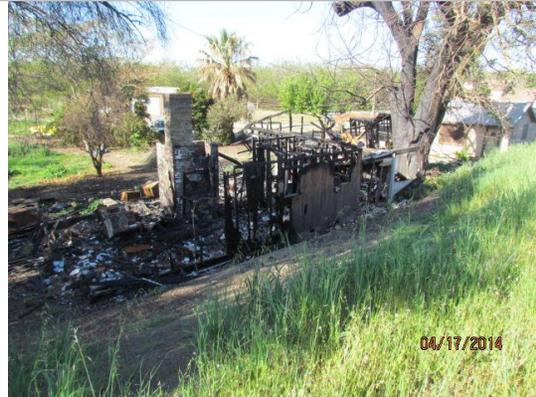
Photo 1 of 1 : rduffey\_s\_20140421\_183.jpg

View of the burned house along the landside toe.

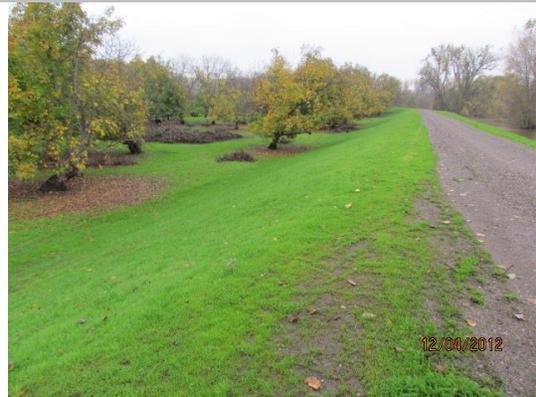
Photo 1 of 1 : rduffey\_s\_20140304\_303.jpg

View of the repaired rodent holes along the landside slope.

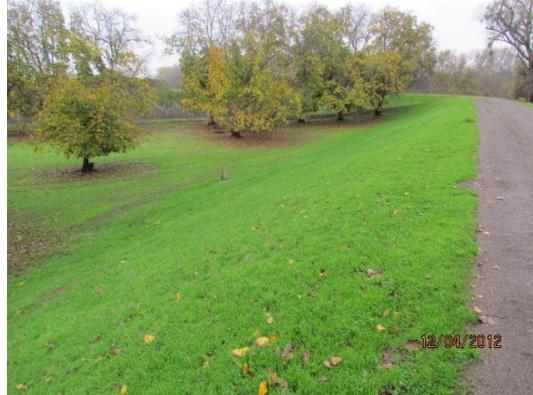
Photo 1 of 1 : rduffey\_s\_20140304\_304.jpg

View of the repaired rodent holes along the landside slope of the levee.

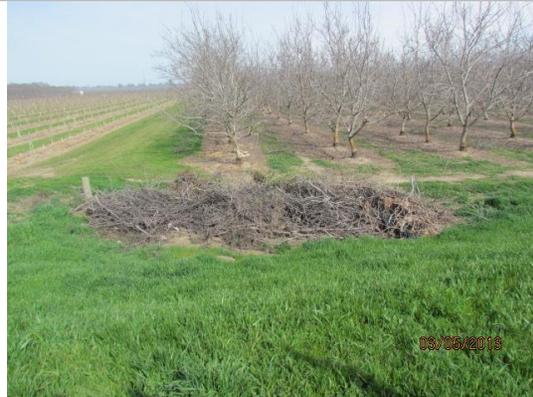
Photo 1 of 1 : rduffey\_s\_20140304\_301.jpg

View of the prunings along the landside slope.

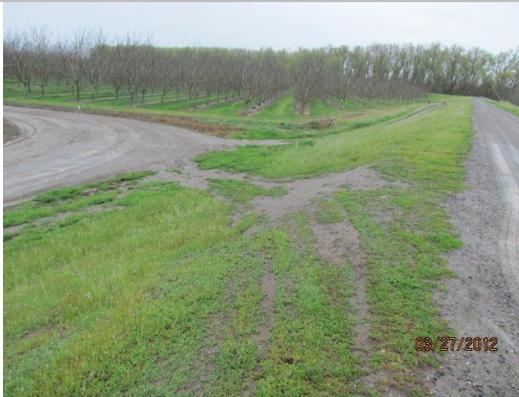
Photo 1 of 1 : rduffey\_s\_20140304\_276.jpg

View of vehicle erosion along landside slope.

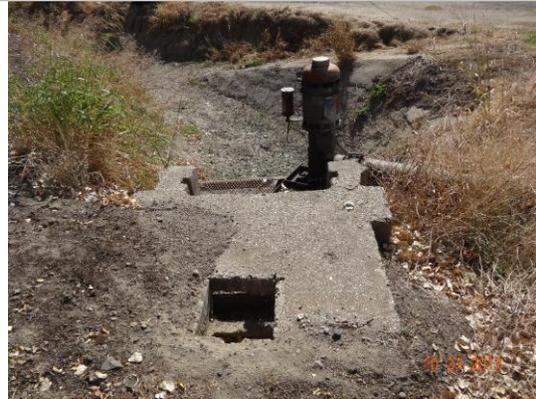
Photo 1 of 1 : UCIP\_4051.jpg

**Action/Comments**  
 Inspector Comments: FS\_ID:24197  
 EP\_NO: 9986  
 Repair Type:  
 Crossing Status:  
 UCIP Comments: Need to coordinate with owner to determine status of crossing. If crossing is no longer in use owner will need to contact the CVFPB to comply with Title 23. This crossing is referenced in the USACE Periodic Inspection as item USACE\_CESPK\_MRD2\_2012\_p\_0527.  
 FIELD\_STRUCT\_DESC: 30-inch steel pipe through the levee, 27.5 feet below the crown. Two electric gate valves in concrete pit on waterward end at end of discharge pipe. Two slant pumps on waterward slope. Control switches in CM shed at waterward shoulder. (USACE-1953). This entry matches the Drainage or Irrigation Structure referenced in O&M manual (Station 889+72). This pipe was retained under ABO No. 9986 (1974). One pump and one gate valve installed under Permit No. 5193 (1966). This pumping plant was demolished with pipes grouted and abandoned under Permit No. 18323 (2009).

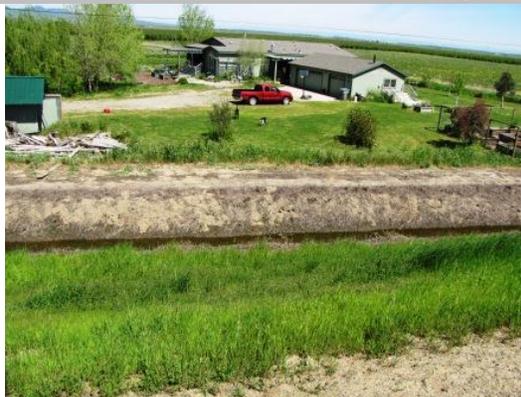
Photo 1 of 1 : rduffey\_s\_20140304\_302.jpg

View of the Ag ditch along the L/S toe.
