**Flood Control Project Maintenance
Levee Inspections**
LMA District Cover Sheet
Spring 2016 Levee Inspection Results

Reclamation District No. 0070 Meridian

Waterway		Bank	Unit Miles
Unit No. 01 Sutter Bypass		Right	7.92

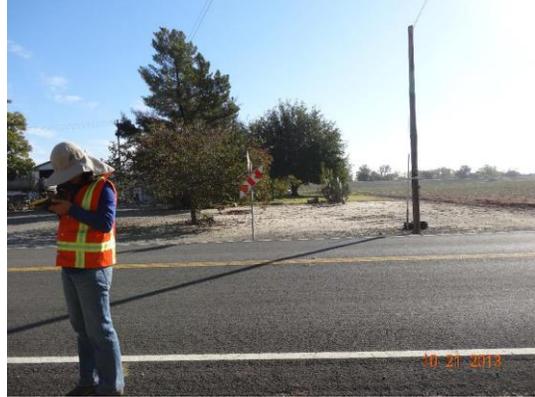
Photo 1 of 2 : UCIP_SP_2016_23384_40249.jpg

LM Start	0.55	Rating **	M	Issue No.	42
LM End	0.55	Issue Type +	En	Location *	WS
Category	Supplemental			GPS Latitude/Longitude	
				Start	End
Item	DWR UCIP Field Study			39.142565 °	39.142565 °
				-121.841600 °	-121.841600 °
DWR ID					
Comment Code					
Inspector Comment					
FS_ID:23384 DS_ID:21415 EP_NO: 15936 Repair Type: Non-Urgent Crossing Status: Indicator Found UCIP Comments: No markers visible on levee slope or levee toe to indicate line crosses levee. Need to contact PG&E to confirm location through levee. Also need to confirm the emergency contact person for this crossing. FIELD_STRUCT_DESC: 8-inch steel pipe through the levee, 2.5 feet below the crown. Gas line markers on the landward side. (Permit No. 15936-2005) FS Date: 10/21/2013

View of markers on the east side of S. Tarke Road.

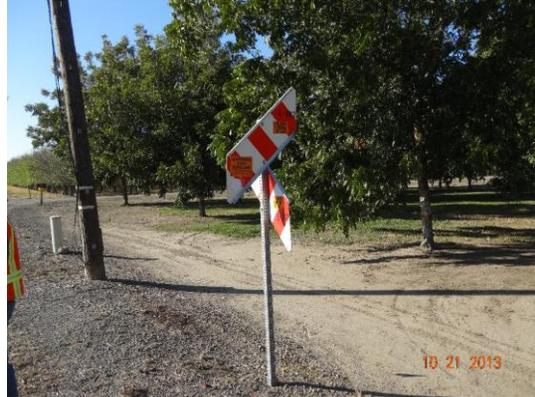
Photo 2 of 2 : UCIP_SP_2016_23384_40247.jpg

View of markers on the west side of S. Tarke Road.

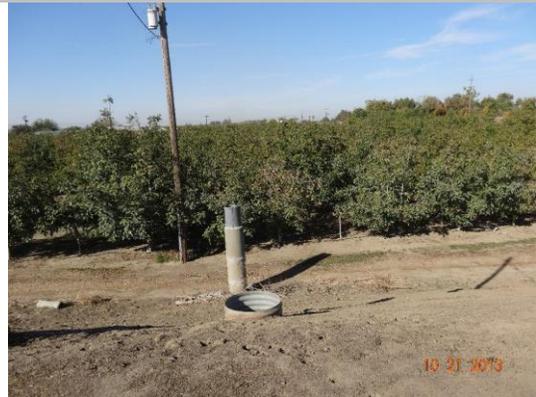
Photo 2 of 2 : UCIP_SP_2016_23526_40941.jpg

Comment Code					
Inspector Comment					
FS_ID:23526 DS_ID:21355 EP_NO: 9961 Repair Type: Non-Urgent Crossing Status: Found UCIP Comments: Dense burrow activity present on both waterward side and landward side. Recommend addressing burrow activity at this location. Also recommend having owner clear vegetation blocking access along walkway. This crossing is referenced in the USACE Periodic Inspection as item USACE_CESPK_MRD1_2012_p_290. FIELD_STRUCT_DESC: 10-inch (not 12-inch as noted in desk study) steel pipe through the levee, 5.4 feet below the crown. Siphon breaker in CM pipe riser on landward slope. 24-inch concrete standpipe at landward toe. Walkway to pump on pile structure in stream. This pipe was retained under ABO No. 9961 (1974). FS Date: 10/21/2013

View of standpipe and CMP riser located on landward side.

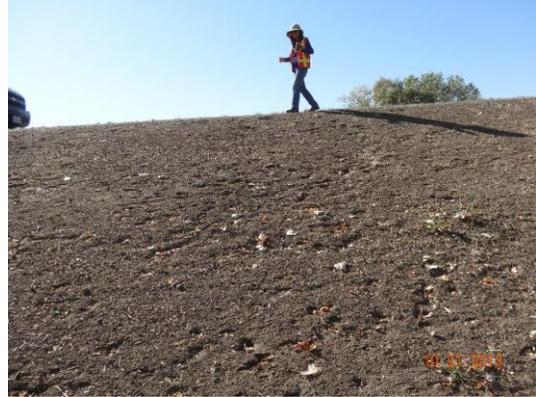
Photo 2 of 2 : UCIP_SP_2016_23530_40972.jpg

Comment Code					
Inspector Comment					
<p>FS_ID:23530 DS_ID:21322 EP_NO: N/A Repair Type: Non-Urgent Crossing Status: Indicator Found UCIP Comments: Unable to determine if crossing exists need to coordinate with LMA to determine if more information is available about crossing. This crossing is referenced in the USACE Periodic Inspection as item USACE_CESPK_MRD1_2012_p_0208 for concrete ditch lined within 15 feet of LS toe, no water present, and no USACE recommendation letter available. FIELD_STRUCT_DESC: 12-inch steel pipe through the levee. Cutoff wall around pipe at center of levee. Two slide gates, on each end of pipe. Pump on waterward side. Concrete distribution box on landward side. (USACE-1953). This entry matches the Drainage or Irrigation Structure referenced in O&M manual (Station 142+70). FS Date: 10/21/2013</p>

View of waterward slope.

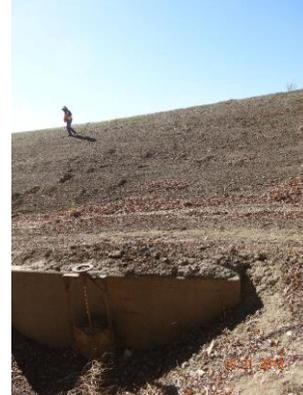
Photo 1 of 2 : UCIP_SP_2016_23510_40837.jpg

Comment Code					
Inspector Comment					
FS_ID:23510 DS_ID:21362 EP_NO: 9944 Repair Type: Non-Urgent Crossing Status: Found UCIP Comments: No pump connection. Need to coordinate with owner to determine status of crossing. If crossing is no longer in use owner will need to contact the CVFPB to comply with Title 23. This crossing is referenced in the USACE Periodic Inspection as item USACE_CESPK_MRD1_2012_p_0183 no USACE recommendation letter available. FIELD_STRUCT_DESC: 18-inch pipe through the levee, 19.5 feet below the crown. Slide gate on waterward end. Pump on waterward side. Concrete distribution box on landward slope. (USACE-1953). This entry matches the Drainage or Irrigation Structure referenced in O&M manual (Station 180+50). This pipe was retained under ABO No. 9944 (1974). FS Date: 10/21/2013

Concrete head wall and screw gate at waterward toe.

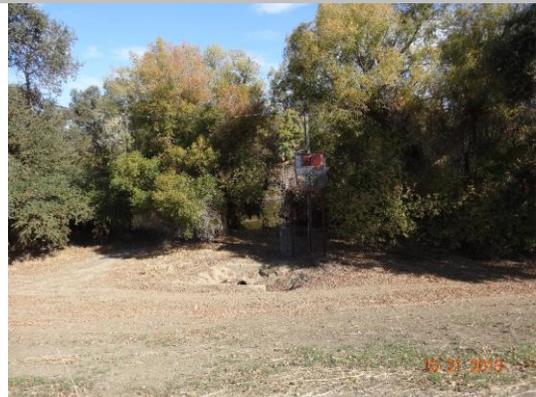
Photo 2 of 2 : UCIP_SP_2016_23510_40838.jpg

View of waterward side.

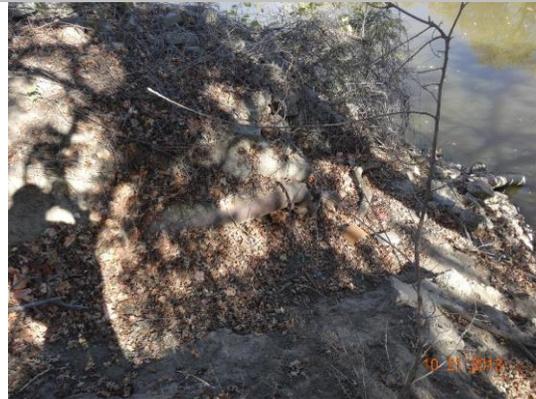
Photo 1 of 2 : UCIP_SP_2016_23516_40873.jpg

Comment Code					
Inspector Comment					
FS_ID:23516 DS_ID:21339 EP_NO: 9951 Repair Type: Non-Urgent Crossing Status: Found UCIP Comments: Need to coordinate with owner to determine status of crossing. If crossing is no longer in use owner will need to contact the CVFPB to comply with Title 23. This crossing is referenced in the USACE Periodic Inspection as item USACE_CESPK_MRD1_2012_p_0144. FIELD_STRUCT_DESC: 10-inch steel pipe through the levee, 16.3 feet below the crown. Pipe crosses levee at a 45 degree angle. Siphon breaker in CM pipe riser on landward slope. Gate valve on waterward end. Discharges into concrete discharge box. This pipe was retained under ABO No. 9951 (1974). FS Date: 10/21/2013

View of pipe located on waterward side.

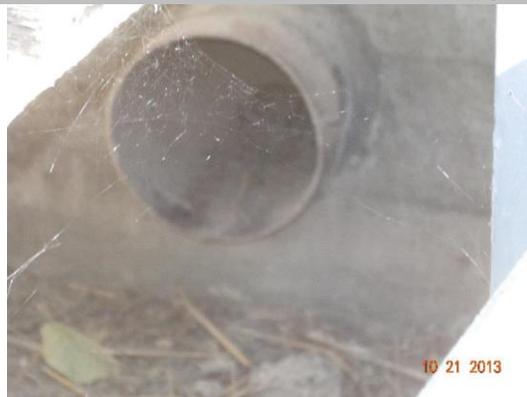
Photo 2 of 2 : UCIP_SP_2016_23516_40872.jpg

View of pipe on landward side inside concrete distribution box.

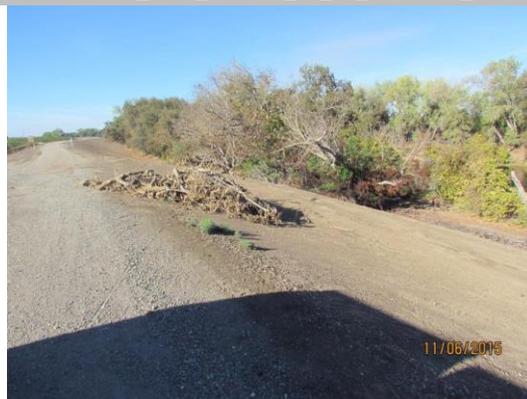
Photo 1 of 1 : SP_2016_RD0070_29_38_20160316_00005.jpg

View of the prunings along the waterside slope.

LM Start	4.60	Rating **	U	Issue No.	38
LM End	4.60	Issue Type +	Ma	Location *	WS
Category	Earthen Levee			GPS Latitude/Longitude	
				Start	End
Item	Encroachments			39.167597 °	39.167597 °
				-121.899363 °	-121.899363 °
DWR ID	DWR_RD0070_01_f_2015_38				
Comment Code					
PR : Prunings					
Inspector Comment					
Remove the prunings from the waterside slope.

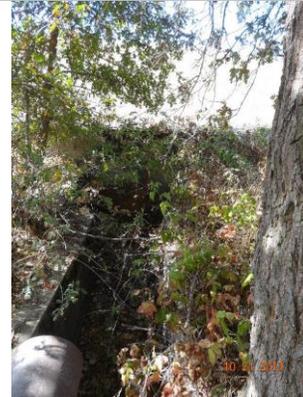
Photo 2 of 2 : UCIP_SP_2016_23517_40877.jpg

Comment Code					
Inspector Comment					
FS_ID:23517 DS_ID:21340 EP_NO: 9954 Repair Type: Non-Urgent Crossing Status: Found UCIP Comments: Burrow activity present on waterward slope. Need to coordinate with owner to determine status of crossing. If crossing is no longer in use owner will need to contact the CVFPB to comply with Title 23. This crossing is referenced in the USACE Periodic Inspection as item USACE_CESPK_MRD1_2012_p_0134. FIELD_STRUCT_DESC: 24-inch CM pipe through the levee, 19.0 feet below the crown. Slide gate on the waterward. Concrete distribution box at landward toe. This pipe was retained under ABO No. 9954 (1974). FS Date: 10/21/2013

View of pipe located on waterward side.

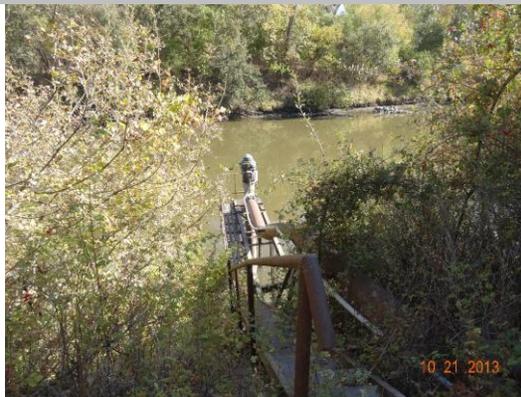
Photo 1 of 2 : UCIP_SP_2016_23519_40896.jpg

LM Start	5.41	Rating **	M	Issue No.	56
LM End	5.41	Issue Type +	En	Location *	WS
Category	Supplemental			GPS Latitude/Longitude	
				Start	End
Item	DWR UCIP Field Study			39.176780 °	39.176780 °
				-121.908025 °	-121.908025 °
DWR ID					
Comment Code					
Inspector Comment					
FS_ID:23519 DS_ID:21357 EP_NO: 9957 Repair Type: Non-Urgent Crossing Status: Found UCIP Comments: Burrow activity on slopes -- recommend addressing issue. This crossing is referenced in the USACE Periodic Inspection as item USACE_CESPK_MRD1_2012_p_0110. FIELD_STRUCT_DESC: 12-inch steel pipe through the levee, 5.5 feet below the crown. Siphon breaker in CM pipe riser on landward slope. Pump on waterward slope. Discharges into concrete box and service pole at landward toe. This pipe was retained under ABO No. 9957 (1975). FS Date: 10/21/2013

View of waterward side--pump, pipe, and walkway.

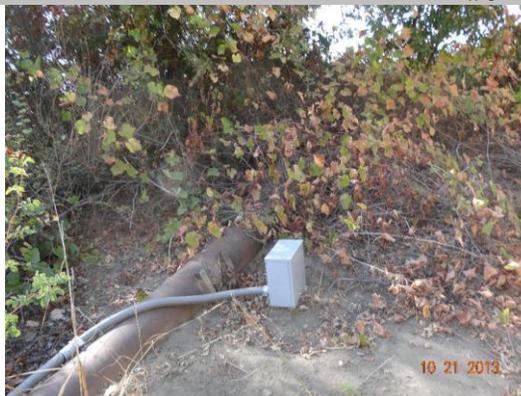
Photo 2 of 2 : UCIP_SP_2016_23519_40898.jpg

Pipe and electrical conduit exposed on levee berm.

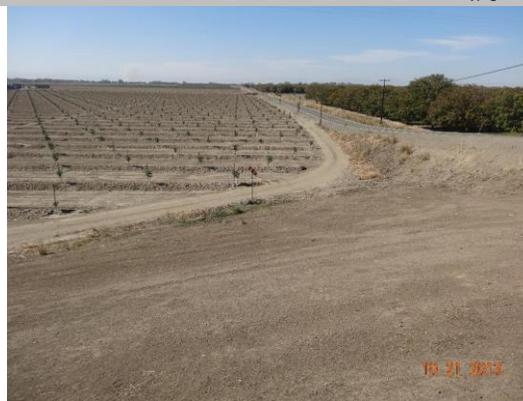
Photo 1 of 2 : UCIP_SP_2016_23479_40724.jpg

LM Start	6.12	Rating **	M	Issue No.	47
LM End	6.12	Issue Type +	En	Location *	LS
Category	Supplemental			GPS Latitude/Longitude	
				Start	End
Item	DWR UCIP Field Study			39.186652 °	39.186652 °
				-121.910549 °	-121.910549 °
DWR ID					
Comment Code					
Inspector Comment					
FS_ID:23479 DS_ID:21360 EP_NO: 4867 Repair Type: Non-Urgent Crossing Status: Found UCIP Comments: Utility marker contact information includes Contact prior to Excavation call 1-800-227-2600 or Emergency Contact 1-800-811-4111. Need to contact owner to determine status of crossing. Need date of last inspection and confirmation that crossing is still in operable condition. FIELD_STRUCT_DESC: 6.5-inch steel gas pipe through the levee, 4.0 feet below the crown. Concrete cutoff wall around pipe at center of levee. Rock revetment on waterward slope. (Permit No. 4867-1966) FS Date: 10/21/2013

View of landward side.

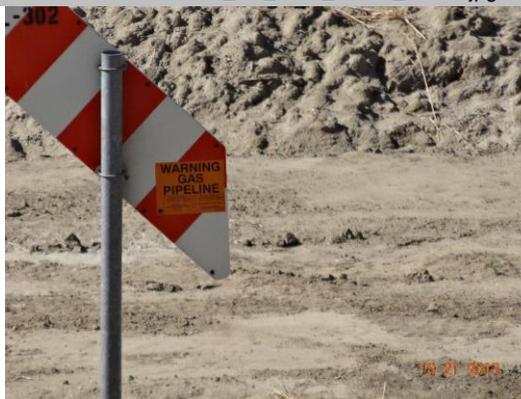
Photo 2 of 2 : UCIP_SP_2016_23479_40723.jpg

Pipeline marker on landward side.

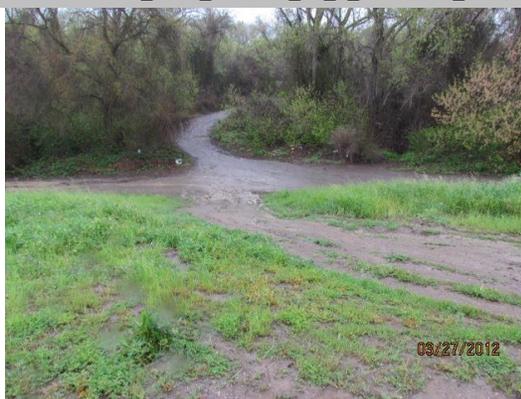
Photo 1 of 2 : SP_2016_RD0070_29_6_20160316_00001.jpg

View of vehicle erosion along the waterside slope.

LM Start	6.18	Rating **	M	Issue No.	6
LM End	6.18	Issue Type +	Ma	Location *	WS
Category	Earthen Levee			GPS Latitude/Longitude	
				Start	End
Item	Slope Stability			39.187481 °	39.187481 °
				-121.910852 °	-121.910852 °
DWR ID	DWR_RD0070_01_s_2012_6				
Comment Code					
S3 : Repair the levee slope damaged by vehicle traffic and prevent access where possible.					
Inspector Comment					
Repair the erosion along the waterside slope.

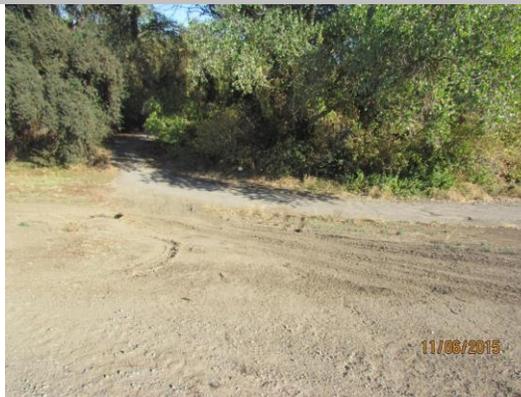
Photo 2 of 2 : SP_2016_RD0070_29_6_20160316_00002.jpg

View of the vehicle erosion along the waterside slope.

LM Start	6.18	Rating **	M	Issue No.	6 (cont)
LM End	6.18	Issue Type +	Ma	Location *	WS
Category	Earthen Levee		GPS Latitude/Longitude		
			Start	End	
Item	Slope Stability		39.187481 °	39.187481 °	
			-121.910852 °	-121.910852 °	
DWR ID	DWR_RD0070_01_s_2012_6				
Comment Code					
S3 : Repair the levee slope damaged by vehicle traffic and prevent access where possible.					
Inspector Comment					
Repair the erosion along the waterside slope.

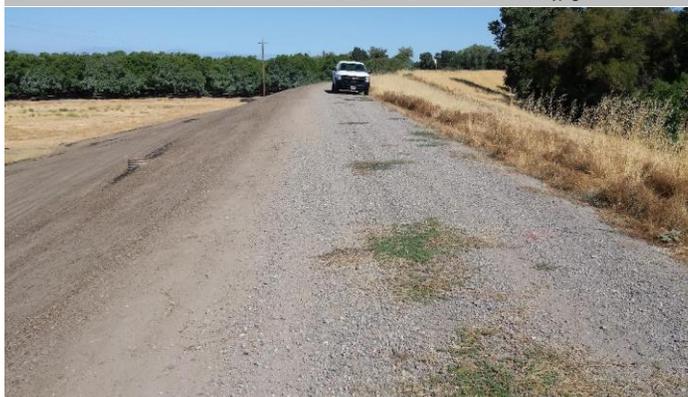
Photo 1 of 2 : UCIP_SP_2016_46422_74619.jpg

Comment Code					
Inspector Comment					
<p>FS_ID:46422 DS_ID:21341 EP_NO: 9960 Repair Type: Non-Urgent Crossing Status: Found UCIP Comments: 07/28/2015 Pipe appears still appears abandoned. Priority was downgraded from Urgent to Non-Urgent due to the inactivity. Need to contact owner to confirm status and future use. If crossing is no longer in use owner will need to coordinate with DWR inspector and CVFPB to remove according to Title 23 requirements.10/21/2013 Hole present on pipe on waterward side. This crossing was determined urgent due to hole on pipe-no signs leaks present on waterward or landward slopes. Unable to find if crossing is being used. Need to contact owner to determine crossing is still in use. If crossing is no longer in use owner will need to coordinate with DWR inspector and CVFPB to remove according to Title 23 requirements. Unable to determine if crossing is in use. This crossing is referenced in the USACE Periodic Inspection as item USACE_CESPK_MRD1_2012_p_0069. FIELD_STRUCT_DESC: 12-inch steel pipe through the levee, 6.2 feet below the crown. Siphon breaker in CM pipe riser on the landward slope. Service pole on the landward shoulder. Concrete distribution box at the landward toe. (USACE-1953). This entry matches the Drainage or Irrigation Structure referenced in O&M manual (Station 332+72). This pipe was retained under ABO No. 9960 (1974). FS Date: 7/28/2015 3:30:00 PM</p>

Overview of levee crown at crossing. No change from last inspection.

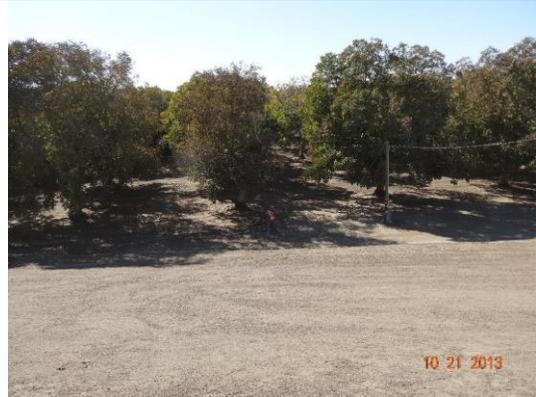
Photo 1 of 2 : UCIP_SP_2016_23523_40922.jpg

LM Start	6.74	Rating **	M	Issue No.	57
LM End	6.74	Issue Type +	En	Location *	WS
Category	Supplemental			GPS Latitude/Longitude	
				Start	End
Item	DWR UCIP Field Study			39.194042 °	39.194042 °
				-121.916630 °	-121.916630 °
DWR ID					
Comment Code					
Inspector Comment					
FS_ID:23523 DS_ID:21342 EP_NO: N/A Repair Type: Non-Urgent Crossing Status: Indicator Found UCIP Comments: Unable to determine if this is an irrigation pipe or groundwater pipe. This crossing is referenced in the USACE Periodic Inspection as item USACE_CESPK_MRD1_2012_p_0062--no permit available. FIELD_STRUCT_DESC: 8-inch (not 12-inch as found in desk study) pipe through the levee. Pump and service pole at landward toe. FS Date: 10/21/2013

View of landward side.

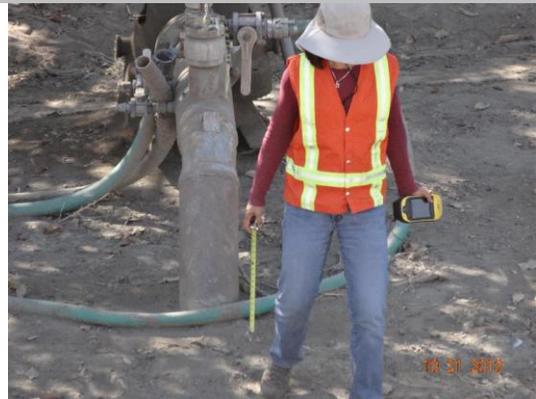
Photo 2 of 2 : UCIP_SP_2016_23523_40921.jpg

Pump system and pipe on landward side.

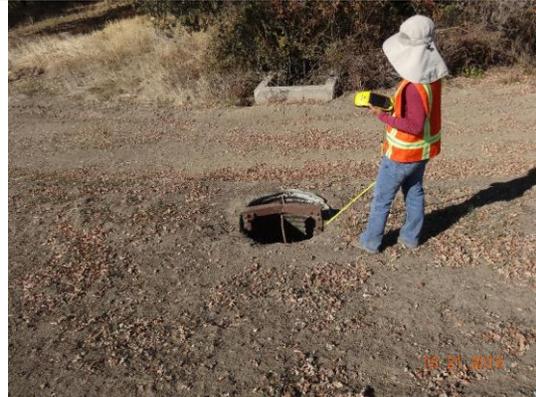
Photo 2 of 2 : UCIP_SP_2016_23529_40963.jpg

Comment Code					
Inspector Comment					
FS_ID:23529 DS_ID:21345 EP_NO: 9942 Repair Type: Non-Urgent Crossing Status: Found UCIP Comments: Dense vegetation limits the inspector's visibility to identify signs of pipe failure (leaks) along the slope. Recommend removing vegetation along pipe alignment to conduct proper inspection of structure and appurtenances. This crossing is referenced in the USACE Periodic Inspection as item USACE_CESPK_MRD1_2012_p_0005. FIELD_STRUCT_DESC: 24-inch CM pipe through the levee, 16.5 feet below the crown. Slide gate in CM pipe rise on waterward slope. Incline pump on waterward side. Discharges to concrete box at the landward toe. Service pole on landward side. (USACE-1953). This entry matches the Drainage or Irrigation Structure referenced in O&M manual (Station 330+00). This pipe was retained under ABO No. 9942 (1974). FS Date: 10/21/2013

CMP riser with screw gate inside. Gate is missing the handle to close gate.

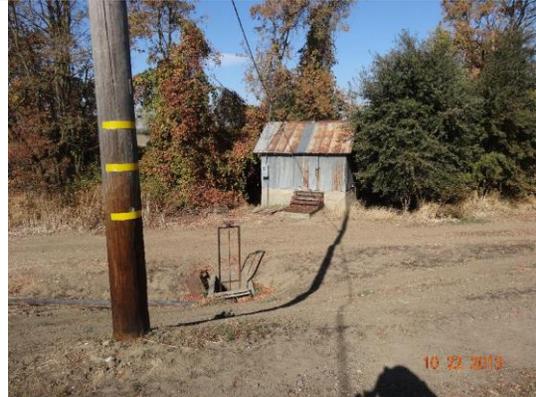
Photo 1 of 2 : UCIP_SP_2016_42923_42036.jpg

Comment Code					
Inspector Comment					
FS_ID:42923 DS_ID:21412 EP_NO: 1575 Repair Type: Non-Urgent Crossing Status: Found UCIP Comments: Debris scattered on waterward side. Concrete structure on waterward side shows major cracks on the walls. Will need to notify owner. Need to obtain maintenance records to confirm integrity of pipe. This crossing is referenced in the USACE Periodic Inspection as item USACE_CESPK_MRD2_2012_p_0075. FIELD_STRUCT_DESC: 20-inch steel pipe through the levee, 17.0 feet below the crown. Pump in pump house and slide gate (10-inch) on waterward side. Concrete collar at waterward toe. Power pole on waterward slope, anchor on landward slope. Rock revetment on waterward slope. (Permit No. 1575-1959) FS Date: 10/23/2013

View of waterward side--appurtenances present pump house, concrete distribution box, screw gate, and power pole.

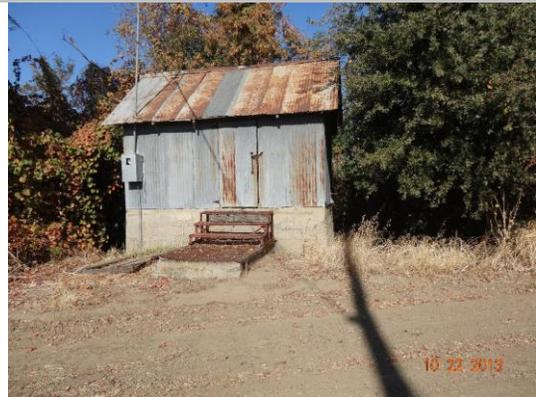
Photo 2 of 2 : UCIP_SP_2016_42923_42041.jpg

Pump station on waterward side.

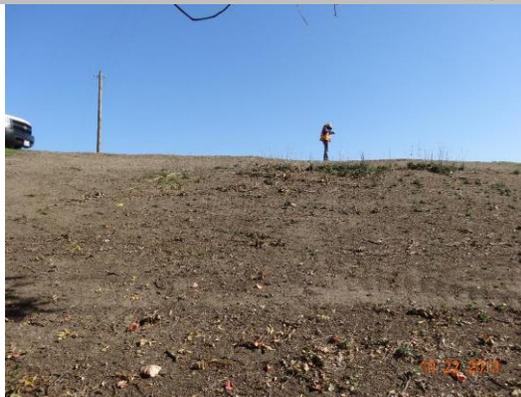
Photo 1 of 2 : UCIP_SP_2016_23885_41814.jpg

Comment Code					
Inspector Comment					
FS_ID:23885 DS_ID:21365 EP_NO: 9973 Repair Type: Non-Urgent Crossing Status: Found UCIP Comments: Cut to levee toe found on landward side. Unable to determine if crossing is being used. If crossing is no longer used by owner, the owner will need to coordinate with DWR Inspector and CVFPB to remove crossing according to Title 23 requirements. This crossing is referenced in the USACE Periodic Inspection as item USACE_CESPK_MRD2_2012_p_0099. FIELD_STRUCT_DESC: 18-inch steel pipe through the levee, 18.8 feet below the crown. Slide gate on gate structure on waterward side. Slant pump on waterward side. (USACE-1953). This entry matches the Drainage or Irrigation Structure referenced in O&M manual (Station 399+34). This pipe was retained under ABO No. 9973 (1974). FS Date: 10/22/2013

View of waterward slope.

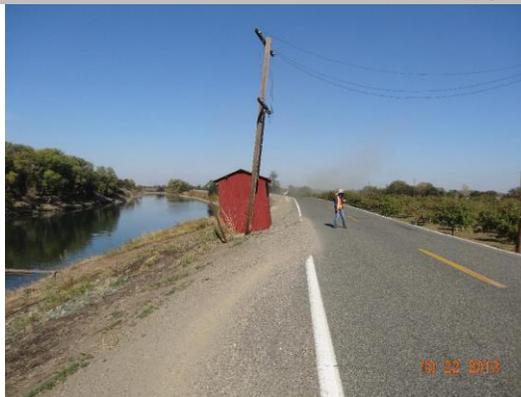
Photo 1 of 2 : UCIP_SP_2016_23888_41819.jpg

Comment Code					
Inspector Comment					
FS_ID:23888 DS_ID:21366 EP_NO: 9996 Repair Type: Non-Urgent Crossing Status: Found UCIP Comments: Need inside photo of the concrete distribution box located at the landward toe. Debris found on waterward slope (conduit running parallel to levee). This crossing is referenced in the USACE Periodic Inspection as item USACE_CESPK_MRD2_2012_p_0124. FIELD_STRUCT_DESC: 12-inch steel pipe through the levee, 24.0 feet below the crown. Gate valve in concrete "U" headwall on waterward slope. Switch house and pump on waterward shoulder. Discharge box at landward toe. This pipe was retained under ABO No. 9996 (1974). FS Date: 10/22/2013

View of levee crown and waterward side.

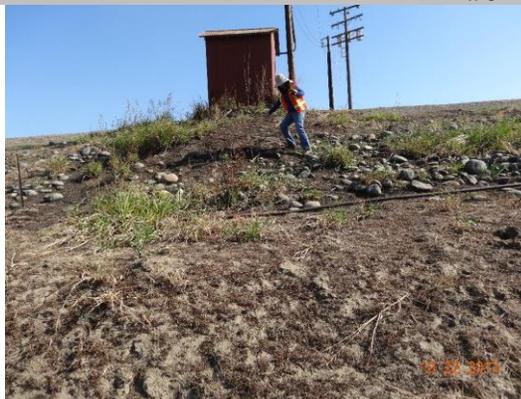
Photo 2 of 2 : UCIP_SP_2016_23888_41822.jpg

View of slope on waterward side.

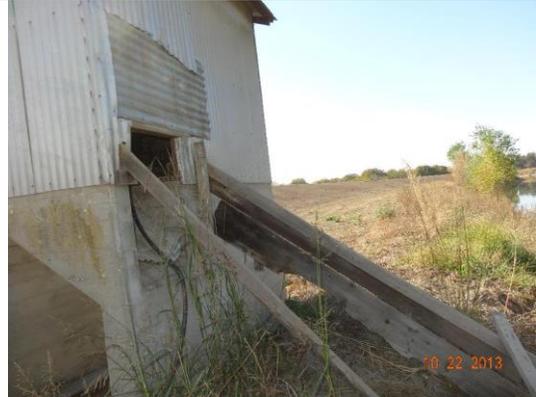
Photo 2 of 2 : UCIP_SP_2016_23964_42116.jpg

No pipe exists the pump house on waterward side.

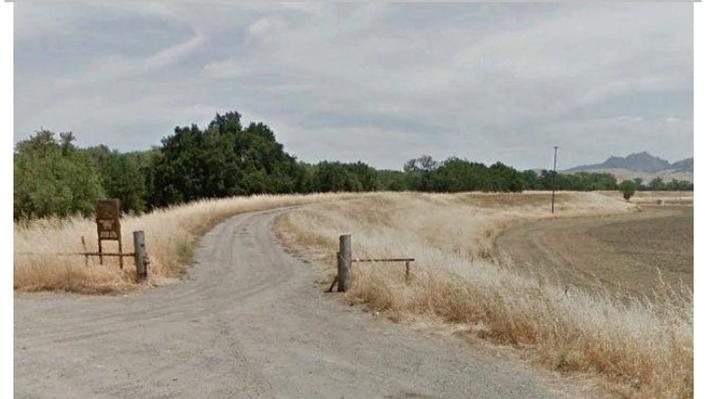
Photo 1 of 1 : SP_2016_RD0070_30_10_20160517_00027.jpg

3/29/2016: Vegetation maintained to minimal levee.

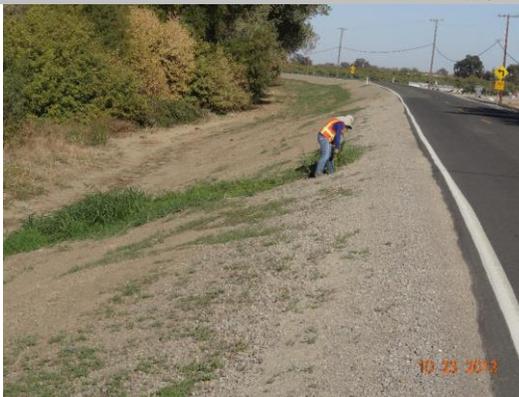
Photo 1 of 2 : UCIP_SP_2016_46401_42684.jpg

Vegetation on waterward side where leak found.

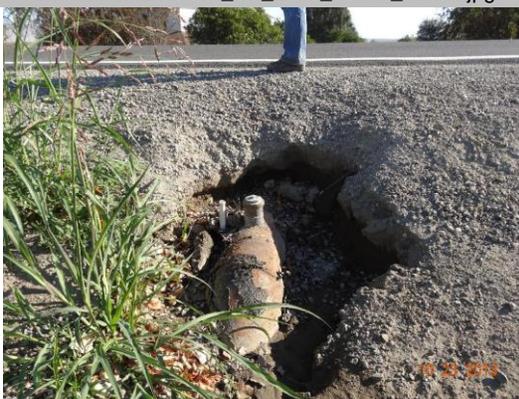
Photo 2 of 2 : UCIP_SP_2016_46401_42680.jpg

Damage to waterward shoulder due to leaky pipe or siphon breaker.

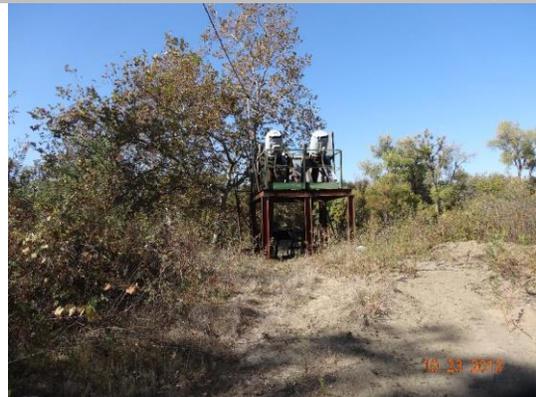
Photo 2 of 2 : UCIP_SP_2016_24196_42692.jpg

Pump station on waterward side dense vegetation on slope.

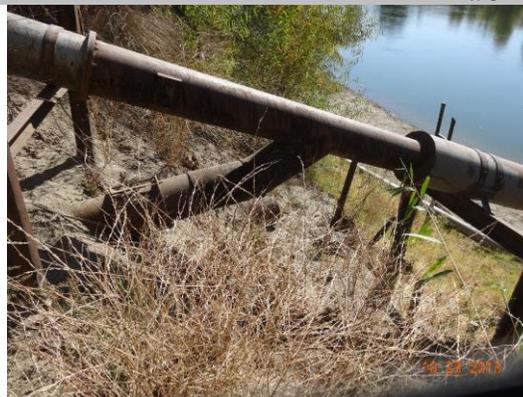
Photo 2 of 2 : UCIP_SP_2016_47033_42139.jpg

Pipe crossing on waterward side. Second pipe comes out approximately 3 feet downstream from this crossing.

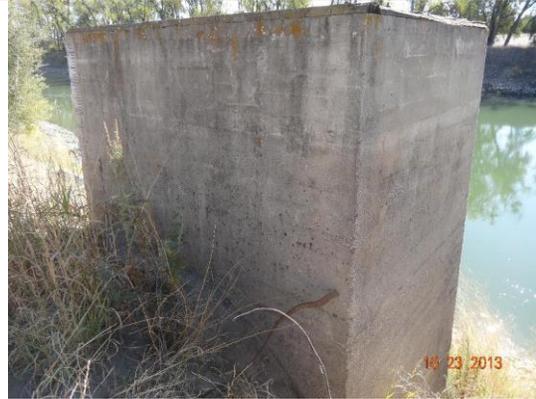
Photo 1 of 1 : UCIP_SP_2016_47039_42800.jpg

Remains of old gaging station associated with 24-inch iron pipe that extends into the river.
