**Flood Control Project Maintenance
Levee Inspections**

Maintenance Issue Types Only, Levee Inspection Report By Mile - Fall 2015

Reclamation District No. 0070 Meridian

Waterway		Bank	Unit Miles	Inspection Start/End	Inspector
Unit No. 01 Sutter Bypass		Right	7.92	11/06/2015 11/06/2015	Bob Duffey

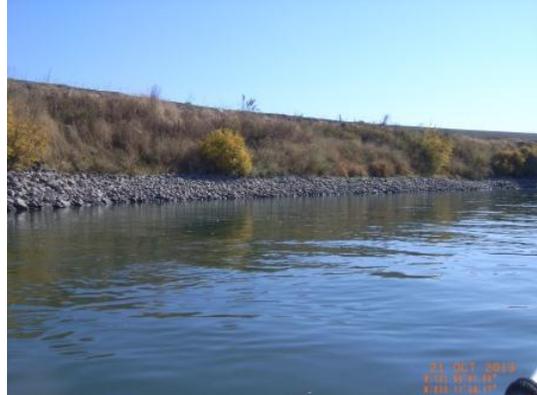
Photo 1 of 1 : USACE2013A_SAC_138-1_L_5.jpg

LM Start	0.05	Rating **	M	Issue No.	10
LM End	0.32	Issue Type +	Ma	Location *	WS
Category	Supplemental			GPS Latitude/Longitude	
				Start	End
Item	2015 USACE Erosion Survey, DRAFT			39.193219 °	39.190038 °
				-121.935783 °	-121.934199 °
DWR ID					
Action/Comments					
Inspector Comments: 1997 - Loss of cobble revetment in levee section. 2004 - New fresh erosion in a short section of the downstream end. 2010 - New deposition on cobbles. 2015: No observed changes. [2015 Site ID: SAC_138-1_L]

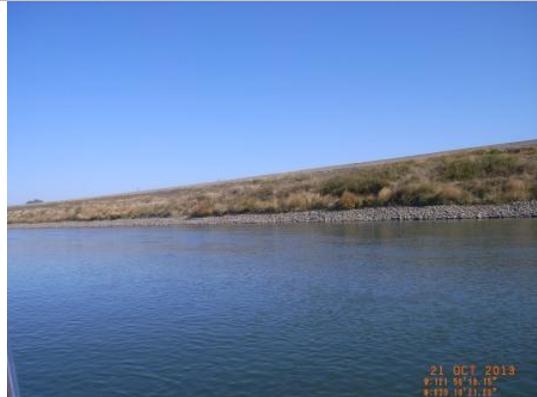
Photo 1 of 2 : USACE2013A_SAC_136-6_L_5.jpg

LM Start	1.78	Rating **	M	Issue No.	16
LM End	1.90	Issue Type +	Ma	Location *	WS
Category	Supplemental			GPS Latitude/Longitude	
				Start	End
Item	2015 USACE Erosion Survey, DRAFT			39.173912 °	39.172344 °
				-121.938745 °	-121.937925 °
DWR ID					
Action/Comments					
Inspector Comments: 1997 - Toe erosion on a cobble revetment on the outside of a low receding bend. 2012 - Toe appears pretty stable with old cobbles. 2015: No observed changes. [2015 Site ID: SAC_136-6_L]

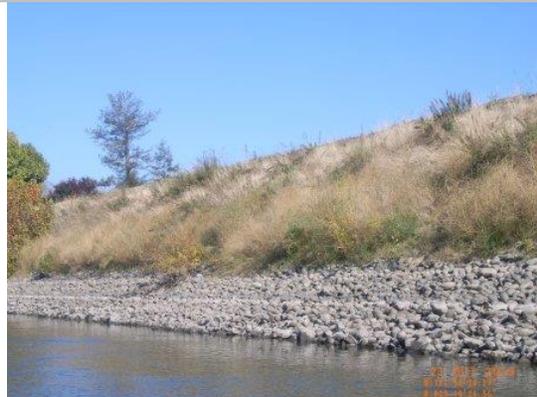
Photo 2 of 2 : USACE2013A_SAC_136-6_L_9.jpg

LM Start	1.78	Rating **	M	Issue No.	16 (cont)
LM End	1.90	Issue Type +	Ma	Location *	WS

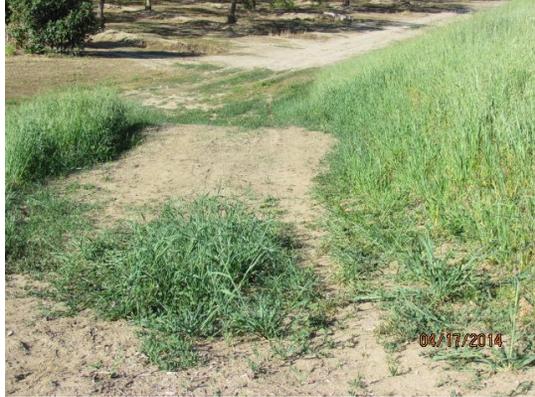
Photo 1 of 1 : FA_2015_RD0070_30_770_20150910_00021.jpg

LM Start	4.57	Rating **	M	Issue No.	770
LM End	4.57	Issue Type +	Ma	Location *	LS
Category	Earthen Levee			GPS Latitude/Longitude	
				Start	End
Item	Erosion / Bank Caving			39.141155 °	39.141155 °
				-121.919432 °	-121.919432 °
DWR ID	DWR_RD0070_02_s_2014_770				
Action/Comments					
Schedule repair of erosion site prior to the next inspection.

View of the damaged ramp along the landside slope.

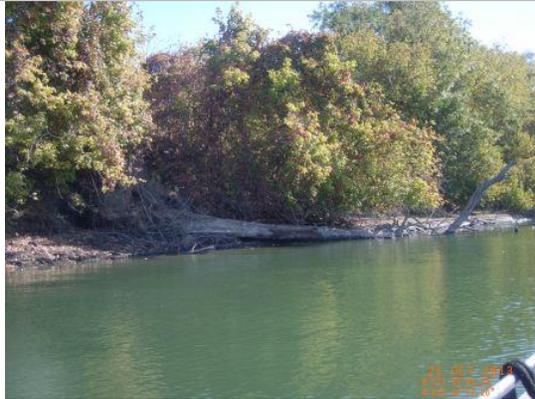
Photo 1 of 1 : USACE2013A_SAC_131-8_L_6.jpg

LM Start	6.42	Rating **	M	Issue No.	11
LM End	6.54	Issue Type +	Ma	Location *	WS
Category	Supplemental			GPS Latitude/Longitude	
				Start	End
Item	2015 USACE Erosion Survey, DRAFT			39.132040 °	39.130900 °
				-121.936521 °	-121.934690 °
DWR ID					
Action/Comments					
Inspector Comments: 2005 - (known as 132) On inside of bend. Erosion of berm toe. Levee slope is steep. Erosion probably due to eddy scour off upstream cobble. 2009 - Groins may be a good option for repair. 2010 - Scour off the upstream rock, some new erosion. 2011 - Site extended downstream. 2012 - Minor new erosion since last year and new animal holes. 2012 - Minor new erosion since last year and new animal holes. 2013 - New tree popout. 2015: No observed changes. [2015 Site ID: SAC_131-8_L]

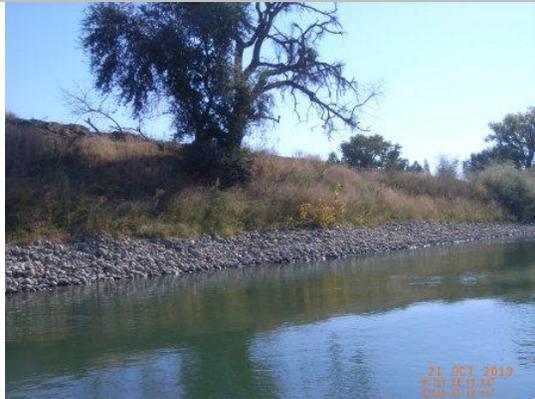
Photo 1 of 1 : USACE2013A_SAC_130-0_L_5.jpg

LM Start	8.10	Rating **	M	Issue No.	2
LM End	8.23	Issue Type +	Ma	Location *	WS
Category	Supplemental			GPS Latitude/Longitude	
				Start	End
Item	2015 USACE Erosion Survey, DRAFT			39.122459 °	39.120684 °
				-121.910121 °	-121.909152 °
DWR ID					
Action/Comments					
Inspector Comments: 1997 - Critical Site - Erosion of cobble site on outside of a bend. Failure caused by erosion of a material from behind the cobbles and cobbles rolling down the slope. Failure is just above the toe levee. Some repairs had been done at the upstream end. 2004 - Some minor new erosion at the top of the berm. 2005 - Trees look okay and the downstream end has some new rock repair. Site is no longer critical. 2006 - No longer critical, some repairs. 2015: No observed changes. [2015 Site ID: SAC_130-0_L]

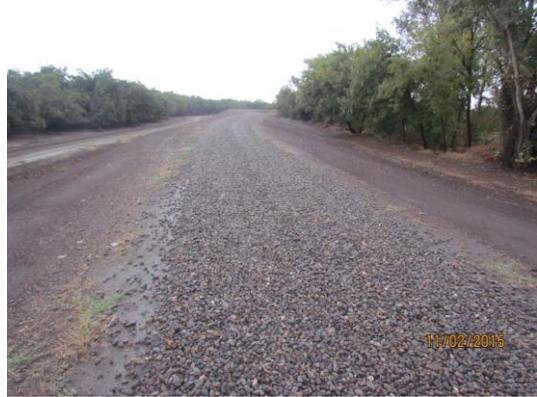
Photo 1 of 1 : FA_2015_RD0070_30_70_20151116_00058.jpg

LM Start	10.02	Rating **	A	Issue No.	70
LM End	10.02	Issue Type +	Ma	Location *	CR
Category	Earthen Levee			GPS Latitude/Longitude	
				Start	End
Item	Crown Surface / Depressions / Rutting			39.097565 °	39.097565 °
				-121.896122 °	-121.896122 °
DWR ID	DWR_RD0070_02_f_2015_70				
Action/Comments					
Add appropriate gravel or road base. Grade and compact. Inspector Comments: The Reclamation District placed gravel on the crown roadway.

View of the new gravel on the crown roadway.

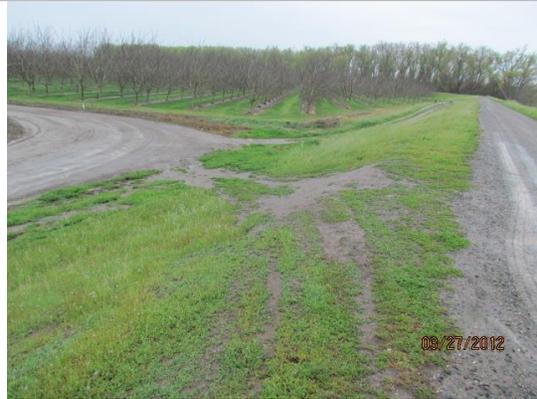
Photo 1 of 1 : FA_2015_RD0070_30_6_20150910_00005.jpg

LM Start	10.64	Rating **	M	Issue No.	6
LM End	10.64	Issue Type +	Ma	Location *	LS
Category	Earthen Levee			GPS Latitude/Longitude	
				Start	End
Item	Slope Stability			39.090300 °	39.090300 °
				-121.893102 °	-121.893102 °
DWR ID	DWR_RD0070_02_s_2012_6				
Action/Comments					
Repair the levee slope damaged by vehicle traffic and prevent access where possible.

View of vehicle erosion along landside slope.

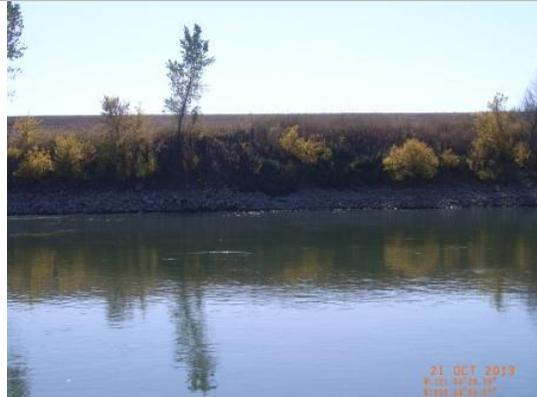
Photo 1 of 1 : USACE2013A_SAC_125-8_L_2.jpg

LM Start	11.64	Rating **	M	Issue No.	15
LM End	11.66	Issue Type +	Ma	Location *	WS
Category	Supplemental			GPS Latitude/Longitude	
				Start	End
Item	2015 USACE Erosion Survey, DRAFT			39.080669 °	39.080621 °
				-121.891164 °	-121.891564 °
DWR ID					
Action/Comments					
Inspector Comments: 2005 - Site was repaired. 2009 - Site is at upstream end of the repair site. 2011 - Still minor erosion. 2012 - Site shortened to remove non-eroding section, minor erosion with failing cobbles. 2015: No observed changes. [2015 Site ID: SAC_125-8_L]

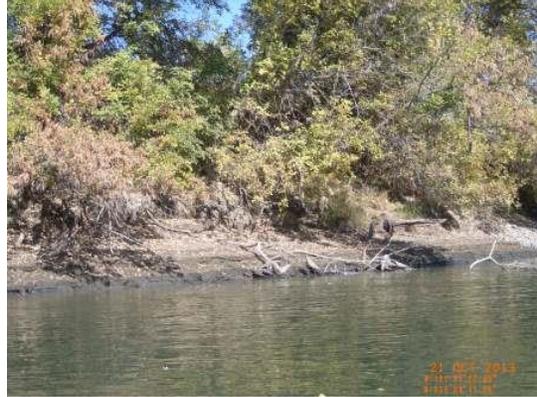
Photo 1 of 2 : USACE2013A_SAC_123-3_L_6.jpg

LM Start	14.08	Rating **	M	Issue No.	14
LM End	14.21	Issue Type +	Ma	Location *	WS
Category	Supplemental		GPS Latitude/Longitude		
			Start	End	
Item	2015 USACE Erosion Survey, DRAFT		39.069166 °	39.070105 °	
			-121.857995 °	-121.855929 °	
DWR ID					
Action/Comments					
Inspector Comments: 2006 - Erosion into the levee toe. Rock at upstream end has poor transition causing eddy scour. 2010 - Minor new erosion. 2011 - Some fresh erosion. 2012 - Additional slumping on the previously slumped bank, site extended downstream. 2015: No observed changes. [2015 Site ID: SAC_123-3_L]

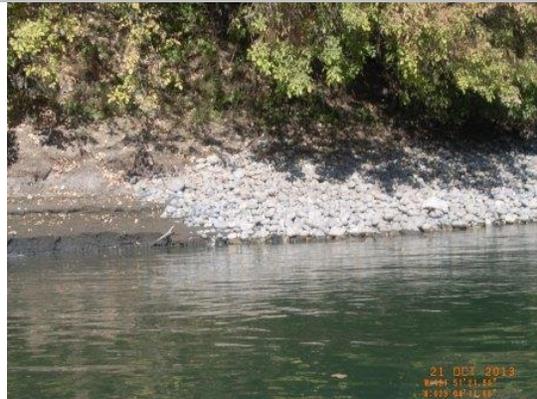
Photo 2 of 2 : USACE2013A_SAC_123-3_L_7.jpg

LM Start	14.08	Rating **	M	Issue No.	14 (cont)
LM End	14.21	Issue Type +	Ma	Location *	WS

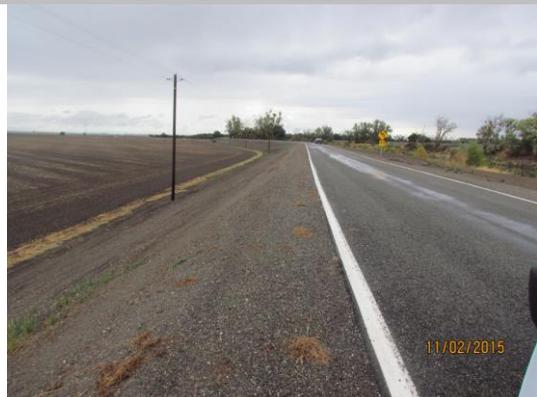
Photo 1 of 1 : FA_2015_RD0070_30_71_20151116_00060.jpg

LM Start	14.96	Rating **	A	Issue No.	71
LM End	14.96	Issue Type +	Ma	Location *	LS
Category	Earthen Levee		GPS Latitude/Longitude		
			Start	End	
Item	Vegetation		39.068708 °	39.068708 °	
			-121.844612 °	-121.844612 °	
DWR ID	DWR_RD0070_02_f_2015_71				
Action/Comments					
Control annual grass and weeds on the levee slopes and easements. Inspector Comments: The Reclamation District burned and dragged both slopes.

View of no vegetation on both slopes.

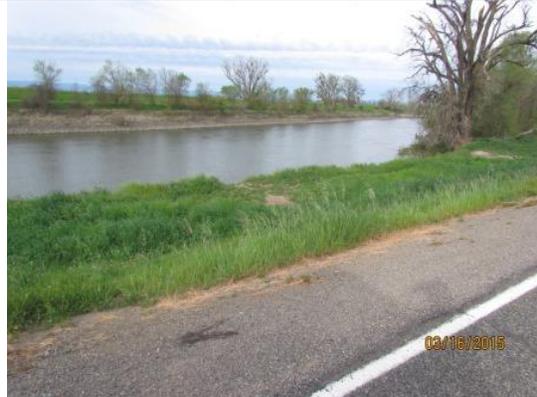
Photo 1 of 1 : FA_2015_RD0070_30_37_20150910_00019.jpg

LM Start	15.41	Rating **	M	Issue No.	37
LM End	15.41	Issue Type +	Ma	Location *	WS
Category	Earthen Levee		GPS Latitude/Longitude		
			Start	End	
Item	Erosion / Bank Caving		39.064557 °	39.064557 °	
			-121.838332 °	-121.838332 °	
DWR ID	DWR_RD0070_02_s_2015_37				
Action/Comments					
Note and monitor erosion site. Inspector Comments: Monitor the erosion along the waterside berm.

View of the erosion along waterside berm.
