**Flood Control Project Maintenance
Levee Inspections**

Maintenance Issue Types Only, Levee Inspection Report By Mile - Spring 2015

Reclamation District No. 0070 Meridian

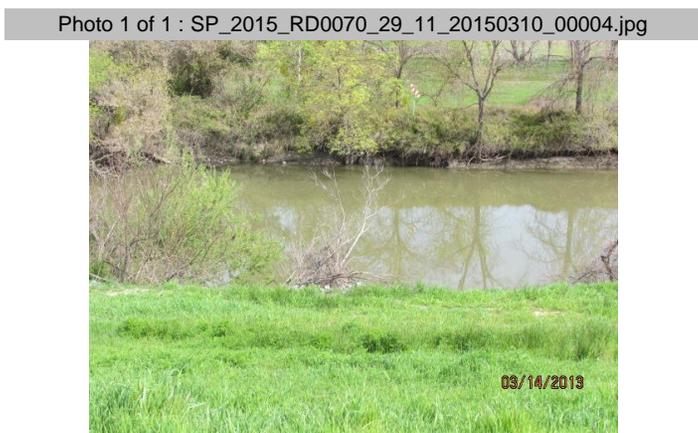
LM Start	0.46	Rating **	M	Issue No.	11
LM End	0.46	Issue Type +	Ma	Location *	WS
Category	Earthen Levee		GPS Latitude/Longitude		
			Start	End	
Item	Erosion / Bank Caving		39.141909 °	39.141909 °	
			-121.840141 °	-121.840141 °	
DWR ID	DWR_RD0070_01_s_2013_11				
Action/Comments					
Note and monitor erosion site.

View of the erosion along the waterside toe.

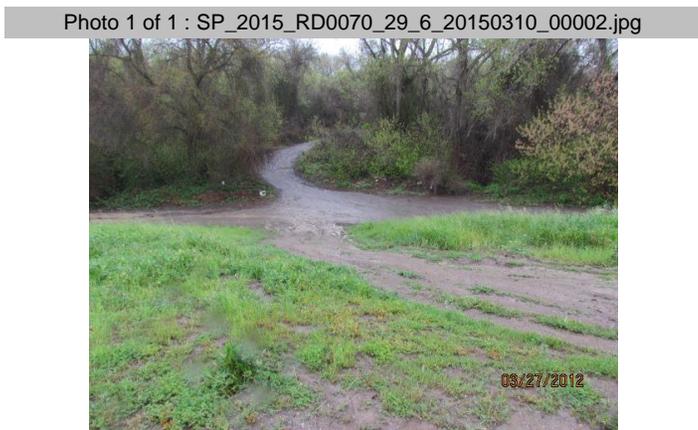
LM Start	6.18	Rating **	M	Issue No.	6
LM End	6.18	Issue Type +	Ma	Location *	WS
Category	Earthen Levee		GPS Latitude/Longitude		
			Start	End	
Item	Slope Stability		39.187481 °	39.187481 °	
			-121.910852 °	-121.910852 °	
DWR ID	DWR_RD0070_01_s_2012_6				
Action/Comments					
Repair the levee slope damaged by vehicle traffic and prevent access where possible.

View of vehicle erosion along the waterside slope.

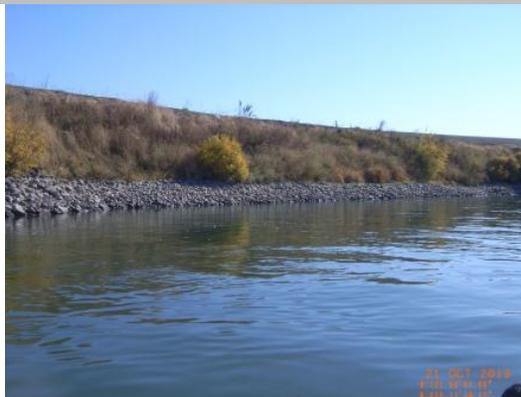
Photo 1 of 1 : SP_2015_RD0070_30_16_20150310_00014.jpg

LM Start	0.04	Rating **	M	Issue No.	16
LM End	0.32	Issue Type +	Ma	Location *	WS
Category	Supplemental		GPS Latitude/Longitude		
			Start	End	
Item	USACE Erosion Survey		39.193219 °	39.190038 °	
			-121.935783 °	-121.934199 °	
DWR ID	DWR_RD0070_02_f_2014_16				
Action/Comments					
Inspector Comments: 1997 - Loss of cobble revetment in levee section. 2004 - New fresh erosion in a short section of the downstream end. 2010 - New deposition on cobbles. 2013: No observed changes. [2013 Site ID: SAC_138-1_L]

USACE 2013 Photo #1

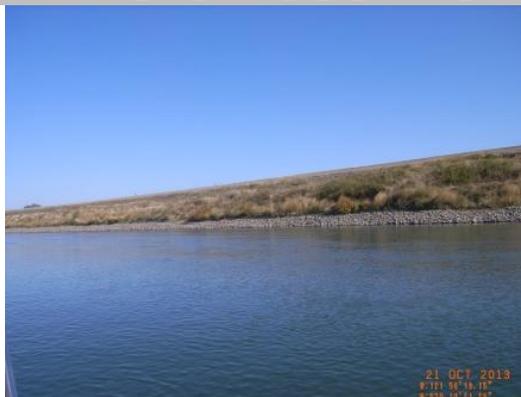
Photo 1 of 2 : SP_2015_RD0070_30_15_20150310_00012.jpg

LM Start	1.78	Rating **	M	Issue No.	15
LM End	1.90	Issue Type +	Ma	Location *	WS
Category	Supplemental		GPS Latitude/Longitude		
			Start	End	
Item	USACE Erosion Survey		39.173912 °	39.172344 °	
			-121.938745 °	-121.937925 °	
DWR ID	DWR_RD0070_02_f_2014_15				
Action/Comments					
Inspector Comments: 1997 - Toe erosion on a cobble revetment on the outside of a low receding bend. 2012 - Toe appears pretty stable with old cobbles. 2013: No observed changes. [2013 Site ID: SAC_136-6_L]

USACE 2013 Photo #1

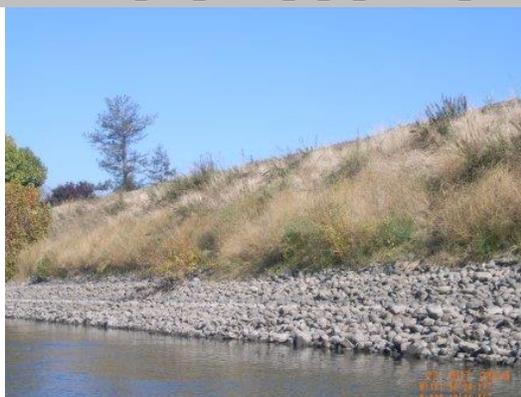
Photo 2 of 2 : SP_2015_RD0070_30_15_20150310_00013.jpg

LM Start	1.78	Rating **	M	Issue No.	15 (cont)
LM End	1.90	Issue Type +	Ma	Location *	WS

USACE 2013 Photo #2

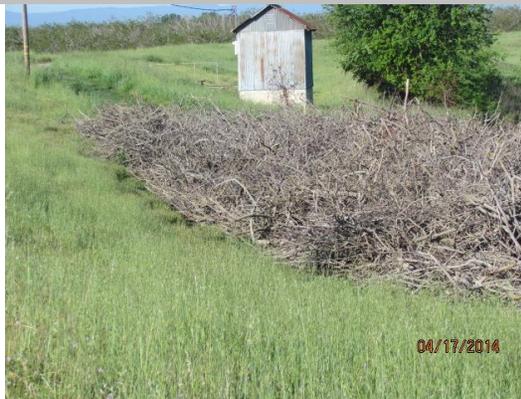
Photo 1 of 1 : SP_2015_RD0070_30_3_20150310_00004.jpg

LM Start	4.50	Rating **	M	Issue No.	3
LM End	4.54	Issue Type +	Ma	Location *	WS
Category	Earthen Levee		GPS Latitude/Longitude		
			Start	End	
Item	Encroachments		39.141707 °	39.141379 °	
			-121.918480 °	-121.918972 °	
DWR ID	DWR_RD0070_02_s_2012_3				
Action/Comments					
Prunings

View of the prunings along the waterside toe.

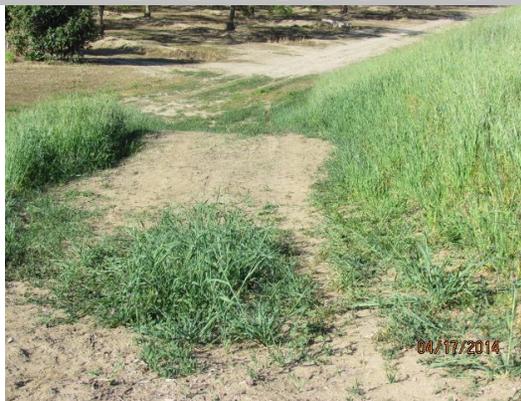
Photo 1 of 1 : SP_2015_RD0070_30_770_20150310_00020.jpg

LM Start	4.57	Rating **	M	Issue No.	770
LM End	4.57	Issue Type +	Ma	Location *	LS
Category	Earthen Levee		GPS Latitude/Longitude		
			Start	End	
Item	Erosion / Bank Caving		39.141155 °	39.141155 °	
			-121.919432 °	-121.919432 °	
DWR ID	DWR_RD0070_02_s_2014_770				
Action/Comments					
Schedule repair of erosion site prior to the next inspection.

View of the damaged ramp along the landside slope.

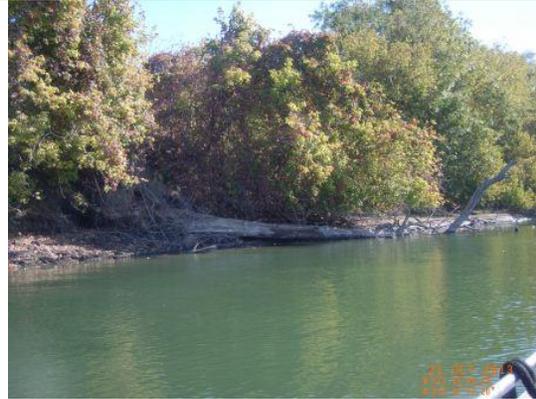
Photo 1 of 1 : SP_2015_RD0070_30_14_20150310_00011.jpg

LM Start	6.42	Rating **	M	Issue No.	14
LM End	6.54	Issue Type +	Ma	Location *	WS
Category	Supplemental		GPS Latitude/Longitude		
			Start	End	
Item	USACE Erosion Survey		39.132040 °	39.130900 °	
			-121.936521 °	-121.934690 °	
DWR ID	DWR_RD0070_02_f_2014_14				
Action/Comments					
Inspector Comments: 2005 - (known as 132) On inside of bend. Erosion of berm toe. Levee slope is steep. Erosion probably due to eddy scour off upstream cobble. 2009 - Groins may be a good option for repair. 2010 - Scour off the upstream rock, some new erosion. 2011 - Site extended downstream. 2012 - Minor new erosion since last year and new animal holes. 2012 - Minor new erosion since last year and new animal holes. 2013: New tree popout. [2013 Site ID: SAC_131-8_L]

USACE 2013 Photo #1

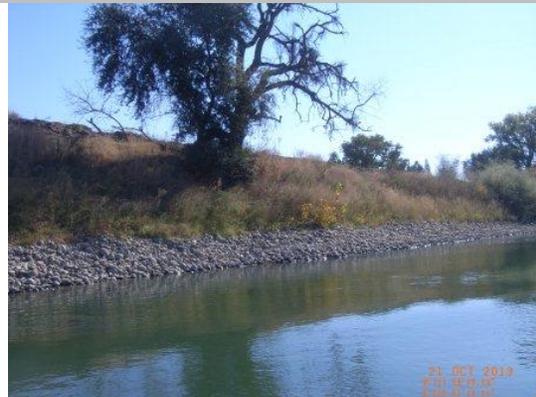
Photo 1 of 1 : SP_2015_RD0070_30_11_20150310_00008.jpg

LM Start	8.10	Rating **	M	Issue No.	11
LM End	8.32	Issue Type +	Ma	Location *	WS
Category	Supplemental		GPS Latitude/Longitude		
			Start	End	
Item	USACE Erosion Survey		39.122459 °	39.120684 °	
			-121.910121 °	-121.909152 °	
DWR ID	DWR_RD0070_02_f_2014_11				
Action/Comments					
Inspector Comments: 1997 - Critical Site - Erosion of cobble site on outside of a bend. Failure caused by erosion of a material from behind the cobbles and cobbles rolling down the slope. Failure is just above the toe levee. Some repairs had been done at the upstream end. 2004 - Some minor new erosion at the top of the berm. 2005 - Trees look okay and the downstream end has some new rock repair. Site is no longer critical. 2006 - No longer critical, some repairs. 2013: No observed changes. [2013 Site ID: SAC_130-0_L]

USACE 2013 Photo #1

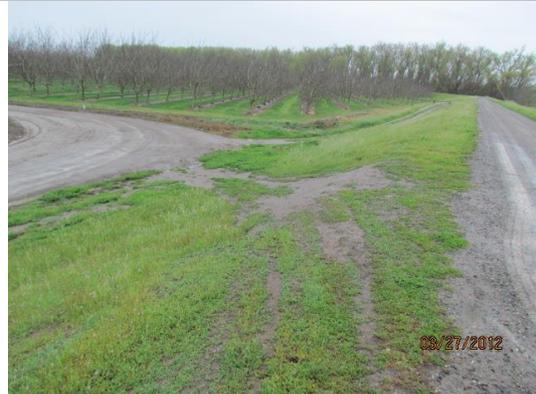
Photo 1 of 1 : SP_2015_RD0070_30_6_20150310_00005.jpg

LM Start	10.64	Rating **	M	Issue No.	6
LM End	10.64	Issue Type +	Ma	Location *	LS
Category	Earthen Levee		GPS Latitude/Longitude		
			Start	End	
Item	Slope Stability		39.090300 °	39.090300 °	
			-121.893102 °	-121.893102 °	
DWR ID	DWR_RD0070_02_s_2012_6				
Action/Comments					
Repair the levee slope damaged by vehicle traffic and prevent access where possible.

View of vehicle erosion along landside slope.

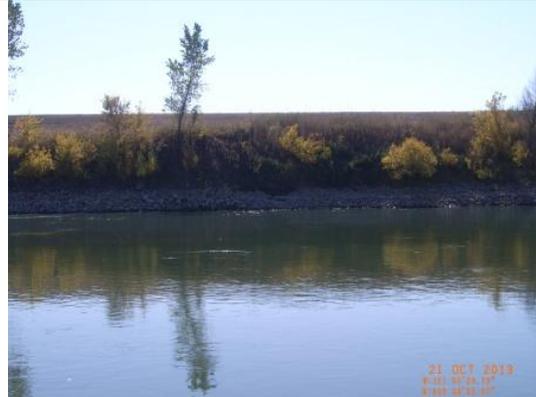
Photo 1 of 1 : SP_2015_RD0070_30_10_20150310_00007.jpg

LM Start	11.64	Rating **	M	Issue No.	10
LM End	11.66	Issue Type +	Ma	Location *	WS
Category	Supplemental			GPS Latitude/Longitude	
				Start	End
Item	USACE Erosion Survey			39.080669 °	39.080621 °
				-121.891164 °	-121.891564 °
DWR ID	DWR_RD0070_02_f_2014_10				
Action/Comments					
Inspector Comments: 2005 - Site was repaired. 2009 - Site is at upstream end of the repair site. 2011 - Still minor erosion. 2012 - Site shortened to remove non-eroding section, minor erosion with failing cobbles. 2013: No observed changes. [2013 Site ID: SAC_125-8_L]

USACE 2013 Photo #1

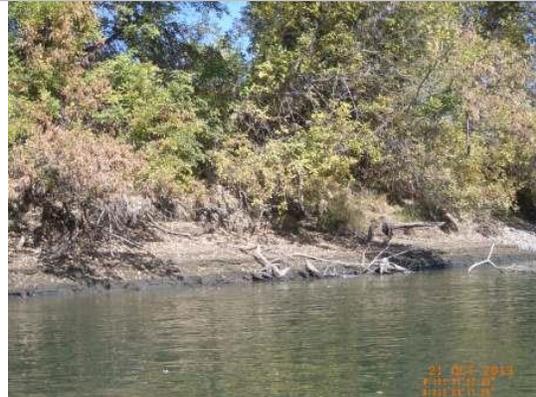
Photo 1 of 2 : SP_2015_RD0070_30_2_20150310_00002.jpg

LM Start	14.08	Rating **	M	Issue No.	2
LM End	14.21	Issue Type +	Ma	Location *	WS
Category	Supplemental			GPS Latitude/Longitude	
				Start	End
Item	USACE Erosion Survey			39.069166 °	39.070105 °
				-121.857995 °	-121.855929 °
DWR ID	DWR_RD0070_02_f_2014_2				
Action/Comments					
Inspector Comments: 2006 - Erosion into the levee toe. Rock at upstream end has poor transition causing eddy scour. 2010 - Minor new erosion. 2011 - Some fresh erosion. 2012 - Additional slumping on the previously slumped bank, site extended downstream. 2013: No observed changes. [2013 Site ID: SAC_123-3_L]

USACE 2013 Photo #1

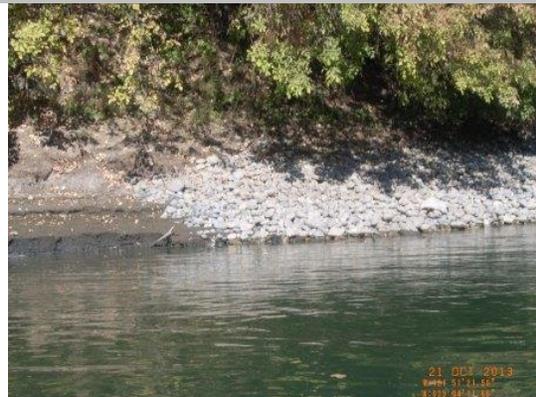
Photo 2 of 2 : SP_2015_RD0070_30_2_20150310_00003.jpg

LM Start	14.08	Rating **	M	Issue No.	2 (cont)
LM End	14.21	Issue Type +	Ma	Location *	WS

USACE 2013 Photo #2

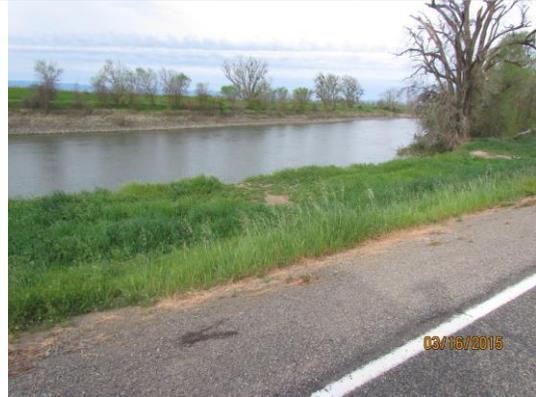
Photo 1 of 1 : SP_2015_RD0070_30_37_20150406_00053.jpg

LM Start	15.41	Rating **	M	Issue No.	37
LM End	15.41	Issue Type +	Ma	Location *	WS
Category	Earthen Levee		GPS Latitude/Longitude		
			Start	End	
Item	Erosion / Bank Caving		39.064557 °	39.064557 °	
			-121.838332 °	-121.838332 °	
DWR ID	DWR_RD0070_02_s_2015_37				
Action/Comments					
Note and monitor erosion site. Inspector Comments: Monitor the erosion along the waterside berm.

View of the erosion along waterside berm.
