**Flood Control Project Maintenance  
Levee Inspections**

**Maintenance Issue Types Only, Levee Inspection Report By Mile - Spring 2016**

**Reclamation District No. 0070 Meridian**

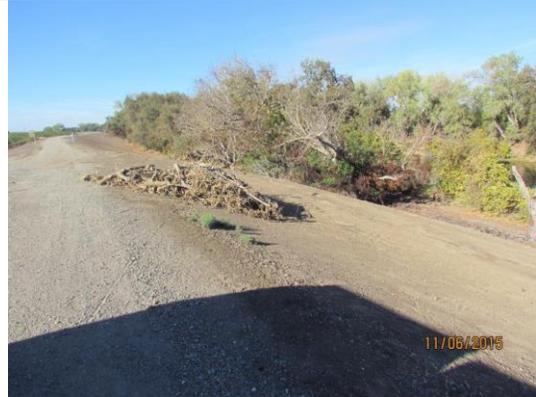
Photo 1 of 1 : SP\_2016\_RD0070\_29\_38\_20160316\_00005.jpg

LM Start	<b>4.60</b>	Rating **	U	Issue No.	<b>38</b>
LM End	<b>4.60</b>	Issue Type +	Ma	Location *	WS
Category	Earthen Levee		GPS Latitude/Longitude		
			Start	End	
Item	Encroachments		39.167597 °	39.167597 °	
			-121.899363 °	-121.899363 °	
DWR ID	DWR_RD0070_01_f_2015_38				
Comment Code					
PR : Prunings					
Inspector Comment					
Remove the prunings from the waterside slope.

View of the prunings along the waterside slope.

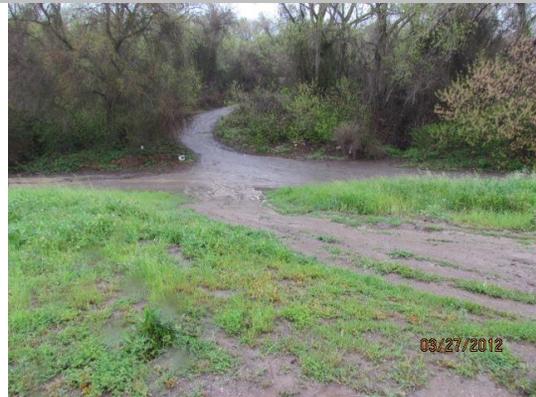
Photo 1 of 2 : SP\_2016\_RD0070\_29\_6\_20160316\_00001.jpg

LM Start	<b>6.18</b>	Rating **	M	Issue No.	<b>6</b>
LM End	<b>6.18</b>	Issue Type +	Ma	Location *	WS
Category	Earthen Levee		GPS Latitude/Longitude		
			Start	End	
Item	Slope Stability		39.187481 °	39.187481 °	
			-121.910852 °	-121.910852 °	
DWR ID	DWR_RD0070_01_s_2012_6				
Comment Code					
S3 : Repair the levee slope damaged by vehicle traffic and prevent access where possible.					
Inspector Comment					
Repair the erosion along the waterside slope.

View of vehicle erosion along the waterside slope.

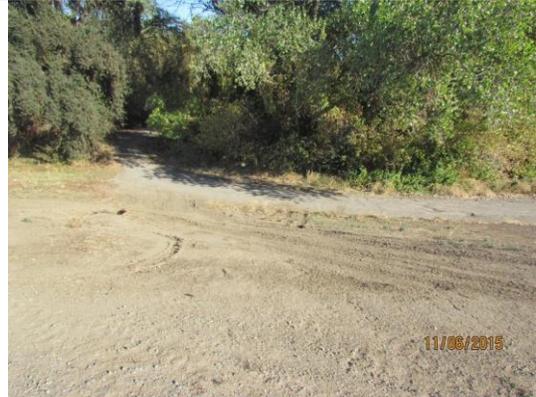
Photo 2 of 2 : SP\_2016\_RD0070\_29\_6\_20160316\_00002.jpg

LM Start	<b>6.18</b>	Rating **	M	Issue No.	<b>6 (cont)</b>	
LM End	<b>6.18</b>	Issue Type +	Ma	Location *	WS	
Category	Earthen Levee			GPS Latitude/Longitude		
				Start	End	
Item	Slope Stability			39.187481 °	39.187481 °	
				-121.910852 °	-121.910852 °	
DWR ID	DWR_RD0070_01_s_2012_6					
Comment Code						
S3 : Repair the levee slope damaged by vehicle traffic and prevent access where possible.						
Inspector Comment						
Repair the erosion along the waterside slope.

View of the vehicle erosion along the waterside slope.

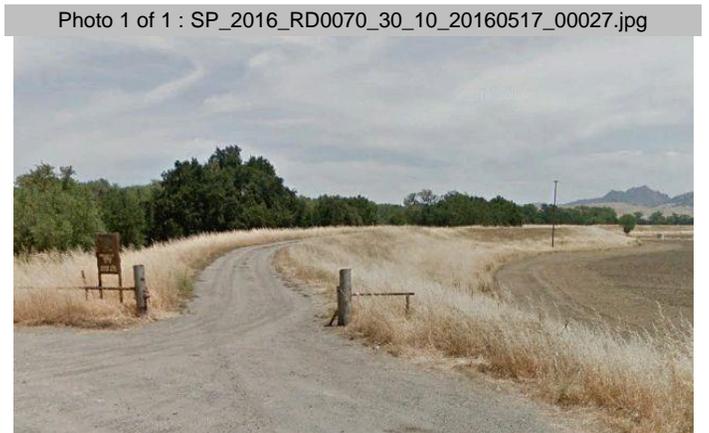
LM Start	<b>7.91</b>	Rating **	A	Issue No.	<b>10</b>
LM End	<b>7.91</b>	Issue Type +	Ma	Location *	LS
Category	Earthen Levee		GPS Latitude/Longitude		
			Start	End	
Item	Vegetation		39.194151 °	39.194151 °	
			-121.935424 °	-121.935424 °	
DWR ID	DWR_RD0070_02_s_2016_10				
Comment Code					
V1 : Control annual grass and weeds on the levee slopes and easements.					
Inspector Comment					
Vegetation well maintained by LMA.

3/29/2016: Vegetation maintained to minimal leve.

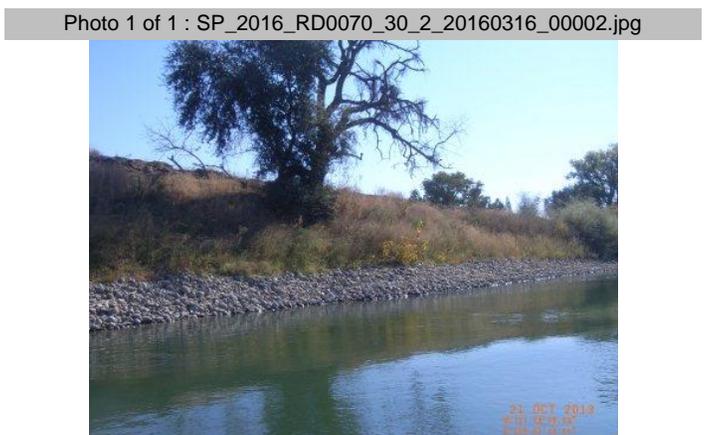
USACE 2013 Photo #1

LM Start	<b>8.10</b>	Rating **	M	Issue No.	<b>2</b>
LM End	<b>8.23</b>	Issue Type +	Ma	Location *	WS
Category	Supplemental		GPS Latitude/Longitude		
			Start	End	
Item	2015 USACE Erosion Survey, DRAFT		39.122459 °	39.120684 °	
			-121.910121 °	-121.909152 °	
DWR ID	DWR_RD0070_02_s_2016_2				
Comment Code					
Inspector Comment					
1997 - Critical Site - Erosion of cobble site on outside of a bend. Failure caused by erosion of a material from behind the cobbles and cobbles rolling down the slope. Failure is just above the toe levee. Some repairs had been done at the upstream end. 2004 - Some minor new erosion at the top of the berm. 2005 - Trees look okay and the downstream end has some new rock repair. Site is no longer critical. 2006 - No longer critical, some repairs. 2015: No observed changes. [2015 Site ID: SAC_130-0_L]

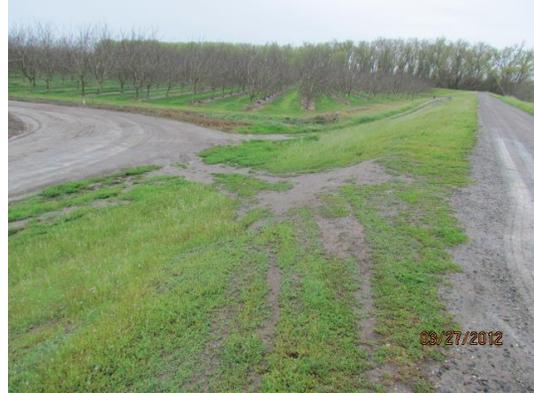
Photo 1 of 1 : SP\_2016\_RD0070\_30\_6\_20160316\_00003.jpg

LM Start	<b>10.64</b>	Rating **	M	Issue No.	<b>6</b>
LM End	<b>10.64</b>	Issue Type +	Ma	Location *	LS
Category	Earthen Levee		GPS Latitude/Longitude		
			Start	End	
Item	Slope Stability		39.090300 °	39.090300 °	
			-121.893102 °	-121.893102 °	
DWR ID	DWR_RD0070_02_s_2012_6				
Comment Code					
S3 : Repair the levee slope damaged by vehicle traffic and prevent access where possible.					
Inspector Comment

View of vehicle erosion along landside slope.
