**Flood Control Project Maintenance
Levee Inspections**

Fall 2011 Levee Maintenance Deficiency Summary Report

Reclamation District No. 0108 River Farms

Waterway				Bank	Unit Miles	Inspection Start/End	Inspector
Unit No. 01 Colusa Basin Drain				Left	20.59	10/03/2011 10/03/2011	John Williamson

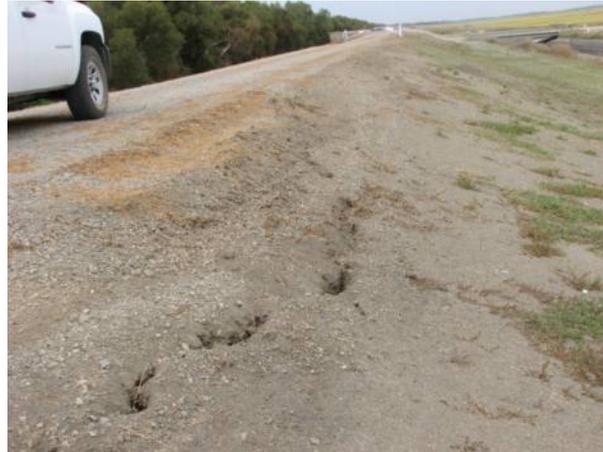
Levee Mile Report Line	8
Start Levee Mile	14.44
End Levee Mile	14.51
Location	Land Side
Category	Earthen Levee
Item	Cracking

A view of the crack at its widest point. Photo taken fall 2011.

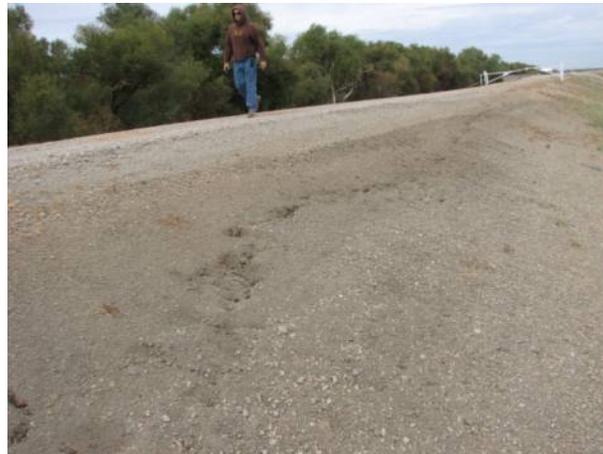
Levee Mile Report Line	8
Start Levee Mile	14.44
End Levee Mile	14.51
Location	Land Side
Category	Earthen Levee
Item	Cracking

A view of the upstream end of the crack which run about 250 feet long.

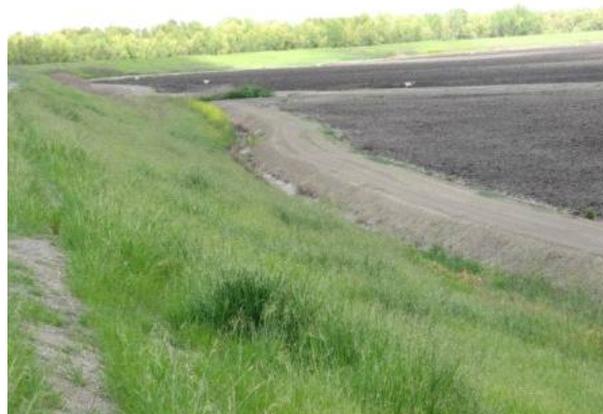
Levee Mile Report Line	10
Start Levee Mile	18.88
End Levee Mile	19.60
Location	Land Side
Category	Earthen Levee
Item	Encroachments

10	18.88	19.60	Earthen Levee	Encroachments	LS	PO	Agricultural Ditch	39.013245 ° -121.980795 °	39.021302 ° -121.988557 °	6 Y
11	19.16	19.16	Supplemental	USACE Erosion Survey	WS	M	Inspector Comments: 2011: Toe scour at the bottom of a steep bank, large sections of the toe are sliding down. Erosion may be due to the upstream bend. [2011 Site ID: CBD_19-2_L]	39.016727 ° -121.985411 °	39.017516 ° -121.986374 °	3 Y
12	19.27	19.27	Earthen Levee	Vegetation	WS	M	Remove the wild growth other than native grasses from the levee slopes. Inspector Comments: Arundo	39.017443 ° -121.985710 °	39.017443 ° -121.985710 °	9 Y

Ag. ditch

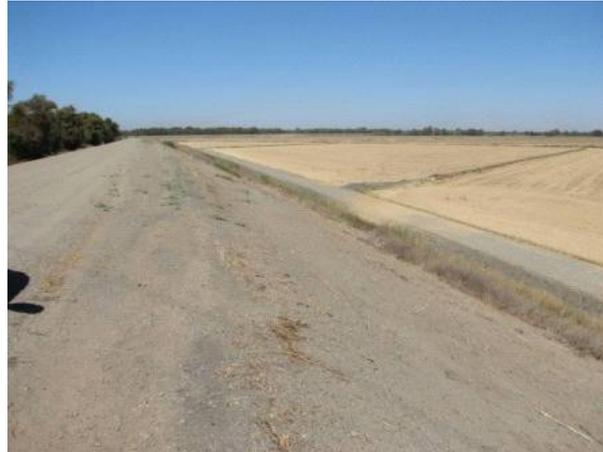
Levee Mile Report Line	10
Start Levee Mile	18.88
End Levee Mile	19.60
Location	Land Side
Category	Earthen Levee
Item	Encroachments
Ag ditch along toe of landside photo taken fall 2011.	
johngw_f_20110923_965.jpg

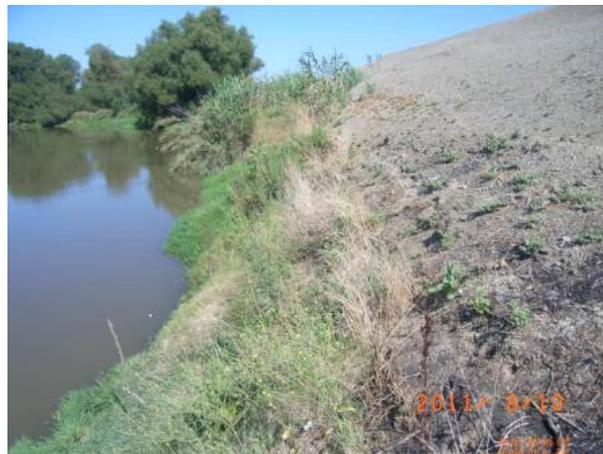
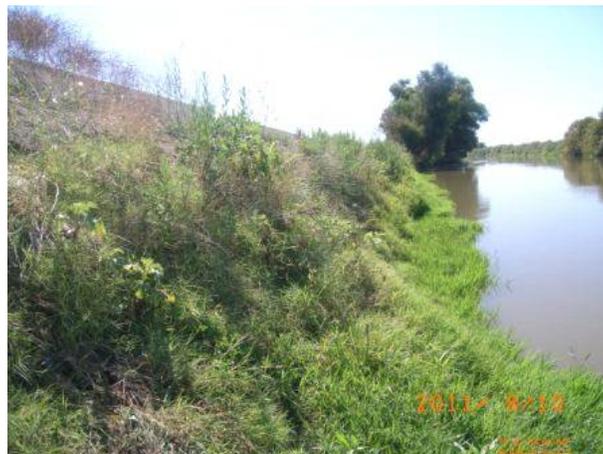
Levee Mile Report Line	11
Start Levee Mile	19.16
End Levee Mile	19.16
Location	Water Side
Category	Supplemental
Item	USACE Erosion Survey
USACE 2011 Photo #1	
USACE2011_CBD_19-2_L_1.jpg

Levee Mile Report Line	11
Start Levee Mile	19.16
End Levee Mile	19.16
Location	Water Side
Category	Supplemental
Item	USACE Erosion Survey
USACE 2011 Photo #2	
USACE2011_CBD_19-2_L_2.jpg

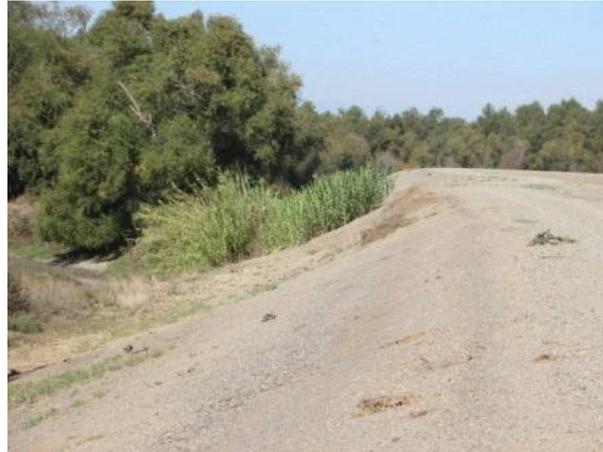
Levee Mile Report Line	12
Start Levee Mile	19.27
End Levee Mile	19.27
Location	Water Side
Category	Earthen Levee
Item	Vegetation
Arundo is growing on the slope.	
johngw_f_20110923_966.jpg

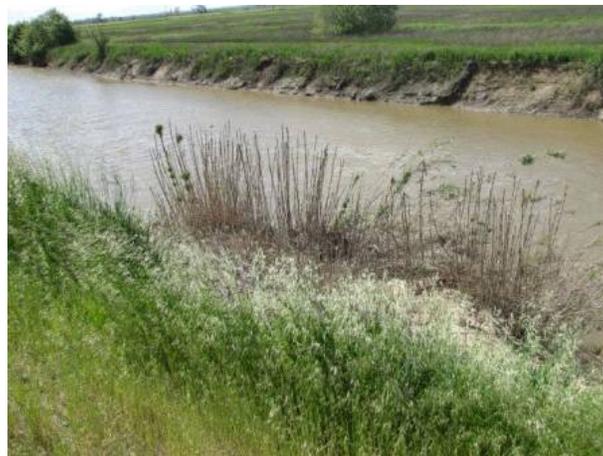
Levee Mile Report Line	12
Start Levee Mile	19.27
End Levee Mile	19.27
Location	Water Side
Category	Earthen Levee
Item	Vegetation
The district has made great efforts to eliminate the Arundo.	
johngw_f_20110923_967.jpg
