**Flood Control Project Maintenance  
Levee Inspections**

**Fall 2009 Levee Maintenance Deficiency Summary Report**

**Reclamation District No. 0108 River Farms**

Waterway		Bank	Unit Miles
Unit No. 01 Colusa Basin Drain		Left	20.59

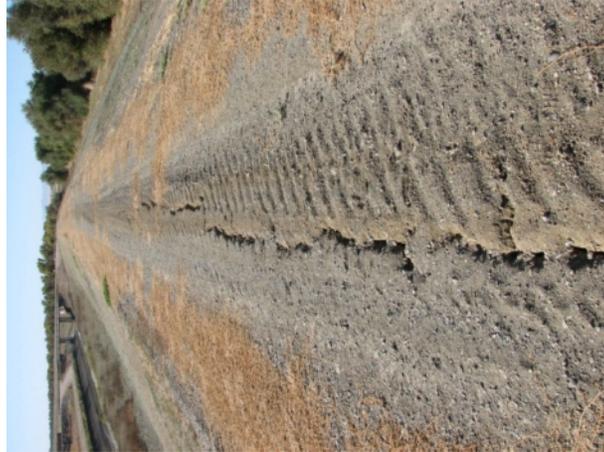
Levee Mile Report Line	11
Start Levee Mile	11.36
End Levee Mile	11.36
Location	Crown
Category	Earthen Levee
Item	Cracking
down center of crown	
johngw_20091007_34.jpg

11	11.36	11.36	Earthen Levee	Cracking	CR	M	Schedule repair of subsidence prior to the next inspection.	38.927606 ° -121.913309 °	38.927606 ° -121.913309 °	26 Y
12	11.52	11.52	Earthen Levee	Cracking	CR	M	Monitor and have inspected by geotechnical engineer.	38.929692 ° -121.912190 °	38.929692 ° -121.912190 °	27 Y
13	11.72	11.72	Earthen Levee	Cracking	CR	M	Monitor and have inspected by geotechnical engineer.	38.932417 ° -121.910782 °	38.932417 ° -121.910782 °	28
14	18.88	19.60	Earthen Levee	Encroachments	LS	PO	Agricultural Ditch	39.013245 ° -121.980795 °	39.021302 ° -121.988557 °	6 Y
15	19.10	19.10	Earthen Levee	Vegetation	WS	M	Remove the wild growth other than native grasses from the levee slopes. Inspector Comments: Arundo	39.015553 ° -121.983767 °	39.015553 ° -121.983767 °	12 Y
16	19.27	19.27	Earthen Levee	Vegetation	WS	M	Remove the wild growth other than native grasses from the levee slopes. Inspector Comments: Arundo	39.017443 ° -121.985710 °	39.017443 ° -121.985710 °	9 Y

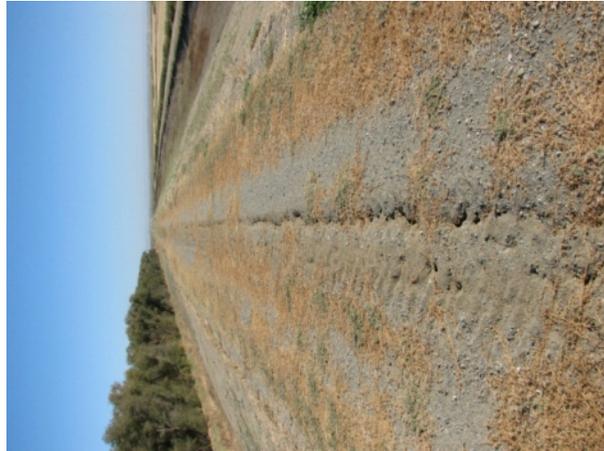
Levee Mile Report Line	12
Start Levee Mile	11.52
End Levee Mile	11.52
Location	Crown
Category	Earthen Levee
Item	Cracking
more cracking smaller cracking through out this area	
johngw_20091007_35.jpg

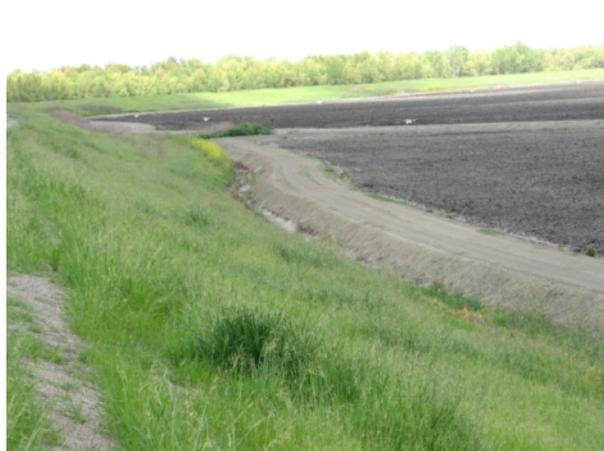
Levee Mile Report Line	14
Start Levee Mile	18.88
End Levee Mile	19.60
Location	Land Side
Category	Earthen Levee
Item	Encroachments
Ag. ditch	
johngw_20090924_12.jpg

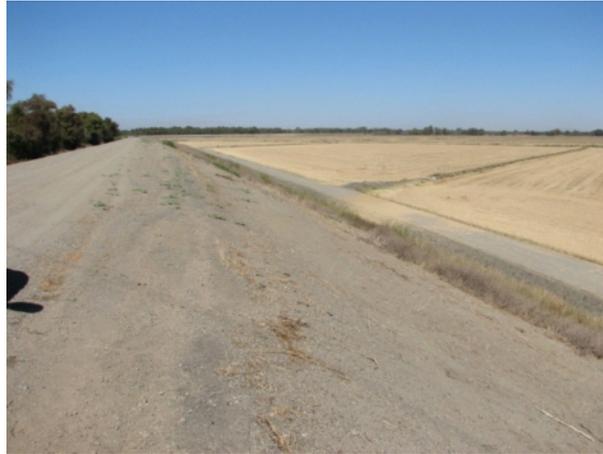
Levee Mile Report Line	14
Start Levee Mile	18.88
End Levee Mile	19.60
Location	Land Side
Category	Earthen Levee
Item	Encroachments
Ag ditch along toe of landside	
johngw_20091007_36.jpg

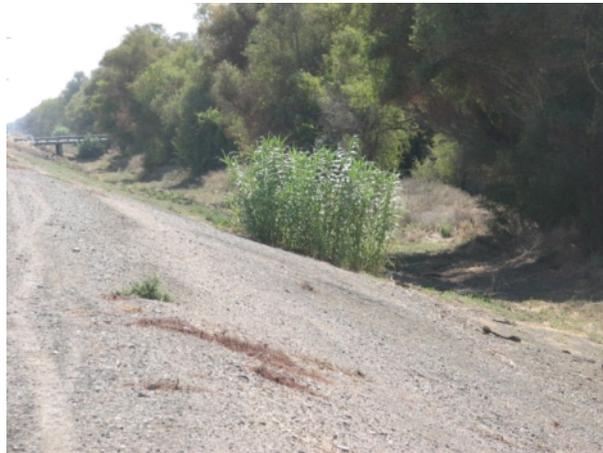
Levee Mile Report Line	15
Start Levee Mile	19.10
End Levee Mile	19.10
Location	Water Side
Category	Earthen Levee
Item	Vegetation
Arundo on slope	
johngw_20091007_37.jpg

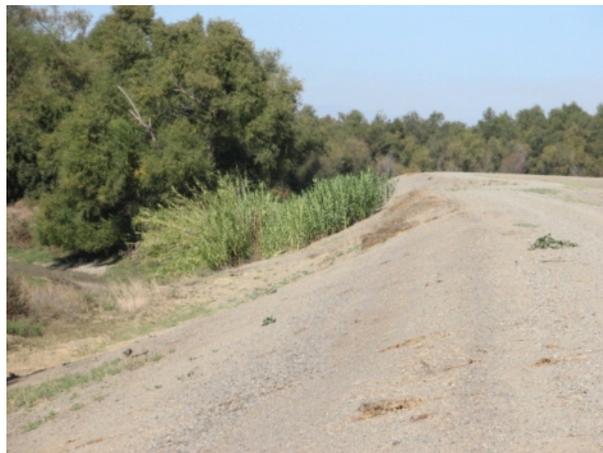
Levee Mile Report Line	16
Start Levee Mile	19.27
End Levee Mile	19.27
Location	Water Side
Category	Earthen Levee
Item	Vegetation
more Arundo on slope	
johngw_20091007_38.jpg
