**Flood Control Project Maintenance
Levee Inspections**

Fall 2012 Levee Maintenance Deficiency Summary Report

Sacramento River Basin

Reclamation District No. 0108 River Farms

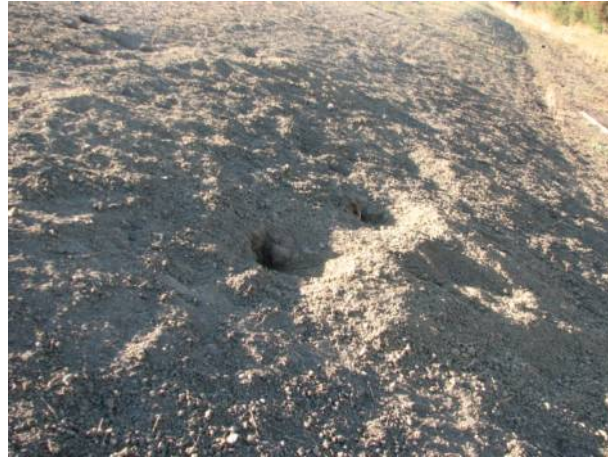
Levee Mile Report Line	10
Start Levee Mile	11.52
End Levee Mile	11.52
Location	Water Side
Category	Earthen Levee
Item	Animal Control

Rodent holes on the waterside levee slope. Fall 2012

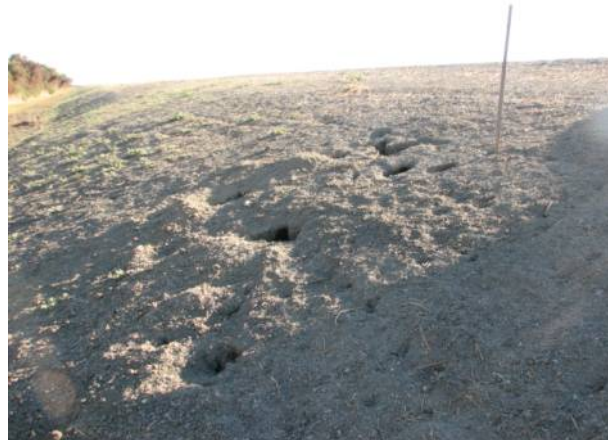
Levee Mile Report Line	10
Start Levee Mile	11.52
End Levee Mile	11.52
Location	Water Side
Category	Earthen Levee
Item	Animal Control

A colony of rodents on the waterside slope. Fall 2012

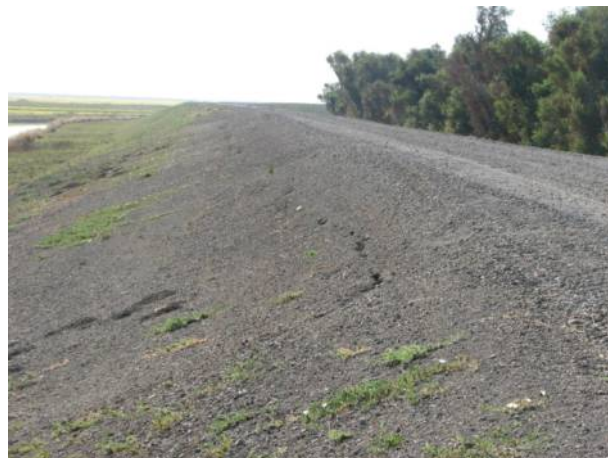
Levee Mile Report Line	11
Start Levee Mile	14.54
End Levee Mile	14.54
Location	Land Side
Category	Earthen Levee
Item	Cracking

A crack running along the landside shoulder app. 50' long. Fall 2012

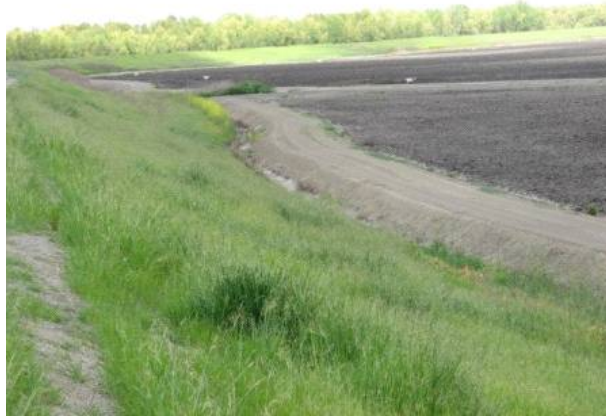
Levee Mile Report Line	12
Start Levee Mile	18.88
End Levee Mile	19.60
Location	Land Side
Category	Earthen Levee
Item	Encroachments

Ag. ditch

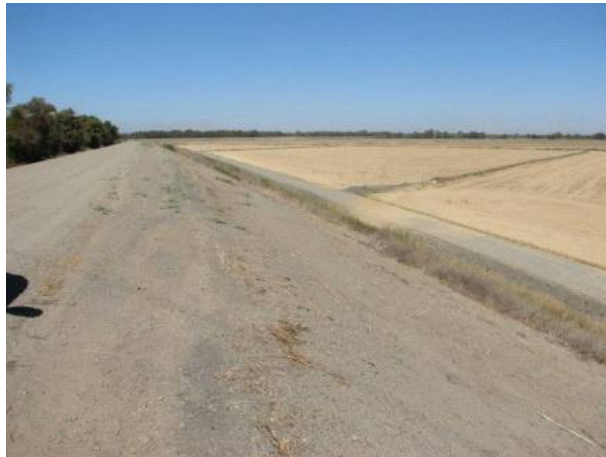
Levee Mile Report Line	12
Start Levee Mile	18.88
End Levee Mile	19.60
Location	Land Side
Category	Earthen Levee
Item	Encroachments

Ag ditch along toe of landside. Photo taken fall 2011.

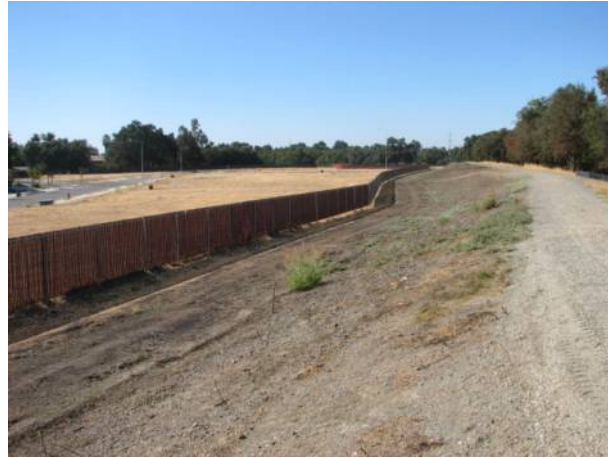
Levee Mile Report Line	1
Start Levee Mile	0.02
End Levee Mile	0.28
Location	Land Side
Category	Earthen Levee
Item	Encroachments
A chain link fence runs along the toe the entire distance of the development. Fall 2012	
johngw_f_20120924_734.jpg

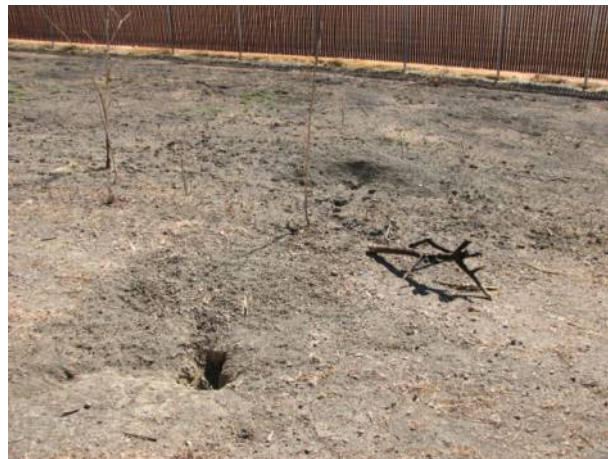
Levee Mile Report Line	2
Start Levee Mile	0.09
End Levee Mile	0.09
Location	Land Side
Category	Earthen Levee
Item	Animal Control
A couple of rodent holes on the landside slope. Fall 2012	
johngw_f_20120924_736.jpg
