**Flood Control Project Maintenance  
Levee Inspections**

**Fall 2013 Levee Maintenance Deficiency Summary Report**

**Reclamation District No. 0108 River Farms**

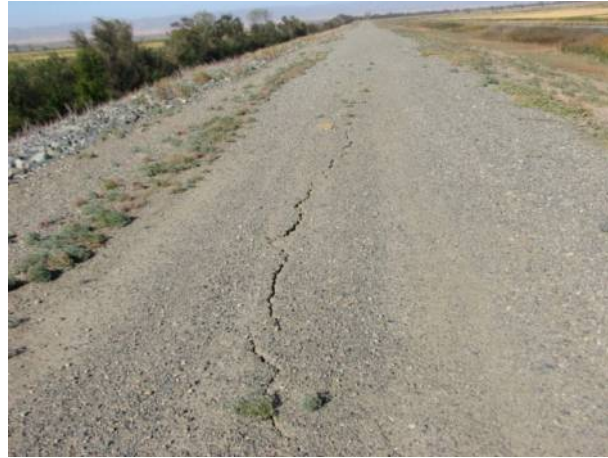
Levee Mile Report Line	4
Start Levee Mile	3.86
End Levee Mile	3.88
Location	Crown
Category	Earthen Levee
Item	Cracking

Cracking along the crown of the levee, fall 2013

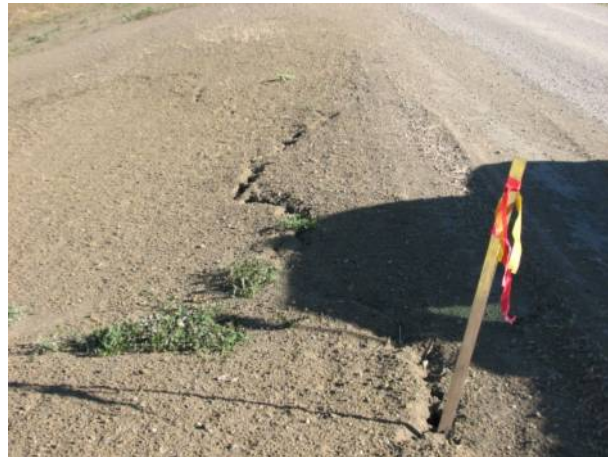
Levee Mile Report Line	9
Start Levee Mile	9.28
End Levee Mile	9.28
Location	Water Side
Category	Earthen Levee
Item	Slope Stability

Slope stability with cracking 1-2 inches open and 12 inches deep Fall 2013 The district is monitoring the site.

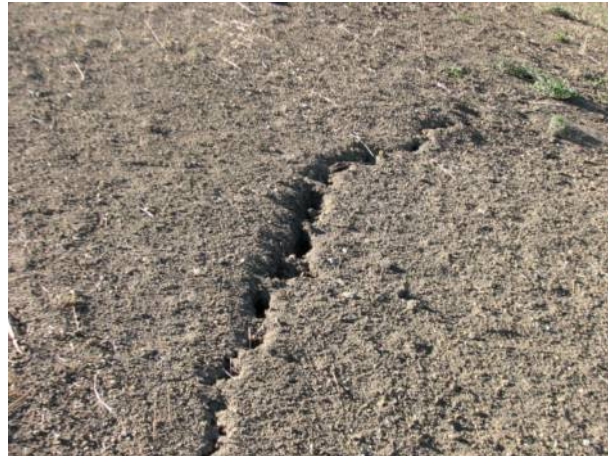
Levee Mile Report Line	9
Start Levee Mile	9.28
End Levee Mile	9.28
Location	Water Side
Category	Earthen Levee
Item	Slope Stability

The cracking runs in a horseshoe pattern on the levee slope Fall 2013

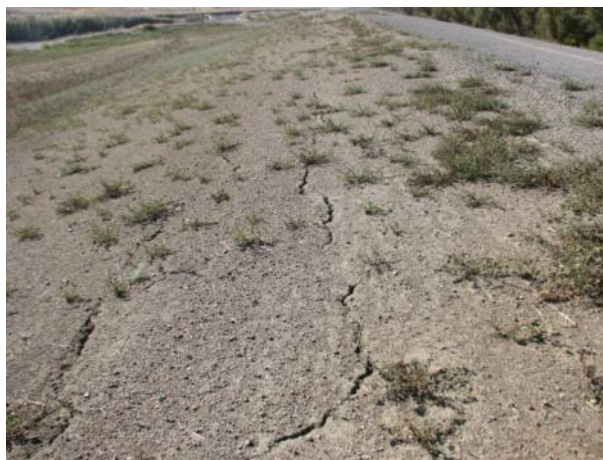
Levee Mile Report Line	10
Start Levee Mile	9.28
End Levee Mile	9.28
Location	Land Side
Category	Earthen Levee
Item	Cracking

Cracking on the landside levee slope Fall 2013

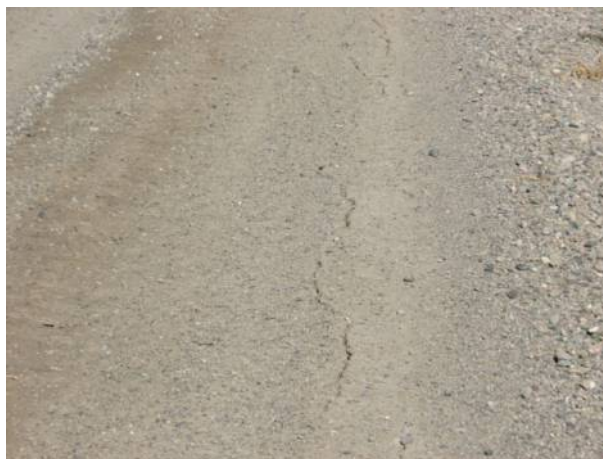
Levee Mile Report Line	14
Start Levee Mile	14.22
End Levee Mile	14.24
Location	Land Side
Category	Earthen Levee
Item	Cracking

Small cracking along the shoulder of the crown, fall 2013.

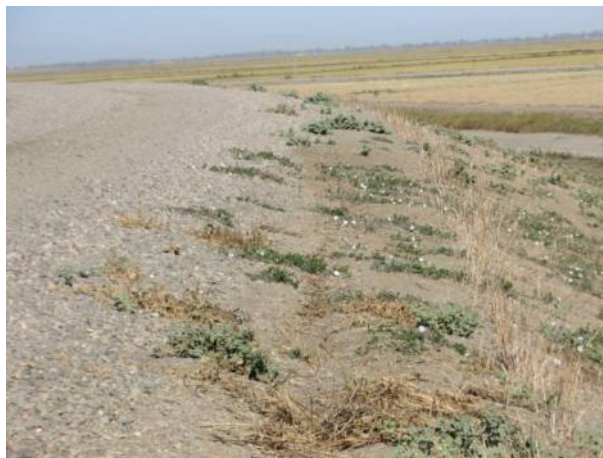
Levee Mile Report Line	14
Start Levee Mile	14.22
End Levee Mile	14.24
Location	Land Side
Category	Earthen Levee
Item	Cracking

It appears to have some slope stability issues with the cracking. Fall 2013

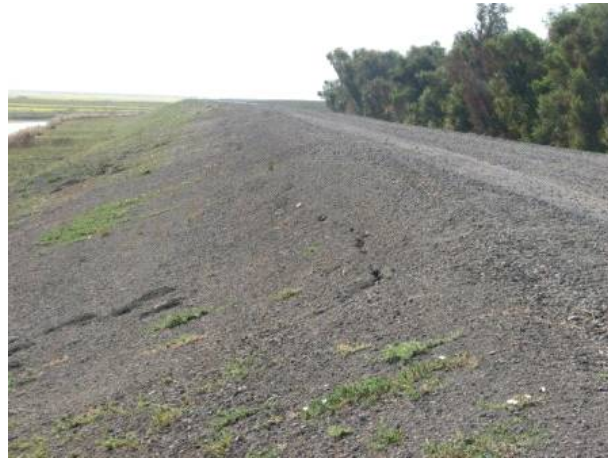
Levee Mile Report Line	15
Start Levee Mile	14.54
End Levee Mile	14.54
Location	Land Side
Category	Earthen Levee
Item	Cracking

A crack running along the landside shoulder app. 50' long. Fall 2012

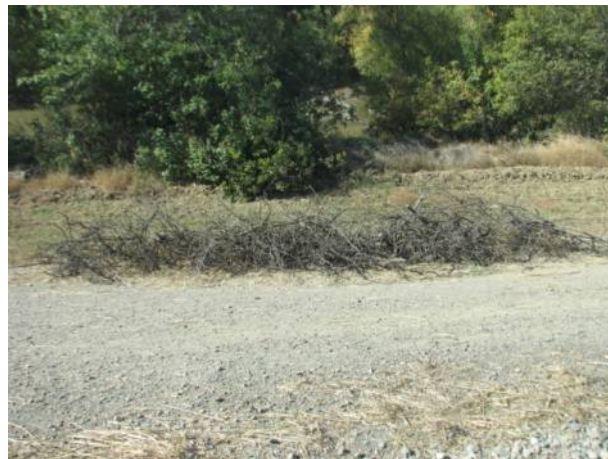
Levee Mile Report Line	16
Start Levee Mile	18.26
End Levee Mile	18.26
Location	Water Side
Category	Earthen Levee
Item	Encroachments

Piles of prunings are at the waterside berm. Fall 2013

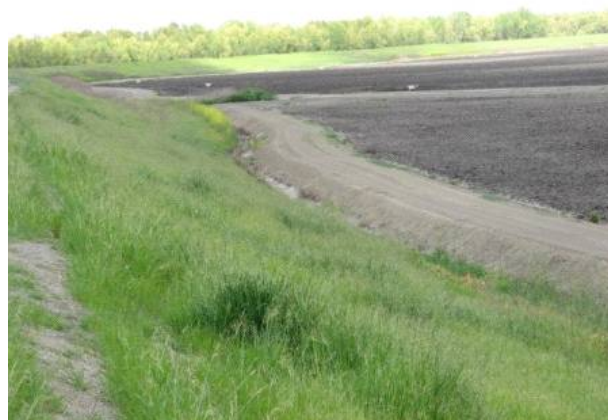
Levee Mile Report Line	17
Start Levee Mile	18.88
End Levee Mile	19.60
Location	Land Side
Category	Earthen Levee
Item	Encroachments

Agricultural ditch

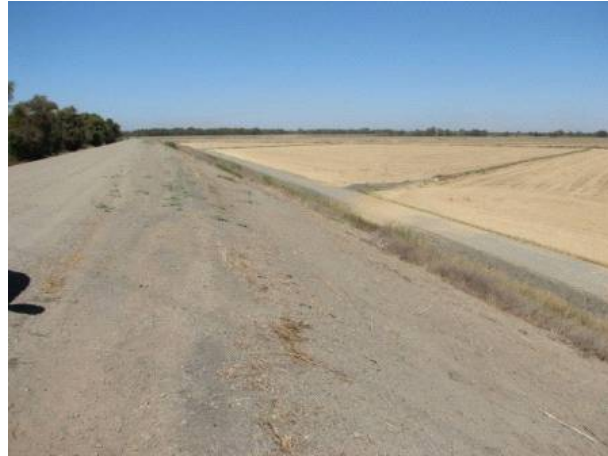
Levee Mile Report Line	17
Start Levee Mile	18.88
End Levee Mile	19.60
Location	Land Side
Category	Earthen Levee
Item	Encroachments

Agricultural ditch along toe of landside. Photo taken fall 2011.

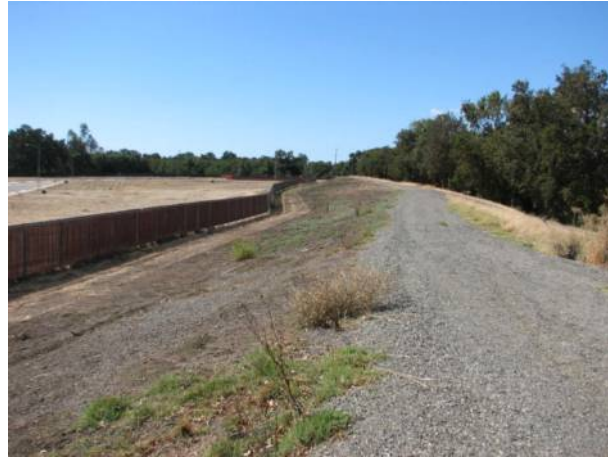
Levee Mile Report Line	1
Start Levee Mile	0.01
End Levee Mile	0.28
Location	Land Side
Category	Earthen Levee
Item	Vegetation

The landside levee slope has been burned. Waterside vegetation is below 12 inches. Fall 2013

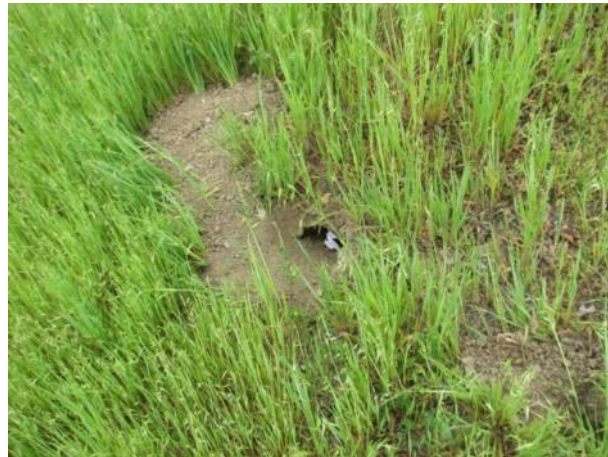
Levee Mile Report Line	2
Start Levee Mile	0.01
End Levee Mile	0.01
Location	Land Side
Category	Earthen Levee
Item	Animal Control

No rodents but holes need to be backfilled. Spring 2013

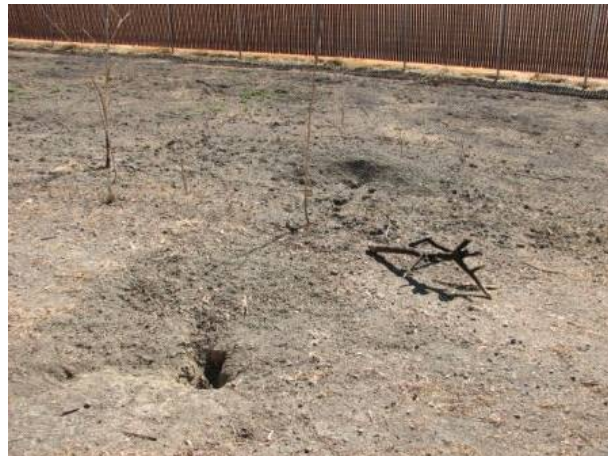
Levee Mile Report Line	3
Start Levee Mile	0.09
End Levee Mile	0.09
Location	Land Side
Category	Earthen Levee
Item	Animal Control

A couple of rodent holes on the landside slope. Fall 2012
