**Flood Control Project Maintenance
Levee Inspections**

**Fall 2014 Levee Maintenance Deficiency Summary Report
Overall LMA & Unit Ratings, including USACE Erosion Survey**

Sacramento River Basin

Reclamation District No. 0108 River Farms

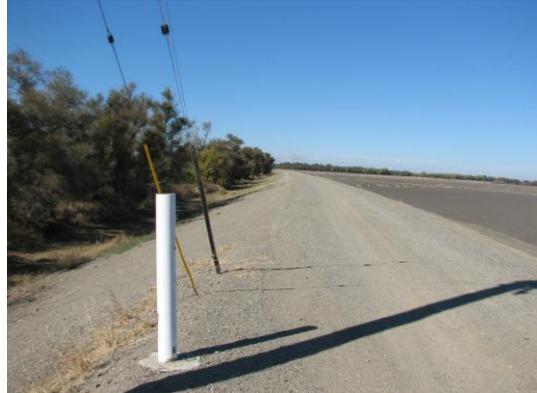
Photo 1 of 2 : FA_2014_RD0108_203_20_20141030_00016.jpg

LM Start	0.00	Rating **	A	Issue No.	20
LM End	20.59	Issue Type +	Ma	Location *	WS
Category	Earthen Levee		GPS Latitude/Longitude		
			Start	End	
Item	Vegetation		°	°	
DWR ID	DWR_RD0108_01_f_2014_20				
Action/Comments					
Control annual grass and weeds on the levee slopes and easements.

Levee mile 18.88, vegetation on water side slope. Fall 2014.

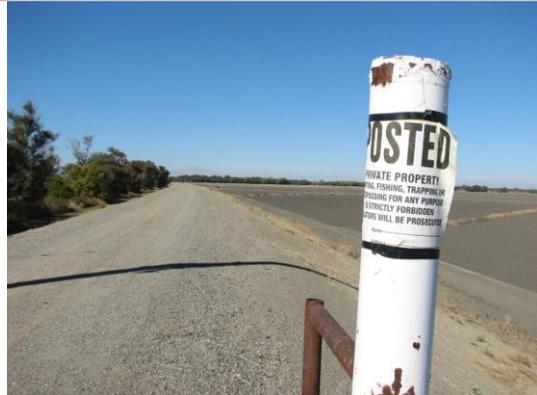
Photo 2 of 2 : FA_2014_RD0108_203_20_20141030_00017.jpg

Levee mile 18.88, vegetation on land side levee slope. Fall 2014.

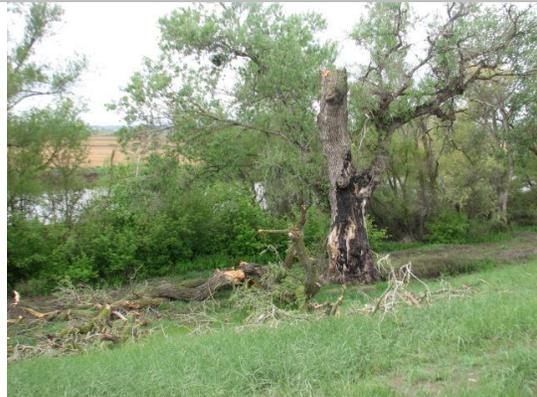
Photo 1 of 1 : FA_2014_RD0108_203_10_20141014_00006.jpg

LM Start	5.19	Rating **	M	Issue No.	10
LM End	5.19	Issue Type +	En	Location *	WS
Category	Earthen Levee			GPS Latitude/Longitude	
				Start	End
Item	Encroachments			38.846086 °	38.846086 °
				-121.886834 °	-121.886834 °
DWR ID	DWR_RD0108_01_s_2014_10				
Action/Comments					
Tree or limb

Tree limbs are along the toe of the levee. Tree is slowing dying and could be a hazard to the levee. Spring 2014

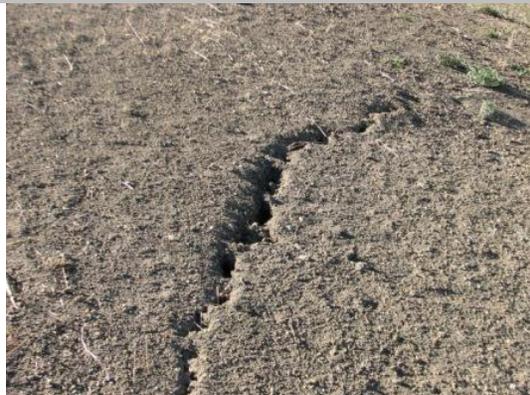
Photo 1 of 2 : FA_2014_RD0108_203_279_20141014_00011.jpg

The cracking runs in a horseshoe pattern on the levee slope Fall 2013

LM Start	9.28	Rating **	A/W	Issue No.	279
LM End	9.28	Issue Type +	Ma	Location *	WS
Category	Earthen Levee		GPS Latitude/Longitude		
			Start	End	
Item	Slope Stability		38.897452 °	38.897452 °	
			-121.914680 °	-121.914680 °	
DWR ID	DWR_RD0108_01_f_2013_279				
Action/Comments					
Repair slope instability.

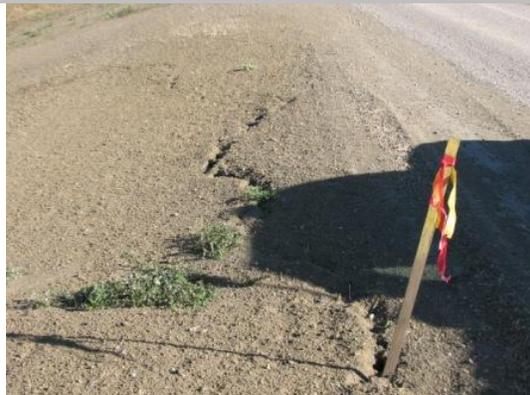
Photo 2 of 2 : FA_2014_RD0108_203_279_20141014_00012.jpg

Slope stability with cracking 1-2 inches open and 12 inches deep Fall 2013 The district is monitoring the site.

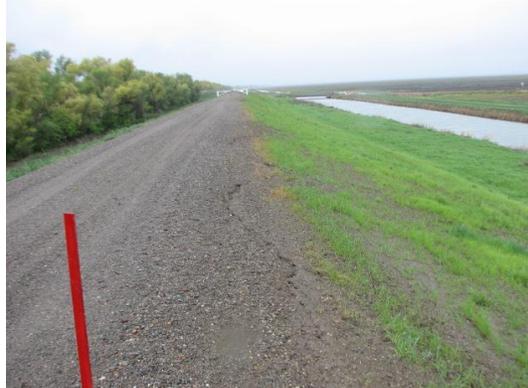
Photo 1 of 1 : FA_2014_RD0108_203_12_20141014_00008.jpg

Cracking along the shoulder of the crown. Some slope instability has occurred. Spring 2014

LM Start	14.46	Rating **	M	Issue No.	12
LM End	14.46	Issue Type +	Ma	Location *	LS
Category	Earthen Levee			GPS Latitude/Longitude	
				Start	End
Item	Cracking			38.967243 °	38.967243 °
				-121.923407 °	-121.923407 °
DWR ID	DWR_RD0108_01_s_2014_12				
Action/Comments					
Schedule repair of subsidence prior to the next inspection.

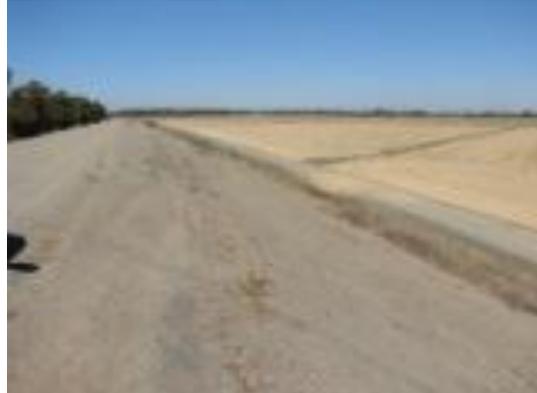
Photo 1 of 2 : FA_2014_RD0108_203_6_20141014_00004.jpg

LM Start	18.88	Rating **	M	Issue No.	6
LM End	19.60	Issue Type +	En	Location *	LS
Category	Earthen Levee		GPS Latitude/Longitude		
			Start	End	
Item	Encroachments		39.013245 °	39.021302 °	
			-121.980795 °	-121.988557 °	
DWR ID	DWR_RD0108_01_s_2012_6				
Action/Comments					
Ditch

Agricultural ditch along toe of landside. Photo taken fall 2011.

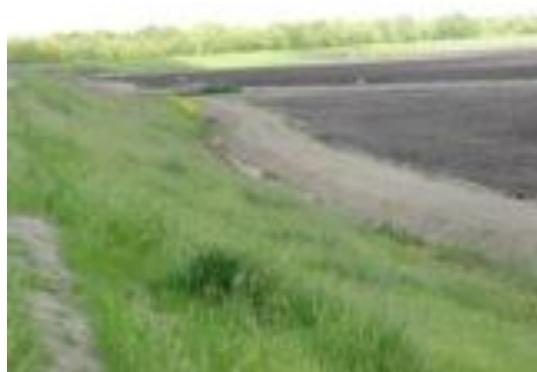
Photo 2 of 2 : FA_2014_RD0108_203_6_20141014_00005.jpg

Agricultural ditch

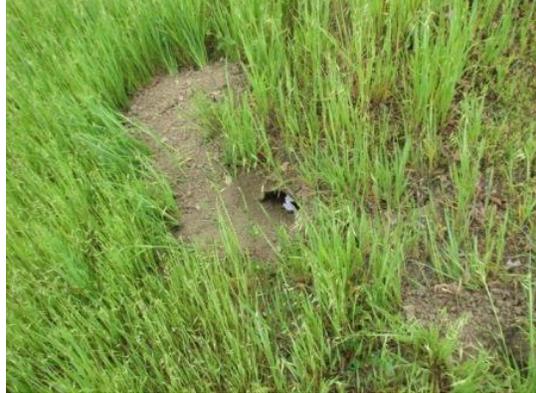
Photo 1 of 1 : FA_2014_RD0108_590_3_20141014_00002.jpg

No rodents but holes need to be backfilled. Spring 2013

LM Start	0.01	Rating **	A/W	Issue No.	3
LM End	0.01	Issue Type +	Ob	Location *	LS
Category	Earthen Levee		GPS Latitude/Longitude		
			Start	End	
Item	Animal Control		38.798992 °	38.798992 °	
			-121.724643 °	-121.724643 °	
DWR ID	DWR_RD0108_02_s_2013_3				
Action/Comments					
No rodents visible, but rodent burrows visible; need to backfill and compact or grout burrows.

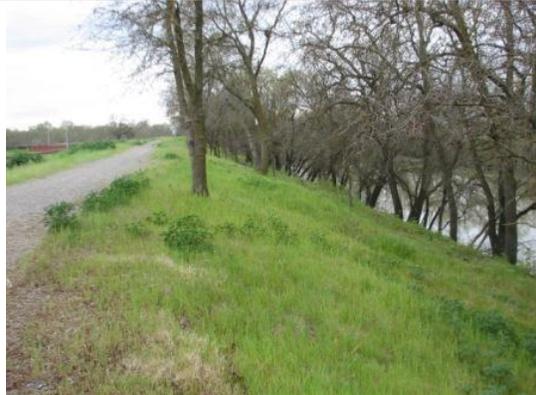
Photo 1 of 2 : FA_2014_RD0108_590_2_20141014_00001.jpg

Brush and trees are on the waterside slope but does not block visibility. Spring 2013

LM Start	0.02	Rating **	A	Issue No.	2
LM End	0.28	Issue Type +	Ma	Location *	WS
Category	Earthen Levee		GPS Latitude/Longitude		
			Start	End	
Item	Vegetation		38.799008 °	38.796205 °	
			-121.724852 °	-121.727988 °	
DWR ID	DWR_RD0108_02_f_2012_2				
Action/Comments					
Control annual grass and weeds on the levee slopes and easements. Inspector Comments: Brush and trees are on the water side levee slope but do not block visibility.

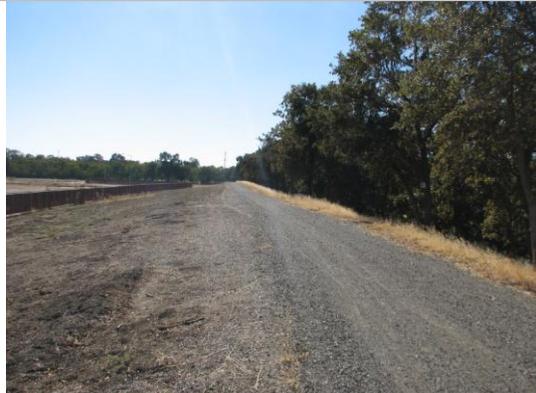
Photo 2 of 2 : FA_2014_RD0108_590_2_20141106_00004.jpg

Levee mile 0.09, vegetation on the land side levee slope. Fall 2014.
