**Flood Control Project Maintenance
Levee Inspections**

Fall 2016 Levee Maintenance Deficiency Summary Report

**Flood Control Project Maintenance
Levee Inspections**
LMA District Cover Sheet
Fall 2016 Levee Inspection Results

Reclamation District No. 0108 River Farms

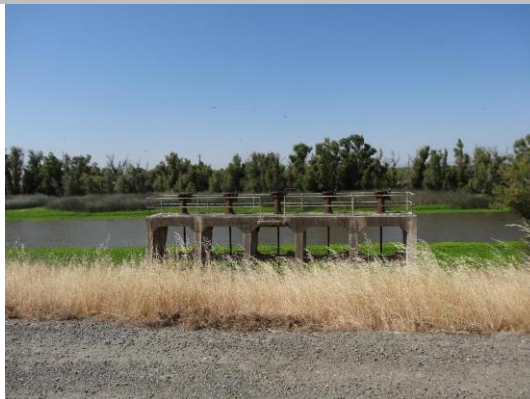
Photo 1 of 2 : UCIP_FA_2016_37608_68207.jpg

LM Start	0.06	Rating **	M	Issue No.	281
LM End	0.06	Issue Type +	En	Location *	N/A
Category	Supplemental			GPS Latitude/Longitude	
				Start	End
Item	DWR UCIP Field Study			38.822897 °	38.822897 °
				-121.797000 °	-121.797000 °
DWR ID					
Comment Code					
Inspector Comment					
FS_ID:37608 DS_ID:17943 EP_NO: 9396 Repair Type: Non-Urgent Crossing Status: Found UCIP Comments: Need to contact owner to determine status of structure. Notes indicate crossing has been abandoned. Owner will need to coordinate with CVFPB and DWR inspector to determine how to properly abandon. FIELD_STRUCT_DESC: 1 of 5. Five 72-inch abandoned pipes or culvert through levee 31.6 feet below crown. Slide gates on both ends. (App. 9736-RD 108) Ramp on landward slope. (App.9396-RD). O&M Manual SAC 132; October 1959 FS Date: 6/10/2014

View of concrete structure visible on waterward side.

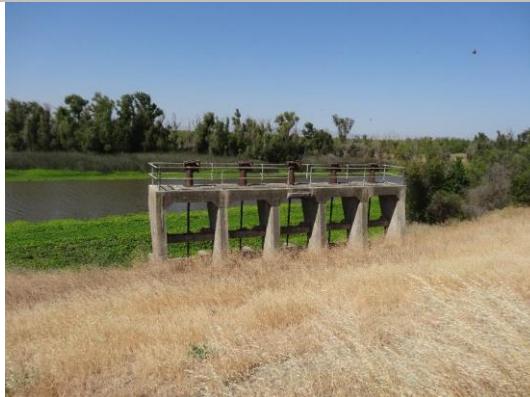
Photo 2 of 2 : UCIP_FA_2016_37608_68210.jpg

Dense vegetation on waterward side.

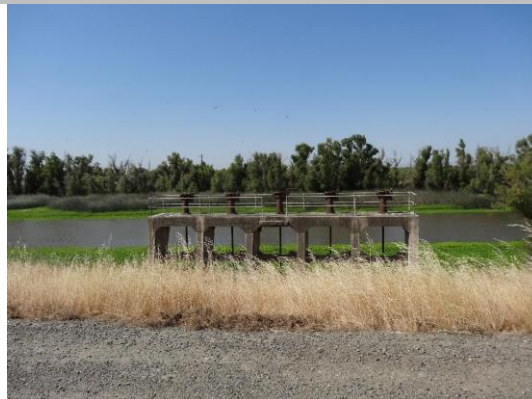
Photo 1 of 2 : UCIP_FA_2016_37609_68211.jpg

LM Start	0.06	Rating **	M	Issue No.	282
LM End	0.06	Issue Type +	En	Location *	N/A
Category	Supplemental			GPS Latitude/Longitude	
				Start	End
Item	DWR UCIP Field Study			38.822919 °	38.822919 °
				-121.797046 °	-121.797046 °
DWR ID					
Comment Code					
Inspector Comment					
FS_ID:37609					
DS_ID:22386					
EP_NO: 9396					
Repair Type: Non-Urgent					
Crossing Status: Found					
UCIP Comments: Need to contact owner to determine status of structure. Notes indicate crossing has been abandoned. Owner will need to coordinate with CVFPB and DWR inspector to determine how to properly abandon.					
FIELD_STRUCT_DESC: 2 of 5. Five 72-inch abandoned pipes or culvert through levee 31.6 feet below crown. Slide gates on both ends. (App. 9736-RD 108) Ramp on landward slope. (App.9396-RD). O&M Manual SAC 132; October 1959					
FS Date: 6/10/2014

Concrete structure located on waterward side.

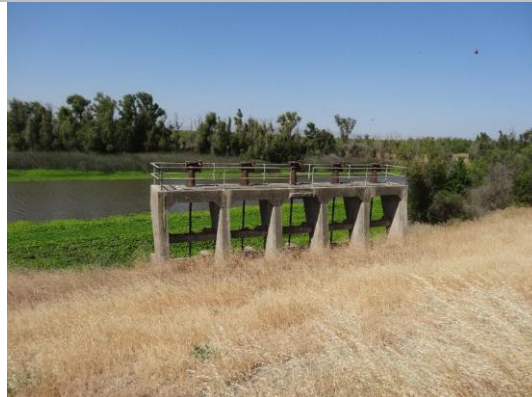
Photo 2 of 2 : UCIP_FA_2016_37609_68215.jpg

Dense vegetation covers the waterward slope.

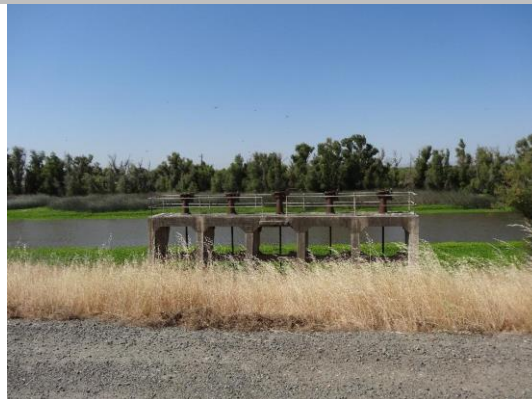
Photo 1 of 2 : UCIP_FA_2016_37610_68216.jpg

LM Start	0.06	Rating **	M	Issue No.	283
LM End	0.06	Issue Type +	En	Location *	N/A
Category	Supplemental			GPS Latitude/Longitude	
				Start	End
Item	DWR UCIP Field Study			38.822933 °	38.822933 °
				-121.797081 °	-121.797081 °
DWR ID					
Comment Code					
Inspector Comment					
FS_ID:37610					
DS_ID:22387					
EP_NO: 9396					
Repair Type: Non-Urgent					
Crossing Status: Found					
UCIP Comments: Need to contact owner to determine status of structure. Notes indicate crossing has been abandoned. Owner will need to coordinate with CVFPB and DWR inspector to determine how to properly abandon.					
FIELD_STRUCT_DESC: 3 of 5. Five 72-inch abandoned pipes or culvert through levee 31.6 feet below crown. Slide gates on both ends. (App. 9736-RD 108) Ramp on landward slope. (App.9396-RD). O&M Manual SAC 132; October 1959					
FS Date: 6/10/2014

Concrete structure located on waterward side.

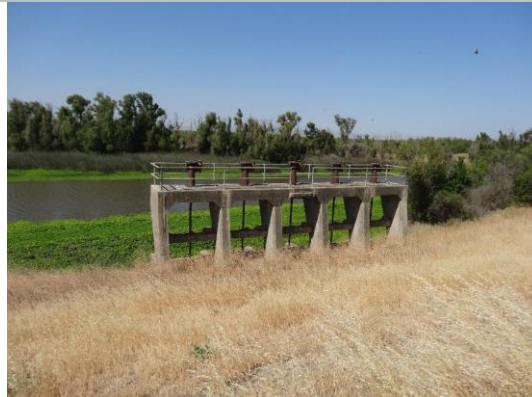
Photo 2 of 2 : UCIP_FA_2016_37610_68219.jpg

Dense vegetation covers waterward side slope.

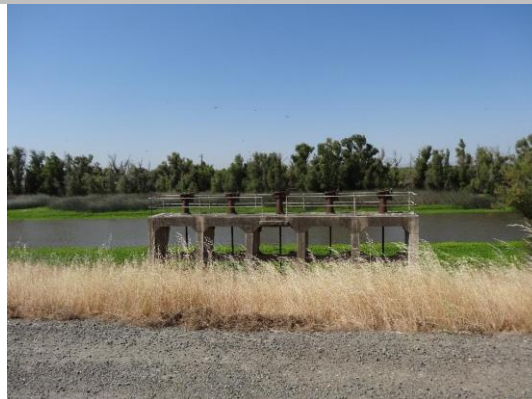
Photo 1 of 2 : UCIP_FA_2016_37611_68220.jpg

LM Start	0.06	Rating **	M	Issue No.	284
LM End	0.06	Issue Type +	En	Location *	N/A
Category	Supplemental			GPS Latitude/Longitude	
				Start	End
Item	DWR UCIP Field Study			38.822897 °	38.822897 °
				-121.797000 °	-121.797000 °
DWR ID					
Comment Code					
Inspector Comment					
FS_ID:37611					
DS_ID:22388					
EP_NO: 9396					
Repair Type: Non-Urgent					
Crossing Status: Found					
UCIP Comments: Need to contact owner to determine status of structure. Notes indicate crossing has been abandoned. Owner will need to coordinate with CVFPB and DWR inspector to determine how to properly abandon.					
FIELD_STRUCT_DESC: 4 of 5. Five 72-inch abandoned pipes or culvert through levee 31.6 feet below crown. Slide gates on both ends. (App. 9736-RD 108) Ramp on landward slope. (App.9396-RD). O&M Manual SAC 132; October 1959					
FS Date: 6/10/2014

Concrete structure located on waterward side.

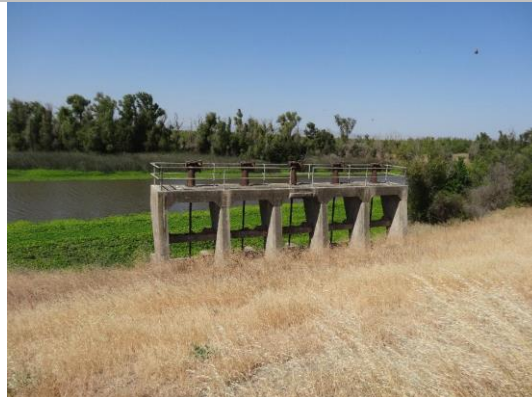
Photo 2 of 2 : UCIP_FA_2016_37611_68224.jpg

Waterward slope covered by dense vegetation.

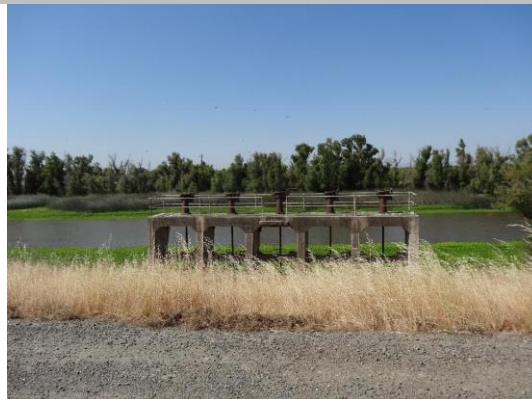
Photo 1 of 2 : UCIP_FA_2016_37607_68203.jpg

LM Start	0.07	Rating **	M	Issue No.	280
LM End	0.07	Issue Type +	En	Location *	N/A
Category	Supplemental			GPS Latitude/Longitude	
				Start	End
Item	DWR UCIP Field Study			38.822954 °	38.822954 °
				-121.797135 °	-121.797135 °
DWR ID					
Comment Code					
Inspector Comment					
FS_ID:37607					
DS_ID:22389					
EP_NO: 9396					
Repair Type: Non-Urgent					
Crossing Status: Found					
UCIP Comments: Need to contact owner to determine status of structure. Notes indicate crossing has been abandoned. Owner will need to coordinate with CVFPB and DWR inspector to determine how to properly abandon.					
FIELD_STRUCT_DESC: 5 of 5. Five 72-inch abandoned pipes or culvert through levee 31.6 feet below crown. Slide gates on both ends. (App. 9736-RD 108) Ramp on landward slope. (App.9396-RD). O&M Manual SAC 132; October 1959					
FS Date: 6/10/2014

Concrete structure located on waterward side.

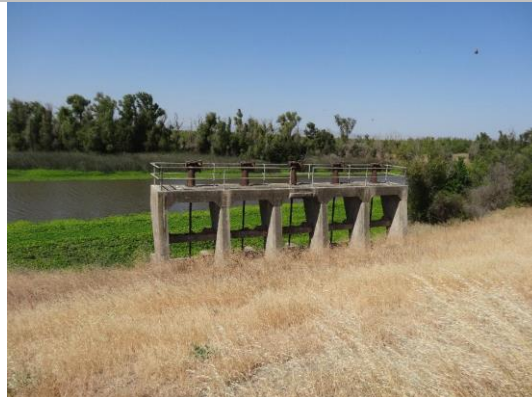
Photo 2 of 2 : UCIP_FA_2016_37607_68206.jpg

Waterward slope covered by dense vegetation.

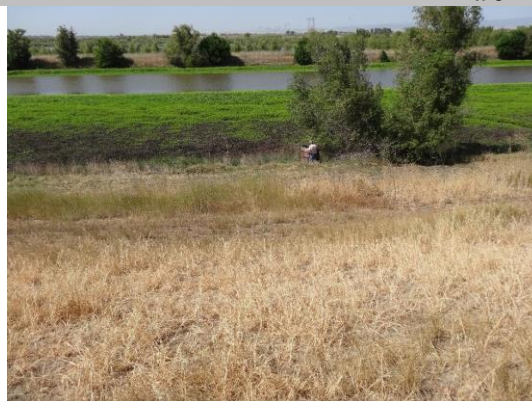
Photo 1 of 2 : UCIP_FA_2016_39707_71682.jpg

Comment Code						
Inspector Comment						
FS_ID:39707						
DS_ID:24875						
EP_NO: N/A						
Repair Type: Non-Urgent						
Crossing Status: Indicator Found						
UCIP Comments: No signs of pipe visible--need to contact owner to obtain permit number authorizing work. If crossing is no longer used by owner, the owner will need to coordinate with DWR Inspector and CVFPB to remove crossing according to Title 23 requirements. Dense vegetation limits the inspector's visibility to identify signs of pipe failure (leaks) along the slope. Recommend removing vegetation along pipe alignment to conduct proper inspection of structure.						
FIELD_STRUCT_DESC: Corrugated Metal (CM) pipe riser located on waterward side. Riser is filled with trash and deris. Unable to determine if crossing exists at this location.						
FS Date: 3/18/2014

View of waterward side.

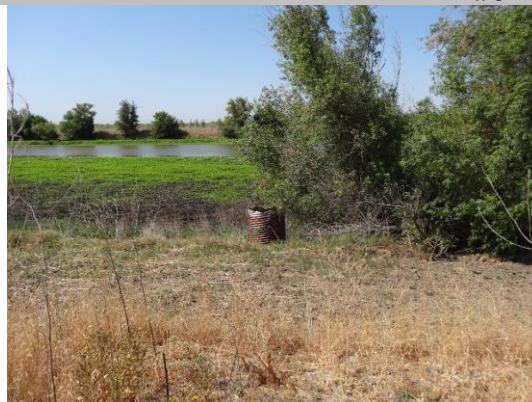
Photo 2 of 2 : UCIP_FA_2016_39707_71681.jpg

CMP riser located on waterward toe--2/3 filled with soil and trash.

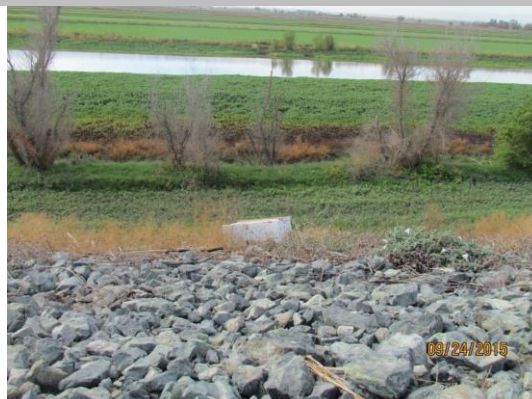
Photo 1 of 1 : FA_2016_RD0108_203_23_20160913_00008.jpg

LM Start	3.65	Rating **	M	Issue No.	23
LM End	3.65	Issue Type +	Ma	Location *	WS
Category	Earthen Levee			GPS Latitude/Longitude	
				Start	End
Item	Encroachments			38.842620 °	38.842620 °
				-121.858732 °	-121.858732 °
DWR ID	DWR_RD0108_01_f_2015_23				
Comment Code					
DE : Debris					
Inspector Comment

View of the debris on the waterward side of the levee. Fall 2015.

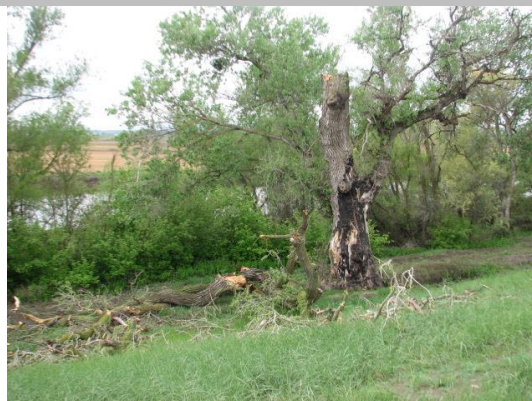
Photo 1 of 2 : FA_2016_RD0108_203_10_20160913_00002.jpg

LM Start	5.20	Rating **	A/W	Issue No.	10
LM End	5.20	Issue Type +	Ma	Location *	WS
Category	Earthen Levee			GPS Latitude/Longitude	
				Start	End
Item	Vegetation			38.846163 °	38.846163 °
				-121.886974 °	-121.886974 °
DWR ID	DWR_RD0108_01_s_2014_10				
Comment Code					
V7 : Trees / Woody Vegetation					
Inspector Comment					
Tree at the toe is dying.

Tree limbs are along the toe of the levee. Tree is slowly dying and could be a hazard to the levee. Spring 2014

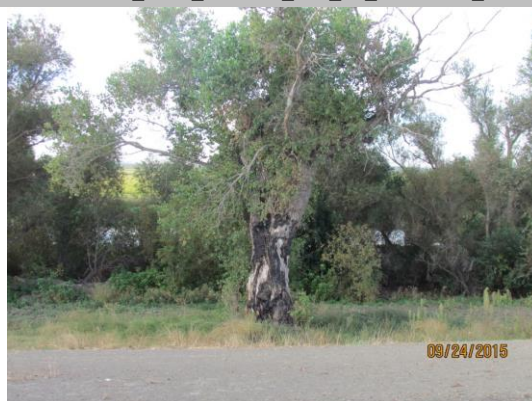
Photo 2 of 2 : FA_2016_RD0108_203_10_20160913_00003.jpg

Tree limbs have been removed but suggest monitoring the dying tree. Fall 2015.

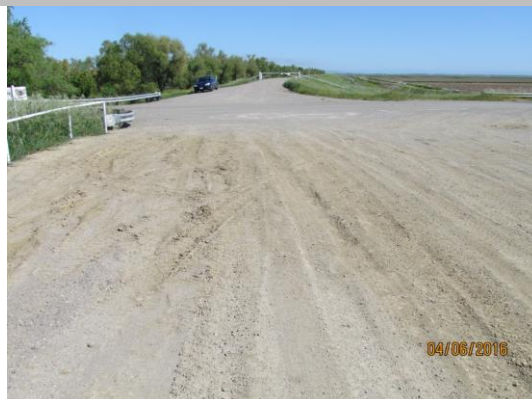
Photo 1 of 1 : FA_2016_RD0108_203_18_20160913_00005.jpg

LM Start	11.20	Rating **	M	Issue No.	18
LM End	11.20	Issue Type +	Ma	Location *	CR
Category	Earthen Levee			GPS Latitude/Longitude	
				Start	End
Item	Crown Surface / Depressions / Rutting			38.925037 °	38.925037 °
				-121.914509 °	-121.914509 °
DWR ID	DWR_RD0108_01_s_2016_18				
Comment Code					
C2 : Repair depressions or ruts in the crown or slope.					
Inspector Comment

View of the crown depression on the crown of the levee looking upstream. Spring 2016.

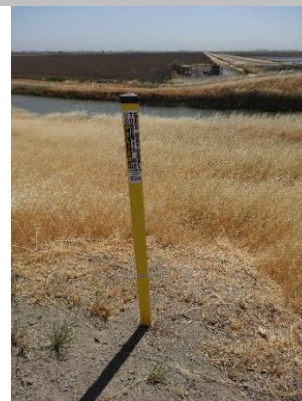
Photo 1 of 2 : UCIP_FA_2016_39717_71705.jpg

LM Start	11.24	Rating **	M	Issue No.	287
LM End	11.24	Issue Type +	En	Location *	CR
Category	Supplemental			GPS Latitude/Longitude	
				Start	End
Item	DWR UCIP Field Study			38.925662 °	38.925662 °
				-121.914303 °	-121.914303 °
DWR ID					
Comment Code					
Inspector Comment					
FS_ID:39717					
DS_ID:24876					
EP_NO: N/A					
Repair Type: Non-Urgent					
Crossing Status: Indicator Found					
UCIP Comments: Need to contact owner to determine additional details of crossing.					
FIELD_STRUCT_DESC: Natural gas line with markers on both side slightly angled through levee. Gas station located across canal on landward side.					
FS Date: 3/18/2014

View of marker visible on shoulder.

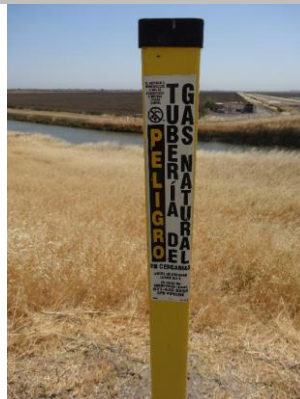
Photo 2 of 2 : UCIP_FA_2016_39717_71704.jpg

Owner contact information listed on marker.

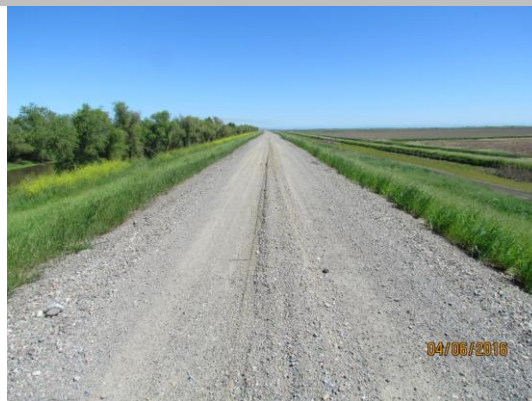
Photo 1 of 1 : FA_2016_RD0108_203_20_20160913_00006.jpg

LM Start	11.36	Rating **	M	Issue No.	20
LM End	12.19	Issue Type +	Ma	Location *	CR
Category	Earthen Levee			GPS Latitude/Longitude	
				Start	End
Item	Crown Surface / Depressions / Rutting			38.927325 °	38.938291 °
				-121.913477 °	-121.907516 °
DWR ID	DWR_RD0108_01_s_2016_20				
Comment Code					
C3 : Add appropriate gravel or road base. Grade and compact.					
Inspector Comment

View of the crown of the levee looking upstream. Spring 2016.

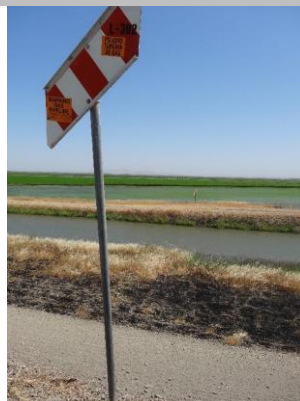
Photo 1 of 2 : UCIP_FA_2016_37623_68246.jpg

LM Start	14.94	Rating **	M	Issue No.	285
LM End	14.94	Issue Type +	En	Location *	CR
Category	Supplemental			GPS Latitude/Longitude	
				Start	End
Item	DWR UCIP Field Study			38.971607 °	38.971607 °
				-121.929499 °	-121.929499 °
DWR ID					
Comment Code					
Inspector Comment					
FS_ID:37623					
DS_ID:17942					
EP_NO: 3800					
Repair Type: Non-Urgent					
Crossing Status: Indicator Found					
UCIP Comments: Need to contact owner--marker missing on waterward side.					
FIELD_STRUCT_DESC: 20-inch concrete encased gas line through levee, 3.0 feet below the crown. Crossing appears to be angled through levee (App. 3800-PG&E) Small rock revetment on the waterward slope. (unable to locate) Gas well approximately 1,000 feet from landward toe.					
FS Date: 6/10/2014

Marker visible on landward side.

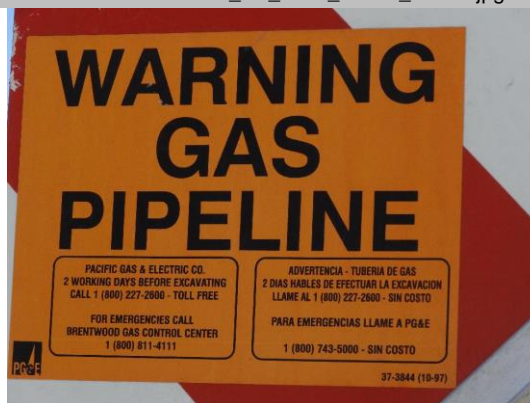
Photo 2 of 2 : UCIP_FA_2016_37623_68245.jpg

Contact information for gas line going through levee.

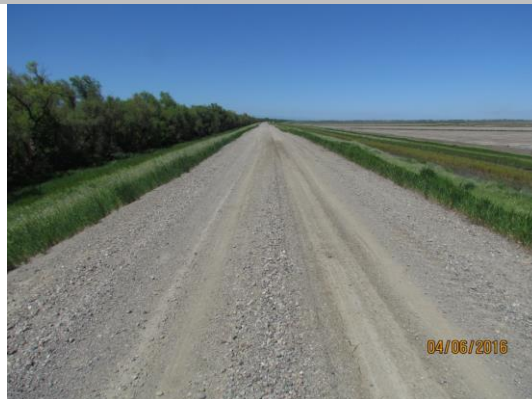
Photo 1 of 1 : FA_2016_RD0108_203_22_20160913_00007.jpg

LM Start	15.46	Rating **	M	Issue No.	22
LM End	15.74	Issue Type +	Ma	Location *	CR
Category	Earthen Levee			GPS Latitude/Longitude	
				Start	End
Item	Crown Surface / Depressions / Rutting			38.976684 °	38.979377 °
				-121.936696 °	-121.940526 °
DWR ID	DWR_RD0108_01_s_2016_22				
Comment Code					
C2 : Repair depressions or ruts in the crown or slope.					
Inspector Comment

View of the crown of the levee looking upstream. Spring 2016.

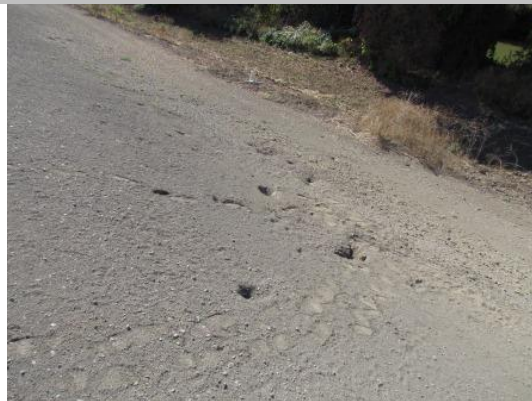
Photo 1 of 2 : FA_2016_RD0108_203_29_20161004_00042.jpg

LM Start	18.24	Rating **	M	Issue No.	29
LM End	18.24	Issue Type +	Ma	Location *	WS
Category	Earthen Levee			GPS Latitude/Longitude	
				Start	End
Item	Animal Control			39.005766 °	39.005766 °
				-121.972346 °	-121.972346 °
DWR ID	DWR_RD0108_01_f_2015_29				
Comment Code					
A3 : No rodents visible, but rodent burrows visible; need to backfill and compact or grout burrows.					
Inspector Comment

Updated view of a site with rodent activity. Fall 2016 inspection.

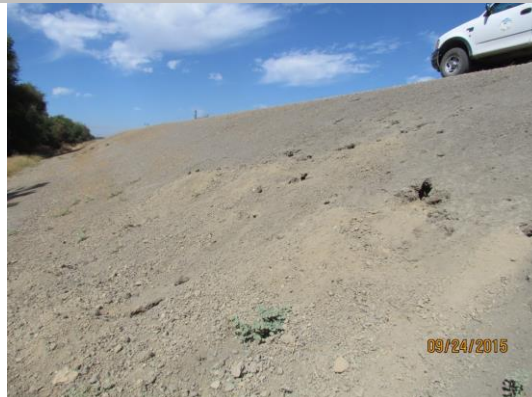
Photo 2 of 2 : FA_2016_RD0108_203_29_20160913_00012.jpg

View of the animal hole on the waterward side of the levee looking upstream. Fall 2015.

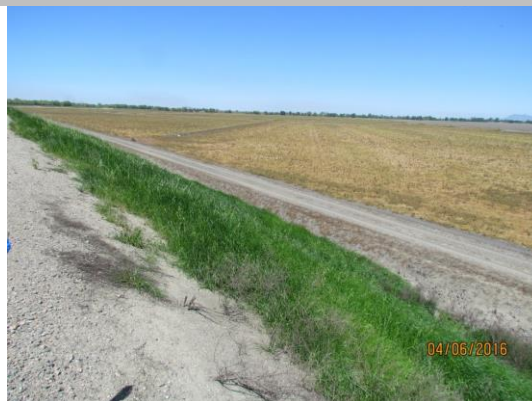
Photo 1 of 1 : FA_2016_RD0108_203_6_20160913_00001.jpg

LM Start	18.92	Rating **	M	Issue No.	6
LM End	19.28	Issue Type +	En	Location *	LS
Category	Earthen Levee			GPS Latitude/Longitude	
				Start	End
Item	Encroachments			39.013160 °	39.017000 °
				-121.980808 °	-121.985364 °
DWR ID	DWR_RD0108_01_s_2012_6				
Comment Code					
DT : Ditch					
Inspector Comment					
Ditch is at the toe of the levee.

View of the ditch at the toe of the levee on the landward side looking upstream. Spring 2016.

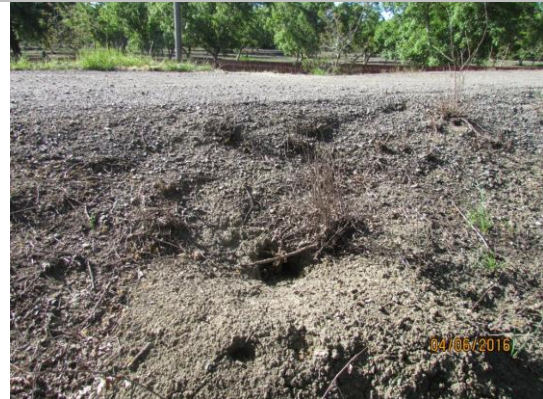
Photo 1 of 3 : FA_2016_RD0108_590_6_20160913_00002.jpg

Mound next to rodent hole is more than 2 cubic feet of material.

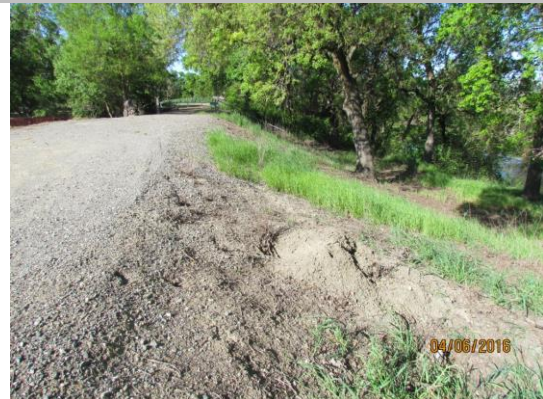
Photo 2 of 3 : FA_2016_RD0108_590_6_20160913_00003.jpg

Perspective view of the rodent hole on the waterward side of the levee looking upstream. Spring 2016.

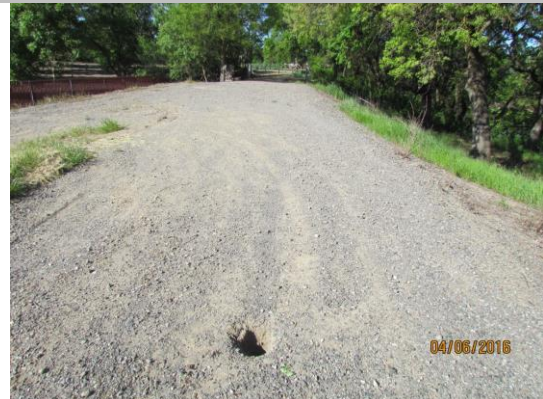
Photo 3 of 3 : FA_2016_RD0108_590_6_20160913_00004.jpg

Another hole is on top of the crown. Spring 2016.
