**Flood Control Project Maintenance  
Levee Inspections**

**Fall 2017 Levee Maintenance Deficiency Summary Report**

**Reclamation District No. 0108 River Farms**

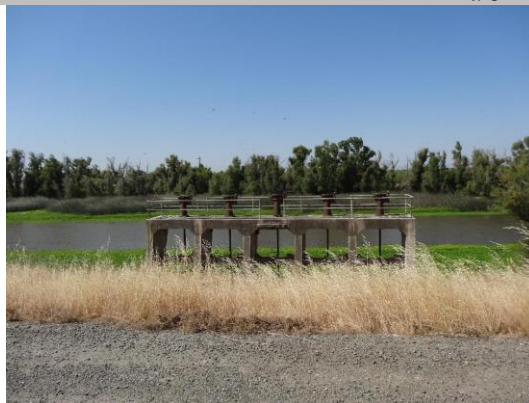
Photo 1 of 3 : UCIP\_FA\_2017\_37608\_68207.jpg

Comment Code						
Inspector Comment						
FS_ID:37608 DS_ID:17943 EP_NO: 9396 Repair Type: Non-Urgent Crossing Status: Found UCIP Comments: Need to contact owner to determine status of structure. Notes indicate crossing has been abandoned. Owner will need to coordinate with CVFPB and DWR inspector to determine how to properly abandon. FIELD_STRUCT_DESC: *ABANDONED* 1 of 5. 72-inch pipes or culvert through levee 31.6 feet below crown. Slide gates on both ends. (five 72-inch pipes [HLM 0.08] authorized under Automatic Board Order (ABO) issued as Permit No. 9736, 1974 - Reclamation District No. 108 [RD0108]) [Additional Reference(s): DWR Levee Log, 2005. USACE Sacramento O&M Manual Unit No. 132, October 1959, (HLM 0.08), referenced as five 6-foot by 8-foot concrete culvert drains]. FS Date: 6/10/2014

View of concrete structure visible on waterward side.

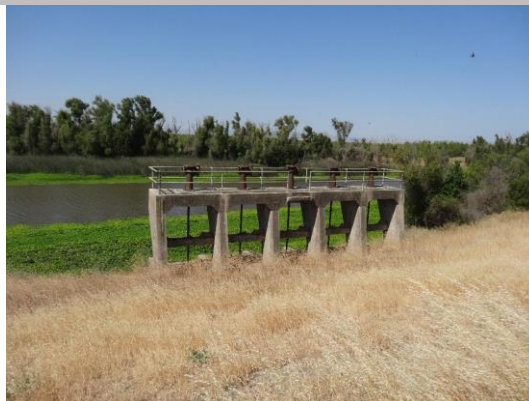
Photo 2 of 3 : UCIP\_FA\_2017\_37608\_68210.jpg

Dense vegetation on waterward side.

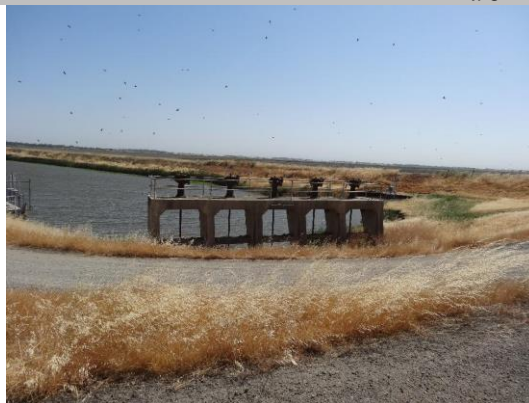
Photo 3 of 3 : UCIP\_FA\_2017\_37608\_68208.jpg

Comment Code						
Inspector Comment						
FS_ID:37608 DS_ID:17943 EP_NO: 9396 Repair Type: Non-Urgent Crossing Status: Found UCIP Comments: Need to contact owner to determine status of structure. Notes indicate crossing has been abandoned. Owner will need to coordinate with CVFPB and DWR inspector to determine how to properly abandon. FIELD_STRUCT_DESC: *ABANDONED* 1 of 5. 72-inch pipes or culvert through levee 31.6 feet below crown. Slide gates on both ends. (five 72-inch pipes [HLM 0.08] authorized under Automatic Board Order (ABO) issued as Permit No. 9736, 1974 - Reclamation District No. 108 [RD0108]) [Additional Reference(s): DWR Levee Log, 2005. USACE Sacramento O&M Manual Unit No. 132, October 1959, (HLM 0.08), referenced as five 6-foot by 8-foot concrete culvert drains]. FS Date: 6/10/2014

View of concrete structure visible on landward side.

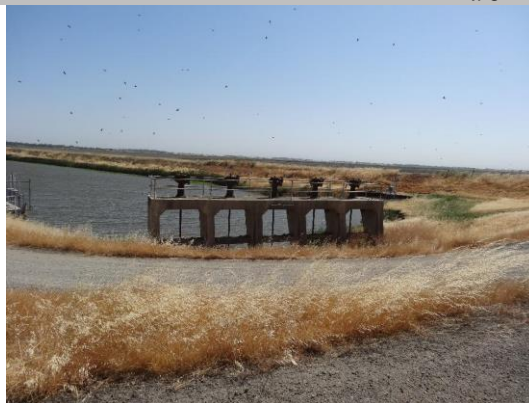
Photo 3 of 3 : UCIP\_FA\_2017\_37609\_68213.jpg

Comment Code						
Inspector Comment						
FS_ID:37609 DS_ID:22386 EP_NO: 9396 Repair Type: Non-Urgent Crossing Status: Found UCIP Comments: Need to contact owner to determine status of structure. Notes indicate crossing has been abandoned. Owner will need to coordinate with CVFPB and DWR inspector to determine how to properly abandon. FIELD_STRUCT_DESC: *ABANDONED* 2 of 5. 72-inch pipes or culvert through levee 31.6 feet below crown. Slide gates on both ends. (five 72-inch pipes [HLM 0.08] authorized under Automatic Board Order (ABO) issued as Permit No. 9736, 1974 - Reclamation District No. 108 [RD0108]) [Additional Reference(s): DWR Levee Log, 2005. USACE Sacramento O&M Manual Unit No. 132, October 1959, (HLM 0.08), referenced as five 6-foot by 8-foot concrete culvert drains]. FS Date: 6/10/2014

View of concrete structure located on landward side.

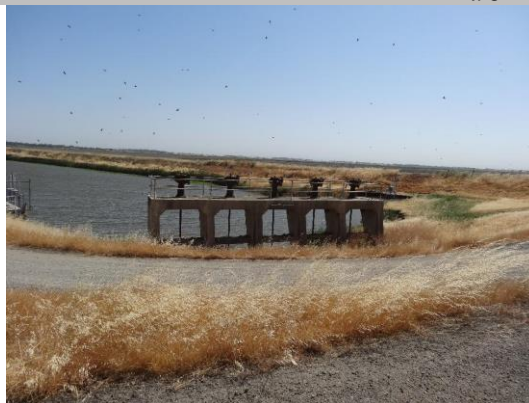
Photo 3 of 3 : UCIP\_FA\_2017\_37610\_68217.jpg

Comment Code						
Inspector Comment						
FS_ID:37610 DS_ID:22387 EP_NO: 9396 Repair Type: Non-Urgent Crossing Status: Found UCIP Comments: Need to contact owner to determine status of structure. Notes indicate crossing has been abandoned. Owner will need to coordinate with CVFPB and DWR inspector to determine how to properly abandon. FIELD_STRUCT_DESC: *ABANDONED* 3 of 5. 72-inch pipes or culvert through levee 31.6 feet below crown. Slide gates on both ends. (five 72-inch pipes [HLM 0.08] authorized under Automatic Board Order (ABO) issued as Permit No. 9736, 1974 - Reclamation District No. 108 [RD0108]) [Additional Reference(s): DWR Levee Log, 2005. USACE Sacramento O&M Manual Unit No. 132, October 1959, (HLM 0.08), referenced as five 6-foot by 8-foot concrete culvert drains]. FS Date: 6/10/2014

Concrete structure located on landward side.

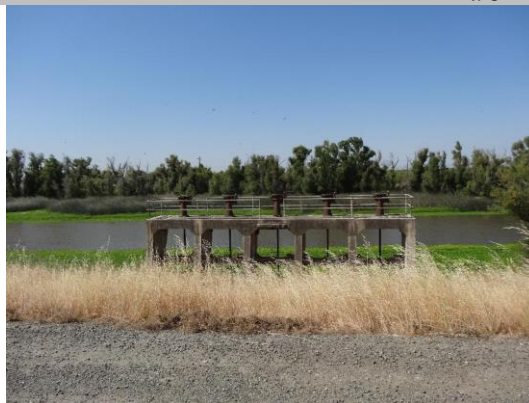
Photo 1 of 3 : UCIP\_FA\_2017\_37611\_68220.jpg

Comment Code						
Inspector Comment						
FS_ID:37611 DS_ID:22388 EP_NO: 9396 Repair Type: Non-Urgent Crossing Status: Found UCIP Comments: Need to contact owner to determine status of structure. Notes indicate crossing has been abandoned. Owner will need to coordinate with CVFPB and DWR inspector to determine how to properly abandon. FIELD_STRUCT_DESC: *ABANDONED* 4 of 5. 72-inch pipes or culvert through levee 31.6 feet below crown. Slide gates on both ends. (five 72-inch pipes [HLM 0.08] authorized under Automatic Board Order (ABO) issued as Permit No. 9736, 1974 - Reclamation District No. 108 [RD0108]) [Additional Reference(s): DWR Levee Log, 2005. USACE Sacramento O&M Manual Unit No. 132, October 1959, (HLM 0.08), referenced as five 6-foot by 8-foot concrete culvert drains]. FS Date: 6/10/2014

Concrete structure located on waterward side.

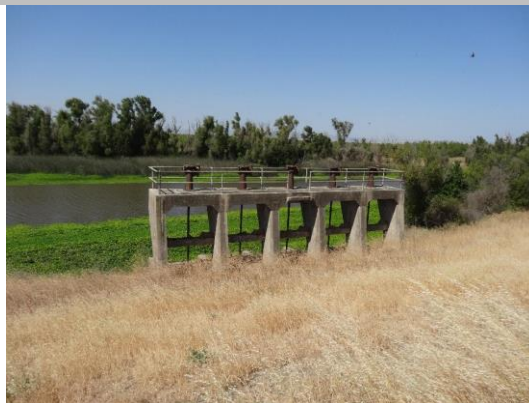
Photo 2 of 3 : UCIP\_FA\_2017\_37611\_68224.jpg

Waterward slope covered by dense vegetation.

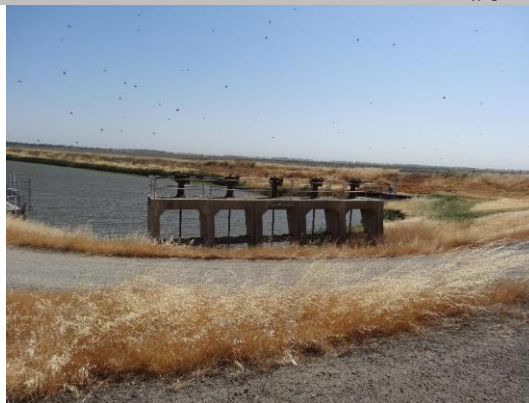
Photo 3 of 3 : UCIP\_FA\_2017\_37611\_68222.jpg

Comment Code						
Inspector Comment						
FS_ID:37611 DS_ID:22388 EP_NO: 9396 Repair Type: Non-Urgent Crossing Status: Found UCIP Comments: Need to contact owner to determine status of structure. Notes indicate crossing has been abandoned. Owner will need to coordinate with CVFPB and DWR inspector to determine how to properly abandon. FIELD_STRUCT_DESC: *ABANDONED* 4 of 5. 72-inch pipes or culvert through levee 31.6 feet below crown. Slide gates on both ends. (five 72-inch pipes [HLM 0.08] authorized under Automatic Board Order (ABO) issued as Permit No. 9736, 1974 - Reclamation District No. 108 [RD0108]) [Additional Reference(s): DWR Levee Log, 2005. USACE Sacramento O&M Manual Unit No. 132, October 1959, (HLM 0.08), referenced as five 6-foot by 8-foot concrete culvert drains]. FS Date: 6/10/2014

Concrete structure visible on landward side.

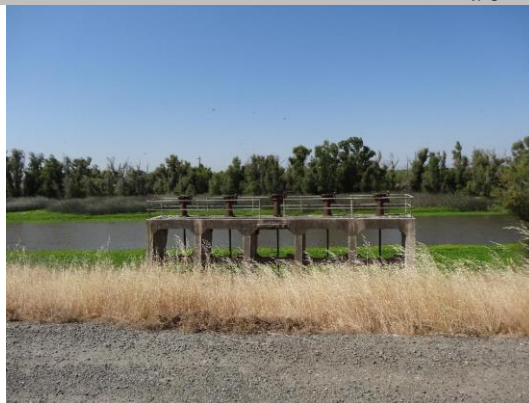
Photo 1 of 3 : UCIP\_FA\_2017\_37607\_68203.jpg

Comment Code						
Inspector Comment						
FS_ID:37607 DS_ID:22389 EP_NO: 9396 Repair Type: Non-Urgent Crossing Status: Found UCIP Comments: Need to contact owner to determine status of structure. Notes indicate crossing has been abandoned. Owner will need to coordinate with CVFPB and DWR inspector to determine how to properly abandon. FIELD_STRUCT_DESC: *ABANDONED* 5 of 5. 72-inch pipes or culvert through levee 31.6 feet below crown. Slide gates on both ends. (five 72-inch pipes [HLM 0.08] authorized under Automatic Board Order (ABO) issued as Permit No. 9736, 1974 - Reclamation District No. 108 [RD0108]) [Additional Reference(s): DWR Levee Log, 2005. USACE Sacramento O&M Manual Unit No. 132, October 1959, (HLM 0.08), referenced as five 6-foot by 8-foot concrete culvert drains]. FS Date: 6/10/2014

Concrete structure located on waterward side.

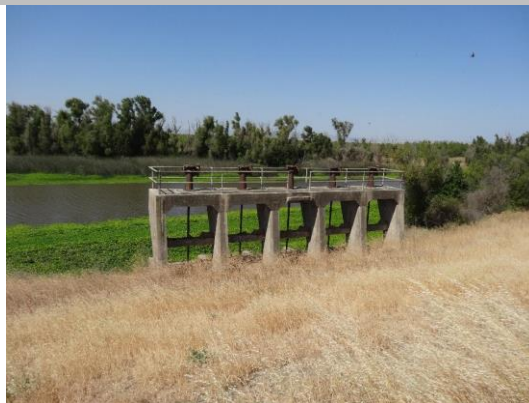
Photo 2 of 3 : UCIP\_FA\_2017\_37607\_68206.jpg

Waterward slope covered by dense vegetation.

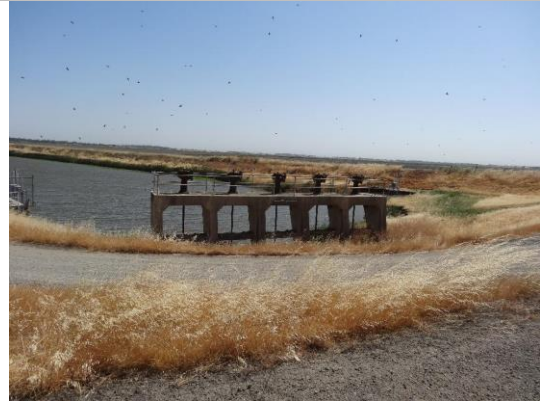
Photo 3 of 3 : UCIP\_FA\_2017\_37607\_68204.jpg

Comment Code						
Inspector Comment						
FS_ID:37607 DS_ID:22389 EP_NO: 9396 Repair Type: Non-Urgent Crossing Status: Found UCIP Comments: Need to contact owner to determine status of structure. Notes indicate crossing has been abandoned. Owner will need to coordinate with CVFPB and DWR inspector to determine how to properly abandon. FIELD_STRUCT_DESC: *ABANDONED* 5 of 5. 72-inch pipes or culvert through levee 31.6 feet below crown. Slide gates on both ends. (five 72-inch pipes [HLM 0.08] authorized under Automatic Board Order (ABO) issued as Permit No. 9736, 1974 - Reclamation District No. 108 [RD0108]) [Additional Reference(s): DWR Levee Log, 2005. USACE Sacramento O&M Manual Unit No. 132, October 1959, (HLM 0.08), referenced as five 6-foot by 8-foot concrete culvert drains]. FS Date: 6/10/2014

Concrete structure located on landward side.

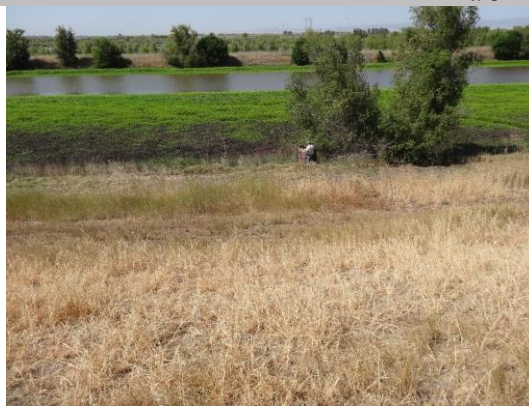
Photo 1 of 3 : UCIP\_FA\_2017\_39707\_71682.jpg

Comment Code					
Inspector Comment					
FS_ID:39707					
DS_ID:24875					
EP_NO: N/A					
Repair Type: Non-Urgent					
Crossing Status: Indicator Found					
UCIP Comments: No signs of pipe visible--need to contact owner to obtain permit number authorizing work. If crossing is no longer used by owner, the owner will need to coordinate with DWR Inspector and CVFPB to remove crossing according to Title 23 requirements. Dense vegetation limits the inspector's visibility to identify signs of pipe failure (leaks) along the slope. Recommend removing vegetation along pipe alignment to conduct proper inspection of structure.					
FIELD_STRUCT_DESC: Corrugated Metal (CM) pipe riser located on waterward side. Riser is filled with trash and debris. Unable to determine if crossing exists at this location.					
FS Date: 3/18/2014

View of waterward side.

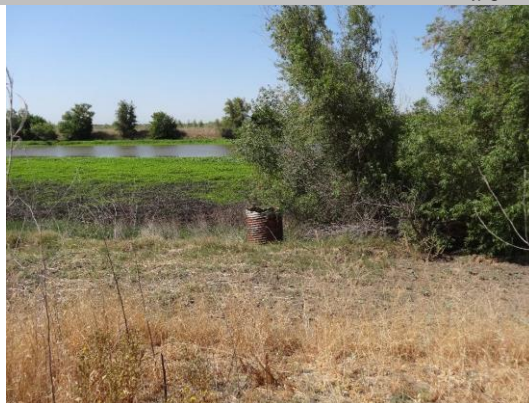
Photo 2 of 3 : UCIP\_FA\_2017\_39707\_71681.jpg

Comment Code						
Inspector Comment						
FS_ID:39707						
DS_ID:24875						
EP_NO: N/A						
Repair Type: Non-Urgent						
Crossing Status: Indicator Found						
UCIP Comments: No signs of pipe visible--need to contact owner to obtain permit number authorizing work. If crossing is no longer used by owner, the owner will need to coordinate with DWR Inspector and CVFPB to remove crossing according to Title 23 requirements. Dense vegetation limits the inspector's visibility to identify signs of pipe failure (leaks) along the slope. Recommend removing vegetation along pipe alignment to conduct proper inspection of structure.						
FIELD_STRUCT_DESC: Corrugated Metal (CM) pipe riser located on waterward side. Riser is filled with trash and debris. Unable to determine if crossing exists at this location.						
FS Date: 3/18/2014

CMP riser located on waterward toe--2/3 filled with soil and trash.

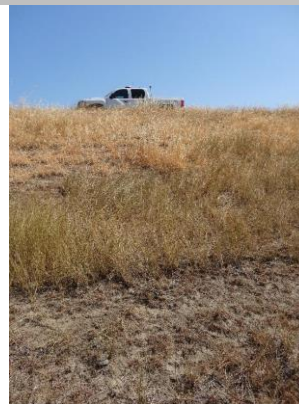
Photo 3 of 3 : UCIP\_FA\_2017\_39707\_71680.jpg

View of waterward slope.

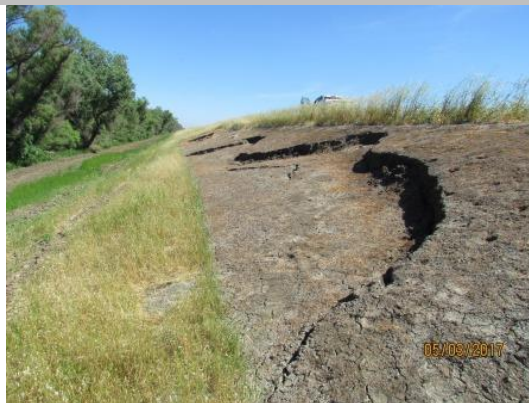
Photo 1 of 1 : FA\_2017\_RD0108\_203\_10\_20170911\_00002.jpg

LM Start	9.17	Rating **	A/W	Issue No.	10
LM End	9.20	Issue Type +	Ma	Location *	WS
Category	Earthen Levee			GPS Latitude/Longitude	
				Start	End
Item	Slope Stability			38.895605 °	38.896086 °
				-121.914645 °	-121.914646 °
DWR ID	DWR_RD0108_01_s_2017_10				
Comment Code					
S1 : Repair slope instability.					
Inspector Comment					
200' section of multiple sloughs. District submitted request for PL 84-99 assistance.

View of sloughing on waterside slope. Spring 2017.

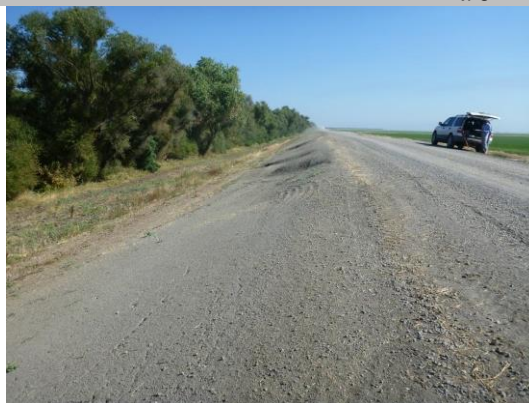
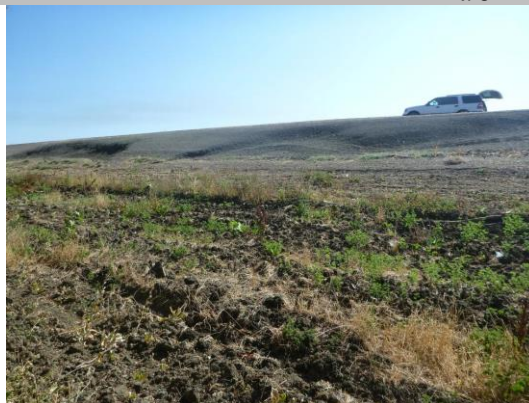
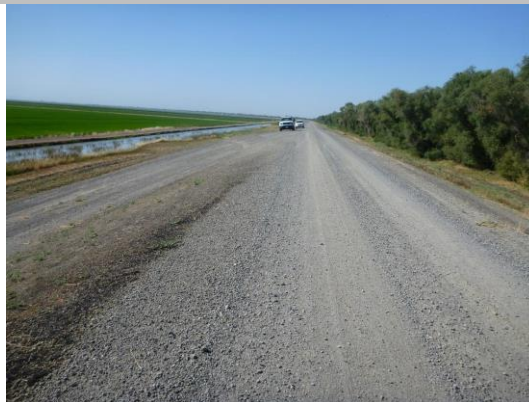
LM Start	9.18	Rating **	A/W	Issue No.	17	
LM End	9.20	Issue Type +	Ma	Location *		
Category	Supplemental			GPS Latitude/Longitude		
				Start	End	
Item	2017 Storm Damage			38.895833 °	38.896142 °	
				-121.914672 °	-121.914445 °	
DWR ID	DWR_RD0108_01_f_2017_17					
Comment Code						
Inspector Comment						
Levee Evaluation Comments						
Description:						
Site ID No:220						
Site Designation:RD 108-05						
Repair Type: Erosion						
Rating:Critical						
Field Date:7/18/2017						
Notes:

LM Start	9.18	Rating **	A/W	Issue No.	17 (cont)	
LM End	9.20	Issue Type +	Ma	Location *		
Category	Supplemental			GPS Latitude/Longitude		
				Start	End	
Item	2017 Storm Damage			38.895833 °	38.896142 °	
				-121.914672 °	-121.914445 °	
DWR ID	DWR_RD0108_01_f_2017_17					
Comment Code						
Inspector Comment						
Levee Evaluation Comments						
Description:						
Site ID No:220						
Site Designation:RD 108-05						
Repair Type: Erosion						
Rating:Critical						
Field Date:7/18/2017						
Notes:

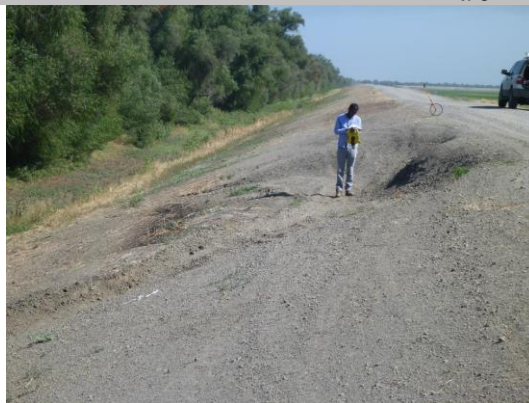
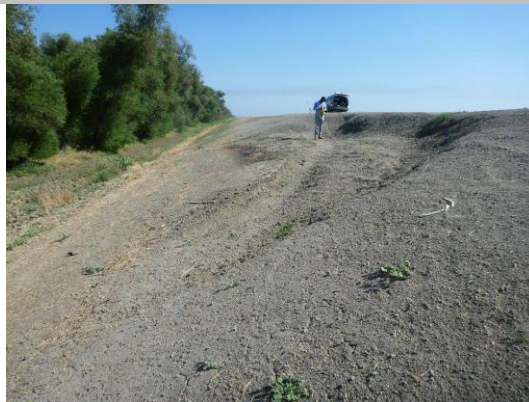
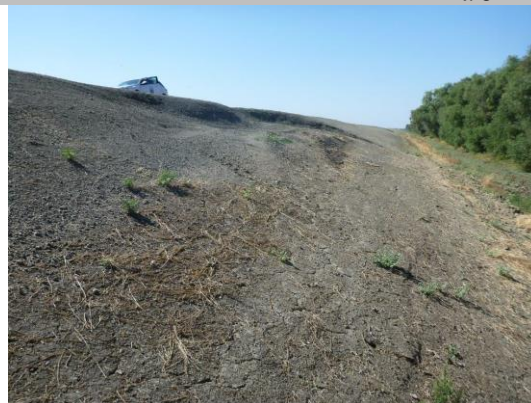
LM Start	9.29	Rating **	A/W	Issue No.	18	
LM End	9.30	Issue Type +	Ma	Location *		
Category	Supplemental			GPS Latitude/Longitude		
				Start	End	
Item	2017 Storm Damage			38.897338 °	38.897583 °	
				-121.914672 °	-121.914688 °	
DWR ID	DWR_RD0108_01_f_2017_18					
Comment Code						
Inspector Comment						
Levee Evaluation Comments						
Description:						
Site ID No:219						
Site Designation:RD 108-04						
Repair Type: Erosion						
Rating:Critical						
Field Date:7/18/2017						
Notes:

LM Start	9.29	Rating **	A/W	Issue No.	18 (cont)	
LM End	9.30	Issue Type +	Ma	Location *		
Category	Supplemental			GPS Latitude/Longitude		
				Start	End	
Item	2017 Storm Damage			38.897338 °	38.897583 °	
				-121.914672 °	-121.914688 °	
DWR ID	DWR_RD0108_01_f_2017_18					
Comment Code						
Inspector Comment						
Levee Evaluation Comments						
Description:						
Site ID No:219						
Site Designation:RD 108-04						
Repair Type: Erosion						
Rating:Critical						
Field Date:7/18/2017						
Notes:

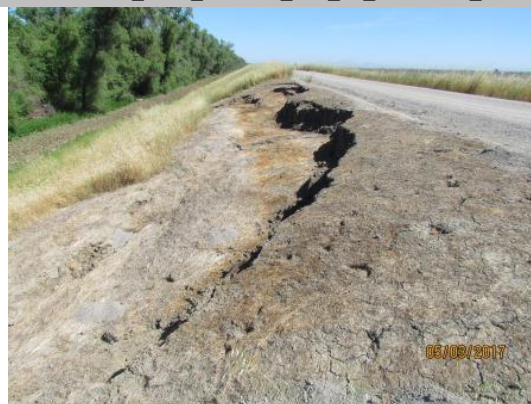
Photo 1 of 1 : FA\_2017\_RD0108\_203\_31\_20170911\_00011.jpg

LM Start	9.30	Rating **	A/W	Issue No.	31
LM End	9.30	Issue Type +	Ma	Location *	WS
Category	Earthen Levee			GPS Latitude/Longitude	
				Start	End
Item	Slope Stability			38.897494 °	38.897494 °
				-121.914680 °	-121.914680 °
DWR ID	DWR_RD0108_01_s_2017_31				
Comment Code					
S1 : Repair slope instability.					
Inspector Comment					
100' sloughing section on waterside slope. District submitted application for PL 84-99 assistance.

View of sloughing on waterside slope. Spring 2017.

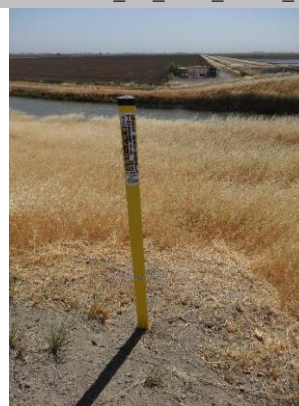
Photo 1 of 3 : UCIP\_FA\_2017\_39717\_71705.jpg

LM Start	11.24	Rating **	M	Issue No.	42	
LM End	11.24	Issue Type +	En	Location *		
Category	Supplemental			GPS Latitude/Longitude		
				Start	End	
Item	DWR UCIP Field Study			38.925662 °	38.925662 °	
				-121.914303 °	-121.914303 °	
DWR ID						
Comment Code						
Inspector Comment						
FS_ID:39717						
DS_ID:24876						
EP_NO: N/A						
Repair Type: Non-Urgent						
Crossing Status: Indicator Found						
UCIP Comments: Need to contact owner to determine additional details of crossing.						
FIELD_STRUCT_DESC: Natural gas line with markers on both side slightly angled through levee. Gas station located across canal on landward side.						
FS Date: 3/18/2014

View of marker visible on shoulder.

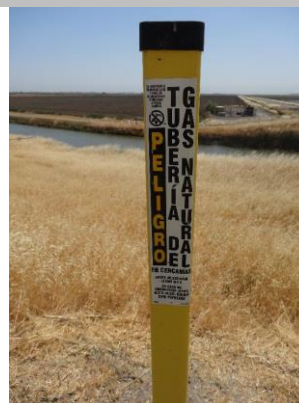
Photo 2 of 3 : UCIP\_FA\_2017\_39717\_71704.jpg

Owner contact information listed on marker.

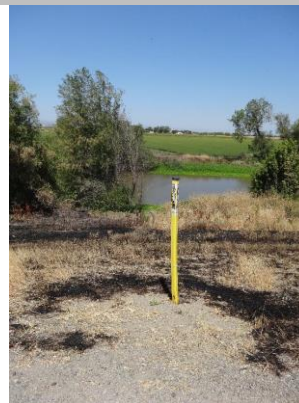
Photo 3 of 3 : UCIP\_FA\_2017\_39717\_71703.jpg

LM Start	11.24	Rating **	M	Issue No.	42 (cont)	
LM End	11.24	Issue Type +	En	Location *		
Category	Supplemental			GPS Latitude/Longitude		
				Start	End	
Item	DWR UCIP Field Study			38.925662 °	38.925662 °	
				-121.914303 °	-121.914303 °	
DWR ID						
Comment Code						
Inspector Comment						
FS_ID:39717						
DS_ID:24876						
EP_NO: N/A						
Repair Type: Non-Urgent						
Crossing Status: Indicator Found						
UCIP Comments: Need to contact owner to determine additional details of crossing.						
FIELD_STRUCT_DESC: Natural gas line with markers on both side slightly angled through levee. Gas station located across canal on landward side.						
FS Date: 3/18/2014

Marker visible on waterward side.

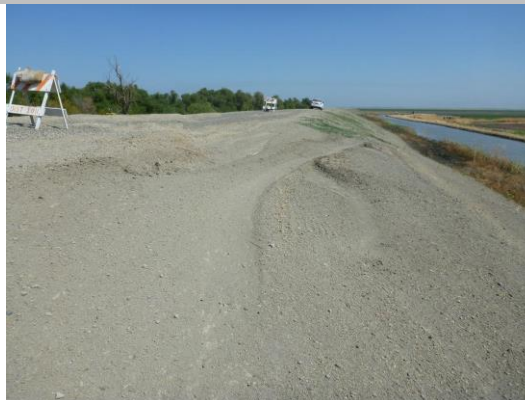
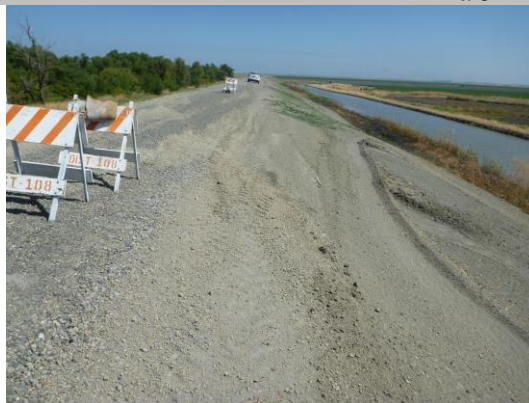
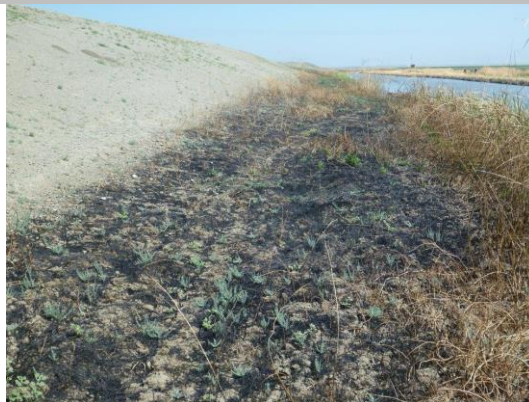
LM Start	12.68	Rating **	A/W	Issue No.	19	
LM End	12.70	Issue Type +	Ma	Location *		
Category	Supplemental			GPS Latitude/Longitude		
				Start	End	
Item	2017 Storm Damage			38.945305	°	38.945717
				-121.906692	°	-121.906717
DWR ID	DWR_RD0108_01_f_2017_19					
Comment Code						
Inspector Comment						
Levee Evaluation Comments						
Description:						
Site ID No:218						
Site Designation:RD 108-03						
Repair Type: Erosion						
Rating:Critical						
Field Date:7/18/2017						
Notes: levee crown is inaccessible by vehicle due to crown slip failure

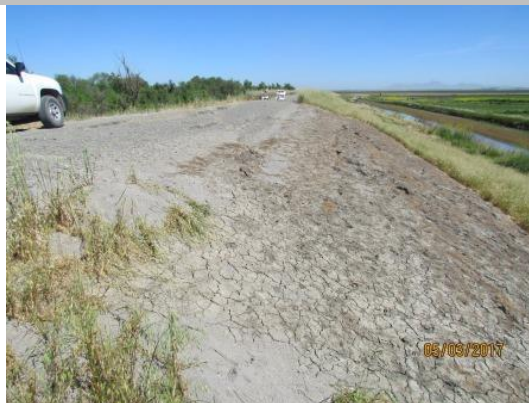
Photo 1 of 2 : FA\_2017\_RD0108\_203\_32\_20170911\_00012.jpg

View of sloughing on crown and slope. Spring 2017.

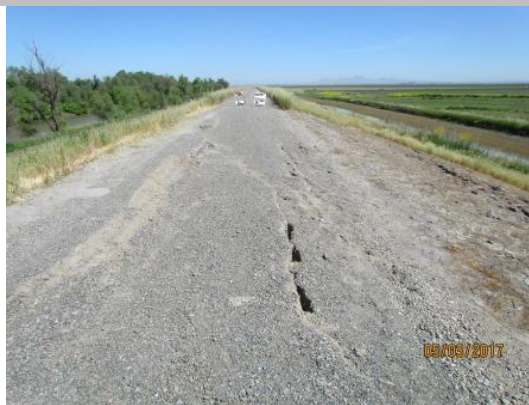
Photo 2 of 2 : FA\_2017\_RD0108\_203\_32\_20170911\_00013.jpg

Additional view of sloughing. Spring 2017.

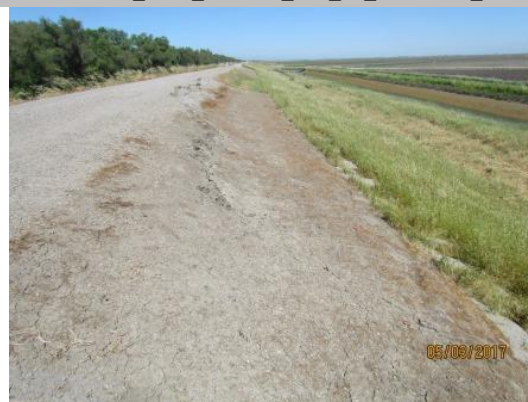
Photo 1 of 1 : FA\_2017\_RD0108\_203\_33\_20170911\_00014.jpg

LM Start	14.47	Rating **	A/W	Issue No.	33
LM End	14.55	Issue Type +	Ma	Location *	LS
Category	Earthen Levee			GPS Latitude/Longitude	
				Start	End
Item	Slope Stability			38.967062 °	38.967784 °
				-121.923113 °	-121.924148 °
DWR ID	DWR_RD0108_01_s_2017_33				
Comment Code					
S1 : Repair slope instability.					
Inspector Comment					
400' sloughing section on landside slope. District submitted an application for PL 84-99 assistance.

View of sloughing on landside slope. Spring 2017.

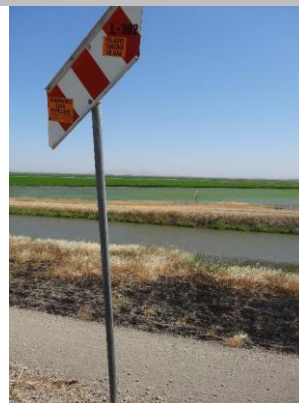
Photo 1 of 3 : UCIP\_FA\_2017\_37623\_68246.jpg

Marker visible on landward side.

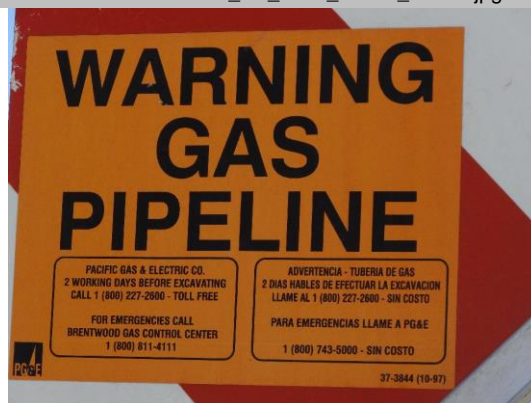
Photo 2 of 3 : UCIP\_FA\_2017\_37623\_68245.jpg

Contact information for gas line going through levee.

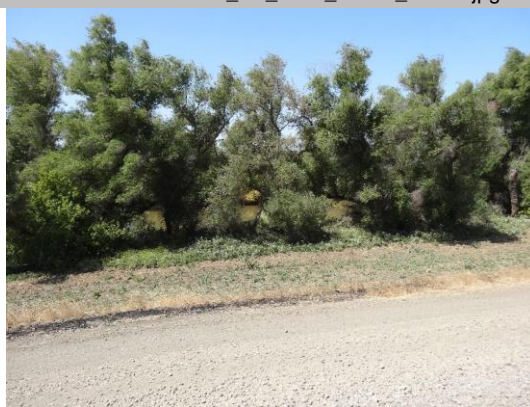
Photo 3 of 3 : UCIP\_FA\_2017\_37623\_68244.jpg

View of waterward side. No marker visible on waterward side.

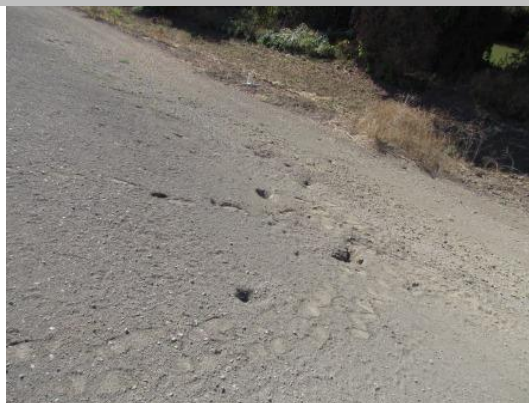
Photo 1 of 2 : FA\_2017\_RD0108\_203\_29\_20170911\_00009.jpg

Updated view of a site with rodent activity. Fall 2016 inspection.

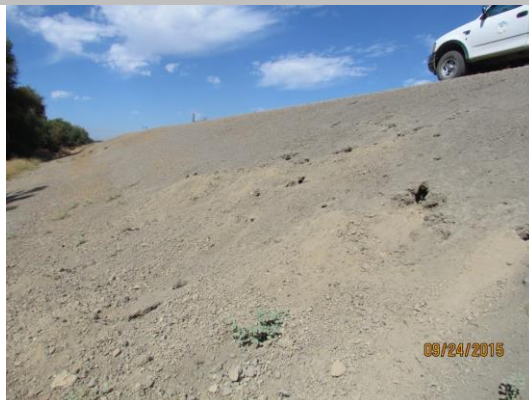
Photo 2 of 2 : FA\_2017\_RD0108\_203\_29\_20170911\_00010.jpg

View of the animal hole on the waterward side of the levee looking upstream. Fall 2015.

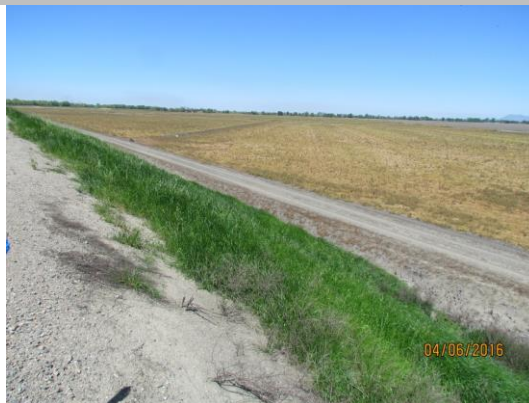
Photo 1 of 1 : FA\_2017\_RD0108\_203\_6\_20170911\_00001.jpg

View of the ditch at the toe of the levee on the landward side looking upstream. Spring 2016.

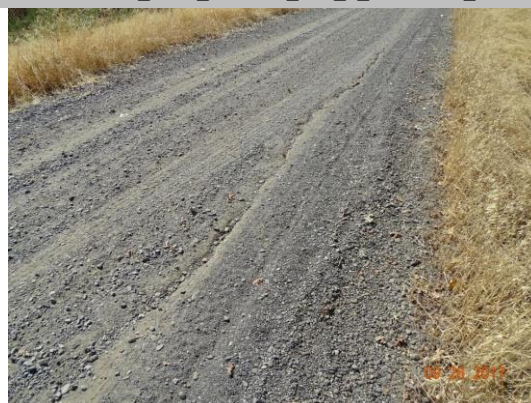
Photo 1 of 2 : FA\_2017\_RD0108\_590\_8\_20170926\_00005.jpg

Updated photo of crack on crown of the levee. Fall 2017.

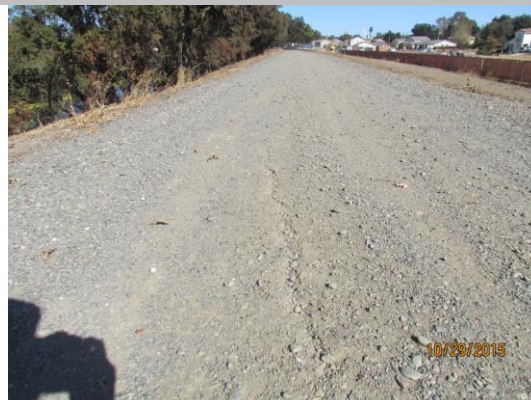
Photo 2 of 2 : FA\_2017\_RD0108\_590\_8\_20170911\_00004.jpg

View of the crack on the crown of the levee looking downstream. Fall 2015.
