**Flood Control Project Maintenance
Levee Inspections**

Fall 2018 Levee Maintenance Deficiency Summary Report

**Flood Control Project Maintenance
Levee Inspections**
LMA District Cover Sheet
Fall 2018 Levee Inspection Results

Reclamation District No. 0108 River Farms

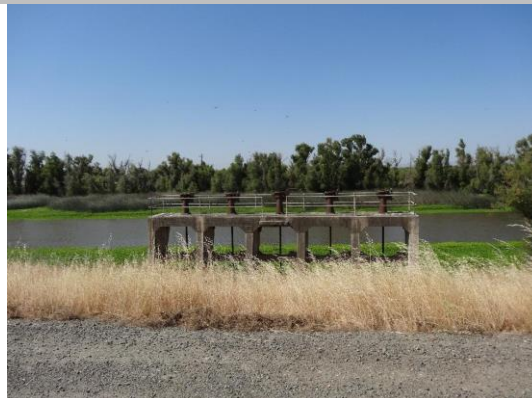
Photo 1 of 3 : UCIP_FA_2018_37608_68207.jpg

LM Start	0.06	Rating **	M	Issue No.	29
LM End	0.06	Issue Type +	Ma	Location *	
Category	Supplemental			GPS Latitude/Longitude	
				Start	End
Item	DWR UCIP LMA Responsibility			38.822897°	38.822897°
				-121.797000°	-121.797000°
DWR ID	17943

Comment Code					
Inspector Comment					
FS_ID:37608 DS_ID:17943 EP_NO: 9396 Repair Type: Non-Urgent Crossing Status: Found UCIP Comments: Need to contact owner to determine status of structure. Notes indicate crossing has been abandoned. Owner will need to coordinate with CVFPB and DWR inspector to determine how to properly abandon. FIELD_STRUCT_DESC: *ABANDONED* 1 of 5: 72-inch reinforced concrete gravity drainage pipe or culvert through the levee, 31.6 feet below the crown. Slide gate on each end. (Retention of five 72-inch pipes through the levee [HLM 0.08] authorized under Automatic Board Order (ABO) issued as Permit No. 9736, 1974 - Reclamation District No. 108 [RD0108]). [Additional Reference(s): DWR Levee Log, 1991. USACE Sacramento O&M Manual 132, October 1959, (HLM 0.08), referenced as five 6-foot by 8-foot concrete drainage culverts]. FS Date: 6/10/2014

View of concrete structure visible on waterward side.

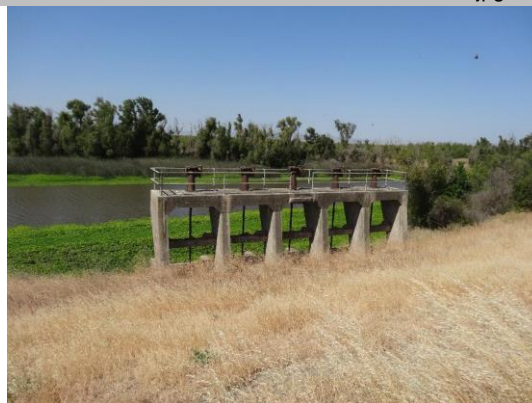
Photo 2 of 3 : UCIP_FA_2018_37608_68210.jpg

Dense vegetation on waterward side.

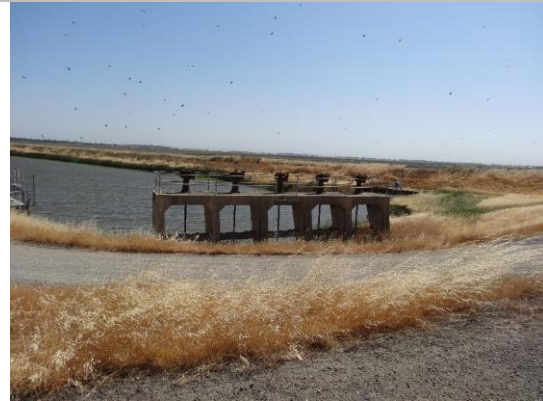
Photo 3 of 3 : UCIP_FA_2018_37608_68208.jpg

View of concrete structure visible on landward side.

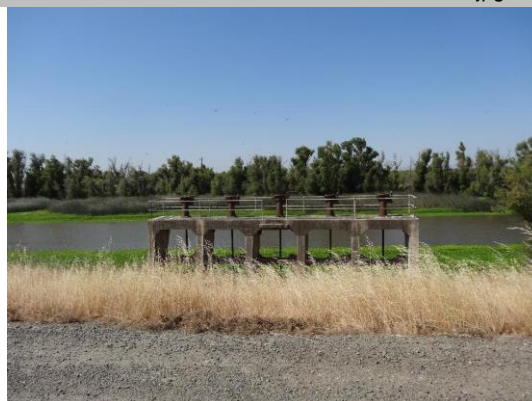
Photo 1 of 3 : UCIP_FA_2018_37609_68211.jpg

LM Start	0.06	Rating **	M	Issue No.	30
LM End	0.06	Issue Type +	Ma	Location *	
Category	Supplemental			GPS Latitude/Longitude	
				Start	End
Item	DWR UCIP LMA Responsibility			38.822919 °	38.822919 °
				-121.797046 °	-121.797046 °
DWR ID	22386

Comment Code					
Inspector Comment					
FS_ID:37609 DS_ID:22386 EP_NO: 9396 Repair Type: Non-Urgent Crossing Status: Found UCIP Comments: Need to contact owner to determine status of structure. Notes indicate crossing has been abandoned. Owner will need to coordinate with CVFPB and DWR inspector to determine how to properly abandon. FIELD_STRUCT_DESC: *ABANDONED* 2 of 5: 72-inch reinforced concrete gravity drainage pipe or culvert through the levee, 31.6 feet below the crown. Slide gate on each end. (Retention of five 72-inch pipes through the levee [HLM 0.08] authorized under Automatic Board Order (ABO) issued as Permit No. 9736, 1974 - Reclamation District No. 108 [RD0108]). [Additional Reference(s): DWR Levee Log, 1991. USACE Sacramento O&M Manual 132, October 1959, (HLM 0.08), referenced as five 6-foot by 8-foot concrete drainage culverts]. FS Date: 6/10/2014

Concrete structure located on waterward side.

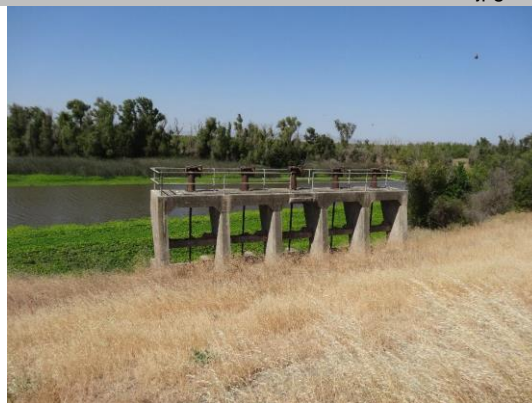
Photo 2 of 3 : UCIP_FA_2018_37609_68215.jpg

Dense vegetation covers the waterward slope.

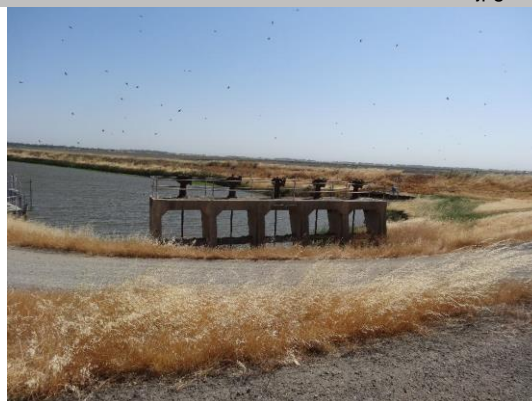
Photo 3 of 3 : UCIP_FA_2018_37609_68213.jpg

View of concrete structure located on landward side.

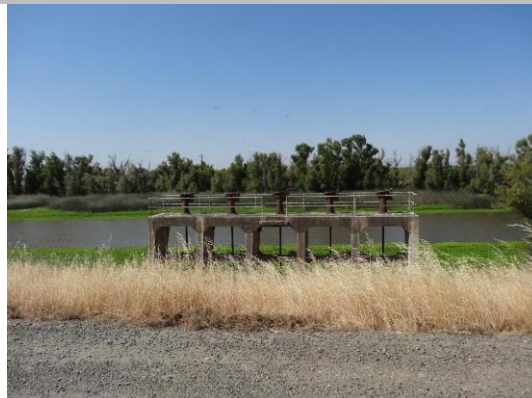
Photo 1 of 3 : UCIP_FA_2018_37610_68216.jpg

LM Start	0.06	Rating **	M	Issue No.	31
LM End	0.06	Issue Type +	Ma	Location *	
Category	Supplemental			GPS Latitude/Longitude	
				Start	End
Item	DWR UCIP LMA Responsibility			38.822933 °	38.822933 °
				-121.797081 °	-121.797081 °
DWR ID	22387

Comment Code					
Inspector Comment					
FS_ID:37610 DS_ID:22387 EP_NO: 9396 Repair Type: Non-Urgent Crossing Status: Found UCIP Comments: Need to contact owner to determine status of structure. Notes indicate crossing has been abandoned. Owner will need to coordinate with CVFPB and DWR inspector to determine how to properly abandon. FIELD_STRUCT_DESC: *ABANDONED* 3 of 5: 72-inch reinforced concrete gravity drainage pipe or culvert through the levee, 31.6 feet below the crown. Slide gate on each end. (Retention of five 72-inch pipes through the levee [HLM 0.08] authorized under Automatic Board Order (ABO) issued as Permit No. 9736, 1974 - Reclamation District No. 108 [RD0108]). [Additional Reference(s): DWR Levee Log, 1991. USACE Sacramento O&M Manual 132, October 1959, (HLM 0.08), referenced as five 6-foot by 8-foot concrete drainage culverts]. FS Date: 6/10/2014

Concrete structure located on waterward side.

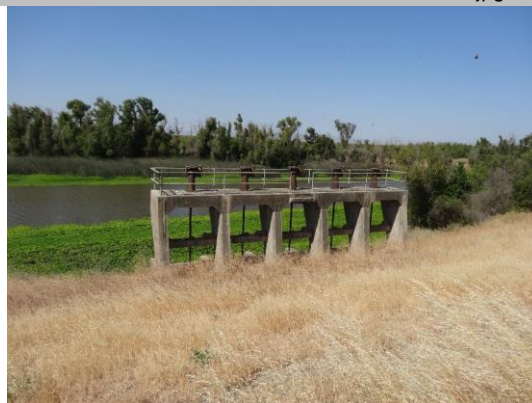
Photo 2 of 3 : UCIP_FA_2018_37610_68219.jpg

Dense vegetation covers waterward side slope.

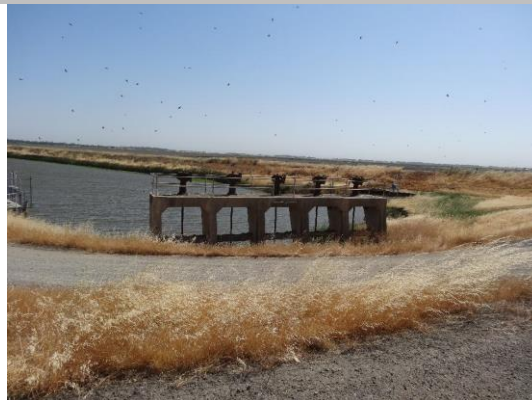
Photo 3 of 3 : UCIP_FA_2018_37610_68217.jpg

Concrete structure located on landward side.

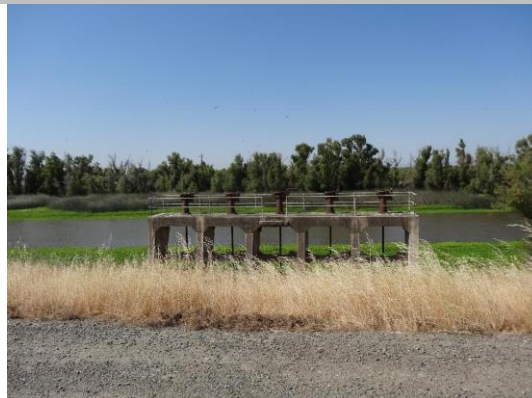
Photo 1 of 3 : UCIP_FA_2018_37611_68220.jpg

LM Start	0.06	Rating **	M	Issue No.	32
LM End	0.06	Issue Type +	Ma	Location *	
Category	Supplemental			GPS Latitude/Longitude	
				Start	End
Item	DWR UCIP LMA Responsibility			38.822897°	38.822897°
				-121.797000°	-121.797000°
DWR ID	22388

Comment Code					
Inspector Comment					
FS_ID:37611 DS_ID:22388 EP_NO: 9396 Repair Type: Non-Urgent Crossing Status: Found UCIP Comments: Need to contact owner to determine status of structure. Notes indicate crossing has been abandoned. Owner will need to coordinate with CVFPB and DWR inspector to determine how to properly abandon. FIELD_STRUCT_DESC: *ABANDONED* 4 of 5: 72-inch reinforced concrete gravity drainage pipe or culvert through the levee, 31.6 feet below the crown. Slide gate on each end. (Retention of five 72-inch pipes through the levee [HLM 0.08] authorized under Automatic Board Order (ABO) issued as Permit No. 9736, 1974 - Reclamation District No. 108 [RD0108]). [Additional Reference(s): DWR Levee Log, 1991. USACE Sacramento O&M Manual 132, October 1959, (HLM 0.08), referenced as five 6-foot by 8-foot concrete drainage culverts]. FS Date: 6/10/2014

Concrete structure located on waterward side.

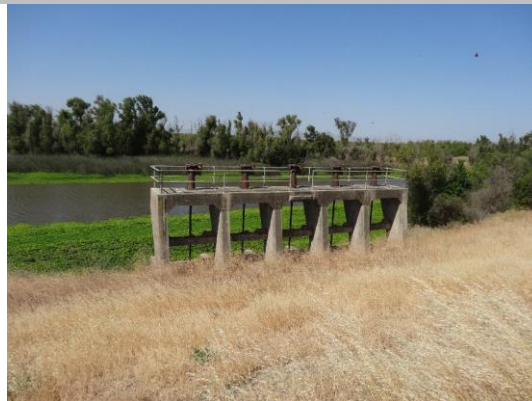
Photo 2 of 3 : UCIP_FA_2018_37611_68224.jpg

Waterward slope covered by dense vegetation.

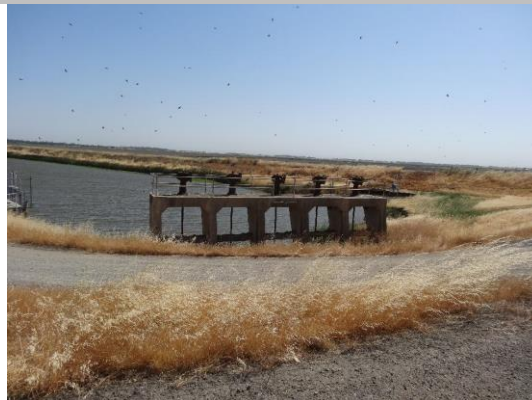
Photo 3 of 3 : UCIP_FA_2018_37611_68222.jpg

Concrete structure visible on landward side.

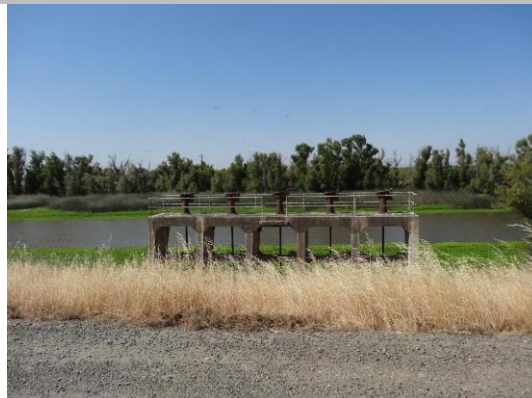
Photo 1 of 3 : UCIP_FA_2018_37607_68203.jpg

LM Start	0.07	Rating **	M	Issue No.	33
LM End	0.07	Issue Type +	Ma	Location *	
Category	Supplemental			GPS Latitude/Longitude	
				Start	End
Item	DWR UCIP LMA Responsibility			38.822954 °	38.822954 °
				-121.797135 °	-121.797135 °
DWR ID	22389

Comment Code					
Inspector Comment					
FS_ID:37607 DS_ID:22389 EP_NO: 9396 Repair Type: Non-Urgent Crossing Status: Found UCIP Comments: Need to contact owner to determine status of structure. Notes indicate crossing has been abandoned. Owner will need to coordinate with CVFPB and DWR inspector to determine how to properly abandon. FIELD_STRUCT_DESC: *ABANDONED* 5 of 5: 72-inch reinforced concrete gravity drainage pipe or culvert through the levee, 31.6 feet below the crown. Slide gate on each end. (Retention of five 72-inch pipes through the levee [HLM 0.08] authorized under Automatic Board Order (ABO) issued as Permit No. 9736, 1974 - Reclamation District No. 108 [RD0108]). [Additional Reference(s): DWR Levee Log, 1991. USACE Sacramento O&M Manual 132, October 1959, (HLM 0.08), referenced as five 6-foot by 8-foot concrete drainage culverts]. FS Date: 6/10/2014

Concrete structure located on waterward side.

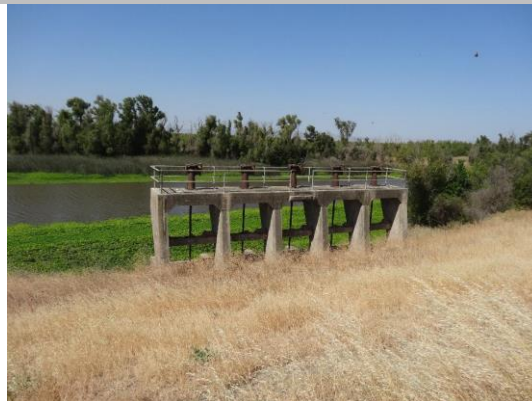
Photo 2 of 3 : UCIP_FA_2018_37607_68206.jpg

Waterward slope covered by dense vegetation.

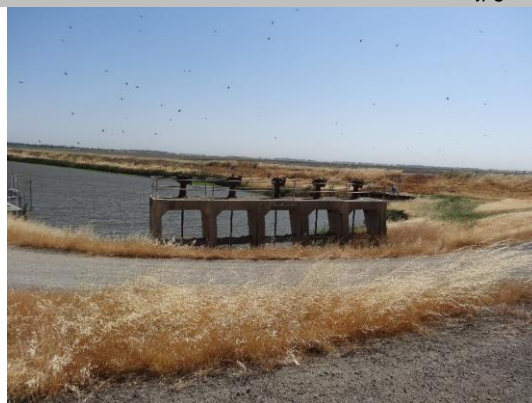
Photo 3 of 3 : UCIP_FA_2018_37607_68204.jpg

Concrete structure located on landward side.

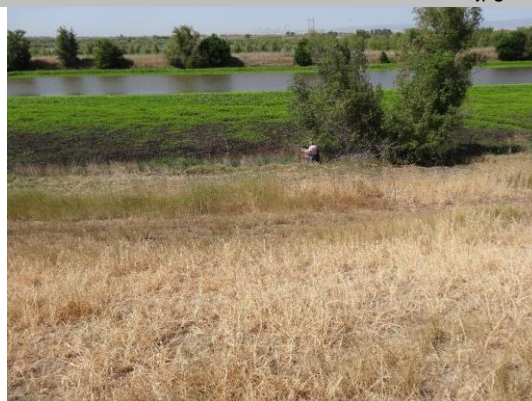
Photo 1 of 3 : UCIP_FA_2018_39707_71682.jpg

Comment Code						
Inspector Comment						
FS_ID:39707						
DS_ID:24875						
EP_NO: N/A						
Repair Type: Non-Urgent						
Crossing Status: Indicator Found						
UCIP Comments: No signs of pipe visible--need to contact owner to obtain permit number authorizing work. If crossing is no longer used by owner, the owner will need to coordinate with DWR Inspector and CVFPB to remove crossing according to Title 23 requirements. Dense vegetation limits the inspector's visibility to identify signs of pipe failure (leaks) along the slope. Recommend removing vegetation along pipe alignment to conduct proper inspection of structure.						
FIELD_STRUCT_DESC: Corrugated metal pipe (CMP) riser on the waterside (WS). Riser is filled with trash and debris. Unable to determine if a crossing exists at this location. This riser was field discovered.						
FS Date: 3/18/2014

View of waterward side.

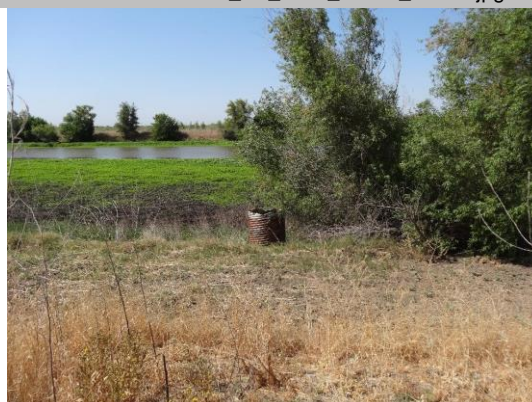
Photo 2 of 3 : UCIP_FA_2018_39707_71681.jpg

CMP riser located on waterward toe--2/3 filled with soil and trash.

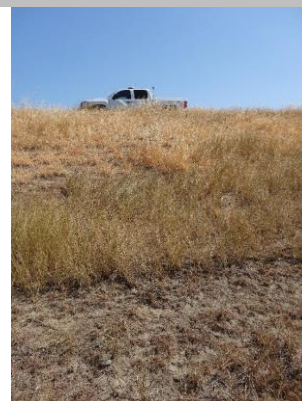
Photo 3 of 3 : UCIP_FA_2018_39707_71680.jpg

View of waterward slope.

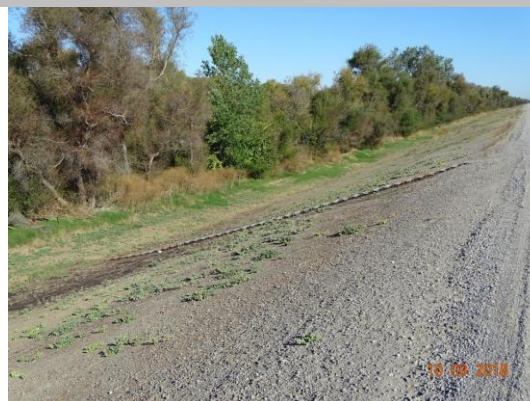
Photo 1 of 2 : FA_2018_RD0108_203_16_20181011_00029.jpg

LM Start	9.66	Rating **	M	Issue No.	16
LM End	9.66	Issue Type +	En	Location *	WS
Category	Earthen Levee			GPS Latitude/Longitude	
				Start	End
Item	Encroachments			38.902691 °	38.902691 °
				-121.914645 °	-121.914645 °
DWR ID	DWR_RD0108_01_f_2016_16				
Comment Code					
ST : Stairway					
Inspector Comment					
Department of Fish and Game staff is using stairway to access their monitoring site. Unable to verify permit.

View of stairway look upstream. Fall 2018.

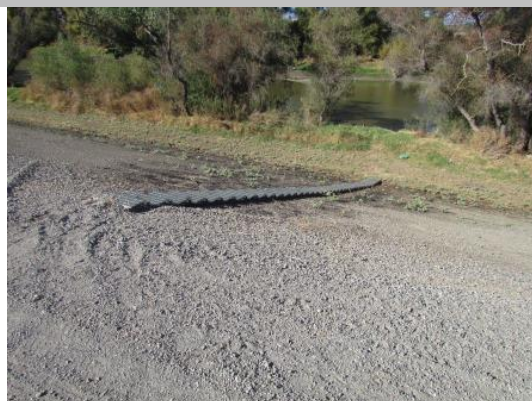
Photo 2 of 2 : FA_2018_RD0108_203_16_20180904_00002.jpg

View of a steel stairway on WS slope. Fall 2016 inspection.

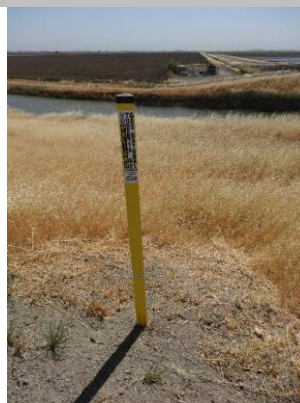
Photo 1 of 3 : UCIP_FA_2018_39717_71705.jpg

LM Start	11.24	Rating **	M	Issue No.	35	
LM End	11.24	Issue Type +	En	Location *		
Category	Supplemental			GPS Latitude/Longitude		
				Start	End	
Item	DWR UCIP Field Study			38.925662 °	38.925662 °	
				-121.914303 °	-121.914303 °	
DWR ID	24876					
Comment Code						
Inspector Comment						
FS_ID:39717						
DS_ID:24876						
EP_NO: N/A						
Repair Type: Non-Urgent						
Crossing Status: Indicator Found						
UCIP Comments: Need to contact owner to determine additional details of crossing.						
FIELD_STRUCT_DESC: Natural gas pipeline of an unknown size or material slightly angled through the levee, at an unknown depth.						
Markers on both sides of the levee. Gas station located across the canal on the landside (LS). This crossing was field discovered.						
FS Date: 3/18/2014

View of marker visible on shoulder.

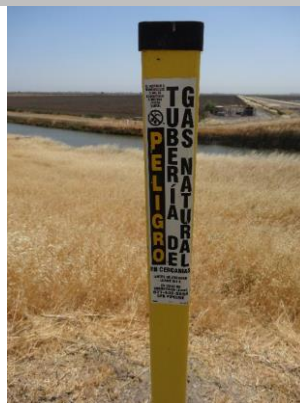
Photo 2 of 3 : UCIP_FA_2018_39717_71704.jpg

Owner contact information listed on marker.

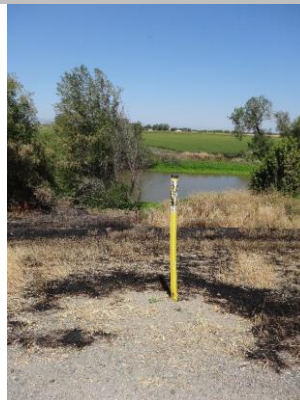
Photo 3 of 3 : UCIP_FA_2018_39717_71703.jpg

Marker visible on waterward side.

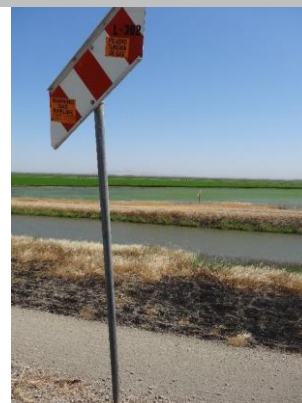
Photo 1 of 3 : UCIP_FA_2018_37623_68246.jpg

Comment Code						
Inspector Comment						
FS_ID:37623						
DS_ID:17942						
EP_NO: 3800						
Repair Type: Non-Urgent						
Crossing Status: Indicator Found						
UCIP Comments: Need to contact owner--marker missing on waterward side.						
FIELD_STRUCT_DESC: 20-inch concrete encased steel natural gas pipeline through the levee, 3 feet below the crown. Crossing appears to be angled through the levee. Small rock revetment on the waterside (WS) slope, unable to locate. Gas well approximately 1000 feet off the landside (LS) toe. (Plans to construct and maintain a 20-inch gas line across the Sacramento River authorized under Permit No. 3800, 1961 - Pacific Gas and Electric Company [PG&E]). [Additional Reference(s): DWR Levee Log, 1991].						
FS Date: 6/10/2014

Marker visible on landward side.

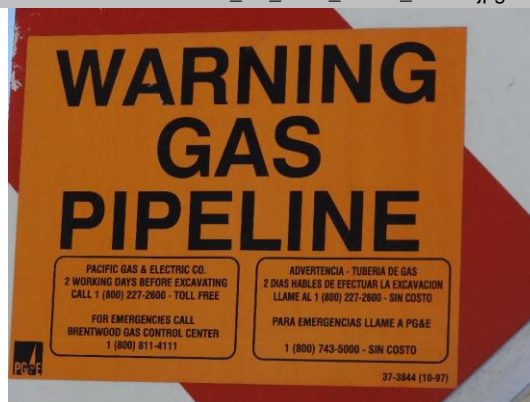
Photo 2 of 3 : UCIP_FA_2018_37623_68245.jpg

Contact information for gas line going through levee.

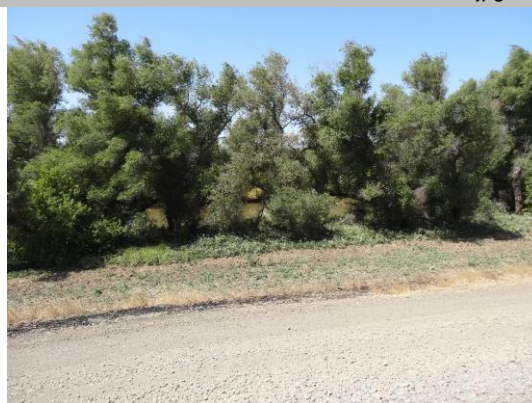
Photo 3 of 3 : UCIP_FA_2018_37623_68244.jpg

View of waterward side. No marker visible on waterward side.

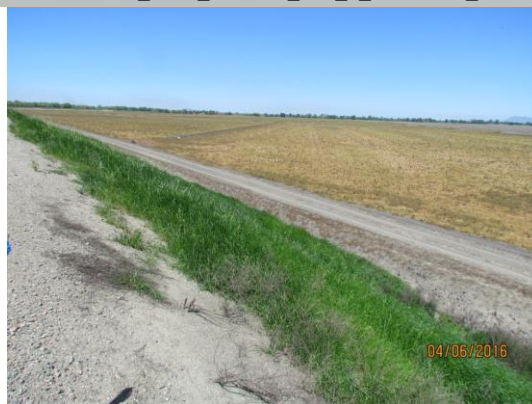
Photo 1 of 1 : FA_2018_RD0108_203_6_20180904_00001.jpg

LM Start	18.92	Rating **	M	Issue No.	6
LM End	19.28	Issue Type +	En	Location *	LS
Category	Earthen Levee			GPS Latitude/Longitude	
				Start	End
Item	Encroachments			39.013160°	39.017000°
				-121.980808°	-121.985364°
DWR ID	DWR_RD0108_01_s_2012_6				
Comment Code					
DT : Ditch					
Inspector Comment					
Ditch is at the toe of the levee.

View of the ditch at the toe of the levee on the landward side looking upstream. Spring 2016.

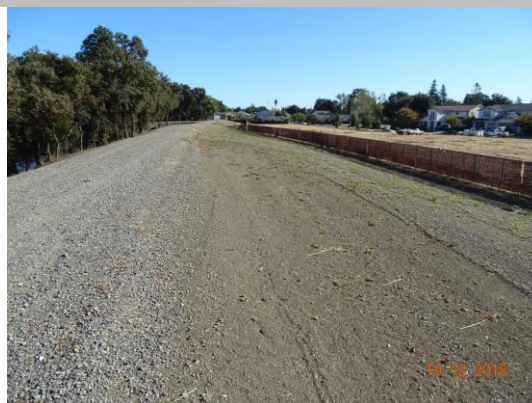
Photo 1 of 1 : FA_2018_RD0108_590_2_20181012_00002.jpg

View of the maintained landside slope. Fall 2018.
