**Flood Control Project Maintenance
Levee Inspections**

Fall 2019 Levee Maintenance Deficiency Summary Report

Levee Inspection Report By Mile - Fall 2019

Reclamation District No. 0108 River Farms

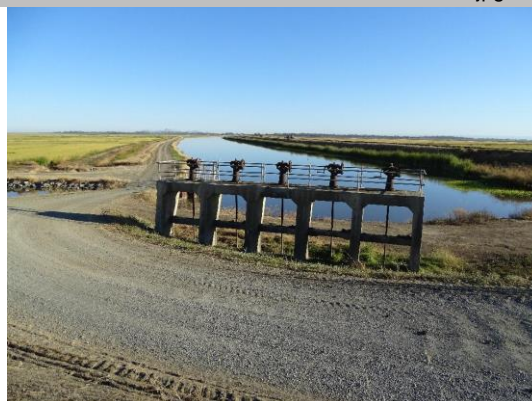
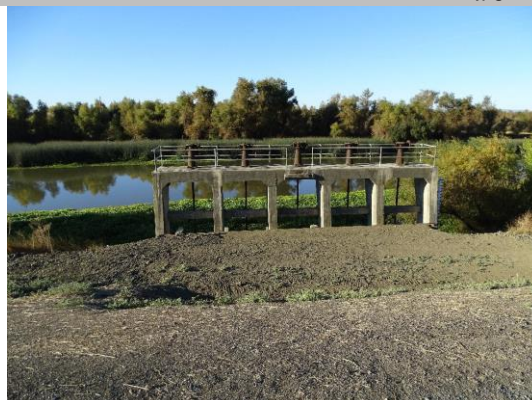
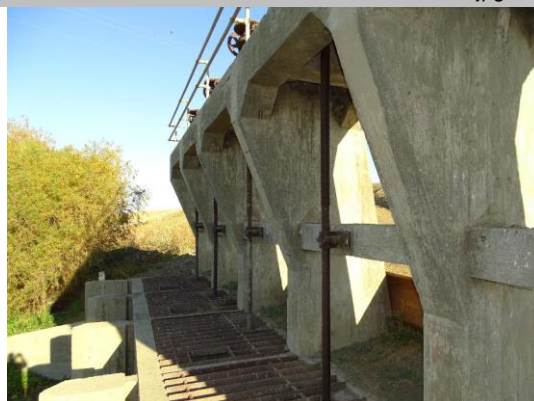
Comment Code						
Inspector Comment						
DS_ID:17943 FS_ID:55919 EP_NO: 9736 Repair Type: Non-Urgent Crossing Status: Found UCIP Comments: 10/02/2019 In 2019 RD 108 took an attempt to bring structure to operable condition. Although this attempt was unsuccessful District will review other options. In the meantime crossing considered abandoned. (O.Yakimov - DWR UCIP) 06/10/2014 Need to contact owner to determine status of structure. Notes indicate crossing has been abandoned. Owner will need to coordinate with CVFPB and DWR inspector to determine how to properly abandon. FIELD_STRUCT_DESC: *ABANDONED* 1 of 5: 72-inch reinforced concrete gravity drainage pipe or culvert through the levee, 31.6 feet below the crown. Slide gate on each end. (Retention of five 72-inch pipes through the levee [HLM 0.08] authorized under Automatic Board Order (ABO) issued as Permit No. 9736, 1974 - Reclamation District No. 108 [RD0108]). [Additional Reference(s): DWR Levee Log, 1991. USACE Sacramento O&M Manual 132, October 1959, (HLM 0.08), referenced as five 6-foot by 8-foot concrete drainage culverts]. FS Date: 10/2/2019

LM Start	0.06	Rating **	M	Issue No.	19 (cont)
LM End	0.06	Issue Type +	Ma	Location *

View of LS looking from levee crown

View of WS looking from levee crown

Slide gate operating structure on WS shoulder

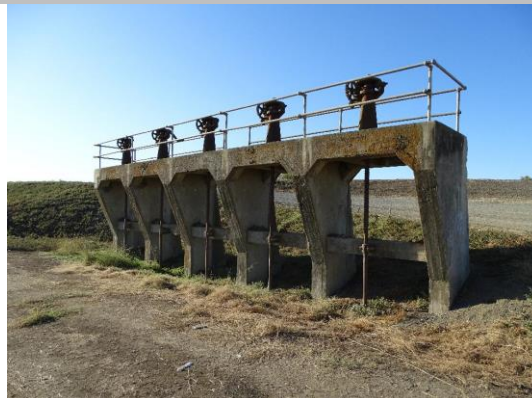
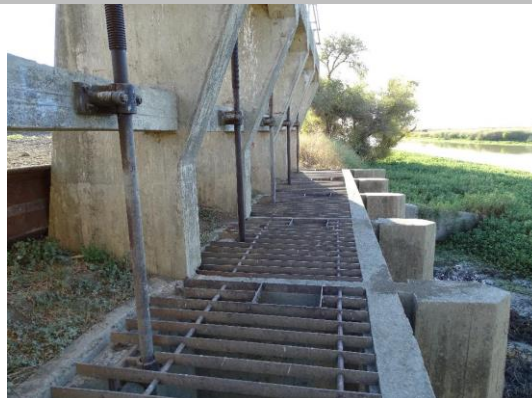
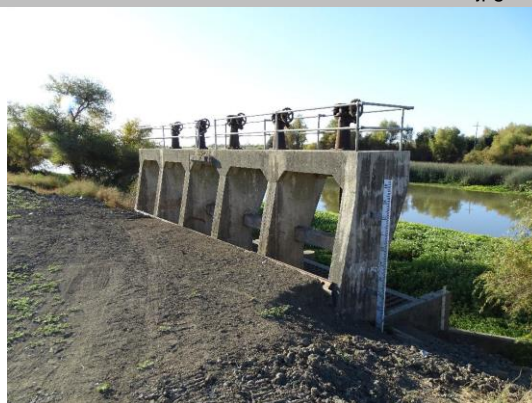
Comment Code					
Inspector Comment					
DS_ID:22386 FS_ID:55920 EP_NO: 9396 Repair Type: Non-Urgent Crossing Status: Found UCIP Comments: 10/02/2019 In 2019 RD 108 took an attempt to bring structure to operable condition. Although this attempt was unsuccessful District will review other options. In the meantime crossing considered abandoned. (O.Yakimov - DWR UCIP) 06/10/2014 Need to contact owner to determine status of structure. Notes indicate crossing has been abandoned. Owner will need to coordinate with CVFPB and DWR inspector to determine how to properly abandon. FIELD_STRUCT_DESC: *ABANDONED* 2 of 5: 72-inch reinforced concrete gravity drainage pipe or culvert through the levee, 31.6 feet below the crown. Slide gate on each end. (Retention of five 72-inch pipes through the levee [HLM 0.08] authorized under Automatic Board Order (ABO) issued as Permit No. 9736, 1974 - Reclamation District No. 108 [RD0108]). [Additional Reference(s): DWR Levee Log, 1991. USACE Sacramento O&M Manual 132, October 1959, (HLM 0.08), referenced as five 6-foot by 8-foot concrete drainage culverts]. FS Date: 8/2/2019

LM Start	0.06	Rating **	M	Issue No.	20 (cont)
LM End	0.06	Issue Type +	Ma	Location *

View of concrete structure located on landward side

Slide gates on waterward side

Comment Code						
Inspector Comment						
DS_ID:22386 FS_ID:55920 EP_NO: 9396 Repair Type: Non-Urgent Crossing Status: Found UCIP Comments: 10/02/2019 In 2019 RD 108 took an attempt to bring structure to operable condition. Although this attempt was unsuccessful District will review other options. In the meantime crossing considered abandoned. (O.Yakimov - DWR UCIP) 06/10/2014 Need to contact owner to determine status of structure. Notes indicate crossing has been abandoned. Owner will need to coordinate with CVFPB and DWR inspector to determine how to properly abandon. FIELD_STRUCT_DESC: *ABANDONED* 2 of 5: 72-inch reinforced concrete gravity drainage pipe or culvert through the levee, 31.6 feet below the crown. Slide gate on each end. (Retention of five 72-inch pipes through the levee [HLM 0.08] authorized under Automatic Board Order (ABO) issued as Permit No. 9736, 1974 - Reclamation District No. 108 [RD0108]). [Additional Reference(s): DWR Levee Log, 1991. USACE Sacramento O&M Manual 132, October 1959, (HLM 0.08), referenced as five 6-foot by 8-foot concrete drainage culverts]. FS Date: 8/2/2019

Concrete structure located on waterward side

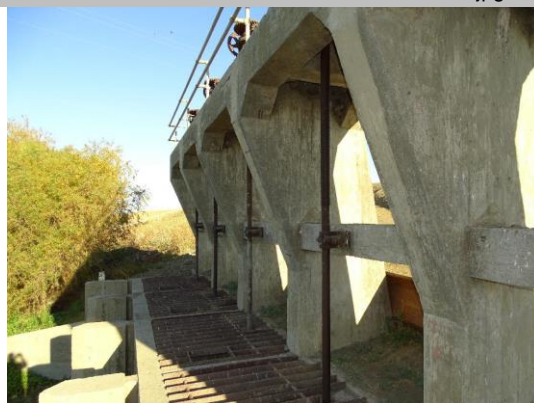
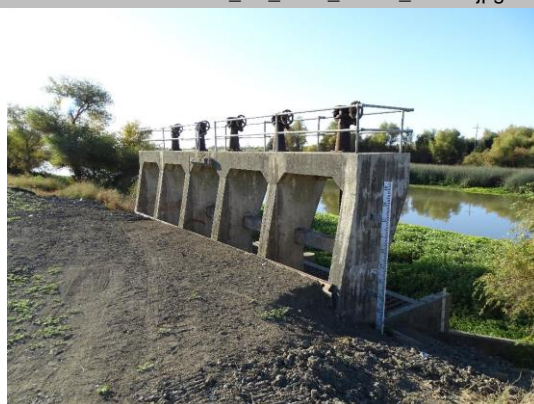
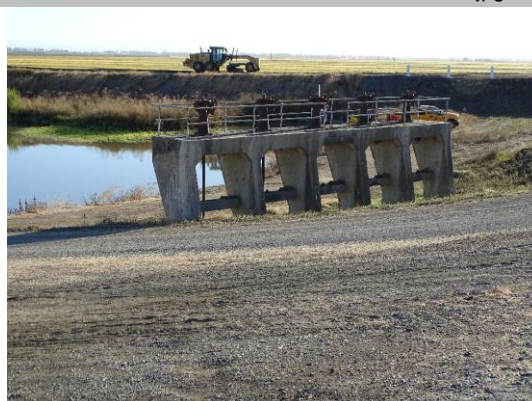
Comment Code					
Inspector Comment					
DS_ID:22387 FS_ID:55921 EP_NO: 9396 Repair Type: Non-Urgent Crossing Status: Found UCIP Comments: 10/02/2019 In 2019 RD 108 took an attempt to bring structure to operable condition. Although this attempt was unsuccessful District will review other options. In the meantime crossing considered abandoned. (O.Yakimov - DWR UCIP)06/10/2014 Need to contact owner to determine status of structure. Notes indicate crossing has been abandoned. Owner will need to coordinate with CVFPB and DWR inspector to determine how to properly abandon. FIELD_STRUCT_DESC: *ABANDONED* 3 of 5: 72-inch reinforced concrete gravity drainage pipe or culvert through the levee, 31.6 feet below the crown. Slide gate on each end. (Retention of five 72-inch pipes through the levee [HLM 0.08] authorized under Automatic Board Order (ABO) issued as Permit No. 9736, 1974 - Reclamation District No. 108 [RD0108]). [Additional Reference(s): DWR Levee Log, 1991. USACE Sacramento O&M Manual 132, October 1959, (HLM 0.08), referenced as five 6-foot by 8-foot concrete drainage culverts]. FS Date: 10/2/2019 7:54:00 AM

LM Start	0.06	Rating **	M	Issue No.	21 (cont)
LM End	0.06	Issue Type +	Ma	Location *

Slide gates on waterward side

Concrete structure located on waterward side

Concrete structure located onlandward side

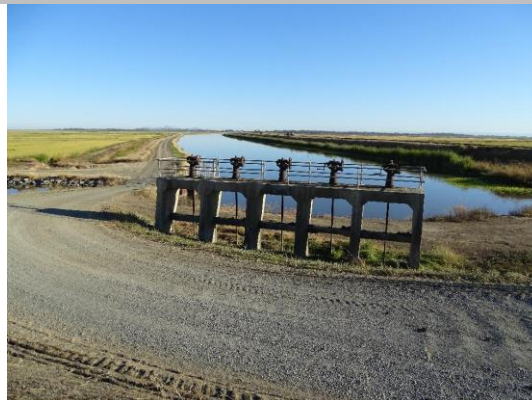
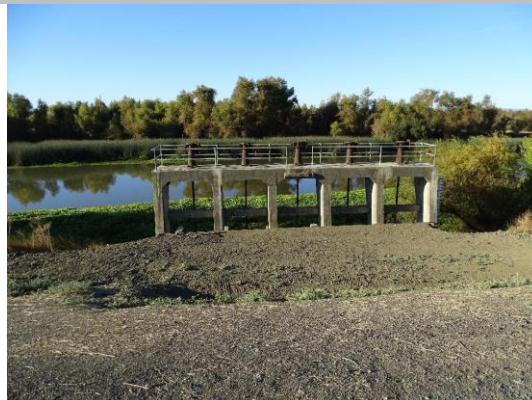
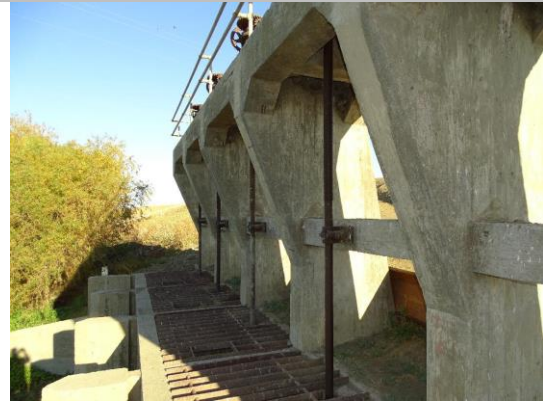
Comment Code					
Inspector Comment					
DS_ID:22388 FS_ID:55922 EP_NO: 9396 Repair Type: Non-Urgent Crossing Status: Found UCIP Comments: 10/02/2019 In 2019 RD 108 took an attempt to bring structure to operable condition. Although this attempt was unsuccessful District will review other options. In the meantime crossing considered abandoned. (O.Yakimov - DWR UCIP)06/10/2014 Need to contact owner to determine status of structure. Notes indicate crossing has been abandoned. Owner will need to coordinate with CVFPB and DWR inspector to determine how to properly abandon. FIELD_STRUCT_DESC: *ABANDONED* 4 of 5: 72-inch reinforced concrete gravity drainage pipe or culvert through the levee, 31.6 feet below the crown. Slide gate on each end. (Retention of five 72-inch pipes through the levee [HLM 0.08] authorized under Automatic Board Order (ABO) issued as Permit No. 9736, 1974 - Reclamation District No. 108 [RD0108]). [Additional Reference(s): DWR Levee Log, 1991. USACE Sacramento O&M Manual 132, October 1959, (HLM 0.08), referenced as five 6-foot by 8-foot concrete drainage culverts]. FS Date: 10/2/2019 7:59:18 AM

LM Start	0.06	Rating **	M	Issue No.	22 (cont)
LM End	0.06	Issue Type +	Ma	Location *

View of concrete structure located on landward side

Concrete structure located on waterward side

Comment Code						
Inspector Comment						
DS_ID:22388 FS_ID:55922 EP_NO: 9396 Repair Type: Non-Urgent Crossing Status: Found UCIP Comments: 10/02/2019 In 2019 RD 108 took an attempt to bring structure to operable condition. Although this attempt was unsuccessful District will review other options. In the meantime crossing considered abandoned. (O.Yakimov - DWR UCIP)06/10/2014 Need to contact owner to determine status of structure. Notes indicate crossing has been abandoned. Owner will need to coordinate with CVFPB and DWR inspector to determine how to properly abandon. FIELD_STRUCT_DESC: *ABANDONED* 4 of 5: 72-inch reinforced concrete gravity drainage pipe or culvert through the levee, 31.6 feet below the crown. Slide gate on each end. (Retention of five 72-inch pipes through the levee [HLM 0.08] authorized under Automatic Board Order (ABO) issued as Permit No. 9736, 1974 - Reclamation District No. 108 [RD0108]). [Additional Reference(s): DWR Levee Log, 1991. USACE Sacramento O&M Manual 132, October 1959, (HLM 0.08), referenced as five 6-foot by 8-foot concrete drainage culverts]. FS Date: 10/2/2019 7:59:18 AM

Slide gates on waterward side

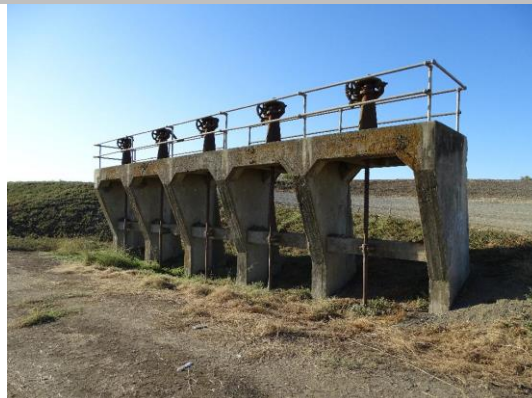
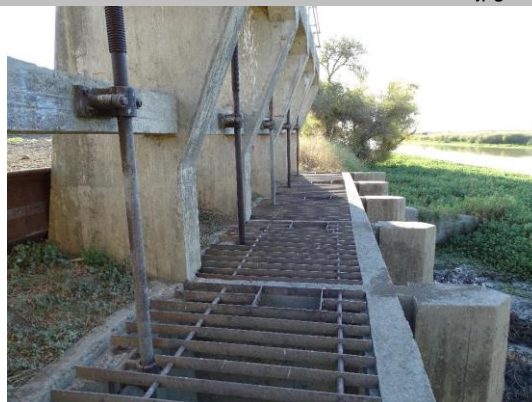
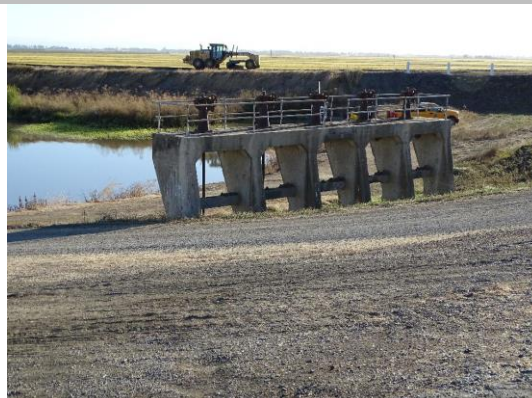
Comment Code					
Inspector Comment					
DS_ID:22389 FS_ID:55923 EP_NO: 9396 Repair Type: Non-Urgent Crossing Status: Found UCIP Comments: 10/02/2019 In 2019 RD 108 took an attempt to bring structure to operable condition. Although this attempt was unsuccessful District will review other options. In the meantime crossing considered abandoned. (O.Yakimov - DWR UCIP)06/10/2014 Need to contact owner to determine status of structure. Notes indicate crossing has been abandoned. Owner will need to coordinate with CVFPB and DWR inspector to determine how to properly abandon. FIELD_STRUCT_DESC: *ABANDONED* 5 of 5: 72-inch reinforced concrete gravity drainage pipe or culvert through the levee, 31.6 feet below the crown. Slide gate on each end. (Retention of five 72-inch pipes through the levee [HLM 0.08] authorized under Automatic Board Order (ABO) issued as Permit No. 9736, 1974 - Reclamation District No. 108 [RD0108]). [Additional Reference(s): DWR Levee Log, 1991. USACE Sacramento O&M Manual 132, October 1959, (HLM 0.08), referenced as five 6-foot by 8-foot concrete drainage culverts]. FS Date: 10/2/2019 8:01:09 AM

LM Start	0.07	Rating **	M	Issue No.	23 (cont)
LM End	0.07	Issue Type +	Ma	Location *

View of concrete structure located on landward side

Slide gates on waterward side

Item	DRAFT DWR UCIP LMA Responsibility		38.822954 °	38.822954 °								
			-121.797135 °	-121.797135 °								
DWR ID	22389											
Comment Code												
Inspector Comment												
DS_ID:22389 FS_ID:55923 EP_NO: 9396 Repair Type: Non-Urgent Crossing Status: Found UCIP Comments: 10/02/2019 In 2019 RD 108 took an attempt to bring structure to operable condition. Although this attempt was unsuccessful District will review other options. In the meantime crossing considered abandoned. (O.Yakimov - DWR UCIP)06/10/2014 Need to contact owner to determine status of structure. Notes indicate crossing has been abandoned. Owner will need to coordinate with CVFPB and DWR inspector to determine how to properly abandon. FIELD_STRUCT_DESC: *ABANDONED* 5 of 5: 72-inch reinforced concrete gravity drainage pipe or culvert through the levee, 31.6 feet below the crown. Slide gate on each end. (Retention of five 72-inch pipes through the levee [HLM 0.08] authorized under Automatic Board Order (ABO) issued as Permit No. 9736, 1974 - Reclamation District No. 108 [RD0108]). [Additional Reference(s): DWR Levee Log, 1991. USACE Sacramento O&M Manual 132, October 1959, (HLM 0.08), referenced as five 6-foot by 8-foot concrete drainage culverts]. FS Date: 10/2/2019 8:01:09 AM

Concrete structure located on waterward side

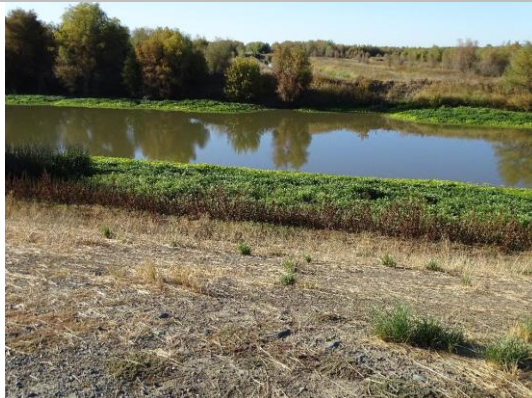
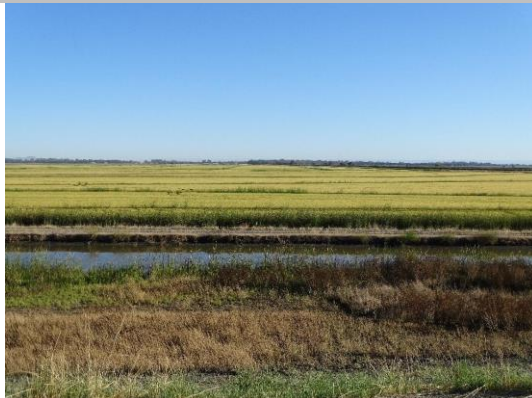
Comment Code						
Inspector Comment						
DS_ID:18662						
FS_ID:55924						
EP_NO: 2283						
Repair Type: Non-Urgent						
Crossing Status: Not Found						
UCIP Comments: 10/02/2019 Crossing not found. Proper gas line markers should be installed on both sides of levee to identify crossing. (O.Yakimov - DWR UCIP)						
FIELD_STRUCT_DESC: 4-inch steel natural gas pipeline through the back borrow pit levee of Reclamation District No. 108 (RD0108), at an unknown depth. (Plans for installation of a 4-inch pipeline through the back borrow pit levee of RD0108 authorized under Permit No. 2283, 1956 - Yolo County Sales Company).						
FS Date: 10/2/2019 8:06:18 AM

View of WS at potential crossing looking from levee crown

LM Start	0.39	Rating **	M	Issue No.	24 (cont)
LM End	0.39	Issue Type +	En	Location *

View of LS at potential crossing looking from levee crown

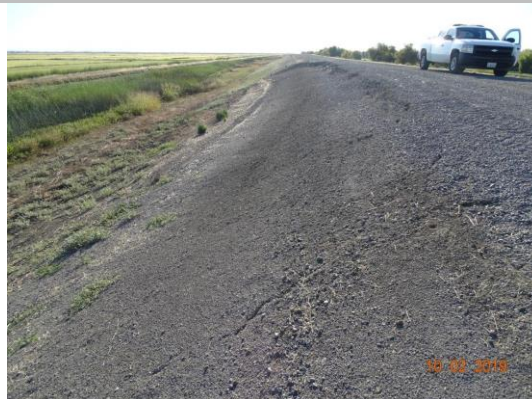
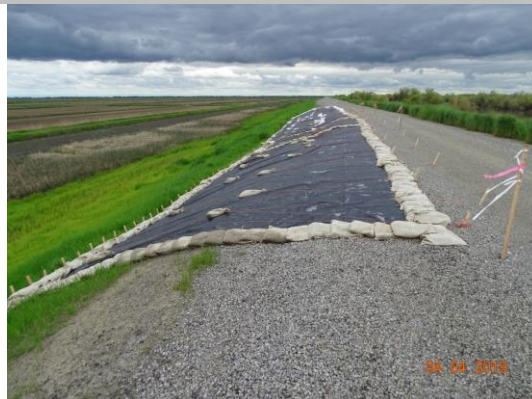
LM Start	1.49	Rating **	M	Issue No.	17
LM End	1.51	Issue Type +	Ma	Location *	LS
Category	Earthen Levee			GPS Latitude/Longitude	
				Start	End
Item	Slope Stability			38.830951 °	38.831043 °
				-121.821574 °	-121.821847 °
DWR ID	DWR_RD0108_01_s_2019_17				
Comment Code					
S1 : Repair slope instability.					
Inspector Comment					
There appears to be a 150' sloughing section that is a result of February 2019 storms. This site will be repaired by the USACE. The LMA will place a raincoat over the damage for the next flood season.

View of the sloughing on the landside slope. Fall 2019.

View of the sloughing on the landside slope. Spring 2019.

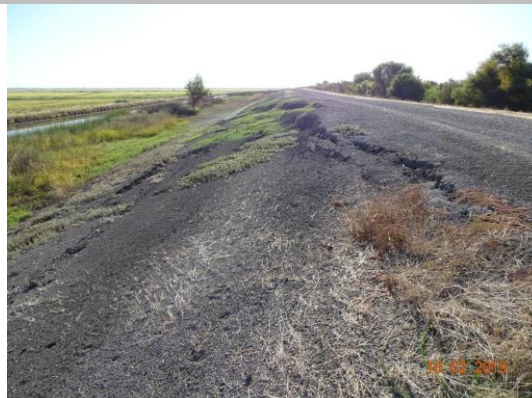
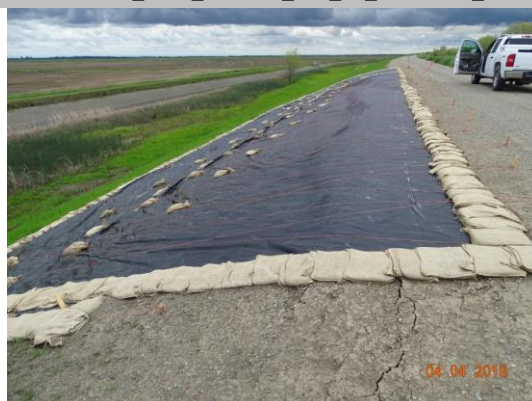
LM Start	2.70	Rating **	M	Issue No.	15
LM End	2.73	Issue Type +	Ma	Location *	LS
Category	Earthen Levee			GPS Latitude/Longitude	
				Start	End
Item	Slope Stability			38.837568 °	38.837749 °
				-121.842218 °	-121.842776 °
DWR ID	DWR_RD0108_01_s_2019_15				
Comment Code					
S1 : Repair slope instability.					
Inspector Comment					
There appears to be a 150' sloughing section that is a result of February 2019 storms. This site will be repaired by the USACE. The LMA will place a raincoat over the damage for the next flood season.

View of the sloughing on the landside slope. Fall 2019.

View of sloughing on the landside slope. Spring 2019.

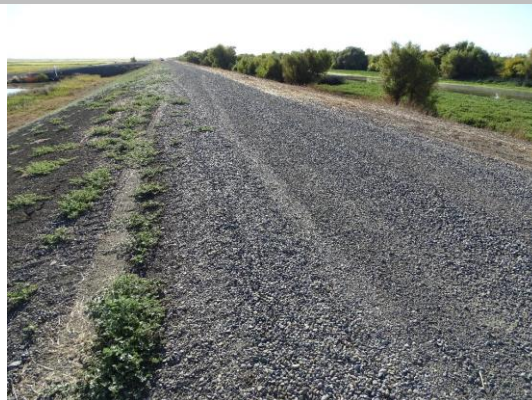
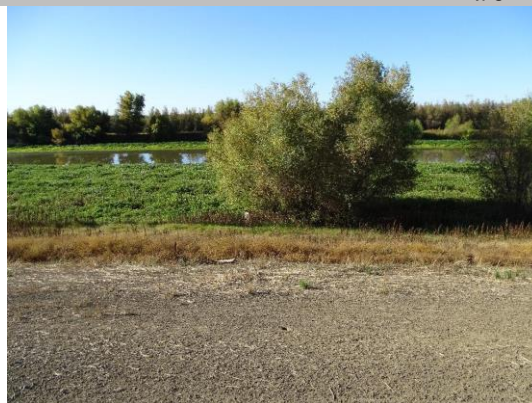
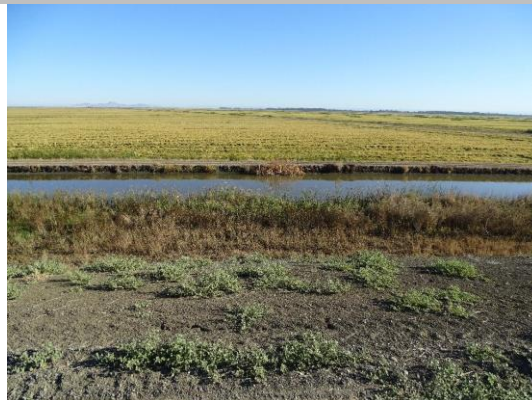
Comment Code					
Inspector Comment					
DS_ID:24875 FS_ID:55925 EP_NO: N/A Repair Type: Non-Urgent Crossing Status: Indicator Found UCIP Comments: 10/02/2019 Abandoned crossing. Needs a removal of proper abandonment. (O.Yakimov - DWR UCIP)03/18/2014 No signs of pipe visible--need to contact owner to obtain permit number authorizing work. If crossing is no longer used by owner, the owner will need to coordinate with DWR Inspector and CVFPB to remove crossing according to Title 23 requirements. Dense vegetation limits the inspector's visibility to identify signs of pipe failure (leaks) along the slope. Recommend removing vegetation along pipe alignment to conduct proper inspection of structure. FIELD_STRUCT_DESC: 44-inch corrugated metal pipe (CMP) riser on the waterside (WS). Riser is filled with trash and debris. Unable to determine if a crossing exists at this location. This riser was field discovered. FS Date: 10/2/2019 8:10:23 AM

View of levee crown at the crossing

View of WS looking from levee crown

View of LS looking from levee crown

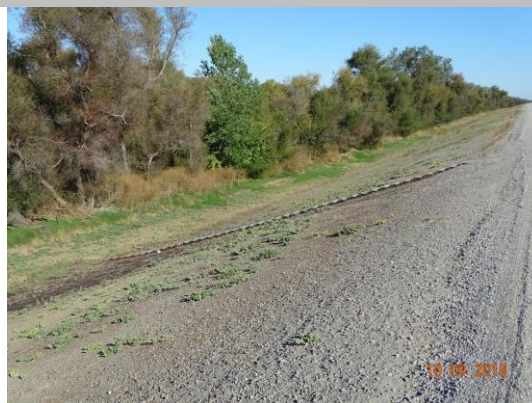
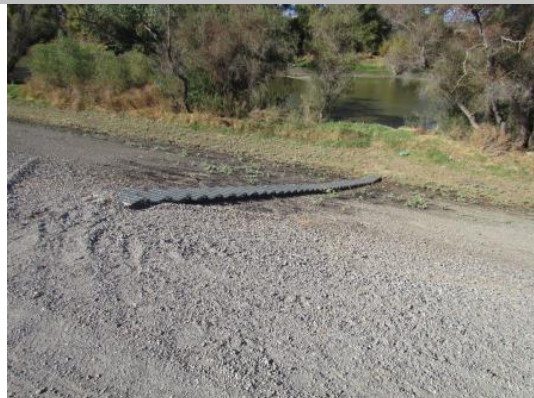
LM Start	9.66	Rating **	M	Issue No.	16
LM End	9.66	Issue Type +	En	Location *	WS
Category	Earthen Levee			GPS Latitude/Longitude	
				Start	End
Item	Encroachments			38.902691 °	38.902691 °
				-121.914645 °	-121.914645 °
DWR ID	DWR_RD0108_01_f_2016_16				
Comment Code					
ST : Stairway					
Inspector Comment					
Department of Fish and Game staff is using a stairway to access their monitoring site. Unable to verify if a permit exists.

View of stairway look upstream. Fall 2018.

View of a steel stairway on WS slope. Fall 2016 inspection.

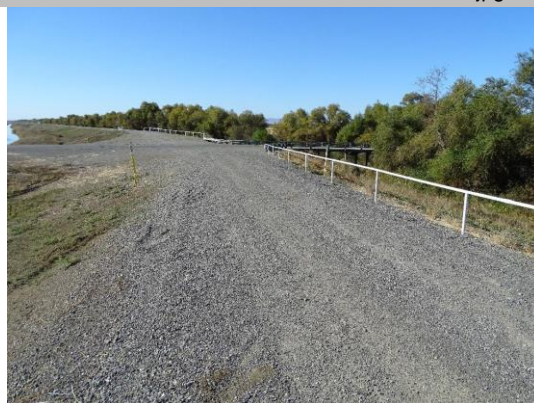
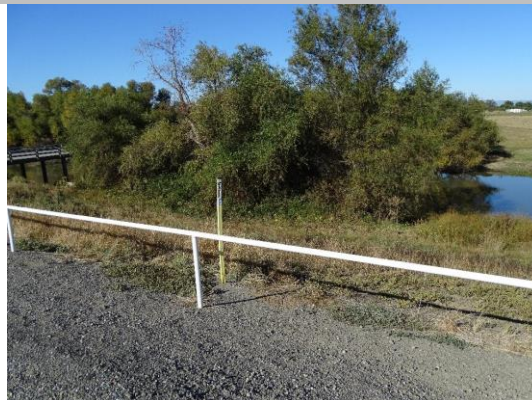
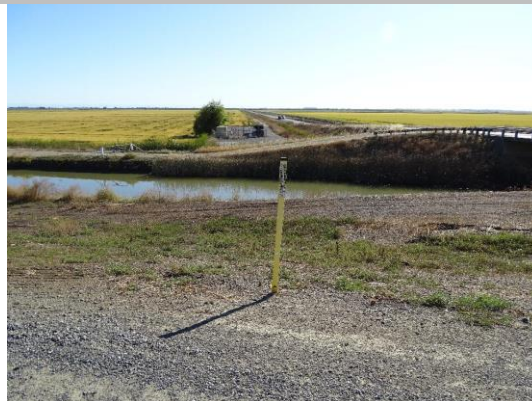
Comment Code					
Inspector Comment					
DS_ID:24876					
FS_ID:55926					
EP_NO: N/A					
Repair Type: Non-Urgent					
Crossing Status: Indicator Found					
UCIP Comments: 10/02/2019 Permit is not available for this crossing.					
(O.Yakimov - DWR UCIP)03/18/2014 Need to contact owner to					
determine additional details of crossing.					
FIELD_STRUCT_DESC: Natural gas pipeline of an unknown size or					
material slightly angled through the levee, at an unknown depth.					
Markers on both sides of the levee. Gas station located across the					
canal on the landside (LS). This crossing was field discovered.					
FS Date: 10/2/2019 8:17:59 AM

View of levee crown at the crossing

View of WS looking from levee crown. Gas line marker installed on levee shoulder

View of LS looking from levee crown. Gas line marker installed on levee shoulder. PG&E facility on LS

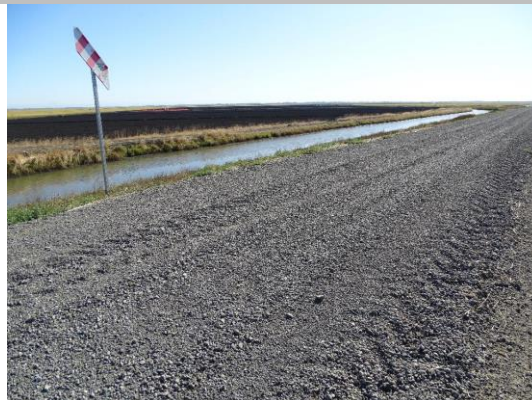
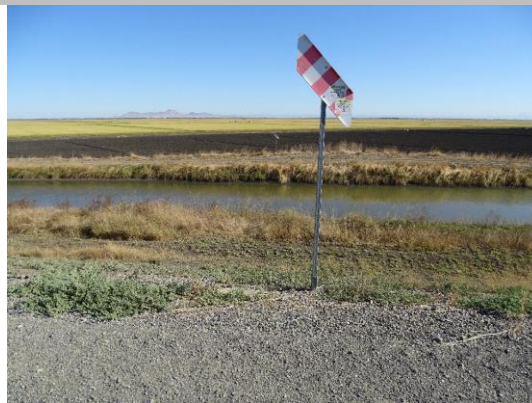
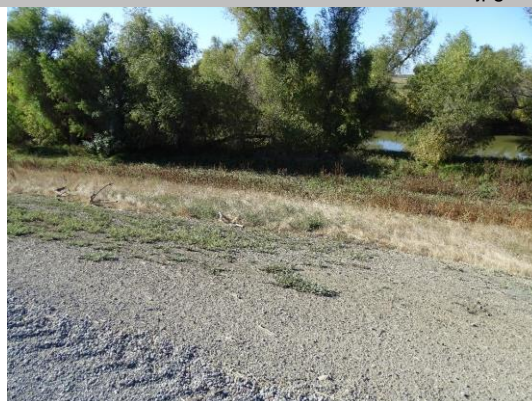
Comment Code						
Inspector Comment						
DS_ID:17942						
FS_ID:55927						
EP_NO: 3800						
Repair Type: Non-Urgent						
Crossing Status: Indicator Found						
UCIP Comments: 10/02/2019 Gas line marker not installed on WS.						
(O.Yakimov - DWR UCIP)06/10/2014 Need to contact owner--marker missing on waterward side.						
FIELD_STRUCT_DESC: 20-inch concrete encased steel natural gas pipeline through the levee, 3 feet below the crown. Crossing appears to be angled through the levee. Small rock revetment on the waterside (WS) slope, unable to locate. Gas well approximately 1000 feet off the landside (LS) toe. (Plans to construct and maintain a 20-inch gas line across the Sacramento River authorized under Permit No. 3800, 1961 - Pacific Gas and Electric Company [PG&E]). [Additional Reference(s): DWR Levee Log, 1991].						
FS Date: 10/2/2019 8:22:46 AM

View of levee crown at the crossing

Marker visible on landward side

View of waterward side. No marker visible on waterward side

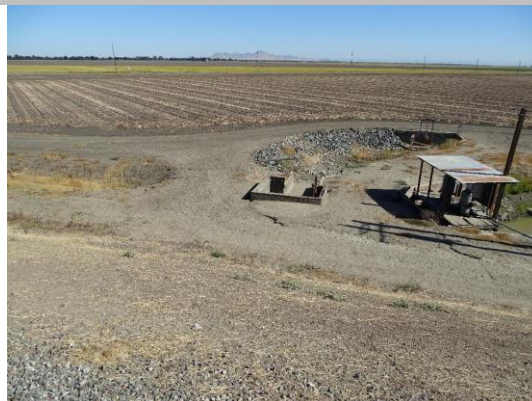
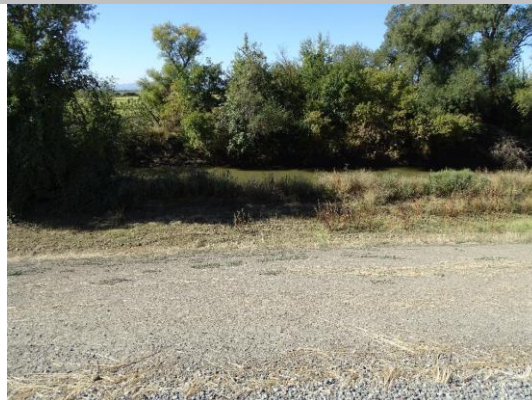
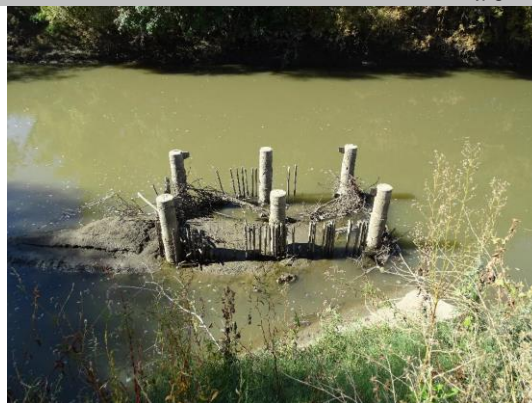
Comment Code						
Inspector Comment						
DS_ID:17940 FS_ID:55933 EP_NO: 9399 Repair Type: Non-Urgent Crossing Status: Indicator Found UCIP Comments: 10/02/2019 Disrupted concrete pile structure observed in riverbank that may belong to this crossing. Immured 24-inch pipe hole is visible inside of concrete distribution box at the landside toe. Unable to confirm proper abandonment. Updated lat/long. (O.Yakimov - DWR UCIP) FIELD_STRUCT_DESC: *ABANDONED* 24-inch steel gravity drainage pipe through the levee, 15 feet below the crown. Pipe is open in a concrete distribution box at the landside (LS) toe. Intake trash rack structure in channel. (Retention of a 24-inch steel pipe through the levee, 15 feet below the crown, a concrete distribution box, and an intake trash rack authorized under Automatic Board Order (ABO) issued as Permit No. 9399, 1974 - Aileen B. Armstrong, Trustee, care of O. M. Durst Jr.). [Additional Reference(s): DWR Levee Log, 1991]. FS Date: 10/2/2019 11:10:08 AM

View of LS looking from levee crown

View of WS looking from levee crown

Ruined intake trash rack structure in channel

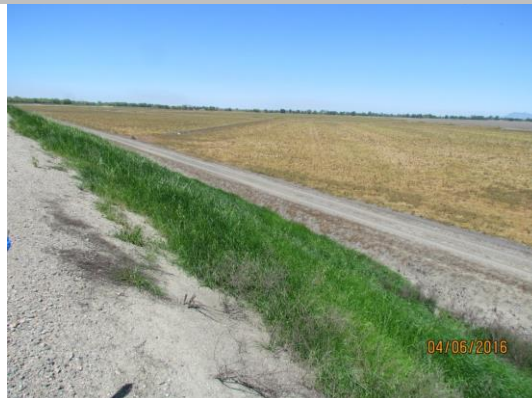
View of the ditch at the toe of the levee on the landward side looking upstream. Spring 2016.

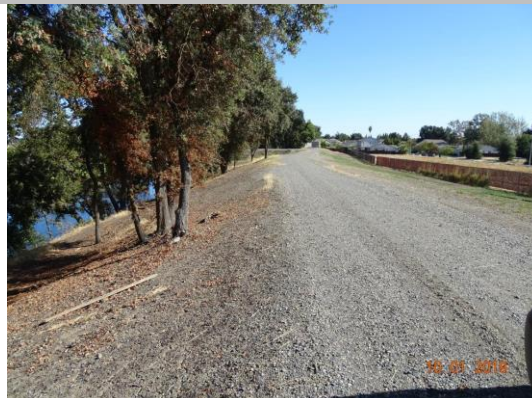
View of the maintained waterside slope. Fall 2019.
