Flood Control Project Maintenance Levee Inspections

Fall 2020 Levee Maintenance Deficiency Summary Report

Reclamation District No. 0108 River Farms

Levee Inspection Report By Mile - Fall 2020

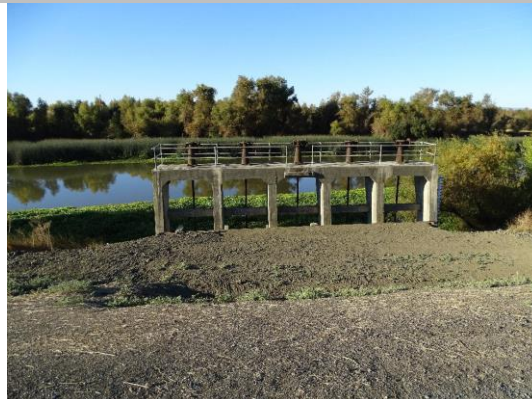
Photo 2 of 3 : UCIP_FA_2020_55919_83216.jpg

Comment Code						
Inspector Comment						
DS_ID:17943 FS_ID:55919 EP_NO: 9736 Repair Type: Non-Urgent EVAL Issue: Unauthorized Encroachment, installed decades prior Crossing Status: Found UCIP Comments: 10/2/2019 Record remains Non-Urgent. In 2019 RD 108 took an attempt to bring structure to operable condition. Although this attempt was unsuccessful District will review other options. In the meantime crossing considered abandoned. Need to have CVFPB review ABO and determine current owner. (O.Yakimov - DWR UCIP) 06/10/2014 Need to contact owner to determine status of structure. Notes indicate crossing has been abandoned. Owner will need to coordinate with CVFPB and DWR inspector to determine how to properly abandon. (O.Magana - DWR UCIP) FIELD_STRUCT_DESC: *ABANDONED* 1 of 5: 72-inch reinforced concrete gravity drainage pipe or culvert through the levee, 31.6 feet below the crown. Slide gate on each end. (Retention of five 72-inch pipes through the levee [HLM 0.08] authorized under Automatic Board Order (ABO) issued as Permit No. 9736, 1974 - Reclamation District No. 108 [RD0108]). [Additional Reference(s): DWR Levee Log, 1991, (HLM 0.08). USACE Sacramento O&M Manual 132, October 1959, (HLM 0.08), referenced as five 6-foot by 8-foot concrete drainage culverts]. FS Date: 10/2/2019

View of WS looking from levee crown

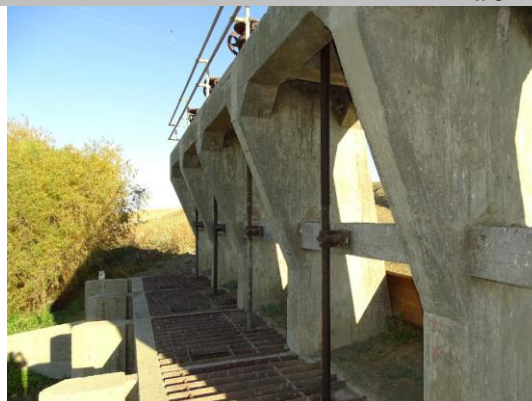
Photo 3 of 3 : UCIP_FA_2020_55919_83217.jpg

Slide gate operating structure on WS shoulder

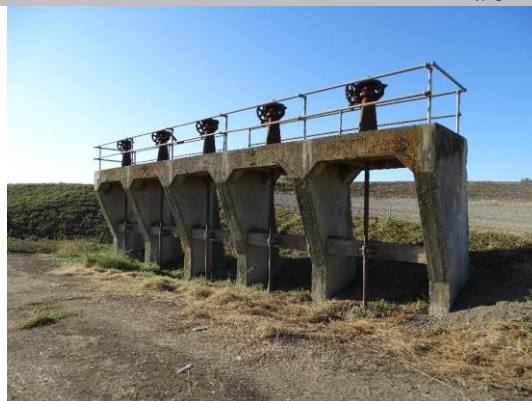
Photo 1 of 3 : UCIP_FA_2020_55920_83222.jpg

DS_ID:22386
 FS_ID:55920
 EP_NO: 9396
 Repair Type: Non-Urgent
 EVAL Issue: Unauthorized Encroachment, installed decades prior
 Crossing Status: Found
 UCIP Comments: 8/2/2019 Record remains Non-Urgent. In 2019 RD 108 took an attempt to bring structure to operable condition. Although this attempt was unsuccessful District will review other options. In the meantime crossing considered abandoned. Need to have CVFPB review ABO and determine current owner. (O.Yakimov - DWR UCIP) 06/10/2014 Need to contact owner to determine status of structure. Notes indicate crossing has been abandoned. Owner will need to coordinate with CVFPB and DWR inspector to determine how to properly abandon. (O.Magana - DWR UCIP)
 FIELD_STRUCT_DESC: *ABANDONED* 2 of 5: 72-inch reinforced concrete gravity drainage pipe or culvert through the levee, 31.6 feet below the crown. Slide gate on each end. (Retention of five 72-inch pipes through the levee [HLM 0.08] authorized under Automatic Board Order (ABO) issued as Permit No. 9736, 1974 - Reclamation District No. 108 [RD0108]). [Additional Reference(s): DWR Levee Log, 1991, (HLM 0.08). USACE Sacramento O&M Manual 132, October 1959, (HLM 0.08), referenced as five 6-foot by 8-foot concrete drainage culverts].

View of concrete structure located on landward side

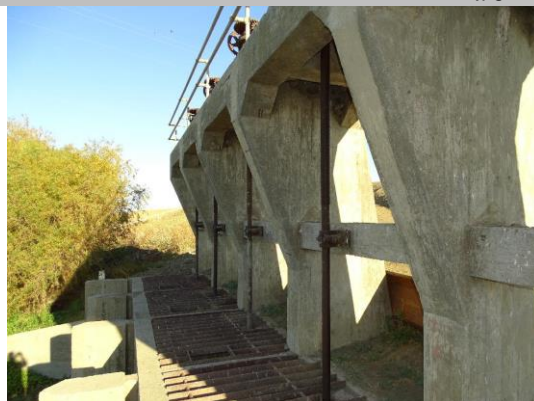
Photo 1 of 3 : UCIP_FA_2020_55921_83223.jpg

DS_ID:22387
FS_ID:55921
EP_NO: 9396
Repair Type: Non-Urgent
EVAL Issue: Unauthorized Encroachment, installed decades prior
Crossing Status: Found
UCIP Comments: 10/2/2019 Record remains Non-Urgent. In 2019 RD 108 took an attempt to bring structure to operable condition. Although This attempt was unsuccessful District will review other options. In the meantime crossing considered abandoned. Need to have CVFPB review ABO and determine current owner. (O.Yakimov - DWR UCIP)06/10/2014 Need to contact owner to determine status of structure. Notes indicate crossing has been abandoned. Owner will need to coordinate with CVFPB and DWR inspector to determine how to properly abandon. (O.Magana - DWR UCIP)
FIELD_STRUCT_DESC: *ABANDONED* 3 of 5: 72-inch reinforced concrete gravity drainage pipe or culvert through the levee, 31.6 feet below the crown. Slide gate on each end. (Retention of five 72-inch pipes through the levee [HLM 0.08] authorized under Automatic Board Order (ABO) issued as Permit No. 9736, 1974 - Reclamation District No. 108 [RD0108]). [Additional Reference(s): DWR Levee Log, 1991. USACE Sacramento O&M Manual 132, October 1959, (HLM 0.08), referenced as five 6-foot by 8-foot concrete drainage culverts].

Slide gates on waterward side

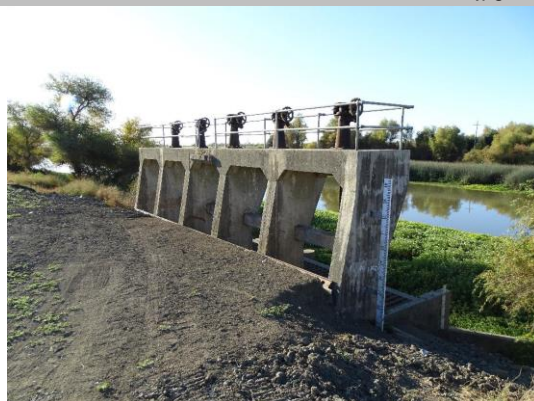
Photo 2 of 3 : UCIP_FA_2020_55921_83224.jpg

Concrete structure located on waterward side

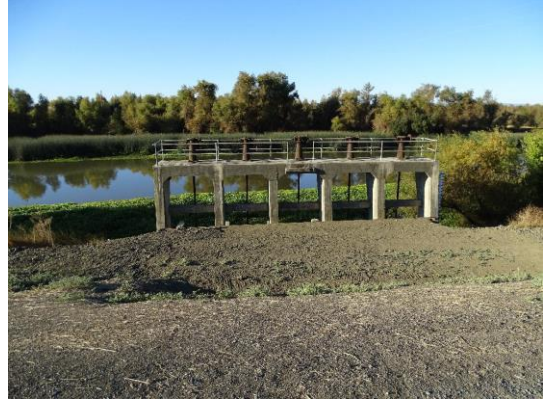
Photo 2 of 3 : UCIP_FA_2020_55922_83229.jpg

DS_ID:22388
 FS_ID:55922
 EP_NO: 9396
 Repair Type: Non-Urgent
 EVAL Issue: Unauthorized Encroachment, installed decades prior
 Crossing Status: Found
 UCIP Comments: 10/2/2019 Record remains Non-Urgent. In 2019 RD 108 took an attempt to bring structure to operable condition. Although this attempt was unsuccessful District will review other options. In the meantime crossing considered abandoned. Need to have CVFPB review ABO and determine current owner. (O.Yakimov - DWR UCIP)06/10/2014 Need to contact owner to determine status of structure. Notes indicate crossing has been abandoned. Owner will need to coordinate with CVFPB and DWR inspector to determine how to properly abandon. (O.Magana - DWR UCIP)
 FIELD_STRUCT_DESC: *ABANDONED* 4 of 5: 72-inch reinforced concrete gravity drainage pipe or culvert through the levee, 31.6 feet below the crown. Slide gate on each end. (Retention of five 72-inch pipes through the levee [HLM 0.08] authorized under Automatic Board Order (ABO) issued as Permit No. 9736, 1974 - Reclamation District No. 108 [RD0108]). [Additional Reference(s): DWR Levee Log, 1991, (HLM 0.08). USACE Sacramento O&M Manual 132, October 1959, (HLM 0.08), referenced as five 6-foot by 8-foot concrete drainage culverts].

Concrete structure located on waterward side

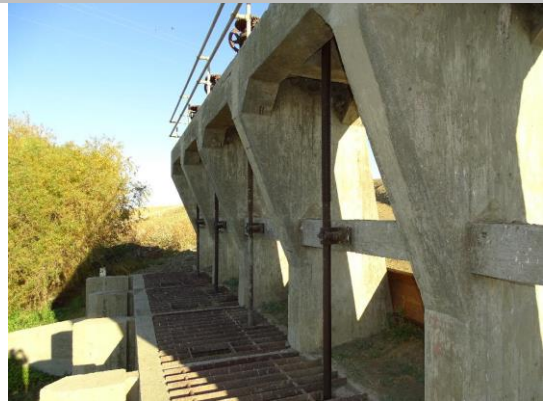
Photo 3 of 3 : UCIP_FA_2020_55922_83230.jpg

Slide gates on waterward side

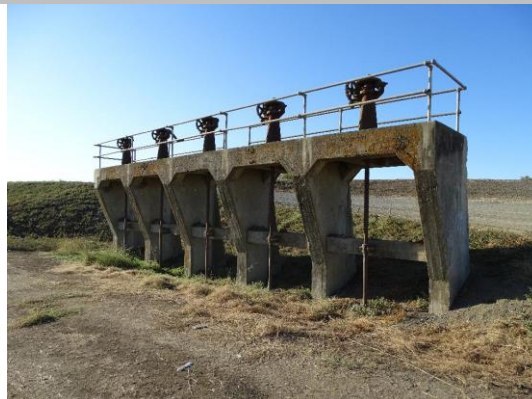
Photo 1 of 3 : UCIP_FA_2020_55923_83231.jpg

DS_ID:22389
FS_ID:55923
EP_NO: 9396
Repair Type: Non-Urgent
EVAL Issue: Unauthorized Encroachment, installed decades prior
Crossing Status: Found
UCIP Comments: 10/2/2019 Record remains Non-Urgent. In 2019 RD 108 took an attempt to bring structure to operable condition. Although this attempt was unsuccessful District will review other options. In the meantime crossing considered abandoned. Need to have CVFPB review ABO and determine current owner. (O.Yakimov - DWR UCIP)06/10/2014 Need to contact owner to determine status of structure. Notes indicate crossing has been abandoned. Owner will need to coordinate with CVFPB and DWR inspector to determine how to properly abandon. (O.Magana - DWR UCIP)
FIELD_STRUCT_DESC: *ABANDONED* 5 of 5: 72-inch reinforced concrete gravity drainage pipe or culvert through the levee, 31.6 feet below the crown. Slide gate on each end. (Retention of five 72-inch pipes through the levee [HLM 0.08] authorized under Automatic Board Order (ABO) issued as Permit No. 9736, 1974 - Reclamation District No. 108 [RD0108]). [Additional Reference(s): DWR Levee Log, 1991. USACE Sacramento O&M Manual 132, October 1959, (HLM 0.08), referenced as five 6-foot by 8-foot concrete drainage culverts].

View of concrete structure located on landward side

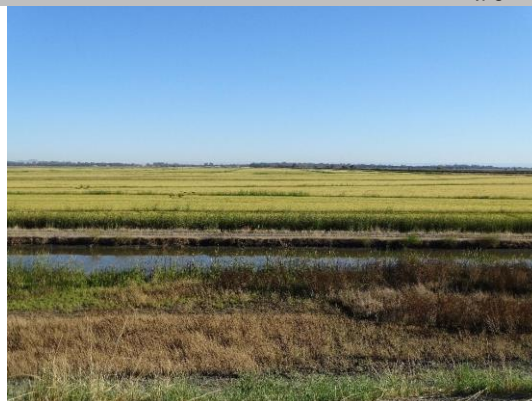
Photo 2 of 2 : UCIP_FA_2020_55924_83235.jpg

View of LS at potential crossing looking from levee crown

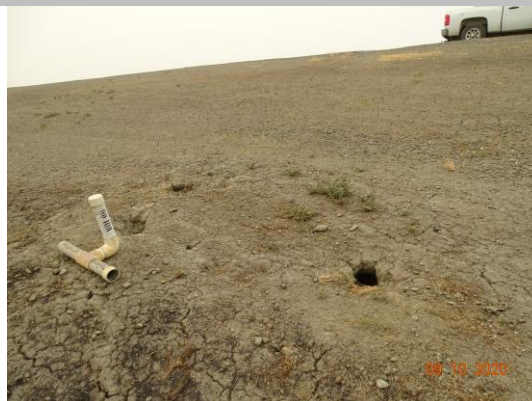
Photo 1 of 1 : FA_2020_RD0108_203_21_20200911_00045.jpg

LM Start	0.55	Rating **	M	Issue No.	21
LM End	0.55	Issue Type +	Ma	Location *	LS
Category	Earthen Levee			GPS Latitude/Longitude	
				Start	End
Item	Animal Control			38.825729 °	38.825729 °
				-121.805307 °	-121.805307 °
DWR ID	DWR_RD0108_01_f _ 2020_21				
Comment Code					
A3 : No rodents visible, but rodent burrows visible; need to backfill and compact or grout burrows.					
Inspector Comment					
Rodent holes near the landside toe.

View of rodent holes on the landside slope. Fall 2020.

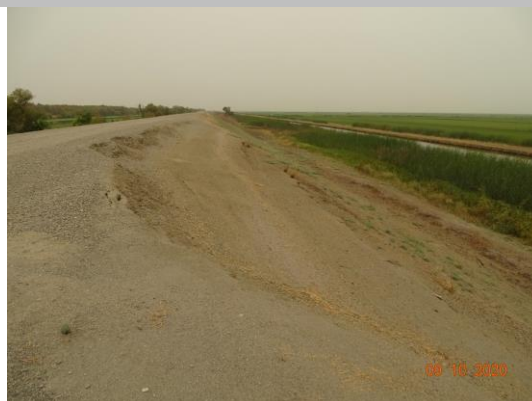
Photo 1 of 2 : FA_2020_RD0108_203_17_20200911_00046.jpg

LM Start	1.49	Rating **	M	Issue No.	17
LM End	1.51	Issue Type +	Ma	Location *	LS
Category	Earthen Levee			GPS Latitude/Longitude	
				Start	End
Item	Slope Stability			38.830951 °	38.831043 °
				-121.821574 °	-121.821847 °
DWR ID	DWR_RD0108_01_s_2020_17				
Comment Code					
S1 : Repair slope instability.					
Inspector Comment					
There appears to be a 150' sloughing section that is a result of February 2019 storms. This site will be repaired by the USACE under PL84-99. There are minor new cracks forming adjacent to the sloughing.

View of sloughing on the landside slope. Fall 2020.

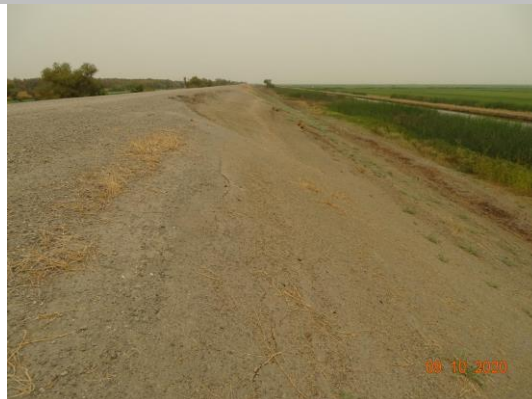
Photo 2 of 2 : FA_2020_RD0108_203_17_20200911_00047.jpg

View of new cracks adjacent to sloughing. Fall 2020.

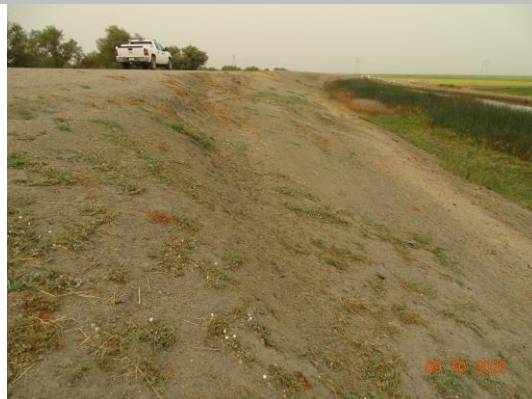
Photo 1 of 1 : FA_2020_RD0108_203_15_20200911_00048.jpg

There appears to be a 150' sloughing section that is a result of February 2019 storms. This site will be repaired by the USACE under PL84-99

View of sloughing on landside slope. Fall 2020.

S1 : Repair slope instability.

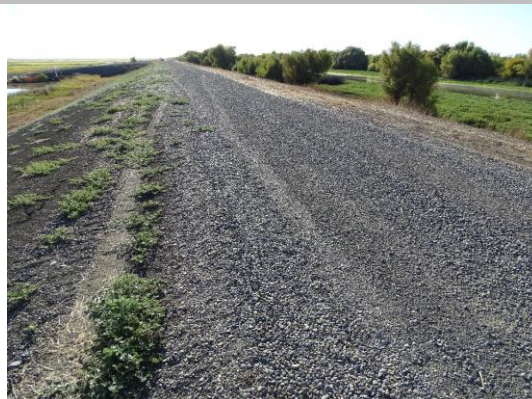
Photo 1 of 3 : UCIP_FA_2020_55925_83236.jpg

Comment Code						
Inspector Comment						
DS_ID:24875 FS_ID:55925 EP_NO: N/A Repair Type: Non-Urgent EVAL Issue: Unauthorized Encroachment Crossing Status: Indicator Found UCIP Comments: 10/2/2019 Record remains Non-Urgent. Geophysical results did not confirm presence of pipe through levee. Abandoned crossing. Needs to be removed or abandoned properly. (O.Yakimov - DWR UCIP)03/18/2014 No signs of pipe visible--need to contact owner to obtain permit number authorizing work. If crossing is no longer used by owner, the owner will need to coordinate with DWR Inspector and CVFPB to remove crossing according to Title 23 requirements. Dense vegetation limits the inspector's visibility to identify signs of pipe failure (leaks) along the slope. Recommend removing vegetation along pipe alignment to conduct proper inspection of structure. (O.Magana - DWR UCIP) FIELD_STRUCT_DESC: 44-inch corrugated metal pipe (CMP) riser on the waterside (WS). Riser is filled with trash and debris. Unable to determine if a crossing exists at this location. This riser was field discovered. FS Date: 10/2/2019 8:10:23 AM

View of levee crown at the crossing

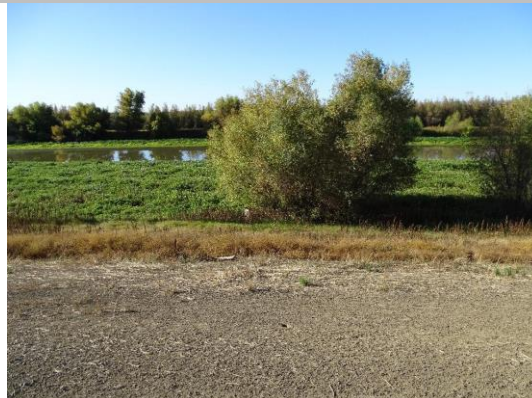
Photo 2 of 3 : UCIP_FA_2020_55925_83237.jpg

View of WS looking from levee crown

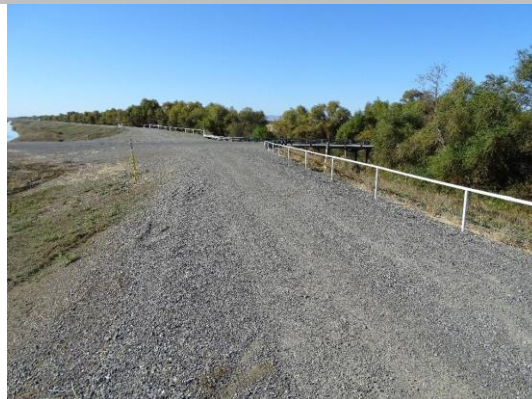
Photo 1 of 3 : UCIP_FA_2020_55926_83243.jpg

Comment Code						
Inspector Comment						
DS_ID:24876 FS_ID:55926 EP_NO: N/A Repair Type: Non-Urgent EVAL Issue: Safety Issue Crossing Status: Indicator Found UCIP Comments: 10/2/2019 Record remains Non-Urgent. No inspection records were available to determine status of line through the levee. Permit is not available for this crossing. (O.Yakimov - DWR UCIP)03/18/2014 Need to contact owner to determine additional details of crossing (O.Magana - DWR UCIP) FIELD_STRUCT_DESC: Natural gas pipeline of an unknown size or material slightly angled through the levee, at an unknown depth. Markers on both sides of the levee. Gas station located across the canal on the landside (LS). This crossing was field discovered. FS Date: 10/2/2019 8:17:59 AM

View of levee crown at the crossing

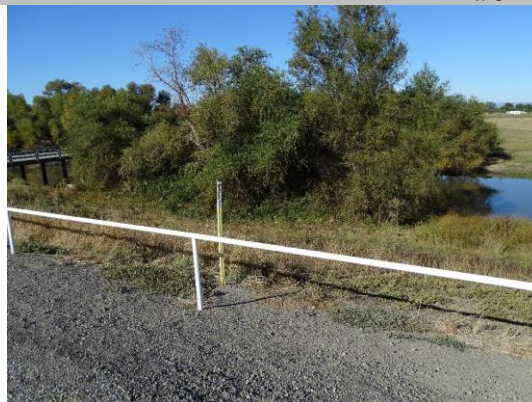
Photo 2 of 3 : UCIP_FA_2020_55926_83244.jpg

View of WS looking from levee crown. Gas line marker installed on levee shoulder

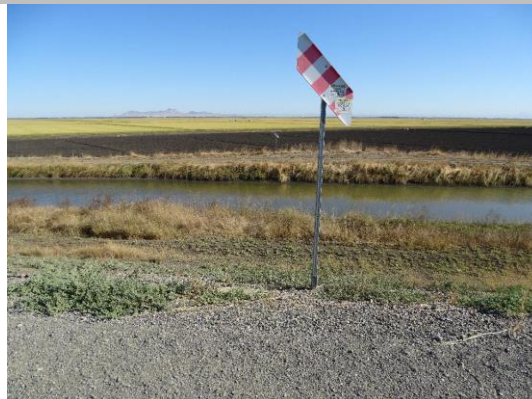
Photo 2 of 3 : UCIP_FA_2020_55927_83247.jpg

Marker visible on landward side

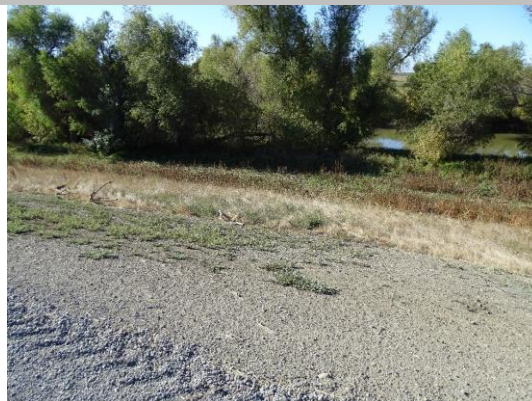
Photo 3 of 3 : UCIP_FA_2020_55927_83248.jpg

View of waterward side. No marker visible on waterward side

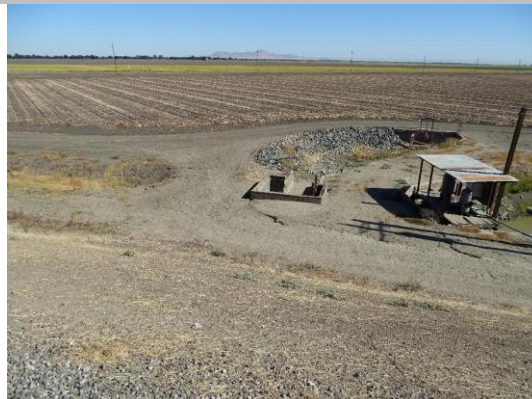
Photo 1 of 3 : UCIP_FA_2020_55933_83271.jpg

DS_ID:17940
FS_ID:55933
EP_NO: 9399
Repair Type: Non-Urgent
EVAL Issue: Geophysical Evaluation (Not Confirmed)
Crossing Status: Indicator Found
UCIP Comments: 10/2/2019 Record updated to Non-Urgent.
Geophysical results did not confirm presence of pipe through levee. No permit has been identified authorizing pipe. Need to have CVFPB review ABO and determine current owner. Disrupted concrete pile structure observed in riverbank that may belong to this crossing. Grouted 24-inch pipe hole is visible inside of concrete distribution box at the landside toe. Unable to confirm proper abandonment. Updated lat/long. (O.Yakimov - DWR UCIP)
FIELD_STRUCT_DESC: 24-inch steel gravity drainage pipe through the levee, 15 feet below the crown. Pipe is open in a concrete distribution box at the landside (LS) toe. Intake trash rack structure in channel. (Retention of a 24-inch steel pipe through the levee, 15 feet below the crown, a concrete distribution box, and an intake trash rack authorized under Automatic Board Order (ABO) issued as Permit No. 9399, 1974 - Aileen B. Armstrong, Trustee, care of O. M. Durst Jr.). [Additional Reference(s): DWR Levee Log, 1991, (HLM 18.67). USACE Sacramento O&M Manual 132, October 1959, (HLM 18.55)].

View of LS looking from levee crown

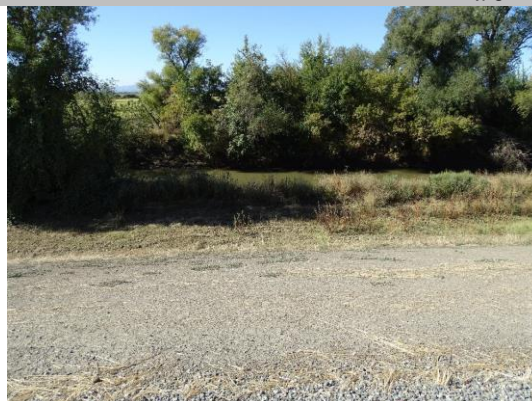
Photo 2 of 3 : UCIP_FA_2020_55933_83272.jpg

View of WS looking from levee crown

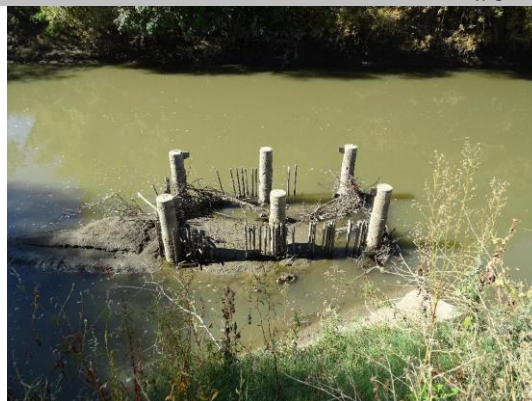
Photo 3 of 3 : UCIP_FA_2020_55933_83270.jpg

Ruined intake trash rack structure in channel

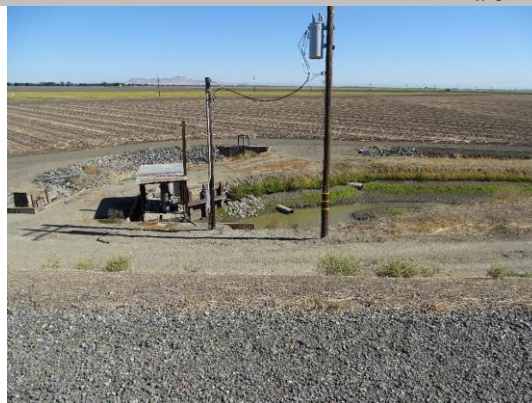
Photo 1 of 3 : UCIP_FA_2020_55932_83441.jpg

DS_ID:18659
 FS_ID:55932
 EP_NO: N/A
 Repair Type: Non-Urgent
 EVAL Issue: Unauthorized Encroachment, installed decades prior
 Crossing Status: Indicator Found
 UCIP Comments: 10/2/2019 Record updated to Non-Urgent. No permit has been identified authorizing pipe. Disrupted concrete pile structure observed in riverbank that may belong to this crossing. Grouted 18-inch pipe hole is visible inside of concrete distribution box at the landside toe. Unable to confirm proper abandonment. Coordinates updated. (O.Yakimov - DWR UCIP)
 FIELD_STRUCT_DESC: 18-inch corrugated metal gravity drainage pipe through the levee, invert elevation 27.4 feet. Pipe hole immured at the landward toe in concrete distribution box. Ruined intake trash rack structure in channel. [Additional Reference(s): USACE Sacramento O&M Manual 132, October 1959, (HLM 18.55)].
 FS Date: 10/2/2019 11:08:25 AM

LS view looking from levee crown

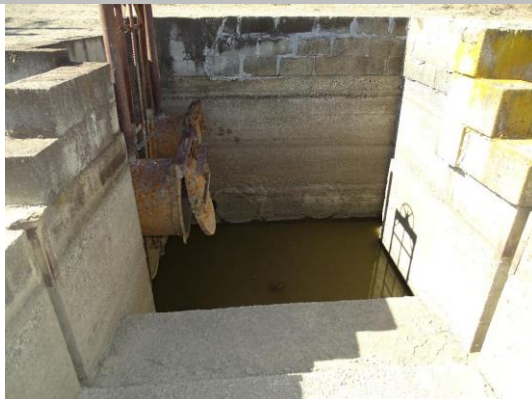
Photo 2 of 3 : UCIP_FA_2020_55932_83442.jpg

View inside of concrete box on LS

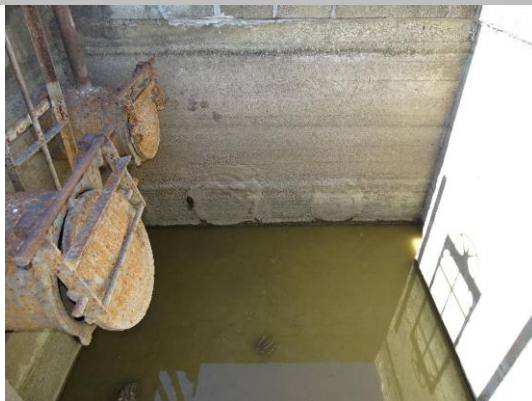
Photo 3 of 3 : UCIP_FA_2020_55932_83440.jpg

Grouted holes of 2 pipes towards levee in concrete box on LS

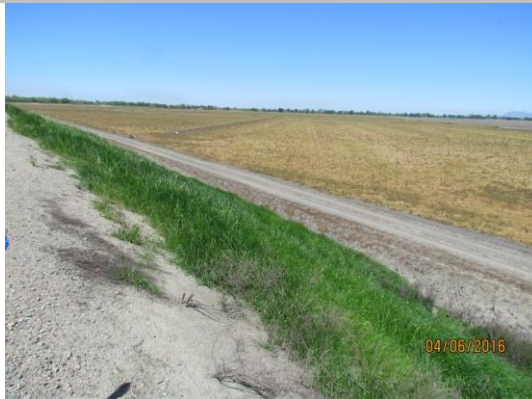
Photo 1 of 1 : FA_2020_RD0108_203_6_20200813_00001.jpg

LM Start	18.92	Rating **	M	Issue No.	6
LM End	19.28	Issue Type +	En	Location *	LS
Category	Earthen Levee			GPS Latitude/Longitude	
				Start	End
Item	Encroachments			39.013160 °	39.017000 °
				-121.980808 °	-121.985364 °
DWR ID	DWR_RD0108_01_s_2012_6				
Comment Code					
DT : Ditch					
Inspector Comment					
A ditch is located at the toe of the levee.

View of the ditch at the toe of the levee on the landward side looking upstream. Spring 2016.

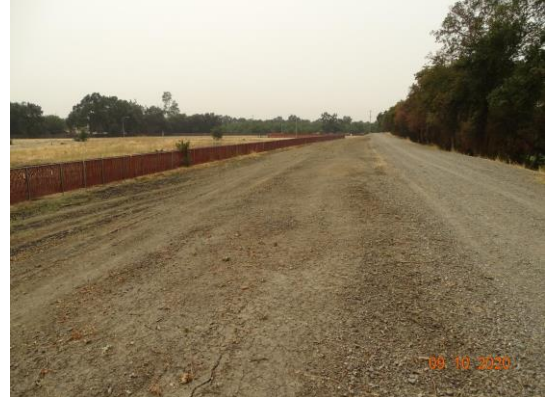
Photo 1 of 1 : FA_2020_RD0108_590_1_20200911_00001.jpg

View of maintained landside slope. Fall 2020.
