Flood Control Project Maintenance Levee Inspections

Fall 2021 Levee Maintenance Deficiency Summary Report

Sacramento River Basin

Reclamation District No. 0108 River Farms

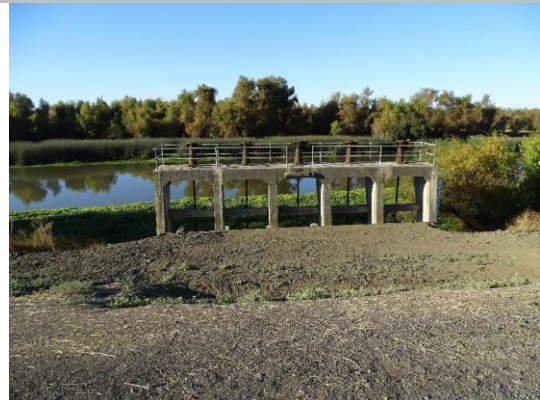
DS_ID:17943
FS_ID:55919
EP_NO: 9736
Repair Type: Non-Urgent
EVAL Issue: Unauthorized Encroachment, installed decades prior
Crossing Status: Found
UCIP Comments: 10/2/2019 Record remains Non-Urgent. In 2019 RD 108 took an attempt to bring structure to operable condition. Although this attempt was unsuccessful District will review other options. In the meantime crossing considered abandoned. Need to have CVFPB review ABO and determine current owner. (O.Yakimov - DWR UCIP) 06/10/2014 Need to contact owner to determine status of structure. Notes indicate crossing has been abandoned. Owner will need to coordinate with CVFPB and DWR inspector to determine how to properly abandon. (O.Magana - DWR UCIP)
FIELD_STRUCT_DESC: *ABANDONED* 1 of 5: 72-inch reinforced concrete gravity drainage pipe or culvert through the levee, 31.6 feet below the crown. Slide gate on each end. (Retention of five 72-inch pipes through the levee [HLM 0.08] authorized under Automatic Board Order (ABO) issued as Permit No. 9736, 1974 - Reclamation District No. 108 [RD0108]). [Additional Reference(s): DWR Levee Log, 1991, (HLM 0.08). USACE Sacramento O&M Manual 132, October 1959, (HLM 0.08), referenced as five 6-foot by 8-foot concrete drainage culverts].

View of LS looking from levee crown

View of WS looking from levee crown

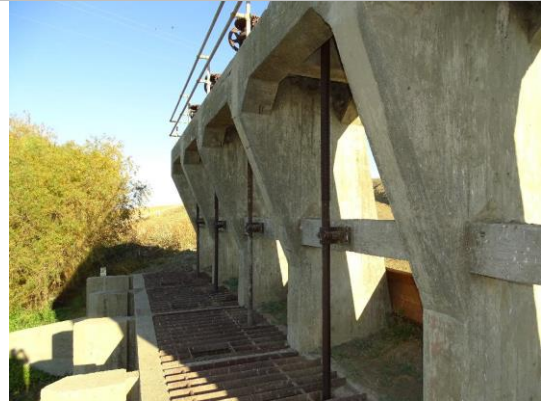
Photo 3 of 3 : UCIP_FA_2021_55919_83217.jpg

Slide gate operating structure on WS shoulder

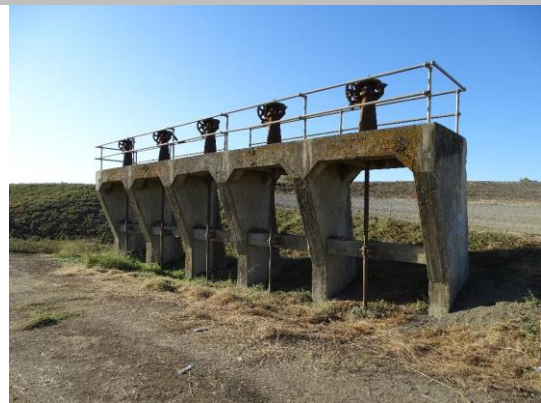
Photo 1 of 3 : UCIP_FA_2021_55920_83222.jpg

DS_ID:22386
 FS_ID:55920
 EP_NO: 9396
 Repair Type: Non-Urgent
 EVAL Issue: Unauthorized Encroachment, installed decades prior
 Crossing Status: Found
 UCIP Comments: 8/2/2019 Record remains Non-Urgent. In 2019 RD 108 took an attempt to bring structure to operable condition. Although this attempt was unsuccessful District will review other options. In the meantime crossing considered abandoned. Need to have CVFPB review ABO and determine current owner. (O.Yakimov - DWR UCIP) 06/10/2014 Need to contact owner to determine status of structure. Notes indicate crossing has been abandoned. Owner will need to coordinate with CVFPB and DWR inspector to determine how to properly abandon. (O.Magana - DWR UCIP)
 FIELD_STRUCT_DESC: *ABANDONED* 2 of 5: 72-inch reinforced concrete gravity drainage pipe or culvert through the levee, 31.6 feet below the crown. Slide gate on each end. (Retention of five 72-inch pipes through the levee [HLM 0.08] authorized under Automatic Board Order (ABO) issued as Permit No. 9736, 1974 - Reclamation District No. 108 [RD0108]). [Additional Reference(s): DWR Levee Log, 1991, (HLM 0.08). USACE Sacramento O&M Manual 132, October 1959, (HLM 0.08), referenced as five 6-foot by 8-foot concrete drainage culverts].

View of concrete structure located on landward side

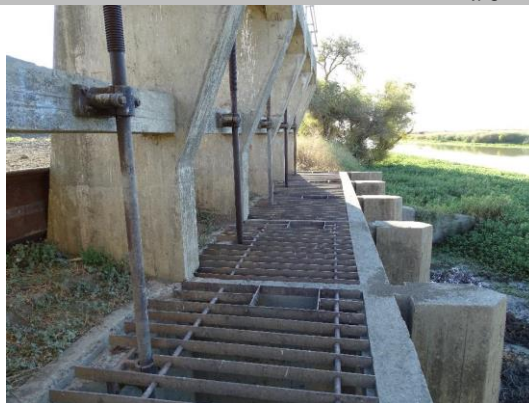
Photo 2 of 3 : UCIP_FA_2021_55920_83226.jpg

Slide gates on waterward side

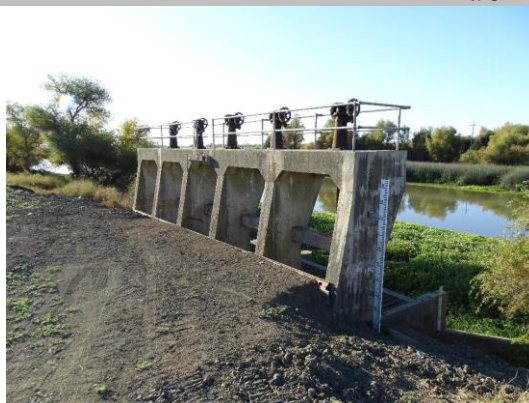
Photo 3 of 3 : UCIP_FA_2021_55920_83227.jpg

Concrete structure located on waterward side

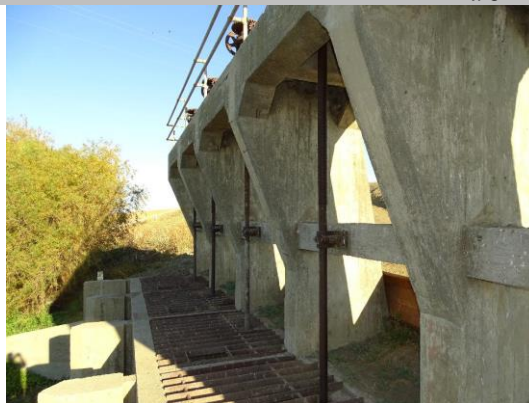
Photo 1 of 3 : UCIP_FA_2021_55921_83223.jpg

DS_ID:22387
FS_ID:55921
EP_NO: 9396
Repair Type: Non-Urgent
EVAL Issue: Unauthorized Encroachment, installed decades prior
Crossing Status: Found
UCIP Comments: 10/2/2019 Record remains Non-Urgent. In 2019 RD 108 took an attempt to bring structure to operable condition. Although This attempt was unsuccessful District will review other options. In the meantime crossing considered abandoned. Need to have CVFPB review ABO and determine current owner. (O.Yakimov - DWR UCIP)06/10/2014 Need to contact owner to determine status of structure. Notes indicate crossing has been abandoned. Owner will need to coordinate with CVFPB and DWR inspector to determine how to properly abandon. (O.Magana - DWR UCIP)
FIELD_STRUCT_DESC: *ABANDONED* 3 of 5: 72-inch reinforced concrete gravity drainage pipe or culvert through the levee, 31.6 feet below the crown. Slide gate on each end. (Retention of five 72-inch pipes through the levee [HLM 0.08] authorized under Automatic Board Order (ABO) issued as Permit No. 9736, 1974 - Reclamation District No. 108 [RD0108]). [Additional Reference(s): DWR Levee Log, 1991. USACE Sacramento O&M Manual 132, October 1959, (HLM 0.08), referenced as five 6-foot by 8-foot concrete drainage culverts].

Slide gates on waterward side

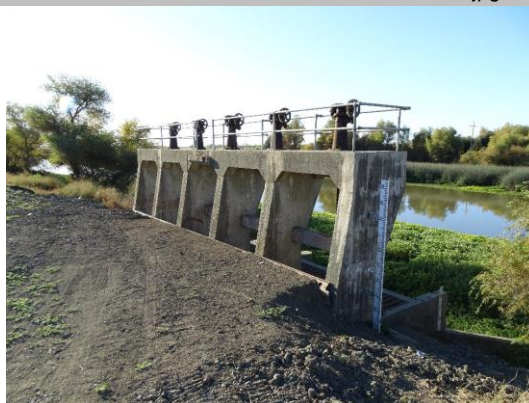
Photo 2 of 3 : UCIP_FA_2021_55921_83224.jpg

Concrete structure located on waterward side

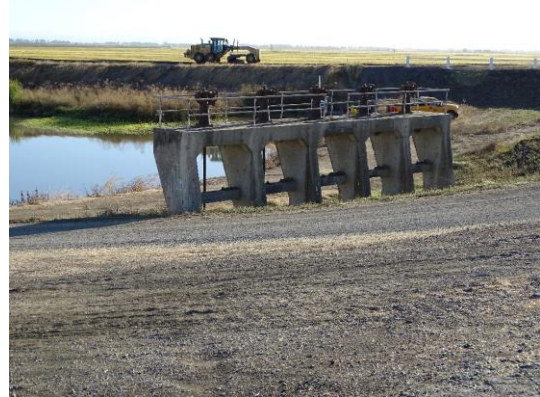
Photo 3 of 3 : UCIP_FA_2021_55921_83225.jpg

Concrete structure located onlandward side

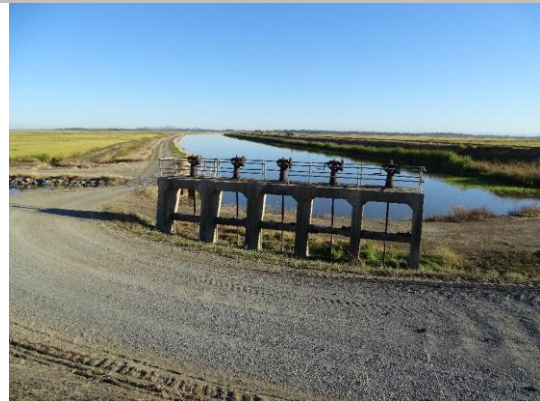
Photo 1 of 3 : UCIP_FA_2021_55922_83228.jpg

DS_ID:22388
 FS_ID:55922
 EP_NO: 9396
 Repair Type: Non-Urgent
 EVAL Issue: Unauthorized Encroachment, installed decades prior
 Crossing Status: Found
 UCIP Comments: 10/2/2019 Record remains Non-Urgent. In 2019 RD 108 took an attempt to bring structure to operable condition. Although this attempt was unsuccessful District will review other options. In the meantime crossing considered abandoned. Need to have CVFPB review ABO and determine current owner. (O.Yakimov - DWR UCIP)06/10/2014 Need to contact owner to determine status of structure. Notes indicate crossing has been abandoned. Owner will need to coordinate with CVFPB and DWR inspector to determine how to properly abandon. (O.Magana - DWR UCIP)
 FIELD_STRUCT_DESC: *ABANDONED* 4 of 5: 72-inch reinforced concrete gravity drainage pipe or culvert through the levee, 31.6 feet below the crown. Slide gate on each end. (Retention of five 72-inch pipes through the levee [HLM 0.08] authorized under Automatic Board Order (ABO) issued as Permit No. 9736, 1974 - Reclamation District No. 108 [RD0108]). [Additional Reference(s): DWR Levee Log, 1991, (HLM 0.08). USACE Sacramento O&M Manual 132, October 1959, (HLM 0.08), referenced as five 6-foot by 8-foot concrete drainage culverts].

View of concrete structure located on landward side

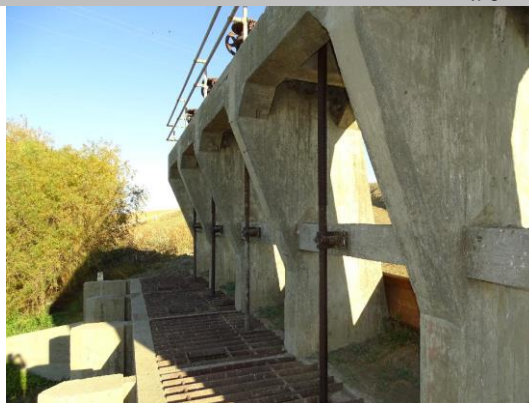
Photo 3 of 3 : UCIP_FA_2021_55922_83230.jpg

Slide gates on waterward side

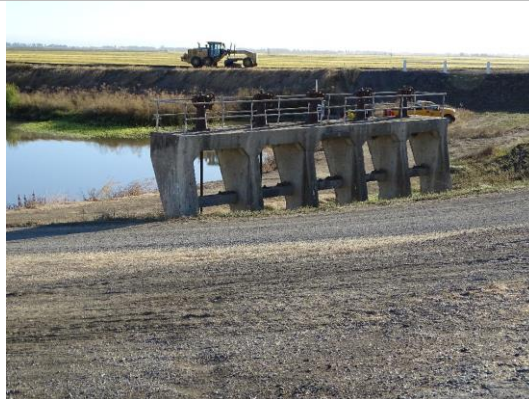
Photo 3 of 3 : UCIP_FA_2021_55923_83233.jpg

Comment Code						
Inspector Comment						
DS_ID:22389 FS_ID:55923 EP_NO: 9396 Repair Type: Non-Urgent EVAL Issue: Unauthorized Encroachment, installed decades prior Crossing Status: Found UCIP Comments: 10/2/2019 Record remains Non-Urgent. In 2019 RD 108 took an attempt to bring structure to operable condition. Although this attempt was unsuccessful District will review other options. In the meantime crossing considered abandoned. Need to have CVFPB review ABO and determine current owner. (O.Yakimov - DWR UCIP)06/10/2014 Need to contact owner to determine status of structure. Notes indicate crossing has been abandoned. Owner will need to coordinate with CVFPB and DWR inspector to determine how to properly abandon. (O.Magana - DWR UCIP) FIELD_STRUCT_DESC: *ABANDONED* 5 of 5: 72-inch reinforced concrete gravity drainage pipe or culvert through the levee, 31.6 feet below the crown. Slide gate on each end. (Retention of five 72-inch pipes through the levee [HLM 0.08] authorized under Automatic Board Order (ABO) issued as Permit No. 9736, 1974 - Reclamation District No. 108 [RD0108]). [Additional Reference(s): DWR Levee Log, 1991. USACE Sacramento O&M Manual 132, October 1959, (HLM 0.08), referenced as five 6-foot by 8-foot concrete drainage culverts]. FS Date: 10/2/2019 8:01:09 AM

Concrete structure located on waterward side

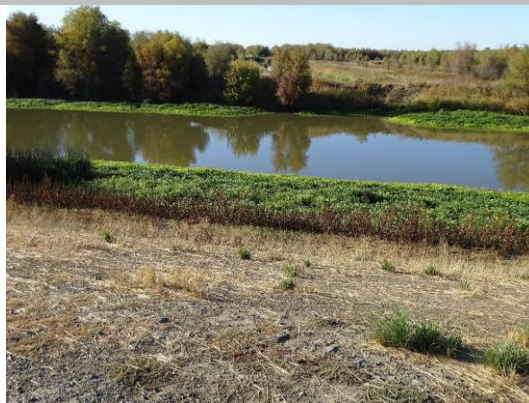
Photo 1 of 2 : UCIP_FA_2021_55924_83234.jpg

DS_ID:18662
 FS_ID:55924
 EP_NO: 2283
 Repair Type: Non-Urgent
 EVAL Issue: Safety Issue
 Crossing Status: Not Found
 UCIP Comments: 10/2/2019 Record updated to Non-Urgent. No inspection records were available to determine status of line through the levee. Crossing not found. Proper gas line markers should be installed on both sides of levee to identify crossing. (O.Yakimov - DWR UCIP)
 FIELD_STRUCT_DESC: 4-inch steel natural gas pipeline through the back borrow pit levee of Reclamation District No. 108 (RD0108), at an unknown depth. (Plans for installation of a 4-inch pipeline through the back borrow pit levee of RD0108 authorized under Permit No. 2283, 1956 - Yolo County Sales Company).
 FS Date: 10/2/2019 8:06:18 AM

View of WS at potential crossing looking from levee crown

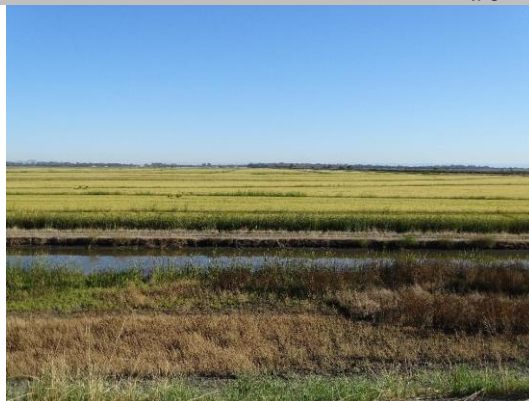
Photo 2 of 2 : UCIP_FA_2021_55924_83235.jpg

View of LS at potential crossing looking from levee crown

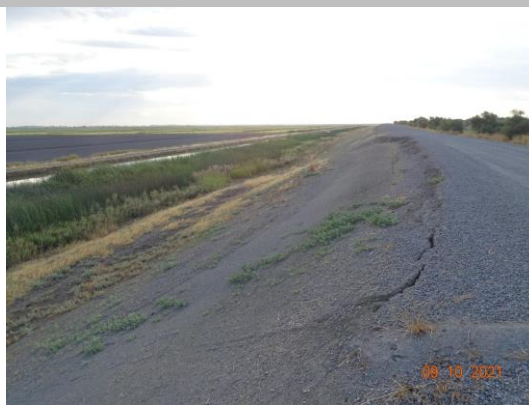
Photo 1 of 1 : FA_2021_RD0108_203_17_20210910_00037.jpg

LM Start	1.49	Rating **	M	Issue No.	17
LM End	1.51	Issue Type +	Ma	Location *	LS
Category	Earthen Levee			GPS Latitude/Longitude	
				Start	End
Item	Slope Stability			38.830951 °	38.831043 °
				-121.821574 °	-121.821847 °
DWR ID	DWR_RD0108_01_s_2020_17				
Comment Code					
S1 : Repair slope instability.					
Inspector Comment					
There appears to be a 150' sloughing section that is a result of February 2019 storms. This site will be repaired by the USACE under PL84-99. There are minor new cracks forming adjacent to the sloughing.

View of sloughing on landside slope. Fall 2021.

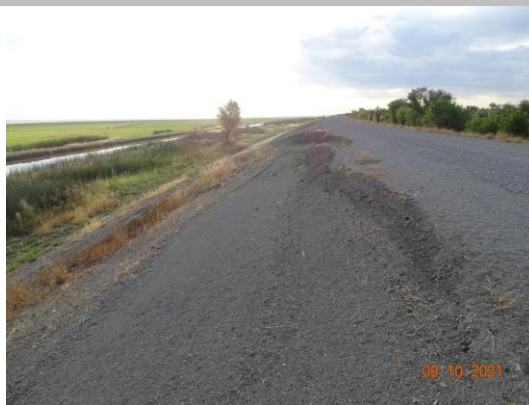
Photo 1 of 1 : FA_2021_RD0108_203_15_20210910_00038.jpg

LM Start	2.70	Rating **	M	Issue No.	15
LM End	2.73	Issue Type +	Ma	Location *	LS
Category	Earthen Levee			GPS Latitude/Longitude	
				Start	End
Item	Slope Stability			38.837568 °	38.837749 °
				-121.842218 °	-121.842776 °
DWR ID	DWR_RD0108_01_s_2019_15				
Comment Code					
S1 : Repair slope instability.					
Inspector Comment					
There appears to be a 150' sloughing section that is a result of February 2019 storms. This site will be repaired by the USACE under PL84-99

View of sloughing on landside slope. Fall 2021.

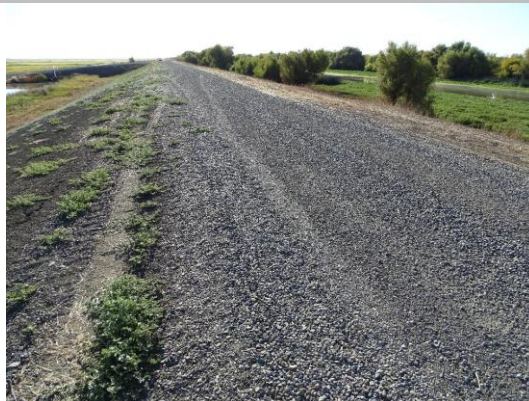
Photo 1 of 3 : UCIP_FA_2021_55925_83236.jpg

Comment Code						
Inspector Comment						
DS_ID:24875 FS_ID:55925 EP_NO: N/A Repair Type: Non-Urgent EVAL Issue: Unauthorized Encroachment Crossing Status: Indicator Found UCIP Comments: 10/2/2019 Record remains Non-Urgent. Geophysical results did not confirm presence of pipe through levee. Abandoned crossing. Needs to be removed or abandoned properly. (O.Yakimov - DWR UCIP)03/18/2014 No signs of pipe visible--need to contact owner to obtain permit number authorizing work. If crossing is no longer used by owner, the owner will need to coordinate with DWR Inspector and CVFPB to remove crossing according to Title 23 requirements. Dense vegetation limits the inspector's visibility to identify signs of pipe failure (leaks) along the slope. Recommend removing vegetation along pipe alignment to conduct proper inspection of structure. (O.Magana - DWR UCIP) FIELD_STRUCT_DESC: 44-inch corrugated metal pipe (CMP) riser on the waterside (WS). Riser is filled with trash and debris. Unable to determine if a crossing exists at this location. This riser was field discovered. FS Date: 10/2/2019 8:10:23 AM

View of levee crown at the crossing

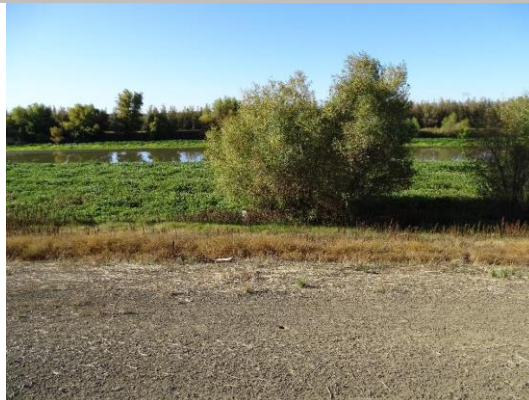
Photo 2 of 3 : UCIP_FA_2021_55925_83237.jpg

View of WS looking from levee crown

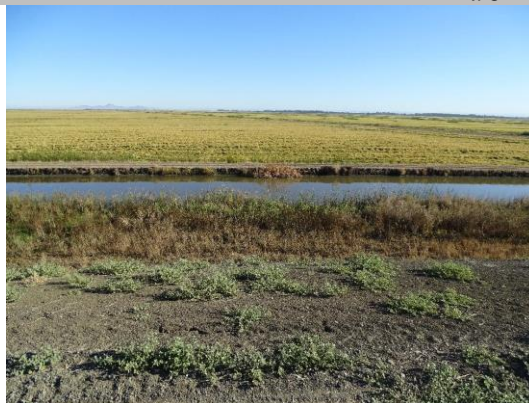
Photo 3 of 3 : UCIP_FA_2021_55925_83238.jpg

View of LS looking from levee crown

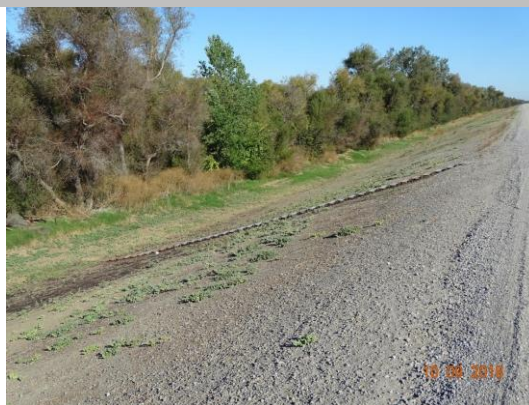
Photo 1 of 1 : FA_2021_RD0108_203_16_20210907_00003.jpg

LM Start	9.66	Rating **	M	Issue No.	16
LM End	9.66	Issue Type +	En	Location *	WS
Category	Earthen Levee			GPS Latitude/Longitude	
				Start	End
Item	Encroachments			38.902691 °	38.902691 °
				-121.914645 °	-121.914645 °
DWR ID	DWR_RD0108_01_f_2016_16				
Comment Code					
ST : Stairway					
Inspector Comment					
Department of Fish and Game staff is using a stairway to access their monitoring site. Unable to verify if a permit exists.

View of stairway look upstream. Fall 2018.

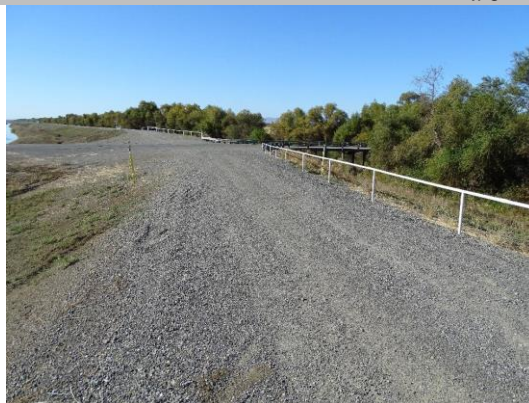
Photo 1 of 3 : UCIP_FA_2021_55926_83243.jpg

Comment Code						
Inspector Comment						
DS_ID:24876						
FS_ID:55926						
EP_NO: N/A						
Repair Type: Non-Urgent						
EVAL Issue: Safety Issue						
Crossing Status: Indicator Found						
UCIP Comments: 10/2/2019 Record remains Non-Urgent. No inspection records were available to determine status of line through the levee. Permit is not available for this crossing. (O.Yakimov - DWR UCIP)03/18/2014 Need to contact owner to determine additional details of crossing (O.Magana - DWR UCIP)						
FIELD_STRUCT_DESC: Natural gas pipeline of an unknown size or material slightly angled through the levee, at an unknown depth. Markers on both sides of the levee. Gas station located across the canal on the landside (LS). This crossing was field discovered.						
FS Date: 10/2/2019 8:17:59 AM

View of levee crown at the crossing

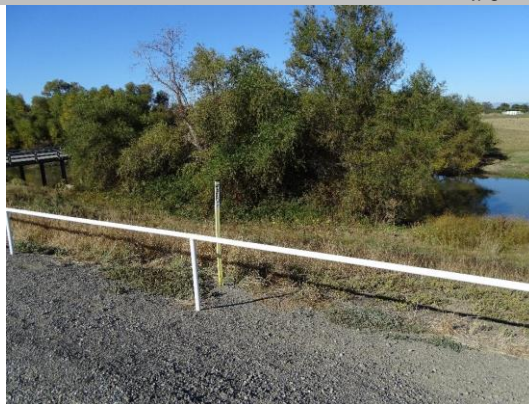
Photo 2 of 3 : UCIP_FA_2021_55926_83244.jpg

View of WS looking from levee crown. Gas line marker installed on levee shoulder

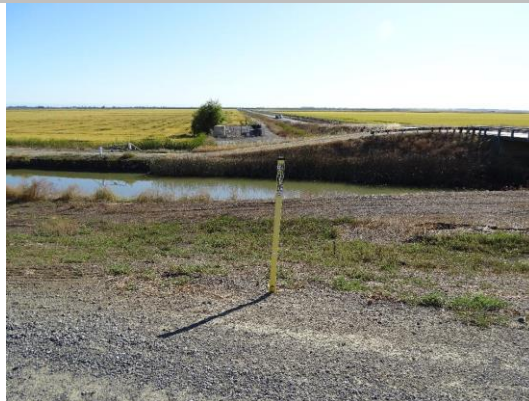
Photo 3 of 3 : UCIP_FA_2021_55926_83245.jpg

View of LS looking from levee crown. Gas line marker installed on levee shoulder. PG&E facility on LS

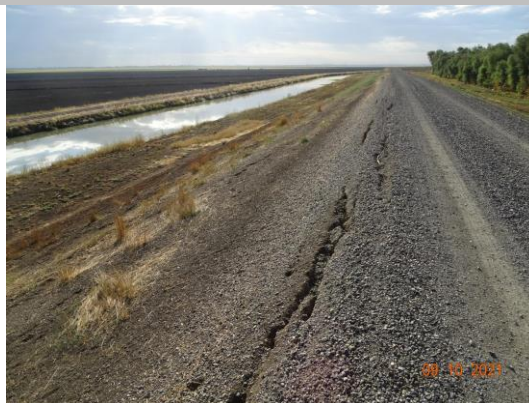
Photo 1 of 1 : FA_2021_RD0108_203_20_20210910_00039.jpg

LM Start	14.49	Rating **	A/W	Issue No.	20
LM End	14.49	Issue Type +	Ma	Location *	LS
Category	Earthen Levee			GPS Latitude/Longitude	
				Start	End
Item	Cracking			38.967259 °	38.967259 °
				-121.923417 °	-121.923417 °
DWR ID	DWR_RD0108_01_f_2021_20				
Comment Code					
CR1 : Monitor and have inspected by geotechnical engineer.					
Inspector Comment					
Approximately 50' of desiccation cracking on the landside hinge point. Appears to be stable. Recommend monitoring.

View of cracking on landside slope. Fall 2021.

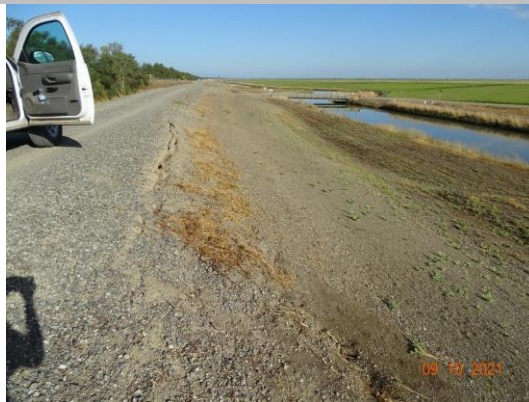
Photo 1 of 1 : FA_2021_RD0108_203_21_20210910_00040.jpg

LM Start	14.57	Rating **	A/W	Issue No.	21
LM End	14.59	Issue Type +	Ma	Location *	LS
Category	Earthen Levee			GPS Latitude/Longitude	
				Start	End
Item	Cracking			38.968018 °	38.968197 °
				-121.924498 °	-121.924735 °
DWR ID	DWR_RD0108_01_f_2021_21				
Comment Code					
CR1 : Monitor and have inspected by geotechnical engineer.					
Inspector Comment					
Approximately 120' of desiccation cracking on the landside hinge point. Appears to be stable. Recommend monitoring.

View of cracking on the landside slope. Fall 2021.

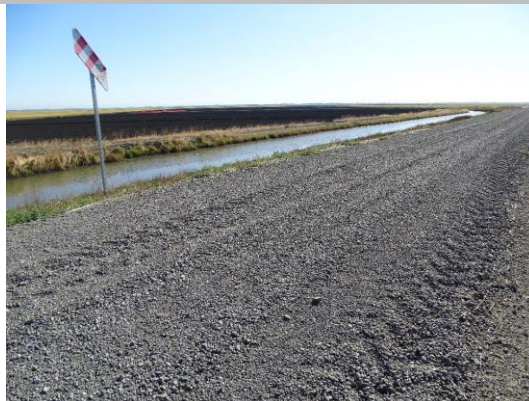
Photo 1 of 3 : UCIP_FA_2021_55927_83246.jpg

DS_ID:17942
FS_ID:55927
EP_NO: 3800
Repair Type: Non-Urgent
EVAL Issue: Safety Issue
Crossing Status: Indicator Found
UCIP Comments: 10/2/2019 Record remains Non-Urgent. No inspection records were available to determine status of line through the levee. Gas line marker not installed on WS. (O.Yakimov - DWR UCIP)06/10/2014 Need to contact owner--marker missing on waterward side.
FIELD_STRUCT_DESC: 20-inch concrete encased steel natural gas pipeline through the levee, 3 feet below the crown. Crossing appears to be angled through the levee. Small rock revetment on the waterside (WS) slope, unable to locate. Gas well approximately 1000 feet off the landside (LS) toe. (Plans to construct and maintain a 20-inch gas line across the Sacramento River authorized under Permit No. 3800, 1961 - Pacific Gas and Electric Company [PG&E]). [Additional Reference(s): DWR Levee Log, 1991, (HLM 14.90)].
FS Date: 10/2/2019 8:22:46 AM

View of levee crown at the crossing

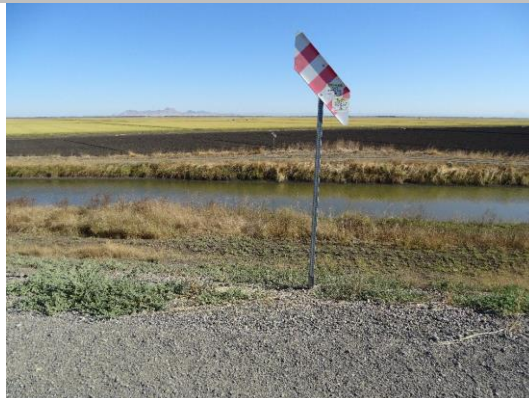
Photo 2 of 3 : UCIP_FA_2021_55927_83247.jpg

Marker visible on landward side

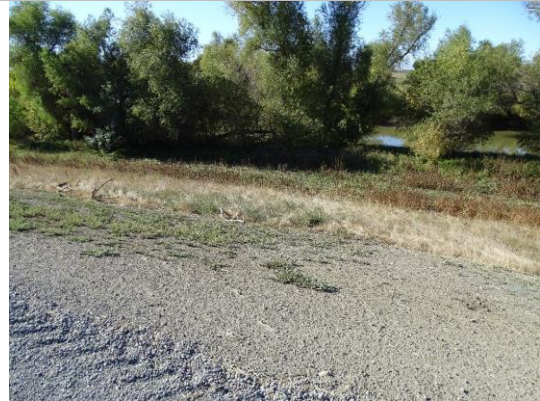
Photo 3 of 3 : UCIP_FA_2021_55927_83248.jpg

View of waterward side. No marker visible on waterward side

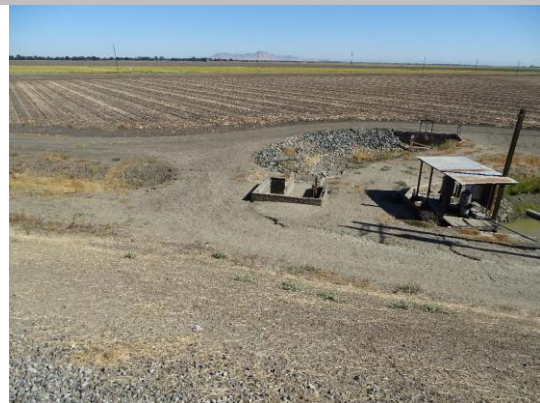
Photo 1 of 3 : UCIP_FA_2021_55933_83271.jpg

DS_ID:17940
 FS_ID:55933
 EP_NO: 9399
 Repair Type: Non-Urgent
 EVAL Issue: Geophysical Evaluation (Not Confirmed)
 Crossing Status: Indicator Found
 UCIP Comments: 10/2/2019 Record updated to Non-Urgent.
 Geophysical results did not confirm presence of pipe through levee. No permit has been identified authorizing pipe. Need to have CVFPB review ABO and determine current owner. Disrupted concrete pile structure observed in riverbank that may belong to this crossing. Grouted 24-inch pipe hole is visible inside of concrete distribution box at the landside toe. Unable to confirm proper abandonment. Updated lat/long. (O.Yakimov - DWR UCIP)
 FIELD_STRUCT_DESC: 24-inch steel gravity drainage pipe through the levee, 15 feet below the crown. Pipe is open in a concrete distribution box at the landside (LS) toe. Intake trash rack structure in channel. (Retention of a 24-inch steel pipe through the levee, 15 feet below the crown, a concrete distribution box, and an intake trash rack authorized under Automatic Board Order (ABO) issued as Permit No. 9399, 1974 - Aileen B. Armstrong, Trustee, care of O. M. Durst Jr.). [Additional Reference(s): DWR Levee Log, 1991, (HLM 18.67). USACE Sacramento O&M Manual 132, October 1959, (HLM 18.55)].

View of LS looking from levee crown

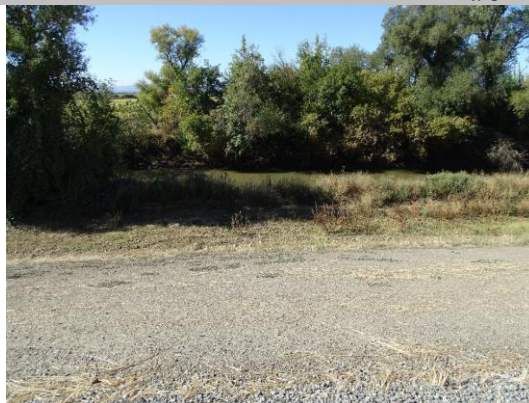
Photo 2 of 3 : UCIP_FA_2021_55933_83272.jpg

View of WS looking from levee crown

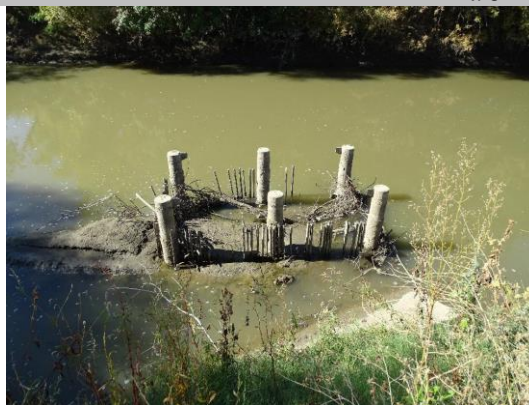
Photo 3 of 3 : UCIP_FA_2021_55933_83270.jpg

Ruined intake trash rack structure in channel

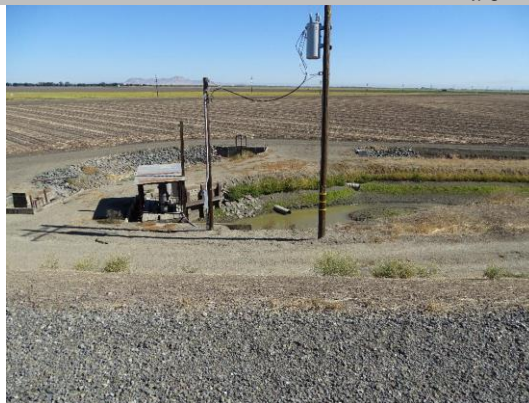
Photo 1 of 3 : UCIP_FA_2021_55932_83441.jpg

DS_ID:18659
FS_ID:55932
EP_NO: N/A
Repair Type: Non-Urgent
EVAL Issue: Unauthorized Encroachment, installed decades prior
Crossing Status: Indicator Found
UCIP Comments: 10/2/2019 Record updated to Non-Urgent. No permit has been identified authorizing pipe. Disrupted concrete pile structure observed in riverbank that may belong to this crossing. Grouted 18-inch pipe hole is visible inside of concrete distribution box at the landside toe. Unable to confirm proper abandonment. Coordinates updated. (O.Yakimov - DWR UCIP)
FIELD_STRUCT_DESC: 18-inch corrugated metal gravity drainage pipe through the levee, invert elevation 27.4 feet. Pipe hole immured at the landward toe in concrete distribution box. Ruined intake trash rack structure in channel. [Additional Reference(s): USACE Sacramento O&M Manual 132, October 1959, (HLM 18.55)].
FS Date: 10/2/2019 11:08:25 AM

LS view looking from levee crown

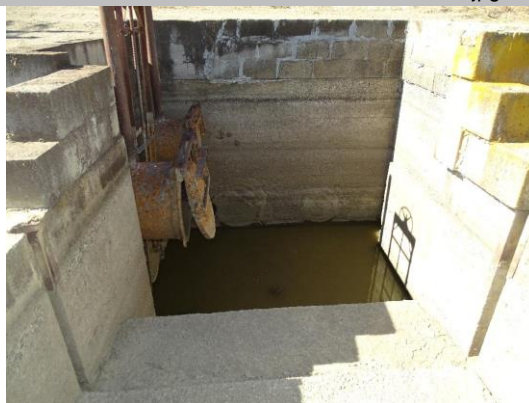
Photo 2 of 3 : UCIP_FA_2021_55932_83442.jpg

View inside of concrete box on LS

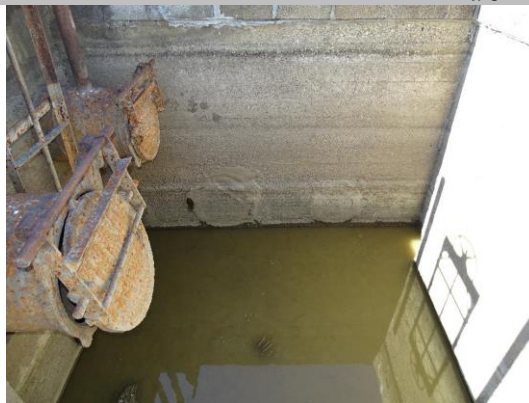
Photo 3 of 3 : UCIP_FA_2021_55932_83440.jpg

Grouted holes of 2 pipes towards levee in concrete box on LS

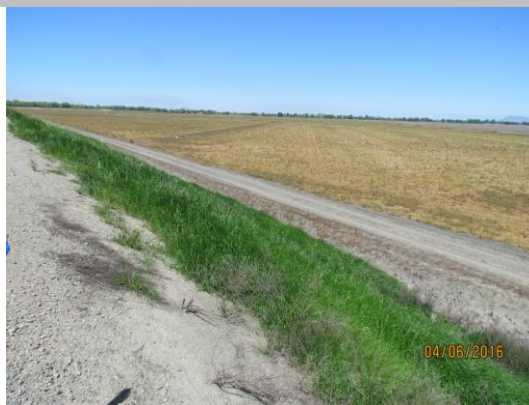
Photo 1 of 1 : FA_2021_RD0108_203_6_20210907_00001.jpg

LM Start	18.92	Rating **	M	Issue No.	6
LM End	19.28	Issue Type +	En	Location *	LS
Category	Earthen Levee			GPS Latitude/Longitude	
				Start	End
Item	Encroachments			39.013160 °	39.017000 °
				-121.980808 °	-121.985364 °
DWR ID	DWR_RD0108_01_s_2012_6				
Comment Code					
DT : Ditch					
Inspector Comment					
A ditch is located at the toe of the levee.

View of the ditch at the toe of the levee on the landward side looking upstream. Spring 2016.

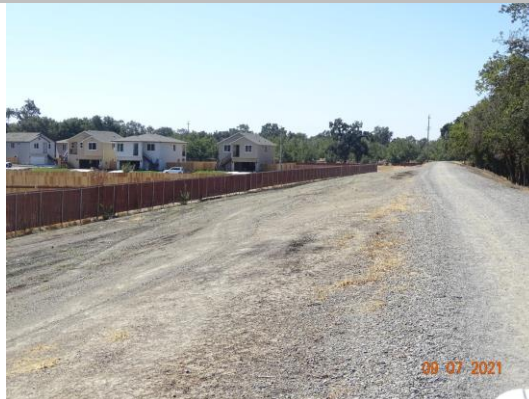
Photo 1 of 1 : FA_2021_RD0108_590_1_20210907_00001.jpg

View of maintained landside slope. Fall 2021.
