**Flood Control Project Maintenance  
Levee Inspections  
Fall 2022 Levee Maintenance Deficiency Summary Report**

**Sacramento River Basin**

# Reclamation District No. 0108 River Farms

**Levee Inspection Report By Mile - Fall 2022**

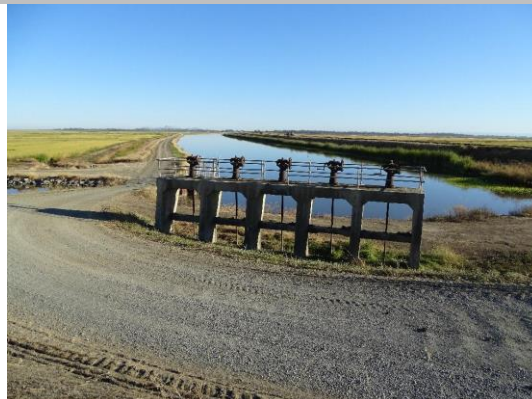
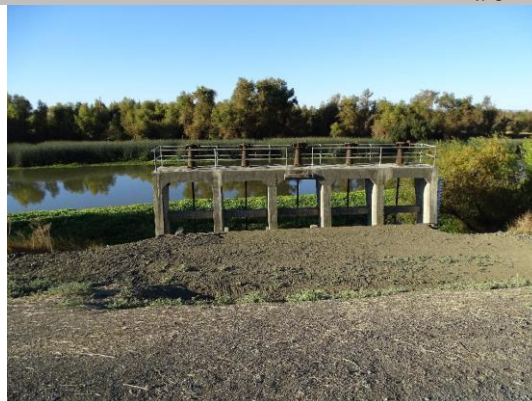
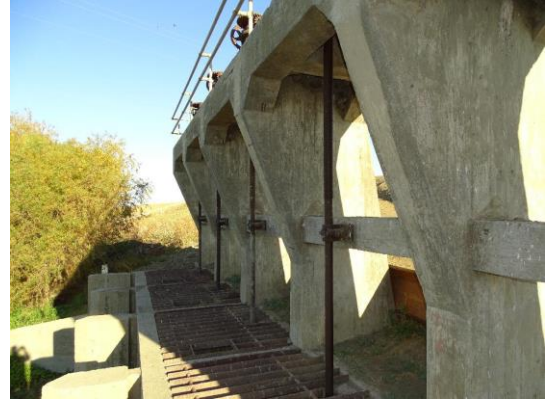
Photo 1 of 3 : UCIP\_FA\_2022\_55919\_83215.jpg

LM Start	0.06	Rating **	M	Issue No.	18	
LM End	0.06	Issue Type +	Ma	Location *		
Category	Supplemental			GPS Latitude/Longitude		
				Start	End	
Item	DWR UCIP LMA Responsibility			38.822897 °	38.822897 °	
				-121.797000 °	-121.797000 °	
DWR ID	17943

Comment Code						
Inspector Comment						
DS_ID:17943 FS_ID:55919 EP_NO: 9736 Repair Type: Non-Urgent EVAL Issue: Crossing Status: Found UCIP Comments: 10/2/2019 Record remains Non-Urgent. In 2019 RD 108 took an attempt to bring structure to operable condition. Although this attempt was unsuccessful District will review other options. In the meantime crossing considered abandoned. Need to have CVFPB review ABO and determine current owner. (O.Yakimov - DWR UCIP) 06/10/2014 Need to contact owner to determine status of structure. Notes indicate crossing has been abandoned. Owner will need to coordinate with CVFPB and DWR inspector to determine how to properly abandon. (O.Magana - DWR UCIP) FIELD_STRUCT_DESC: *ABANDONED* 1 of 5: 72-inch reinforced concrete gravity drainage pipe or culvert through the levee, 31.6 feet below the crown. Slide gate on each end. (Retention of five 72-inch pipes through the levee [HLM 0.08] authorized under Automatic Board Order (ABO) issued as Permit No. 9736, 1974 - Reclamation District No. 108 [RD0108]). [Additional Reference(s): DWR Levee Log, 1991, (HLM 0.08). USACE Sacramento O&M Manual 132, October 1959, (HLM 0.08), referenced as five 6-foot by 8-foot concrete drainage culverts]. FS Date: 10/2/2019

View of LS looking from levee crown

View of WS looking from levee crown

Slide gate operating structure on WS shoulder

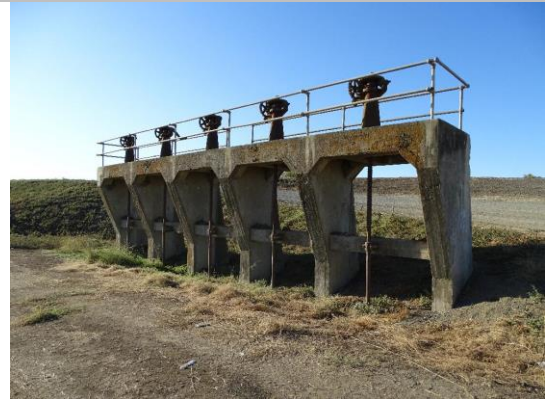
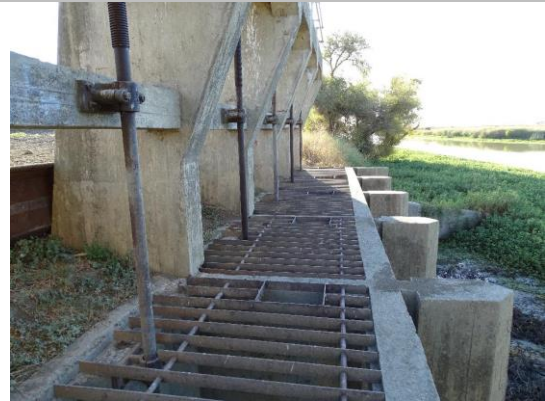
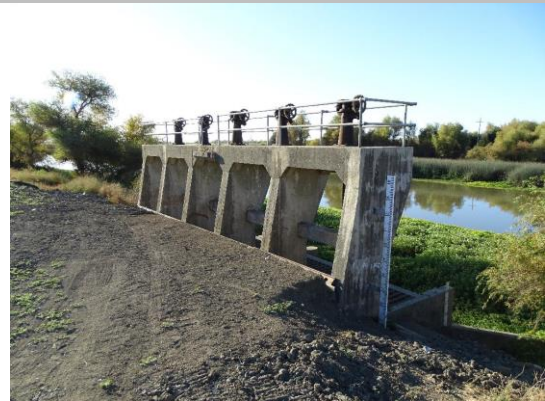
Photo 1 of 3 : UCIP\_FA\_2022\_55920\_83222.jpg

LM Start	<b>0.06</b>	Rating **	M	Issue No.	<b>19</b>
LM End	<b>0.06</b>	Issue Type +	Ma	Location *	
Category	Supplemental		GPS Latitude/Longitude		
			Start	End	
Item	DWR UCIP LMA Responsibility		38.822919 °	38.822919 °	
			-121.797046 °	-121.797046 °	
DWR ID	22386

DS\_ID:22386  
 FS\_ID:55920  
 EP\_NO: 9396  
 Repair Type: Non-Urgent  
 EVAL Issue:  
 Crossing Status: Found  
 UCIP Comments: 8/2/2019 Record remains Non-Urgent. In 2019 RD 108 took an attempt to bring structure to operable condition. Although this attempt was unsuccessful District will review other options. In the meantime crossing considered abandoned. Need to have CVFPB review ABO and determine current owner. (O.Yakimov - DWR UCIP) 06/10/2014 Need to contact owner to determine status of structure. Notes indicate crossing has been abandoned. Owner will need to coordinate with CVFPB and DWR inspector to determine how to properly abandon. (O.Magana - DWR UCIP)  
 FIELD\_STRUCT\_DESC: \*ABANDONED\* 2 of 5: 72-inch reinforced concrete gravity drainage pipe or culvert through the levee, 31.6 feet below the crown. Slide gate on each end. (Retention of five 72-inch pipes through the levee [HLM 0.08] authorized under Automatic Board Order (ABO) issued as Permit No. 9736, 1974 - Reclamation District No. 108 [RD0108]). [Additional Reference(s): DWR Levee Log, 1991, (HLM 0.08). USACE Sacramento O&M Manual 132, October 1959, (HLM 0.08), referenced as five 6-foot by 8-foot concrete drainage culverts].

View of concrete structure located on landward side

Slide gates on waterward side

Concrete structure located on waterward side

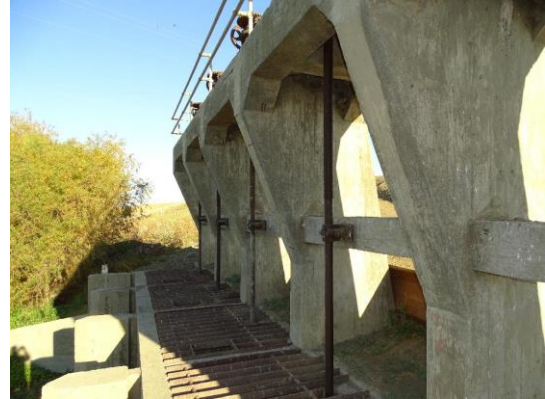
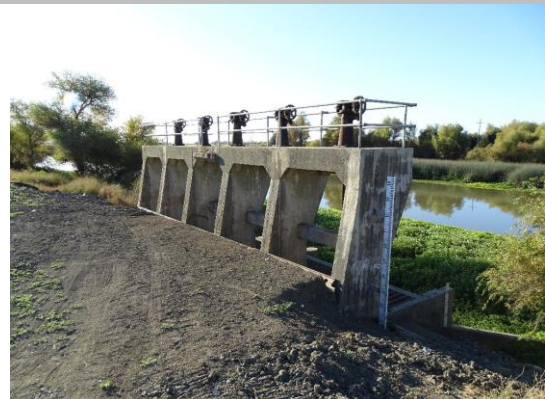
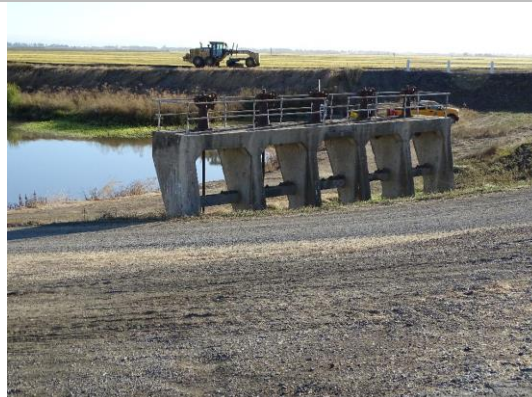
Photo 1 of 3 : UCIP\_FA\_2022\_55921\_83223.jpg

LM Start	0.06	Rating **	M	Issue No.	20
LM End	0.06	Issue Type +	Ma	Location *	
Category	Supplemental			GPS Latitude/Longitude	
				Start	End
Item	DWR UCIP LMA Responsibility			38.822933 °	38.822933 °
				-121.797081 °	-121.797081 °
DWR ID	22387

DS\_ID:22387  
FS\_ID:55921  
EP\_NO: 9396  
Repair Type: Non-Urgent  
EVAL Issue:  
Crossing Status: Found  
UCIP Comments: 10/2/2019 Record remains Non-Urgent. In 2019 RD 108 took an attempt to bring structure to operable condition. Although This attempt was unsuccessful District will review other options. In the meantime crossing considered abandoned. Need to have CVFPB review ABO and determine current owner. (O.Yakimov - DWR UCIP)06/10/2014 Need to contact owner to determine status of structure. Notes indicate crossing has been abandoned. Owner will need to coordinate with CVFPB and DWR inspector to determine how to properly abandon. (O.Magana - DWR UCIP)  
FIELD\_STRUCT\_DESC: \*ABANDONED\* 3 of 5: 72-inch reinforced concrete gravity drainage pipe or culvert through the levee, 31.6 feet below the crown. Slide gate on each end. (Retention of five 72-inch pipes through the levee [HLM 0.08] authorized under Automatic Board Order (ABO) issued as Permit No. 9736, 1974 - Reclamation District No. 108 [RD0108]). [Additional Reference(s): DWR Levee Log, 1991. USACE Sacramento O&M Manual 132, October 1959, (HLM 0.08), referenced as five 6-foot by 8-foot concrete drainage culverts].

Slide gates on waterward side

Concrete structure located on waterward side

Concrete structure located onlandward side

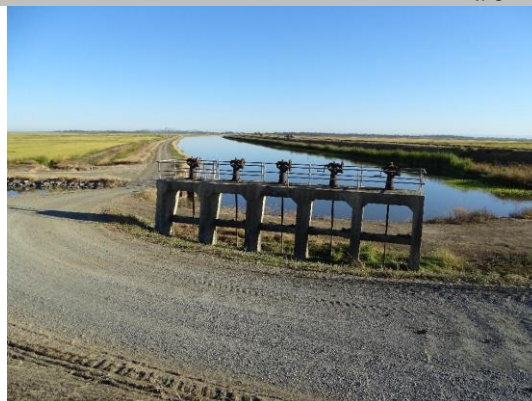
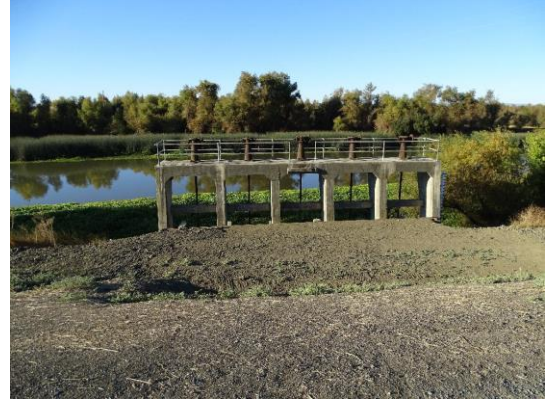
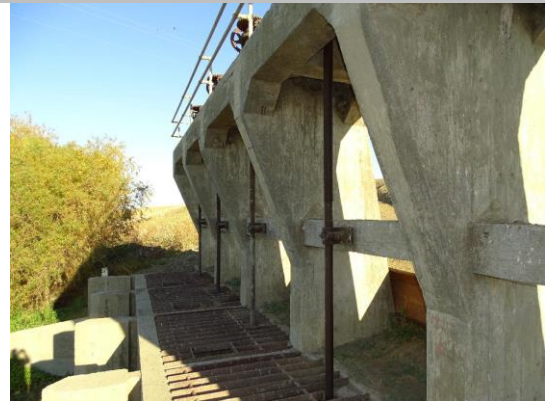
Photo 1 of 3 : UCIP\_FA\_2022\_55922\_83228.jpg

LM Start	<b>0.06</b>	Rating **	M	Issue No.	<b>21</b>
LM End	<b>0.06</b>	Issue Type +	Ma	Location *	
Category	Supplemental		GPS Latitude/Longitude		
			Start	End	
Item	DWR UCIP LMA Responsibility		38.822897 °	38.822897 °	
			-121.797000 °	-121.797000 °	
DWR ID	22388

DS\_ID:22388  
 FS\_ID:55922  
 EP\_NO: 9396  
 Repair Type: Non-Urgent  
 EVAL Issue:  
 Crossing Status: Found  
 UCIP Comments: 10/2/2019 Record remains Non-Urgent. In 2019 RD 108 took an attempt to bring structure to operable condition. Although this attempt was unsuccessful District will review other options. In the meantime crossing considered abandoned. Need to have CVFPB review ABO and determine current owner. (O.Yakimov - DWR UCIP)06/10/2014 Need to contact owner to determine status of structure. Notes indicate crossing has been abandoned. Owner will need to coordinate with CVFPB and DWR inspector to determine how to properly abandon. (O.Magana - DWR UCIP)  
 FIELD\_STRUCT\_DESC: \*ABANDONED\* 4 of 5: 72-inch reinforced concrete gravity drainage pipe or culvert through the levee, 31.6 feet below the crown. Slide gate on each end. (Retention of five 72-inch pipes through the levee [HLM 0.08] authorized under Automatic Board Order (ABO) issued as Permit No. 9736, 1974 - Reclamation District No. 108 [RD0108]). [Additional Reference(s): DWR Levee Log, 1991, (HLM 0.08). USACE Sacramento O&M Manual 132, October 1959, (HLM 0.08), referenced as five 6-foot by 8-foot concrete drainage culverts].

View of concrete structure located on landward side

Concrete structure located on waterward side

Slide gates on waterward side

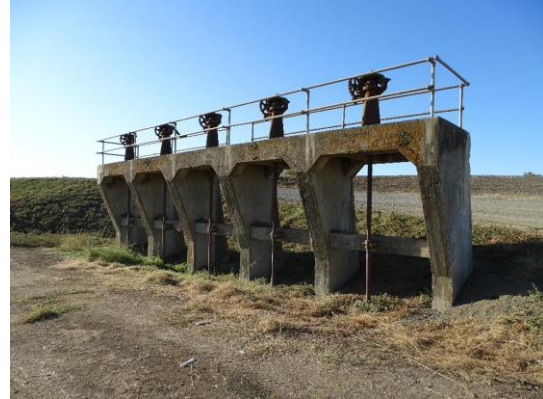
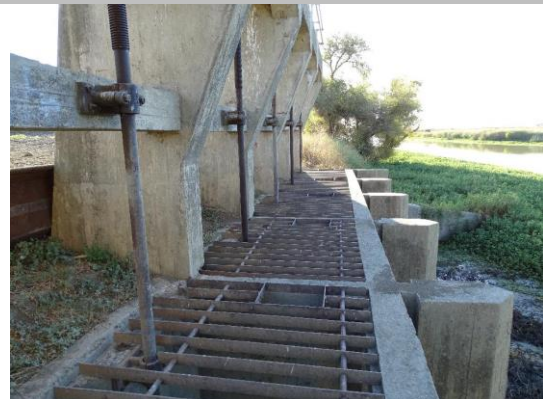
Photo 1 of 3 : UCIP\_FA\_2022\_55923\_83231.jpg

LM Start	0.07	Rating **	M	Issue No.	22
LM End	0.07	Issue Type +	Ma	Location *	
Category	Supplemental			GPS Latitude/Longitude	
				Start	End
Item	DWR UCIP LMA Responsibility			38.822954 °	38.822954 °
				-121.797135 °	-121.797135 °
DWR ID	22389

Comment Code					
Inspector Comment					
DS_ID:22389 FS_ID:55923 EP_NO: 9396 Repair Type: Non-Urgent EVAL Issue: Crossing Status: Found UCIP Comments: 10/2/2019 Record remains Non-Urgent. In 2019 RD 108 took an attempt to bring structure to operable condition. Although this attempt was unsuccessful District will review other options. In the meantime crossing considered abandoned. Need to have CVFPB review ABO and determine current owner. (O.Yakimov - DWR UCIP)06/10/2014 Need to contact owner to determine status of structure. Notes indicate crossing has been abandoned. Owner will need to coordinate with CVFPB and DWR inspector to determine how to properly abandon. (O.Magana - DWR UCIP) FIELD_STRUCT_DESC: *ABANDONED* 5 of 5: 72-inch reinforced concrete gravity drainage pipe or culvert through the levee, 31.6 feet below the crown. Slide gate on each end. (Retention of five 72-inch pipes through the levee [HLM 0.08] authorized under Automatic Board Order (ABO) issued as Permit No. 9736, 1974 - Reclamation District No. 108 [RD0108]). [Additional Reference(s): DWR Levee Log, 1991. USACE Sacramento O&M Manual 132, October 1959, (HLM 0.08), referenced as five 6-foot by 8-foot concrete drainage culverts]. FS Date: 10/2/2019 8:01:09 AM

View of concrete structure located on landward side

Slide gates on waterward side

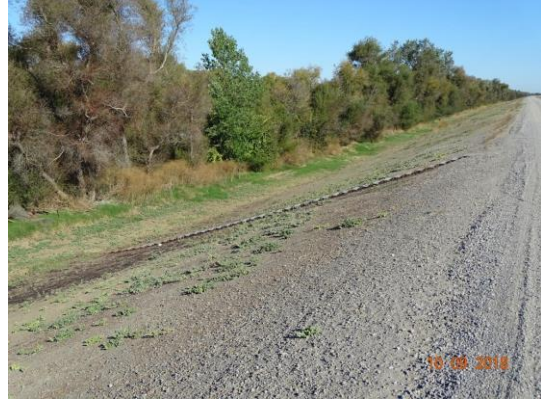
Photo 1 of 1 : FA\_2022\_RD0108\_203\_16\_20220921\_00004.jpg

LM Start	9.66	Rating **	M	Issue No.	16
LM End	9.66	Issue Type +	En	Location *	WS
Category	Earthen Levee			GPS Latitude/Longitude	
				Start	End
Item	Encroachments			38.902691 °	38.902691 °
				-121.914645 °	-121.914645 °
DWR ID	DWR_RD0108_01_f_2016_16				
Comment Code					
ST : Stairway					
Inspector Comment					
Department of Fish and Game staff is using a stairway to access their monitoring site. Unable to verify if a permit exists.

View of stairway look upstream. Fall 2018.

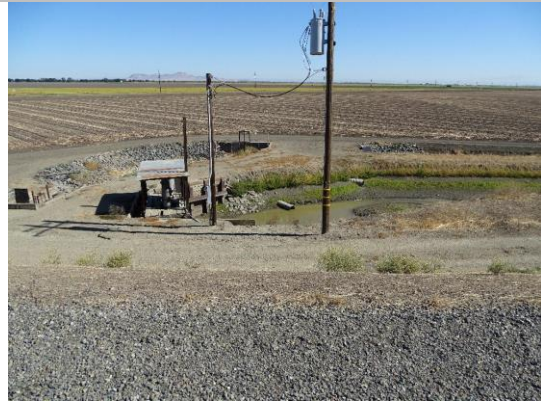
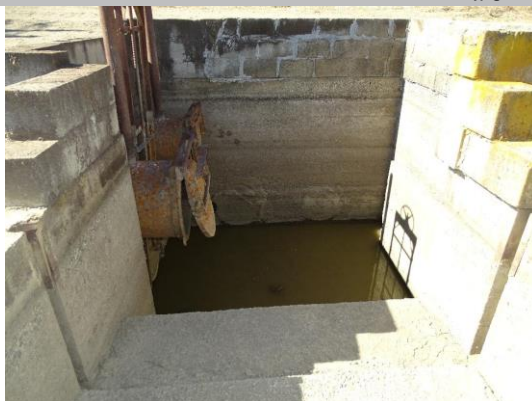
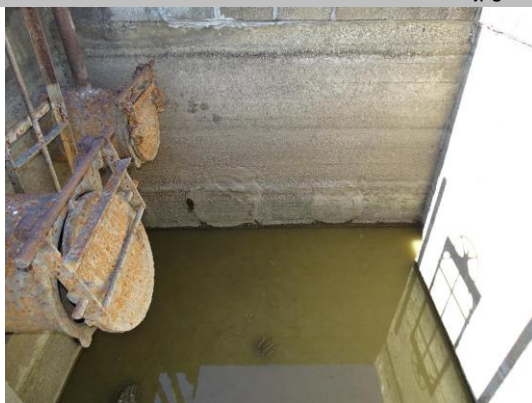
Photo 1 of 3 : UCIP\_FA\_2022\_55932\_83441.jpg

LM Start	18.73	Rating **	M	Issue No.	23	
LM End	18.73	Issue Type +	Ma	Location *		
Category	Supplemental			GPS Latitude/Longitude		
				Start	End	
Item	DWR UCIP LMA Responsibility			39.011044 °	39.011044 °	
				-121.978446 °	-121.978446 °	
DWR ID	18659

Comment Code						
Inspector Comment						
DS_ID:18659 FS_ID:55932 EP_NO: N/A Repair Type: Non-Urgent EVAL Issue: Crossing Status: Indicator Found UCIP Comments: 10/2/2019 Record updated to Non-Urgent. No permit has been identified authorizing pipe. Disrupted concrete pile structure observed in riverbank that may belong to this crossing. Grouted 18-inch pipe hole is visible inside of concrete distribution box at the landside toe. Unable to confirm proper abandonment. Coordinates updated. (O.Yakimov - DWR UCIP) FIELD_STRUCT_DESC: 18-inch corrugated metal gravity drainage pipe through the levee, invert elevation 27.4 feet. Pipe hole immured at the landward toe in concrete distribution box. Ruined intake trash rack structure in channel. [Additional Reference(s): USACE Sacramento O&M Manual 132, October 1959, (HLM 18.55)]. FS Date: 10/2/2019 11:08:25 AM

LS view looking from levee crown

View inside of concrete box on LS

Grouted holes of 2 pipes towards levee in concrete box on LS

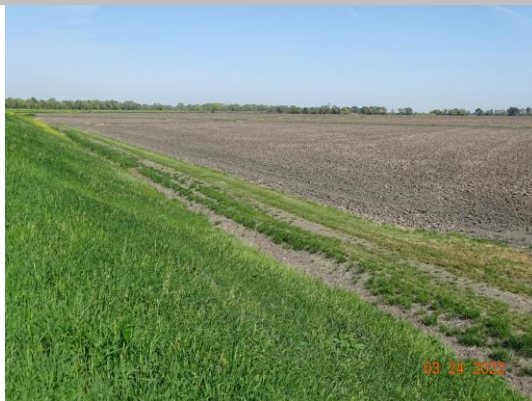
Photo 1 of 1 : FA\_2022\_RD0108\_203\_6\_20220921\_00001.jpg

LM Start	18.92	Rating **	M	Issue No.	6
LM End	19.28	Issue Type +	En	Location *	LS
Category	Earthen Levee			GPS Latitude/Longitude	
				Start	End
Item	Encroachments			39.013160 °	39.017000 °
				-121.980808 °	-121.985364 °
DWR ID	DWR_RD0108_01_s_2012_6				
Comment Code					
DT : Ditch					
Inspector Comment					
A ditch is located at the toe of the levee.

View of ditch at the landside toe. Spring 2022.

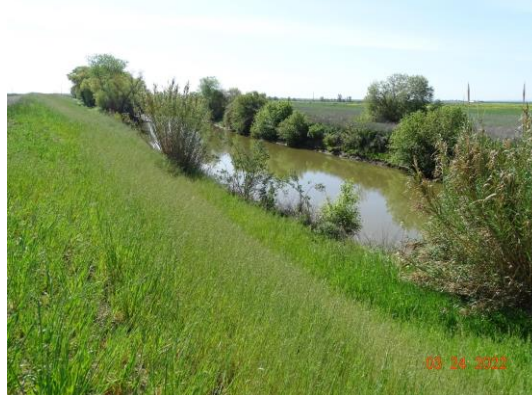
Photo 1 of 1 : FA\_2022\_RD0108\_203\_13\_20220921\_00002.jpg

LM Start	19.27	Rating **	M	Issue No.	13
LM End	19.35	Issue Type +	Ma	Location *	WS
Category	Supplemental			GPS Latitude/Longitude	
				Start	End
Item	2018 USACE Erosion Survey			39.016727 °	39.017516 °
				-121.985411 °	-121.986374 °
DWR ID	DWR_RD0108_01_s_2022_13				
Comment Code					
Inspector Comment					
2018 Site ID: CBD 19.2 L					
Status: Eroding					
2018 Field Notes: Last observed in 2011. Access issues prevented inspection in 2017.					
Site History: 2011 - Toe scour at the bottom of a steep bank, large sections of the toe are sliding down. Erosion may be due to the upstream bend.

View of erosion at the waterside toe. Spring 2022.

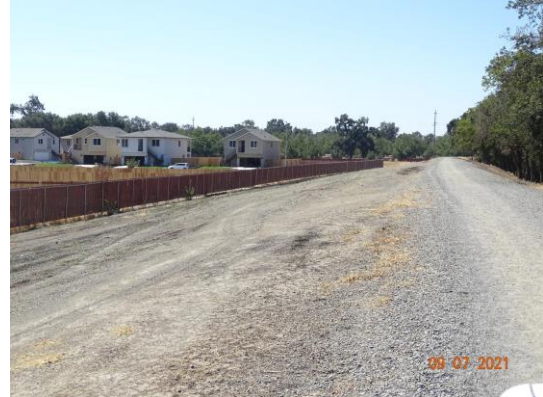
Photo 1 of 1 : FA\_2022\_RD0108\_590\_1\_20221012\_00001.jpg

LM Start	0.21	Rating **	A	Issue No.	1
LM End	0.21	Issue Type +	Ma	Location *	LS
Category	Earthen Levee			GPS Latitude/Longitude	
				Start	End
Item	Vegetation			38.798377 °	38.798377 °
				-121.725394 °	-121.725394 °
DWR ID	DWR_RD0108_02_f_2022_1				
Comment Code					
V1 : Control annual grass and weeds on the levee slopes and easements.					
Inspector Comment					
LMA maintains the levee at a high level, Fall 2022.

View of well maintained landside slope.
