Flood Control Project Maintenance Levee Inspections

Fall 2023 Levee Maintenance Deficiency Summary Report

Sacramento River Basin

Reclamation District No. 0108 River Farms

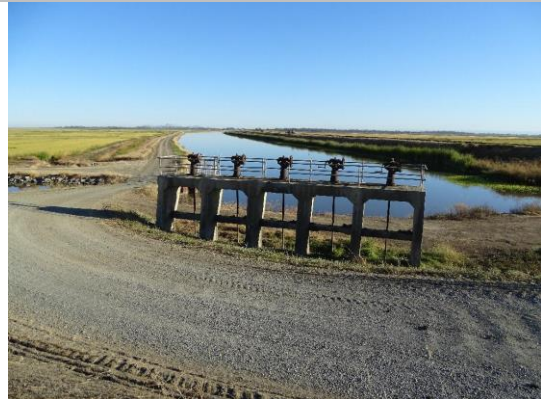
Photo 1 of 3 : UCIP_FA_2023_55919_83215.jpg

Comment Code					
Inspector Comment					
DS_ID:17943 FS_ID:55919 EP_NO: 9736 Repair Type: Non-Urgent EVAL Issue: Crossing Status: Found UCIP Comments: 10/2/2019 Record remains Non-Urgent. In 2019 RD 108 took an attempt to bring structure to operable condition. Although this attempt was unsuccessful District will review other options. In the meantime crossing considered abandoned. Need to have CVFPB review ABO and determine current owner. (O.Yakimov - DWR UCIP) 06/10/2014 Need to contact owner to determine status of structure. Notes indicate crossing has been abandoned. Owner will need to coordinate with CVFPB and DWR inspector to determine how to properly abandon. (O.Magana - DWR UCIP) FIELD_STRUCT_DESC: 1 of 5: 72-inch reinforced concrete gravity drainage pipe or culvert through the levee, 31.6 feet below the crown. Slide gate on each end. (Retention of five 72-inch pipes through the levee [HLM 0.08] authorized under Automatic Board Order (ABO) issued as Permit No. 9736, 1974 - Reclamation District No. 108 [RD0108]). [Additional Reference(s): DWR Levee Log, 1991, (HLM 0.08). USACE Sacramento O&M Manual 132, October 1959, (HLM 0.08), referenced as five 6-foot by 8-foot concrete drainage culverts]. FS Date: 10/2/2019

View of LS looking from levee crown

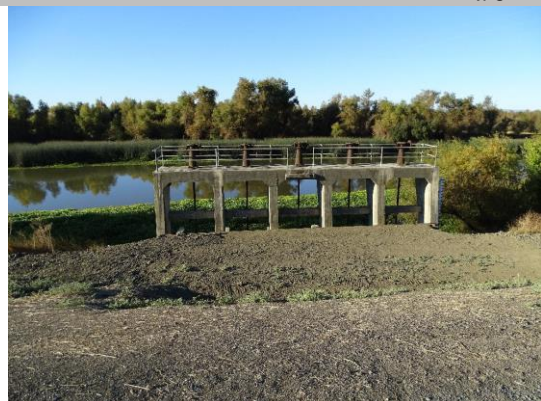
Photo 2 of 3 : UCIP_FA_2023_55919_83216.jpg

View of WS looking from levee crown

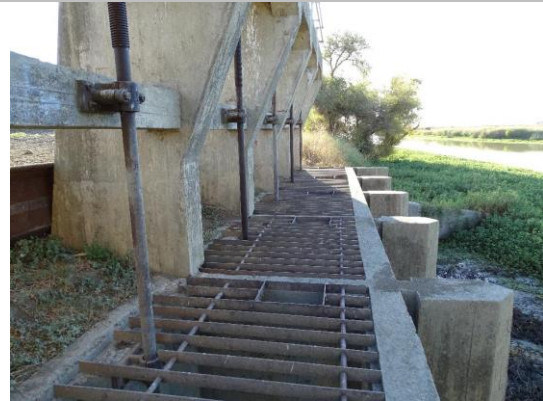
Photo 2 of 3 : UCIP_FA_2023_55920_83226.jpg

Slide gates on waterward side

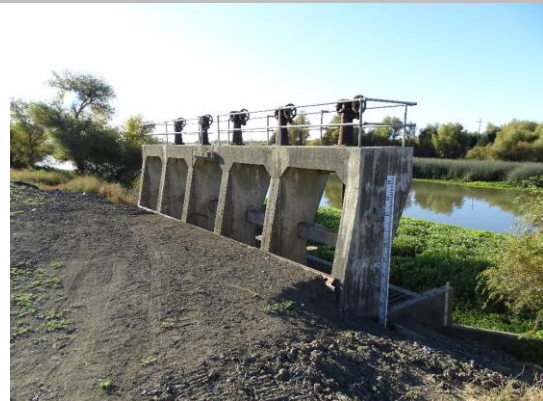
Photo 3 of 3 : UCIP_FA_2023_55920_83227.jpg

Concrete structure located on waterward side

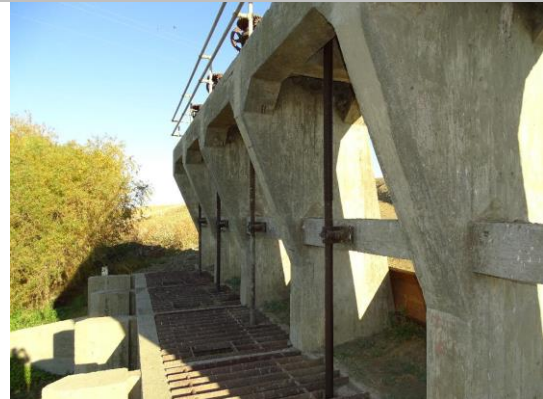
Photo 1 of 3 : UCIP_FA_2023_55921_83223.jpg

Comment Code						
Inspector Comment						
DS_ID:22387 FS_ID:55921 EP_NO: 9396 Repair Type: Non-Urgent EVAL Issue: Crossing Status: Found UCIP Comments: 10/2/2019 Record remains Non-Urgent. In 2019 RD 108 took an attempt to bring structure to operable condition. Although This attempt was unsuccessful District will review other options. In the meantime crossing considered abandoned. Need to have CVFPB review ABO and determine current owner. (O.Yakimov - DWR UCIP)06/10/2014 Need to contact owner to determine status of structure. Notes indicate crossing has been abandoned. Owner will need to coordinate with CVFPB and DWR inspector to determine how to properly abandon. (O.Magana - DWR UCIP) FIELD_STRUCT_DESC: *ABANDONED* 3 of 5: 72-inch reinforced concrete gravity drainage pipe or culvert through the levee, 31.6 feet below the crown. Slide gate on each end. (Retention of five 72-inch pipes through the levee [HLM 0.08] authorized under Automatic Board Order (ABO) issued as Permit No. 9736, 1974 - Reclamation District No. 108 [RD0108]). [Additional Reference(s): DWR Levee Log, 1991. USACE Sacramento O&M Manual 132, October 1959, (HLM 0.08), referenced as five 6-foot by 8-foot concrete drainage culverts]. FS Date: 10/2/2019 7:54:00 AM

Slide gates on waterward side

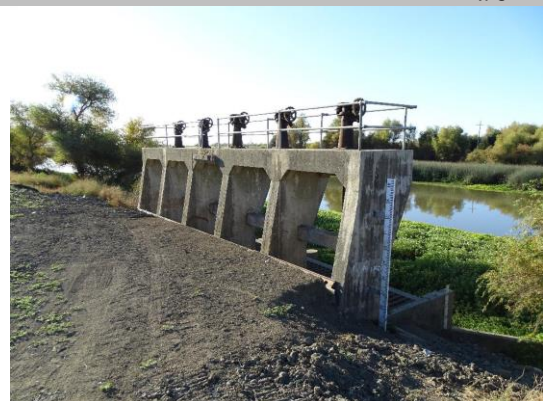
Photo 2 of 3 : UCIP_FA_2023_55921_83224.jpg

Concrete structure located on waterward side

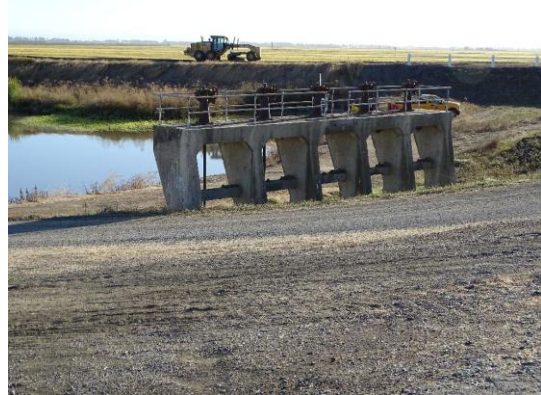
Photo 3 of 3 : UCIP_FA_2023_55921_83225.jpg

Concrete structure located onlandward side

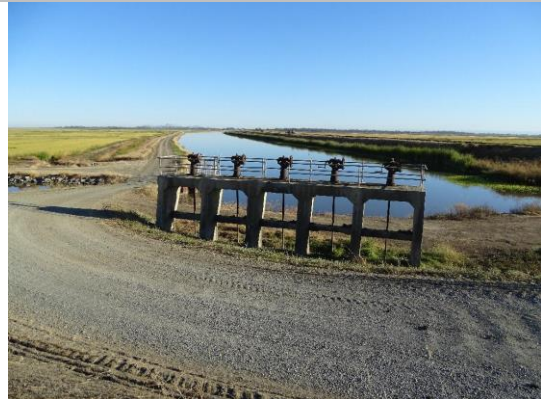
Photo 1 of 3 : UCIP_FA_2023_55922_83228.jpg

DS_ID:22388
FS_ID:55922
EP_NO: 9396
Repair Type: Non-Urgent
EVAL Issue:
Crossing Status: Found
UCIP Comments: 10/2/2019 Record remains Non-Urgent. In 2019 RD 108 took an attempt to bring structure to operable condition. Although this attempt was unsuccessful District will review other options. In the meantime crossing considered abandoned. Need to have CVFPB review ABO and determine current owner. (O.Yakimov - DWR UCIP)06/10/2014 Need to contact owner to determine status of structure. Notes indicate crossing has been abandoned. Owner will need to coordinate with CVFPB and DWR inspector to determine how to properly abandon. (O.Magana - DWR UCIP)
FIELD_STRUCT_DESC: *ABANDONED* 4 of 5: 72-inch reinforced concrete gravity drainage pipe or culvert through the levee, 31.6 feet below the crown. Slide gate on each end. (Retention of five 72-inch pipes through the levee [HLM 0.08] authorized under Automatic Board Order (ABO) issued as Permit No. 9736, 1974 - Reclamation District No. 108 [RD0108]). [Additional Reference(s): DWR Levee Log, 1991, (HLM 0.08). USACE Sacramento O&M Manual 132, October 1959, (HLM 0.08), referenced as five 6-foot by 8-foot concrete drainage culverts].

View of concrete structure located on landward side

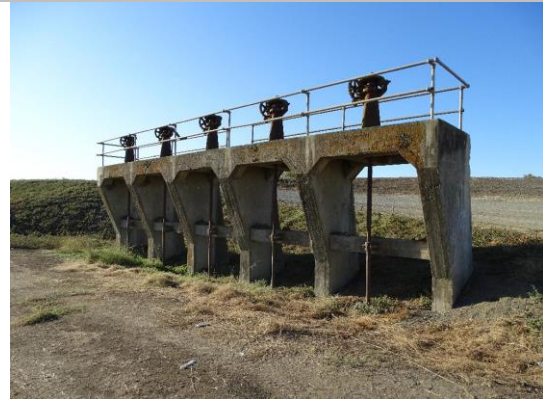
Photo 1 of 3 : UCIP_FA_2023_55923_83231.jpg

Comment Code						
Inspector Comment						
DS_ID:22389 FS_ID:55923 EP_NO: 9396 Repair Type: Non-Urgent EVAL Issue: Crossing Status: Found UCIP Comments: 10/2/2019 Record remains Non-Urgent. In 2019 RD 108 took an attempt to bring structure to operable condition. Although this attempt was unsuccessful District will review other options. In the meantime crossing considered abandoned. Need to have CVFPB review ABO and determine current owner. (O.Yakimov - DWR UCIP)06/10/2014 Need to contact owner to determine status of structure. Notes indicate crossing has been abandoned. Owner will need to coordinate with CVFPB and DWR inspector to determine how to properly abandon. (O.Magana - DWR UCIP) FIELD_STRUCT_DESC: *ABANDONED* 5 of 5: 72-inch reinforced concrete gravity drainage pipe or culvert through the levee, 31.6 feet below the crown. Slide gate on each end. (Retention of five 72-inch pipes through the levee [HLM 0.08] authorized under Automatic Board Order (ABO) issued as Permit No. 9736, 1974 - Reclamation District No. 108 [RD0108]). [Additional Reference(s): DWR Levee Log, 1991. USACE Sacramento O&M Manual 132, October 1959, (HLM 0.08), referenced as five 6-foot by 8-foot concrete drainage culverts]. FS Date: 10/2/2019 8:01:09 AM

View of concrete structure located on landward side

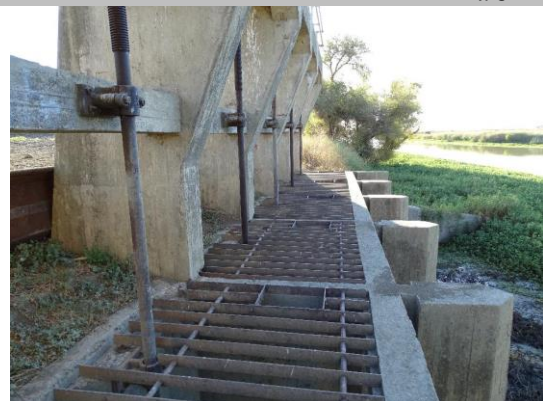
Photo 2 of 3 : UCIP_FA_2023_55923_83232.jpg

Slide gates on waterward side

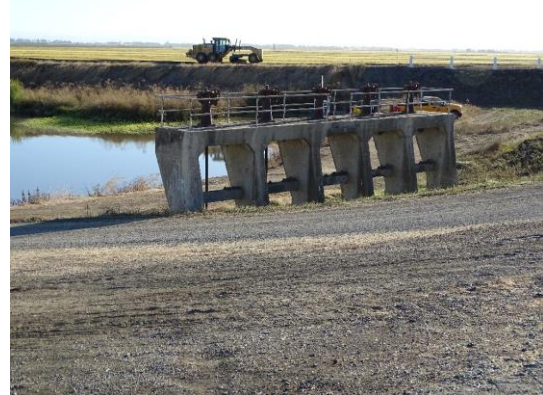
Photo 3 of 3 : UCIP_FA_2023_55923_83233.jpg

Concrete structure located on waterward side

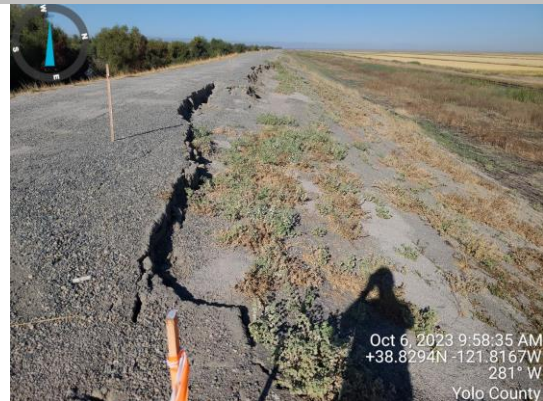
Photo 1 of 1 : FA_2023_RD0108_203_12_20231010_00032.jpg

LM Start	1.21	Rating **	U	Issue No.	12
LM End	1.24	Issue Type +	Ma	Location *	LS
Category	Earthen Levee			GPS Latitude/Longitude	
				Start	End
Item	Slope Stability			38.829411°	38.829582°
				-121.816712°	-121.817274°
DWR ID	DWR_RD0108_01_s_2023_12				
Comment Code					
S1 : Repair slope instability.					
Inspector Comment					
150' of sloughing on the landside slope with approximately 3ft of vertical scarp at worst section. District installed a raincoat over the damage during the spring storms.

View of sloughing on the landside shoulder and slope. Fall 2023.

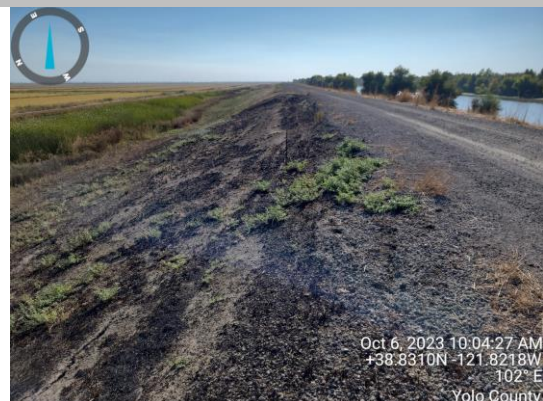
Photo 1 of 1 : FA_2023_RD0108_203_17_20231010_00033.jpg

LM Start	1.49	Rating **	M	Issue No.	17
LM End	1.51	Issue Type +	Ma	Location *	LS
Category	Earthen Levee			GPS Latitude/Longitude	
				Start	End
Item	Slope Stability			38.830951°	38.831043°
				-121.821574°	-121.821847°
DWR ID	DWR_RD0108_01_f_2022_17				
Comment Code					
S1 : Repair slope instability.					
Inspector Comment					
There appears to be a 150' sloughing section that is a result of February 2019 storms. This site will be repaired by the USACE under PL84-99. There are minor new cracks forming adjacent to the sloughing.

View of sloughing on the landside slope. Fall 2023.

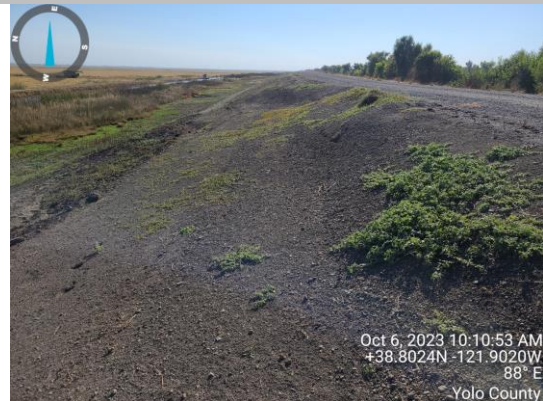
Photo 1 of 1 : FA_2023_RD0108_203_15_20231010_00034.jpg

LM Start	2.70	Rating **	M	Issue No.	15
LM End	2.73	Issue Type +	Ma	Location *	LS
Category	Earthen Levee			GPS Latitude/Longitude	
				Start	End
Item	Slope Stability			38.837568°	38.837749°
				-121.842218°	-121.842776°
DWR ID	DWR_RD0108_01_s_2019_15				
Comment Code					
S1 : Repair slope instability.					
Inspector Comment					
There appears to be a 150' sloughing section that is a result of February 2019 storms. This site will be repaired by the USACE under PL84-99.

View of sloughing on the landside slope. Fall 2023.

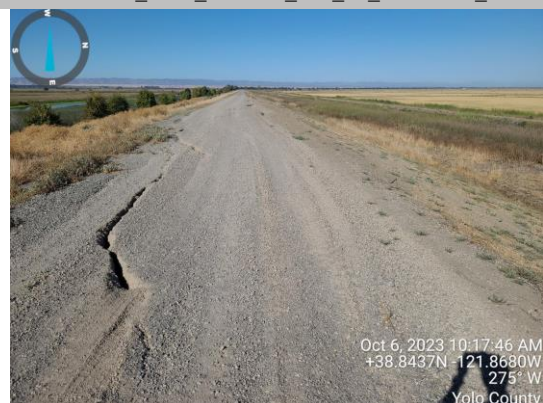
Photo 1 of 1 : FA_2023_RD0108_203_19_20231010_00031.jpg

LM Start	4.16	Rating **	M	Issue No.	19
LM End	4.20	Issue Type +	Ma	Location *	CR
Category	Earthen Levee			GPS Latitude/Longitude	
				Start	End
Item	Cracking			38.843700°	38.843785°
				-121.868000°	-121.868725°
DWR ID	DWR_RD0108_01_f_2023_19				
Comment Code					
CR2 : Schedule repair of subsidence prior to the next inspection.					
Inspector Comment					
Approximately 200' of deep cracks through the crown and landside shoulder.

View of cracks in crown and landside shoulder. Fall 2023.

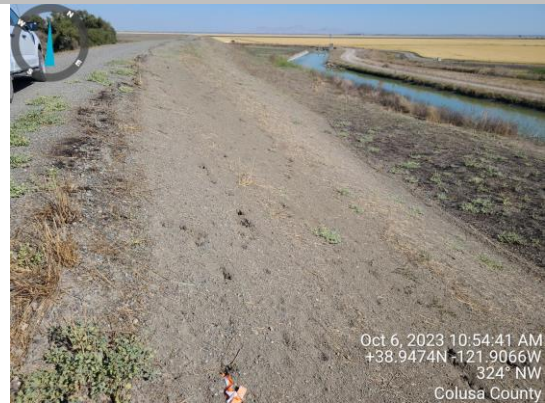
Photo 1 of 1 : FA_2023_RD0108_203_16_20231010_00035.jpg

LM Start	12.82	Rating **	M	Issue No.	16
LM End	12.84	Issue Type +	Ma	Location *	LS
Category	Earthen Levee			GPS Latitude/Longitude	
				Start	End
Item	Slope Stability			38.947400°	38.947675°
				-121.906600°	-121.906793°
DWR ID	DWR_RD0108_01_f _ 2023_16				
Comment Code					
S1 : Repair slope instability.					
Inspector Comment					
Approximately 100' of sloughing on the landside slope.

View of sloughing on the landside slope. Fall 2023.

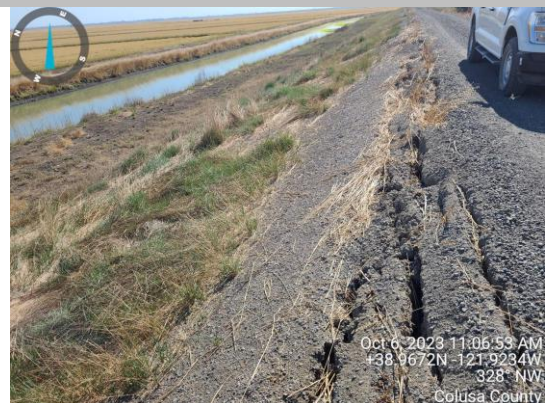
Photo 1 of 1 : FA_2023_RD0108_203_21_20231010_00036.jpg

LM Start	14.48	Rating **	M	Issue No.	21
LM End	14.49	Issue Type +	Ma	Location *	LS
Category	Earthen Levee			GPS Latitude/Longitude	
				Start	End
Item	Slope Stability			38.967107°	38.967205°
				-121.923162°	-121.923299°
DWR ID	DWR_RD0108_01_s_2023_21				
Comment Code					
S1 : Repair slope instability.					
Inspector Comment					
100' of sloughing on the landside shoulder.

View of sloughing on the landside shoulder. Fall 2023.

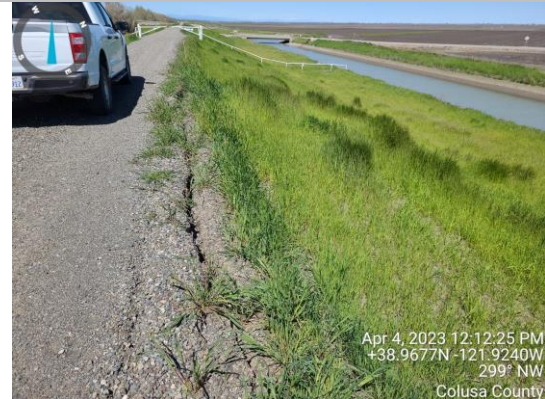
Photo 1 of 1 : FA_2023_RD0108_203_22_20230907_00009.jpg

LM Start	14.53	Rating **	M	Issue No.	22
LM End	14.54	Issue Type +	Ma	Location *	LS
Category	Earthen Levee			GPS Latitude/Longitude	
				Start	End
Item	Slope Stability			38.967652°	38.967716°
				-121.923930°	-121.924020°
DWR ID	DWR_RD0108_01_s_2023_22				
Comment Code					
S1 : Repair slope instability.					
Inspector Comment					
Approximately 250' of sloughing on the landside slope.

View of cracking on the landside shoulder. Spring 2023.

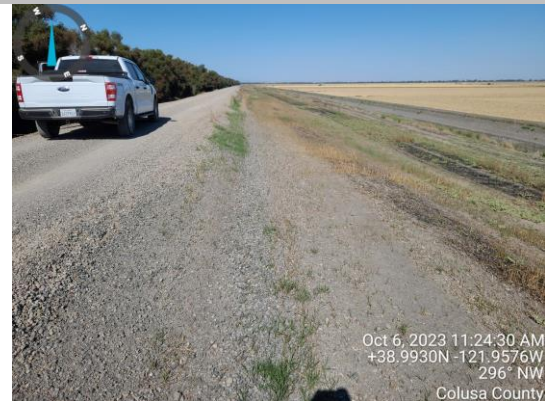
Photo 1 of 1 : FA_2023_RD0108_203_20_20231010_00037.jpg

LM Start	17.05	Rating **	M	Issue No.	20
LM End	17.09	Issue Type +	Ma	Location *	LS
Category	Earthen Levee			GPS Latitude/Longitude	
				Start	End
Item	Slope Stability			38.993000°	38.993420°
				-121.957600°	-121.958032°
DWR ID	DWR_RD0108_01_f _ 2023_20				
Comment Code					
S1 : Repair slope instability.					
Inspector Comment					
250' of sloughing on the landside slope.

View of sloughing on the landside slope. Fall 2023.

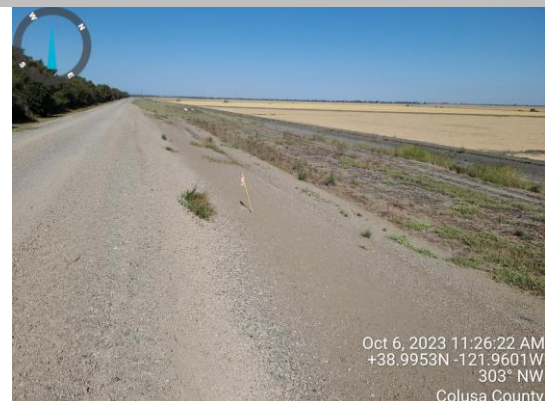
Photo 1 of 1 : FA_2023_RD0108_203_23_20231010_00038.jpg

LM Start	17.26	Rating **	M	Issue No.	23
LM End	17.28	Issue Type +	Ma	Location *	LS
Category	Earthen Levee			GPS Latitude/Longitude	
				Start	End
Item	Slope Stability			38.995300°	38.995467°
				-121.960100°	-121.960396°
DWR ID	DWR_RD0108_01_f_2023_23				
Comment Code					
S1 : Repair slope instability.					
Inspector Comment					
Approximately 150' of sloughing on the landside slope.

View of sloughing on the landside slope. Fall 2023.

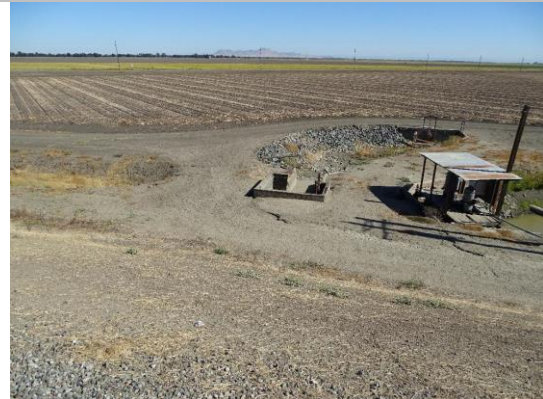
Photo 1 of 3 : UCIP_FA_2023_55933_83271.jpg

DS_ID:17940
FS_ID:55933
EP_NO: 9399
Repair Type: Non-Urgent
EVAL Issue:
Crossing Status: Indicator Found
UCIP Comments: 10/2/2019 Record updated to Non-Urgent.
Geophysical results did not confirm presence of pipe through levee.
Disrupted concrete pile structure observed in riverbank that may belong to this crossing. Grouted 24-inch pipe hole is visible inside of concrete distribution box at the landside toe. Unable to confirm proper abandonment. Updated lat/long. (O.Yakimov - DWR UCIP)
FIELD_STRUCT_DESC: 24-inch steel gravity drainage pipe through the levee, 15 feet below the crown. Pipe is open in a concrete distribution box at the landside (LS) toe. Intake trash rack structure in channel.
(Retention of a 24-inch steel pipe through the levee, 15 feet below the crown, a concrete distribution box, and an intake trash rack authorized under Automatic Board Order (ABO) issued as Permit No. 9399, 1974 - Aileen B. Armstrong, Trustee, care of O. M. Durst Jr.). [Additional Reference(s): DWR Levee Log, 1991, (HLM 18.67). USACE Sacramento O&M Manual 132, October 1959, (HLM 18.55)].

View of LS looking from levee crown

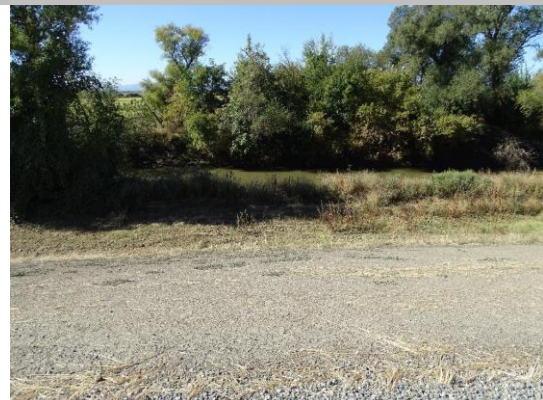
Photo 2 of 3 : UCIP_FA_2023_55933_83272.jpg

View of WS looking from levee crown

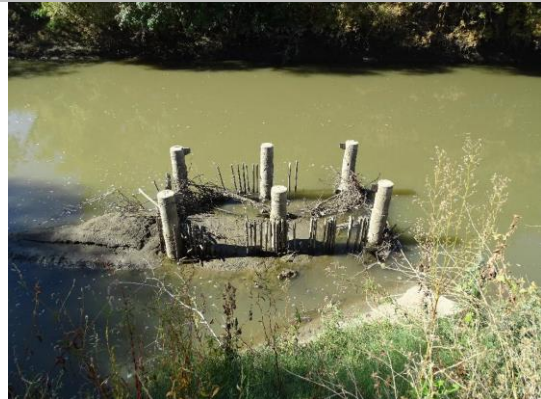
Photo 3 of 3 : UCIP_FA_2023_55933_83270.jpg

Ruined intake trash rack structure in channel

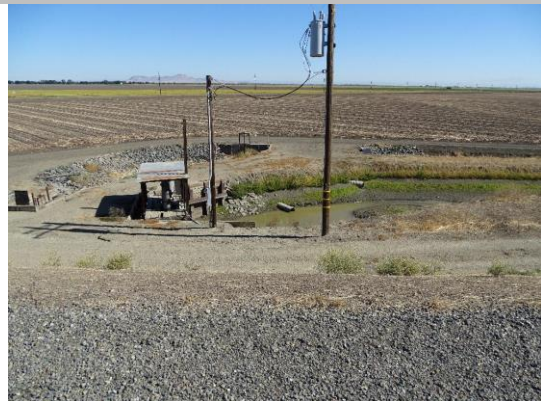
Photo 1 of 3 : UCIP_FA_2023_55932_83441.jpg

DS_ID:18659
 FS_ID:55932
 EP_NO: N/A
 Repair Type: Non-Urgent
 EVAL Issue:
 Crossing Status: Indicator Found
 UCIP Comments: 10/2/2019 Record updated to Non-Urgent. No permit has been identified authorizing pipe. Disrupted concrete pile structure observed in riverbank that may belong to this crossing. Grouted 18-inch pipe hole is visible inside of concrete distribution box at the landside toe. Unable to confirm proper abandonment. Coordinates updated. (O.Yakimov - DWR UCIP)
 FIELD_STRUCT_DESC: 18-inch corrugated metal gravity drainage pipe through the levee, invert elevation 27.4 feet. Pipe hole immured at the landward toe in concrete distribution box. Ruined intake trash rack structure in channel. [Additional Reference(s): USACE Sacramento O&M Manual 132, October 1959, (HLM 18.55)].
 FS Date: 10/2/2019 11:08:25 AM

LS view looking from levee crown

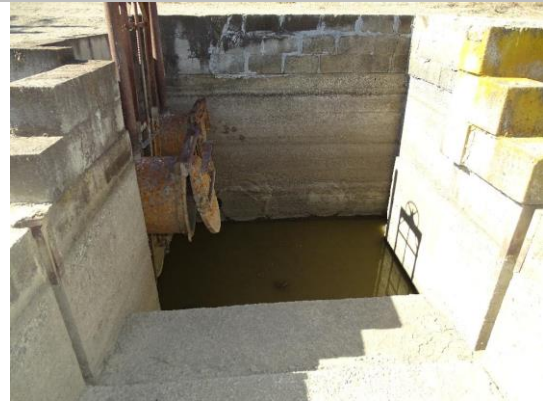
Photo 2 of 3 : UCIP_FA_2023_55932_83442.jpg

View inside of concrete box on LS

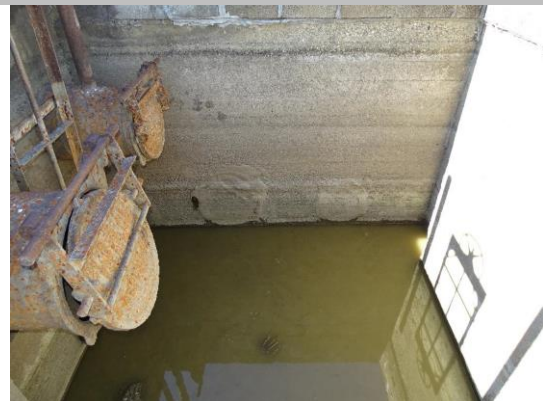
Photo 3 of 3 : UCIP_FA_2023_55932_83440.jpg

Grouted holes of 2 pipes towards levee in concrete box on LS

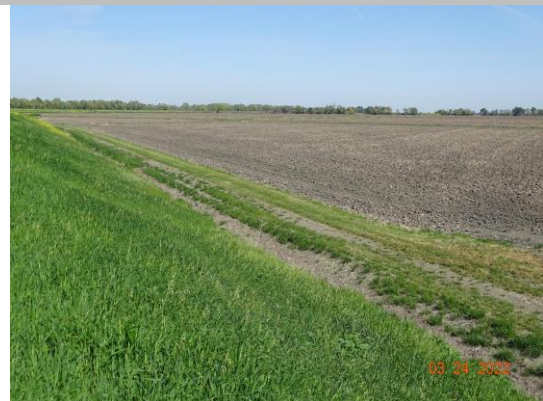
Photo 1 of 1 : FA_2023_RD0108_203_6_20230907_00001.jpg

LM Start	18.92	Rating **	M	Issue No.	6
LM End	19.28	Issue Type +	En	Location *	LS
Category	Earthen Levee			GPS Latitude/Longitude	
				Start	End
Item	Encroachments			39.013160 °	39.017000 °
				-121.980808 °	-121.985364 °
DWR ID	DWR_RD0108_01_s_2012_6				
Comment Code					
DT : Ditch					
Inspector Comment					
A ditch is located at the toe of the levee.

View of ditch at the landside toe. Spring 2022.

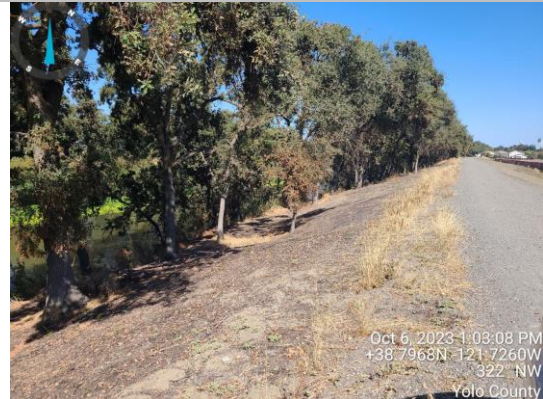
Photo 1 of 1 : FA_2023_RD0108_590_1_20231010_00001.jpg

View of the well maintained waterside slope. Fall 2023.
