Flood Control Project Maintenance Levee Inspections

Fall 2024 Levee Maintenance Deficiency Summary Report

Sacramento River Basin

Reclamation District No. 0108 River Farms

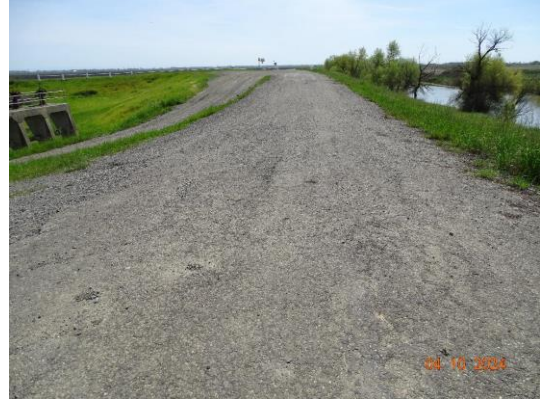
Photo 1 of 3 : UCIP_FA_2024_83766_122940.jpg

LM Start	0.06	Rating **	M	Issue No.	25	
LM End	0.06	Issue Type +	Ma	Location *		
Category	Supplemental			GPS Latitude/Longitude		
				Start	End	
Item	DWR UCIP LMA Responsibility			38.822897 °	38.822897 °	
				-121.797000 °	-121.797000 °	
DWR ID	17943

Comment Code						
Inspector Comment						
DS_ID:17943 FS_ID:83766 EP_NO: 9736 Repair Type: Non-Urgent EVAL Issue: Crossing Status: Found UCIP Comments: 04/10/2024 Record remains Non-Urgent. Crossing appears abandoned. Slide gates at waterside toe buried in soil. DMP internal video inspection has found none or minor pipe defects. (O. Yakimov - DWR UCIP) 10/02/2019 Record remains Non-Urgent. In 2019 RD 108 took an attempt to bring structure to operable condition. Although this attempt was unsuccessful District will review other options. In the meantime crossing considered abandoned. Need to have CVFPB review ABO and determine current owner. (O.Yakimov - DWR UCIP) 06/10/2014 Need to contact owner to determine status of structure. Notes indicate crossing has been abandoned. Owner will need to coordinate with CVFPB and DWR inspector to determine how to properly abandon. (O.Magana - DWR UCIP) FIELD_STRUCT_DESC: 1 of 5: 72-inch reinforced concrete gravity drainage pipe or culvert through the levee, 31.6 feet below the crown. Slide gate on each end. (Five 72-inch pipes through the levee [HLM 0.08] authorized under Automatic Board Order (ABO) issued as Permit No. 9736, 1974 - Reclamation District No. 108 [RD0108]). [Additional Reference(s): DWR Levee Log, 1991 (HLM 0.08). USACE Sacramento O&M Manual, Unit 132, October 1959, Revised 28 July 2022, (HLM 0.08), listed as five 6-foot by 8-foot concrete culvert drains. USACE As-Built Drawing No. 50-04-3073, December 1956, Sheet 5, upstream of STA 234+00, listed as five 6-foot by 8-foot concrete box culverts]. FS Date: 4/10/2024 8:41:21 AM

Top of Levee: View of levee crown looking downstream

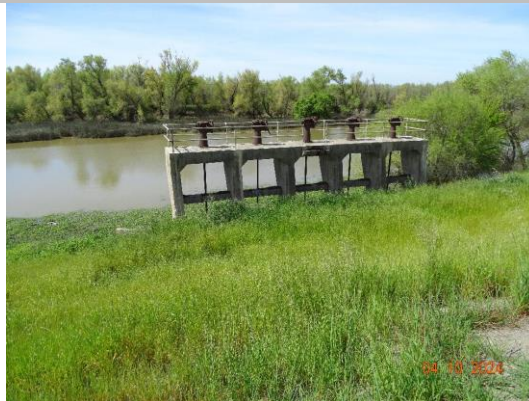
Photo 2 of 3 : UCIP_FA_2024_83766_122941.jpg

Water-Side: View of levee slope looking from crown. Slide gates at riverbank

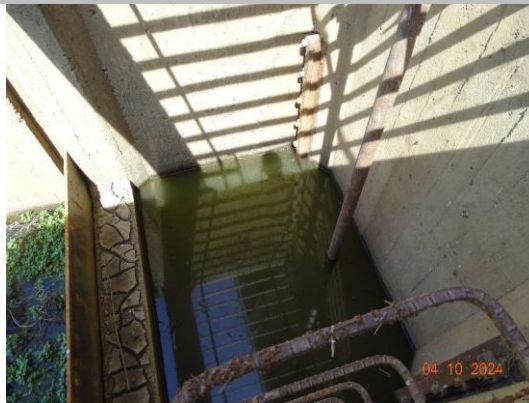
Photo 3 of 3 : UCIP_FA_2024_83766_122939.jpg

Water-Side: View inside of the bay at slide gate structure at riverbank

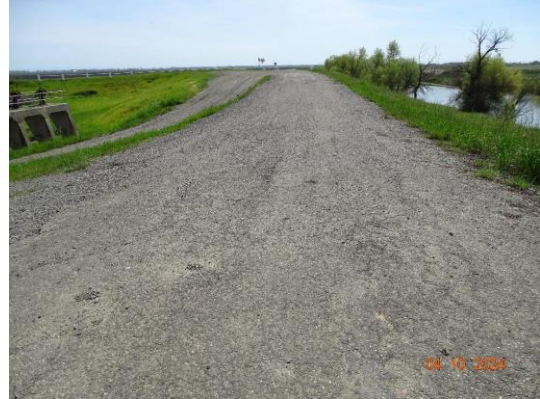
Photo 1 of 3 : UCIP_FA_2024_83765_122935.jpg

LM Start	0.06	Rating **	M	Issue No.	26	
LM End	0.06	Issue Type +	Ma	Location *		
Category	Supplemental			GPS Latitude/Longitude		
				Start	End	
Item	DWR UCIP LMA Responsibility			38.822919 °	38.822919 °	
				-121.797046 °	-121.797046 °	
DWR ID	22386

Comment Code						
Inspector Comment						
DS_ID:22386 FS_ID:83765 EP_NO: 9396 Repair Type: Non-Urgent EVAL Issue: Crossing Status: Found UCIP Comments: 04/10/2024 Record remains Non-Urgent. Crossing appears abandoned. Slide gates at waterside toe buried in soil. (O. Yakimov - DWR UCIP) 10/02/2019 Record remains Non-Urgent. In 2019 RD 108 took an attempt to bring structure to operable condition. Although this attempt was unsuccessful District will review other options. In the meantime crossing considered abandoned. Need to have CVFPB review ABO and determine current owner. (O.Yakimov - DWR UCIP) 06/10/2014 Need to contact owner to determine status of structure. Notes indicate crossing has been abandoned. Owner will need to coordinate with CVFPB and DWR inspector to determine how to properly abandon. (O.Magana - DWR UCIP) FIELD_STRUCT_DESC: 2 of 5: 72-inch reinforced concrete gravity drainage pipe or culvert through the levee, 31.6 feet below the crown. Slide gate on each end. (Five 72-inch pipes through the levee [HLM 0.08] authorized under Automatic Board Order (ABO) issued as Permit No. 9736, 1974 - Reclamation District No. 108 [RD0108]). [Additional Reference(s): DWR Levee Log, 1991 (HLM 0.08). USACE Sacramento O&M Manual, Unit 132, October 1959, Revised 28 July 2022, (HLM 0.08), listed as five 6-foot by 8-foot concrete culvert drains. USACE As-Built Drawing No. 50-04-3073, December 1956, Sheet 5, upstream of STA 234+00, listed as five 6-foot by 8-foot concrete box culverts]. FS Date: 4/10/2024 8:40:26 AM

Top of Levee: View of levee crown looking downstream

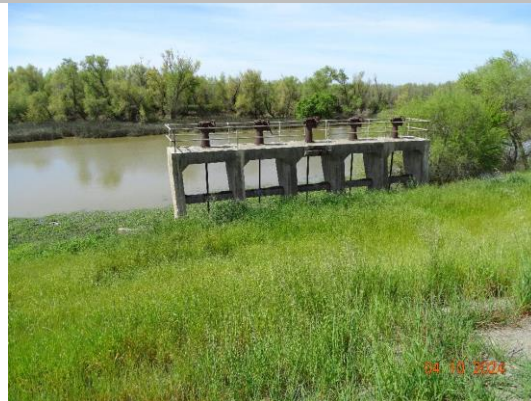
Photo 2 of 3 : UCIP_FA_2024_83765_122930.jpg

Water-Side: View of levee slope looking from crown. Slide gates at riverbank

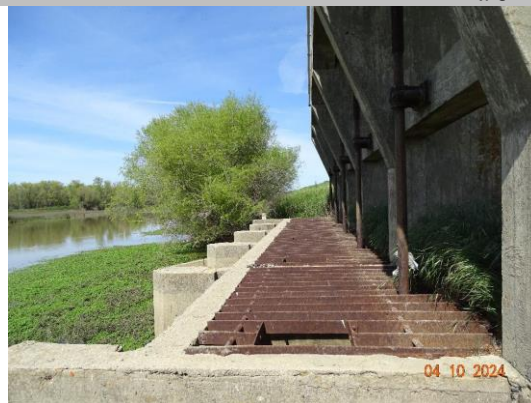
Photo 3 of 3 : UCIP_FA_2024_83765_122934.jpg

Water-Side: Slide gate structure at riverbank

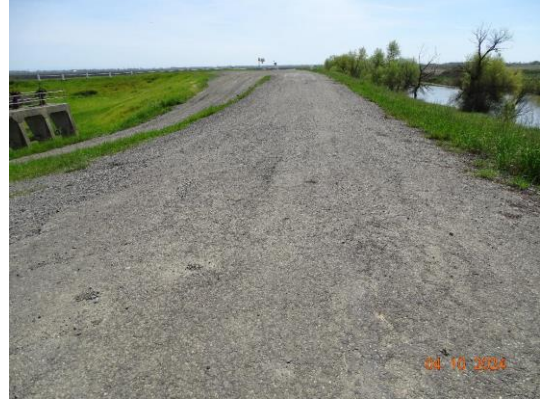
Photo 1 of 3 : UCIP_FA_2024_83764_122929.jpg

LM Start	0.06	Rating **	M	Issue No.	27	
LM End	0.06	Issue Type +	Ma	Location *		
Category	Supplemental			GPS Latitude/Longitude		
				Start	End	
Item	DWR UCIP LMA Responsibility			38.822933 °	38.822933 °	
				-121.797081 °	-121.797081 °	
DWR ID	22387

Comment Code						
Inspector Comment						
DS_ID:22387 FS_ID:83764 EP_NO: 9396 Repair Type: Non-Urgent EVAL Issue: Crossing Status: Found UCIP Comments: 04/10/2024 Record remains Non-Urgent. Crossing appears abandoned. Slide gates at waterside toe buried in soil. (O. Yakimov - DWR UCIP) 10/02/2019 Record remains Non-Urgent. In 2019 RD 108 took an attempt to bring structure to operable condition. Although This attempt was unsuccessful District will review other options. In the meantime crossing considered abandoned. Need to have CVFPB review ABO and determine current owner. (O.Yakimov - DWR UCIP) 06/10/2014 Need to contact owner to determine status of structure. Notes indicate crossing has been abandoned. Owner will need to coordinate with CVFPB and DWR inspector to determine how to properly abandon. (O.Magana - DWR UCIP) FIELD_STRUCT_DESC: 3 of 5: 72-inch reinforced concrete gravity drainage pipe or culvert through the levee, 31.6 feet below the crown. Slide gate on each end. (Five 72-inch pipes through the levee [HLM 0.08] authorized under Automatic Board Order (ABO) issued as Permit No. 9736, 1974 - Reclamation District No. 108 [RD0108]). [Additional Reference(s): DWR Levee Log, 1991 (HLM 0.08). USACE Sacramento O&M Manual, Unit 132, October 1959, Revised 28 July 2022, (HLM 0.08), listed as five 6-foot by 8-foot concrete culvert drains. USACE As-Built Drawing No. 50-04-3073, December 1956, Sheet 5, upstream of STA 234+00, listed as five 6-foot by 8-foot concrete box culverts]. FS Date: 4/10/2024 8:38:26 AM

Top of Levee: View of levee crown looking downstream

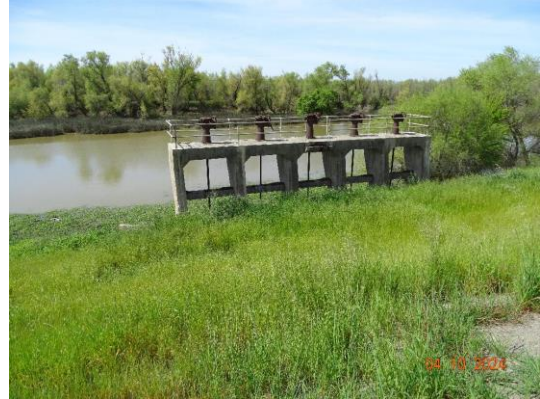
Photo 2 of 3 : UCIP_FA_2024_83764_122925.jpg

Water-Side: View of levee slope looking from crown. Slide gates at riverbank

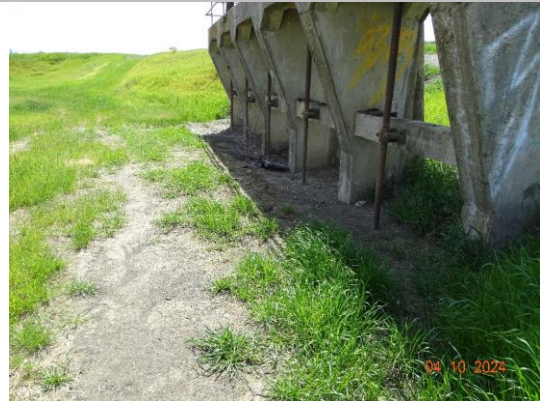
Photo 3 of 3 : UCIP_FA_2024_83764_122927.jpg

Land-Side: View of slide gates buried in soil at levee toe

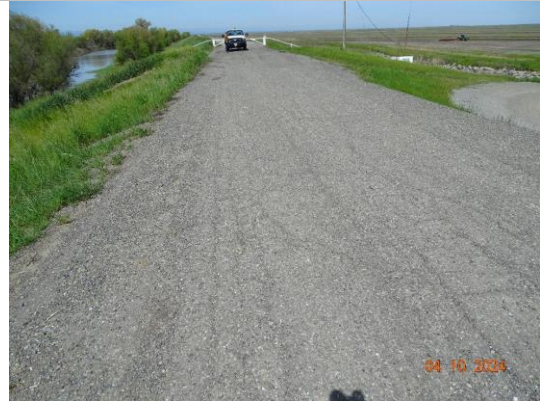
Photo 1 of 3 : UCIP_FA_2024_83763_122922.jpg

LM Start	0.06	Rating **	M	Issue No.	28
LM End	0.06	Issue Type +	Ma	Location *	
Category	Supplemental			GPS Latitude/Longitude	
				Start	End
Item	DWR UCIP LMA Responsibility			38.822943 °	38.822943 °
				-121.797110 °	-121.797110 °
DWR ID	22388

Comment Code					
Inspector Comment					
DS_ID:22388 FS_ID:83763 EP_NO: 9396 Repair Type: Non-Urgent EVAL Issue: Crossing Status: Found UCIP Comments: 04/10/2024 Record remains Non-Urgent. Crossing appears abandoned. Slide gates at waterside toe buried in soil. (O. Yakimov - DWR UCIP) 10/02/2019 Record remains Non-Urgent. In 2019 RD 108 took an attempt to bring structure to operable condition. Although this attempt was unsuccessful District will review other options. In the meantime crossing considered abandoned. Need to have CVFPB review ABO and determine current owner. (O.Yakimov - DWR UCIP) 06/10/2014 Need to contact owner to determine status of structure. Notes indicate crossing has been abandoned. Owner will need to coordinate with CVFPB and DWR inspector to determine how to properly abandon. (O.Magana - DWR UCIP) FIELD_STRUCT_DESC: 4 of 5: 72-inch reinforced concrete gravity drainage pipe or culvert through the levee, 31.6 feet below the crown. Slide gate on each end. (Five 72-inch pipes through the levee [HLM 0.08] authorized under Automatic Board Order (ABO) issued as Permit No. 9736, 1974 - Reclamation District No. 108 [RD0108]). [Additional Reference(s): DWR Levee Log, 1991 (HLM 0.08). USACE Sacramento O&M Manual, Unit 132, October 1959, Revised 28 July 2022, (HLM 0.08), listed as five 6-foot by 8-foot concrete culvert drains. USACE As-Built Drawing No. 50-04-3073, December 1956, Sheet 5, upstream of STA 234+00, listed as five 6-foot by 8-foot concrete box culverts]. FS Date: 4/10/2024 8:37:03 AM

Top of Levee: View of levee crown looking upstream

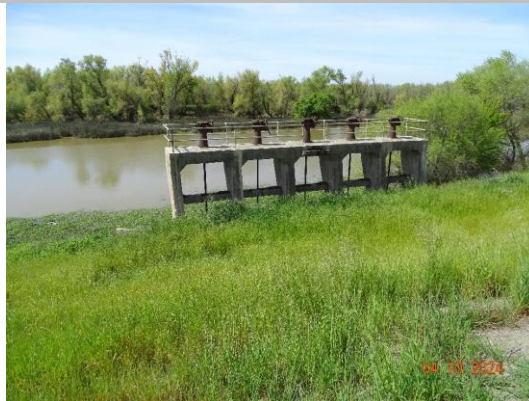
Photo 2 of 3 : UCIP_FA_2024_83763_122921.jpg

Water-Side: View of levee slope looking from crown. Slide gates at riverbank

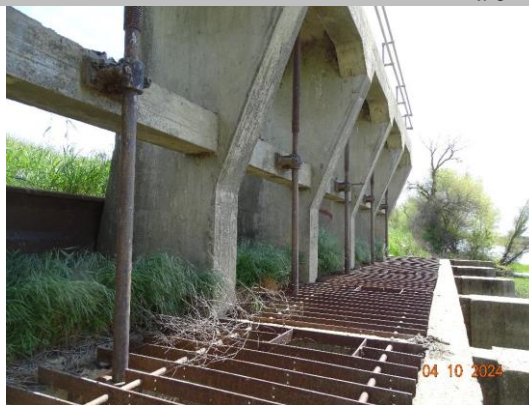
Photo 3 of 3 : UCIP_FA_2024_83763_122920.jpg

Water-Side: Slide gate structure at riverbank

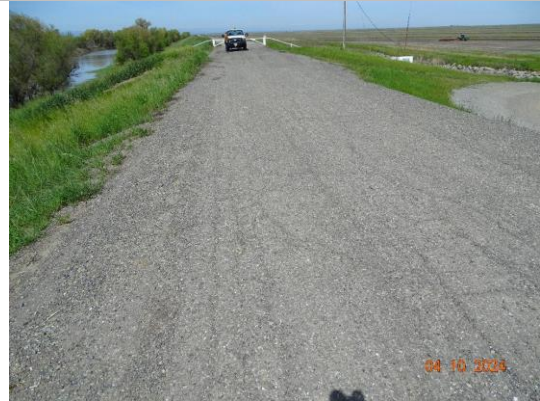
Photo 1 of 3 : UCIP_FA_2024_83762_122917.jpg

LM Start	0.07	Rating **	M	Issue No.	29	
LM End	0.07	Issue Type +	Ma	Location *		
Category	Supplemental			GPS Latitude/Longitude		
				Start	End	
Item	DWR UCIP LMA Responsibility			38.822954 °	38.822954 °	
				-121.797135 °	-121.797135 °	
DWR ID	22389

Comment Code						
Inspector Comment						
DS_ID:22389 FS_ID:83762 EP_NO: 9396 Repair Type: Non-Urgent EVAL Issue: Crossing Status: Found UCIP Comments: 04/10/2024 Record remains Non-Urgent. Crossing appears abandoned. Slide gates at waterside toe buried in soil. (O. Yakimov - DWR UCIP) 10/02/2019 Record remains Non-Urgent. In 2019 RD 108 took an attempt to bring structure to operable condition. Although this attempt was unsuccessful District will review other options. In the meantime crossing considered abandoned. Need to have CVFPB review ABO and determine current owner. (O.Yakimov - DWR UCIP) 06/10/2014 Need to contact owner to determine status of structure. Notes indicate crossing has been abandoned. Owner will need to coordinate with CVFPB and DWR inspector to determine how to properly abandon. (O.Magana - DWR UCIP) FIELD_STRUCT_DESC: 5 of 5: 72-inch reinforced concrete gravity drainage pipe or culvert through the levee, 31.6 feet below the crown. Slide gate on each end. (Five 72-inch pipes through the levee [HLM 0.08] authorized under Automatic Board Order (ABO) issued as Permit No. 9736, 1974 - Reclamation District No. 108 [RD0108]). [Additional Reference(s): DWR Levee Log, 1991 (HLM 0.08). USACE Sacramento O&M Manual, Unit 132, October 1959, Revised 28 July 2022, (HLM 0.08), listed as five 6-foot by 8-foot concrete culvert drains. USACE As-Built Drawing No. 50-04-3073, December 1956, Sheet 5, upstream of STA 234+00, listed as five 6-foot by 8-foot concrete box culverts]. FS Date: 4/10/2024 8:34:06 AM

Top of Levee: View of levee crown looking upstream

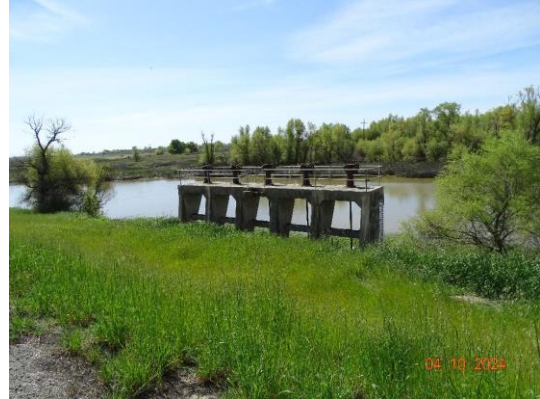
Photo 2 of 3 : UCIP_FA_2024_83762_122916.jpg

Water-Side: View of levee slope looking from crown. Slide gates at riverbank

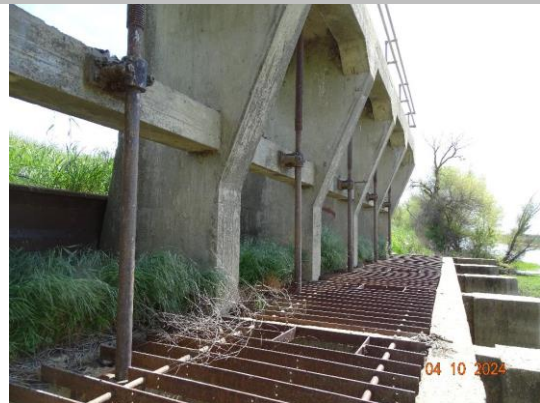
Photo 3 of 3 : UCIP_FA_2024_83762_122914.jpg

Water-Side: Slide gate structure at riverbank

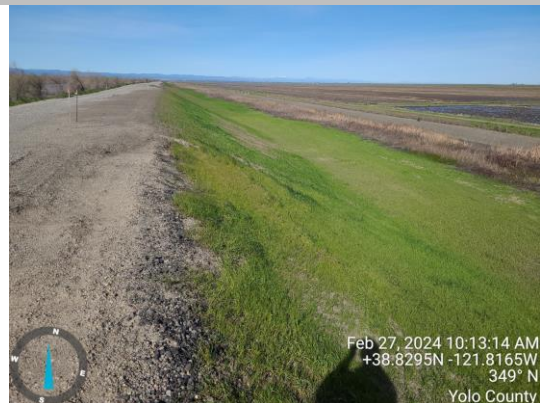
Photo 1 of 1 : FA_2024_RD0108_203_12_20240909_00002.jpg

LM Start	1.21	Rating **	A/W	Issue No.	12
LM End	1.24	Issue Type +	Ma	Location *	LS
Category	Earthen Levee			GPS Latitude/Longitude	
				Start	End
Item	Slope Stability			38.829411 °	38.829582 °
				-121.816712 °	-121.817274 °
DWR ID	DWR_RD0108_01_s _ 2023_12				
Comment Code					
S1 : Repair slope instability.					
Inspector Comment					
150' of sloughing on the landside slope with approximately 3ft of vertical scarp at worst section. District installed a temporary repair. USACE will complete a permanent repair.

View of temporary sloughing repair on the landside slope. Spring 2024.

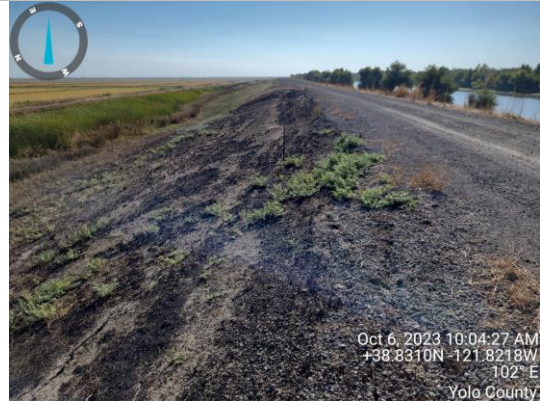
Photo 1 of 1 : FA_2024_RD0108_203_17_20240909_00006.jpg

LM Start	1.49	Rating **	M	Issue No.	17
LM End	1.51	Issue Type +	Ma	Location *	LS
Category	Earthen Levee			GPS Latitude/Longitude	
				Start	End
Item	Slope Stability			38.830951°	38.831043°
				-121.821574°	-121.821847°
DWR ID	DWR_RD0108_01_f_2022_17				
Comment Code					
S1 : Repair slope instability.					
Inspector Comment					
There appears to be a 150' sloughing section that is a result of February 2019 storms. This site will be repaired by the USACE under PL84-99. There are minor new cracks forming adjacent to the sloughing.

View of sloughing on the landside slope. Fall 2023.

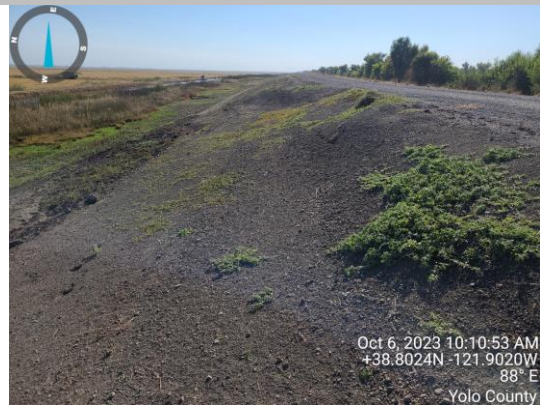
Photo 1 of 1 : FA_2024_RD0108_203_15_20240909_00004.jpg

LM Start	2.70	Rating **	M	Issue No.	15
LM End	2.73	Issue Type +	Ma	Location *	LS
Category	Earthen Levee			GPS Latitude/Longitude	
				Start	End
Item	Slope Stability			38.837568°	38.837749°
				-121.842218°	-121.842776°
DWR ID	DWR_RD0108_01_s_2019_15				
Comment Code					
S1 : Repair slope instability.					
Inspector Comment					
There appears to be a 150' sloughing section that is a result of February 2019 storms. This site will be repaired by the USACE under PL84-99.

View of sloughing on the landside slope. Fall 2023.

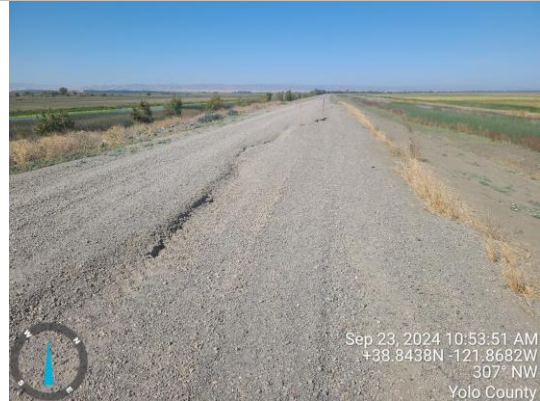
Photo 1 of 1 : FA_2024_RD0108_203_19_20240923_00027.jpg

LM Start	4.16	Rating **	M	Issue No.	19
LM End	4.20	Issue Type +	Ma	Location *	CR
Category	Earthen Levee			GPS Latitude/Longitude	
				Start	End
Item	Cracking			38.843700 °	38.843785 °
				-121.868000 °	-121.868725 °
DWR ID	DWR_RD0108_01_f_2023_19				
Comment Code					
CR2 : Schedule repair of subsidence prior to the next inspection.					
Inspector Comment					
Approximately 200' of deep cracks through the crown and landside shoulder. This will be repaired by the USACE under PL 84-99.

View of cracking on the crown and landside shoulder. Fall 2024.

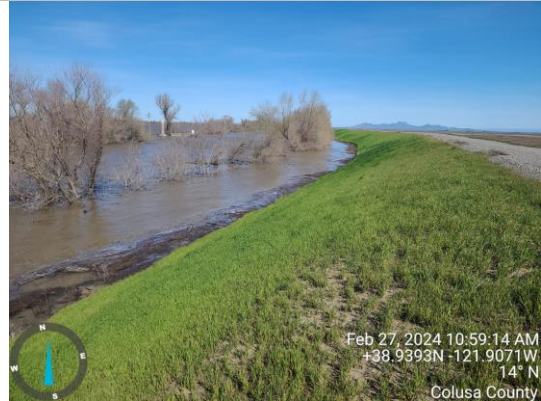
Photo 1 of 1 : FA_2024_RD0108_203_18_20240909_00007.jpg

LM Start	12.26	Rating **	A/W	Issue No.	18
LM End	12.37	Issue Type +	Ma	Location *	WS
Category	Earthen Levee			GPS Latitude/Longitude	
				Start	End
Item	Erosion / Bank Caving			38.939236 °	38.940843 °
				-121.907072 °	-121.906736 °
DWR ID	DWR_RD0108_01_s_2024_18				
Comment Code					
E1 : Note and monitor erosion site.					
Inspector Comment					
Appears to be minor wavewash erosion beginning due to high water. Recommend monitoring.

View of wavewash on the waterside toe. Spring 2024.

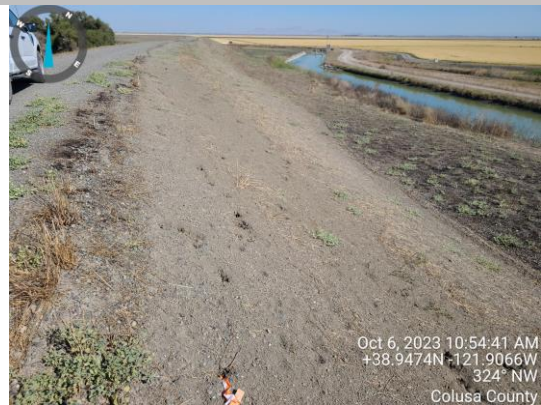
Photo 1 of 1 : FA_2024_RD0108_203_16_20240909_00005.jpg

LM Start	12.82	Rating **	M	Issue No.	16
LM End	12.84	Issue Type +	Ma	Location *	LS
Category	Earthen Levee			GPS Latitude/Longitude	
				Start	End
Item	Slope Stability			38.947400°	38.947675°
				-121.906600°	-121.906793°
DWR ID	DWR_RD0108_01_f_2023_16				
Comment Code					
S1 : Repair slope instability.					
Inspector Comment					
Approximately 100' of sloughing on the landside slope. The repairs will be funded by DWR Emergency Repairs.

View of sloughing on the landside slope. Fall 2023.

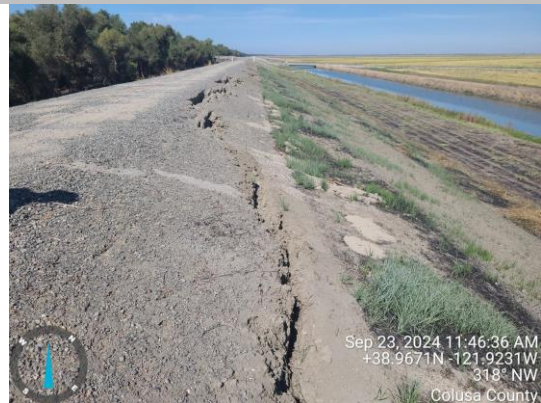
Photo 1 of 1 : FA_2024_RD0108_203_21_20240923_00028.jpg

LM Start	14.48	Rating **	M	Issue No.	21
LM End	14.54	Issue Type +	Ma	Location *	LS
Category	Earthen Levee			GPS Latitude/Longitude	
				Start	End
Item	Slope Stability			38.967107°	38.967716°
				-121.923162°	-121.924020°
DWR ID	DWR_RD0108_01_s_2023_21				
Comment Code					
S1 : Repair slope instability.					
Inspector Comment					
100' of sloughing on the landside shoulder. District installed an envelope over the slough. USACE will repair under PL 84-99.

View of sloughing on the landside shoulder. Fall 2024.

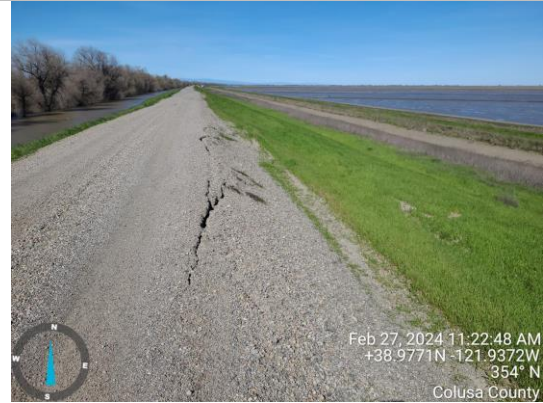
Photo 1 of 1 : FA_2024_RD0108_203_22_20240909_00010.jpg

LM Start	14.54	Rating **	M	Issue No.	22
LM End	15.47	Issue Type +	Ma	Location *	LS
Category	Earthen Levee			GPS Latitude/Longitude	
				Start	End
Item	Slope Stability			38.967757°	38.976745°
				-121.924090°	-121.936790°
DWR ID	DWR_RD0108_01_s_2024_22				
Comment Code					
S1 : Repair slope instability.					
Inspector Comment					
Cracking and sloughing on the landside shoulder and crown.

View of sloughing on the landside shoulder. Spring 2024.

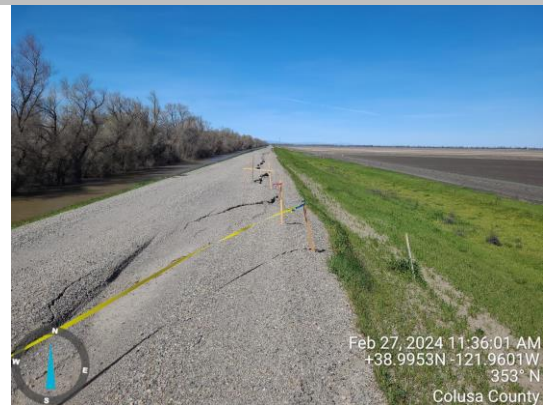
Photo 1 of 1 : FA_2024_RD0108_203_23_20240909_00011.jpg

LM Start	17.26	Rating **	M	Issue No.	23
LM End	17.32	Issue Type +	Ma	Location *	LS
Category	Earthen Levee			GPS Latitude/Longitude	
				Start	End
Item	Slope Stability			38.995300°	38.995889°
				-121.960100°	-121.960894°
DWR ID	DWR_RD0108_01_f_2023_23				
Comment Code					
S1 : Repair slope instability.					
Inspector Comment					
Approximately 300' of sloughing on the landside slope and crown. The repairs will be funded by DWR Emergency Repairs.

View of sloughing on the landside shoulder and crown. Spring 2024.

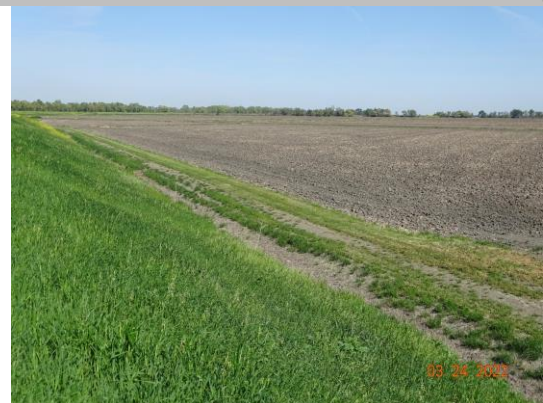
Photo 1 of 1 : FA_2024_RD0108_203_6_20240909_00001.jpg

LM Start	18.92	Rating **	M	Issue No.	6
LM End	19.28	Issue Type +	En	Location *	LS
Category	Earthen Levee			GPS Latitude/Longitude	
				Start	End
Item	Encroachments			39.013160 °	39.017000 °
				-121.980808 °	-121.985364 °
DWR ID	DWR_RD0108_01_s_2012_6				
Comment Code					
DT : Ditch					
Inspector Comment					
A ditch is located at the toe of the levee.

View of ditch at the landside toe. Spring 2022.

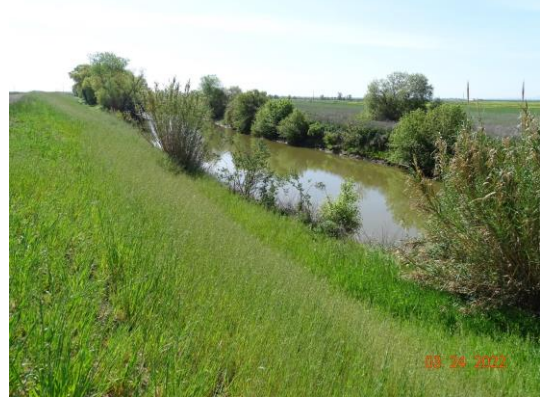
Photo 1 of 1 : FA_2024_RD0108_203_13_20240909_00003.jpg

LM Start	19.27	Rating **	M	Issue No.	13
LM End	19.35	Issue Type +	Ma	Location *	WS
Category	Supplemental			GPS Latitude/Longitude	
				Start	End
Item	2018 USACE Erosion Survey			39.016727 °	39.017516 °
				-121.985411 °	-121.986374 °
DWR ID	DWR_RD0108_01_s _ 2022_13				
Comment Code					
Inspector Comment					
2018 Site ID: CBD 19.2 L					
Status: Eroding					
2018 Field Notes: Last observed in 2011. Access issues prevented inspection in 2017.					
Site History: 2011 - Toe scour at the bottom of a steep bank, large sections of the toe are sliding down. Erosion may be due to the upstream bend.

View of erosion at the waterside toe. Spring 2022.

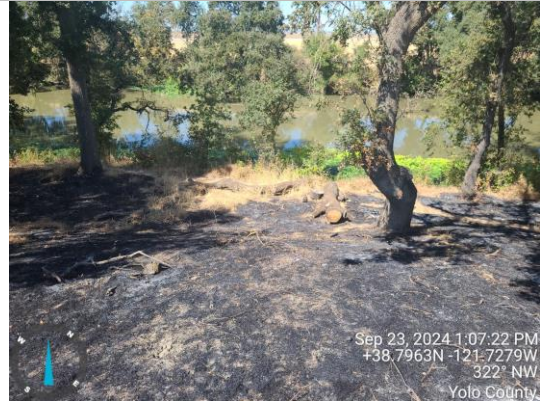
Photo 1 of 1 : FA_2024_RD0108_590_1_20240923_00001.jpg

View of tree limbs on the waterside slope. Fall 2024.

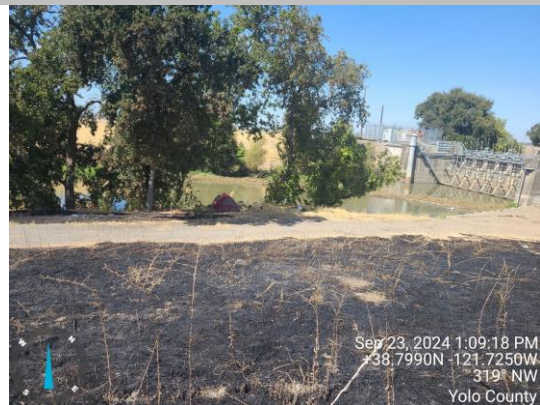
Photo 1 of 1 : FA_2024_RD0108_590_2_20240923_00002.jpg

LM Start	0.25	Rating **	M	Issue No.	2
LM End	0.25	Issue Type +	En	Location *	WS
Category	Earthen Levee			GPS Latitude/Longitude	
				Start	End
Item	Encroachments			38.798818 °	38.798818 °
				-121.724912 °	-121.724912 °
DWR ID	DWR_RD0108_02_f_2024_2				
Comment Code					
CA : Campers					
Inspector Comment					
Campers on the waterside berm.

View of camp site on the waterside berm. Fall 2024.
