**Flood Control Project Maintenance
Levee Inspections**
LMA District Cover Sheet
Spring 2009 Levee Inspection Results

Reclamation District No. 0108

Levee Inspection Report By Mile - Spring 2009

Waterway	Bank	Unit Miles	Inspection Start/End	Inspector
Unit No. 01 Colusa Basin Drain	Left	20.60	04/08/2009 04/08/2009	John Williamson

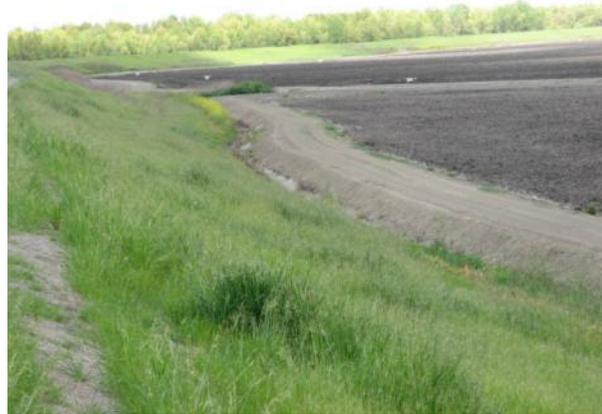
Levee Mile Report Line	11
Start Levee Mile	18.88
End Levee Mile	19.60
Location	Land Side
Category	Earthen Levee
Item	Encroachments
Ag. ditch
