**Flood Control Project Maintenance
Levee Inspections**
LMA District Cover Sheet
Spring 2015 Levee Inspection Results

Reclamation District No. 0108 River Farms

Spring 2015 Levee Inspection Results

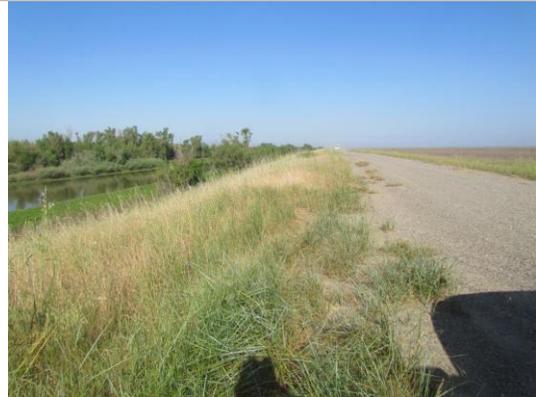
Photo 1 of 1 : SP_2015_RD0108_203_17_20150421_00010.jpg

LM Start	0.09	Rating **	M	Issue No.	17
LM End	18.82	Issue Type +	Ma	Location *	WS
Category	Earthen Levee			GPS Latitude/Longitude	
				Start	End
Item	Vegetation			38.823146 °	39.012007 °
				-121.797630 °	-121.979559 °
DWR ID	DWR_RD0108_01_s_2015_17				
Action/Comments					
Control annual grass and weeds on the levee slopes and easements.

View of the vegetation on the water ward side of the levee looking upstream. Spring 2015.

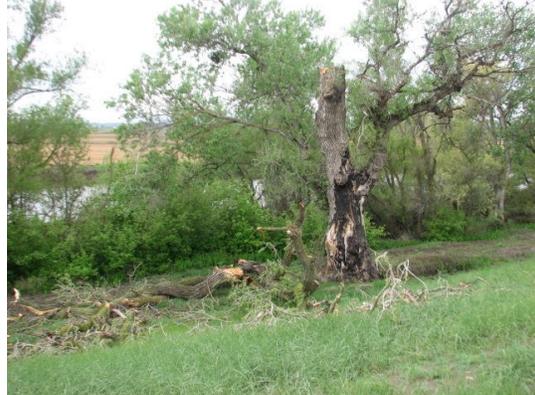
Photo 1 of 1 : SP_2015_RD0108_203_10_20150401_00005.jpg

LM Start	5.19	Rating **	M	Issue No.	10
LM End	5.19	Issue Type +	En	Location *	WS
Category	Earthen Levee		GPS Latitude/Longitude		
			Start	End	
Item	Encroachments		38.846086 °	38.846086 °	
			-121.886834 °	-121.886834 °	
DWR ID	DWR_RD0108_01_s_2014_10				
Action/Comments					
Tree or limb

Tree limbs are along the toe of the levee. Tree is slowly dying and could be a hazard to the levee. Spring 2014

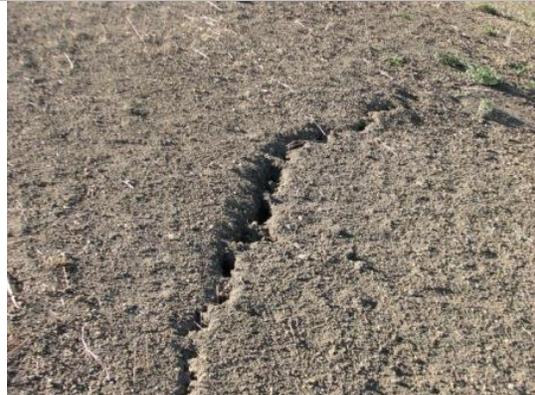
Photo 1 of 2 : SP_2015_RD0108_203_279_20150401_00007.jpg

LM Start	9.29	Rating **	A/W	Issue No.	279
LM End	9.29	Issue Type +	Ma	Location *	WS
Category	Earthen Levee		GPS Latitude/Longitude		
			Start	End	
Item	Slope Stability		38.897452 °	38.897452 °	
			-121.914680 °	-121.914680 °	
DWR ID	DWR_RD0108_01_f_2013_279				
Action/Comments					
Repair slope instability.

The cracking runs in a horseshoe pattern on the levee slope. Fall 2013

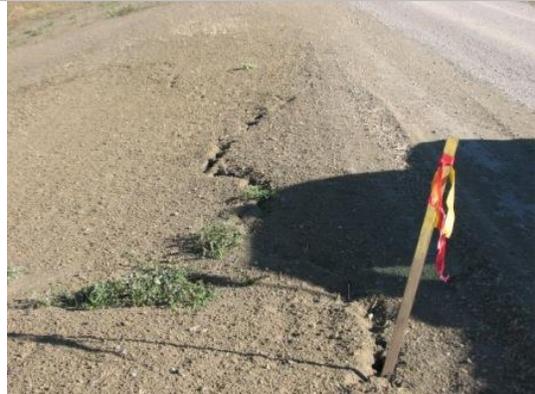
Photo 2 of 2 : SP_2015_RD0108_203_279_20150401_00008.jpg

Slope stability with cracking 1-2 inches open and 12 inches deep. The district is monitoring the site. Fall 2013

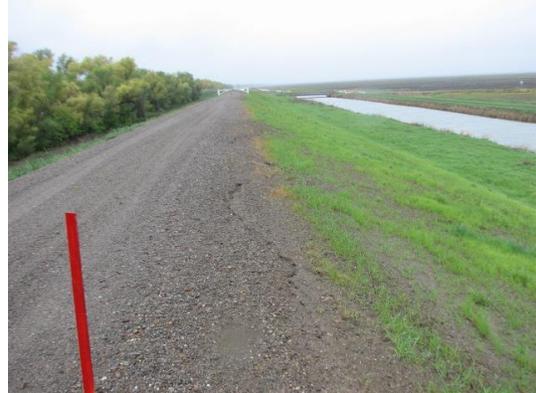
Photo 1 of 1 : SP_2015_RD0108_203_12_20150401_00006.jpg

LM Start	14.49	Rating **	M	Issue No.	12
LM End	14.49	Issue Type +	Ma	Location *	LS
Category	Earthen Levee			GPS Latitude/Longitude	
				Start	End
Item	Cracking			38.967243 °	38.967243 °
				-121.923407 °	-121.923407 °
DWR ID	DWR_RD0108_01_s_2014_12				
Action/Comments					
Schedule repair of subsidence prior to the next inspection.

Cracking along the shoulder of the crown. Some slope instability has occurred. Spring 2014

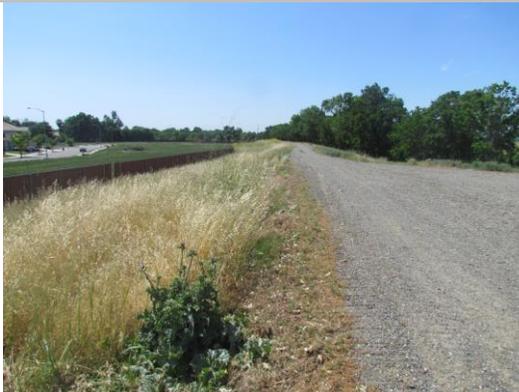
Photo 1 of 1 : SP_2015_RD0108_590_1_20150421_00003.jpg

LM Start	0.09	Rating **	M	Issue No.	1
LM End	0.28	Issue Type +	Ma	Location *	LS
Category	Earthen Levee		GPS Latitude/Longitude		
			Start	End	
Item	Vegetation		38.797091 °	38.799138 °	
			-121.726729 °	-121.724456 °	
DWR ID	DWR_RD0108_02_s_2015_1				
Action/Comments					
Control annual grass and weeds on the levee slopes and easements.

View of the vegetation on the landward side of the levee looking downstream. Spring 2015.

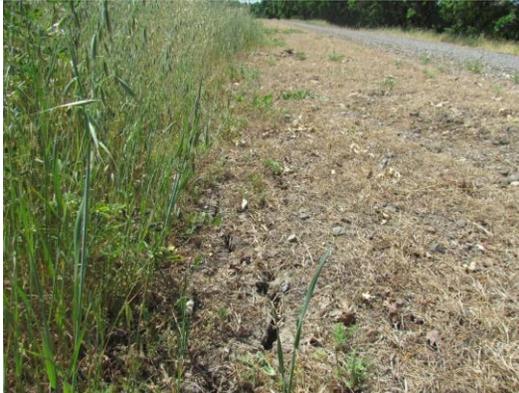
Photo 1 of 1 : SP_2015_RD0108_590_5_20150421_00004.jpg

LM Start	0.17	Rating **	A/W	Issue No.	5
LM End	0.17	Issue Type +	Ma	Location *	LS
Category	Earthen Levee		GPS Latitude/Longitude		
			Start	End	
Item	Cracking		38.797922 °	38.797922 °	
			-121.725865 °	-121.725865 °	
DWR ID	DWR_RD0108_02_s_2015_5				
Action/Comments					
Monitor and have inspected by geotechnical engineer.

View of the crack on the landward side of the levee looking downstream. Spring 2015.

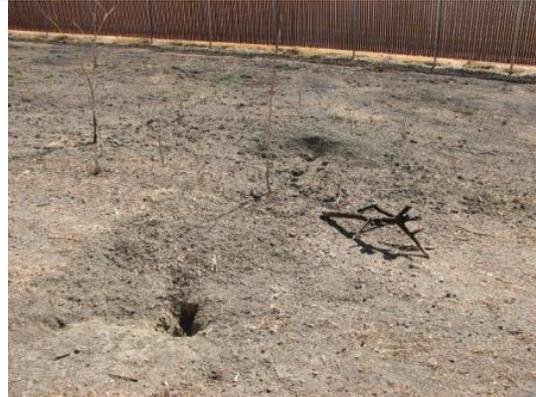
Photo 1 of 1 : SP_2015_RD0108_590_4_20150401_00002.jpg

LM Start	0.19	Rating **	A/W	Issue No.	4
LM End	0.19	Issue Type +	Ob	Location *	LS
Category	Earthen Levee			GPS Latitude/Longitude	
				Start	End
Item	Animal Control			38.798196 °	38.798196 °
				-121.725660 °	-121.725660 °
DWR ID	DWR_RD0108_02_f_2012_4				
Action/Comments					
No rodents visible, but rodent burrows visible; need to backfill and compact or grout burrows.

A couple of rodent holes on the landside slope. Fall 2012

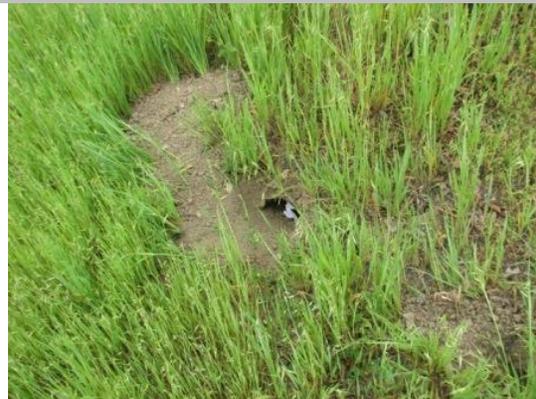
Photo 1 of 1 : SP_2015_RD0108_590_3_20150401_00001.jpg

LM Start	0.27	Rating **	A/W	Issue No.	3
LM End	0.27	Issue Type +	Ob	Location *	LS
Category	Earthen Levee			GPS Latitude/Longitude	
				Start	End
Item	Animal Control			38.798992 °	38.798992 °
				-121.724643 °	-121.724643 °
DWR ID	DWR_RD0108_02_s_2013_3				
Action/Comments					
No rodents visible, but rodent burrows visible; need to backfill and compact or grout burrows.

No rodents but holes need to be backfilled. Spring 2013
