**Flood Control Project Maintenance
Levee Inspections**
LMA District Cover Sheet
Spring 2016 Levee Inspection Results

Reclamation District No. 0108 River Farms

Levee Inspection Report By Mile - Spring 2016

Waterway	Bank	Unit Miles	Inspection Start/End	Inspector
Unit No. 01 Colusa Basin Drain	Left	20.64	04/06/2016 04/06/2016	Jai Lor

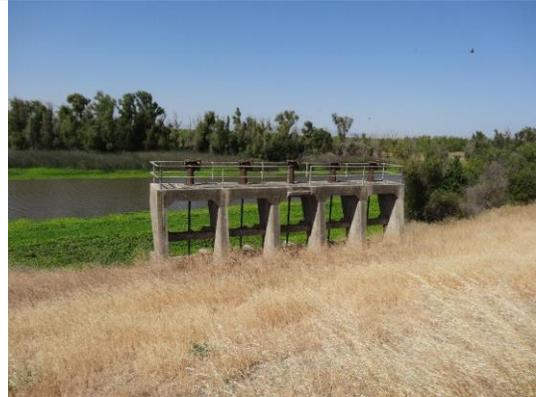
Photo 2 of 2 : UCIP_SP_2016_37608_68210.jpg

LM Start	0.06	Rating **	M	Issue No.	281 (cont)
LM End	0.06	Issue Type +	En	Location *	WS
Category	Supplemental			GPS Latitude/Longitude	
				Start	End
Item	DWR UCIP Field Study			38.822897 °	38.822897 °
				-121.797000 °	-121.797000 °
DWR ID					
Comment Code					
Inspector Comment					
FS_ID:37608 DS_ID:17943 EP_NO: 9396 Repair Type: Non-Urgent Crossing Status: Found UCIP Comments: Need to contact owner to determine status of structure. Notes indicate crossing has been abandoned. Owner will need to coordinate with CVFPB and DWR inspector to determine how to properly abandon. FIELD_STRUCT_DESC: 1 of 5. Five 72-inch abandoned pipes or culvert through levee 31.6 feet below crown. Slide gates on both ends. (App. 9736-RD 108) Ramp on landward slope. (App.9396-RD). O&M Manual SAC 132; October 1959 FS Date: 6/10/2014

Dense vegetation on waterward side.

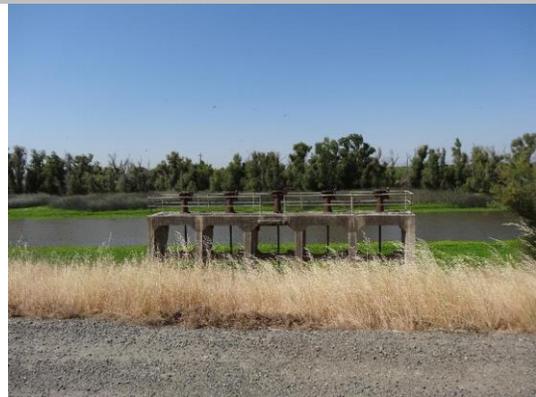
Photo 1 of 2 : UCIP_SP_2016_37609_68211.jpg

LM Start	0.06	Rating **	M	Issue No.	282
LM End	0.06	Issue Type +	En	Location *	WS
Category	Supplemental			GPS Latitude/Longitude	
				Start	End
Item	DWR UCIP Field Study			38.822919 °	38.822919 °
				-121.797046 °	-121.797046 °
DWR ID					
Comment Code					
Inspector Comment					
FS_ID:37609 DS_ID:22386 EP_NO: 9396 Repair Type: Non-Urgent Crossing Status: Found UCIP Comments: Need to contact owner to determine status of structure. Notes indicate crossing has been abandoned. Owner will need to coordinate with CVFPB and DWR inspector to determine how to properly abandon. FIELD_STRUCT_DESC: 2 of 5. Five 72-inch abandoned pipes or culvert through levee 31.6 feet below crown. Slide gates on both ends. (App. 9736-RD 108) Ramp on landward slope. (App.9396-RD). O&M Manual SAC 132; October 1959 FS Date: 6/10/2014

Concrete structure located on waterward side.

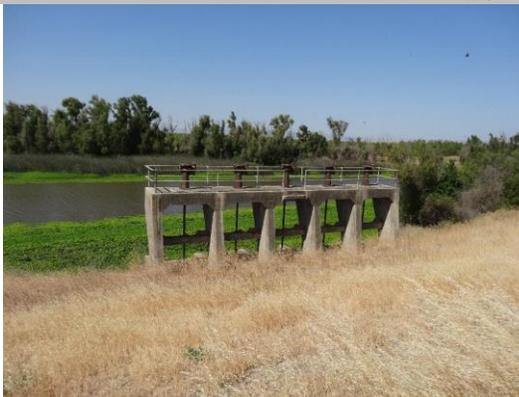
Photo 2 of 2 : UCIP_SP_2016_37611_68224.jpg

LM Start	0.06	Rating **	M	Issue No.	284 (cont)
LM End	0.06	Issue Type +	En	Location *	WS
Category	Supplemental			GPS Latitude/Longitude	
				Start	End
Item	DWR UCIP Field Study			38.822897 °	38.822897 °
				-121.797000 °	-121.797000 °
DWR ID					
Comment Code					
Inspector Comment					
FS_ID:37611 DS_ID:22388 EP_NO: 9396 Repair Type: Non-Urgent Crossing Status: Found UCIP Comments: Need to contact owner to determine status of structure. Notes indicate crossing has been abandoned. Owner will need to coordinate with CVFPB and DWR inspector to determine how to properly abandon. FIELD_STRUCT_DESC: 4 of 5. Five 72-inch abandoned pipes or culvert through levee 31.6 feet below crown. Slide gates on both ends. (App. 9736-RD 108) Ramp on landward slope. (App.9396-RD). O&M Manual SAC 132; October 1959 FS Date: 6/10/2014

Waterward slope covered by dense vegetation.

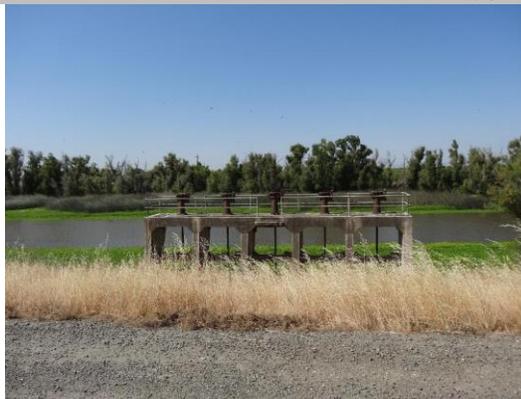
Photo 1 of 2 : UCIP_SP_2016_37607_68203.jpg

LM Start	0.07	Rating **	M	Issue No.	280
LM End	0.07	Issue Type +	En	Location *	LS
Category	Supplemental			GPS Latitude/Longitude	
				Start	End
Item	DWR UCIP Field Study			38.822954 °	38.822954 °
				-121.797135 °	-121.797135 °
DWR ID					
Comment Code					
Inspector Comment					
FS_ID:37607 DS_ID:22389 EP_NO: 9396 Repair Type: Non-Urgent Crossing Status: Found UCIP Comments: Need to contact owner to determine status of structure. Notes indicate crossing has been abandoned. Owner will need to coordinate with CVFPB and DWR inspector to determine how to properly abandon. FIELD_STRUCT_DESC: 5 of 5. Five 72-inch abandoned pipes or culvert through levee 31.6 feet below crown. Slide gates on both ends. (App. 9736-RD 108) Ramp on landward slope. (App.9396-RD). O&M Manual SAC 132; October 1959 FS Date: 6/10/2014

Concrete structure located on waterward side.

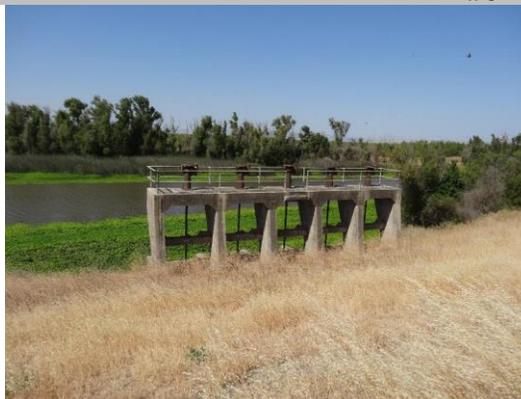
Photo 2 of 2 : UCIP_SP_2016_37607_68206.jpg

Waterward slope covered by dense vegetation.

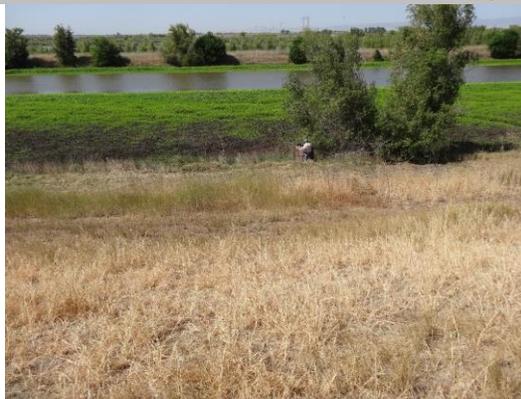
Photo 1 of 2 : UCIP_SP_2016_39707_71682.jpg

LM Start	2.91	Rating **	M	Issue No.	286
LM End	2.91	Issue Type +	En	Location *	LS
Category	Supplemental			GPS Latitude/Longitude	
				Start	End
Item	DWR UCIP Field Study			38.838696 °	38.838696 °
				-121.845843 °	-121.845843 °
DWR ID

Comment Code					
Inspector Comment					
FS_ID:39707 DS_ID:24875 EP_NO: N/A Repair Type: Non-Urgent Crossing Status: Indicator Found UCIP Comments: No signs of pipe visible--need to contact owner to obtain permit number authorizing work. If crossing is no longer used by owner, the owner will need to coordinate with DWR Inspector and CVFPB to remove crossing according to Title 23 requirements. Dense vegetation limits the inspector's visibility to identify signs of pipe failure (leaks) along the slope. Recommend removing vegetation along pipe alignment to conduct proper inspection of structure. FIELD_STRUCT_DESC: Corrugated Metal (CM) pipe riser located on waterward side. Riser is filled with trash and deris. Unable to determine if crossing exists at this location. FS Date: 3/18/2014

View of waterward side.

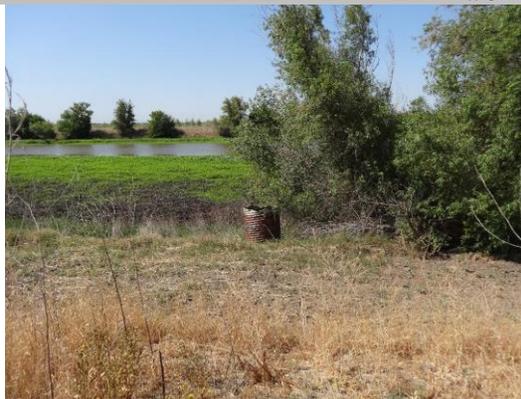
Photo 2 of 2 : UCIP_SP_2016_39707_71681.jpg

CMP riser located on waterward toe--2/3 filled with soil and trash.

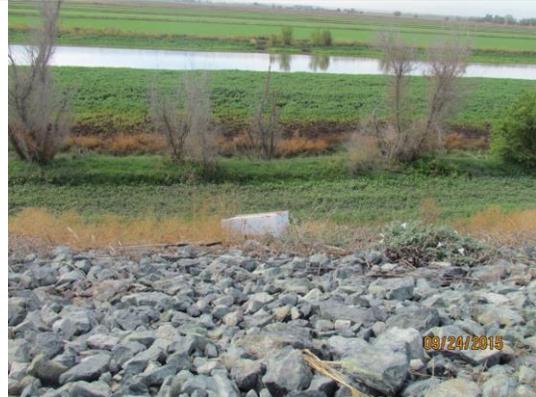
Photo 1 of 1 : SP_2016_RD0108_203_23_20160304_00007.jpg

LM Start	3.65	Rating **	M	Issue No.	23
LM End	3.65	Issue Type +	Ma	Location *	WS
Category	Earthen Levee		GPS Latitude/Longitude		
			Start	End	
Item	Encroachments		38.842620 °	38.842620 °	
			-121.858732 °	-121.858732 °	
DWR ID	DWR_RD0108_01_f_2015_23				
Comment Code					
DE : Debris					
Inspector Comment

View of the debris on the waterward side of the levee. Fall 2015.

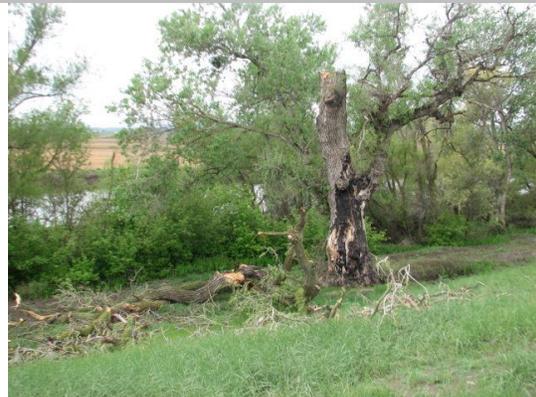
Photo 1 of 2 : SP_2016_RD0108_203_10_20160304_00005.jpg

LM Start	5.20	Rating **	A/W	Issue No.	10
LM End	5.20	Issue Type +	Ma	Location *	WS
Category	Earthen Levee		GPS Latitude/Longitude		
			Start	End	
Item	Vegetation		38.846163 °	38.846163 °	
			-121.886974 °	-121.886974 °	
DWR ID	DWR_RD0108_01_s_2014_10				
Comment Code					
V7 : Trees / Woody Vegetation					
Inspector Comment					
Tree at the toe is dying.

Tree limbs are along the toe of the levee. Tree is slowly dying and could be a hazard to the levee. Spring 2014

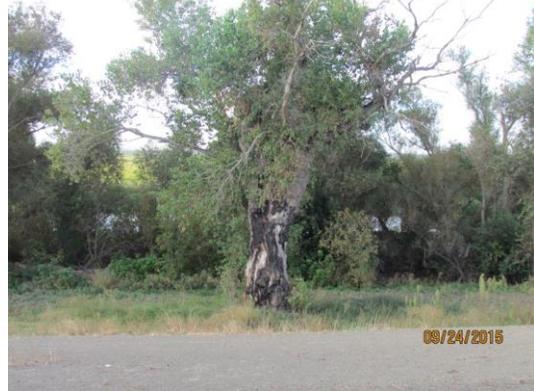
Photo 2 of 2 : SP_2016_RD0108_203_10_20160304_00006.jpg

LM Start	5.20	Rating **	A/W	Issue No.	10 (cont)
LM End	5.20	Issue Type +	Ma	Location *	WS
Category	Earthen Levee			GPS Latitude/Longitude	
				Start	End
Item	Vegetation			38.846163 °	38.846163 °
				-121.886974 °	-121.886974 °
DWR ID	DWR_RD0108_01_s_2014_10				
Comment Code					
V7 : Trees / Woody Vegetation					
Inspector Comment					
Tree at the toe is dying.

Tree limbs have been removed but suggest monitoring the dying tree. Fall 2015.

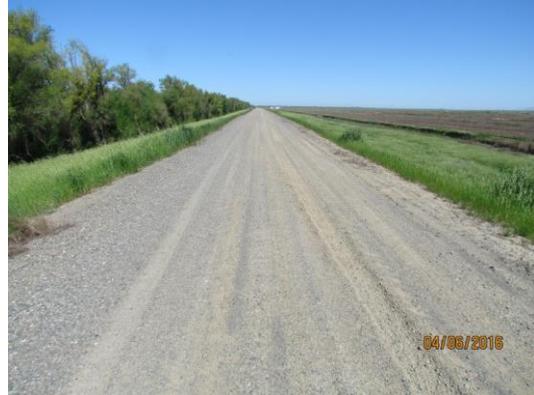
Photo 1 of 1 : SP_2016_RD0108_203_17_20160411_00040.jpg

LM Start	5.92	Rating **	M	Issue No.	17
LM End	5.99	Issue Type +	Ma	Location *	CR
Category	Earthen Levee			GPS Latitude/Longitude	
				Start	End
Item	Crown Surface / Depressions / Rutting			38.852230 °	38.853171 °
				-121.897211 °	-121.897930 °
DWR ID	DWR_RD0108_01_s_2016_17				
Comment Code					
C2 : Repair depressions or ruts in the crown or slope.					
Inspector Comment

View of the crown of the levee looking upstream. Spring 2016.

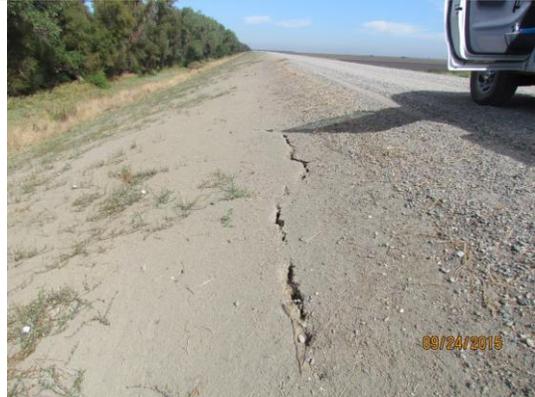
Photo 1 of 1 : SP_2016_RD0108_203_26_20160304_00009.jpg

LM Start	8.27	Rating **	A/W	Issue No.	26
LM End	8.27	Issue Type +	Ma	Location *	WS
Category	Earthen Levee		GPS Latitude/Longitude		
			Start	End	
Item	Cracking		38.882595 °	38.882595 °	
			-121.914669 °	-121.914669 °	
DWR ID	DWR_RD0108_01_f_2015_26				
Comment Code					
CR1 : Monitor and have inspected by geotechnical engineer.					
Inspector Comment

View of the crack on the waterward side of the levee looking upstream. Suggest monitoring the crack. Fall 2015.

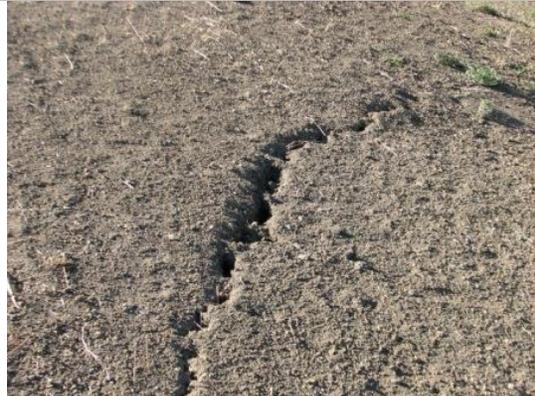
Photo 1 of 2 : SP_2016_RD0108_203_279_20160304_00013.jpg

LM Start	9.29	Rating **	A/W	Issue No.	279
LM End	9.29	Issue Type +	Ma	Location *	WS
Category	Earthen Levee		GPS Latitude/Longitude		
			Start	End	
Item	Slope Stability		38.897452 °	38.897452 °	
			-121.914680 °	-121.914680 °	
DWR ID	DWR_RD0108_01_f_2013_279				
Comment Code					
S1 : Repair slope instability.					
Inspector Comment

The cracking runs in a horseshoe pattern on the levee slope. Fall 2013

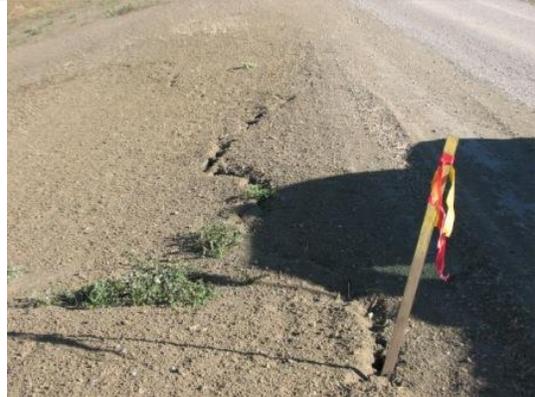
Photo 2 of 2 : SP_2016_RD0108_203_279_20160304_00014.jpg

LM Start	9.29	Rating **	A/W	Issue No.	279 (cont)
LM End	9.29	Issue Type +	Ma	Location *	WS
Category	Earthen Levee			GPS Latitude/Longitude	
				Start	End
Item	Slope Stability			38.897452 °	38.897452 °
				-121.914680 °	-121.914680 °
DWR ID	DWR_RD0108_01_f_2013_279				
Comment Code					
S1 : Repair slope instability.					
Inspector Comment

Slope stability with cracking 1-2 inches open and 12 inches deep. The district is monitoring the site. Fall 2013

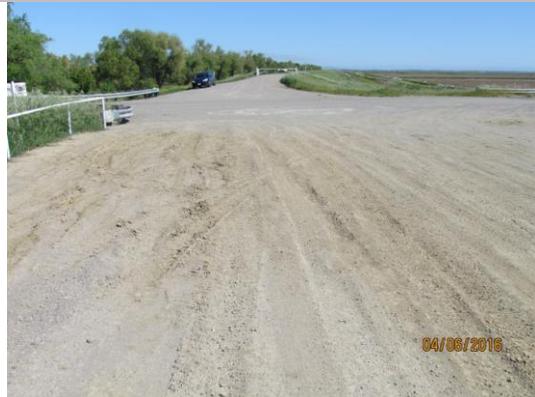
Photo 1 of 1 : SP_2016_RD0108_203_18_20160411_00041.jpg

LM Start	11.20	Rating **	M	Issue No.	18
LM End	11.20	Issue Type +	Ma	Location *	CR
Category	Earthen Levee			GPS Latitude/Longitude	
				Start	End
Item	Crown Surface / Depressions / Rutting			38.925037 °	38.925037 °
				-121.914509 °	-121.914509 °
DWR ID	DWR_RD0108_01_s_2016_18				
Comment Code					
C2 : Repair depressions or ruts in the crown or slope.					
Inspector Comment

View of the crown depression on the crown of the levee looking upstream. Spring 2016.

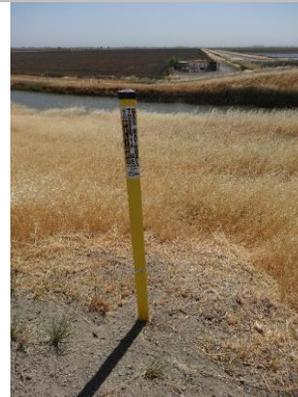
Photo 1 of 2 : UCIP_SP_2016_39717_71705.jpg

LM Start	11.24	Rating **	M	Issue No.	287
LM End	11.24	Issue Type +	En	Location *	CR
Category	Supplemental			GPS Latitude/Longitude	
				Start	End
Item	DWR UCIP Field Study			38.925662 °	38.925662 °
				-121.914303 °	-121.914303 °
DWR ID					
Comment Code					
Inspector Comment					
FS_ID:39717 DS_ID:24876 EP_NO: N/A Repair Type: Non-Urgent Crossing Status: Indicator Found UCIP Comments: Need to contact owner to determine additional details of crossing. FIELD_STRUCT_DESC: Natural gas line with markers on both side slightly angled through levee. Gas station located across canal on landward side. FS Date: 3/18/2014

View of marker visible on shoulder.

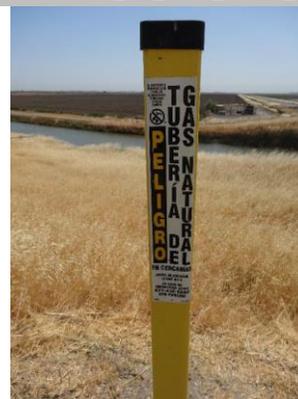
Photo 2 of 2 : UCIP_SP_2016_39717_71704.jpg

Owner contact information listed on marker.

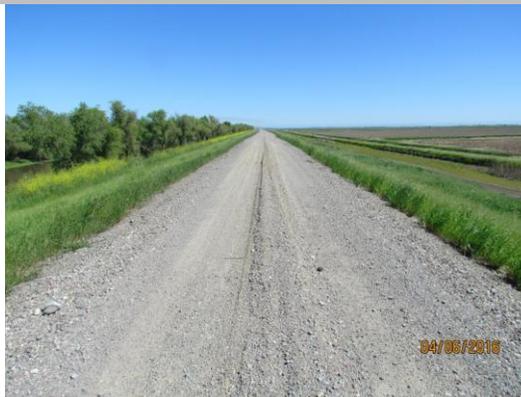
Photo 1 of 1 : SP_2016_RD0108_203_20_20160411_00042.jpg

View of the crown of the levee looking upstream. Spring 2016.

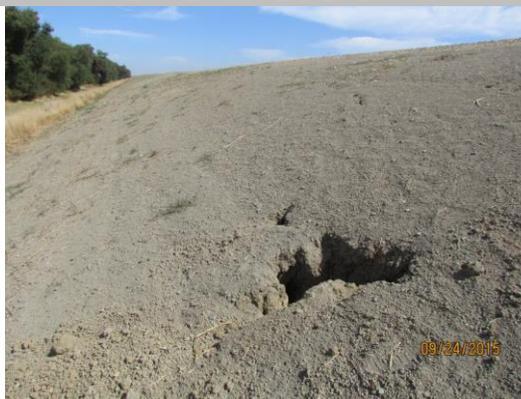
Photo 1 of 1 : SP_2016_RD0108_203_28_20160304_00011.jpg

LM Start	11.64	Rating **	M	Issue No.	28
LM End	11.64	Issue Type +	Ma	Location *	WS
Category	Earthen Levee		GPS Latitude/Longitude		
			Start	End	
Item	Animal Control		38.930980 °	38.930980 °	
			-121.911489 °	-121.911489 °	
DWR ID	DWR_RD0108_01_f_2015_28				
Comment Code					
A3 : No rodents visible, but rodent burrows visible; need to backfill and compact or grout burrows.					
Inspector Comment

View of the animal hole on the waterward side of the levee looking upstream. Fall 2015.

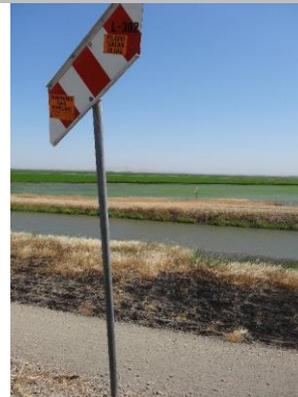
Photo 1 of 2 : UCIP_SP_2016_37623_68246.jpg

LM Start	14.94	Rating **	M	Issue No.	285
LM End	14.94	Issue Type +	En	Location *	CR
Category	Supplemental			GPS Latitude/Longitude	
				Start	End
Item	DWR UCIP Field Study			38.971607°	38.971607°
				-121.929499°	-121.929499°
DWR ID					
Comment Code					
Inspector Comment					
FS_ID:37623 DS_ID:17942 EP_NO: 3800 Repair Type: Non-Urgent Crossing Status: Indicator Found UCIP Comments: Need to contact owner--marker missing on waterward side. FIELD_STRUCT_DESC: 20-inch concrete encased gas line through levee, 3.0 feet below the crown. Crossing appears to be angled through levee (App. 3800-PG&E) Small rock revetment on the waterward slope. (unable to locate) Gas well approximately 1,000 feet from landward toe. FS Date: 6/10/2014

Marker visible on landward side.

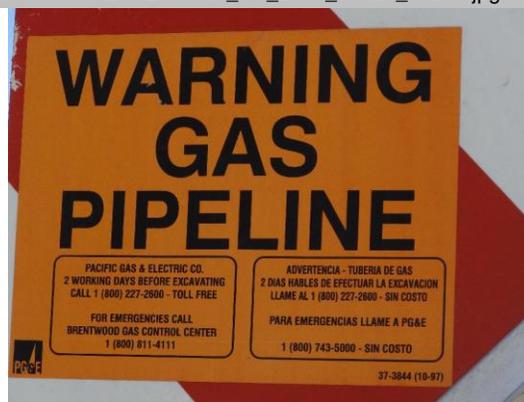
Photo 2 of 2 : UCIP_SP_2016_37623_68245.jpg

Contact information for gas line going through levee.

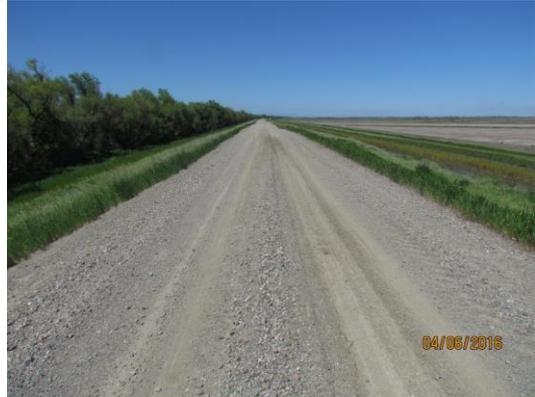
Photo 1 of 1 : SP_2016_RD0108_203_22_20160411_00043.jpg

LM Start	15.46	Rating **	M	Issue No.	22
LM End	15.74	Issue Type +	Ma	Location *	CR
Category	Earthen Levee		GPS Latitude/Longitude		
			Start	End	
Item	Crown Surface / Depressions / Rutting		38.976684 °	38.979377 °	
			-121.936696 °	-121.940526 °	
DWR ID	DWR_RD0108_01_s_2016_22				
Comment Code					
C2 : Repair depressions or ruts in the crown or slope.					
Inspector Comment

View of the crown of the levee looking upstream. Spring 2016.

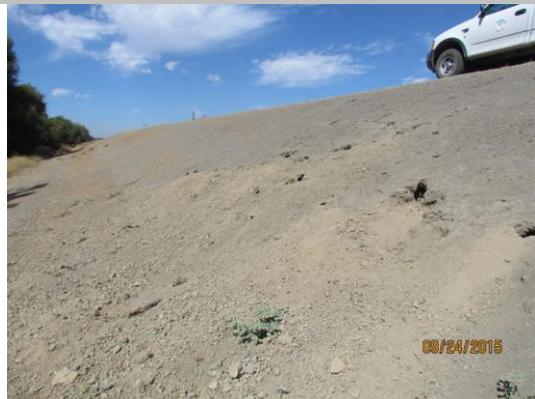
Photo 1 of 1 : SP_2016_RD0108_203_29_20160304_00012.jpg

LM Start	18.24	Rating **	M	Issue No.	29
LM End	18.24	Issue Type +	Ma	Location *	WS
Category	Earthen Levee		GPS Latitude/Longitude		
			Start	End	
Item	Animal Control		39.005766 °	39.005766 °	
			-121.972346 °	-121.972346 °	
DWR ID	DWR_RD0108_01_f_2015_29				
Comment Code					
A3 : No rodents visible, but rodent burrows visible; need to backfill and compact or grout burrows.					
Inspector Comment

View of the animal hole on the waterward side of the levee looking upstream. Fall 2015.

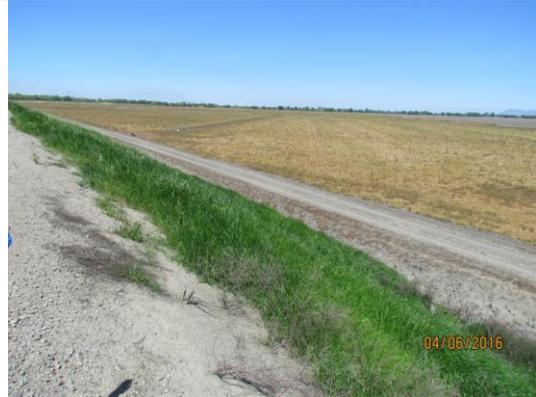
Photo 1 of 1 : SP_2016_RD0108_203_6_20160411_00044.jpg

View of the ditch at the toe of the levee on the landward side looking upstream. Spring 2016.

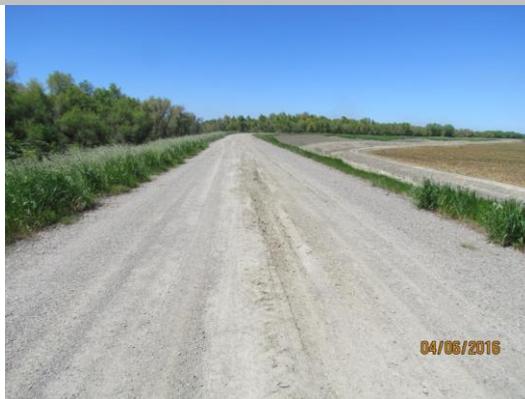
Photo 1 of 1 : SP_2016_RD0108_203_25_20160411_00045.jpg

View of the crown of the levee looking upstream. Spring 2016.

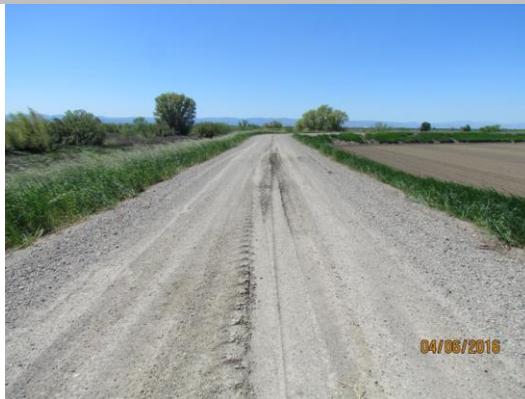
Photo 1 of 1 : SP_2016_RD0108_203_30_20160411_00046.jpg

LM Start	20.38	Rating **	M	Issue No.	30
LM End	20.43	Issue Type +	Ma	Location *	CR
Category	Earthen Levee			GPS Latitude/Longitude	
				Start	End
Item	Crown Surface / Depressions / Rutting			39.031526°	39.031477°
				-121.990258°	-121.991089°
DWR ID	DWR_RD0108_01_s_2016_30				
Comment Code					
C2 : Repair depressions or ruts in the crown or slope.					
Inspector Comment

View of the crown of the levee looking upstream. Spring 2016.

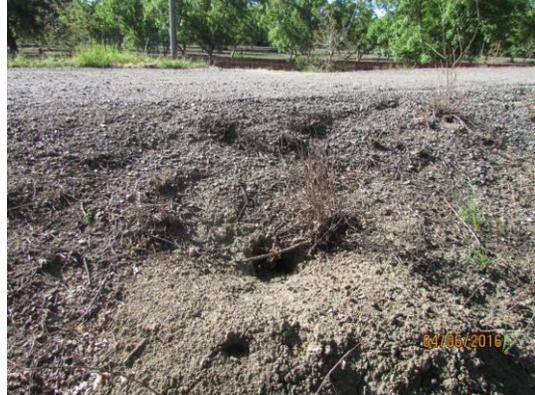
Photo 1 of 3 : SP_2016_RD0108_590_6_20160411_00007.jpg

Mound next to rodent hole is more than 2 cubic feet of material.

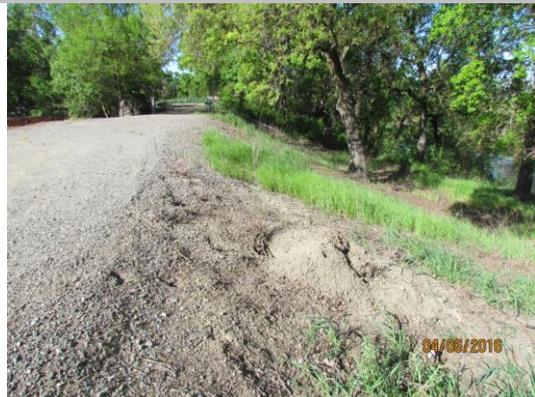
Photo 2 of 3 : SP_2016_RD0108_590_6_20160411_00006.jpg

Perspective view of the rodent hole on the waterward side of the levee looking upstream. Spring 2016.

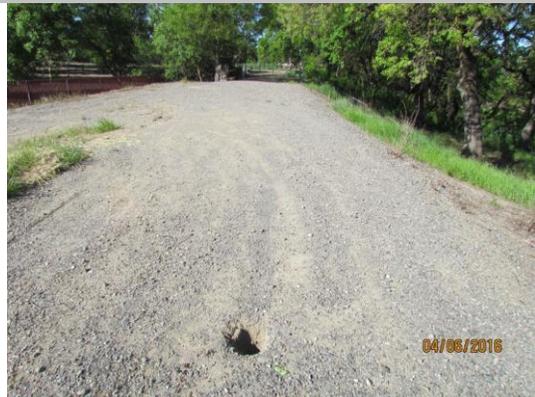
Photo 3 of 3 : SP_2016_RD0108_590_6_20160411_00008.jpg

Another hole is on top of the crown. Spring 2016.

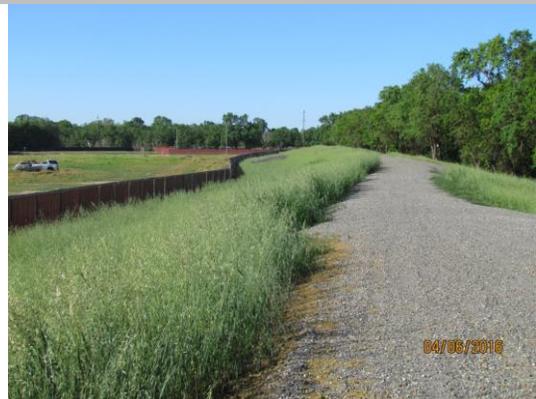
Photo 1 of 1 : SP_2016_RD0108_590_1_20160411_00005.jpg

View of the vegetation on the landward side of the levee looking upstream. Spring 2016.

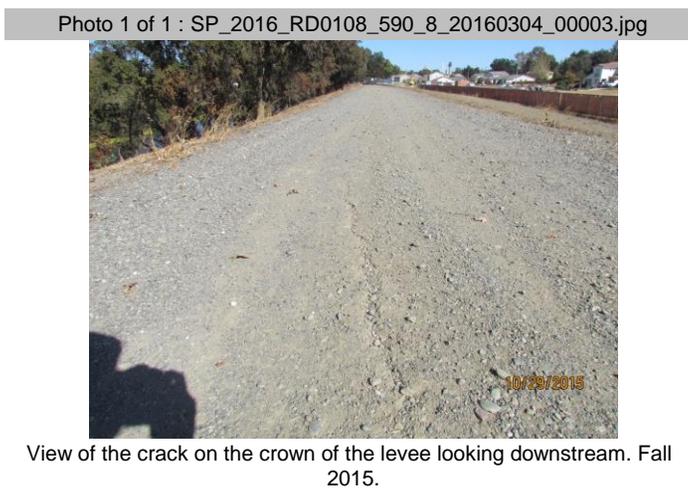
LM Start	0.14	Rating **	A/W	Issue No.	8
LM End	0.15	Issue Type +	Ob	Location *	CR
Category	Earthen Levee			GPS Latitude/Longitude	
				Start	End
Item	Cracking			38.797632 °	38.797760 °
				-121.726162 °	-121.726070 °
DWR ID	DWR_RD0108_02_f_2015_8				
Comment Code					
CR1 : Monitor and have inspected by geotechnical engineer.					
Inspector Comment					
Cracks seems to have closed up after the rain.

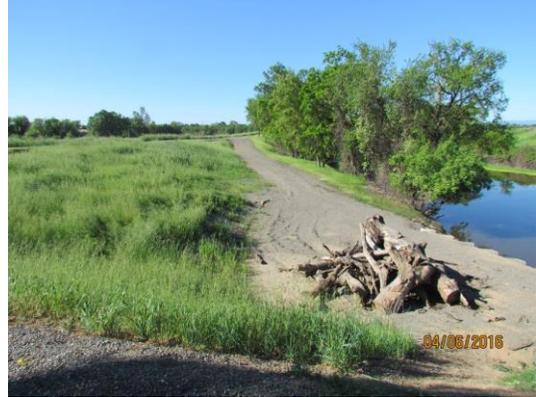
Photo 1 of 1 : SP_2016_RD0108_590_3_20160411_00009.jpg

View of the pruning pile on the berm of levee on the waterward side. Spring 2016.
