**Flood Control Project Maintenance
Levee Inspections**

Maintenance Issue Types Only, Levee Inspection Report By Mile - Fall 2014

Reclamation District No. 0108 River Farms

Waterway	Bank	Unit Miles	Inspection Start/End	Inspector
Unit No. 01 Colusa Basin Drain	Left	20.64	10/28/2014 10/28/2014	Clay Thomas

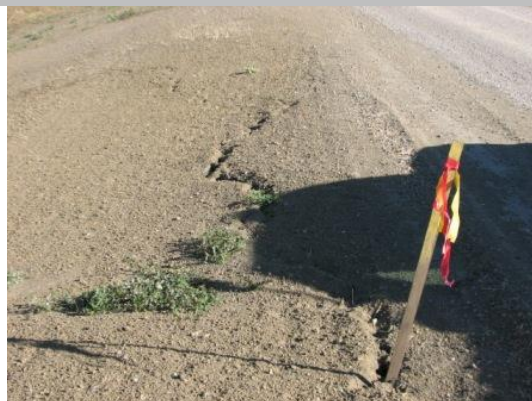
Photo 2 of 2 : FA_2014_RD0108_203_279_20141014_00012.jpg

LM Start	9.28	Rating **	A/W	Issue No.	279 (cont)	
LM End	9.28	Issue Type +	Ma	Location *	WS	
Category	Earthen Levee			GPS Latitude/Longitude		
				Start		End
Item	Slope Stability			38.897452 °		38.897452 °
				-121.914680 °		-121.914680 °
DWR ID	DWR_RD0108_01_f_2013_279					
Action/Comments						
Repair slope instability.

Slope stability with cracking 1-2 inches open and 12 inches deep Fall 2013 The district is monitoring the site.

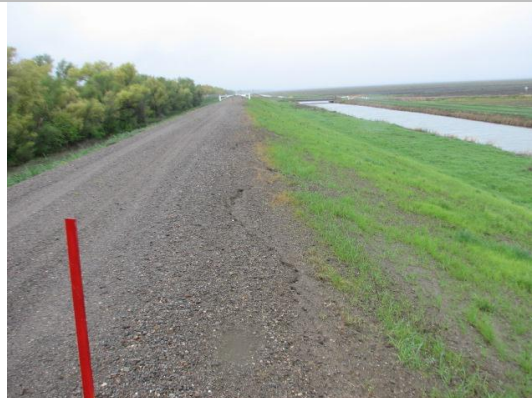
Photo 1 of 1 : FA_2014_RD0108_203_12_20141014_00008.jpg

LM Start	14.46	Rating **	M	Issue No.	12
LM End	14.46	Issue Type +	Ma	Location *	LS
Category	Earthen Levee			GPS Latitude/Longitude	
				Start	End
Item	Cracking			38.967243 °	38.967243 °
				-121.923407 °	-121.923407 °
DWR ID	DWR_RD0108_01_s_2014_12				
Action/Comments					
Schedule repair of subsidence prior to the next inspection.

Cracking along the shoulder of the crown. Some slope instability has occurred. Spring 2014

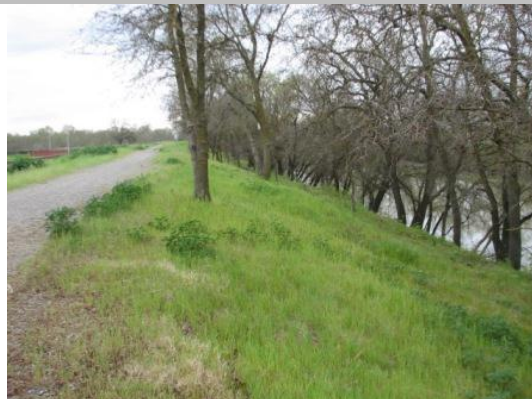
Photo 1 of 2 : FA_2014_RD0108_590_2_20141014_00001.jpg

LM Start	0.02	Rating **	A	Issue No.	2
LM End	0.28	Issue Type +	Ma	Location *	WS
Category	Earthen Levee			GPS Latitude/Longitude	
				Start	End
Item	Vegetation			38.799008 °	38.796205 °
				-121.724852 °	-121.727988 °
DWR ID	DWR_RD0108_02_f_2012_2				
Action/Comments					
Control annual grass and weeds on the levee slopes and easements. Inspector Comments: Brush and trees are on the water side levee slope but do not block visibility.

Brush and trees are on the waterside slope but does not block visibility.
Spring 2013

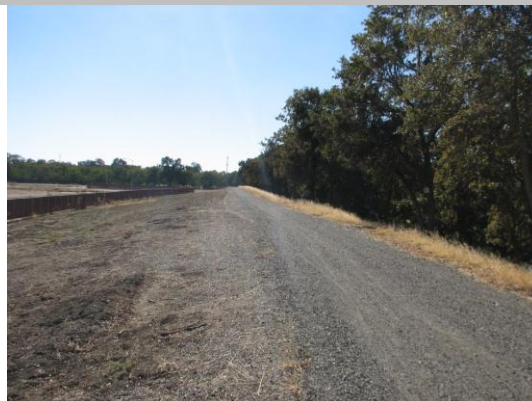
Photo 2 of 2 : FA_2014_RD0108_590_2_20141106_00004.jpg

Levee mile 0.09, vegetation on the land side levee slope. Fall 2014.
