**Flood Control Project Maintenance
Levee Inspections**

Maintenance Issue Types Only, Levee Inspection Report By Mile - Fall 2015

Reclamation District No. 0108 River Farms

Waterway	Bank	Unit Miles	Inspection Start/End	Inspector
Unit No. 01 Colusa Basin Drain	Left	20.64	09/24/2015 09/24/2015	Jai Lor

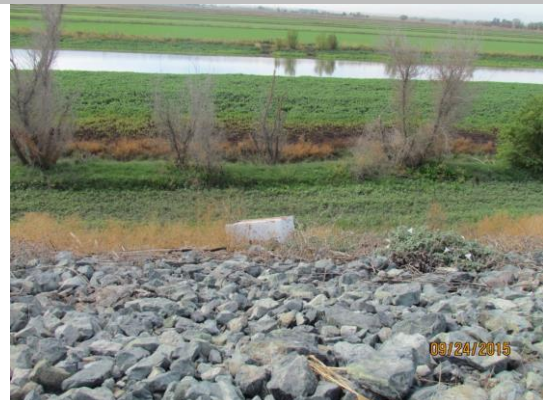
Photo 1 of 1 : FA_2015_RD0108_203_23_20151001_00011.jpg

LM Start	3.65	Rating **	M	Issue No.	23
LM End	3.65	Issue Type +	Ma	Location *	WS
Category	Earthen Levee			GPS Latitude/Longitude	
				Start	End
Item	Encroachments			38.842620 °	38.842620 °
				-121.858732 °	-121.858732 °
DWR ID	DWR_RD0108_01_f _ 2015_23				
Action/Comments					
Debris

View of the debris on the waterward side of the levee. Fall 2015.

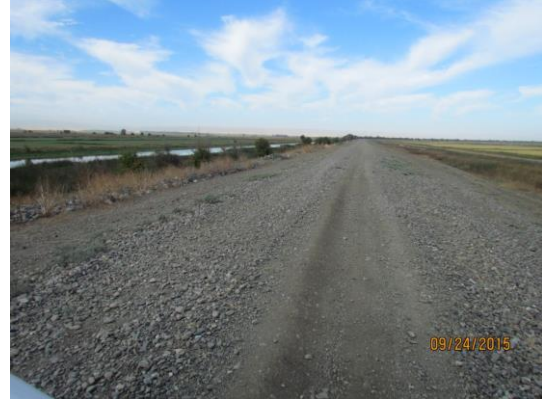
Photo 1 of 1 : FA_2015_RD0108_203_24_20151001_00012.jpg

LM Start	4.17	Rating **	M	Issue No.	24
LM End	4.17	Issue Type +	Ma	Location *	CR
Category	Earthen Levee			GPS Latitude/Longitude	
				Start	End
Item	Crown Surface / Depressions / Rutting			38.843708 °	38.843708 °
				-121.868215 °	-121.868215 °
DWR ID	DWR_RD0108_01_f_2015_24				
Action/Comments					
Repair depressions or ruts in the crown or slope.

View of the depression on the crown of the levee looking upstream. Fall 2015.

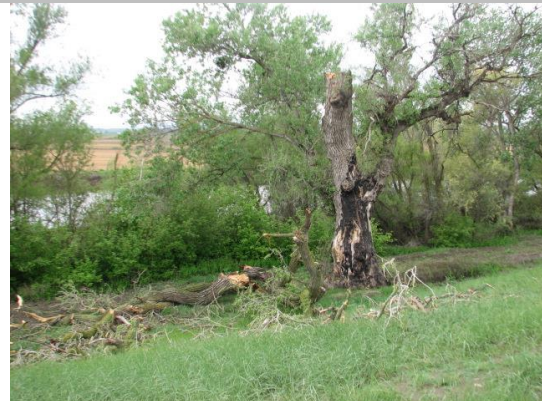
Photo 1 of 2 : FA_2015_RD0108_203_10_20150914_00005.jpg

LM Start	5.19	Rating **	A/W	Issue No.	10
LM End	5.19	Issue Type +	Ma	Location *	WS
Category	Earthen Levee			GPS Latitude/Longitude	
				Start	End
Item	Vegetation			38.846086 °	38.846086 °
				-121.886834 °	-121.886834 °
DWR ID	DWR_RD0108_01_s_2014_10				
Action/Comments					
Trees / Woody Vegetation					
Inspector Comments: Tree at the toe is dying.

Tree limbs are along the toe of the levee. Tree is slowly dying and could be a hazard to the levee. Spring 2014

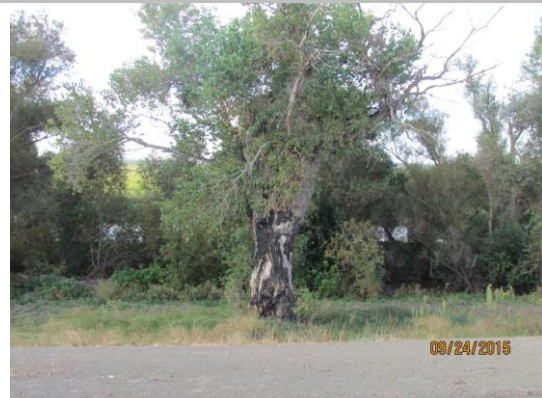
Photo 2 of 2 : FA_2015_RD0108_203_10_20151001_00013.jpg

LM Start	5.19	Rating **	A/W	Issue No.	10 (cont)
LM End	5.19	Issue Type +	Ma	Location *	WS

Tree limbs have been removed but suggest monitoring the dying tree. Fall 2015.

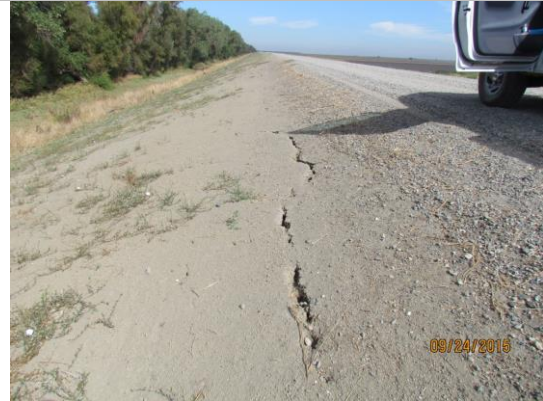
Photo 1 of 1 : FA_2015_RD0108_203_26_20151001_00014.jpg

LM Start	8.27	Rating **	A/W	Issue No.	26
LM End	8.27	Issue Type +	Ma	Location *	WS
Category	Earthen Levee			GPS Latitude/Longitude	
				Start	End
Item	Cracking			38.882595 °	38.882595
				-121.914669 °	-121.914669
DWR ID	DWR_RD0108_01_f_2015_26				
Action/Comments					
Monitor and have inspected by geotechnical engineer.

View of the crack on the waterward side of the levee looking upstream.
Suggest monitoring the crack. Fall 2015.

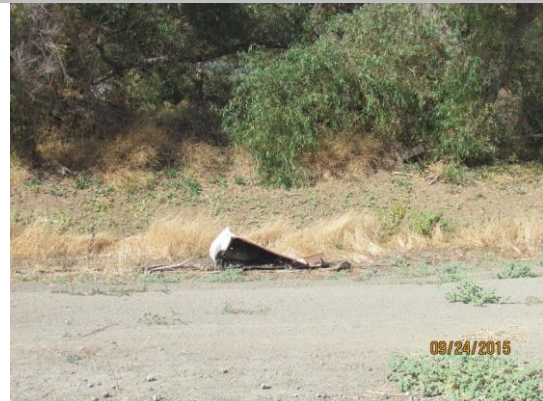
Photo 1 of 1 : FA_2015_RD0108_203_27_20151001_00015.jpg

LM Start	8.98	Rating **	M	Issue No.	27
LM End	8.98	Issue Type +	Ma	Location *	WS
Category	Earthen Levee			GPS Latitude/Longitude	
				Start	End
Item	Encroachments			38.892888 °	38.892888 °
				-121.914642 °	-121.914642 °
DWR ID	DWR_RD0108_01_f_2015_27				
Action/Comments					
Debris

View of the debris on the waterward side of the levee. Fall 2015.

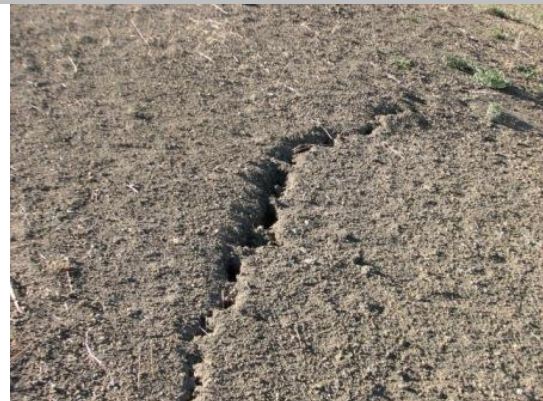
Photo 1 of 2 : FA_2015_RD0108_203_279_20150914_00007.jpg

LM Start	9.29	Rating **	A/W	Issue No.	279
LM End	9.29	Issue Type +	Ma	Location *	WS
Category	Earthen Levee			GPS Latitude/Longitude	
				Start	End
Item	Slope Stability			38.897452 °	38.897452 °
				-121.914680 °	-121.914680 °
DWR ID	DWR_RD0108_01_f_2013_279				
Action/Comments					
Repair slope instability.

The cracking runs in a horseshoe pattern on the levee slope. Fall 2013

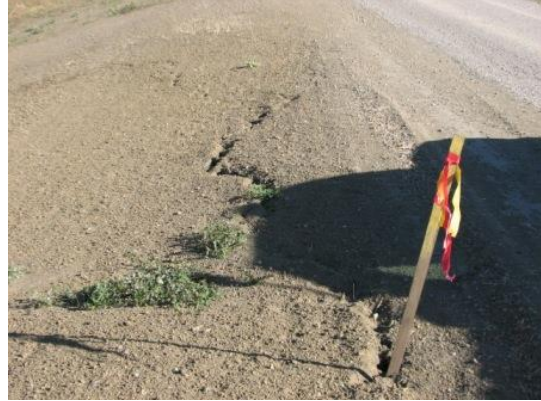
Photo 2 of 2 : FA_2015_RD0108_203_279_20150914_00008.jpg

LM Start	9.29	Rating **	A/W	Issue No.	279 (cont)	
LM End	9.29	Issue Type +	Ma	Location *	WS	
Category	Earthen Levee			GPS Latitude/Longitude		
				Start		End
Item	Slope Stability			38.897452 °		38.897452 °
				-121.914680 °		-121.914680 °
DWR ID	DWR_RD0108_01_f_2013_279					
Action/Comments						
Repair slope instability.

Slope stability with cracking 1-2 inches open and 12 inches deep. The district is monitoring the site. Fall 2013

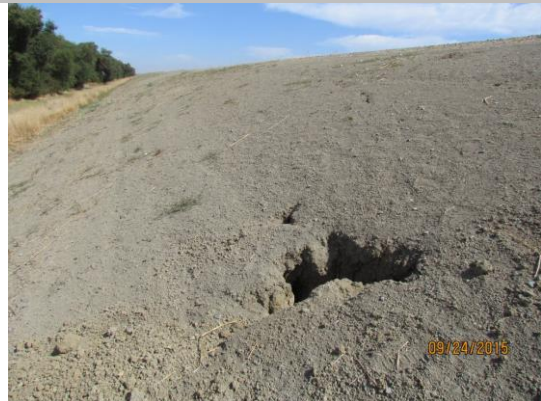
Photo 1 of 1 : FA_2015_RD0108_203_28_20151001_00016.jpg

LM Start	11.64	Rating **	M	Issue No.	28
LM End	11.64	Issue Type +	Ma	Location *	WS
Category	Earthen Levee			GPS Latitude/Longitude	
				Start	End
Item	Animal Control			38.930980 °	38.930980 °
				-121.911489 °	-121.911489 °
DWR ID	DWR_RD0108_01_f_2015_28				
Action/Comments					
No rodents visible, but rodent burrows visible; need to backfill and compact or grout burrows.

View of the animal hole on the waterward side of the levee looking upstream. Fall 2015.

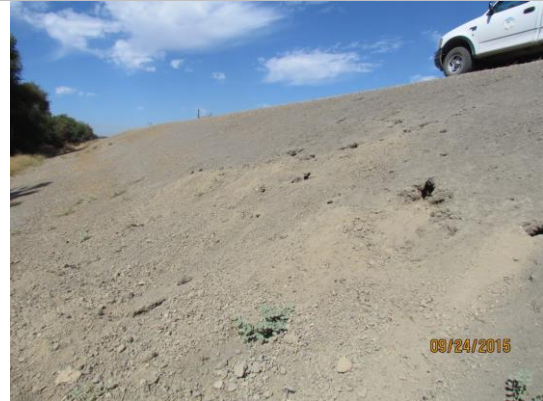
Photo 1 of 1 : FA_2015_RD0108_203_29_20151001_00017.jpg

LM Start	18.24	Rating **	M	Issue No.	29
LM End	18.24	Issue Type +	Ma	Location *	WS
Category	Earthen Levee			GPS Latitude/Longitude	
				Start	End
Item	Animal Control			39.005766 °	39.005766 °
				-121.972346 °	-121.972346 °
DWR ID	DWR_RD0108_01_f _ 2015_29				
Action/Comments					
No rodents visible, but rodent burrows visible; need to backfill and compact or grout burrows.

View of the animal hole on the waterward side of the levee looking upstream. Fall 2015.

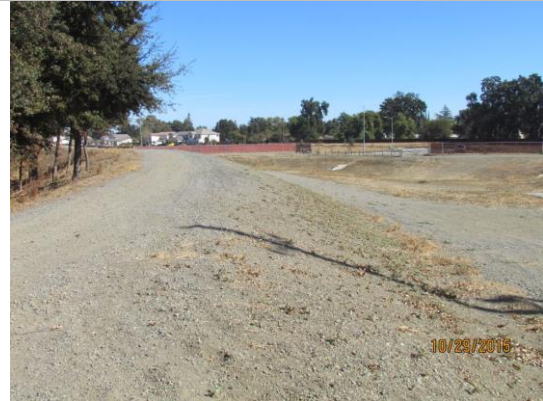
Photo 1 of 1 : FA_2015_RD0108_590_2_20151103_00005.jpg

LM Start	0.01	Rating **	A	Issue No.	2
LM End	0.27	Issue Type +	Ma	Location *	LS
Category	Earthen Levee			GPS Latitude/Longitude	
				Start	End
Item	Vegetation			38.796267 °	38.799003 °
				-121.727812 °	-121.724500 °
DWR ID	DWR_RD0108_02_f_2015_2				
Action/Comments					
Control annual grass and weeds on the levee slopes and easements. Inspector Comments: Vegetation on slope has been maintained.

View of the vegetation on the landward side of the levee looking downstream. Fall 2015.

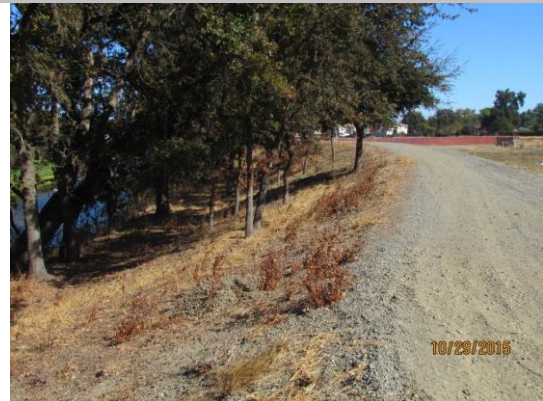
Photo 1 of 1 : FA_2015_RD0108_590_1_20151103_00004.jpg

LM Start	0.01	Rating **	A	Issue No.	1
LM End	0.27	Issue Type +	Ma	Location *	WS
Category	Earthen Levee			GPS Latitude/Longitude	
				Start	End
Item	Vegetation			38.796267 °	38.799003 °
				-121.727812 °	-121.724495 °
DWR ID	DWR_RD0108_02_f_2015_1				
Action/Comments					
Control annual grass and weeds on the levee slopes and easements. Inspector Comments: Slope has been maintained.

View of the vegetation on the waterward side of the levee looking downstream. Fall 2015.

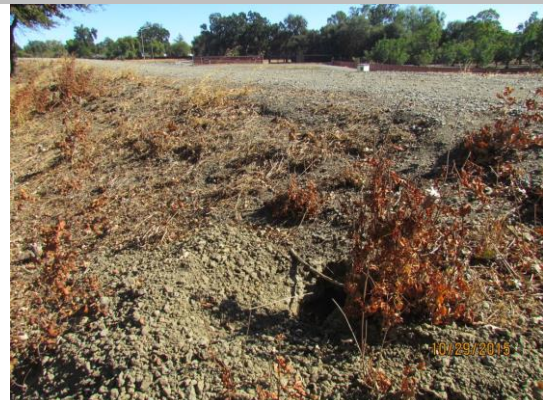
Photo 1 of 1 : FA_2015_RD0108_590_6_20151103_00006.jpg

LM Start	0.02	Rating **	M	Issue No.	6
LM End	0.02	Issue Type +	Ma	Location *	WS
Category	Earthen Levee			GPS Latitude/Longitude	
				Start	End
Item	Animal Control			38.796335 °	38.796335 °
				-121.727717 °	-121.727717 °
DWR ID	DWR_RD0108_02_f_2015_6				
Action/Comments					
No rodents visible, but rodent burrows visible; need to backfill and compact or grout burrows.

View of the rodent hole on the waterward side of the levee looking downstream. Fall 2015.

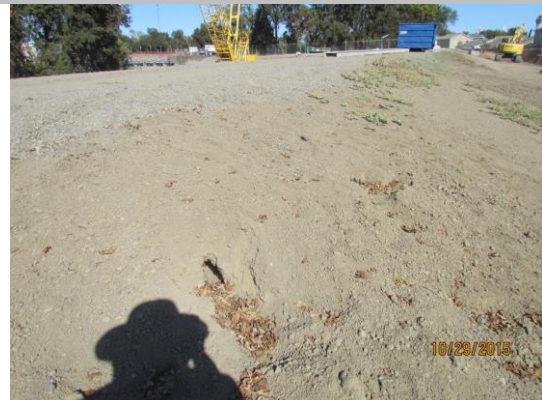
Photo 1 of 1 : FA_2015_RD0108_590_10_20151103_00009.jpg

LM Start	0.23	Rating **	M	Issue No.	10
LM End	0.23	Issue Type +	Ma	Location *	LS
Category	Earthen Levee			GPS Latitude/Longitude	
				Start	End
Item	Animal Control			38.798600 °	38.798600 °
				-121.725055 °	-121.725055 °
DWR ID	DWR_RD0108_02_f _ 2015_10				
Action/Comments					
No rodents visible, but rodent burrows visible; need to backfill and compact or grout burrows.

View of the rodent hole on the landward side of the levee looking downstream. Fall 2015.
