**Flood Control Project Maintenance
Levee Inspections**

Maintenance Issue Types Only, Levee Inspection Report By Mile - Fall 2016

Reclamation District No. 0108 River Farms

Waterway	Bank	Unit Miles	Inspection Start/End	Inspector
Unit No. 01 Colusa Basin Drain	Left	20.64	10/04/2016 10/04/2016	Oleg Yakimov

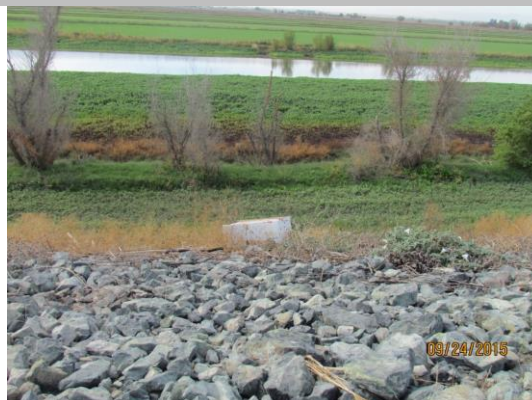
Photo 1 of 1 : FA_2016_RD0108_203_23_20160913_00008.jpg

LM Start	3.65	Rating **	M	Issue No.	23
LM End	3.65	Issue Type +	Ma	Location *	WS
Category	Earthen Levee			GPS Latitude/Longitude	
				Start	End
Item	Encroachments			38.842620 °	38.842620 °
				-121.858732 °	-121.858732 °
DWR ID	DWR_RD0108_01_f_2015_23				
Comment Code					
DE : Debris					
Inspector Comment

View of the debris on the waterward side of the levee. Fall 2015.

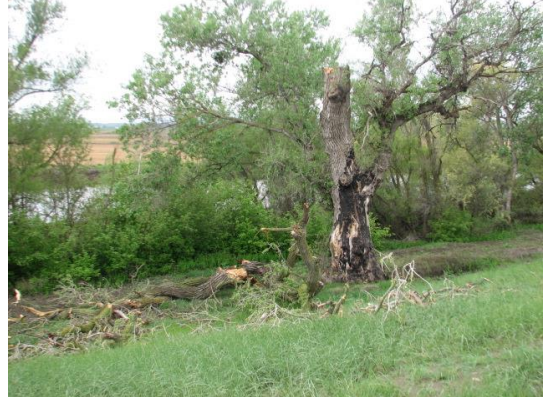
Photo 1 of 2 : FA_2016_RD0108_203_10_20160913_00002.jpg

LM Start	5.20	Rating **	A/W	Issue No.	10
LM End	5.20	Issue Type +	Ma	Location *	WS
Category	Earthen Levee			GPS Latitude/Longitude	
				Start	End
Item	Vegetation			38.846163 °	38.846163 °
				-121.886974 °	-121.886974 °
DWR ID	DWR_RD0108_01_s_2014_10				
Comment Code					
V7 : Trees / Woody Vegetation					
Inspector Comment					
Tree at the toe is dying.

Tree limbs are along the toe of the levee. Tree is slowing dying and could be a hazard to the levee. Spring 2014

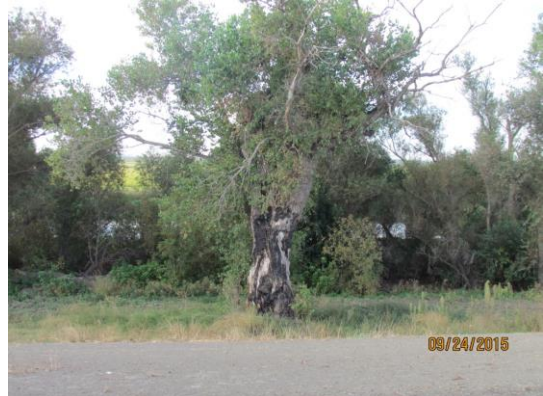
Photo 2 of 2 : FA_2016_RD0108_203_10_20160913_00003.jpg

Tree limbs have been removed but suggest monitoring the dying tree. Fall 2015.

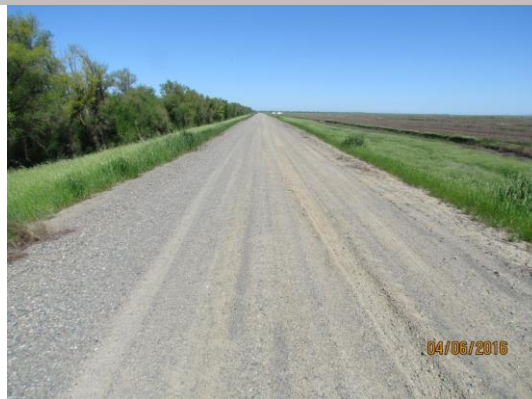
Photo 1 of 1 : FA_2016_RD0108_203_17_20160913_00004.jpg

LM Start	5.92	Rating **	M	Issue No.	17
LM End	6.06	Issue Type +	Ma	Location *	CR
Category	Earthen Levee			GPS Latitude/Longitude	
				Start	End
Item	Crown Surface / Depressions / Rutting			38.852230 °	38.853967 °
				-121.897211 °	-121.898571 °
DWR ID	DWR_RD0108_01_s_2016_17				
Comment Code					
C2 : Repair depressions or ruts in the crown or slope.					
Inspector Comment

View of the crown of the levee looking upstream. Spring 2016.

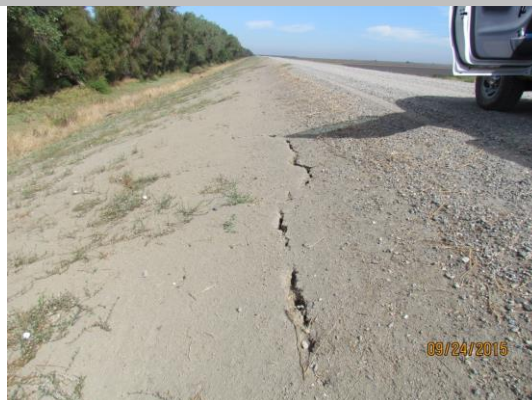
Photo 1 of 1 : FA_2016_RD0108_203_26_20160913_00010.jpg

LM Start	8.27	Rating **	A/W	Issue No.	26
LM End	8.27	Issue Type +	Ma	Location *	WS
Category	Earthen Levee			GPS Latitude/Longitude	
				Start	End
Item	Cracking			38.882595 °	38.882595 °
				-121.914669 °	-121.914669 °
DWR ID	DWR_RD0108_01_f_2015_26				
Comment Code					
CR1 : Monitor and have inspected by geotechnical engineer.					
Inspector Comment

View of the crack on the waterward side of the levee looking upstream. Suggest monitoring the crack. Fall 2015.

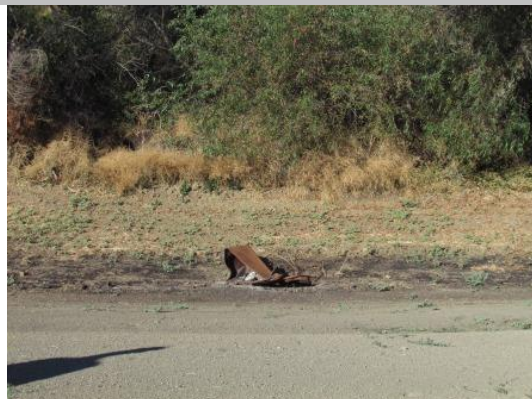
Photo 1 of 1 : FA_2016_RD0108_203_15_20161004_00040.jpg

LM Start	8.98	Rating **	M	Issue No.	15
LM End	8.98	Issue Type +	Ma	Location *	WS
Category	Earthen Levee			GPS Latitude/Longitude	
				Start	End
Item	Encroachments			38.892912 °	38.892912 °
				-121.914636 °	-121.914636 °
DWR ID	DWR_RD0108_01_f_2016_15				
Comment Code					
GA : Garbage					
Inspector Comment

Trash on waterward side on the levee. Fall 2016 inspection.

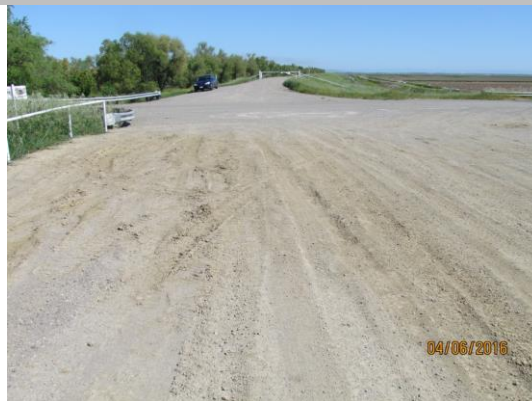
Photo 1 of 1 : FA_2016_RD0108_203_18_20160913_00005.jpg

LM Start	11.20	Rating **	M	Issue No.	18
LM End	11.20	Issue Type +	Ma	Location *	CR
Category	Earthen Levee			GPS Latitude/Longitude	
				Start	End
Item	Crown Surface / Depressions / Rutting			38.925037°	38.925037°
				-121.914509°	-121.914509°
DWR ID	DWR_RD0108_01_s_2016_18				
Comment Code					
C2 : Repair depressions or ruts in the crown or slope.					
Inspector Comment

View of the crown depression on the crown of the levee looking upstream. Spring 2016.

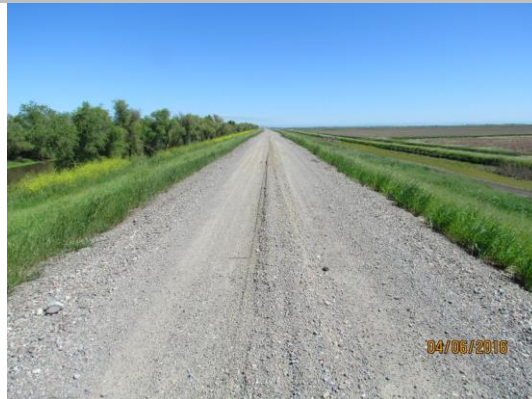
Photo 1 of 1 : FA_2016_RD0108_203_20_20160913_00006.jpg

LM Start	11.36	Rating **	M	Issue No.	20
LM End	12.19	Issue Type +	Ma	Location *	CR
Category	Earthen Levee			GPS Latitude/Longitude	
				Start	End
Item	Crown Surface / Depressions / Rutting			38.927325 °	38.938291 °
				-121.913477 °	-121.907516 °
DWR ID	DWR_RD0108_01_s_2016_20				
Comment Code					
C3 : Add appropriate gravel or road base. Grade and compact.					
Inspector Comment

View of the crown of the levee looking upstream. Spring 2016.

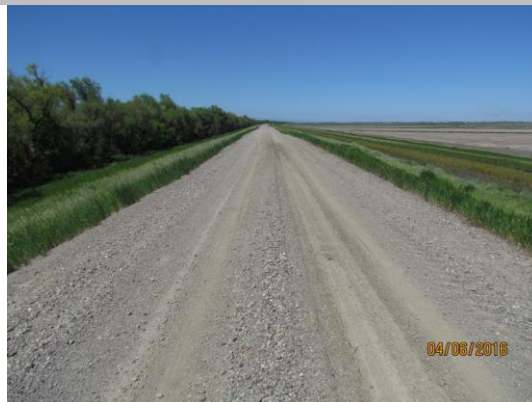
Photo 1 of 1 : FA 2016 RD0108 203 22 20160913 00007.jpg

LM Start	15.46	Rating **	M	Issue No.	22
LM End	15.74	Issue Type +	Ma	Location *	CR
Category	Earthen Levee			GPS Latitude/Longitude	
				Start	End
Item	Crown Surface / Depressions / Rutting			38.976684 °	38.979377 °
				-121.936696 °	-121.940526 °
DWR ID	DWR_RD0108_01_s_2016_22				
Comment Code					
C2 : Repair depressions or ruts in the crown or slope.					
Inspector Comment

View of the crown of the levee looking upstream. Spring 2016.

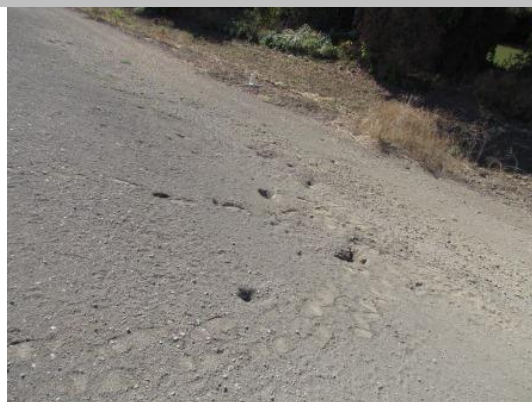
Photo 1 of 2 : FA_2016_RD0108_203_29_20161004_00042.jpg

LM Start	18.24	Rating **	M	Issue No.	29
LM End	18.24	Issue Type +	Ma	Location *	WS
Category	Earthen Levee			GPS Latitude/Longitude	
				Start	End
Item	Animal Control			39.005766 °	39.005766 °
				-121.972346 °	-121.972346 °
DWR ID	DWR_RD0108_01_f_2015_29				
Comment Code					
A3 : No rodents visible, but rodent burrows visible; need to backfill and compact or grout burrows.					
Inspector Comment

Updated view of a site with rodent activity. Fall 2016 inspection.

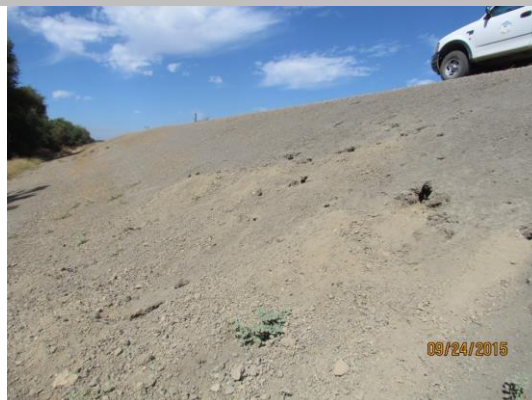
Photo 2 of 2 : FA_2016_RD0108_203_29_20160913_00012.jpg

View of the animal hole on the waterward side of the levee looking upstream. Fall 2015.

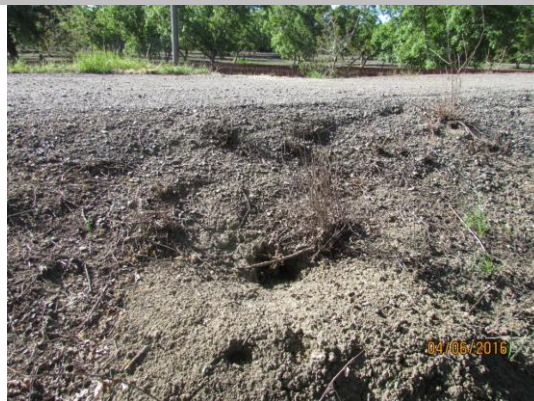
Photo 1 of 3 : FA_2016_RD0108_590_6_20160913_00002.jpg

LM Start	0.02	Rating **	U	Issue No.	6
LM End	0.02	Issue Type +	Ma	Location *	WS
Category	Earthen Levee			GPS Latitude/Longitude	
				Start	End
Item	Animal Control			38.796355°	38.796355°
				-121.727721°	-121.727721°
DWR ID	DWR_RD0108_02_f_2015_6				
Comment Code					
A3 : No rodents visible, but rodent burrows visible; need to backfill and compact or grout burrows.					
Inspector Comment					
Mound does not look fresh but seems to have come from the rodent hole.

Mound next to rodent hole is more than 2 cubic feet of material.

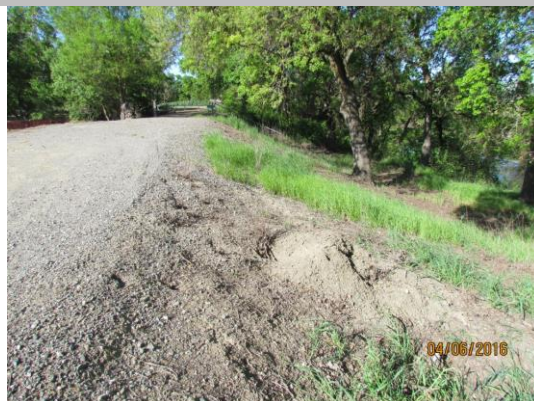
Photo 2 of 3 : FA_2016_RD0108_590_6_20160913_00003.jpg

Perspective view of the rodent hole on the waterward side of the levee looking upstream. Spring 2016.

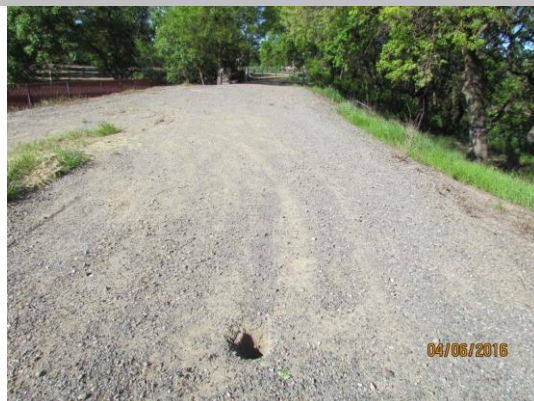
Photo 3 of 3 : FA_2016_RD0108_590_6_20160913_00004.jpg

Another hole is on top of the crown. Spring 2016.

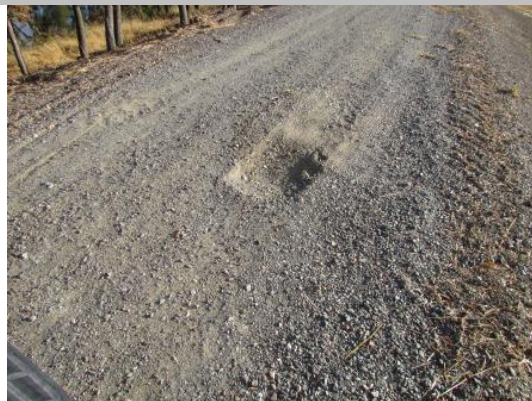
Photo 1 of 1 : FA_2016_RD0108_590_1_20161004_00006.jpg

LM Start	0.03	Rating **	M	Issue No.	1
LM End	0.03	Issue Type +	Ma	Location *	CR
Category	Earthen Levee			GPS Latitude/Longitude	
				Start	End
Item	Crown Surface / Depressions / Rutting			38.796447 °	38.796447 °
				-121.727487 °	-121.727487 °
DWR ID	DWR_RD0108_02_f _ 2016_1				
Comment Code					
C3 : Add appropriate gravel or road base. Grade and compact.					
Inspector Comment					
Crown surface is damaged due to vehicular activity.

Crown surface damaged due to intensive vehicle acceleration. Fall 2016 inspection.
