**Flood Control Project Maintenance
Levee Inspections**

Maintenance Issue Types Only, Levee Inspection Report By Mile - Fall 2017

Reclamation District No. 0108 River Farms

Waterway	Bank	Unit Miles	Inspection Start/End	Inspector
Unit No. 01 Colusa Basin Drain	Left	20.64	10/11/2017 10/11/2017	Zach Jojola

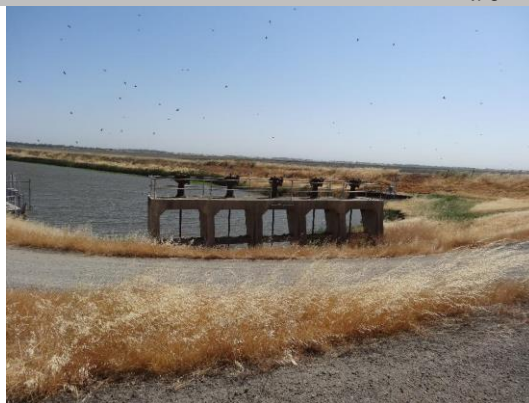
Photo 3 of 3 : UCIP_FA_2017_37608_68208.jpg

View of concrete structure visible on landward side.

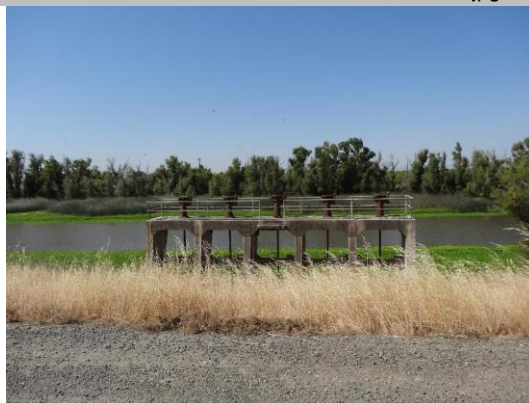
Photo 1 of 3 : UCIP_FA_2017_37609_68211.jpg

FS_ID:37609
DS_ID:22386
EP_NO: 9396
Repair Type: Non-Urgent
Crossing Status: Found
UCIP Comments: Need to contact owner to determine status of structure. Notes indicate crossing has been abandoned. Owner will need to coordinate with CVFPB and DWR inspector to determine how to properly abandon.
FIELD_STRUCT_DESC: *ABANDONED* 2 of 5. 72-inch pipes or culvert through levee 31.6 feet below crown. Slide gates on both ends. (five 72-inch pipes [HLM 0.08] authorized under Automatic Board Order (ABO) issued as Permit No. 9736, 1974 - Reclamation District No. 108 [RD0108]) [Additional Reference(s): DWR Levee Log, 2005. USACE Sacramento O&M Manual Unit No. 132, October 1959, (HLM 0.08), referenced as five 6-foot by 8-foot concrete culvert drains].
FS Date: 6/10/2014

Concrete structure located on waterward side.

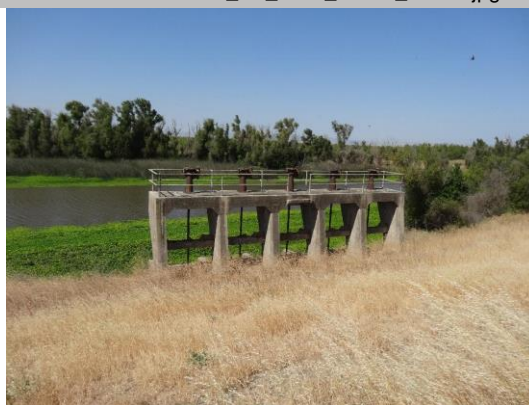
Photo 2 of 3 : UCIP_FA_2017_37609_68215.jpg

Dense vegetation covers the waterward slope.

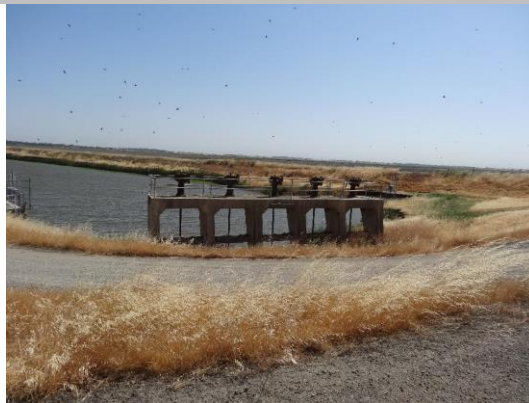
Photo 3 of 3 : UCIP_FA_2017_37610_68217.jpg

Comment Code						
Inspector Comment						
FS_ID:37610 DS_ID:22387 EP_NO: 9396 Repair Type: Non-Urgent Crossing Status: Found UCIP Comments: Need to contact owner to determine status of structure. Notes indicate crossing has been abandoned. Owner will need to coordinate with CVFPB and DWR inspector to determine how to properly abandon. FIELD_STRUCT_DESC: *ABANDONED* 3 of 5. 72-inch pipes or culvert through levee 31.6 feet below crown. Slide gates on both ends. (five 72-inch pipes [HLM 0.08] authorized under Automatic Board Order (ABO) issued as Permit No. 9736, 1974 - Reclamation District No. 108 [RD0108]) [Additional Reference(s): DWR Levee Log, 2005. USACE Sacramento O&M Manual Unit No. 132, October 1959, (HLM 0.08), referenced as five 6-foot by 8-foot concrete culvert drains]. FS Date: 6/10/2014

Concrete structure located on landward side.

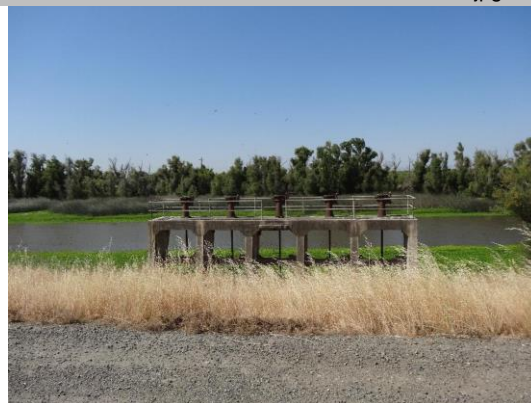
Photo 1 of 3 : UCIP_FA_2017_37611_68220.jpg

FS_ID:37611
DS_ID:22388
EP_NO: 9396
Repair Type: Non-Urgent
Crossing Status: Found
UCIP Comments: Need to contact owner to determine status of structure. Notes indicate crossing has been abandoned. Owner will need to coordinate with CVFPB and DWR inspector to determine how to properly abandon.
FIELD_STRUCT_DESC: *ABANDONED* 4 of 5. 72-inch pipes or culvert through levee 31.6 feet below crown. Slide gates on both ends. (five 72-inch pipes [HLM 0.08] authorized under Automatic Board Order (ABO) issued as Permit No. 9736, 1974 - Reclamation District No. 108 [RD0108]) [Additional Reference(s): DWR Levee Log, 2005. USACE Sacramento O&M Manual Unit No. 132, October 1959, (HLM 0.08), referenced as five 6-foot by 8-foot concrete culvert drains].
FS Date: 6/10/2014

Concrete structure located on waterward side.

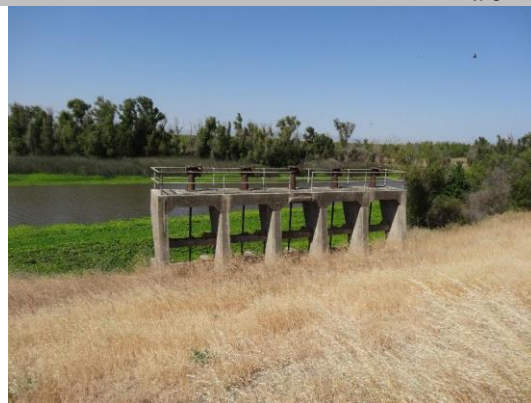
Photo 2 of 3 : UCIP_FA_2017_37611_68224.jpg

Waterward slope covered by dense vegetation.

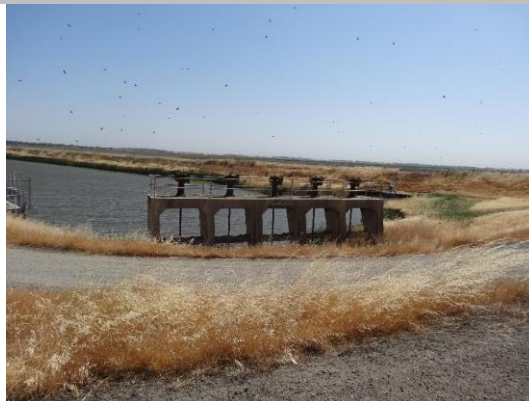
Photo 3 of 3 : UCIP_FA_2017_37611_68222.jpg

Concrete structure visible on landward side.

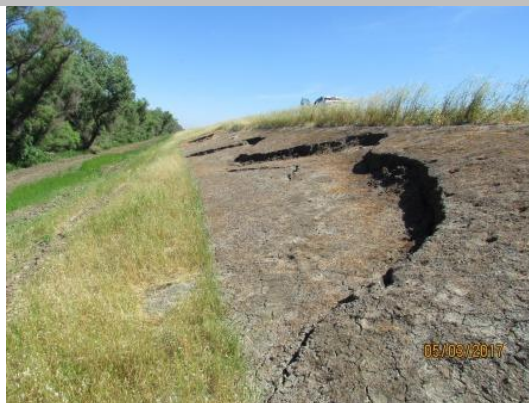
Photo 1 of 1 : FA_2017_RD0108_203_10_20170911_00002.jpg

LM Start	9.17	Rating **	A/W	Issue No.	10
LM End	9.20	Issue Type +	Ma	Location *	WS
Category	Earthen Levee			GPS Latitude/Longitude	
				Start	End
Item	Slope Stability			38.895605 °	38.896086 °
				-121.914645 °	-121.914646 °
DWR ID	DWR_RD0108_01_s_2017_10				
Comment Code					
S1 : Repair slope instability.					
Inspector Comment					
200' section of multiple sloughs. District submitted request for PL 84-99 assistance.

View of sloughing on waterside slope. Spring 2017.

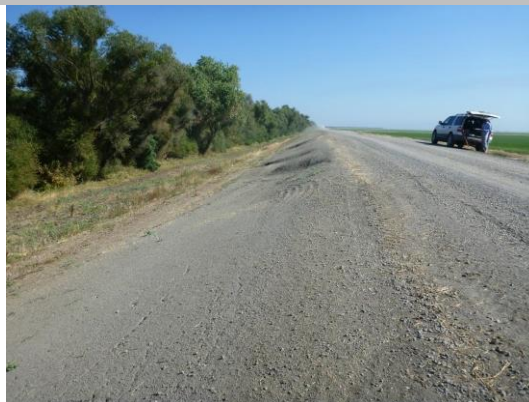
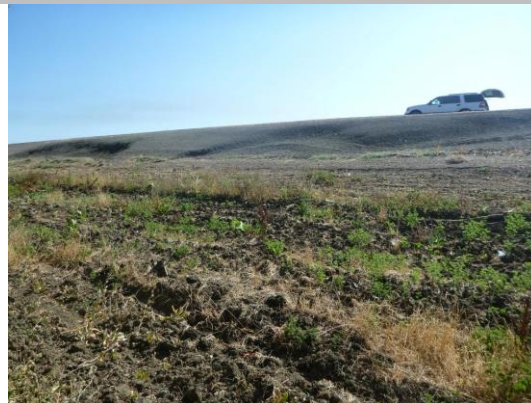
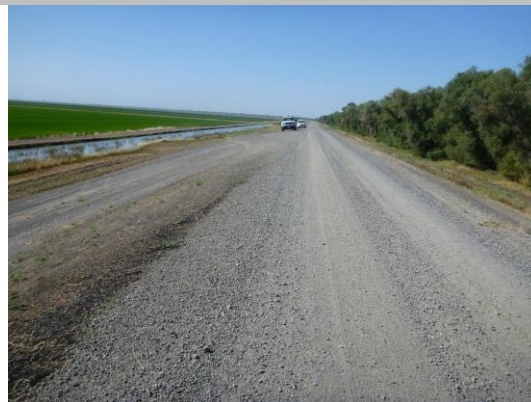
LM Start	9.18	Rating **	A/W	Issue No.	17	
LM End	9.20	Issue Type +	Ma	Location *		
Category	Supplemental			GPS Latitude/Longitude		
				Start		End
Item	2017 Storm Damage			38.895833	°	38.896142
				-121.914672		°
DWR ID	DWR_RD0108_01_f_2017_17					
Comment Code						
Inspector Comment						
Levee Evaluation Comments						
Description:						
Site ID No:220						
Site Designation:RD 108-05						
Repair Type: Erosion						
Rating:Critical						
Field Date:7/18/2017						
Notes:

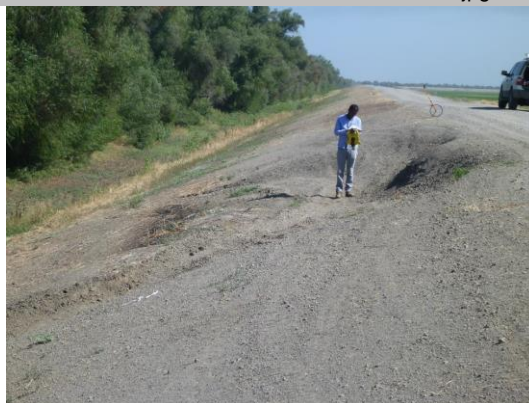
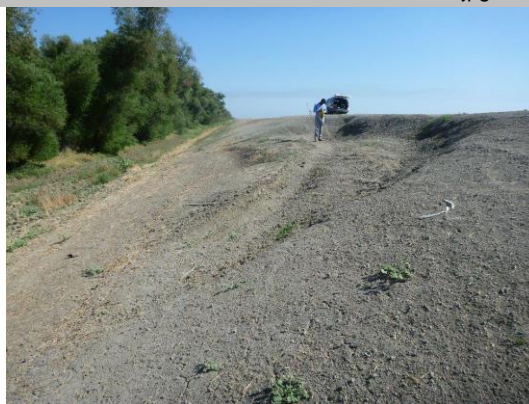
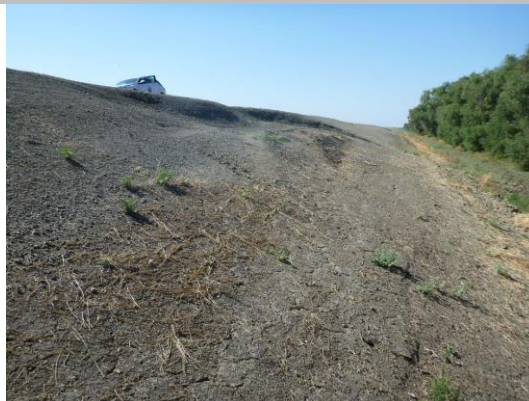
LM Start	9.29	Rating **	A/W	Issue No.	18	
LM End	9.30	Issue Type +	Ma	Location *		
Category	Supplemental			GPS Latitude/Longitude		
				Start		End
Item	2017 Storm Damage			38.897338 °	38.897583 °	
				-121.914672 °	-121.914688 °	
DWR ID	DWR_RD0108_01_f_2017_18					
Comment Code						
Inspector Comment						
Levee Evaluation Comments						
Description:						
Site ID No:219						
Site Designation:RD 108-04						
Repair Type: Erosion						
Rating:Critical						
Field Date:7/18/2017						
Notes:

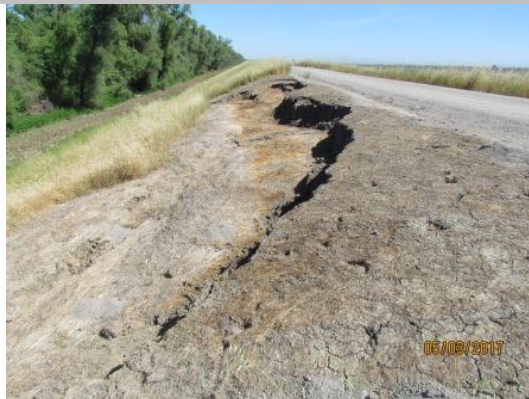
Photo 1 of 1 : FA_2017_RD0108_203_31_20170911_00011.jpg

LM Start	9.30	Rating **	A/W	Issue No.	31
LM End	9.30	Issue Type +	Ma	Location *	WS
Category	Earthen Levee			GPS Latitude/Longitude	
				Start	End
Item	Slope Stability			38.897494 °	38.897494 °
				-121.914680 °	-121.914680 °
DWR ID	DWR_RD0108_01_s_2017_31				
Comment Code					
S1 : Repair slope instability.					
Inspector Comment					
100' sloughing section on waterside slope. District submitted application for PL 84-99 assistance.

View of sloughing on waterside slope. Spring 2017.

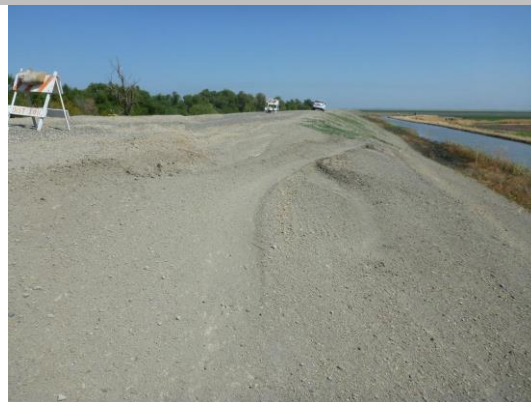
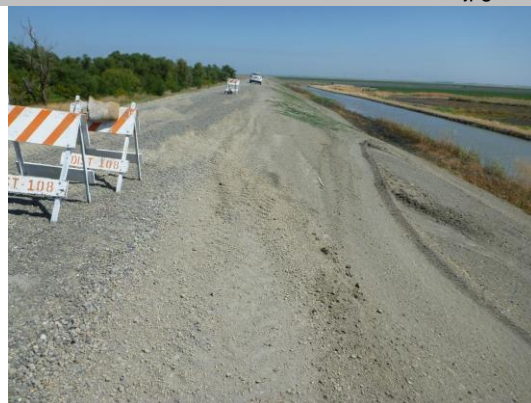
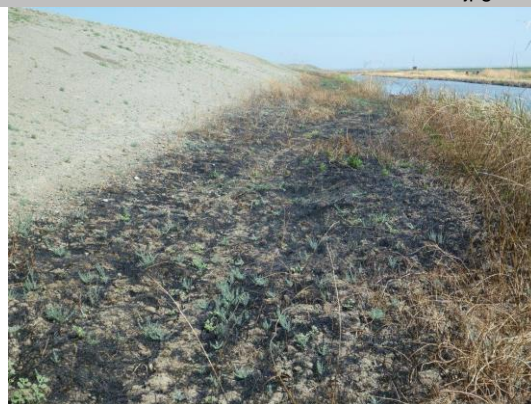
LM Start	12.68	Rating **	A/W	Issue No.	19
LM End	12.70	Issue Type +	Ma	Location *	
Category	Supplemental		GPS Latitude/Longitude		
			Start	End	
Item	2017 Storm Damage		38.945305 °	38.945717 °	
			-121.906692 °	-121.906717 °	
DWR ID	DWR_RD0108_01_f_2017_19				
Comment Code					
Inspector Comment					
Levee Evaluation Comments					
Description:					
Site ID No:218					
Site Designation:RD 108-03					
Repair Type: Erosion					
Rating:Critical					
Field Date:7/18/2017					
Notes: levee crown is inaccessible by vehicle due to crown slip failure

Notes: levee crown is inaccessible by vehicle due to crown slip failure

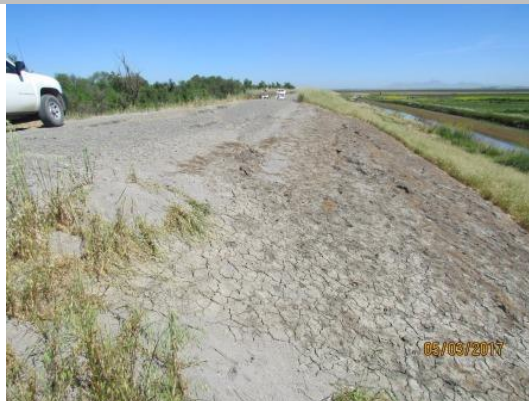
Photo 1 of 2 : FA_2017_RD0108_203_32_20170911_00012.jpg

LM Start	12.68	Rating **	A/W	Issue No.	32
LM End	12.71	Issue Type +	Ma	Location *	LS
Category	Earthen Levee			GPS Latitude/Longitude	
				Start	End
Item	Slope Stability			38.945376 °	38.945719 °
				-121.906768 °	-121.906773 °
DWR ID	DWR_RD0108_01_s_2017_32				
Comment Code					
S1 : Repair slope instability.					
Inspector Comment					
150' sloughing section on crown and landside slope. District submitted an application for PL 84-99 assistance.

View of sloughing on crown and slope. Spring 2017.

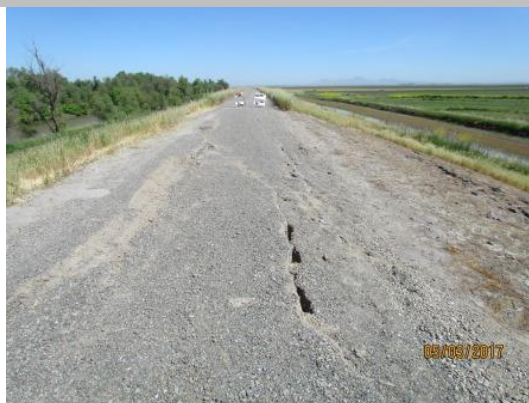
Photo 2 of 2 : FA_2017_RD0108_203_32_20170911_00013.jpg

Additional view of sloughing. Spring 2017.

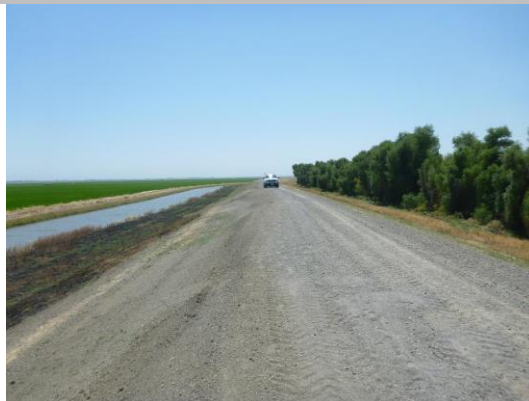
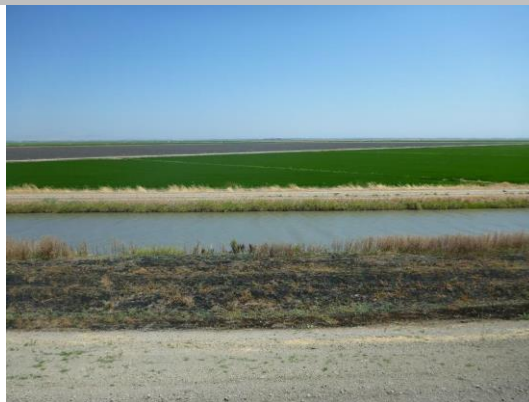
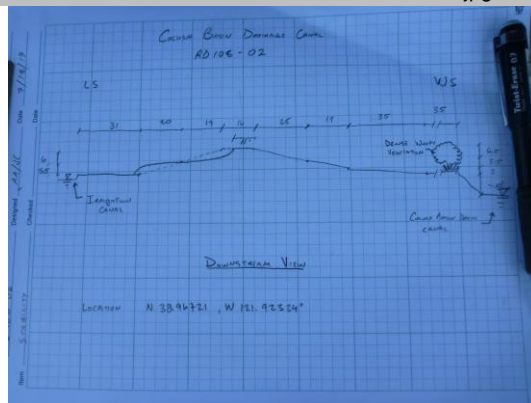
LM Start	14.47	Rating **	A/W	Issue No.	20
LM End	14.55	Issue Type +	Ma	Location *	
Category	Supplemental			GPS Latitude/Longitude	
				Start	End
Item	2017 Storm Damage			38.967062 °	38.967770 °
				-121.923103 °	-121.924178 °
DWR ID	DWR_RD0108_01_f_2017_20				
Comment Code					
Inspector Comment					
Levee Evaluation Comments					
Description:					
Site ID No:217					
Site Designation:RD 108-02					
Repair Type: Erosion					
Rating:Critical					
Field Date:7/18/2017					
Notes:

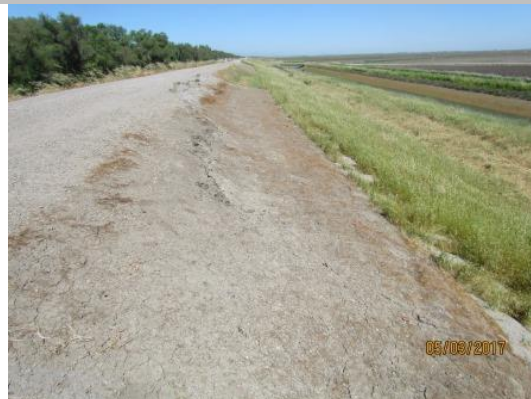
Photo 1 of 1 : FA_2017_RD0108_203_33_20170911_00014.jpg

LM Start	14.47	Rating **	A/W	Issue No.	33
LM End	14.55	Issue Type +	Ma	Location *	LS
Category	Earthen Levee			GPS Latitude/Longitude	
				Start	End
Item	Slope Stability			38.967062 °	38.967784 °
				-121.923113 °	-121.924148 °
DWR ID	DWR_RD0108_01_s_2017_33				
Comment Code					
S1 : Repair slope instability.					
Inspector Comment					
400' sloughing section on landside slope. District submitted an application for PL 84-99 assistance.

View of sloughing on landside slope. Spring 2017.

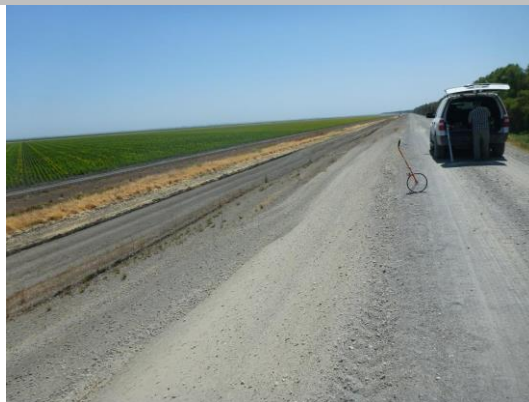
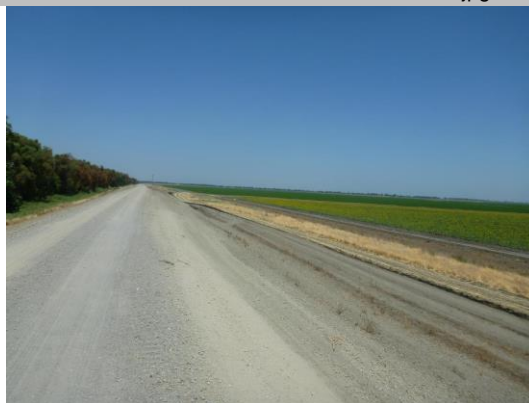
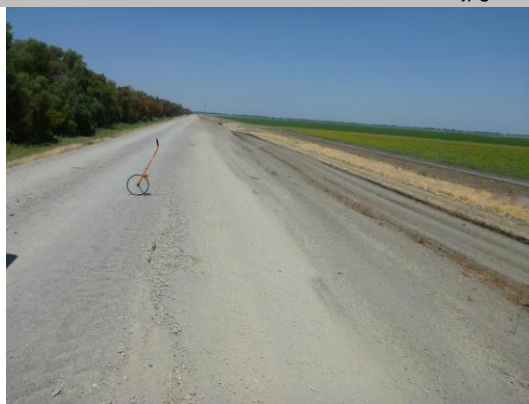
LM Start	17.26	Rating **	A/W	Issue No.	22
LM End	17.30	Issue Type +	Ma	Location *	
Category	Supplemental			GPS Latitude/Longitude	
				Start	End
Item	2017 Storm Damage			38.995187 °	38.995772 °
				-121.960158 °	-121.960617 °
DWR ID	DWR_RD0108_01_f_2017_22				
Comment Code					
Inspector Comment					
Levee Evaluation Comments					
Description:					
Site ID No:216					
Site Designation:RD 108-01					
Repair Type: Erosion					
Rating:Serious					
Field Date:7/18/2017					
Notes:

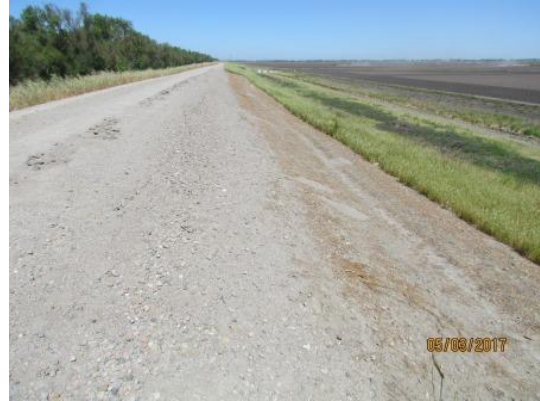
Photo 1 of 1 : FA_2017_RD0108_203_35_20170911_00015.jpg

LM Start	17.26	Rating **	A/W	Issue No.	35
LM End	17.31	Issue Type +	Ma	Location *	LS
Category	Earthen Levee			GPS Latitude/Longitude	
				Start	End
Item	Slope Stability			38.995293 °	38.995785 °
				-121.960200 °	-121.960776 °
DWR ID	DWR_RD0108_01_s_2017_35				
Comment Code					
S1 : Repair slope instability.					
Inspector Comment					
200' sloughing section on landside slope. District submitted an application for PL 84-99 assistance.

View of sloughing on landside slope. Spring 2017.

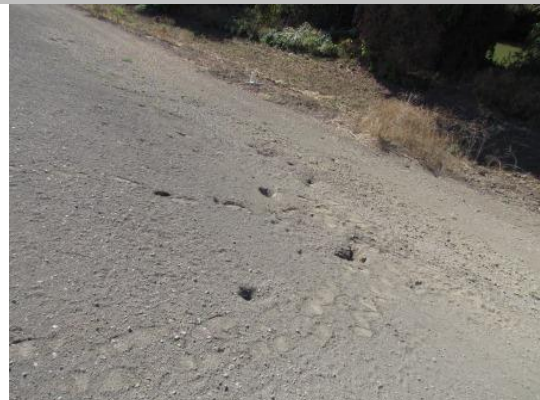
Photo 1 of 2 : FA_2017_RD0108_203_29_20170911_00009.jpg

Updated view of a site with rodent activity. Fall 2016 inspection.
