**Flood Control Project Maintenance
Levee Inspections**

Maintenance Issue Types Only, Levee Inspection Report By Mile - Fall 2019

Reclamation District No. 0108 River Farms

Waterway	Bank	Unit Miles	Inspection Start/End	Inspector
Unit No. 01 Colusa Basin Drain	Left	20.64	10/02/2019 10/02/2019	Zach Jojola

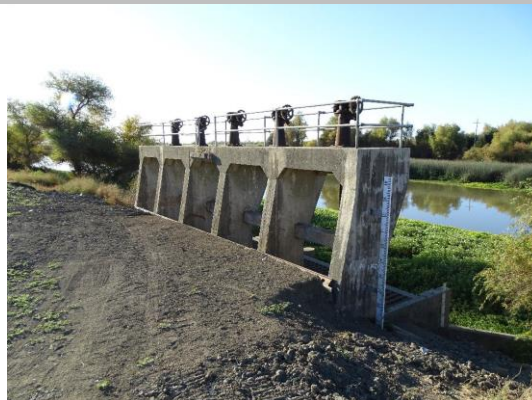
Photo 3 of 3 : UCIP_FA_2019_55920_83227.jpg

Comment Code						
Inspector Comment						
DS_ID:22386 FS_ID:55920 EP_NO: 9396 Repair Type: Non-Urgent Crossing Status: Found UCIP Comments: 10/02/2019 In 2019 RD 108 took an attempt to bring structure to operable condition. Although this attempt was unsuccessful District will review other options. In the meantime crossing considered abandoned. (O.Yakimov - DWR UCIP) 06/10/2014 Need to contact owner to determine status of structure. Notes indicate crossing has been abandoned. Owner will need to coordinate with CVFPB and DWR inspector to determine how to properly abandon. FIELD_STRUCT_DESC: *ABANDONED* 2 of 5: 72-inch reinforced concrete gravity drainage pipe or culvert through the levee, 31.6 feet below the crown. Slide gate on each end. (Retention of five 72-inch pipes through the levee [HLM 0.08] authorized under Automatic Board Order (ABO) issued as Permit No. 9736, 1974 - Reclamation District No. 108 [RD0108]). [Additional Reference(s): DWR Levee Log, 1991. USACE Sacramento O&M Manual 132, October 1959, (HLM 0.08), referenced as five 6-foot by 8-foot concrete drainage culverts]. FS Date: 8/2/2019

Concrete structure located on waterward side

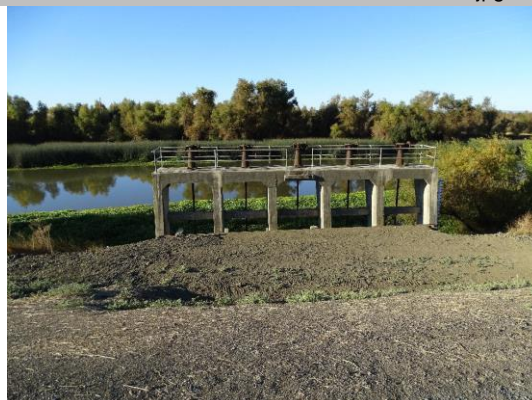
Photo 2 of 3 : UCIP_FA_2019_55922_83229.jpg

Comment Code					
Inspector Comment					
DS_ID:22388 FS_ID:55922 EP_NO: 9396 Repair Type: Non-Urgent Crossing Status: Found UCIP Comments: 10/02/2019 In 2019 RD 108 took an attempt to bring structure to operable condition. Although this attempt was unsuccessful District will review other options. In the meantime crossing considered abandoned. (O.Yakimov - DWR UCIP)06/10/2014 Need to contact owner to determine status of structure. Notes indicate crossing has been abandoned. Owner will need to coordinate with CVFPB and DWR inspector to determine how to properly abandon. FIELD_STRUCT_DESC: *ABANDONED* 4 of 5: 72-inch reinforced concrete gravity drainage pipe or culvert through the levee, 31.6 feet below the crown. Slide gate on each end. (Retention of five 72-inch pipes through the levee [HLM 0.08] authorized under Automatic Board Order (ABO) issued as Permit No. 9736, 1974 - Reclamation District No. 108 [RD0108]). [Additional Reference(s): DWR Levee Log, 1991. USACE Sacramento O&M Manual 132, October 1959, (HLM 0.08), referenced as five 6-foot by 8-foot concrete drainage culverts]. FS Date: 10/2/2019 7:59:18 AM

Concrete structure located on waterward side

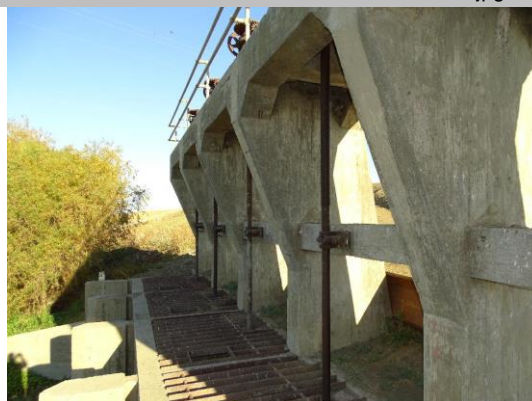
Photo 3 of 3 : UCIP_FA_2019_55922_83230.jpg

Comment Code					
Inspector Comment					
DS_ID:22388 FS_ID:55922 EP_NO: 9396 Repair Type: Non-Urgent Crossing Status: Found UCIP Comments: 10/02/2019 In 2019 RD 108 took an attempt to bring structure to operable condition. Although this attempt was unsuccessful District will review other options. In the meantime crossing considered abandoned. (O.Yakimov - DWR UCIP)06/10/2014 Need to contact owner to determine status of structure. Notes indicate crossing has been abandoned. Owner will need to coordinate with CVFPB and DWR inspector to determine how to properly abandon. FIELD_STRUCT_DESC: *ABANDONED* 4 of 5: 72-inch reinforced concrete gravity drainage pipe or culvert through the levee, 31.6 feet below the crown. Slide gate on each end. (Retention of five 72-inch pipes through the levee [HLM 0.08] authorized under Automatic Board Order (ABO) issued as Permit No. 9736, 1974 - Reclamation District No. 108 [RD0108]). [Additional Reference(s): DWR Levee Log, 1991. USACE Sacramento O&M Manual 132, October 1959, (HLM 0.08), referenced as five 6-foot by 8-foot concrete drainage culverts]. FS Date: 10/2/2019 7:59:18 AM

Slide gates on waterward side

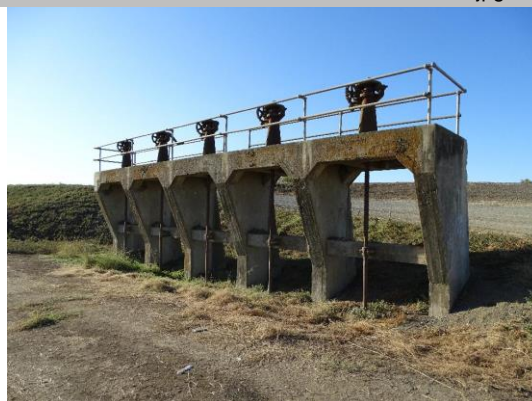
Photo 1 of 3 : UCIP_FA_2019_55923_83231.jpg

Comment Code					
Inspector Comment					
DS_ID:22389 FS_ID:55923 EP_NO: 9396 Repair Type: Non-Urgent Crossing Status: Found UCIP Comments: 10/02/2019 In 2019 RD 108 took an attempt to bring structure to operable condition. Although this attempt was unsuccessful District will review other options. In the meantime crossing considered abandoned. (O.Yakimov - DWR UCIP)06/10/2014 Need to contact owner to determine status of structure. Notes indicate crossing has been abandoned. Owner will need to coordinate with CVFPB and DWR inspector to determine how to properly abandon. FIELD_STRUCT_DESC: *ABANDONED* 5 of 5: 72-inch reinforced concrete gravity drainage pipe or culvert through the levee, 31.6 feet below the crown. Slide gate on each end. (Retention of five 72-inch pipes through the levee [HLM 0.08] authorized under Automatic Board Order (ABO) issued as Permit No. 9736, 1974 - Reclamation District No. 108 [RD0108]). [Additional Reference(s): DWR Levee Log, 1991. USACE Sacramento O&M Manual 132, October 1959, (HLM 0.08), referenced as five 6-foot by 8-foot concrete drainage culverts]. FS Date: 10/2/2019 8:01:09 AM

View of concrete structure located on landward side

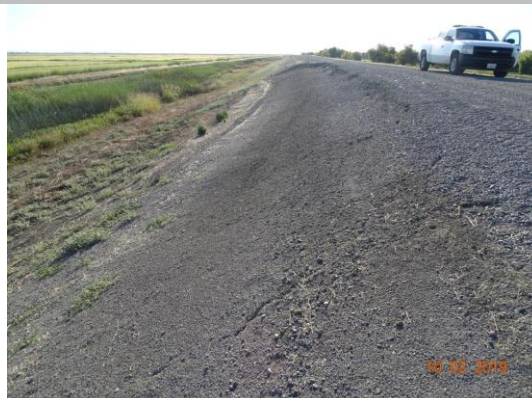
Photo 1 of 2 : FA_2019_RD0108_203_17_20191003_00031.jpg

LM Start	1.49	Rating **	M	Issue No.	17
LM End	1.51	Issue Type +	Ma	Location *	LS
Category	Earthen Levee			GPS Latitude/Longitude	
				Start	End
Item	Slope Stability			38.830951°	38.831043°
				-121.821574°	-121.821847°
DWR ID	DWR_RD0108_01_s_2019_17				
Comment Code					
S1 : Repair slope instability.					
Inspector Comment					
There appears to be a 150' sloughing section that is a result of February 2019 storms. This site will be repaired by the USACE. The LMA will place a raincoat over the damage for the next flood season.

View of the sloughing on the landside slope. Fall 2019.

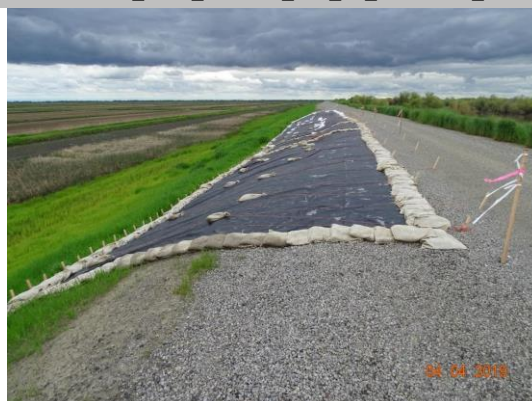
Photo 2 of 2 : FA_2019_RD0108_203_17_20190829_00006.jpg

View of the sloughing on the landside slope. Spring 2019.

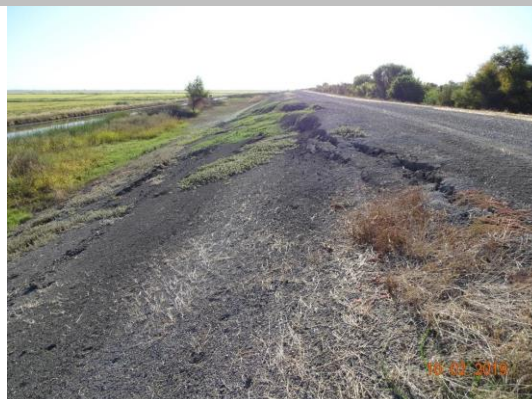
Photo 1 of 2 : FA_2019_RD0108_203_15_20191003_00032.jpg

LM Start	2.70	Rating **	M	Issue No.	15
LM End	2.73	Issue Type +	Ma	Location *	LS
Category	Earthen Levee			GPS Latitude/Longitude	
				Start	End
Item	Slope Stability			38.837568 °	38.837749 °
				-121.842218 °	-121.842776 °
DWR ID	DWR_RD0108_01_s_2019_15				
Comment Code					
S1 : Repair slope instability.					
Inspector Comment					
There appears to be a 150' sloughing section that is a result of February 2019 storms. This site will be repaired by the USACE. The LMA will place a raincoat over the damage for the next flood season.

View of the sloughing on the landside slope. Fall 2019.

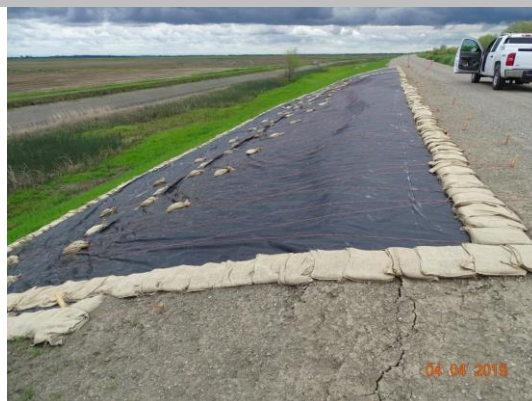
Photo 2 of 2 : FA_2019_RD0108_203_15_20190829_00003.jpg

LM Start	2.70	Rating **	M	Issue No.	15 (cont)	
LM End	2.73	Issue Type +	Ma	Location *	LS	
Category	Earthen Levee			GPS Latitude/Longitude		
				Start		End
Item	Slope Stability			38.837568 °		38.837749 °
				-121.842218 °		-121.842776 °
DWR ID	DWR_RD0108_01_s_2019_15					
Comment Code						
S1 : Repair slope instability.						
Inspector Comment						
There appears to be a 150' sloughing section that is a result of February 2019 storms. This site will be repaired by the USACE. The LMA will place a raincoat over the damage for the next flood season.

View of sloughing on the landside slope. Spring 2019.
