**Flood Control Project Maintenance  
Levee Inspections**

**Maintenance Issue Types Only, Levee Inspection Report By Mile - Fall 2020**

**Reclamation District No. 0108 River Farms**

Waterway	Bank	Unit Miles	Inspection Start/End	Inspector
Unit No. 01 Colusa Basin Drain	Left	20.64	09/10/2020 09/10/2020	Zach Jojola

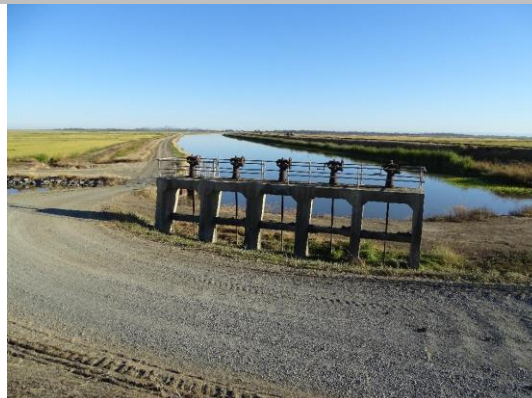
Photo 1 of 3 : UCIP\_FA\_2020\_55919\_83215.jpg

DS\_ID:17943  
FS\_ID:55919  
EP\_NO: 9736  
Repair Type: Non-Urgent  
EVAL Issue: Unauthorized Encroachment, installed decades prior  
Crossing Status: Found  
UCIP Comments: 10/2/2019 Record remains Non-Urgent. In 2019 RD 108 took an attempt to bring structure to operable condition. Although this attempt was unsuccessful District will review other options. In the meantime crossing considered abandoned. Need to have CVFPB review ABO and determine current owner. (O.Yakimov - DWR UCIP) 06/10/2014 Need to contact owner to determine status of structure. Notes indicate crossing has been abandoned. Owner will need to coordinate with CVFPB and DWR inspector to determine how to properly abandon. (O.Magana - DWR UCIP)  
FIELD\_STRUCT\_DESC: \*ABANDONED\* 1 of 5: 72-inch reinforced concrete gravity drainage pipe or culvert through the levee, 31.6 feet below the crown. Slide gate on each end. (Retention of five 72-inch pipes through the levee [HLM 0.08] authorized under Automatic Board Order (ABO) issued as Permit No. 9736, 1974 - Reclamation District No. 108 [RD0108]). [Additional Reference(s): DWR Levee Log, 1991, (HLM 0.08). USACE Sacramento O&M Manual 132, October 1959, (HLM 0.08), referenced as five 6-foot by 8-foot concrete drainage culverts].

View of LS looking from levee crown

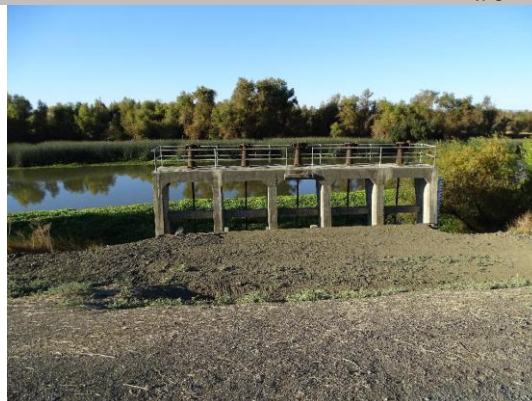
Photo 2 of 3 : UCIP\_FA\_2020\_55919\_83216.jpg

View of WS looking from levee crown

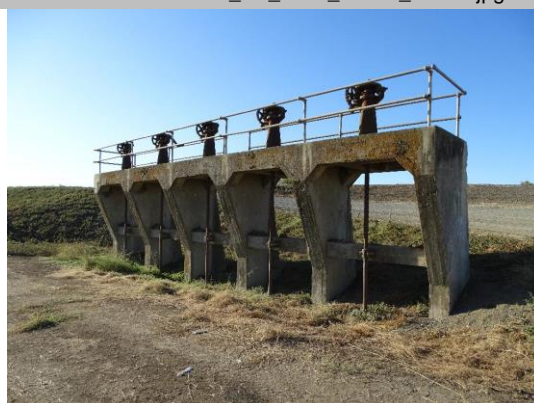
Photo 1 of 3 : UCIP\_FA\_2020\_55920\_83222.jpg

View of concrete structure located on landward side

Comment Code					
Inspector Comment					
DS_ID:22386 FS_ID:55920 EP_NO: 9396 Repair Type: Non-Urgent EVAL Issue: Unauthorized Encroachment, installed decades prior Crossing Status: Found UCIP Comments: 8/2/2019 Record remains Non-Urgent. In 2019 RD 108 took an attempt to bring structure to operable condition. Although this attempt was unsuccessful District will review other options. In the meantime crossing considered abandoned. Need to have CVFPB review ABO and determine current owner. (O.Yakimov - DWR UCIP) 06/10/2014 Need to contact owner to determine status of structure. Notes indicate crossing has been abandoned. Owner will need to coordinate with CVFPB and DWR inspector to determine how to properly abandon. (O.Magana - DWR UCIP) FIELD_STRUCT_DESC: *ABANDONED* 2 of 5: 72-inch reinforced concrete gravity drainage pipe or culvert through the levee, 31.6 feet below the crown. Slide gate on each end. (Retention of five 72-inch pipes through the levee [HLM 0.08] authorized under Automatic Board Order (ABO) issued as Permit No. 9736, 1974 - Reclamation District No. 108 [RD0108]). [Additional Reference(s): DWR Levee Log, 1991, (HLM 0.08). USACE Sacramento O&M Manual 132, October 1959, (HLM 0.08), referenced as five 6-foot by 8-foot concrete drainage culverts]. FS Date: 8/2/2019

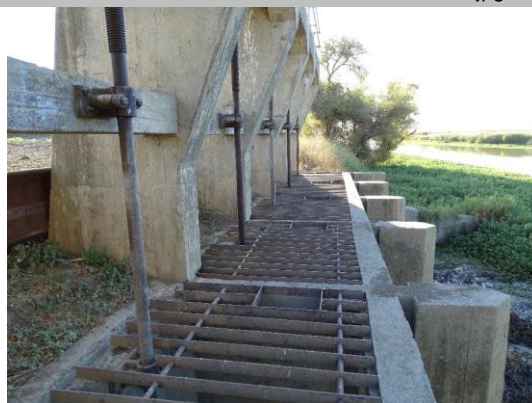
Photo 2 of 3 : UCIP\_FA\_2020\_55920\_83226.jpg

Slide gates on waterward side

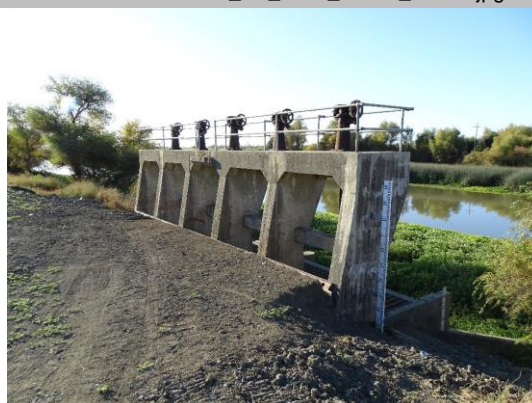
Photo 3 of 3 : UCIP\_FA\_2020\_55920\_83227.jpg

Concrete structure located on waterward side

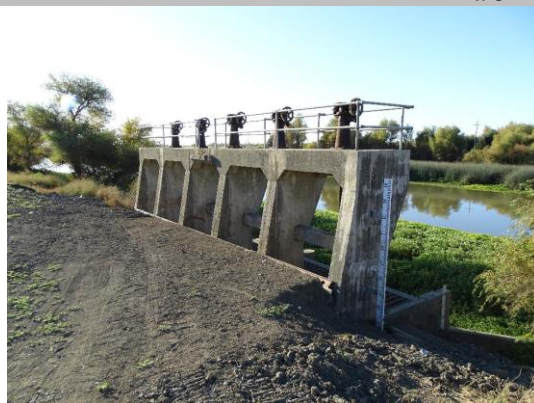
Photo 2 of 3 : UCIP\_FA\_2020\_55921\_83224.jpg

Comment Code						
Inspector Comment						
DS_ID:22387 FS_ID:55921 EP_NO: 9396 Repair Type: Non-Urgent EVAL Issue: Unauthorized Encroachment, installed decades prior Crossing Status: Found UCIP Comments: 10/2/2019 Record remains Non-Urgent. In 2019 RD 108 took an attempt to bring structure to operable condition. Although This attempt was unsuccessful District will review other options. In the meantime crossing considered abandoned. Need to have CVFPB review ABO and determine current owner. (O.Yakimov - DWR UCIP)06/10/2014 Need to contact owner to determine status of structure. Notes indicate crossing has been abandoned. Owner will need to coordinate with CVFPB and DWR inspector to determine how to properly abandon. (O.Magana - DWR UCIP) FIELD_STRUCT_DESC: *ABANDONED* 3 of 5: 72-inch reinforced concrete gravity drainage pipe or culvert through the levee, 31.6 feet below the crown. Slide gate on each end. (Retention of five 72-inch pipes through the levee [HLM 0.08] authorized under Automatic Board Order (ABO) issued as Permit No. 9736, 1974 - Reclamation District No. 108 [RD0108]). [Additional Reference(s): DWR Levee Log, 1991. USACE Sacramento O&M Manual 132, October 1959, (HLM 0.08), referenced as five 6-foot by 8-foot concrete drainage culverts]. FS Date: 10/2/2019 7:54:00 AM

Concrete structure located on waterward side

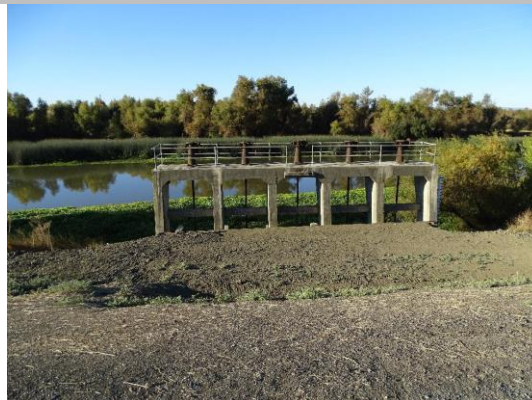
Photo 2 of 3 : UCIP\_FA\_2020\_55922\_83229.jpg

DS\_ID:22388  
FS\_ID:55922  
EP\_NO: 9396  
Repair Type: Non-Urgent  
EVAL Issue: Unauthorized Encroachment, installed decades prior  
Crossing Status: Found  
UCIP Comments: 10/2/2019 Record remains Non-Urgent. In 2019 RD 108 took an attempt to bring structure to operable condition. Although this attempt was unsuccessful District will review other options. In the meantime crossing considered abandoned. Need to have CVFPB review ABO and determine current owner. (O.Yakimov - DWR UCIP)06/10/2014 Need to contact owner to determine status of structure. Notes indicate crossing has been abandoned. Owner will need to coordinate with CVFPB and DWR inspector to determine how to properly abandon. (O.Magana - DWR UCIP)  
FIELD\_STRUCT\_DESC: \*ABANDONED\* 4 of 5: 72-inch reinforced concrete gravity drainage pipe or culvert through the levee, 31.6 feet below the crown. Slide gate on each end. (Retention of five 72-inch pipes through the levee [HLM 0.08] authorized under Automatic Board Order (ABO) issued as Permit No. 9736, 1974 - Reclamation District No. 108 [RD0108]). [Additional Reference(s): DWR Levee Log, 1991, (HLM 0.08). USACE Sacramento O&M Manual 132, October 1959, (HLM 0.08), referenced as five 6-foot by 8-foot concrete drainage culverts].

Concrete structure located on waterward side

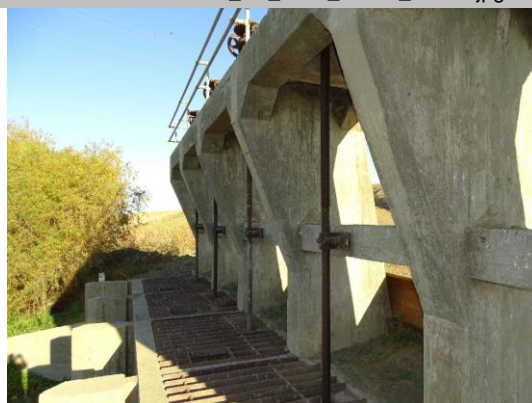
Photo 3 of 3 : UCIP\_FA\_2020\_55922\_83230.jpg

Slide gates on waterward side

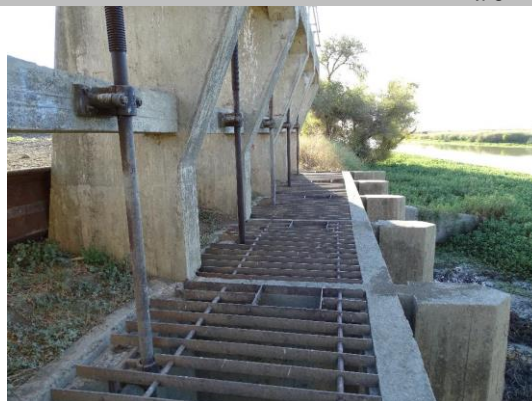
Photo 2 of 3 : UCIP\_FA\_2020\_55923\_83232.jpg

Comment Code					
Inspector Comment					
DS_ID:22389 FS_ID:55923 EP_NO: 9396 Repair Type: Non-Urgent EVAL Issue: Unauthorized Encroachment, installed decades prior Crossing Status: Found UCIP Comments: 10/2/2019 Record remains Non-Urgent. In 2019 RD 108 took an attempt to bring structure to operable condition. Although this attempt was unsuccessful District will review other options. In the meantime crossing considered abandoned. Need to have CVFPB review ABO and determine current owner. (O.Yakimov - DWR UCIP)06/10/2014 Need to contact owner to determine status of structure. Notes indicate crossing has been abandoned. Owner will need to coordinate with CVFPB and DWR inspector to determine how to properly abandon. (O.Magana - DWR UCIP) FIELD_STRUCT_DESC: *ABANDONED* 5 of 5: 72-inch reinforced concrete gravity drainage pipe or culvert through the levee, 31.6 feet below the crown. Slide gate on each end. (Retention of five 72-inch pipes through the levee [HLM 0.08] authorized under Automatic Board Order (ABO) issued as Permit No. 9736, 1974 - Reclamation District No. 108 [RD0108]). [Additional Reference(s): DWR Levee Log, 1991. USACE Sacramento O&M Manual 132, October 1959, (HLM 0.08), referenced as five 6-foot by 8-foot concrete drainage culverts]. FS Date: 10/2/2019 8:01:09 AM

Slide gates on waterward side

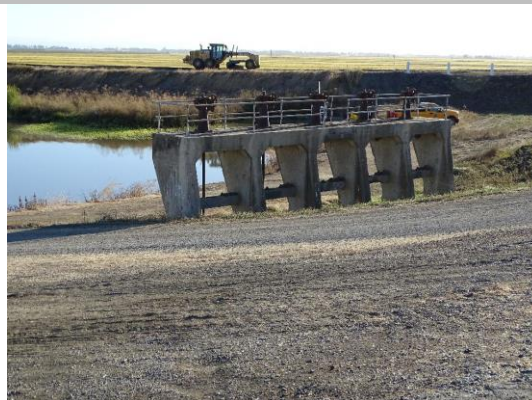
Photo 3 of 3 : UCIP\_FA\_2020\_55923\_83233.jpg

Concrete structure located on waterward side

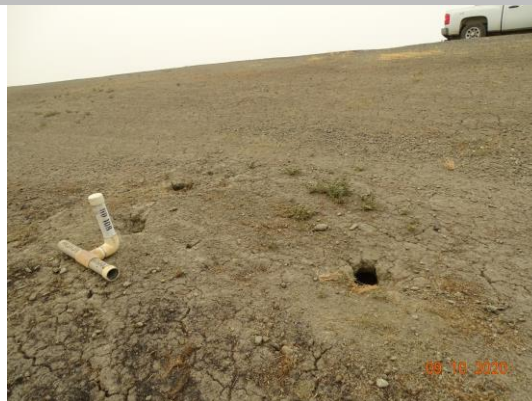
Photo 1 of 1 : FA\_2020\_RD0108\_203\_21\_20200911\_00045.jpg

LM Start	0.55	Rating **	M	Issue No.	21
LM End	0.55	Issue Type +	Ma	Location *	LS
Category	Earthen Levee			GPS Latitude/Longitude	
				Start	End
Item	Animal Control			38.825729 °	38.825729 °
				-121.805307 °	-121.805307 °
DWR ID	DWR_RD0108_01_f_2020_21				
Comment Code					
A3 : No rodents visible, but rodent burrows visible; need to backfill and compact or grout burrows.					
Inspector Comment					
Rodent holes near the landside toe.

View of rodent holes on the landside slope. Fall 2020.

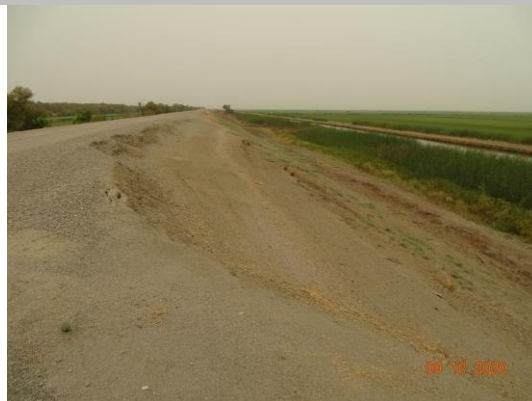
Photo 1 of 2 : FA\_2020\_RD0108\_203\_17\_20200911\_00046.jpg

LM Start	1.49	Rating **	M	Issue No.	17
LM End	1.51	Issue Type +	Ma	Location *	LS
Category	Earthen Levee			GPS Latitude/Longitude	
				Start	End
Item	Slope Stability			38.830951 °	38.831043 °
				-121.821574 °	-121.821847 °
DWR ID	DWR_RD0108_01_s_2020_17				
Comment Code					
S1 : Repair slope instability.					
Inspector Comment					
There appears to be a 150' sloughing section that is a result of February 2019 storms. This site will be repaired by the USACE under PL84-99. There are minor new cracks forming adjacent to the sloughing.

View of sloughing on the landside slope. Fall 2020.

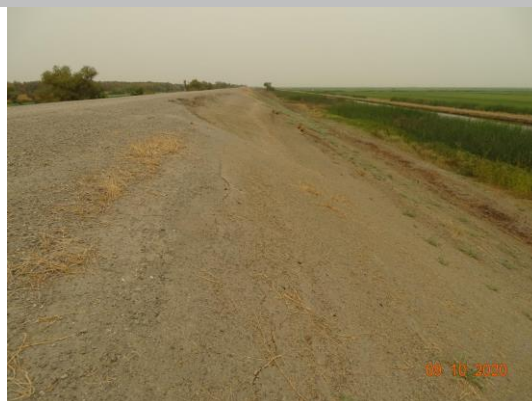
Photo 2 of 2 : FA\_2020\_RD0108\_203\_17\_20200911\_00047.jpg

View of new cracks adjacent to sloughing. Fall 2020.

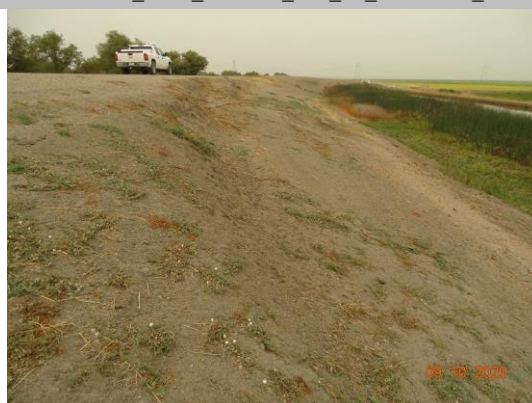
Photo 1 of 1 : FA\_2020\_RD0108\_203\_15\_20200911\_00048.jpg

There appears to be a 150' sloughing section that is a result of February 2019 storms. This site will be repaired by the USACE under PL84-99

View of sloughing on landside slope. Fall 2020.

S1 : Repair slope instability.

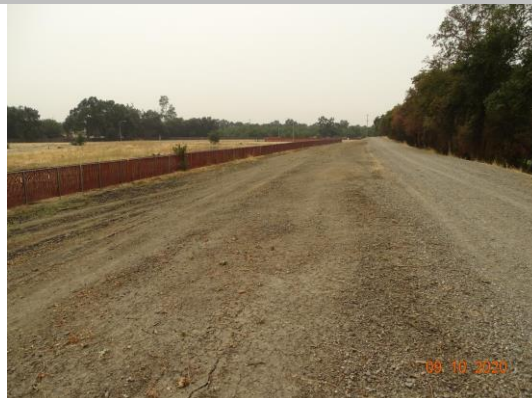
Photo 1 of 1 : FA\_2020\_RD0108\_590\_1\_20200911\_00001.jpg

LM Start	0.21	Rating **	A	Issue No.	1
LM End	0.21	Issue Type +	Ma	Location *	LS
Category	Earthen Levee			GPS Latitude/Longitude	
				Start	End
Item	Vegetation			38.798368 °	38.798368 °
				-121.725380 °	-121.725380 °
DWR ID	DWR_RD0108_02_f_2020_1				
Comment Code					
V1 : Control annual grass and weeds on the levee slopes and easements.					
Inspector Comment					
The LMA maintains the vegetation at a high level.

View of maintained landside slope. Fall 2020.
