**Flood Control Project Maintenance
Levee Inspections**

Maintenance Issue Types Only, Levee Inspection Report By Mile - Fall 2021

Reclamation District No. 0108 River Farms

Waterway	Bank	Unit Miles	Inspection Start/End	Inspector
Unit No. 01 Colusa Basin Drain	Left	20.64	09/10/2021 09/10/2021	Zach Jojola

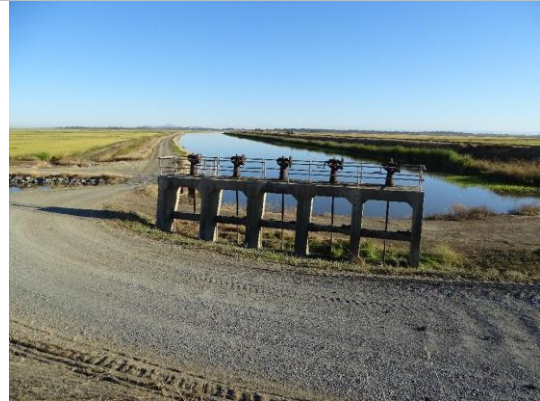
Photo 1 of 3 : UCIP_FA_2021_55919_83215.jpg

Comment Code						
Inspector Comment						
DS_ID:17943 FS_ID:55919 EP_NO: 9736 Repair Type: Non-Urgent EVAL Issue: Unauthorized Encroachment, installed decades prior Crossing Status: Found UCIP Comments: 10/2/2019 Record remains Non-Urgent. In 2019 RD 108 took an attempt to bring structure to operable condition. Although this attempt was unsuccessful District will review other options. In the meantime crossing considered abandoned. Need to have CVFPB review ABO and determine current owner. (O.Yakimov - DWR UCIP) 06/10/2014 Need to contact owner to determine status of structure. Notes indicate crossing has been abandoned. Owner will need to coordinate with CVFPB and DWR inspector to determine how to properly abandon. (O.Magana - DWR UCIP) FIELD_STRUCT_DESC: *ABANDONED* 1 of 5: 72-inch reinforced concrete gravity drainage pipe or culvert through the levee, 31.6 feet below the crown. Slide gate on each end. (Retention of five 72-inch pipes through the levee [HLM 0.08] authorized under Automatic Board Order (ABO) issued as Permit No. 9736, 1974 - Reclamation District No. 108 [RD0108]). [Additional Reference(s): DWR Levee Log, 1991, (HLM 0.08). USACE Sacramento O&M Manual 132, October 1959, (HLM 0.08), referenced as five 6-foot by 8-foot concrete drainage culverts]. FS Date: 10/2/2019

View of LS looking from levee crown

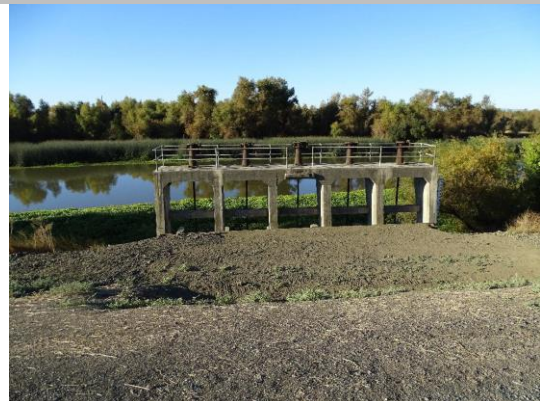
Photo 2 of 3 : UCIP_FA_2021_55919_83216.jpg

View of WS looking from levee crown

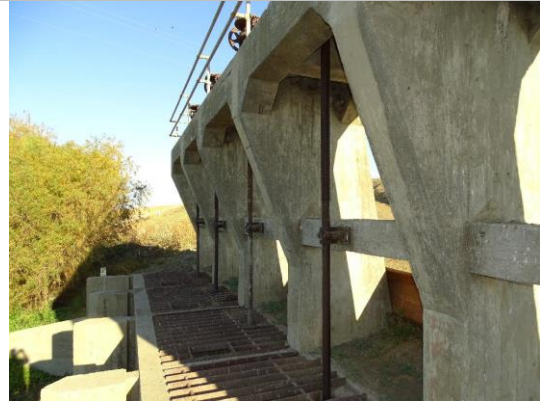
Photo 3 of 3 : UCIP_FA_2021_55919_83217.jpg

Slide gate operating structure on WS shoulder

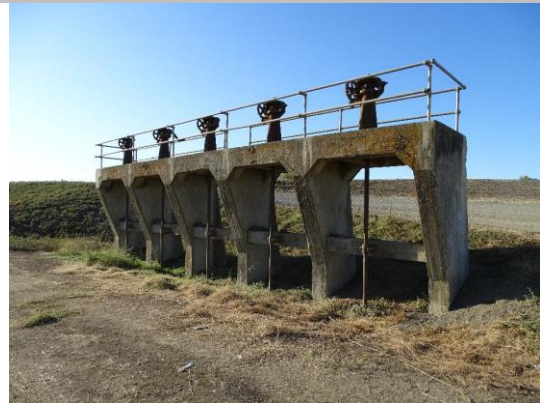
Photo 1 of 3 : UCIP_FA_2021_55920_83222.jpg

DS_ID:22386
FS_ID:55920
EP_NO: 9396
Repair Type: Non-Urgent
EVAL Issue: Unauthorized Encroachment, installed decades prior
Crossing Status: Found
UCIP Comments: 8/2/2019 Record remains Non-Urgent. In 2019 RD 108 took an attempt to bring structure to operable condition. Although this attempt was unsuccessful District will review other options. In the meantime crossing considered abandoned. Need to have CVFPB review ABO and determine current owner. (O.Yakimov - DWR UCIP) 06/10/2014 Need to contact owner to determine status of structure. Notes indicate crossing has been abandoned. Owner will need to coordinate with CVFPB and DWR inspector to determine how to properly abandon. (O.Magana - DWR UCIP)
FIELD_STRUCT_DESC: *ABANDONED* 2 of 5: 72-inch reinforced concrete gravity drainage pipe or culvert through the levee, 31.6 feet below the crown. Slide gate on each end. (Retention of five 72-inch pipes through the levee [HLM 0.08] authorized under Automatic Board Order (ABO) issued as Permit No. 9736, 1974 - Reclamation District No. 108 [RD0108]). [Additional Reference(s): DWR Levee Log, 1991, (HLM 0.08). USACE Sacramento O&M Manual 132, October 1959, (HLM 0.08), referenced as five 6-foot by 8-foot concrete drainage culverts].

View of concrete structure located on landward side

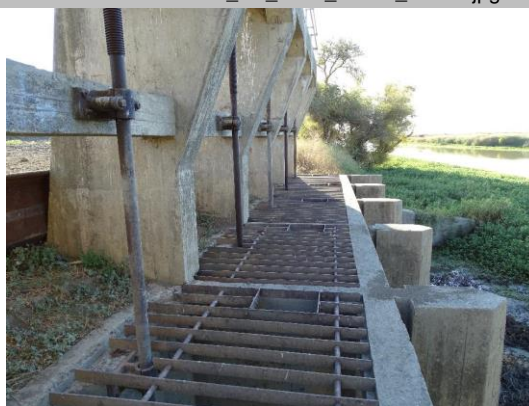
Photo 2 of 3 : UCIP_FA_2021_55920_83226.jpg

Slide gates on waterward side

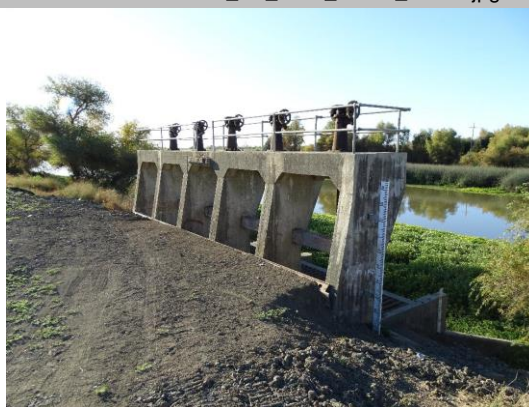
Photo 3 of 3 : UCIP_FA_2021_55920_83227.jpg

Concrete structure located on waterward side

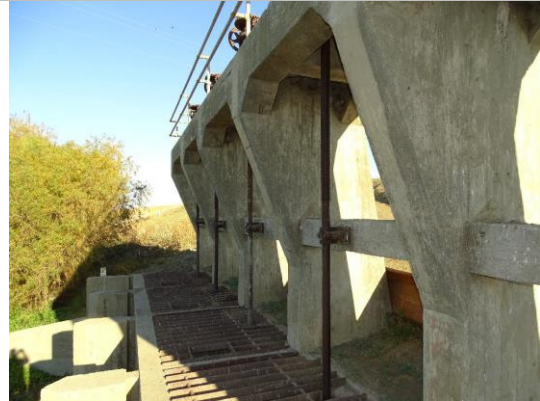
Photo 1 of 3 : UCIP_FA_2021_55921_83223.jpg

Comment Code						
Inspector Comment						
DS_ID:22387 FS_ID:55921 EP_NO: 9396 Repair Type: Non-Urgent EVAL Issue: Unauthorized Encroachment, installed decades prior Crossing Status: Found UCIP Comments: 10/2/2019 Record remains Non-Urgent. In 2019 RD 108 took an attempt to bring structure to operable condition. Although This attempt was unsuccessfull District will review other options. In the meantime crossing considered abandoned. Need to have CVFPB review ABO and determine current owner. (O.Yakimov - DWR UCIP)06/10/2014 Need to contact owner to determine status of structure. Notes indicate crossing has been abandoned. Owner will need to coordinate with CVFPB and DWR inspector to determine how to properly abandon. (O.Magana - DWR UCIP) FIELD_STRUCT_DESC: *ABANDONED* 3 of 5: 72-inch reinforced concrete gravity drainage pipe or culvert through the levee, 31.6 feet below the crown. Slide gate on each end. (Retention of five 72-inch pipes through the levee [HLM 0.08] authorized under Automatic Board Order (ABO) issued as Permit No. 9736, 1974 - Reclamation District No. 108 [RD0108]). [Additional Reference(s): DWR Levee Log, 1991. USACE Sacramento O&M Manual 132, October 1959, (HLM 0.08), referenced as five 6-foot by 8-foot concrete drainage culverts]. FS Date: 10/2/2019 7:54:00 AM

Slide gates on waterward side

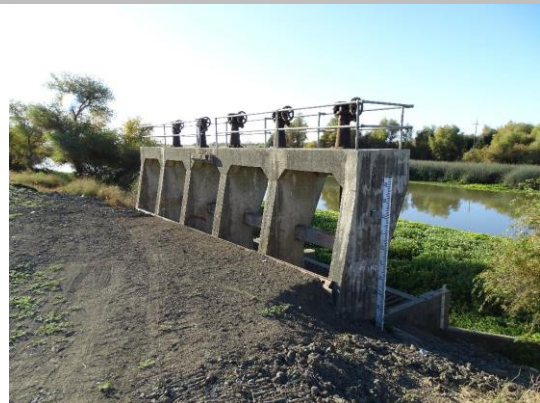
Photo 2 of 3 : UCIP_FA_2021_55921_83224.jpg

Concrete structure located on waterward side

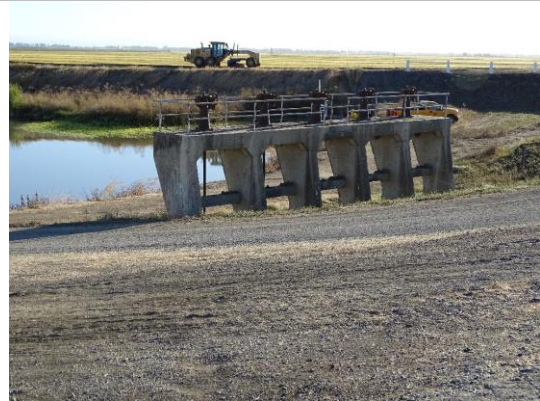
Photo 3 of 3 : UCIP_FA_2021_55921_83225.jpg

Concrete structure located onlandward side

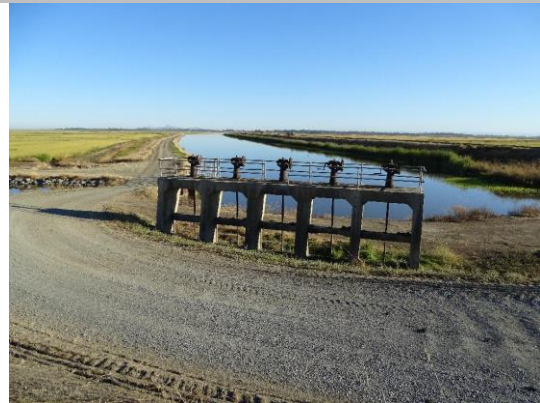
Photo 1 of 3 : UCIP_FA_2021_55922_83228.jpg

DS_ID:22388
FS_ID:55922
EP_NO: 9396
Repair Type: Non-Urgent
EVAL Issue: Unauthorized Encroachment, installed decades prior
Crossing Status: Found
UCIP Comments: 10/2/2019 Record remains Non-Urgent. In 2019 RD 108 took an attempt to bring structure to operable condition. Although this attempt was unsuccessful District will review other options. In the meantime crossing considered abandoned. Need to have CVFPB review ABO and determine current owner. (O.Yakimov - DWR UCIP)06/10/2014 Need to contact owner to determine status of structure. Notes indicate crossing has been abandoned. Owner will need to coordinate with CVFPB and DWR inspector to determine how to properly abandon. (O.Magana - DWR UCIP)
FIELD_STRUCT_DESC: *ABANDONED* 4 of 5: 72-inch reinforced concrete gravity drainage pipe or culvert through the levee, 31.6 feet below the crown. Slide gate on each end. (Retention of five 72-inch pipes through the levee [HLM 0.08] authorized under Automatic Board Order (ABO) issued as Permit No. 9736, 1974 - Reclamation District No. 108 [RD0108]). [Additional Reference(s): DWR Levee Log, 1991, (HLM 0.08). USACE Sacramento O&M Manual 132, October 1959, (HLM 0.08), referenced as five 6-foot by 8-foot concrete drainage culverts].

View of concrete structure located on landward side

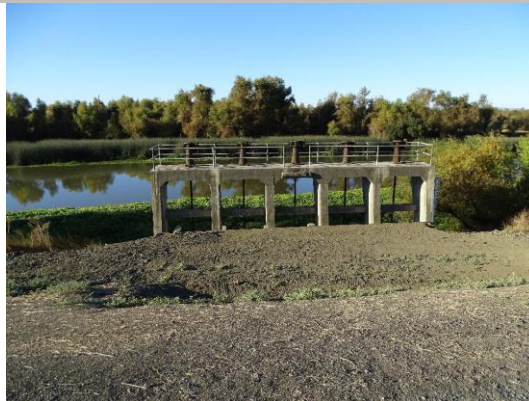
Photo 2 of 3 : UCIP_FA_2021_55922_83229.jpg

Concrete structure located on waterward side

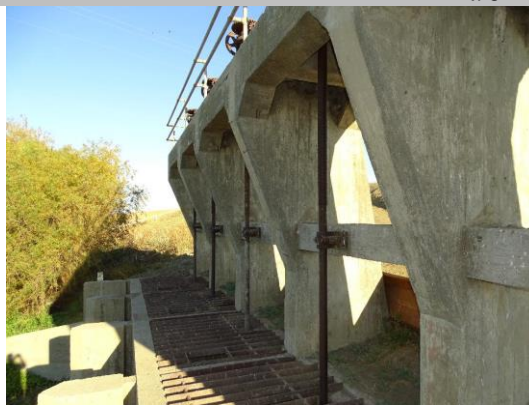
Photo 3 of 3 : UCIP_FA_2021_55922_83230.jpg

Slide gates on waterward side

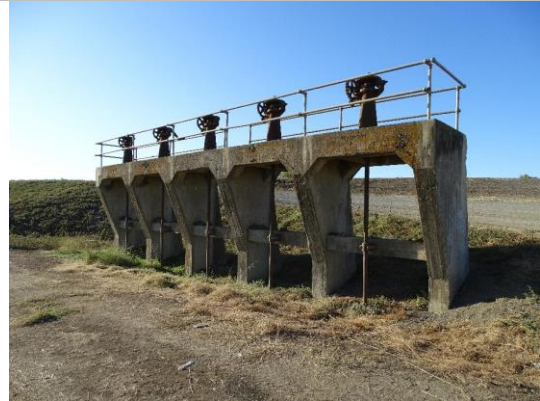
Photo 1 of 3 : UCIP_FA_2021_55923_83231.jpg

Comment Code						
Inspector Comment						
DS_ID:22389 FS_ID:55923 EP_NO: 9396 Repair Type: Non-Urgent EVAL Issue: Unauthorized Encroachment, installed decades prior Crossing Status: Found UCIP Comments: 10/2/2019 Record remains Non-Urgent. In 2019 RD 108 took an attempt to bring structure to operable condition. Although this attempt was unsuccessful District will review other options. In the meantime crossing considered abandoned. Need to have CVFPB review ABO and determine current owner. (O.Yakimov - DWR UCIP)06/10/2014 Need to contact owner to determine status of structure. Notes indicate crossing has been abandoned. Owner will need to coordinate with CVFPB and DWR inspector to determine how to properly abandon. (O.Magana - DWR UCIP) FIELD_STRUCT_DESC: *ABANDONED* 5 of 5: 72-inch reinforced concrete gravity drainage pipe or culvert through the levee, 31.6 feet below the crown. Slide gate on each end. (Retention of five 72-inch pipes through the levee [HLM 0.08] authorized under Automatic Board Order (ABO) issued as Permit No. 9736, 1974 - Reclamation District No. 108 [RD0108]). [Additional Reference(s): DWR Levee Log, 1991. USACE Sacramento O&M Manual 132, October 1959, (HLM 0.08), referenced as five 6-foot by 8-foot concrete drainage culverts]. FS Date: 10/2/2019 8:01:09 AM

View of concrete structure located on landward side

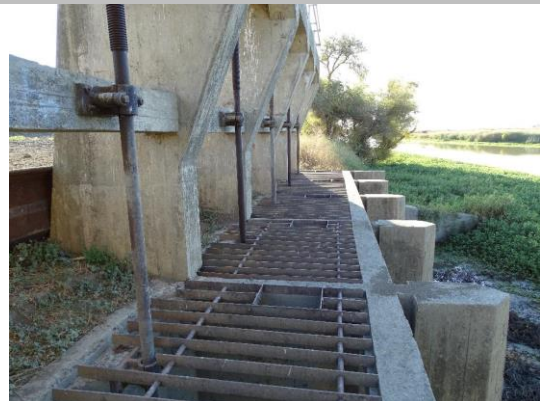
Photo 2 of 3 : UCIP_FA_2021_55923_83232.jpg

Slide gates on waterward side

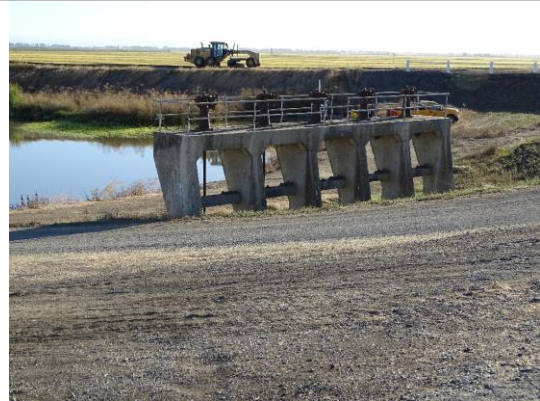
Photo 3 of 3 : UCIP_FA_2021_55923_83233.jpg

Concrete structure located on waterward side

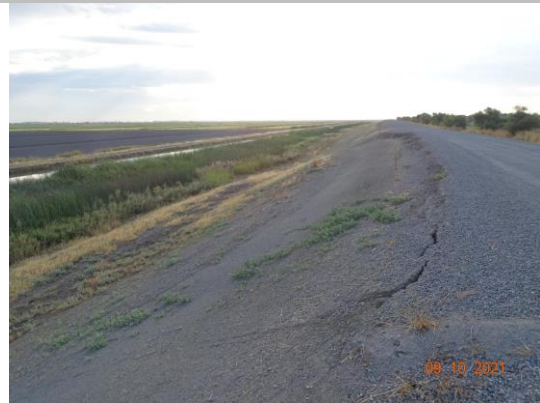
Photo 1 of 1 : FA_2021_RD0108_203_17_20210910_00037.jpg

There appears to be a 150' sloughing section that is a result of February 2019 storms. This site will be repaired by the USACE under PL84-99. There are minor new cracks forming adjacent to the sloughing.

View of sloughing on landside slope. Fall 2021.

S1 : Repair slope instability.

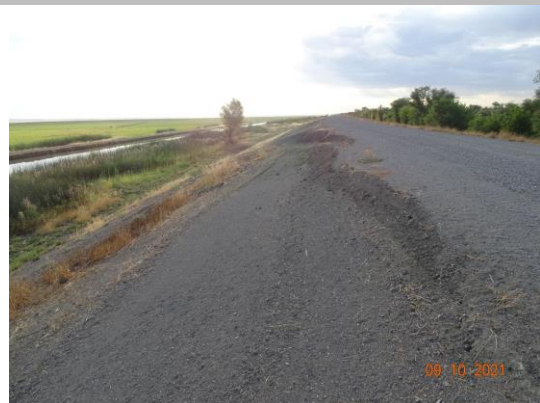
Photo 1 of 1 : FA_2021_RD0108_203_15_20210910_00038.jpg

There appears to be a 150' sloughing section that is a result of February 2019 storms. This site will be repaired by the USACE under PL84-99

View of sloughing on landside slope. Fall 2021.

S1 : Repair slope instability.

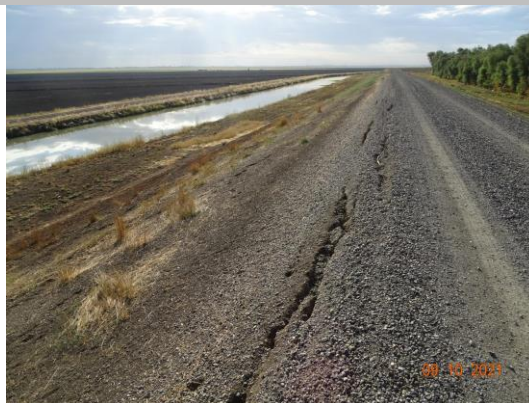
Photo 1 of 1 : FA_2021_RD0108_203_20_20210910_00039.jpg

LM Start	14.49	Rating **	A/W	Issue No.	20
LM End	14.49	Issue Type +	Ma	Location *	LS
Category	Earthen Levee			GPS Latitude/Longitude	
				Start	End
Item	Cracking			38.967259 °	38.967259 °
				-121.923417 °	-121.923417 °
DWR ID	DWR_RD0108_01_f_2021_20				
Comment Code					
CR1 : Monitor and have inspected by geotechnical engineer.					
Inspector Comment					
Approximately 50' of desiccation cracking on the landside hinge point. Appears to be stable. Recommend monitoring.

View of cracking on landside slope. Fall 2021.

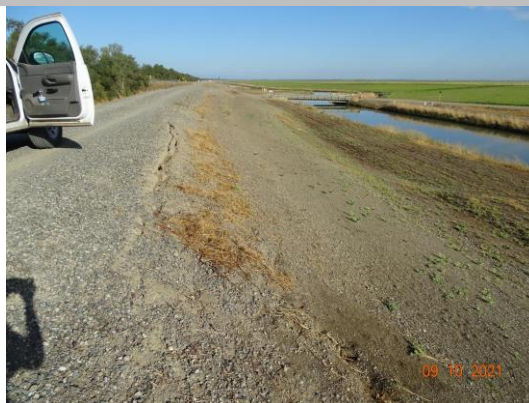
Photo 1 of 1 : FA_2021_RD0108_203_21_20210910_00040.jpg

LM Start	14.57	Rating **	A/W	Issue No.	21
LM End	14.59	Issue Type +	Ma	Location *	LS
Category	Earthen Levee			GPS Latitude/Longitude	
				Start	End
Item	Cracking			38.968018 °	38.968197 °
				-121.924498 °	-121.924735 °
DWR ID	DWR_RD0108_01_f_2021_21				
Comment Code					
CR1 : Monitor and have inspected by geotechnical engineer.					
Inspector Comment					
Approximately 120' of desiccation cracking on the landside hinge point. Appears to be stable. Recommend monitoring.

View of cracking on the landside slope. Fall 2021.

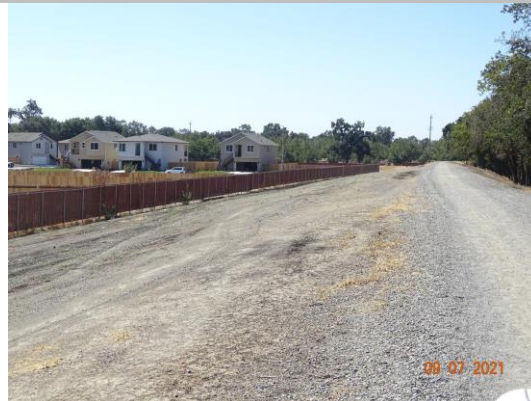
Photo 1 of 1 : FA_2021_RD0108_590_1_20210907_00001.jpg

LM Start	0.21	Rating **	A	Issue No.	1
LM End	0.21	Issue Type +	Ma	Location *	LS
Category	Earthen Levee			GPS Latitude/Longitude	
				Start	End
Item	Vegetation			38.798461 °	38.798461 °
				-121.725305 °	-121.725305 °
DWR ID	DWR_RD0108_02_f_2021_1				
Comment Code					
V1 : Control annual grass and weeds on the levee slopes and easements.					
Inspector Comment					
The LMA maintains the vegetation at a high level.

View of maintained landside slope. Fall 2021.
