**Flood Control Project Maintenance  
Levee Inspections**

**Maintenance Issue Types Only, Levee Inspection Report By Mile - Fall 2022**

**Reclamation District No. 0108 River Farms**

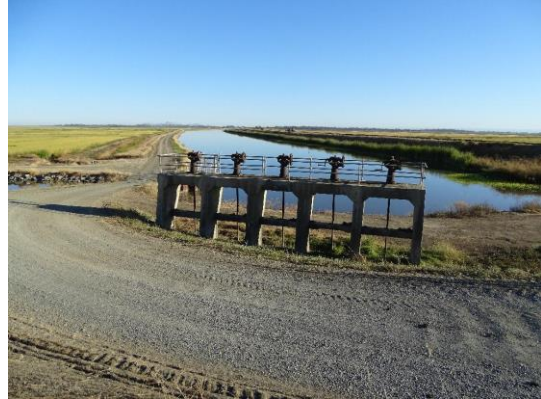
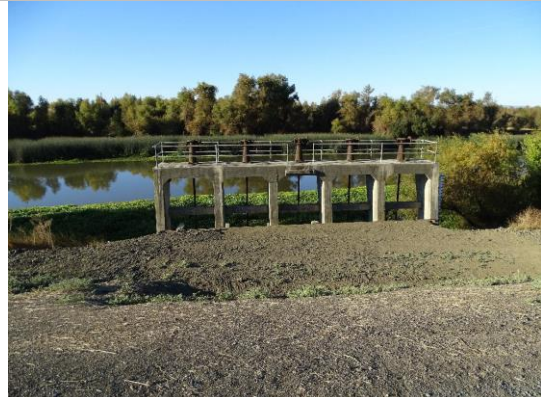
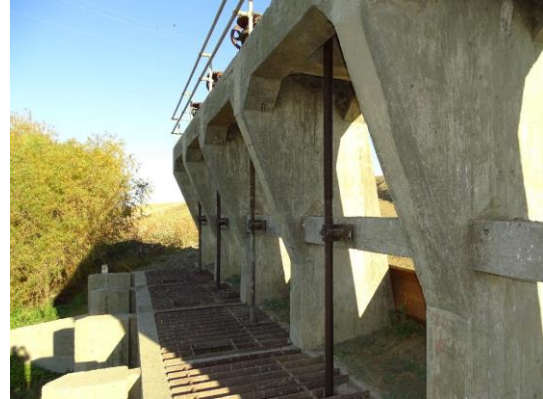
| DS_ID:17943<br>FS_ID:55919<br>EP_NO: 9736<br>Repair Type: Non-Urgent<br>EVAL Issue:<br>Crossing Status: Found<br>UCIP Comments: 10/2/2019 Record remains Non-Urgent. In 2019 RD 108 took an attempt to bring structure to operable condition. Although this attempt was unsuccessful District will review other options. In the meantime crossing considered abandoned. Need to have CVFPB review ABO and determine current owner. (O.Yakimov - DWR UCIP) 06/10/2014 Need to contact owner to determine status of structure. Notes indicate crossing has been abandoned. Owner will need to coordinate with CVFPB and DWR inspector to determine how to properly abandon. (O.Magana - DWR UCIP)<br>FIELD_STRUCT_DESC: *ABANDONED* 1 of 5: 72-inch reinforced concrete gravity drainage pipe or culvert through the levee, 31.6 feet below the crown. Slide gate on each end. (Retention of five 72-inch pipes through the levee [HLM 0.08] authorized under Automatic Board Order (ABO) issued as Permit No. 9736, 1974 - Reclamation District No. 108 [RD0108]). [Additional Reference(s): DWR Levee Log, 1991, (HLM 0.08). USACE Sacramento O&M Manual 132, October 1959, (HLM 0.08), referenced as five 6-foot by 8-foot concrete drainage culverts].<br>FS Date: 10/2/2019 | | | | | | |

View of LS looking from levee crown

View of WS looking from levee crown

Slide gate operating structure on WS shoulder

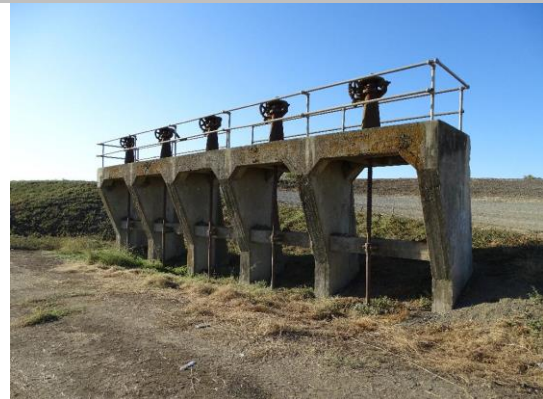
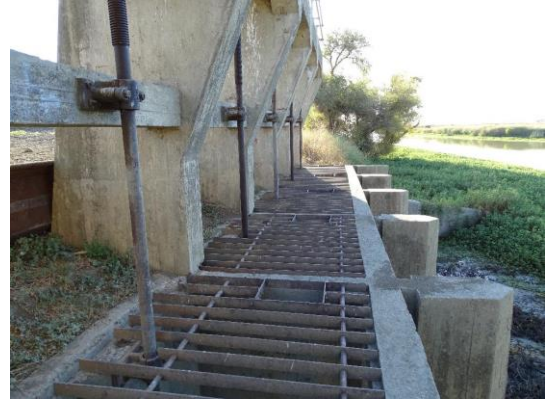
DS\_ID:22386  
 FS\_ID:55920  
 EP\_NO: 9396  
 Repair Type: Non-Urgent  
 EVAL Issue:  
 Crossing Status: Found  
 UCIP Comments: 8/2/2019 Record remains Non-Urgent. In 2019 RD 108 took an attempt to bring structure to operable condition. Although this attempt was unsuccessful District will review other options. In the meantime crossing considered abandoned. Need to have CVFPB review ABO and determine current owner. (O.Yakimov - DWR UCIP) 06/10/2014 Need to contact owner to determine status of structure. Notes indicate crossing has been abandoned. Owner will need to coordinate with CVFPB and DWR inspector to determine how to properly abandon. (O.Magana - DWR UCIP)  
 FIELD\_STRUCT\_DESC: \*ABANDONED\* 2 of 5: 72-inch reinforced concrete gravity drainage pipe or culvert through the levee, 31.6 feet below the crown. Slide gate on each end. (Retention of five 72-inch pipes through the levee [HLM 0.08] authorized under Automatic Board Order (ABO) issued as Permit No. 9736, 1974 - Reclamation District No. 108 [RD0108]). [Additional Reference(s): DWR Levee Log, 1991, (HLM 0.08). USACE Sacramento O&M Manual 132, October 1959, (HLM 0.08), referenced as five 6-foot by 8-foot concrete drainage culverts].

View of concrete structure located on landward side

Slide gates on waterward side

Concrete structure located on waterward side

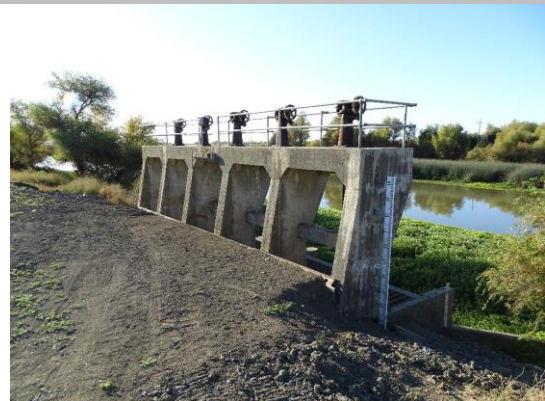
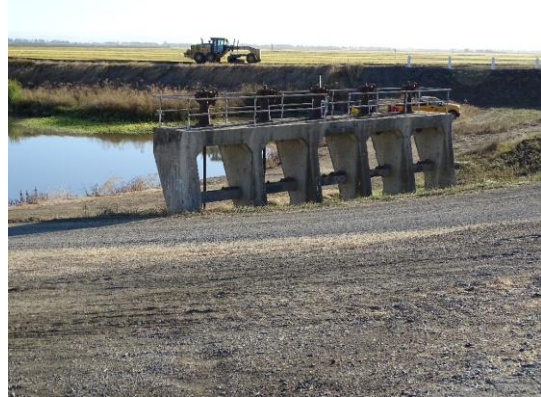
| DS_ID:22387<br>FS_ID:55921<br>EP_NO: 9396<br>Repair Type: Non-Urgent<br>EVAL Issue:<br>Crossing Status: Found<br>UCIP Comments: 10/2/2019 Record remains Non-Urgent. In 2019 RD 108 took an attempt to bring structure to operable condition. Although This attempt was unsuccessful District will review other options. In the meantime crossing considered abandoned. Need to have CVFPB review ABO and determine current owner. (O.Yakimov - DWR UCIP)06/10/2014 Need to contact owner to determine status of structure. Notes indicate crossing has been abandoned. Owner will need to coordinate with CVFPB and DWR inspector to determine how to properly abandon. (O.Magana - DWR UCIP)<br>FIELD_STRUCT_DESC: *ABANDONED* 3 of 5: 72-inch reinforced concrete gravity drainage pipe or culvert through the levee, 31.6 feet below the crown. Slide gate on each end. (Retention of five 72-inch pipes through the levee [HLM 0.08] authorized under Automatic Board Order (ABO) issued as Permit No. 9736, 1974 - Reclamation District No. 108 [RD0108]). [Additional Reference(s): DWR Levee Log, 1991. USACE Sacramento O&M Manual 132, October 1959, (HLM 0.08), referenced as five 6-foot by 8-foot concrete drainage culverts].<br>FS Date: 10/2/2019 7:54:00 AM | | | | | |

Slide gates on waterward side

Concrete structure located on waterward side

Concrete structure located onlandward side

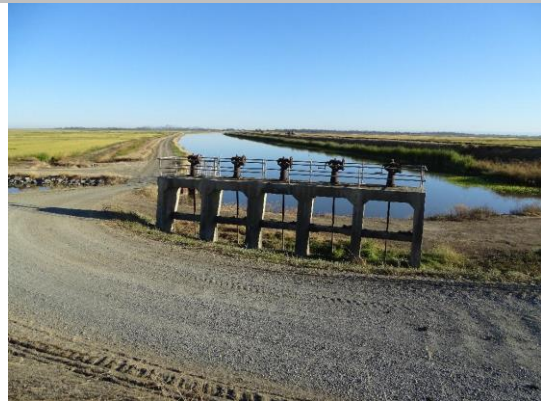
DS\_ID:22388  
FS\_ID:55922  
EP\_NO: 9396  
Repair Type: Non-Urgent  
EVAL Issue:  
Crossing Status: Found  
UCIP Comments: 10/2/2019 Record remains Non-Urgent. In 2019 RD 108 took an attempt to bring structure to operable condition. Although this attempt was unsuccessful District will review other options. In the meantime crossing considered abandoned. Need to have CVFPB review ABO and determine current owner. (O.Yakimov - DWR UCIP)06/10/2014 Need to contact owner to determine status of structure. Notes indicate crossing has been abandoned. Owner will need to coordinate with CVFPB and DWR inspector to determine how to properly abandon. (O.Magana - DWR UCIP)  
FIELD\_STRUCT\_DESC: \*ABANDONED\* 4 of 5: 72-inch reinforced concrete gravity drainage pipe or culvert through the levee, 31.6 feet below the crown. Slide gate on each end. (Retention of five 72-inch pipes through the levee [HLM 0.08] authorized under Automatic Board Order (ABO) issued as Permit No. 9736, 1974 - Reclamation District No. 108 [RD0108]). [Additional Reference(s): DWR Levee Log, 1991, (HLM 0.08). USACE Sacramento O&M Manual 132, October 1959, (HLM 0.08), referenced as five 6-foot by 8-foot concrete drainage culverts].

View of concrete structure located on landward side

Concrete structure located on waterward side

Slide gates on waterward side

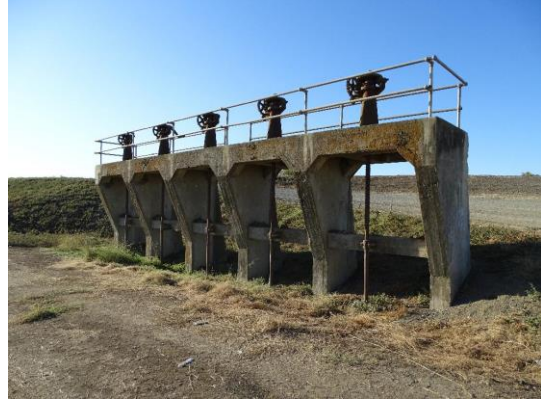
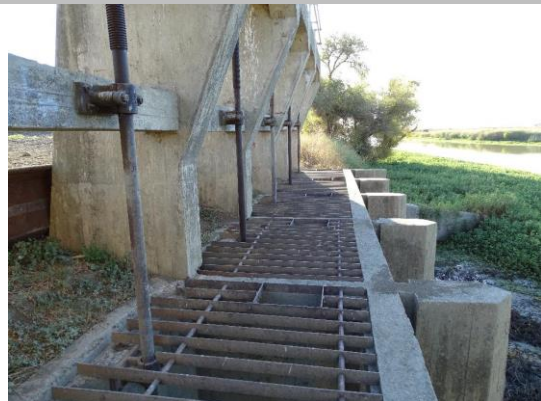
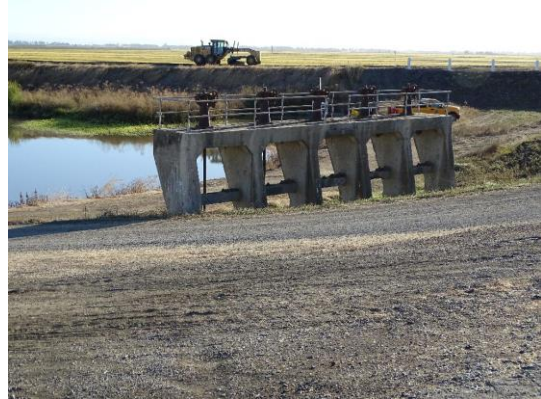
| DS_ID:22389<br>FS_ID:55923<br>EP_NO: 9396<br>Repair Type: Non-Urgent<br>EVAL Issue:<br>Crossing Status: Found<br>UCIP Comments: 10/2/2019 Record remains Non-Urgent. In 2019 RD 108 took an attempt to bring structure to operable condition. Although this attempt was unsuccessful District will review other options. In the meantime crossing considered abandoned. Need to have CVFPB review ABO and determine current owner. (O.Yakimov - DWR UCIP)06/10/2014 Need to contact owner to determine status of structure. Notes indicate crossing has been abandoned. Owner will need to coordinate with CVFPB and DWR inspector to determine how to properly abandon. (O.Magana - DWR UCIP)<br>FIELD_STRUCT_DESC: *ABANDONED* 5 of 5: 72-inch reinforced concrete gravity drainage pipe or culvert through the levee, 31.6 feet below the crown. Slide gate on each end. (Retention of five 72-inch pipes through the levee [HLM 0.08] authorized under Automatic Board Order (ABO) issued as Permit No. 9736, 1974 - Reclamation District No. 108 [RD0108]). [Additional Reference(s): DWR Levee Log, 1991. USACE Sacramento O&M Manual 132, October 1959, (HLM 0.08), referenced as five 6-foot by 8-foot concrete drainage culverts].<br>FS Date: 10/2/2019 8:01:09 AM | | | | | |

View of concrete structure located on landward side

Slide gates on waterward side

Concrete structure located on waterward side

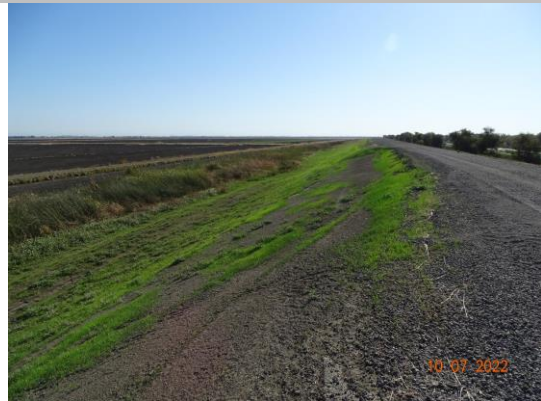
Photo 1 of 1 : FA\_2022\_RD0108\_203\_17\_20221010\_00038.jpg

| There appears to be a 150' sloughing section that is a result of February 2019 storms. This site will be repaired by the USACE under PL84-99. There are minor new cracks forming adjacent to the sloughing. | | | | | |

View of sloughing on the landside slope. Fall 2022.

| S1 : Repair slope instability. | | | | | |

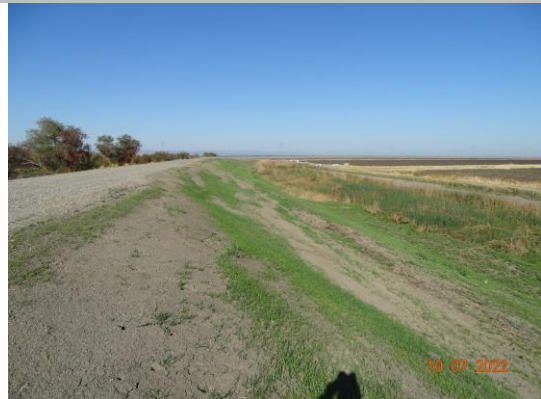
Photo 1 of 1 : FA\_2022\_RD0108\_203\_15\_20221010\_00039.jpg

| There appears to be a 150' sloughing section that is a result of February 2019 storms. This site will be repaired by the USACE under PL84-99 | | | | | |

View of sloughing on the landside slope. Fall 2022.

| S1 : Repair slope instability. | | | | | |

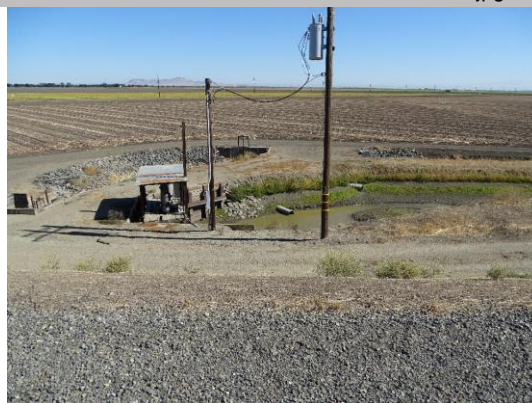
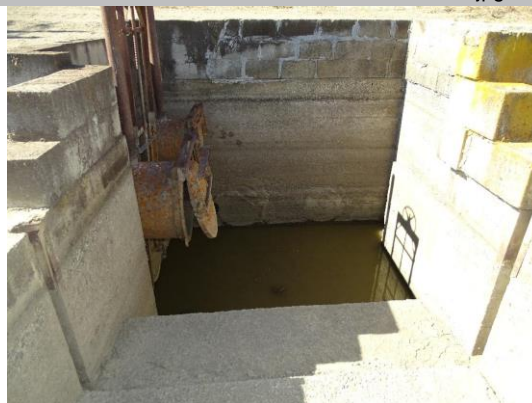
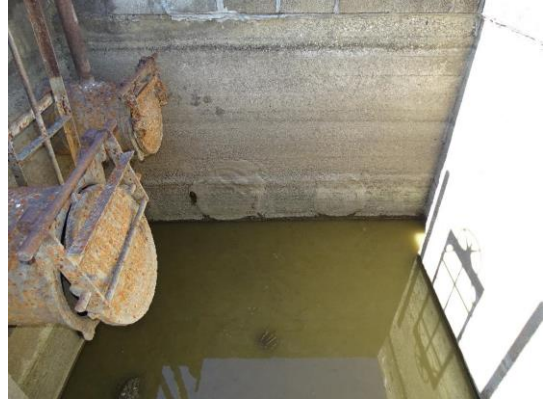
| DS_ID:18659<br>FS_ID:55932<br>EP_NO: N/A<br>Repair Type: Non-Urgent<br>EVAL Issue:<br>Crossing Status: Indicator Found<br>UCIP Comments: 10/2/2019 Record updated to Non-Urgent. No permit has been identified authorizing pipe. Disrupted concrete pile structure observed in riverbank that may belong to this crossing. Grouted 18-inch pipe hole is visible inside of concrete distribution box at the landside toe. Unable to confirm proper abandonment. Coordinates updated. (O.Yakimov - DWR UCIP)<br>FIELD_STRUCT_DESC: 18-inch corrugated metal gravity drainage pipe through the levee, invert elevation 27.4 feet. Pipe hole immured at the landward toe in concrete distribution box. Ruined intake trash rack structure in channel. [Additional Reference(s): USACE Sacramento O&M Manual 132, October 1959, (HLM 18.55)].<br>FS Date: 10/2/2019 11:08:25 AM | | | | | |

LS view looking from levee crown

View inside of concrete box on LS

Grouted holes of 2 pipes towards levee in concrete box on LS

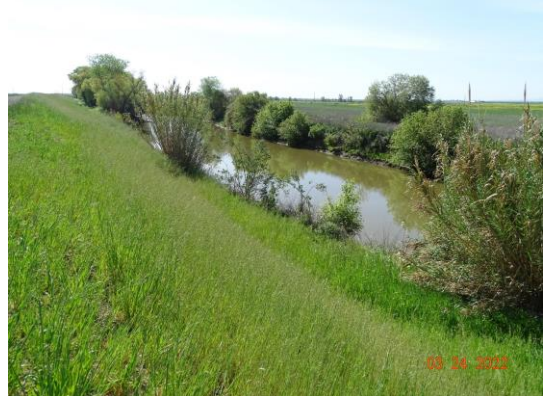
Photo 1 of 1 : FA\_2022\_RD0108\_203\_13\_20220921\_00002.jpg

View of erosion at the waterside toe. Spring 2022.

| 2018 Site ID: CBD 19.2 L<br>Status: Eroding<br>2018 Field Notes: Last observed in 2011. Access issues prevented inspection in 2017.<br>Site History: 2011 - Toe scour at the bottom of a steep bank, large sections of the toe are sliding down. Erosion may be due to the upstream bend. | | | | | |

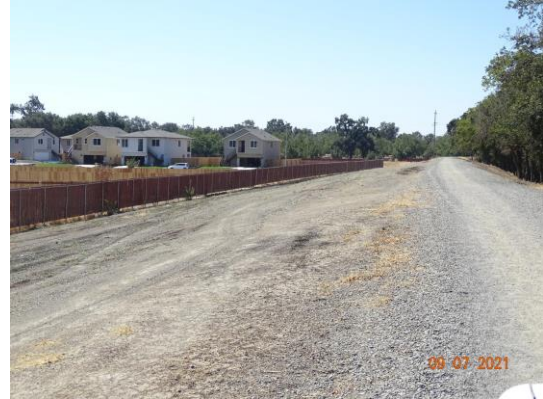
Photo 1 of 1 : FA\_2022\_RD0108\_590\_1\_20221012\_00001.jpg

| LMA maintains the levee at a high level, Fall 2022. | | | | | |

View of well maintained landside slope.

| V1 : Control annual grass and weeds on the levee slopes and easements. | | | | | |
