**Flood Control Project Maintenance  
Levee Inspections**

**Maintenance Issue Types Only, Levee Inspection Report By Mile - Fall 2023**

**Reclamation District No. 0108 River Farms**

Waterway	Bank	Unit Miles	Inspection Start/End	Inspector
Unit No. 01 Colusa Basin Drain	Left	20.64	10/06/2023 10/06/2023	Zach Jojola

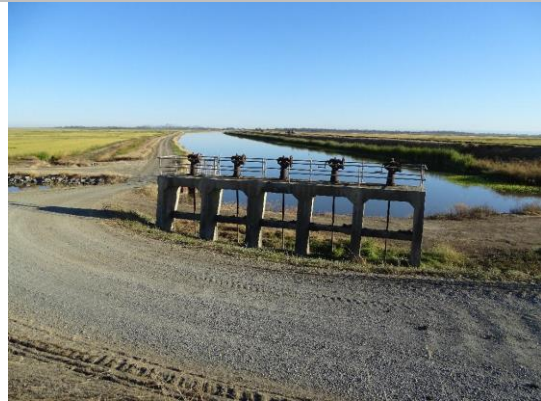
Photo 1 of 3 : UCIP\_FA\_2023\_55919\_83215.jpg

Comment Code						
Inspector Comment						
DS_ID:17943 FS_ID:55919 EP_NO: 9736 Repair Type: Non-Urgent EVAL Issue: Crossing Status: Found UCIP Comments: 10/2/2019 Record remains Non-Urgent. In 2019 RD 108 took an attempt to bring structure to operable condition. Although this attempt was unsuccessful District will review other options. In the meantime crossing considered abandoned. Need to have CVFPB review ABO and determine current owner. (O.Yakimov - DWR UCIP) 06/10/2014 Need to contact owner to determine status of structure. Notes indicate crossing has been abandoned. Owner will need to coordinate with CVFPB and DWR inspector to determine how to properly abandon. (O.Magana - DWR UCIP) FIELD_STRUCT_DESC: 1 of 5: 72-inch reinforced concrete gravity drainage pipe or culvert through the levee, 31.6 feet below the crown. Slide gate on each end. (Retention of five 72-inch pipes through the levee [HLM 0.08] authorized under Automatic Board Order (ABO) issued as Permit No. 9736, 1974 - Reclamation District No. 108 [RD0108]). [Additional Reference(s): DWR Levee Log, 1991, (HLM 0.08). USACE Sacramento O&M Manual 132, October 1959, (HLM 0.08), referenced as five 6-foot by 8-foot concrete drainage culverts]. FS Date: 10/2/2019

View of LS looking from levee crown

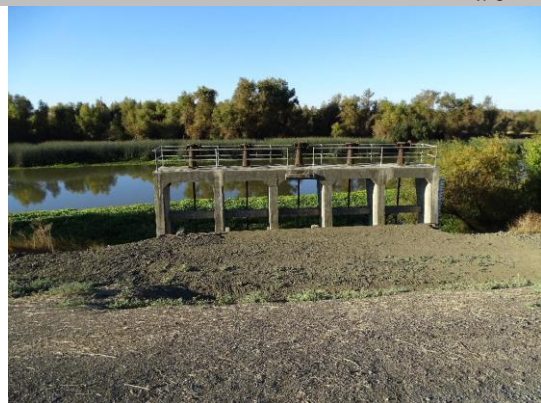
Photo 2 of 3 : UCIP\_FA\_2023\_55919\_83216.jpg

View of WS looking from levee crown

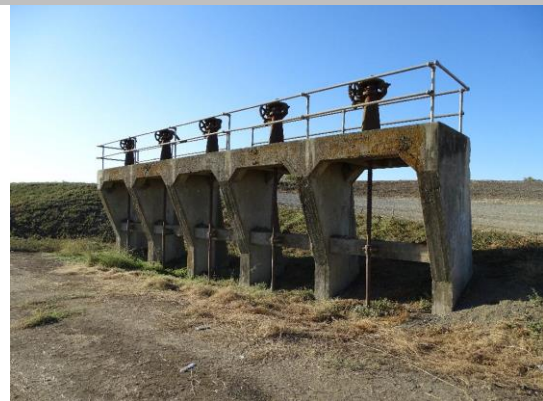
Photo 1 of 3 : UCIP\_FA\_2023\_55920\_83222.jpg

DS\_ID:22386  
 FS\_ID:55920  
 EP\_NO: 9396  
 Repair Type: Non-Urgent  
 EVAL Issue:  
 Crossing Status: Found  
 UCIP Comments: 8/2/2019 Record remains Non-Urgent. In 2019 RD 108 took an attempt to bring structure to operable condition. Although this attempt was unsuccessful District will review other options. In the meantime crossing considered abandoned. Need to have CVFPB review ABO and determine current owner. (O.Yakimov - DWR UCIP) 06/10/2014 Need to contact owner to determine status of structure. Notes indicate crossing has been abandoned. Owner will need to coordinate with CVFPB and DWR inspector to determine how to properly abandon. (O.Magana - DWR UCIP)  
 FIELD\_STRUCT\_DESC: \*ABANDONED\* 2 of 5: 72-inch reinforced concrete gravity drainage pipe or culvert through the levee, 31.6 feet below the crown. Slide gate on each end. (Retention of five 72-inch pipes through the levee [HLM 0.08] authorized under Automatic Board Order (ABO) issued as Permit No. 9736, 1974 - Reclamation District No. 108 [RD0108]). [Additional Reference(s): DWR Levee Log, 1991, (HLM 0.08). USACE Sacramento O&M Manual 132, October 1959, (HLM 0.08), referenced as five 6-foot by 8-foot concrete drainage culverts].

View of concrete structure located on landward side

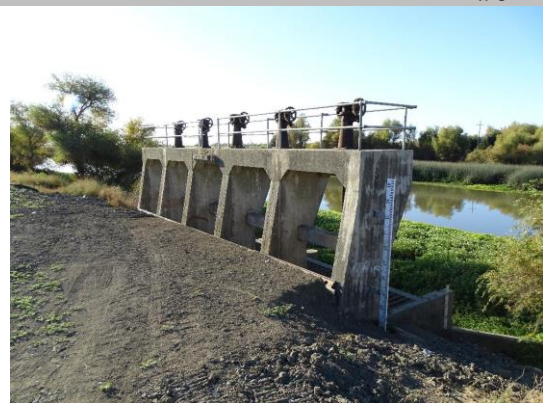
Photo 2 of 3 : UCIP\_FA\_2023\_55921\_83224.jpg

Comment Code						
Inspector Comment						
DS_ID:22387 FS_ID:55921 EP_NO: 9396 Repair Type: Non-Urgent EVAL Issue: Crossing Status: Found UCIP Comments: 10/2/2019 Record remains Non-Urgent. In 2019 RD 108 took an attempt to bring structure to operable condition. Although This attempt was unsuccessful District will review other options. In the meantime crossing considered abandoned. Need to have CVFPB review ABO and determine current owner. (O.Yakimov - DWR UCIP)06/10/2014 Need to contact owner to determine status of structure. Notes indicate crossing has been abandoned. Owner will need to coordinate with CVFPB and DWR inspector to determine how to properly abandon. (O.Magana - DWR UCIP) FIELD_STRUCT_DESC: *ABANDONED* 3 of 5: 72-inch reinforced concrete gravity drainage pipe or culvert through the levee, 31.6 feet below the crown. Slide gate on each end. (Retention of five 72-inch pipes through the levee [HLM 0.08] authorized under Automatic Board Order (ABO) issued as Permit No. 9736, 1974 - Reclamation District No. 108 [RD0108]). [Additional Reference(s): DWR Levee Log, 1991. USACE Sacramento O&M Manual 132, October 1959, (HLM 0.08), referenced as five 6-foot by 8-foot concrete drainage culverts]. FS Date: 10/2/2019 7:54:00 AM

Concrete structure located on waterward side

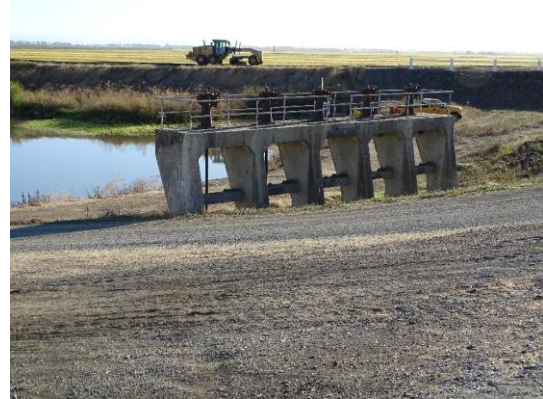
Photo 3 of 3 : UCIP\_FA\_2023\_55921\_83225.jpg

Concrete structure located onlandward side

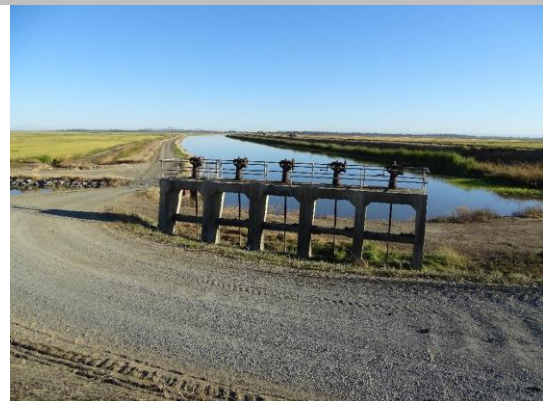
Photo 1 of 3 : UCIP\_FA\_2023\_55922\_83228.jpg

DS\_ID:22388  
FS\_ID:55922  
EP\_NO: 9396  
Repair Type: Non-Urgent  
EVAL Issue:  
Crossing Status: Found  
UCIP Comments: 10/2/2019 Record remains Non-Urgent. In 2019 RD 108 took an attempt to bring structure to operable condition. Although this attempt was unsuccessful District will review other options. In the meantime crossing considered abandoned. Need to have CVFPB review ABO and determine current owner. (O.Yakimov - DWR UCIP)06/10/2014 Need to contact owner to determine status of structure. Notes indicate crossing has been abandoned. Owner will need to coordinate with CVFPB and DWR inspector to determine how to properly abandon. (O.Magana - DWR UCIP)  
FIELD\_STRUCT\_DESC: \*ABANDONED\* 4 of 5: 72-inch reinforced concrete gravity drainage pipe or culvert through the levee, 31.6 feet below the crown. Slide gate on each end. (Retention of five 72-inch pipes through the levee [HLM 0.08] authorized under Automatic Board Order (ABO) issued as Permit No. 9736, 1974 - Reclamation District No. 108 [RD0108]). [Additional Reference(s): DWR Levee Log, 1991, (HLM 0.08). USACE Sacramento O&M Manual 132, October 1959, (HLM 0.08), referenced as five 6-foot by 8-foot concrete drainage culverts].

View of concrete structure located on landward side

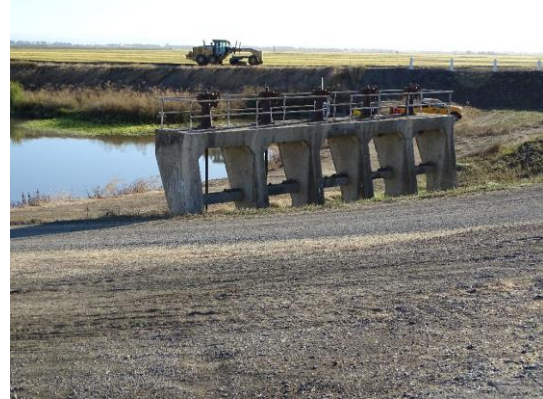
Photo 3 of 3 : UCIP\_FA\_2023\_55923\_83233.jpg

Comment Code					
Inspector Comment					
DS_ID:22389 FS_ID:55923 EP_NO: 9396 Repair Type: Non-Urgent EVAL Issue: Crossing Status: Found UCIP Comments: 10/2/2019 Record remains Non-Urgent. In 2019 RD 108 took an attempt to bring structure to operable condition. Although this attempt was unsuccessful District will review other options. In the meantime crossing considered abandoned. Need to have CVFPB review ABO and determine current owner. (O.Yakimov - DWR UCIP)06/10/2014 Need to contact owner to determine status of structure. Notes indicate crossing has been abandoned. Owner will need to coordinate with CVFPB and DWR inspector to determine how to properly abandon. (O.Magana - DWR UCIP) FIELD_STRUCT_DESC: *ABANDONED* 5 of 5: 72-inch reinforced concrete gravity drainage pipe or culvert through the levee, 31.6 feet below the crown. Slide gate on each end. (Retention of five 72-inch pipes through the levee [HLM 0.08] authorized under Automatic Board Order (ABO) issued as Permit No. 9736, 1974 - Reclamation District No. 108 [RD0108]). [Additional Reference(s): DWR Levee Log, 1991. USACE Sacramento O&M Manual 132, October 1959, (HLM 0.08), referenced as five 6-foot by 8-foot concrete drainage culverts]. FS Date: 10/2/2019 8:01:09 AM

Concrete structure located on waterward side

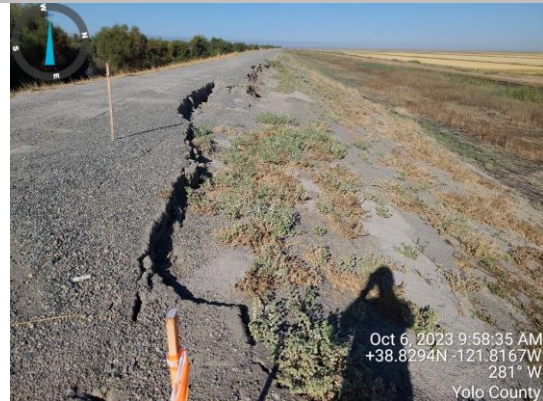
Photo 1 of 1 : FA\_2023\_RD0108\_203\_12\_20231010\_00032.jpg

150' of sloughing on the landside slope with approximately 3ft of vertical scarp at worst section. District installed a raincoat over the damage during the spring storms.

View of sloughing on the landside shoulder and slope. Fall 2023.

S1 : Repair slope instability.

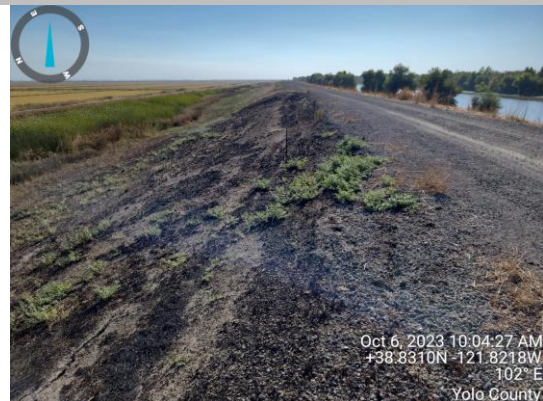
Photo 1 of 1 : FA\_2023\_RD0108\_203\_17\_20231010\_00033.jpg

There appears to be a 150' sloughing section that is a result of February 2019 storms. This site will be repaired by the USACE under PL84-99. There are minor new cracks forming adjacent to the sloughing.

View of sloughing on the landside slope. Fall 2023.

S1 : Repair slope instability.

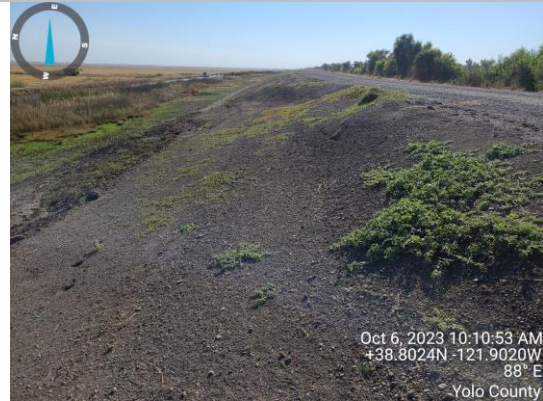
Photo 1 of 1 : FA\_2023\_RD0108\_203\_15\_20231010\_00034.jpg

LM Start	2.70	Rating **	M	Issue No.	15
LM End	2.73	Issue Type +	Ma	Location *	LS
Category	Earthen Levee			GPS Latitude/Longitude	
				Start	End
Item	Slope Stability			38.837568°	38.837749°
				-121.842218°	-121.842776°
DWR ID	DWR_RD0108_01_s_2019_15				
Comment Code					
S1 : Repair slope instability.					
Inspector Comment					
There appears to be a 150' sloughing section that is a result of February 2019 storms. This site will be repaired by the USACE under PL84-99.

View of sloughing on the landside slope. Fall 2023.

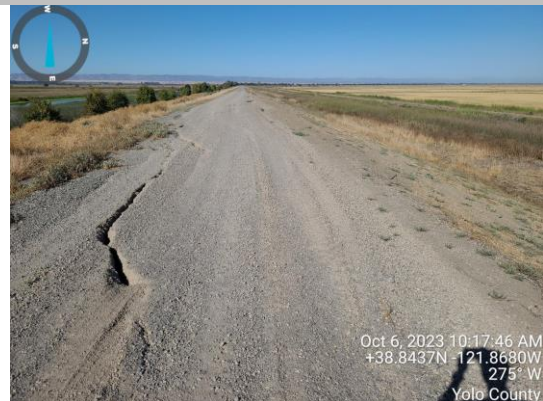
Photo 1 of 1 : FA\_2023\_RD0108\_203\_19\_20231010\_00031.jpg

LM Start	4.16	Rating **	M	Issue No.	19
LM End	4.20	Issue Type +	Ma	Location *	CR
Category	Earthen Levee			GPS Latitude/Longitude	
				Start	End
Item	Cracking			38.843700°	38.843785°
				-121.868000°	-121.868725°
DWR ID	DWR_RD0108_01_f_2023_19				
Comment Code					
CR2 : Schedule repair of subsidence prior to the next inspection.					
Inspector Comment					
Approximately 200' of deep cracks through the crown and landside shoulder.

View of cracks in crown and landside shoulder. Fall 2023.

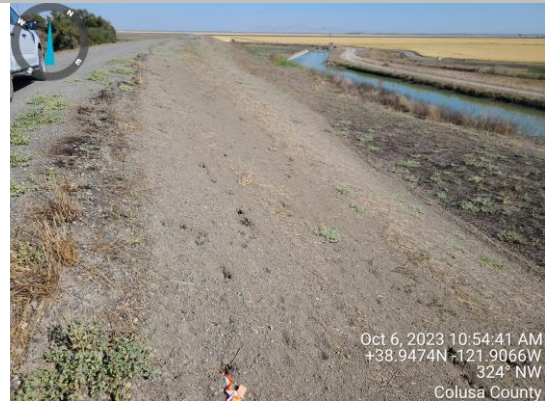
Photo 1 of 1 : FA\_2023\_RD0108\_203\_16\_20231010\_00035.jpg

LM Start	12.82	Rating **	M	Issue No.	16
LM End	12.84	Issue Type +	Ma	Location *	LS
Category	Earthen Levee			GPS Latitude/Longitude	
				Start	End
Item	Slope Stability			38.947400°	38.947675°
				-121.906600°	-121.906793°
DWR ID	DWR_RD0108_01_f_2023_16				
Comment Code					
S1 : Repair slope instability.					
Inspector Comment					
Approximately 100' of sloughing on the landside slope.

View of sloughing on the landside slope. Fall 2023.

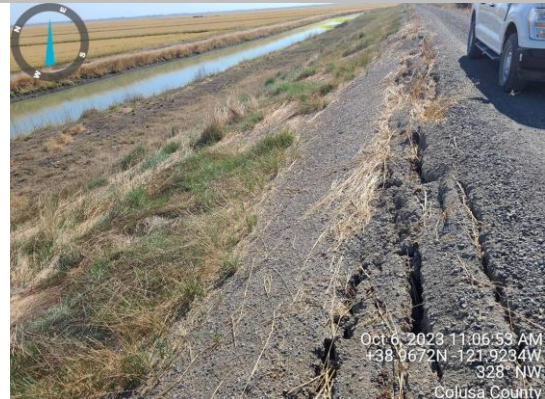
Photo 1 of 1 : FA\_2023\_RD0108\_203\_21\_20231010\_00036.jpg

LM Start	14.48	Rating **	M	Issue No.	21
LM End	14.49	Issue Type +	Ma	Location *	LS
Category	Earthen Levee			GPS Latitude/Longitude	
				Start	End
Item	Slope Stability			38.967107°	38.967205°
				-121.923162°	-121.923299°
DWR ID	DWR_RD0108_01_s_2023_21				
Comment Code					
S1 : Repair slope instability.					
Inspector Comment					
100' of sloughing on the landside shoulder.

View of sloughing on the landside shoulder. Fall 2023.

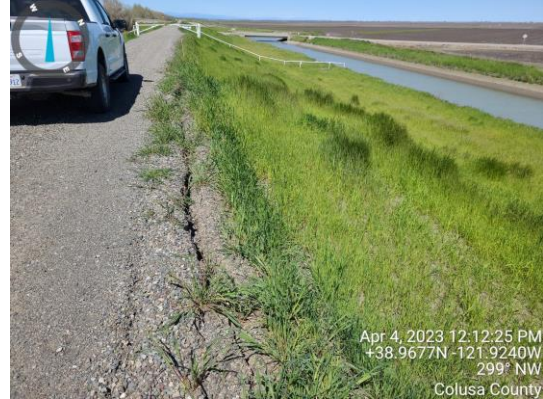
Photo 1 of 1 : FA\_2023\_RD0108\_203\_22\_20230907\_00009.jpg

LM Start	14.53	Rating **	M	Issue No.	22
LM End	14.54	Issue Type +	Ma	Location *	LS
Category	Earthen Levee			GPS Latitude/Longitude	
				Start	End
Item	Slope Stability			38.967652°	38.967716°
				-121.923930°	-121.924020°
DWR ID	DWR_RD0108_01_s_2023_22				
Comment Code					
S1 : Repair slope instability.					
Inspector Comment					
Approximately 250' of sloughing on the landside slope.

View of cracking on the landside shoulder. Spring 2023.

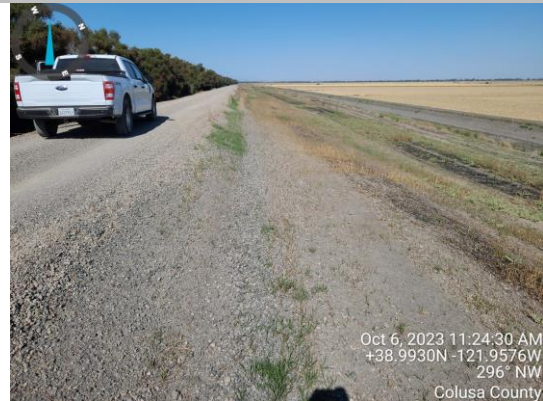
Photo 1 of 1 : FA\_2023\_RD0108\_203\_20\_20231010\_00037.jpg

LM Start	17.05	Rating **	M	Issue No.	20
LM End	17.09	Issue Type +	Ma	Location *	LS
Category	Earthen Levee			GPS Latitude/Longitude	
				Start	End
Item	Slope Stability			38.993000°	38.993420°
				-121.957600°	-121.958032°
DWR ID	DWR_RD0108_01_f_2023_20				
Comment Code					
S1 : Repair slope instability.					
Inspector Comment					
250' of sloughing on the landside slope.

View of sloughing on the landside slope. Fall 2023.

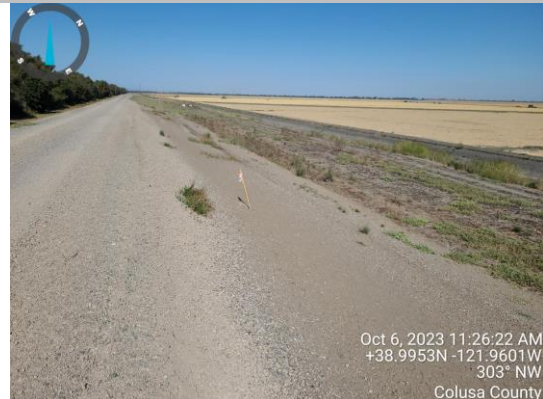
Photo 1 of 1 : FA\_2023\_RD0108\_203\_23\_20231010\_00038.jpg

LM Start	17.26	Rating **	M	Issue No.	23
LM End	17.28	Issue Type +	Ma	Location *	LS
Category	Earthen Levee			GPS Latitude/Longitude	
				Start	End
Item	Slope Stability			38.995300°	38.995467°
				-121.960100°	-121.960396°
DWR ID	DWR_RD0108_01_f_2023_23				
Comment Code					
S1 : Repair slope instability.					
Inspector Comment					
Approximately 150' of sloughing on the landside slope.

View of sloughing on the landside slope. Fall 2023.

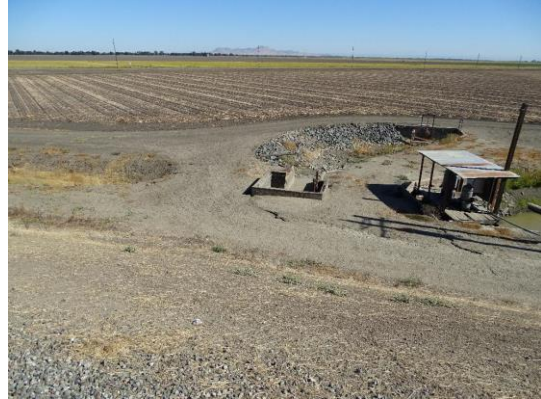
Photo 1 of 3 : UCIP\_FA\_2023\_55933\_83271.jpg

Comment Code						
Inspector Comment						
DS_ID:17940 FS_ID:55933 EP_NO: 9399 Repair Type: Non-Urgent EVAL Issue: Crossing Status: Indicator Found UCIP Comments: 10/2/2019 Record updated to Non-Urgent. Geophysical results did not confirm presence of pipe through levee. Disrupted concrete pile structure observed in riverbank that may belong to this crossing. Grouted 24-inch pipe hole is visible inside of concrete distribution box at the landside toe. Unable to confirm proper abandonment. Updated lat/long. (O.Yakimov - DWR UCIP) FIELD_STRUCT_DESC: 24-inch steel gravity drainage pipe through the levee, 15 feet below the crown. Pipe is open in a concrete distribution box at the landside (LS) toe. Intake trash rack structure in channel. (Retention of a 24-inch steel pipe through the levee, 15 feet below the crown, a concrete distribution box, and an intake trash rack authorized under Automatic Board Order (ABO) issued as Permit No. 9399, 1974 - Aileen B. Armstrong, Trustee, care of O. M. Durst Jr.). [Additional Reference(s): DWR Levee Log, 1991, (HLM 18.67). USACE Sacramento O&M Manual 132, October 1959, (HLM 18.55)]. FS Date: 10/2/2019 11:10:08 AM

View of LS looking from levee crown

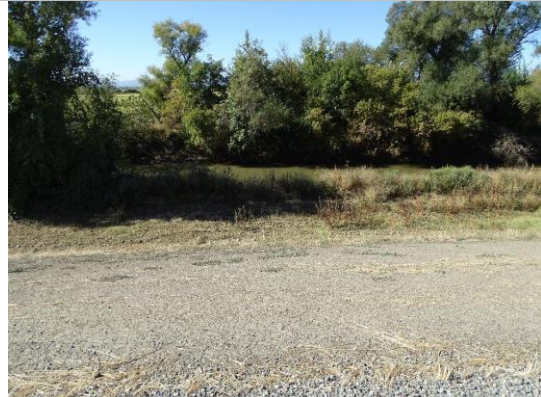
Photo 2 of 3 : UCIP\_FA\_2023\_55933\_83272.jpg

View of WS looking from levee crown

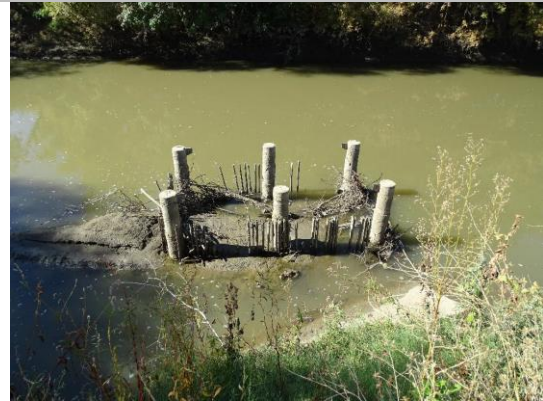
Photo 3 of 3 : UCIP\_FA\_2023\_55933\_83270.jpg

Ruined intake trash rack structure in channel

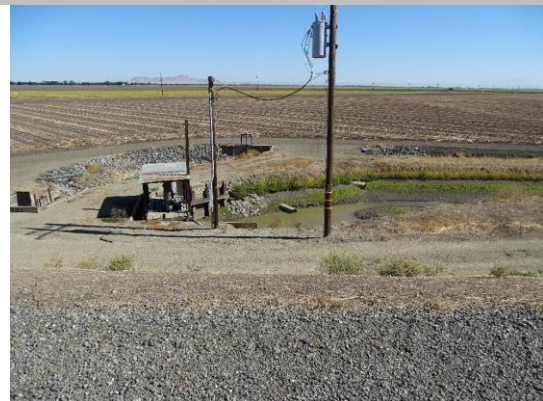
Photo 1 of 3 : UCIP\_FA\_2023\_55932\_83441.jpg

DS\_ID:18659  
 FS\_ID:55932  
 EP\_NO: N/A  
 Repair Type: Non-Urgent  
 EVAL Issue:  
 Crossing Status: Indicator Found  
 UCIP Comments: 10/2/2019 Record updated to Non-Urgent. No permit has been identified authorizing pipe. Disrupted concrete pile structure observed in riverbank that may belong to this crossing. Grouted 18-inch pipe hole is visible inside of concrete distribution box at the landside toe. Unable to confirm proper abandonment. Coordinates updated. (O.Yakimov - DWR UCIP)  
 FIELD\_STRUCT\_DESC: 18-inch corrugated metal gravity drainage pipe through the levee, invert elevation 27.4 feet. Pipe hole immured at the landward toe in concrete distribution box. Ruined intake trash rack structure in channel. [Additional Reference(s): USACE Sacramento O&M Manual 132, October 1959, (HLM 18.55)].  
 FS Date: 10/2/2019 11:08:25 AM

LS view looking from levee crown

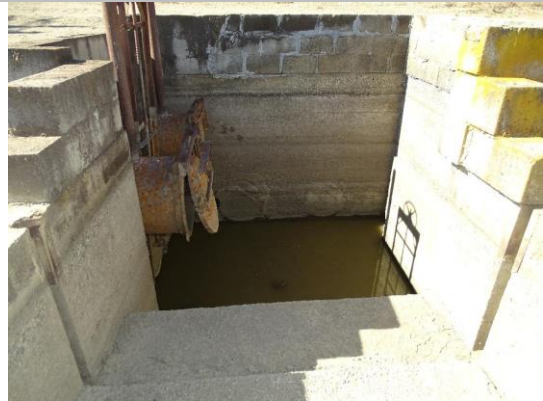
Photo 2 of 3 : UCIP\_FA\_2023\_55932\_83442.jpg

View inside of concrete box on LS

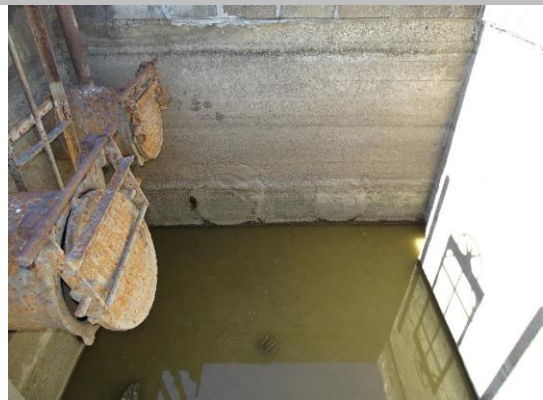
Photo 3 of 3 : UCIP\_FA\_2023\_55932\_83440.jpg

Grouted holes of 2 pipes towards levee in concrete box on LS

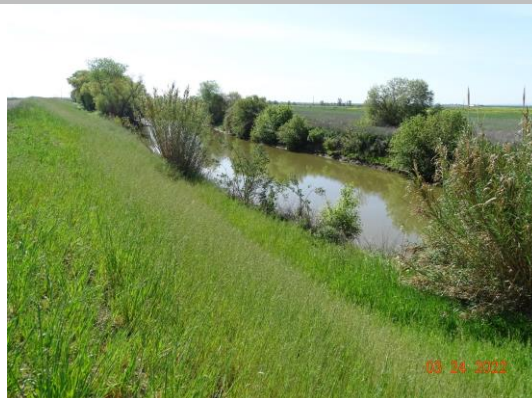
Photo 1 of 1 : FA\_2023\_RD0108\_203\_13\_20230907\_00004.jpg

LM Start	19.27	Rating **	M	Issue No.	13
LM End	19.35	Issue Type +	Ma	Location *	WS
Category	Supplemental			GPS Latitude/Longitude	
				Start	End
Item	2018 USACE Erosion Survey			39.016727°	39.017516°
				-121.985411°	-121.986374°
DWR ID	DWR_RD0108_01_s_2022_13				
Comment Code					
Inspector Comment					
2018 Site ID: CBD 19.2 L					
Status: Eroding					
2018 Field Notes: Last observed in 2011. Access issues prevented inspection in 2017.					
Site History: 2011 - Toe scour at the bottom of a steep bank, large sections of the toe are sliding down. Erosion may be due to the upstream bend.

View of erosion at the waterside toe. Spring 2022.

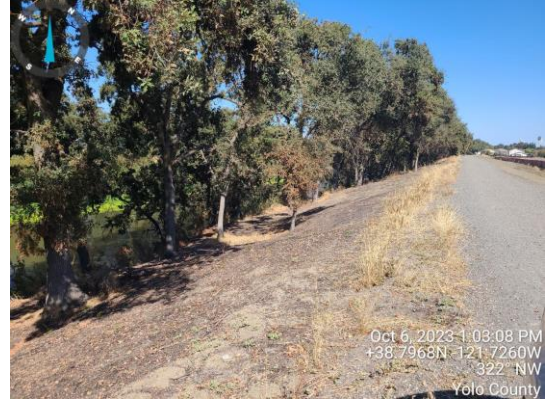
Photo 1 of 1 : FA\_2023\_RD0108\_590\_1\_20231010\_00001.jpg

View of the well maintained waterside slope. Fall 2023.
