**Flood Control Project Maintenance
Levee Inspections****Maintenance Issue Types Only, Levee Inspection Report By Mile - Fall 2024****Reclamation District No. 0108 River Farms**

Waterway	Bank	Unit Miles	Inspection Start/End	Inspector
Unit No. 01 Colusa Basin Drain	Left	20.64	09/23/2024 09/23/2024	Zach Jojoia

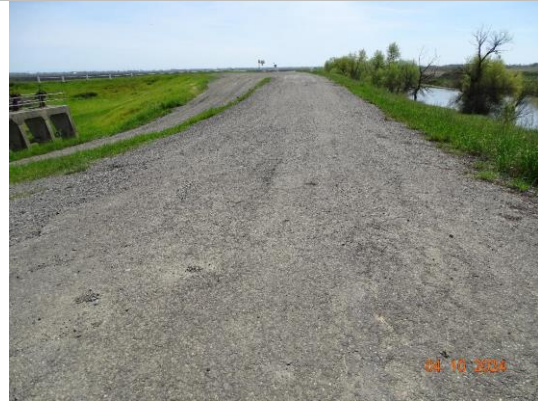
Photo 1 of 3 : UCIP_FA_2024_83766_122940.jpg

LM Start	0.06	Rating **	M	Issue No.	25	
LM End	0.06	Issue Type +	Ma	Location *		
Category	Supplemental			GPS Latitude/Longitude		
				Start		End
Item	DWR UCIP LMA Responsibility			38.822897°		38.822897°
				-121.797000°		-121.797000°
DWR ID	17943

Comment Code						
Inspector Comment						
DS_ID:17943 FS_ID:83766 EP_NO: 9736 Repair Type: Non-Urgent EVAL Issue: Crossing Status: Found UCIP Comments: 04/10/2024 Record remains Non-Urgent. Crossing appears abandoned. Slide gates at waterside toe buried in soil. DMP internal video inspection has found none or minor pipe defects. (O. Yakimov - DWR UCIP) 10/02/2019 Record remains Non-Urgent. In 2019 RD 108 took an attempt to bring structure to operable condition. Although this attempt was unsuccessful District will review other options. In the meantime crossing considered abandoned. Need to have CVFPB review ABO and determine current owner. (O.Yakimov - DWR UCIP) 06/10/2014 Need to contact owner to determine status of structure. Notes indicate crossing has been abandoned. Owner will need to coordinate with CVFPB and DWR inspector to determine how to properly abandon. (O.Magana - DWR UCIP) FIELD_STRUCT_DESC: 1 of 5: 72-inch reinforced concrete gravity drainage pipe or culvert through the levee, 31.6 feet below the crown. Slide gate on each end. (Five 72-inch pipes through the levee [HLM 0.08] authorized under Automatic Board Order (ABO) issued as Permit No. 9736, 1974 - Reclamation District No. 108 [RD0108]). [Additional Reference(s): DWR Levee Log, 1991 (HLM 0.08). USACE Sacramento O&M Manual, Unit 132, October 1959, Revised 28 July 2022, (HLM 0.08), listed as five 6-foot by 8-foot concrete culvert drains. USACE As-Built Drawing No. 50-04-3073, December 1956, Sheet 5, upstream of STA 234+00, listed as five 6-foot by 8-foot concrete box culverts]. FS Date: 4/10/2024 8:41:21 AM

Top of Levee: View of levee crown looking downstream

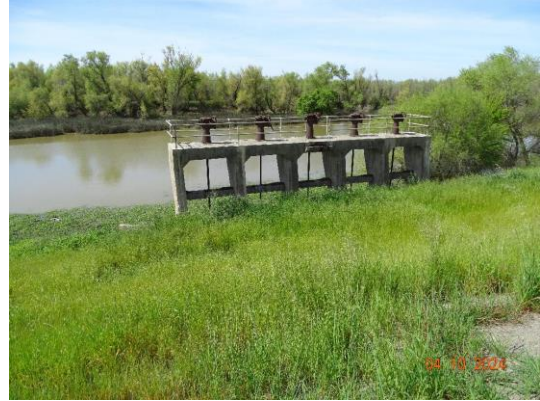
Photo 2 of 3 : UCIP_FA_2024_83766_122941.jpg

Water-Side: View of levee slope looking from crown. Slide gates at riverbank

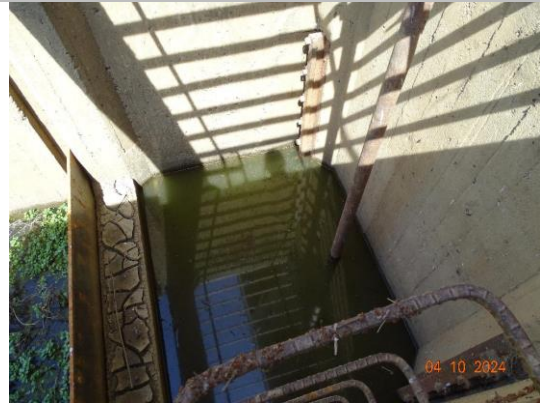
Photo 3 of 3 : UCIP_FA_2024_83766_122939.jpg

Water-Side: View inside of the bay at slide gate structure at riverbank

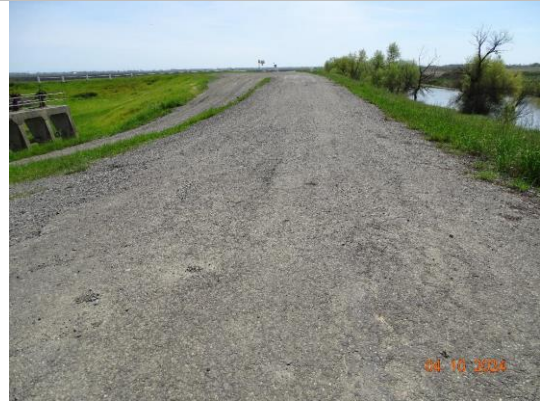
Photo 1 of 3 : UCIP_FA_2024_83765_122935.jpg

LM Start	0.06	Rating **	M	Issue No.	26	
LM End	0.06	Issue Type +	Ma	Location *		
Category	Supplemental			GPS Latitude/Longitude		
				Start		End
Item	DWR UCIP LMA Responsibility			38.822919°		38.822919°
				-121.797046°		-121.797046°
DWR ID	22386

Comment Code						
Inspector Comment						
DS_ID:22386 FS_ID:83765 EP_NO: 9396 Repair Type: Non-Urgent EVAL Issue: Crossing Status: Found UCIP Comments: 04/10/2024 Record remains Non-Urgent. Crossing appears abandoned. Slide gates at waterside toe buried in soil. (O. Yakimov - DWR UCIP) 10/02/2019 Record remains Non-Urgent. In 2019 RD 108 took an attempt to bring structure to operable condition. Although this attempt was unsuccessful District will review other options. In the meantime crossing considered abandoned. Need to have CVFPB review ABO and determine current owner. (O.Yakimov - DWR UCIP) 06/10/2014 Need to contact owner to determine status of structure. Notes indicate crossing has been abandoned. Owner will need to coordinate with CVFPB and DWR inspector to determine how to properly abandon. (O.Magana - DWR UCIP) FIELD_STRUCT_DESC: 2 of 5: 72-inch reinforced concrete gravity drainage pipe or culvert through the levee, 31.6 feet below the crown. Slide gate on each end. (Five 72-inch pipes through the levee [HLM 0.08] authorized under Automatic Board Order (ABO) issued as Permit No. 9736, 1974 - Reclamation District No. 108 [RD0108]). [Additional Reference(s): DWR Levee Log, 1991 (HLM 0.08). USACE Sacramento O&M Manual, Unit 132, October 1959, Revised 28 July 2022, (HLM 0.08), listed as five 6-foot by 8-foot concrete culvert drains. USACE As-Built Drawing No. 50-04-3073, December 1956, Sheet 5, upstream of STA 234+00, listed as five 6-foot by 8-foot concrete box culverts]. FS Date: 4/10/2024 8:40:26 AM

Top of Levee: View of levee crown looking downstream

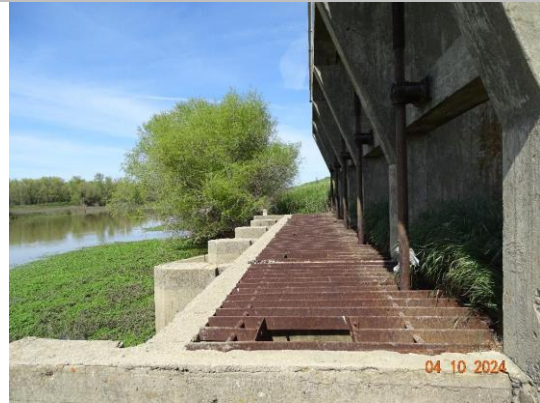
Photo 3 of 3 : UCIP_FA_2024_83765_122934.jpg

Water-Side: Slide gate structure at riverbank

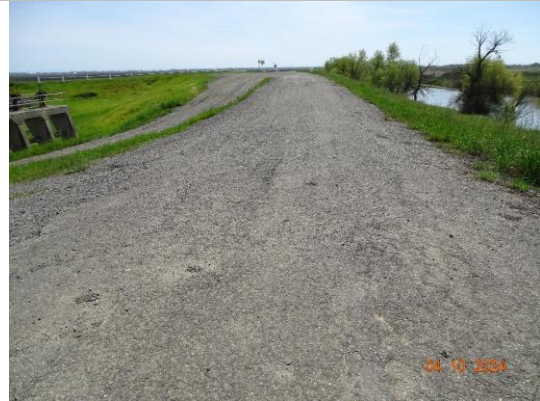
Photo 1 of 3 : UCIP_FA_2024_83764_122929.jpg

LM Start	0.06	Rating **	M	Issue No.	27
LM End	0.06	Issue Type +	Ma	Location *	
Category	Supplemental			GPS Latitude/Longitude	
				Start	End
Item	DWR UCIP LMA Responsibility			38.822933°	38.822933°
				-121.797081°	-121.797081°
DWR ID	22387

DS_ID:22387
FS_ID:83764
EP_NO: 9396
Repair Type: Non-Urgent
EVAL Issue:
Crossing Status: Found
UCIP Comments: 04/10/2024 Record remains Non-Urgent. Crossing appears abandoned. Slide gates at waterside toe buried in soil. (O. Yakimov - DWR UCIP)
10/02/2019 Record remains Non-Urgent. In 2019 RD 108 took an attempt to bring structure to operable condition. Although This attempt was unsuccessful District will review other options. In the meantime crossing considered abandoned. Need to have CVFPB review ABO and determine current owner. (O.Yakimov - DWR UCIP)
06/10/2014 Need to contact owner to determine status of structure. Notes indicate crossing has been abandoned. Owner will need to coordinate with CVFPB and DWR inspector to determine how to properly abandon. (O.Magana - DWR UCIP)
FIELD_STRUCT_DESC: 3 of 5: 72-inch reinforced concrete gravity drainage pipe or culvert through the levee, 31.6 feet below the crown. Slide gate on each end. (Five 72-inch pipes through the levee [HLM 0.08] authorized under Automatic Board Order (ABO) issued as Permit No. 9736, 1974 - Reclamation District No. 108 [RD0108]). [Additional Reference(s): DWR Levee Log, 1991 (HLM 0.08). USACE Sacramento O&M Manual, Unit 132, October 1959, Revised 28 July 2022, (HLM 0.08), listed as five 6-foot by 8-foot concrete culvert drains. USACE As-Built Drawing No. 50-04-3073, December 1956, Sheet 5, upstream of STA 234+00, listed as five 6-foot by 8-foot concrete box culverts].

Top of Levee: View of levee crown looking downstream

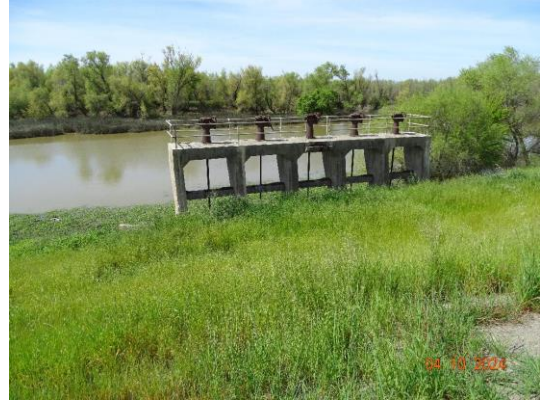
Photo 2 of 3 : UCIP_FA_2024_83764_122925.jpg

Water-Side: View of levee slope looking from crown. Slide gates at riverbank

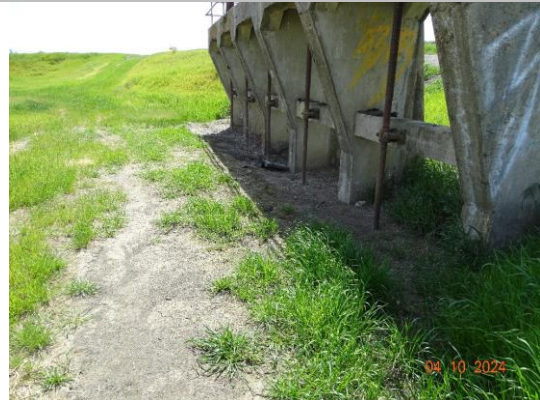
Photo 3 of 3 : UCIP_FA_2024_83764_122927.jpg

Land-Side: View of slide gates buried in soil at levee toe

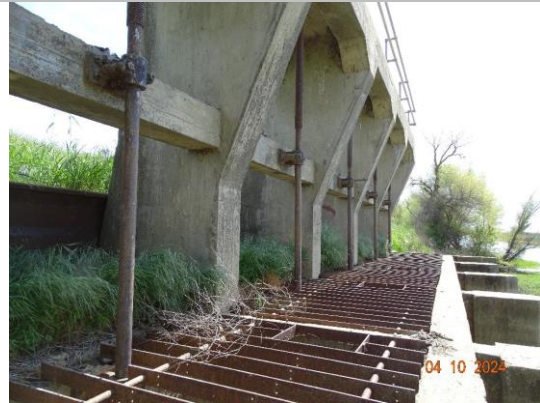
Photo 3 of 3 : UCIP_FA_2024_83763_122920.jpg

Water-Side: Slide gate structure at riverbank

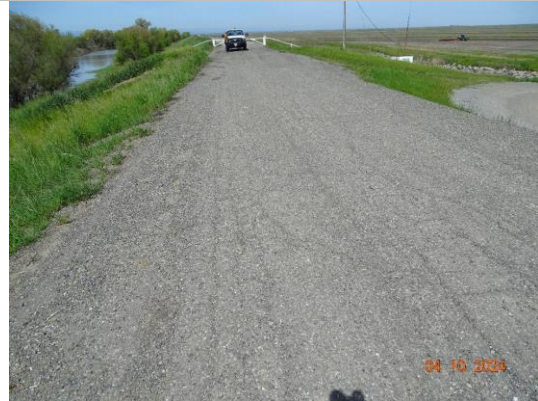
Photo 1 of 3 : UCIP_FA_2024_83762_122917.jpg

LM Start	0.07	Rating **	M	Issue No.	29
LM End	0.07	Issue Type +	Ma	Location *	
Category	Supplemental			GPS Latitude/Longitude	
				Start	End
Item	DWR UCIP LMA Responsibility			38.822954°	38.822954°
				-121.797135°	-121.797135°
DWR ID	22389

DS_ID:22389
FS_ID:83762
EP_NO: 9396
Repair Type: Non-Urgent
EVAL Issue:
Crossing Status: Found
UCIP Comments: 04/10/2024 Record remains Non-Urgent. Crossing appears abandoned. Slide gates at waterside toe buried in soil. (O. Yakimov - DWR UCIP)
10/02/2019 Record remains Non-Urgent. In 2019 RD 108 took an attempt to bring structure to operable condition. Although this attempt was unsuccessful District will review other options. In the meantime crossing considered abandoned. Need to have CVFPB review ABO and determine current owner. (O.Yakimov - DWR UCIP)
06/10/2014 Need to contact owner to determine status of structure. Notes indicate crossing has been abandoned. Owner will need to coordinate with CVFPB and DWR inspector to determine how to properly abandon. (O.Magana - DWR UCIP)
FIELD_STRUCT_DESC: 5 of 5: 72-inch reinforced concrete gravity drainage pipe or culvert through the levee, 31.6 feet below the crown. Slide gate on each end. (Five 72-inch pipes through the levee [HLM 0.08] authorized under Automatic Board Order (ABO) issued as Permit No. 9736, 1974 - Reclamation District No. 108 [RD0108]). [Additional Reference(s): DWR Levee Log, 1991 (HLM 0.08). USACE Sacramento O&M Manual, Unit 132, October 1959, Revised 28 July 2022, (HLM 0.08), listed as five 6-foot by 8-foot concrete culvert drains. USACE As-Built Drawing No. 50-04-3073, December 1956, Sheet 5, upstream of STA 234+00, listed as five 6-foot by 8-foot concrete box culverts].

Top of Levee: View of levee crown looking upstream

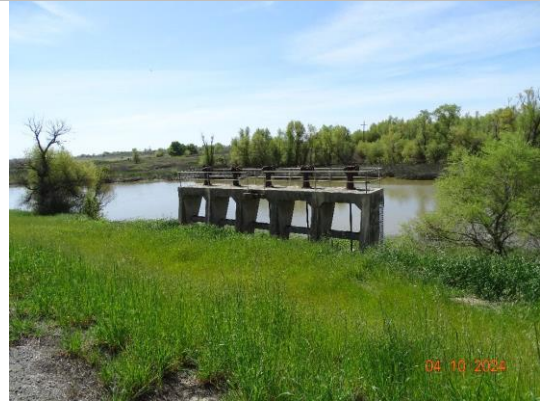
Photo 2 of 3 : UCIP_FA_2024_83762_122916.jpg

Water-Side: View of levee slope looking from crown. Slide gates at riverbank

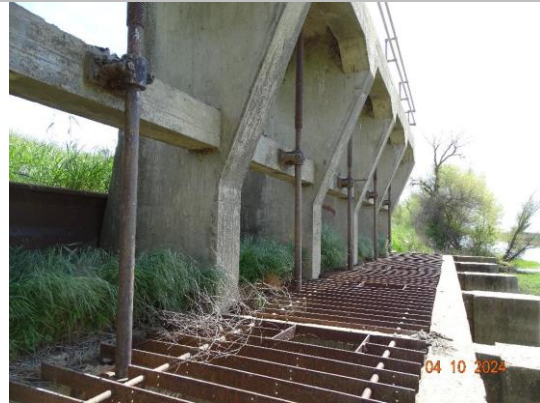
Photo 3 of 3 : UCIP_FA_2024_83762_122914.jpg

Water-Side: Slide gate structure at riverbank

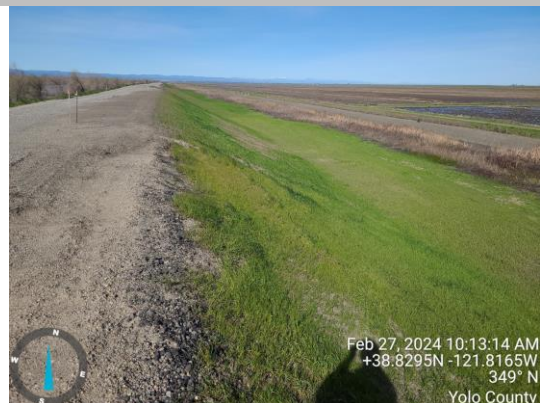
Photo 1 of 1 : FA_2024_RD0108_203_12_20240909_00002.jpg

LM Start	1.21	Rating **	A/W	Issue No.	12
LM End	1.24	Issue Type +	Ma	Location *	LS
Category	Earthen Levee			GPS Latitude/Longitude	
				Start	End
Item	Slope Stability			38.829411°	38.829582°
				-121.816712°	-121.817274°
DWR ID	DWR_RD0108_01_s_2023_12				
Comment Code					
S1 : Repair slope instability.					
Inspector Comment					
150' of sloughing on the landside slope with approximately 3ft of vertical scarp at worst section. District installed a temporary repair. USACE will complete a permanent repair.

View of temporary sloughing repair on the landside slope. Spring 2024.

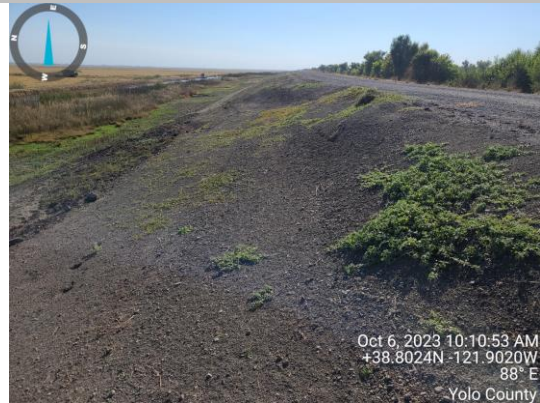
Photo 1 of 1 : FA_2024_RD0108_203_15_20240909_00004.jpg

LM Start	2.70	Rating **	M	Issue No.	15
LM End	2.73	Issue Type +	Ma	Location *	LS
Category	Earthen Levee			GPS Latitude/Longitude	
				Start	End
Item	Slope Stability			38.837568°	38.837749°
				-121.842218°	-121.842776°
DWR ID	DWR_RD0108_01_s_2019_15				
Comment Code					
S1 : Repair slope instability.					
Inspector Comment					
There appears to be a 150' sloughing section that is a result of February 2019 storms. This site will be repaired by the USACE under PL84-99.

View of sloughing on the landside slope. Fall 2023.

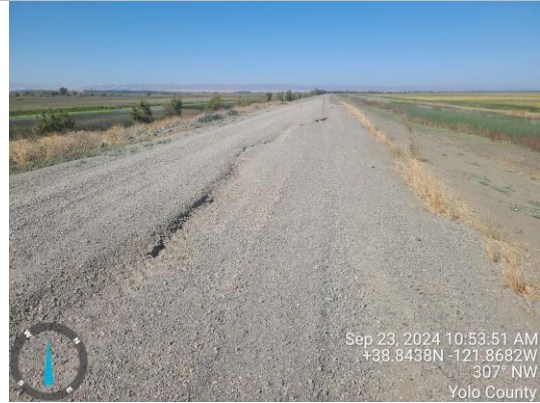
Photo 1 of 1 : FA_2024_RD0108_203_19_20240923_00027.jpg

LM Start	4.16	Rating **	M	Issue No.	19
LM End	4.20	Issue Type +	Ma	Location *	CR
Category	Earthen Levee			GPS Latitude/Longitude	
				Start	End
Item	Cracking			38.843700°	38.843785°
				-121.868000°	-121.868725°
DWR ID	DWR_RD0108_01_f_2023_19				
Comment Code					
CR2 : Schedule repair of subsidence prior to the next inspection.					
Inspector Comment					
Approximately 200' of deep cracks through the crown and landside shoulder. This will be repaired by the USACE under PL 84-99.

View of cracking on the crown and landside shoulder. Fall 2024.

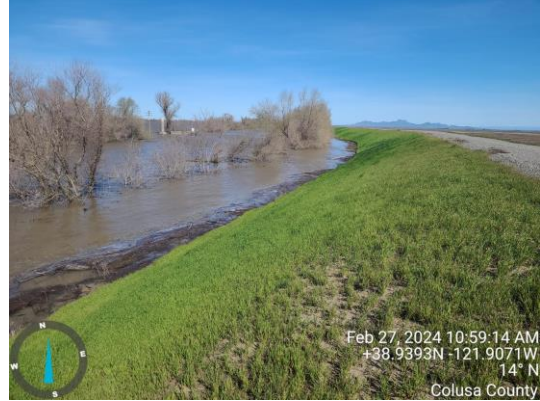
Photo 1 of 1 : FA_2024_RD0108_203_18_20240909_00007.jpg

LM Start	12.26	Rating **	A/W	Issue No.	18
LM End	12.37	Issue Type +	Ma	Location *	WS
Category	Earthen Levee			GPS Latitude/Longitude	
				Start	End
Item	Erosion / Bank Caving			38.939236°	38.940843°
				-121.907072°	-121.906736°
DWR ID	DWR_RD0108_01_s_2024_18				
Comment Code					
E1 : Note and monitor erosion site.					
Inspector Comment					
Appears to be minor wavewash erosion beginning due to high water. Recommend monitoring.

View of wavewash on the waterside toe. Spring 2024.

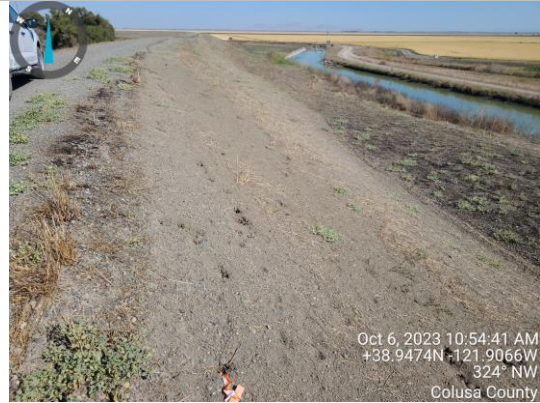
Photo 1 of 1 : FA_2024_RD0108_203_16_20240909_00005.jpg

LM Start	12.82	Rating **	M	Issue No.	16
LM End	12.84	Issue Type +	Ma	Location *	LS
Category	Earthen Levee			GPS Latitude/Longitude	
				Start	End
Item	Slope Stability			38.947400°	38.947675°
				-121.906600°	-121.906793°
DWR ID	DWR_RD0108_01_f_2023_16				
Comment Code					
S1 : Repair slope instability.					
Inspector Comment					
Approximately 100' of sloughing on the landside slope. The repairs will be funded by DWR Emergency Repairs.

View of sloughing on the landside slope. Fall 2023.

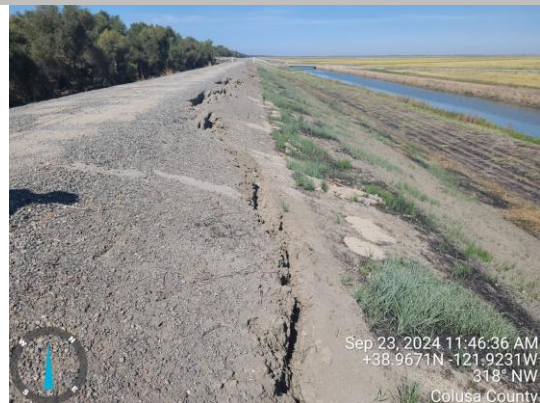
Photo 1 of 1 : FA_2024_RD0108_203_21_20240923_00028.jpg

LM Start	14.48	Rating **	M	Issue No.	21
LM End	14.54	Issue Type +	Ma	Location *	LS
Category	Earthen Levee			GPS Latitude/Longitude	
				Start	End
Item	Slope Stability			38.967107°	38.967716°
				-121.923162°	-121.924020°
DWR ID	DWR_RD0108_01_s_2023_21				
Comment Code					
S1 : Repair slope instability.					
Inspector Comment					
100' of sloughing on the landside shoulder. District installed an envelope over the slough. USACE will repair under PL 84-99.

View of sloughing on the landside shoulder. Fall 2024.

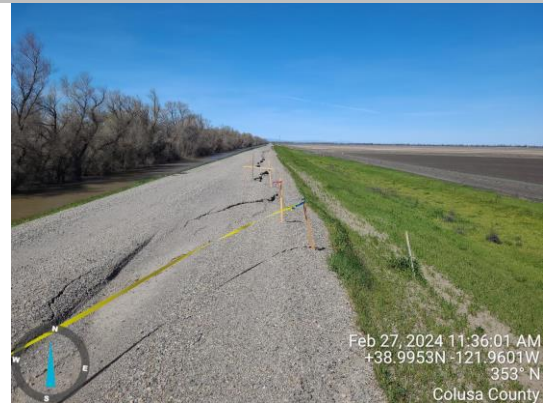
Photo 1 of 1 : FA_2024_RD0108_203_23_20240909_00011.jpg

LM Start	17.26	Rating **	M	Issue No.	23
LM End	17.32	Issue Type +	Ma	Location *	LS
Category	Earthen Levee			GPS Latitude/Longitude	
				Start	End
Item	Slope Stability			38.995300°	38.995889°
				-121.960100°	-121.960894°
DWR ID	DWR_RD0108_01_f_2023_23				
Comment Code					
S1 : Repair slope instability.					
Inspector Comment					
Approximately 300' of sloughing on the landside slope and crown. The repairs will be funded by DWR Emergency Repairs.

View of sloughing on the landside shoulder and crown. Spring 2024.

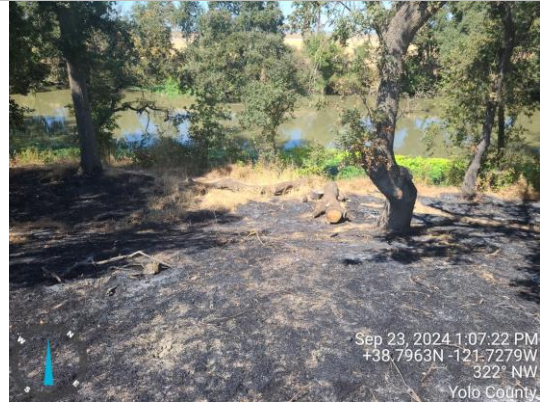
Photo 1 of 1 : FA_2024_RD0108_590_1_20240923_00001.jpg

LM Start	0.02	Rating **	M	Issue No.	1
LM End	0.02	Issue Type +	Ma	Location *	WS
Category	Earthen Levee			GPS Latitude/Longitude	
				Start	End
Item	Trim / Thin Trees			38.796333°	38.796333°
				-121.727751°	-121.727751°
DWR ID	DWR_RD0108_02_s_2024_1				
Comment Code					
T2 : Tree or limb.					
Inspector Comment					
Tree limbs on the waterside slope.

View of tree limbs on the waterside slope. Fall 2024.
