**Flood Control Project Maintenance
Levee Inspections**

Fall 2009 Levee Maintenance Deficiency Summary Report

Reclamation District No. 0150 Merrit Island

Levee Inspection Report By Mile - Fall 2009

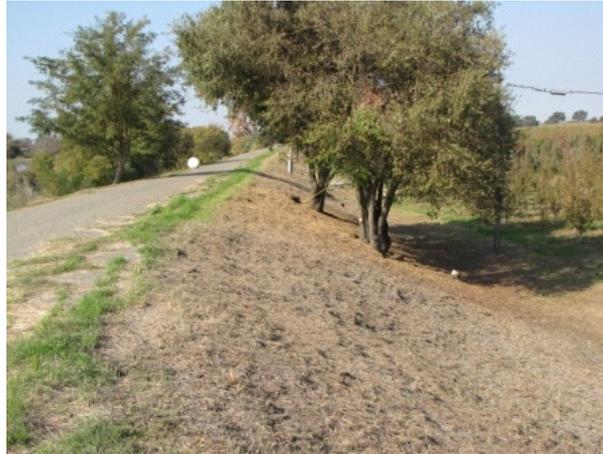
Levee Mile Report Line	1
Start Levee Mile	0.51
End Levee Mile	0.51
Location	Land Side
Category	Earthen Levee
Item	Vegetation
View of landward slope showing good vegetation maintenance typical along this unit.	
dpesaven_20091104_390.jpg

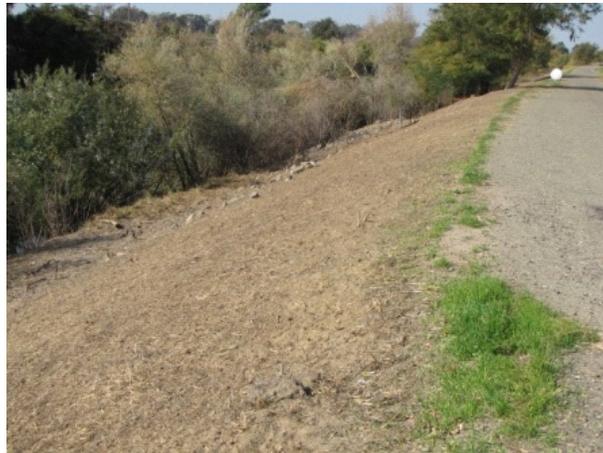
Levee Mile Report Line	2
Start Levee Mile	0.51
End Levee Mile	0.51
Location	Water Side
Category	Earthen Levee
Item	Vegetation
View of the waterward slope showing example of good vegetation maintenance typical of this unit.	
dpesaven_20091104_391.jpg

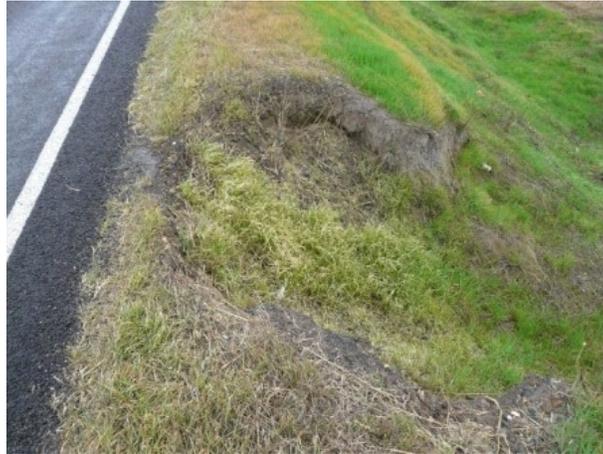
Levee Mile Report Line	1
Start Levee Mile	0.06
End Levee Mile	0.06
Location	Land Side
Category	Earthen Levee
Item	Erosion / Bank Caving
Repair errosion/slumping on landside slope of levee at LM 0.06	
dpesaven_20091028_250.JPG

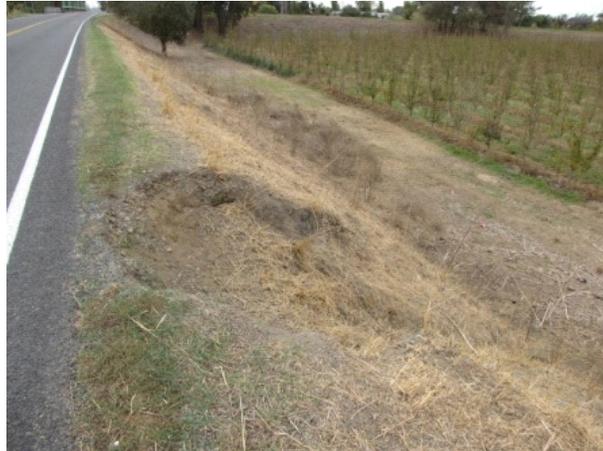
Levee Mile Report Line	1
Start Levee Mile	0.06
End Levee Mile	0.06
Location	Land Side
Category	Earthen Levee
Item	Erosion / Bank Caving
Updated view of erosion occurring on the landward slope looking downstream. The erosion appears to be getting larger.	
dpesaven_20091110_427.jpg

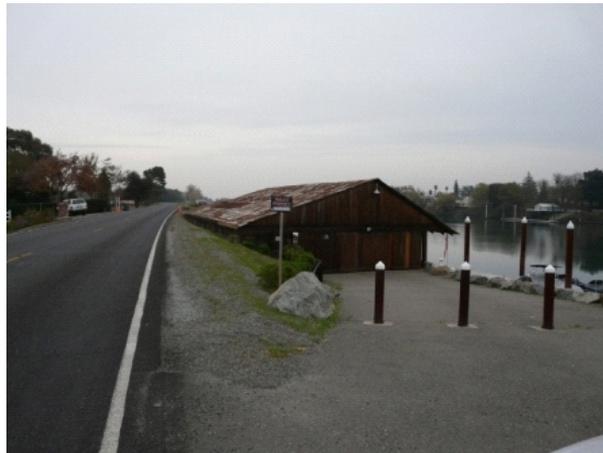
Levee Mile Report Line	2
Start Levee Mile	0.16
End Levee Mile	0.16
Location	Water Side
Category	Earthen Levee
Item	Encroachments
Building located on waterside of levee at LM 0.16	
dpesaven_20091028_235.JPG

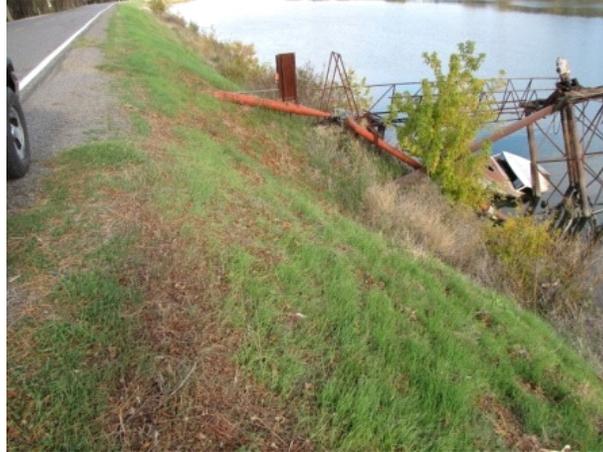
Levee Mile Report Line	37
Start Levee Mile	3.29
End Levee Mile	3.29
Location	Water Side
Category	Earthen Levee
Item	Erosion / Bank Caving
<p>Additional view of erosion on the waterward slope looking upstream. Note the damaged pump support, pump, and pipe just upstream of the site.</p>	
<p>dpesaven_20091110_411.jpg</p>

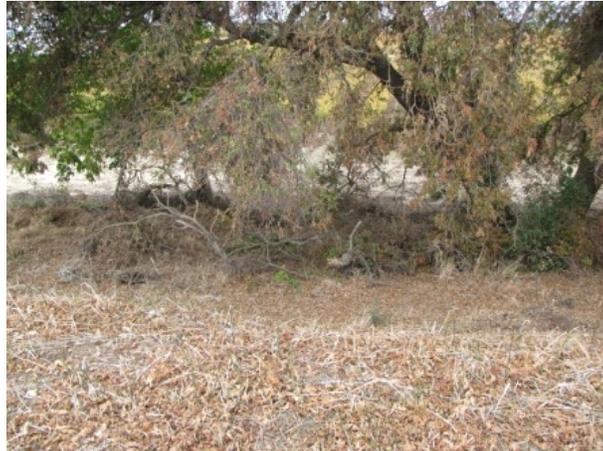
Levee Mile Report Line	42
Start Levee Mile	3.57
End Levee Mile	3.57
Location	Land Side
Category	Earthen Levee
Item	Encroachments
<p>View of dead branches and plant material on the landward slope blocking visibility and access.</p>	
<p>dpesaven_20091110_425.jpg</p>

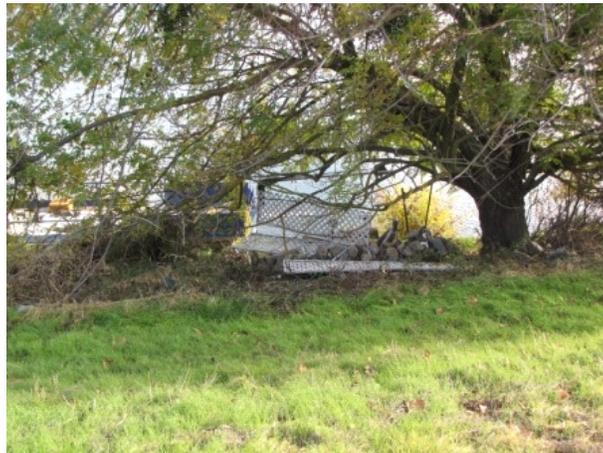
Levee Mile Report Line	45
Start Levee Mile	3.76
End Levee Mile	3.76
Location	Water Side
Category	Earthen Levee
Item	Encroachments
<p>View of debris along the waterward slope.</p>	
<p>dpesaven_20091110_412.jpg</p>

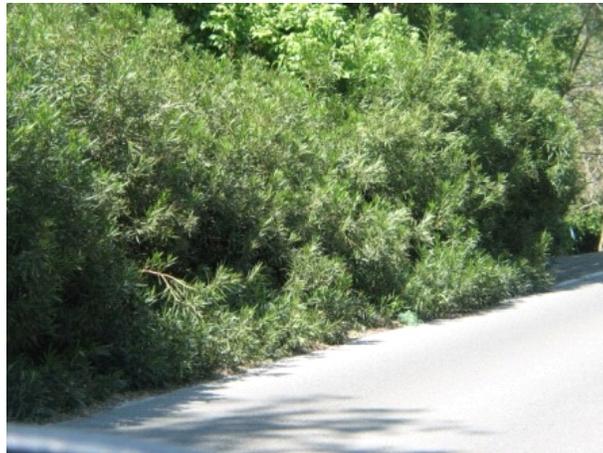
Levee Mile Report Line	48
Start Levee Mile	4.33
End Levee Mile	4.35
Location	Land Side
Category	Earthen Levee
Item	Encroachments
<p>Landscaping (Oleander) on landward slope from 4.33 to 4.35</p>	
<p>dpesaven_20091028_230.jpg</p>

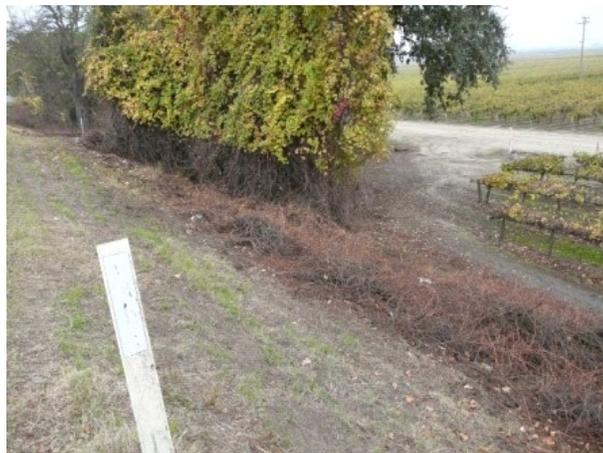
Levee Mile Report Line	52
Start Levee Mile	4.55
End Levee Mile	4.57
Location	Land Side
Category	Earthen Levee
Item	Vegetation
<p>Remove/mow vegetation on landside of levee to allow for visibility from LM 4.55 to LM 4.57</p>	
<p>dpesaven_20091028_245.JPG</p>

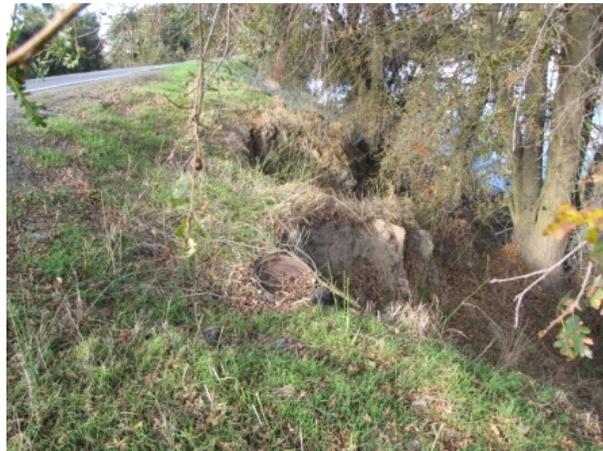
Levee Mile Report Line	60
Start Levee Mile	5.03
End Levee Mile	5.03
Location	Water Side
Category	Earthen Levee
Item	Erosion / Bank Caving
View of erosion occurring along the waterward slope behind trees looking upstream.	
dpesaven_20091110_413.jpg

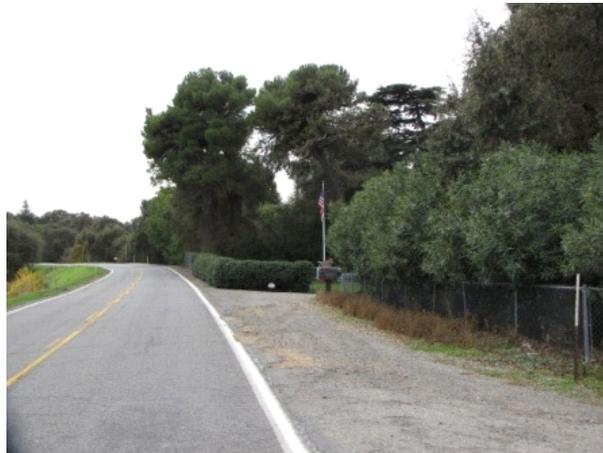
Levee Mile Report Line	63
Start Levee Mile	5.19
End Levee Mile	5.23
Location	Land Side
Category	Earthen Levee
Item	Encroachments
View of landscaping along the landward shoulder and slope looking downstream.	
dpesaven_20091110_423.jpg

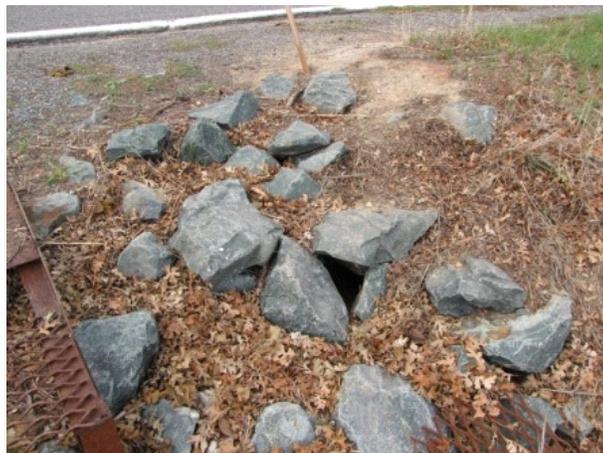
Levee Mile Report Line	64
Start Levee Mile	5.33
End Levee Mile	5.33
Location	Water Side
Category	Earthen Levee
Item	Slope Stability
View of rock placed on a pipe penetration on the waterward slope. Cavities can be seen under the rocks.	
dpesaven_20091110_422.jpg

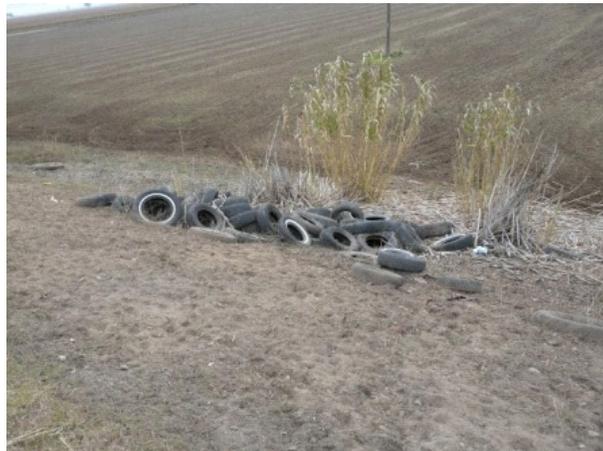
Levee Mile Report Line	73
Start Levee Mile	6.28
End Levee Mile	6.28
Location	Land Side
Category	Earthen Levee
Item	Encroachments
Remove tires from landside of levee at LM 6.28	
dpesaven_20091028_244.JPG

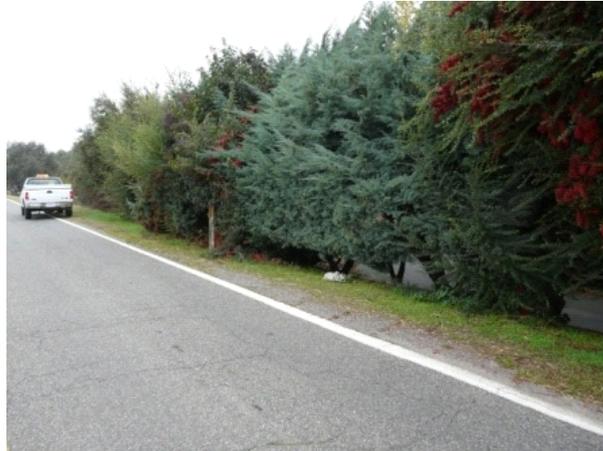
Levee Mile Report Line	82
Start Levee Mile	6.68
End Levee Mile	6.72
Location	Land Side
Category	Earthen Levee
Item	Encroachments
Landscaping providing a screen for a residence on landside of levee from LM 6.68 to LM 6.72	
dpesaven_20091028_243.JPG

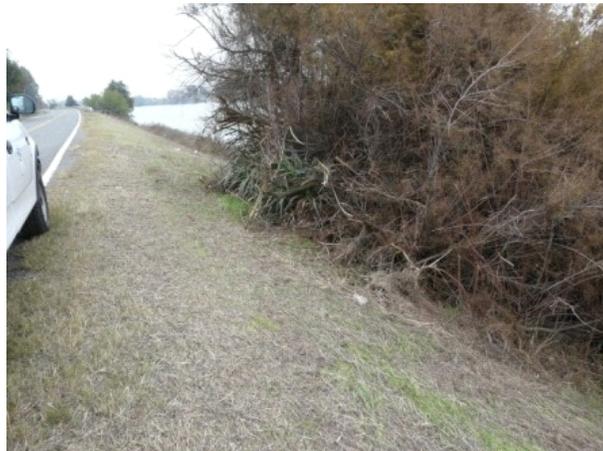
Levee Mile Report Line	83
Start Levee Mile	6.75
End Levee Mile	6.75
Location	Water Side
Category	Earthen Levee
Item	Trim / Thin Trees
Trim/thin trees and brush on waterside of levee within 20' of shoulder to allow visibility at LM 6.75	
dpesaven_20091028_232.JPG

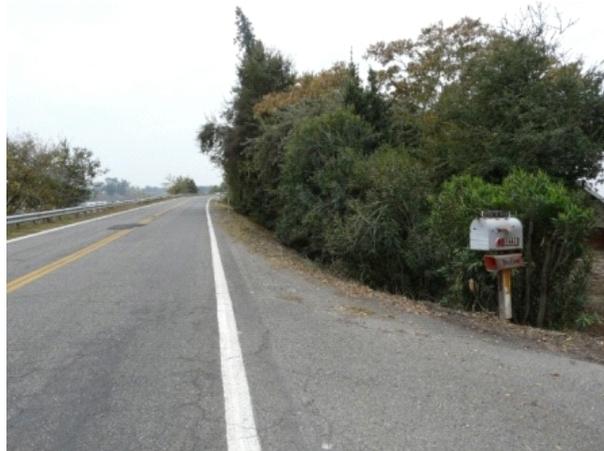
Levee Mile Report Line	89
Start Levee Mile	6.93
End Levee Mile	7.05
Location	Land Side
Category	Earthen Levee
Item	Encroachments
Landscaping providing a screen for a residence on landside of levee from LM 6.93 to LM 7.05	
dpesaven_20091028_242.JPG

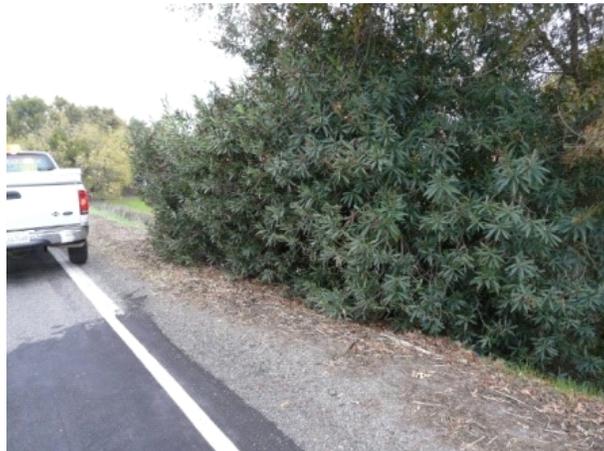
Levee Mile Report Line	91
Start Levee Mile	7.12
End Levee Mile	7.12
Location	Land Side
Category	Earthen Levee
Item	Encroachments
Landscaping providing a screen for a residence on landside of levee at LM 7.12	
dpesaven_20091028_240.JPG

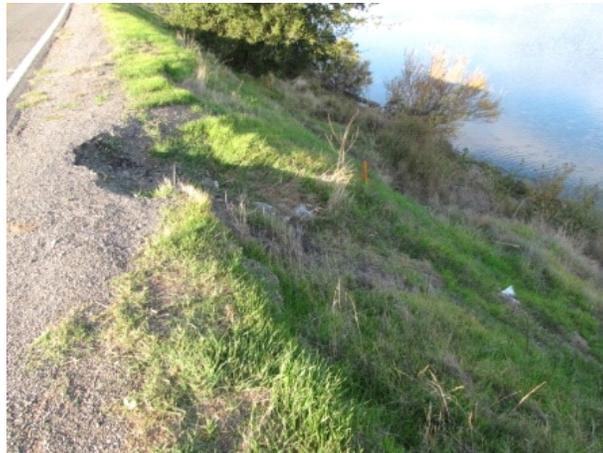
Levee Mile Report Line	94
Start Levee Mile	7.28
End Levee Mile	7.28
Location	Water Side
Category	Earthen Levee
Item	Slope Stability
View of minor erosion along the top portion of the waterward slope likely cause by foot traffic. The erosion has started to encroach into the shoulder of the road.	
dpesaven_20091110_417.jpg

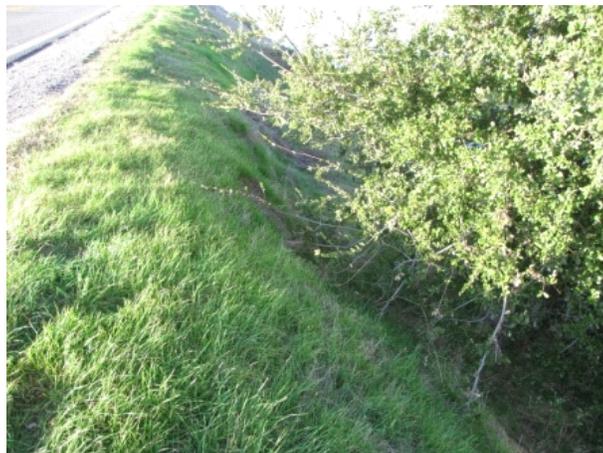
Levee Mile Report Line	95
Start Levee Mile	7.30
End Levee Mile	7.30
Location	Water Side
Category	Earthen Levee
Item	Erosion / Bank Caving
View of erosion occurring along the waterward slope along a tree.	
dpesaven_20091110_418.jpg

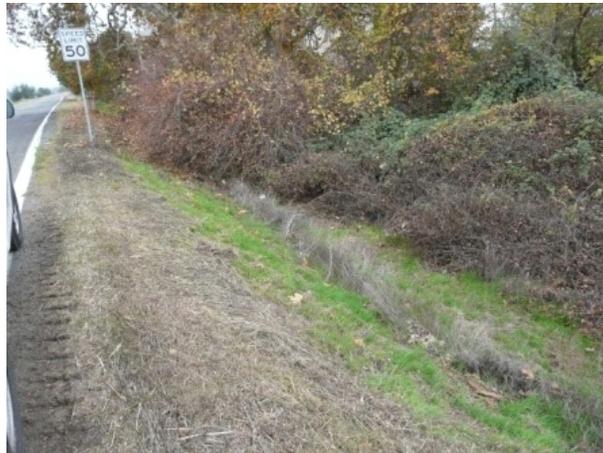
Levee Mile Report Line	98
Start Levee Mile	7.36
End Levee Mile	7.41
Location	Land Side
Category	Earthen Levee
Item	Trim / Thin Trees
Trim/thin trees and brush on landside of levee from LM 7.36 to LM 7.41	
dpesaven_20091028_234.JPG

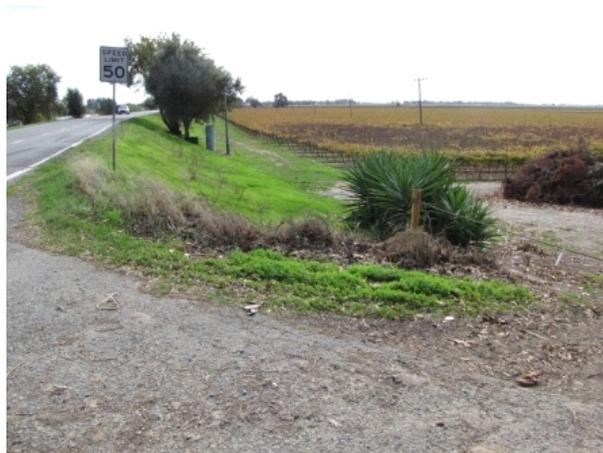
Levee Mile Report Line	99
Start Levee Mile	7.84
End Levee Mile	7.84
Location	Land Side
Category	Earthen Levee
Item	Encroachments
View of landowner planted and maintained landscaping along the landward slope looking downstream.	
dpesaven_20091110_419.jpg

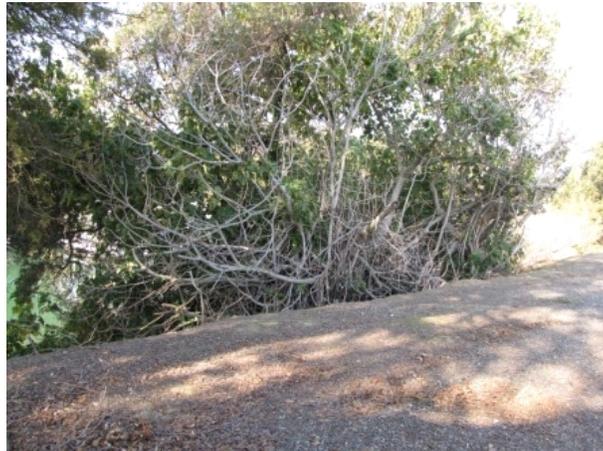
Levee Mile Report Line	7
Start Levee Mile	0.56
End Levee Mile	0.56
Location	Water Side
Category	Earthen Levee
Item	Trim / Thin Trees
View of trees and bushes within 20 feet of the shoulder blocking visibility and access.	
dpesaven_20091105_393.jpg

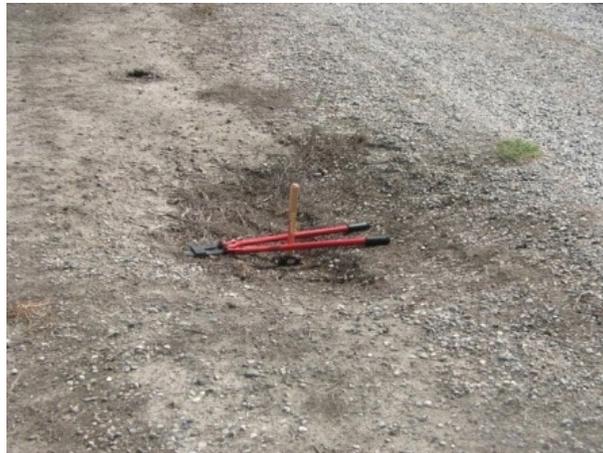
Levee Mile Report Line	11
Start Levee Mile	1.22
End Levee Mile	1.22
Location	Crown
Category	Earthen Levee
Item	Crown Surface / Depressions / Rutting
Minor depression on levee crown at LM 1.22	
dpesaven_20091028_253.jpg

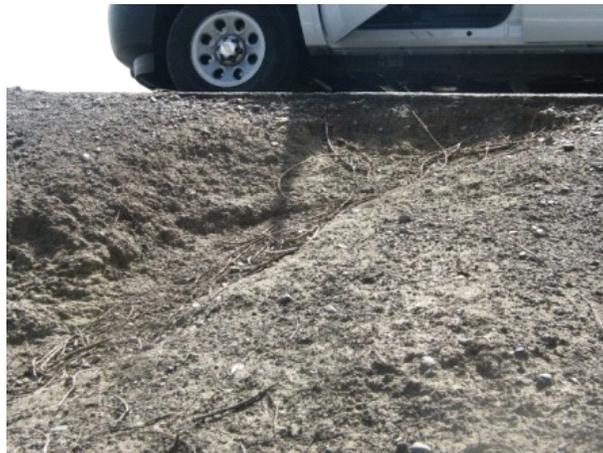
Levee Mile Report Line	12
Start Levee Mile	1.23
End Levee Mile	1.23
Location	Land Side
Category	Earthen Levee
Item	Slope Stability
Damage slope from foot traffic and rain runoff at LM 1.23	
dpesaven_20091028_254.jpg

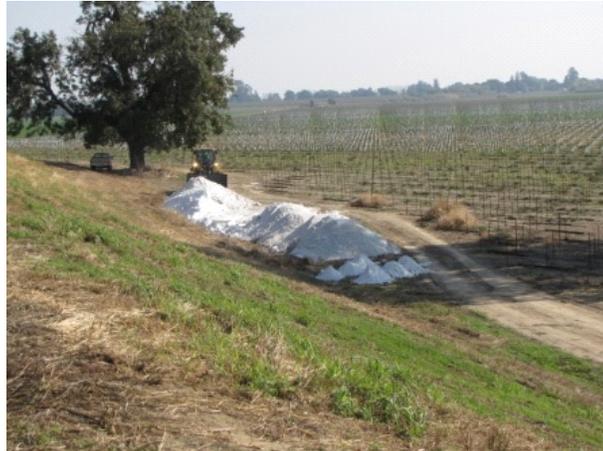
Levee Mile Report Line	16
Start Levee Mile	3.27
End Levee Mile	3.27
Location	Land Side
Category	Earthen Levee
Item	Encroachments
View of material, possibly a soil amendment, piled at the toe of the levee.	
dpesaven_20091105_394.jpg

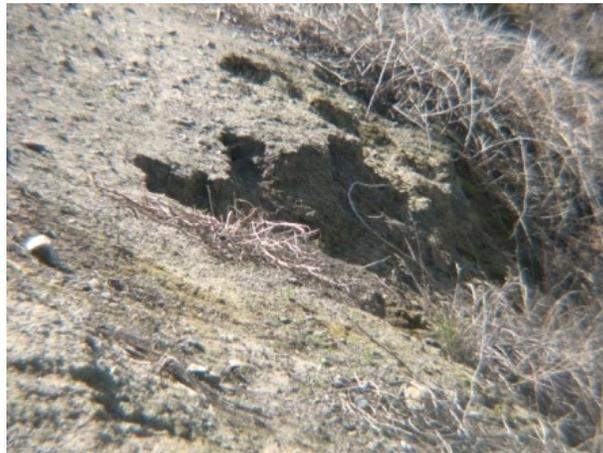
Levee Mile Report Line	17
Start Levee Mile	3.43
End Levee Mile	3.48
Location	Water Side
Category	Earthen Levee
Item	Erosion / Bank Caving
Erosion damage on waterward toe from LM 3.43 to 3.48	
dpesaven_20091028_255.jpg

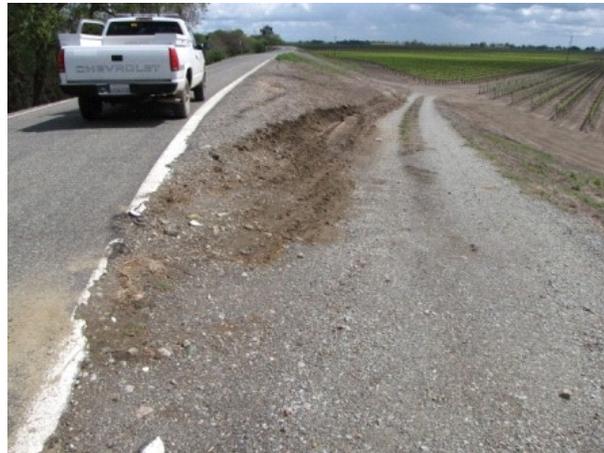
Levee Mile Report Line	19
Start Levee Mile	3.75
End Levee Mile	3.75
Location	Land Side
Category	Earthen Levee
Item	Slope Stability
Repair minor damage to levee slope along landward ramp at LM 3.75.	
dpesaven_20091028_276.jpg

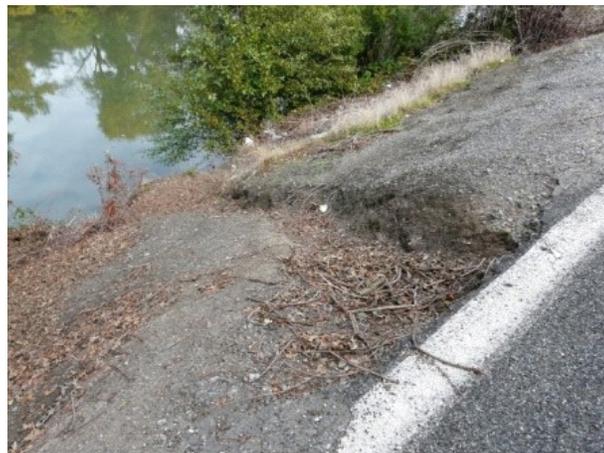
Levee Mile Report Line	20
Start Levee Mile	3.77
End Levee Mile	3.77
Location	Water Side
Category	Earthen Levee
Item	Slope Stability
Repair slope damaged by foot traffic at LM 3.77.	
dpesaven_20091028_256.JPG

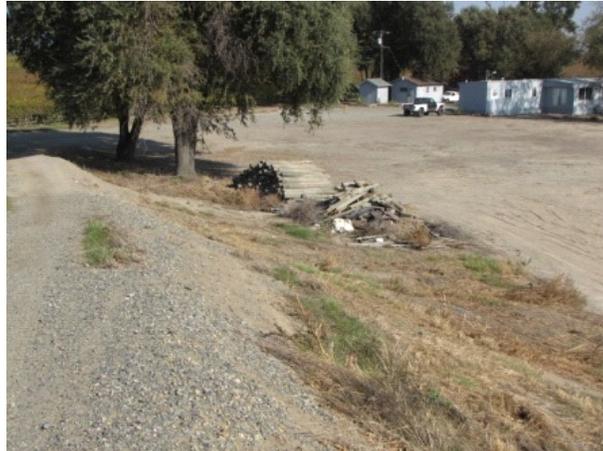
Levee Mile Report Line	21
Start Levee Mile	3.95
End Levee Mile	3.95
Location	Land Side
Category	Earthen Levee
Item	Encroachments
Updated view of material piled at the toe of the levee as of fall 2009.	
dpesaven_20091105_395.jpg

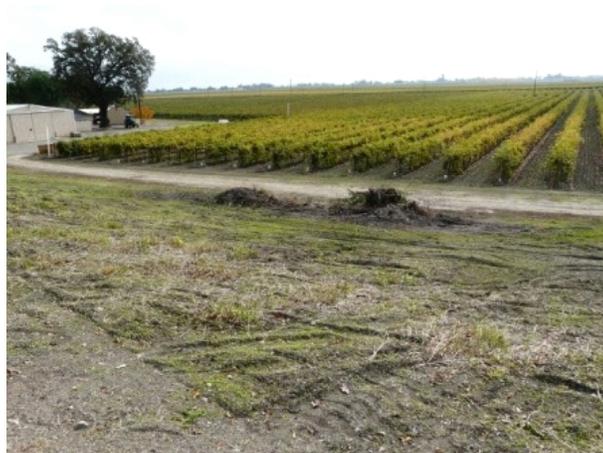
Levee Mile Report Line	23
Start Levee Mile	4.46
End Levee Mile	4.46
Location	Land Side
Category	Earthen Levee
Item	Encroachments
Remove pruning pile on landward slope at LM 4.46.	
dpesaven_20091028_267.JPG

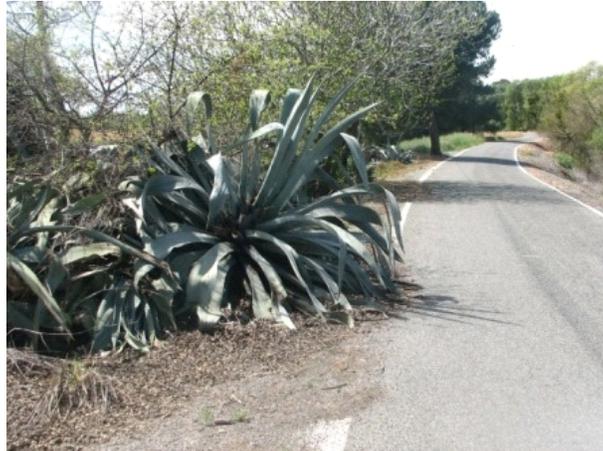
Levee Mile Report Line	26
Start Levee Mile	4.55
End Levee Mile	4.58
Location	Land Side
Category	Earthen Levee
Item	Encroachments
Landscaping blocking view of landward slope from 4.50 to 4.58	
dpesaven_20091028_257.jpg

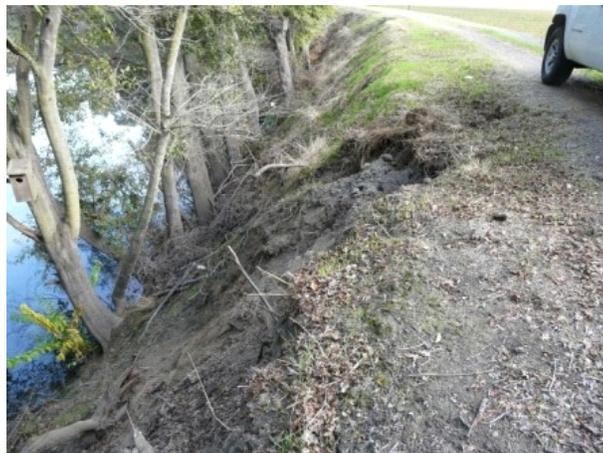
Levee Mile Report Line	64
Start Levee Mile	8.46
End Levee Mile	8.46
Location	Water Side
Category	Earthen Levee
Item	Erosion / Bank Caving
Repair erosion on waterward slope near shoulder at LM 8.46.	
dpesaven_20091028_270.JPG

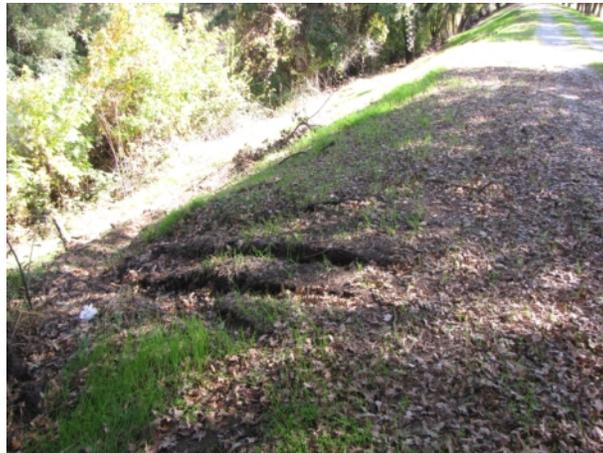
Levee Mile Report Line	71
Start Levee Mile	9.19
End Levee Mile	9.19
Location	Water Side
Category	Earthen Levee
Item	Slope Stability
View of erosion on the landward slope caused by a vehicle driving along it.	
dpesaven_20091105_408.jpg
