**Flood Control Project Maintenance  
Levee Inspections**

**Fall 2010 Levee Maintenance Deficiency Summary Report**

**Reclamation District No. 0150 Merrit Island**

**Levee Inspection Report By Mile - Fall 2010**

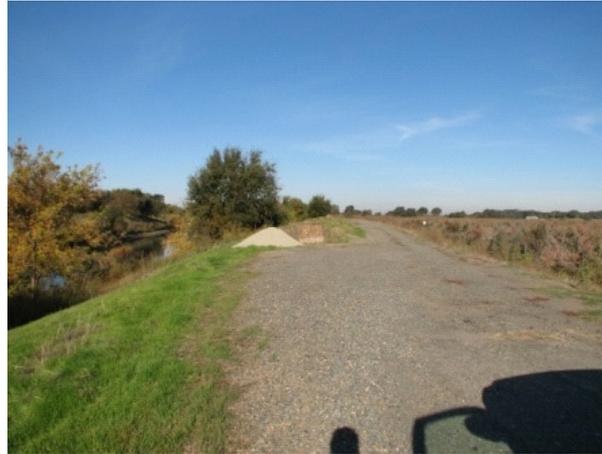
Levee Mile Report Line	1
Start Levee Mile	0.33
End Levee Mile	0.33
Location	Crown
Category	Earthen Levee
Item	Encroachments

View of a hay bale target on the crown of the levee looking west.

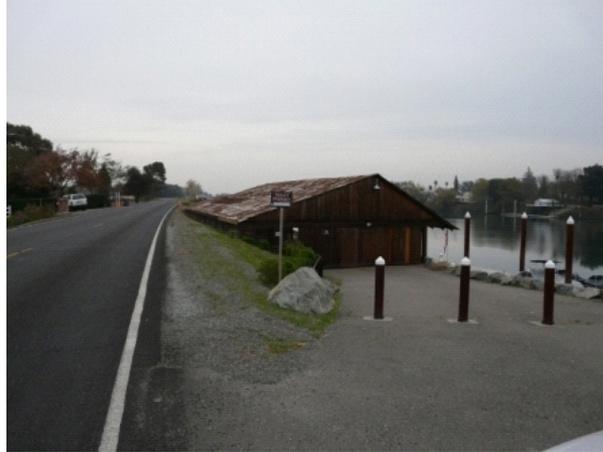
Levee Mile Report Line	5
Start Levee Mile	0.24
End Levee Mile	0.24
Location	Water Side
Category	Earthen Levee
Item	Vegetation
Remove century plant within 20' of waterside shoulder on waterside of the levee at LM 0.24	
rduffey_f_20101007_110.JPG

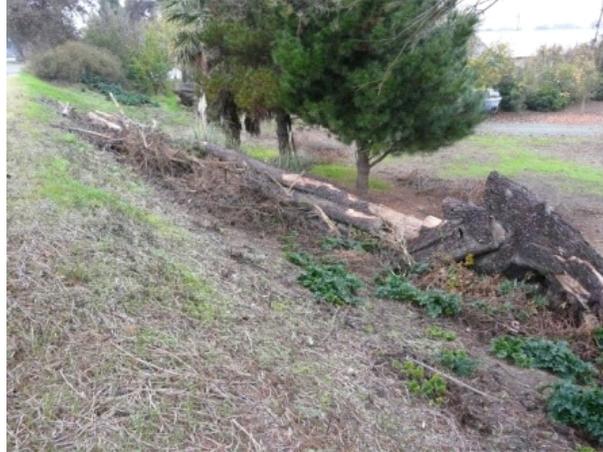
Levee Mile Report Line	10
Start Levee Mile	0.59
End Levee Mile	0.59
Location	Water Side
Category	Earthen Levee
Item	Trim / Thin Trees
Trim trees above 5' from surface of the wateside of the levee within 20' from shoulder at LM 0.59	
rduffey_f_20101007_111.JPG

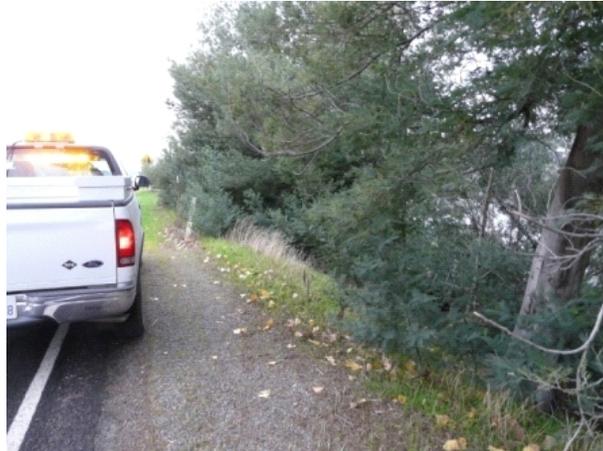
Levee Mile Report Line	15
Start Levee Mile	1.16
End Levee Mile	1.16
Location	Land Side
Category	Earthen Levee
Item	Trim / Thin Trees
View of a tree stump on the landward slope.	
rduffey_f_20101007_097.jpg

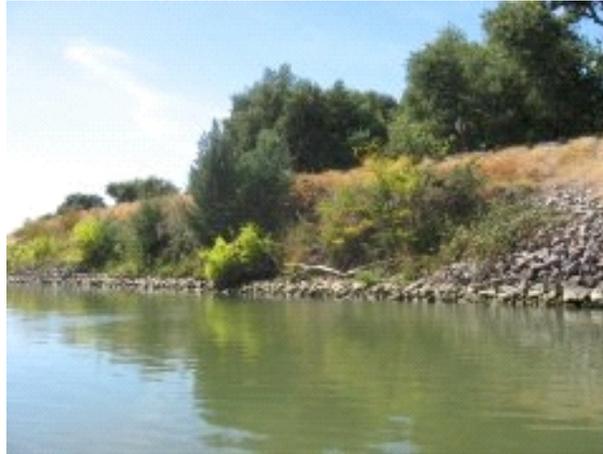
Levee Mile Report Line	19
Start Levee Mile	1.42
End Levee Mile	1.45
Location	Water Side
Category	Supplemental
Item	USACE Erosion Survey
2009: no berm, 2:1 slope, holes and slumping, clays and silts, 6.52 ft/s [2009 SiteID:SAC_35-4_R]	
rduffey_f_20101007_105.JPG

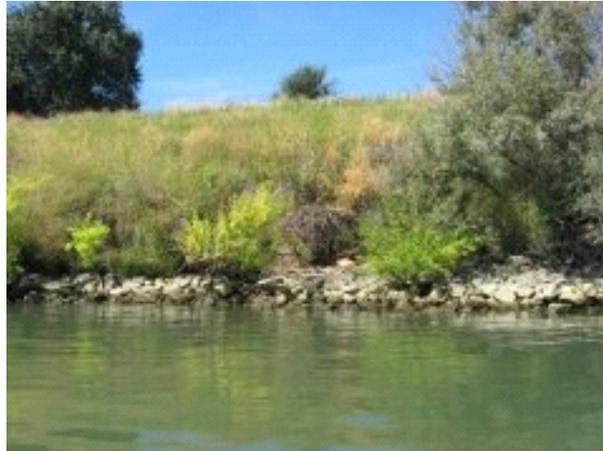
Levee Mile Report Line	29
Start Levee Mile	2.46
End Levee Mile	2.46
Location	Water Side
Category	Earthen Levee
Item	Encroachments
View of debris located on the waterward slope looking upstream.	
rduffey_f_20101007_126.jpg

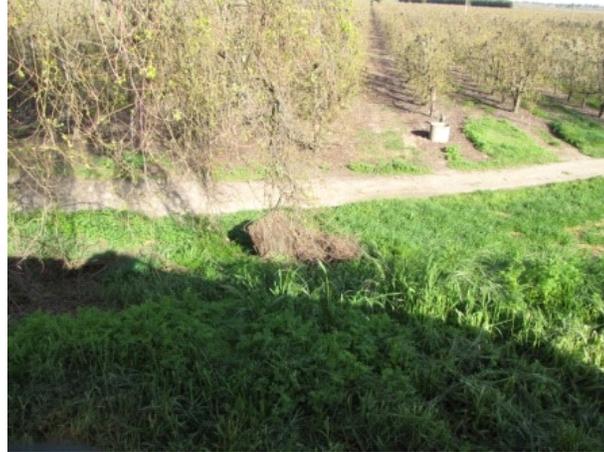
Levee Mile Report Line	34
Start Levee Mile	2.84
End Levee Mile	2.84
Location	Land Side
Category	Earthen Levee
Item	Encroachments
Down tree limbs on landward slope at LM 2.84	
rduffey_f_20101007_099.jpg

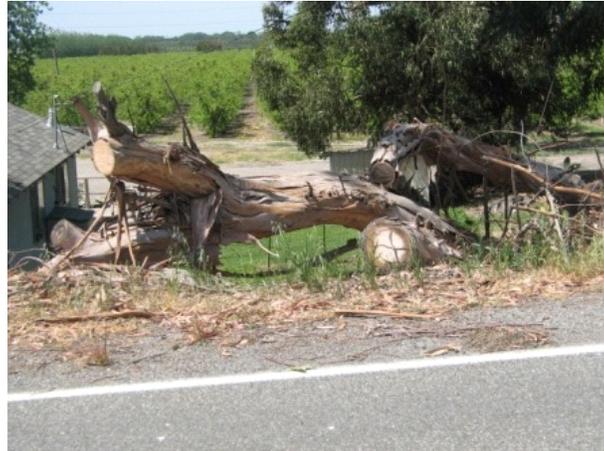
Levee Mile Report Line	35
Start Levee Mile	3.02
End Levee Mile	3.06
Location	Land Side
Category	Earthen Levee
Item	Encroachments
Landscaping providing a screen for a residence on landside of levee from LM 3.02 to LM 3.06	
rduffey_f_20101007_121.JPG

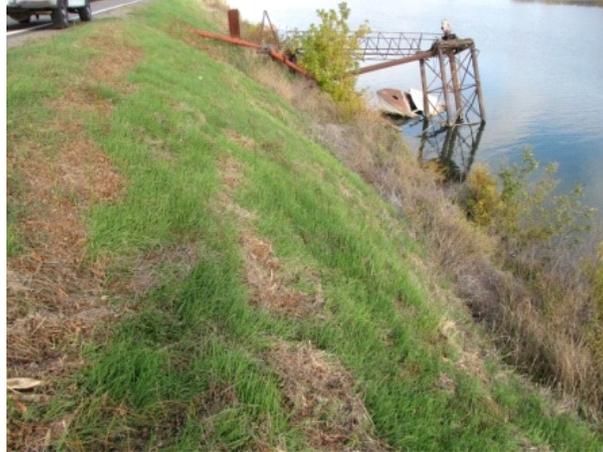
Levee Mile Report Line	37
Start Levee Mile	3.29
End Levee Mile	3.29
Location	Water Side
Category	Earthen Levee
Item	Erosion / Bank Caving
Additional view of erosion on the waterward slope looking upstream. Note the damaged pump support, pump, and pipe just upstream of the site.	
rduffey_f_20101007_128.jpg

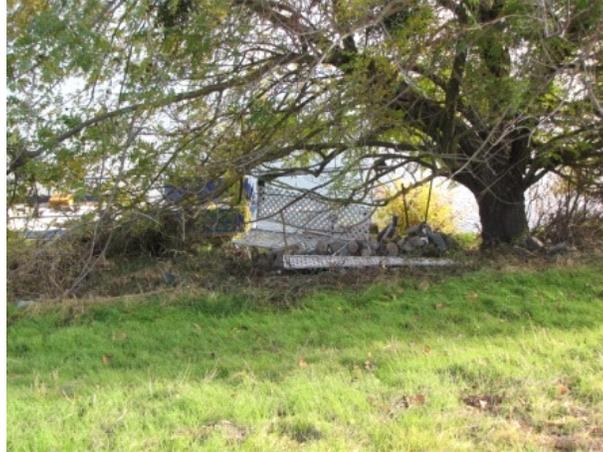
Levee Mile Report Line	45
Start Levee Mile	3.90
End Levee Mile	3.93
Location	Land Side
Category	Earthen Levee
Item	Encroachments
Landscaping in front of a residence on landside of levee from LM 3.90 to LM 3.93. The levee in this location is greater than 100' wide.	
rduffey_f_20101007_120.JPG

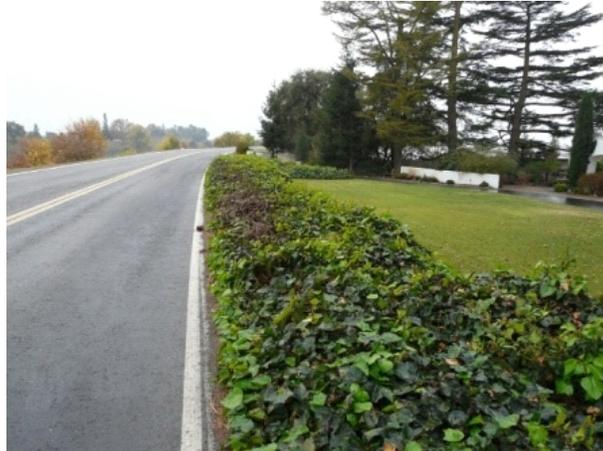
Levee Mile Report Line	46
Start Levee Mile	4.15
End Levee Mile	4.16
Location	Land Side
Category	Earthen Levee
Item	Encroachments
View of a retaining wall on the landward slope looking upstream.	
rduffey_f_20101007_100.jpg

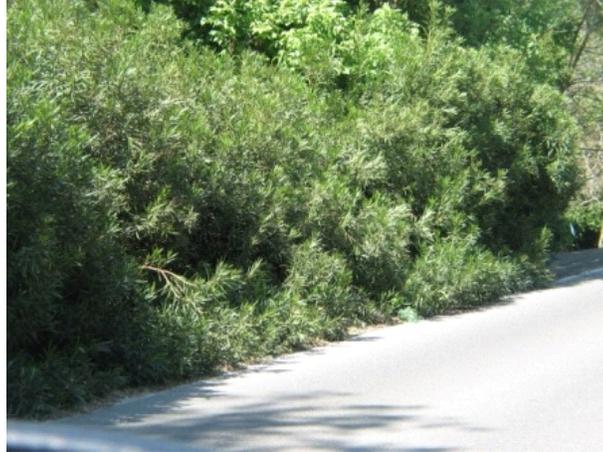
Levee Mile Report Line	51
Start Levee Mile	4.57
End Levee Mile	4.64
Location	Water Side
Category	Supplemental
Item	USACE Erosion Survey
2009: 5 ft berm, 1.5:1 slope, slumping, clays and silts, 5.46 ft/s [2009 SiteID:SAC_38-5_R]	
rduffey_f_20101007_106.JPG

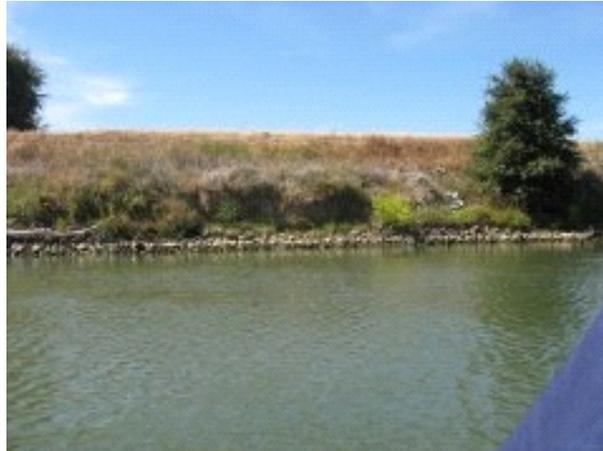
Levee Mile Report Line	52
Start Levee Mile	4.68
End Levee Mile	4.68
Location	Land Side
Category	Earthen Levee
Item	Trim / Thin Trees
View of a tree on the landward slope with lower branches blocking visibility and access. Most of these branches appear to already be dead and should be removed.	
rduffey_f_20101007_134.jpg

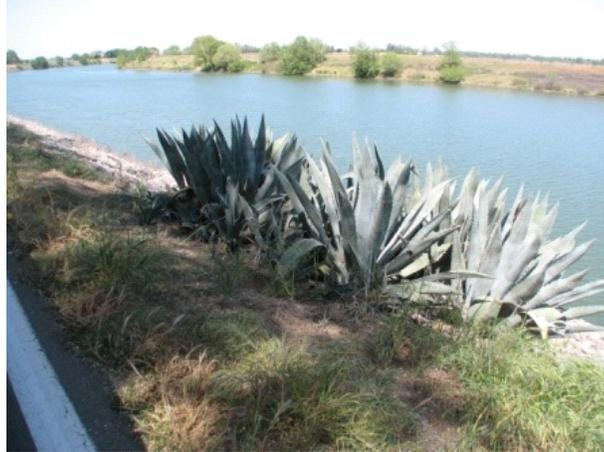
Levee Mile Report Line	58
Start Levee Mile	5.17
End Levee Mile	5.22
Location	Land Side
Category	Earthen Levee
Item	Encroachments
View of landscaping along the landward shoulder and slope looking downstream.	
rduffey_f_20101007_119.jpg

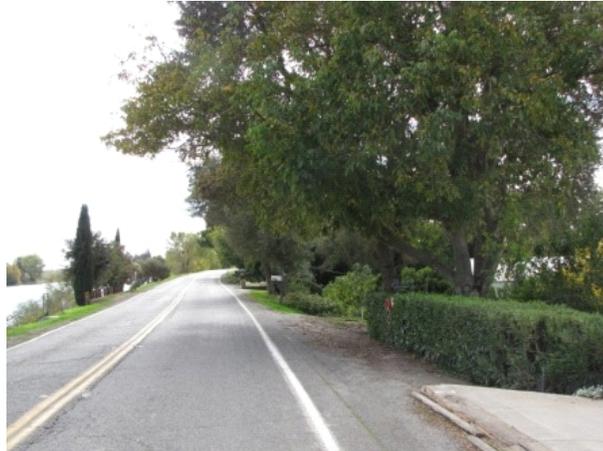
Levee Mile Report Line	78
Start Levee Mile	6.67
End Levee Mile	6.72
Location	Land Side
Category	Earthen Levee
Item	Encroachments
Landscaping providing a screen for a residence on landside of levee from LM 6.68 to LM 6.72	
rduffey_f_20101007_116.JPG

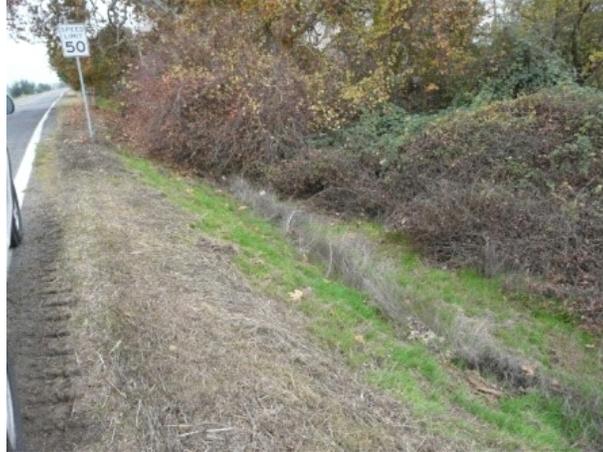
Levee Mile Report Line	92
Start Levee Mile	7.92
End Levee Mile	7.92
Location	Land Side
Category	Earthen Levee
Item	Encroachments
Landscaping on landside of levee at LM 7.92	
rduffey_f_20101007_112.JPG

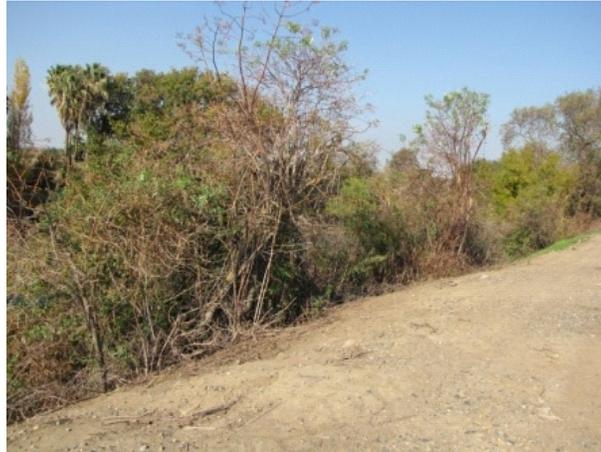
Levee Mile Report Line	2
Start Levee Mile	0.20
End Levee Mile	0.21
Location	Water Side
Category	Supplemental
Item	USACE Erosion Survey
2009: no berm, 1:1 slope, tree hazards, clays and cobbles, 3 ft/s [2009 SiteID:ELK_0-2_L]	
rduffey_f_20101007_178.JPG

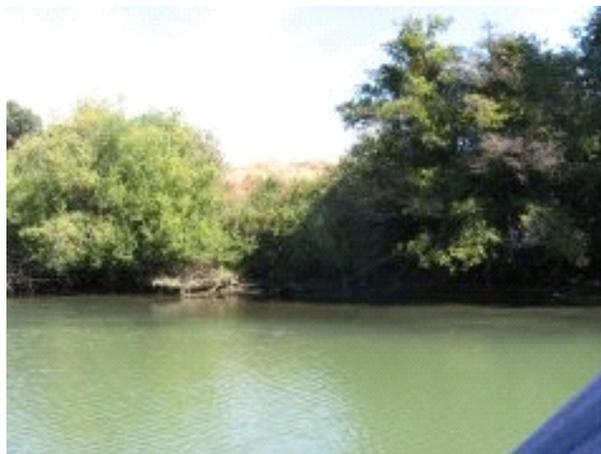
Levee Mile Report Line	3
Start Levee Mile	0.36
End Levee Mile	0.36
Location	Water Side
Category	Earthen Levee
Item	Encroachments
View of steps, a dock, and associated utilities on the waterward slope.	
rduffey_f_20101007_136.jpg

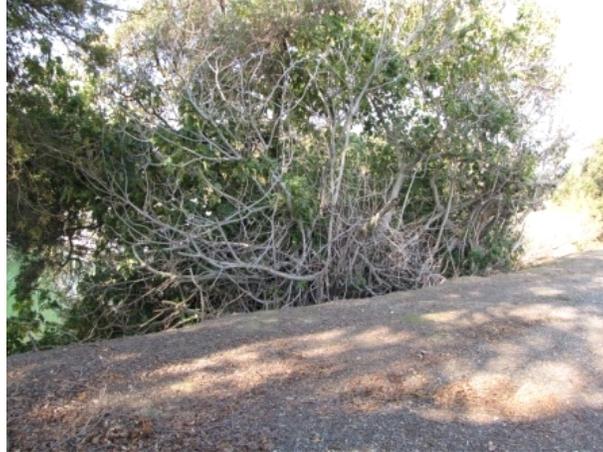
Levee Mile Report Line	6
Start Levee Mile	0.92
End Levee Mile	0.95
Location	Land Side
Category	Earthen Levee
Item	Vegetation
View of elderberries on the landward slope blocking visibility and access.	
rduffey_f_20101007_137.jpg

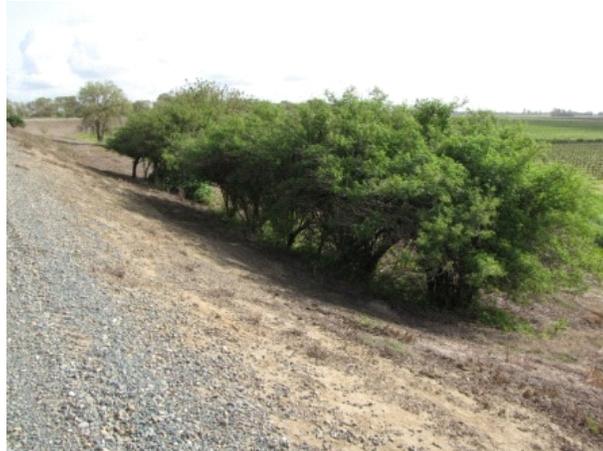
Levee Mile Report Line	7
Start Levee Mile	1.23
End Levee Mile	1.23
Location	Land Side
Category	Earthen Levee
Item	Slope Stability
Damaged slope from foot traffic and rain runoff at LM 1.23	
rduffey_f_20101007_139.jpg

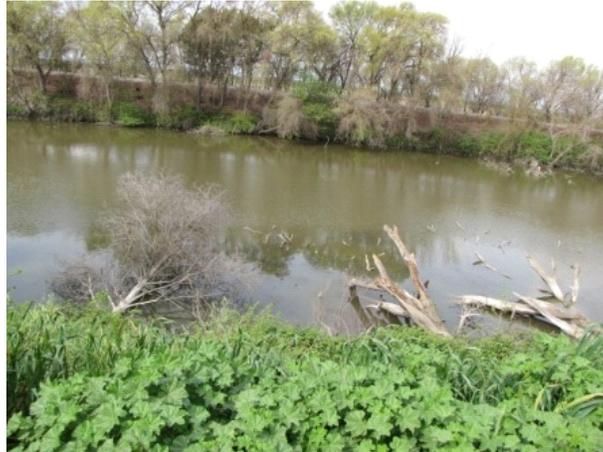
Levee Mile Report Line	14
Start Levee Mile	3.18
End Levee Mile	3.18
Location	Water Side
Category	Earthen Levee
Item	Trim / Thin Trees
View of tree stumps on the waterward slope.	
rduffey_f_20101007_148.jpg

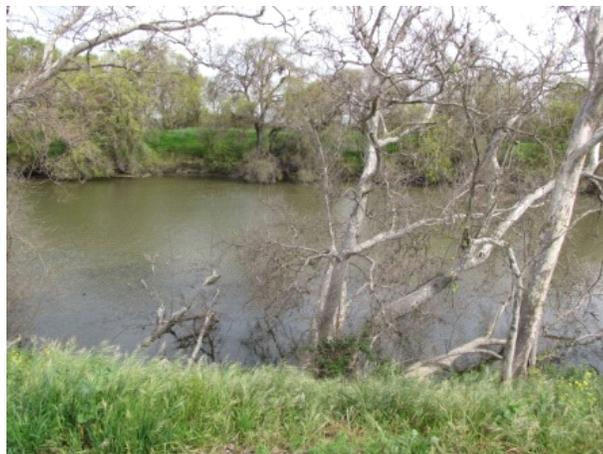
Levee Mile Report Line	15
Start Levee Mile	3.21
End Levee Mile	3.21
Location	Water Side
Category	Earthen Levee
Item	Trim / Thin Trees
View of tree stumps on the waterward slope.	
rduffey_f_20101007_149.jpg

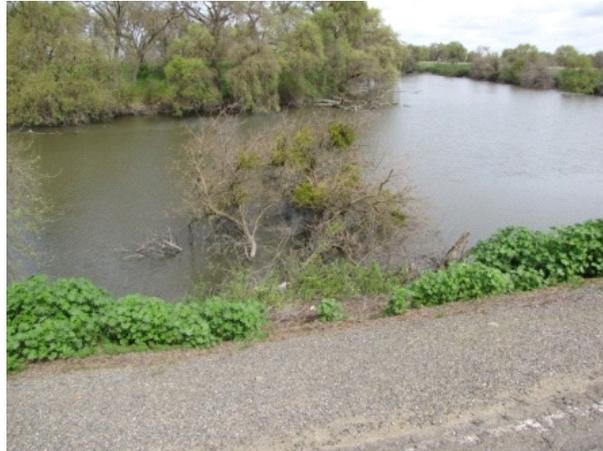
Levee Mile Report Line	18
Start Levee Mile	3.43
End Levee Mile	3.48
Location	Water Side
Category	Earthen Levee
Item	Erosion / Bank Caving
Erosion damage on waterward toe from LM 3.43 to 3.48	
rduffey_f_20101007_142.jpg

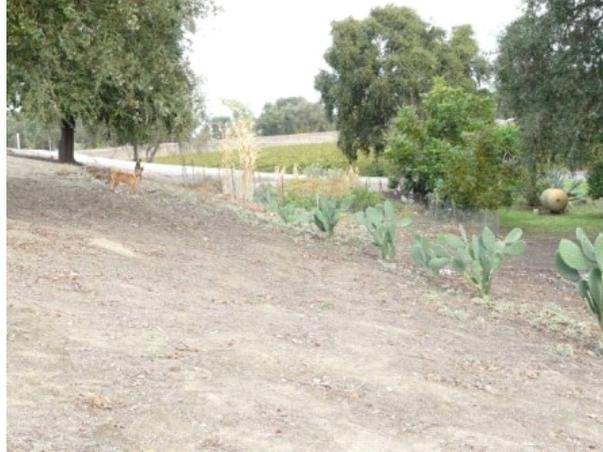
Levee Mile Report Line	20
Start Levee Mile	3.75
End Levee Mile	3.75
Location	Land Side
Category	Earthen Levee
Item	Slope Stability
Repair minor damage to levee slope along landward ramp at LM 3.75.	
rduffey_f_20101007_179.jpg

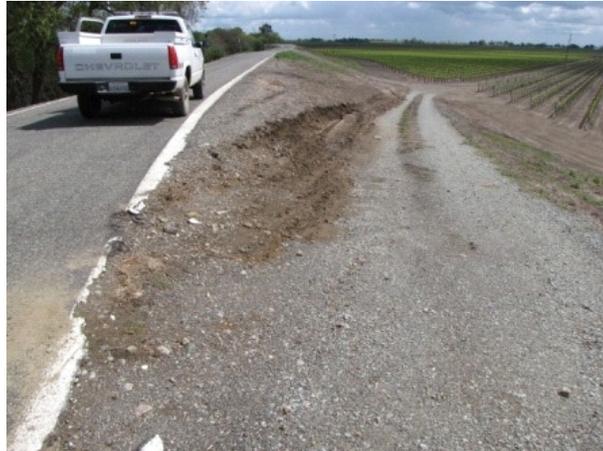
Levee Mile Report Line	21
Start Levee Mile	3.77
End Levee Mile	3.77
Location	Water Side
Category	Earthen Levee
Item	Slope Stability
Repair slope damaged by foot traffic at LM 3.77.	
rduffey_f_20101007_143.JPG

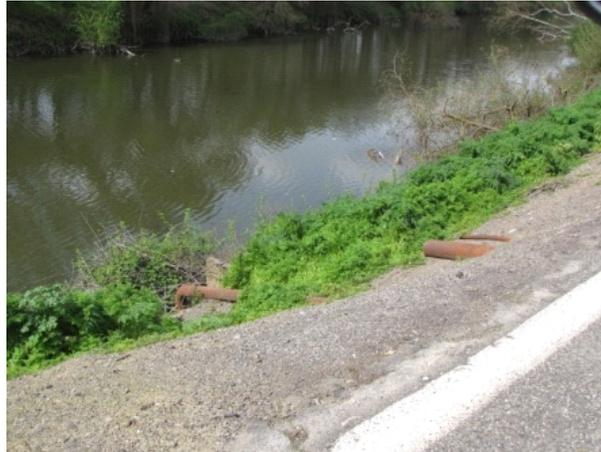
Levee Mile Report Line	42
Start Levee Mile	6.06
End Levee Mile	6.06
Location	Water Side
Category	Earthen Levee
Item	Encroachments
View of an improperly abandoned pipe through the levee looking upstream.	
rduffey_f_20101007_162.jpg

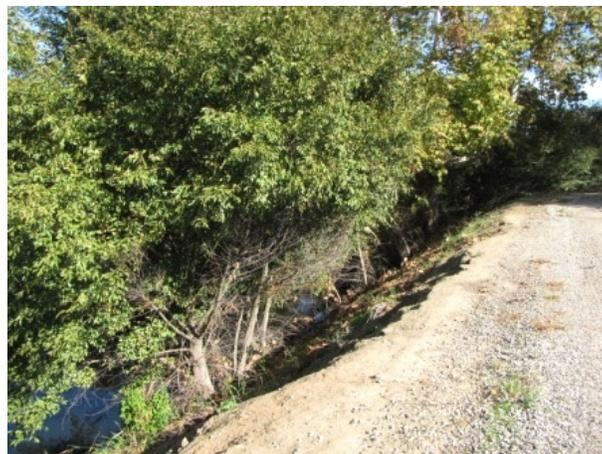
Levee Mile Report Line	62
Start Levee Mile	8.46
End Levee Mile	8.46
Location	Water Side
Category	Earthen Levee
Item	Erosion / Bank Caving
Repair erosion on waterward slope near shoulder at LM 8.46.	
rduffey_f_20101007_175.JPG
