**Flood Control Project Maintenance  
Levee Inspections**

**Fall 2015 Levee Maintenance Deficiency Summary Report**

**Sacramento River Basin**

| RD0150<br>Reclamation District No. 0150 Merrit Island | | Overall LMA Rating | Total LMA Miles | * Overall LMA Threshold Percent is less than 10.00%; however, U Rated Miles are present, so the Overall LMA Rating is M instead of A. | | | | | |

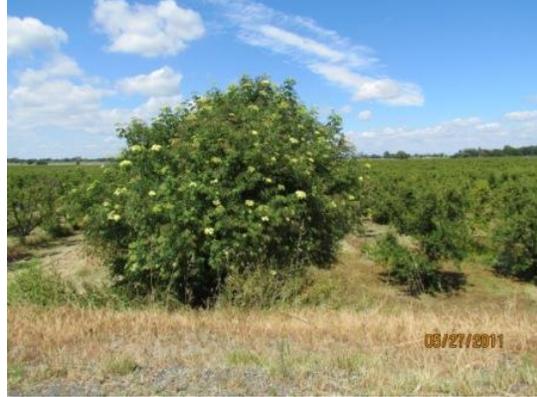
Photo 1 of 1 : FA\_2015\_RD0150\_15\_3\_20150911\_00003.jpg

Elderberry bush was found on the landside of the levee. The picture was taken from the crown looking downstream.

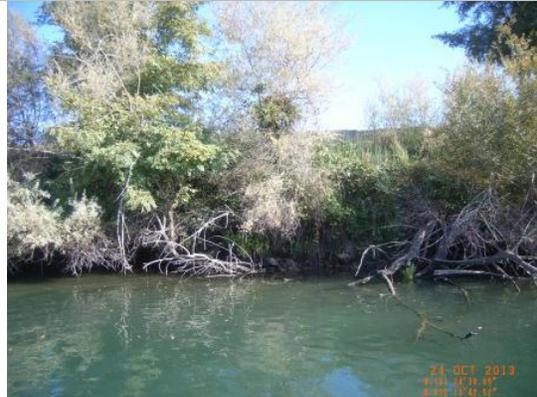
Photo 1 of 2 : USACE2013A\_STR\_28-4\_R\_14.jpg

| Inspector Comments: 2013 - Old toe repair unraveling. Bridge at upstream end of site. 2015: No observed changes. [2015 Site ID: STR_28-4_R] | | | | | |

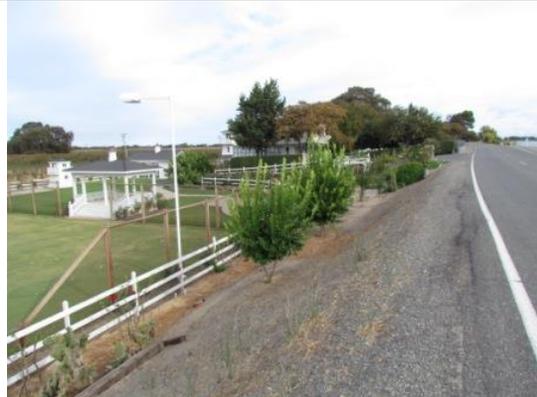
Photo 1 of 1 : FA\_2015\_RD0150\_16\_990\_20150911\_00057.jpg

Landscaping was found on the landside of the levee looking upstream.

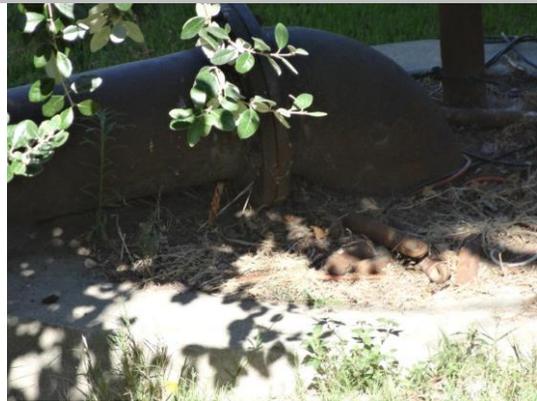
Photo 1 of 3 : UCIP\_FA\_2015\_2001.jpg

| Inspector Comments: FS_ID:42700<br>DS_ID:22416<br>EP_NO: N/A<br>FS_HLM: 0.237<br>Repair Type: Non-Urgent<br>Crossing Status: Found<br>UCIP Comments: Appears abandoned and if so should be done so properly.- Dense vegetation on waterside.- Seems abandoned pipe and pump.<br>FIELD_STRUCT_DESC: Abandoned 10-inch steel pipe through the levee, 2.8 feet below the crown. Pump on landside. Concrete box on landside. O&M Manual SAC 112, March 1957.<br>FS Date: 08/27/2013 | | | | | |

LS view: abandoned pipe and concrete box on landside toe.

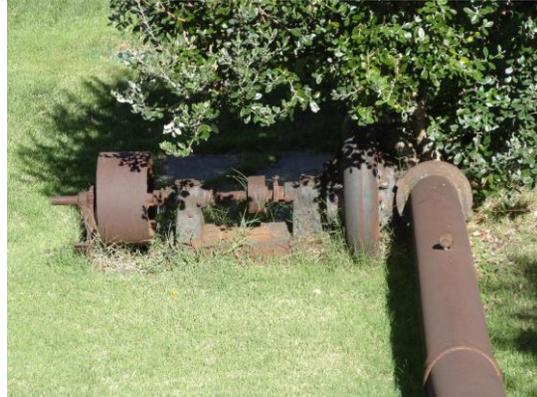
Photo 2 of 3 : UCIP\_FA\_2015\_2037.jpg

LS view: abandoned pipe and pump on landside toe.

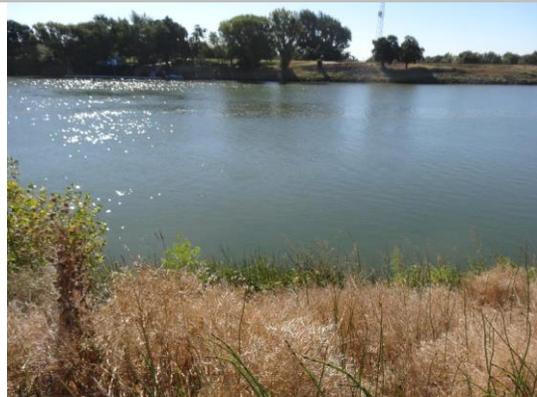
Photo 3 of 3 : UCIP\_FA\_2015\_2038.jpg

WS view: No pipe found on waterside slope. Dense vegetation on waterside.

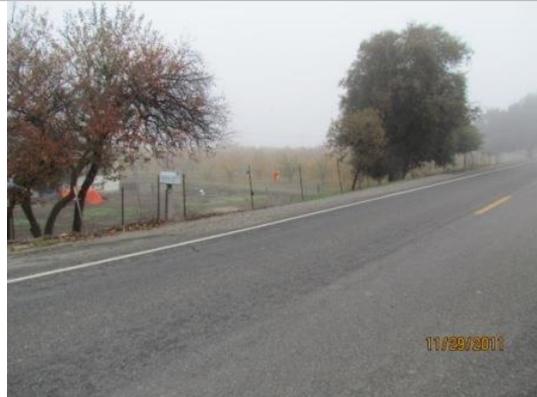
Photo 1 of 1 : FA\_2015\_RD0150\_16\_9\_20150911\_00005.jpg

Fence was found on the landside of the levee looking upstream.

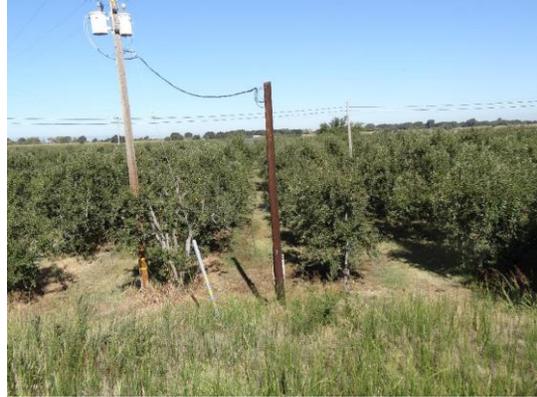
Photo 1 of 3 : UCIP\_FA\_2015\_1998.jpg

**Action/Comments**  
 Inspector Comments: FS\_ID:20268  
 DS\_ID:22417  
 EP\_NO: N/A  
 FS\_HLM: 0.3906  
 Repair Type: Non-Urgent  
 Crossing Status: Found  
 UCIP Comments: - Water leaks from pressure breaker.- Distribution box at the landward toe not found/visible.- Service pole on LS toe.  
 FIELD\_STRUCT\_DESC: 4-inch steel pipe joined to 6-inch steel pipe and the 6-inch pipe joined to 10-inch steel pipe through the levee, 5.8 feet below the crown. 1.5-inch conduit through the levee, 3 feet below the crown. Pump and gate valve on the waterward slope. (Runyon).  
 FS Date: 08/27/2013

LS view: distribution box not found/visible on levee toe.

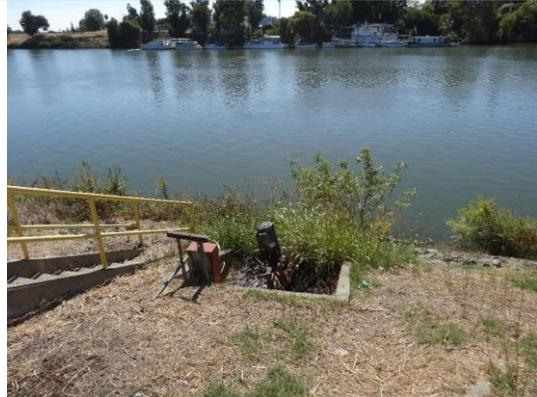
Photo 3 of 3 : UCIP\_FA\_2015\_2000.jpg

WS view: walkway/stairs, pump on levee slope.

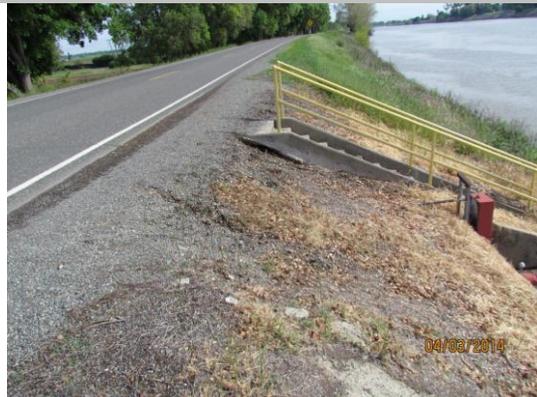
Photo 1 of 2 : FA\_2015\_RD0150\_16\_6\_20150911\_00002.jpg

Updated photo of the slope instability on the waterside of the levee looking upstream during spring 2014 inspection.

| Repair the levee slope damaged by foot traffic and prevent access where possible. | | | | | |

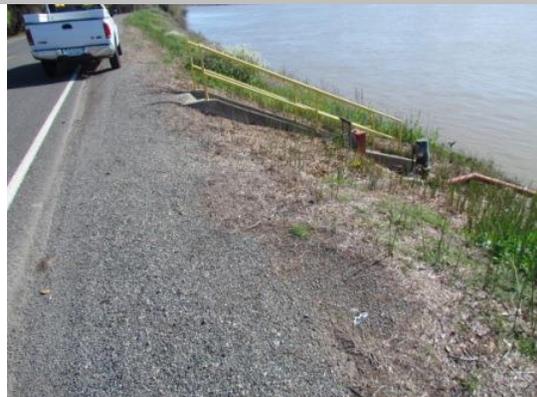
Photo 2 of 2 : FA\_2015\_RD0150\_16\_6\_20150911\_00003.jpg

Slope instability was found on the waterside of the levee looking upstream.

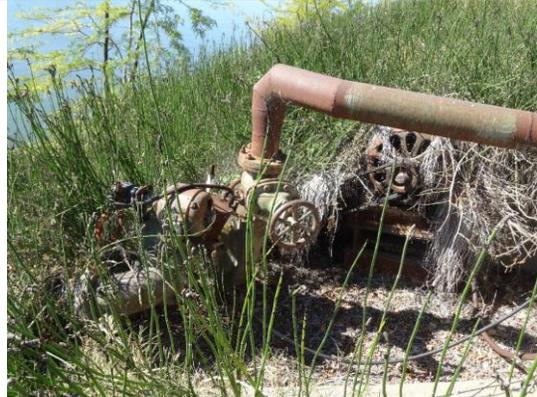
Photo 1 of 3 : UCIP\_FA\_2015\_1902.jpg

WS view: steel pipe, gate valve, and pump on levee slope. Seems abandoned.

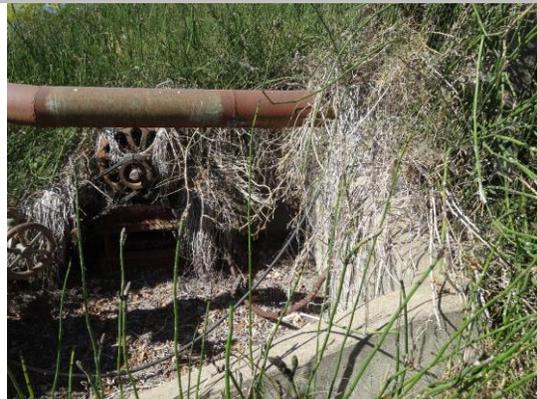
Photo 2 of 3 : UCIP\_FA\_2015\_1903.jpg

WS view: steel pipe and pump on concrete pad. Seems abandoned.

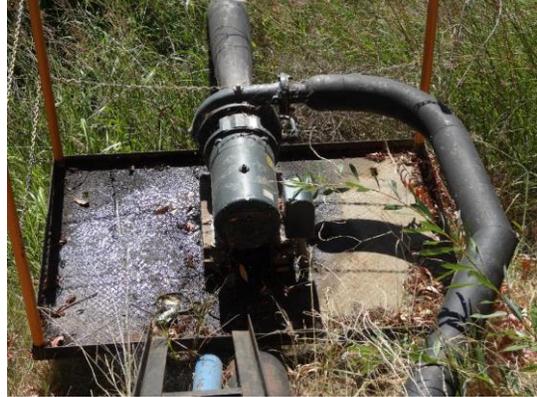
Photo 2 of 3 : UCIP\_FA\_2015\_2042.jpg

WS view: steel pipes and leaky slant pump on steel deck.

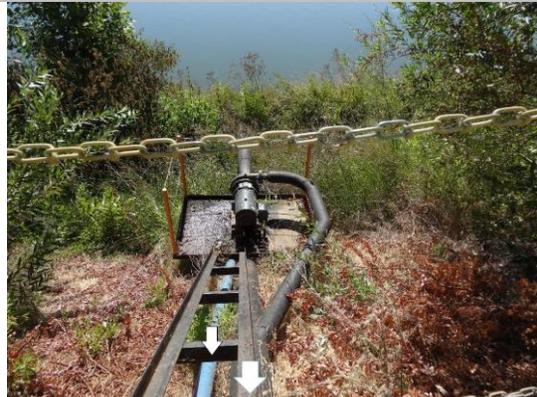
Photo 3 of 3 : UCIP\_FA\_2015\_2043.jpg

WS view: slant pump on steel deck, 4-inch pipe (left) and 10-inch pipe (right) on levee slope.

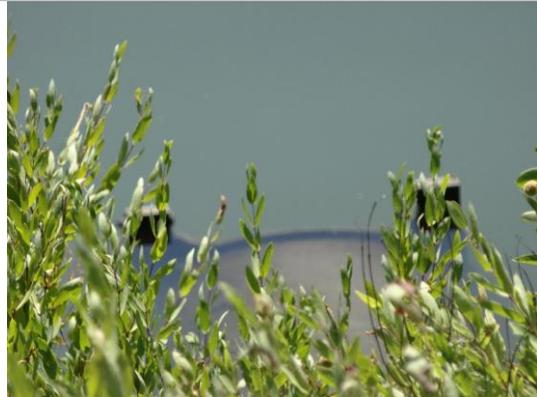
Photo 1 of 3 : UCIP\_FA\_2015\_1720.jpg

WS view: submerged flap gate in the stream.

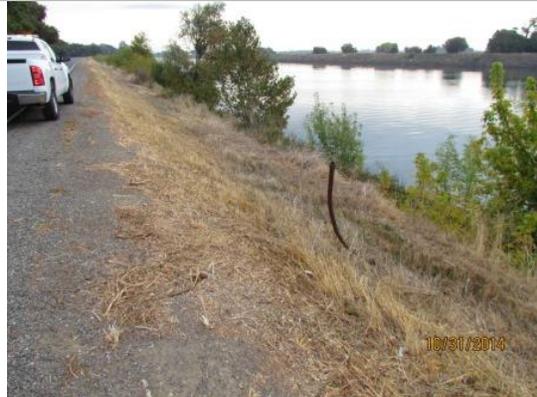
Photo 1 of 1 : FA\_2015\_RD0150\_16\_48\_20150911\_00026.jpg

A pole/pipe was found on the waterside slope of the levee looking upstream.

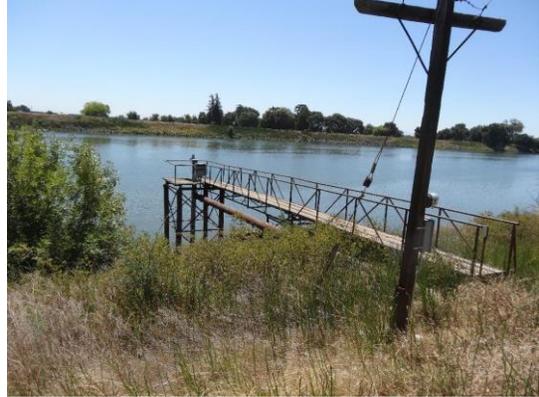
Photo 3 of 3 : UCIP\_FA\_2015\_1945.jpg

WS view: service pole, pipe & pump on piling structure in the stream.

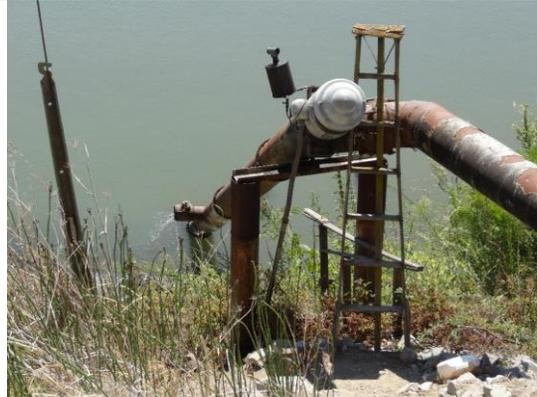
Photo 2 of 2 : UCIP\_FA\_2015\_1724.jpg

WS view: slant pump on steel frame support and exposed pipe on levee slope.

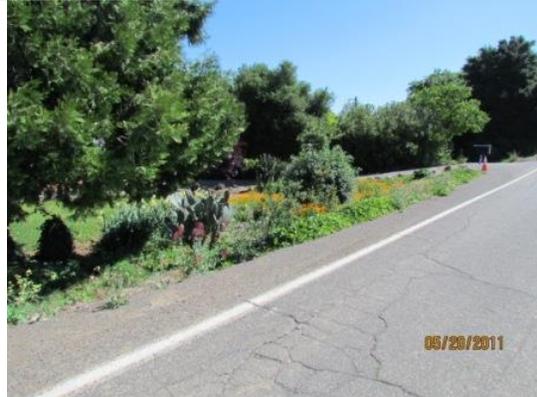
Photo 1 of 1 : FA\_2015\_RD0150\_16\_88\_20150911\_00045.jpg

Landscaping was found on the landside of the levee. The picture was taken from the crown looking upstream.

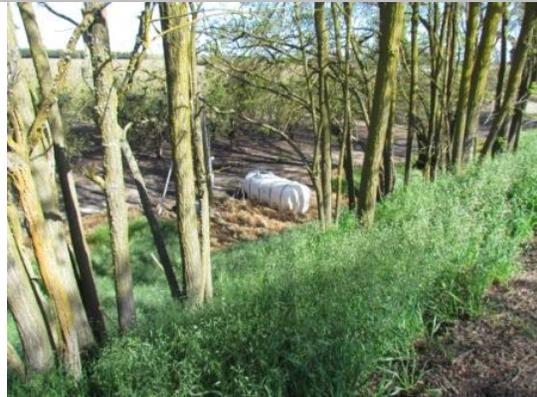
Photo 1 of 1 : FA\_2015\_RD0150\_16\_23\_20150911\_00015.jpg

A tank was found on the landside toe of the levee looking upstream.

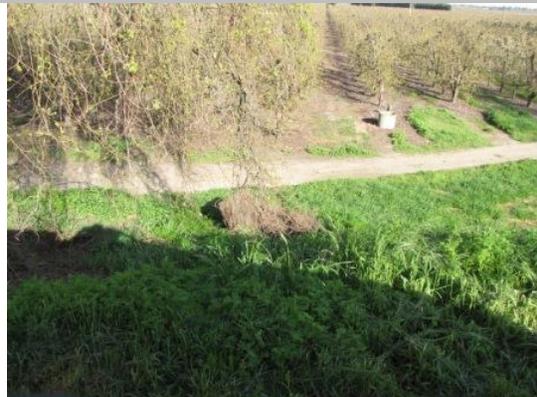
Photo 1 of 1 : FA\_2015\_RD0150\_16\_14\_20150911\_00009.jpg

View of a tree stump on the landward slope.

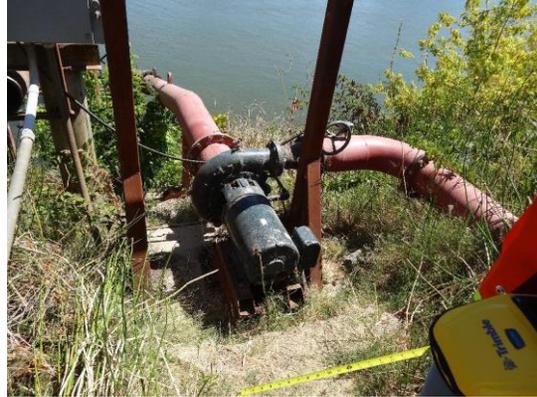
Photo 1 of 3 : UCIP\_FA\_2015\_1725.jpg

WS view: pipe, electric conduit (left), and pump on levee slope.

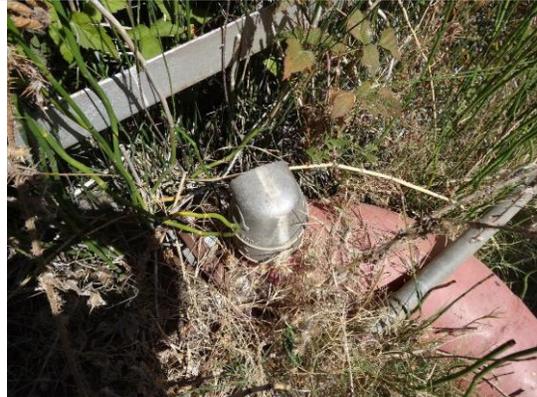
Photo 2 of 3 : UCIP\_FA\_2015\_1726.jpg

WS view: air vent on steel pipe on levee slope. Electric conduit over pipe (right)

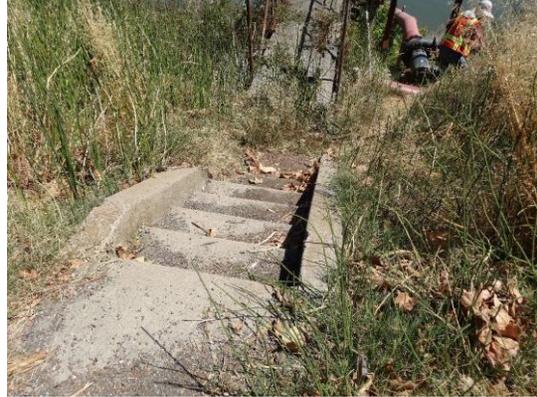
Photo 3 of 3 : UCIP\_FA\_2015\_1727.jpg

WS view: walkway steps, pipe, and pump on levee slope.

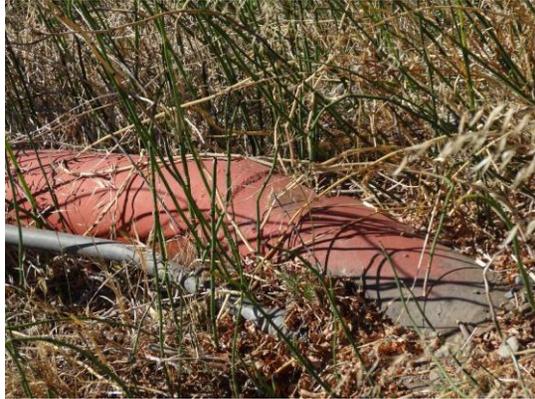
Photo 2 of 3 : UCIP\_FA\_2015\_1813.jpg

WS view: steel pipe and GI conduit on levee slope.

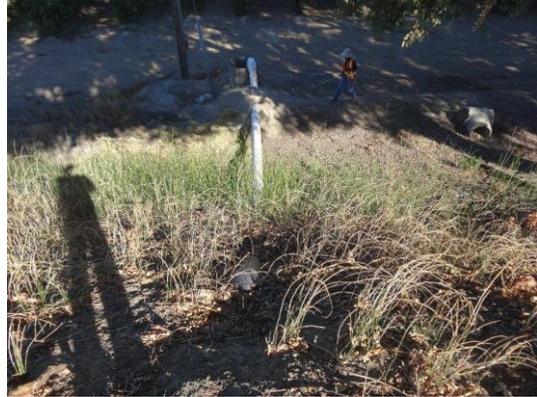
Photo 1 of 3 : UCIP\_FA\_2015\_1820.jpg

LS view: exposed pipe on levee slope and standpipe on the toe.

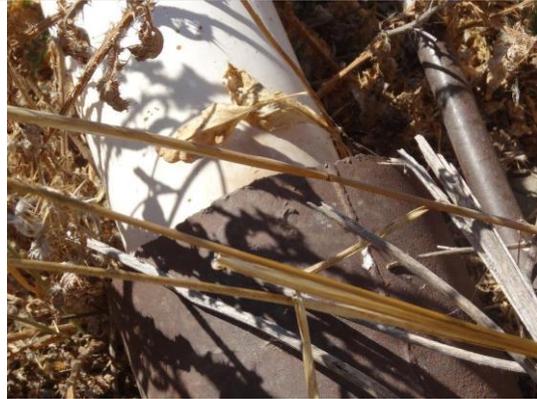
Photo 2 of 3 : UCIP\_FA\_2015\_1821.jpg

WS view: steel conduit (right); 8" pvc pipe sleeved into 12" steel pipe.

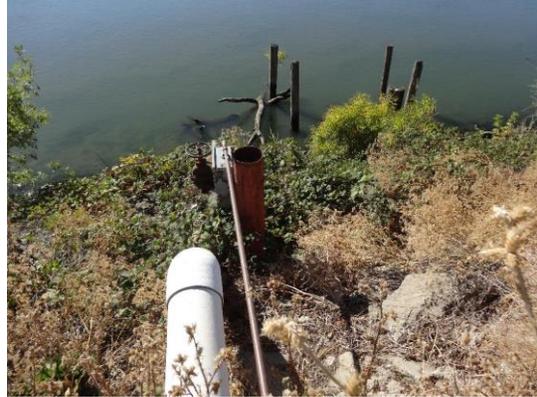
Photo 3 of 3 : UCIP\_FA\_2015\_1822.jpg

WS view: pipe, pump, and conduit on levee slope.

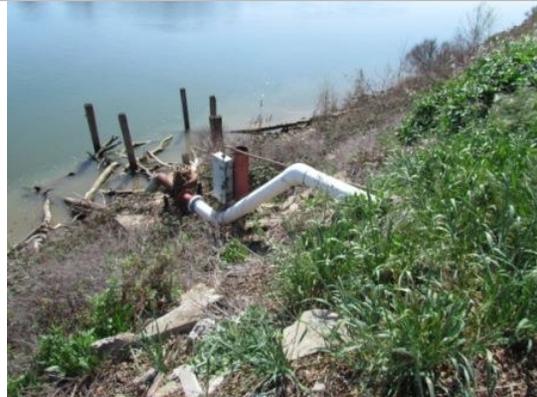
Photo 1 of 2 : FA\_2015\_RD0150\_16\_15\_20150911\_00010.jpg

A PVC pipe was used to pump the water from waterside of the levee. It appeared that the PVC pipe was penetrating through a corroded steel casing through the levee crown. The picture was taken from the crown of the levee looking upstream during spring 2013 inspection.

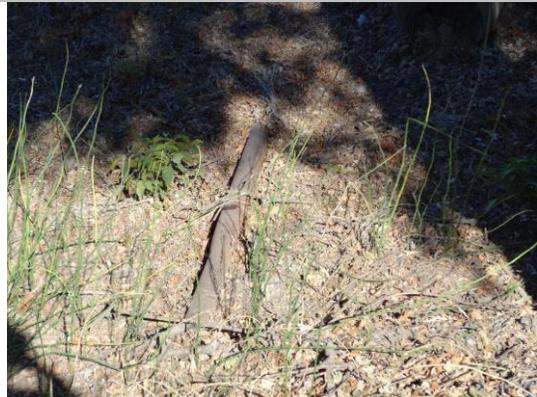
Photo 1 of 3 : UCIP\_FA\_2015\_1823.jpg

LS view: abandoned 4-inch steel pipe on levee slope.

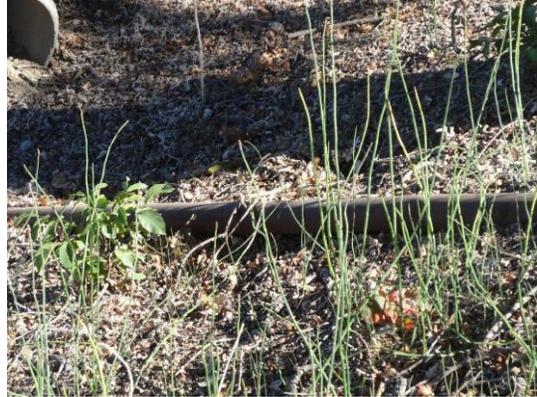
Photo 2 of 3 : UCIP\_FA\_2015\_1905.jpg

LS view: exposed 4-inch steel pipe on levee slope.

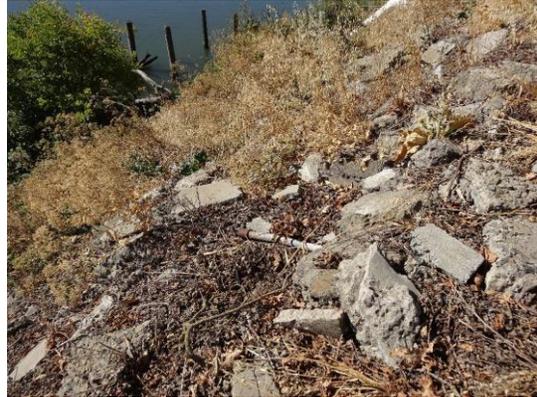
Photo 3 of 3 : UCIP\_FA\_2015\_1906.jpg

WS view: abandoned 1-inch conduit on levee slope.

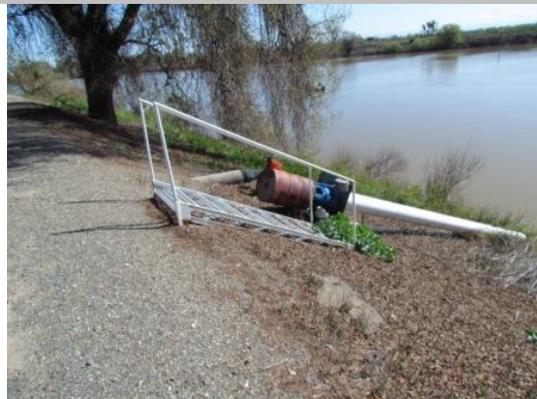
Photo 1 of 1 : FA\_2015\_RD0150\_16\_33\_20150911\_00021.jpg

A stairway was found on the waterside slope of the levee.

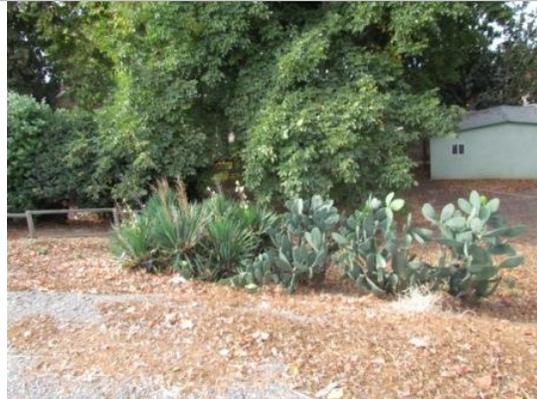
Photo 1 of 1 : FA\_2015\_RD0150\_16\_953\_20150911\_00049.jpg

View of cacti on the landside of the levee looking from the crown.

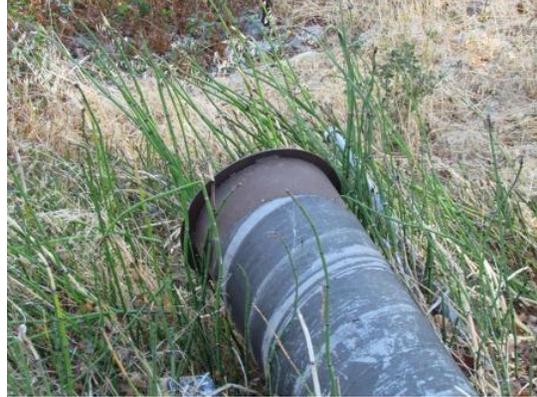
Photo 1 of 1 : FA\_2015\_RD0150\_16\_69\_20150911\_00038.jpg

The pipe cover doesn't appear to be water tight on the waterside slope of the levee. The picture was taken from the crown looking towards the toe of the levee during fall 2013 inspection.

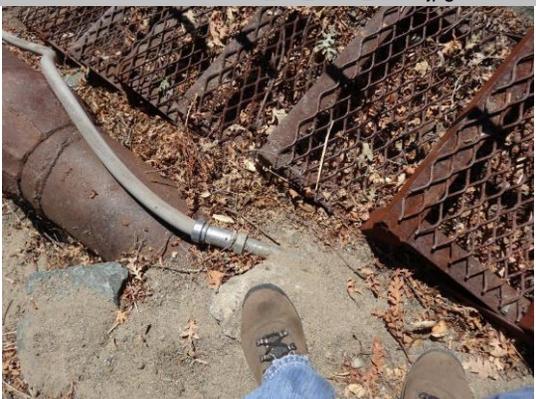
Photo 1 of 3 : UCIP\_FA\_2015\_1870.jpg

WS view: steel steps to pump platform, exposed steel pipe, and electric conduit on levee slope.

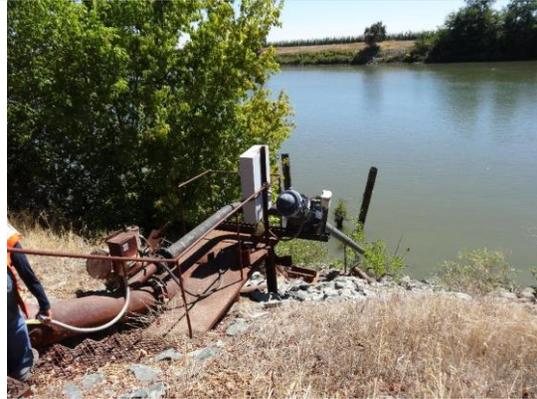
Photo 3 of 3 : UCIP\_FA\_2015\_1872.jpg

WS view: pipe, walkway, slant pump & pump platform on stream bank.

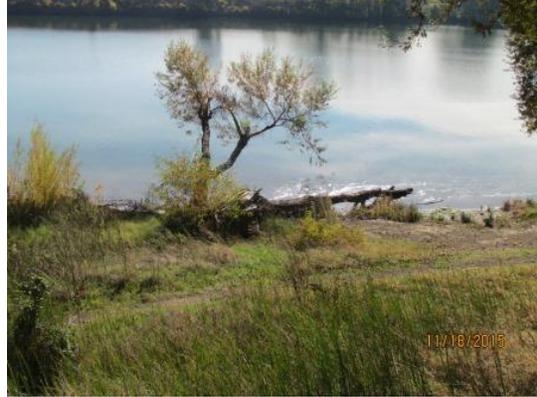
Photo 1 of 1 : FA\_2015\_RD0150\_16\_47\_20151119\_00075.jpg

View of tree trunk on the waterside toe of the levee.

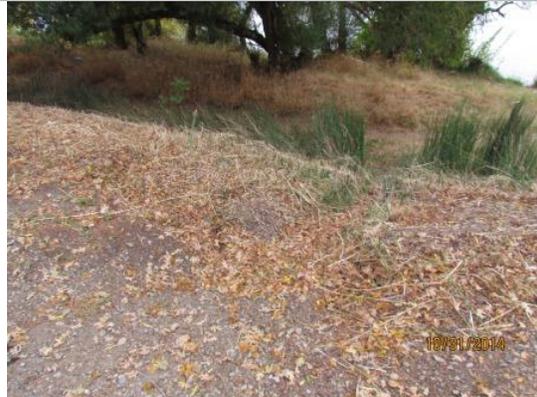
Photo 1 of 1 : FA\_2015\_RD0150\_16\_54\_20150911\_00031.jpg

View of a slope instability on the waterside of the levee looking towards the toe.

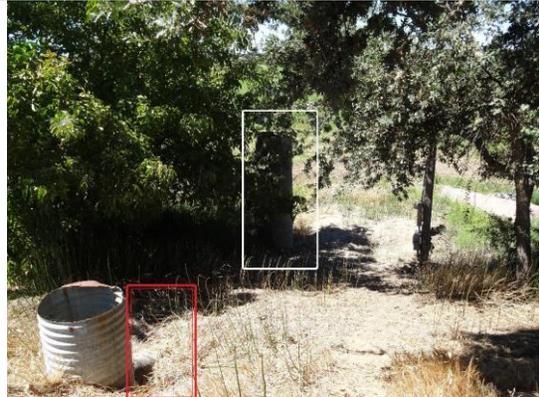
Photo 1 of 3 : UCIP\_FA\_2015\_1827.jpg

LS view: siphon breaker in CMP riser (left) on levee slope and concrete standpipe at levee toe (right).

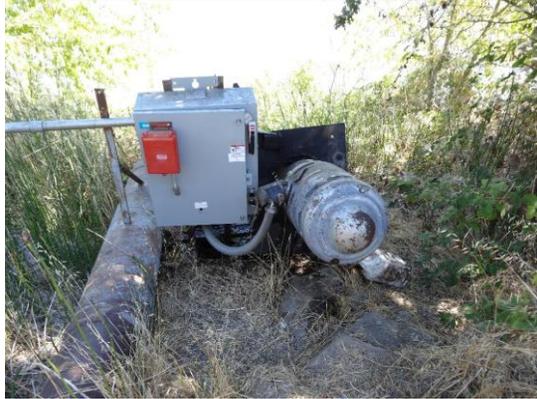
Photo 3 of 3 : UCIP\_FA\_2015\_1829.jpg

WS view: steel pipe and slant pump on levee slope.

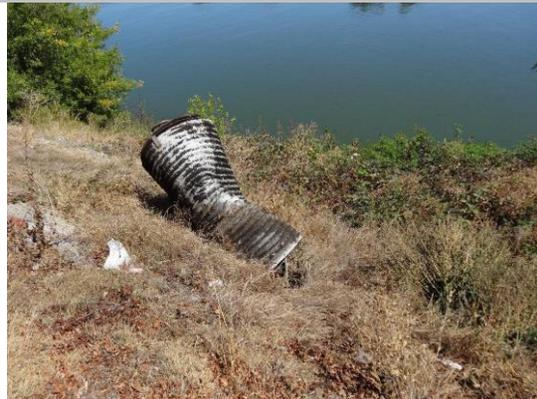
Photo 3 of 3 : UCIP\_FA\_2015\_1832.jpg

WS view: an abandoned and dismantled CMP riser on WS levee slope.

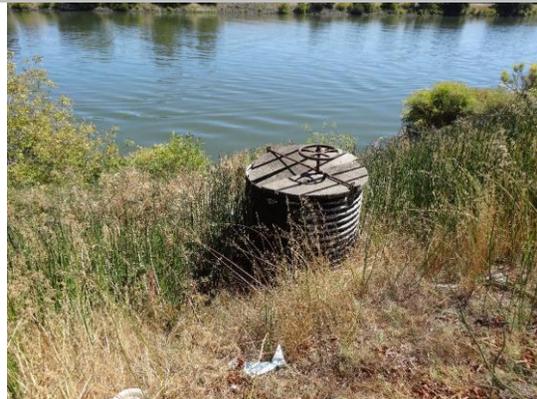
Photo 2 of 2 : UCIP\_FA\_2015\_2090.jpg

WS view: CMP riser with gate valve on levee slope. Dense vegetation on levee slope and stream bank.

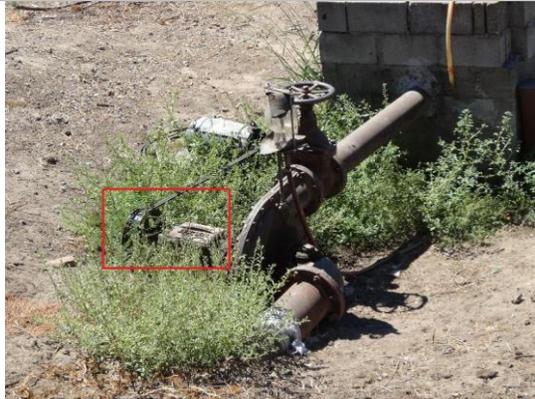
Photo 1 of 3 : UCIP\_FA\_2015\_2091.jpg

LS view: concrete masonry distribution box (top), steel pipe, gate valve, air vent, and pump (left) on levee toe.

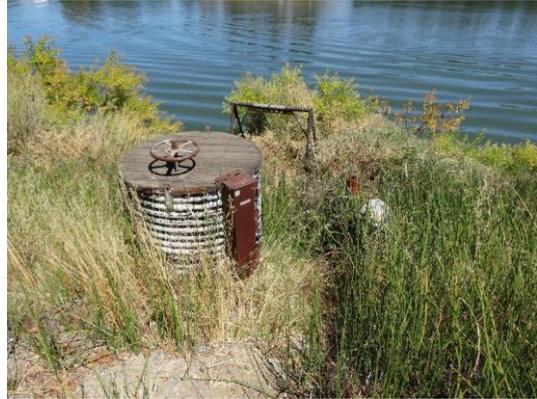
Photo 3 of 3 : UCIP\_FA\_2015\_1730.jpg

WS view: CMP riser with slide gate and pump (right) on levee slope.

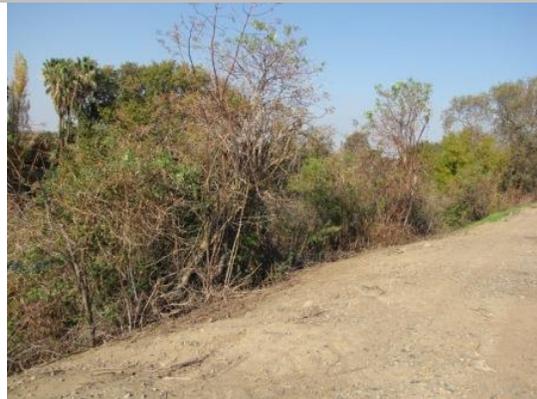
Photo 1 of 1 : FA\_2015\_RD0150\_17\_936\_20150911\_00106.jpg

View of elderberry bush within 20 feet of shoulder blocking visibility and access.

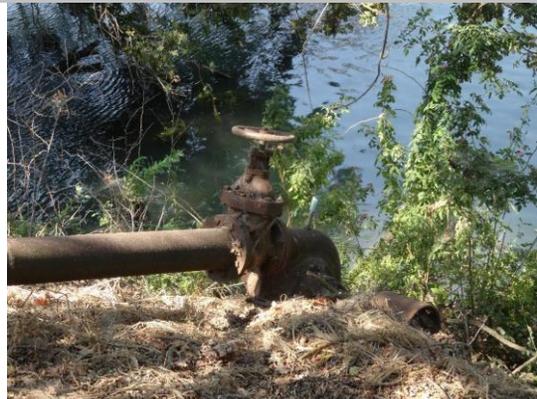
Photo 3 of 3 : UCIP\_FA\_2015\_1626.jpg

WS view: pipe and pump on levee slope.

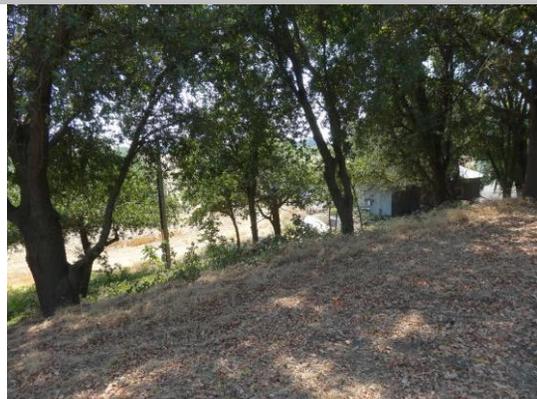
Photo 2 of 3 : UCIP\_FA\_2015\_1622.jpg

LS view: no pipe on levee slope.

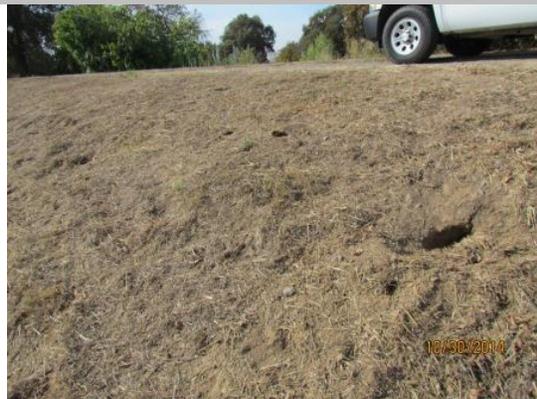
Photo 1 of 1 : FA\_2015\_RD0150\_17\_54\_20150911\_00047.jpg

View of an animal hole on the landside of the levee looking downstream.

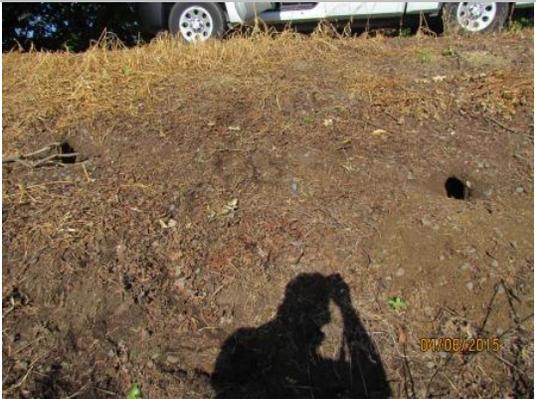
Photo 1 of 1 : FA\_2015\_RD0150\_17\_390\_20150911\_00095.jpg

Rodent holes were found on the landside of the levee looking downstream.

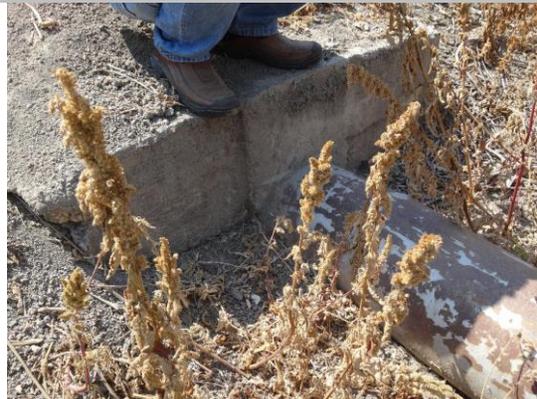
Photo 2 of 3 : UCIP\_FA\_2015\_1508.jpg

WS view: concrete headwall and exposed pipe on levee slope.

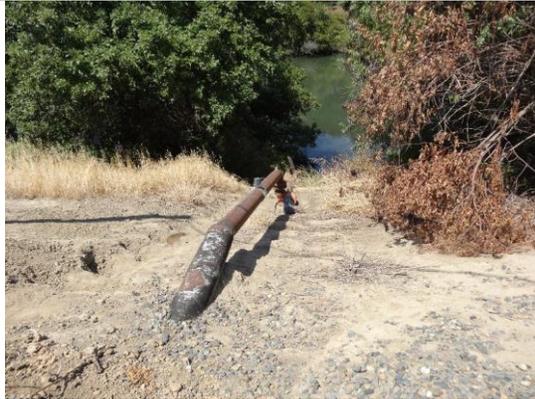
Photo 2 of 3 : UCIP\_FA\_2015\_1560.jpg

WS view: exposed pipe on levee slope.

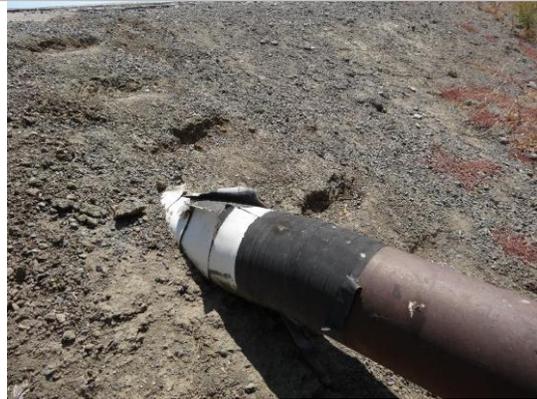
Photo 1 of 3 : UCIP\_FA\_2015\_1836.jpg

LS view: exposed pipe on levee slope.

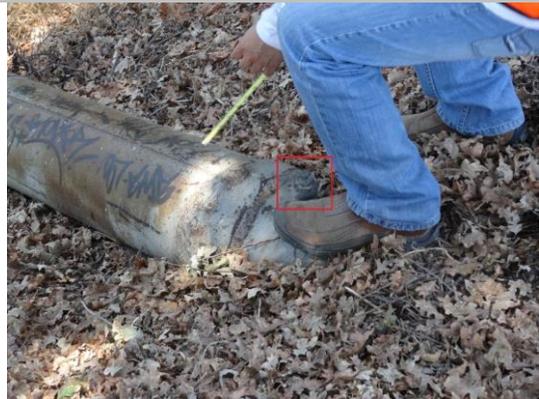
Photo 3 of 3 : UCIP\_FA\_2015\_1949.jpg

WS view: steel pipe with safety valve (marked) on levee slope.

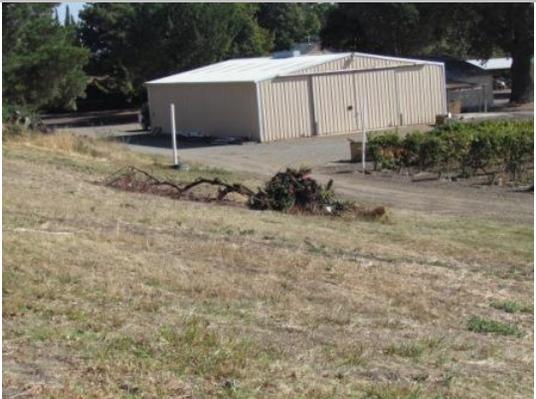
Photo 3 of 4 : FA\_2015\_RD0150\_17\_51\_20150911\_00045.jpg

Prunings were found on the landside of the levee looking upstream. This picture was taken during fall 2012 inspection.

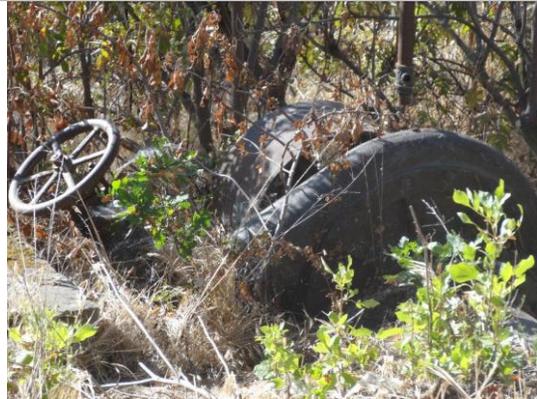
Photo 1 of 3 : UCIP\_FA\_2015\_1402.jpg

LS view: abandoned pump and gate valve on levee slope.

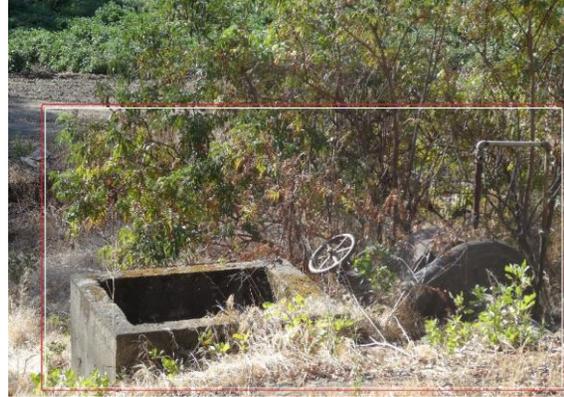
Photo 2 of 3 : UCIP\_FA\_2015\_1403.jpg

LS view: abandoned pump set and concrete box on levee slope.

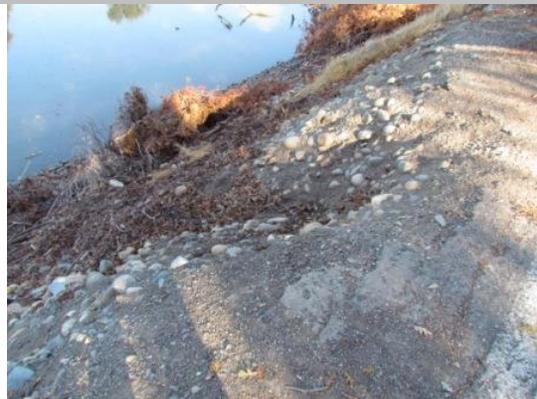
Photo 2 of 2 : FA\_2015\_RD0150\_17\_36\_20150911\_00031.jpg

Slope instability was found on the waterside of the levee looking upstream.

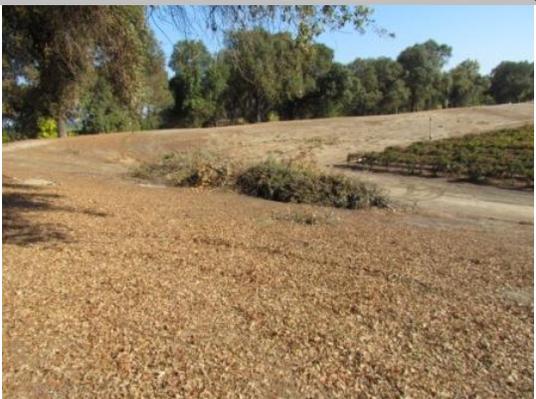
Photo 4 of 4 : FA\_2015\_RD0150\_17\_12\_20150911\_00012.jpg

Pruning was found on the landside toe of the levee looking upstream. This picture was taken during fall 2012 inspection.

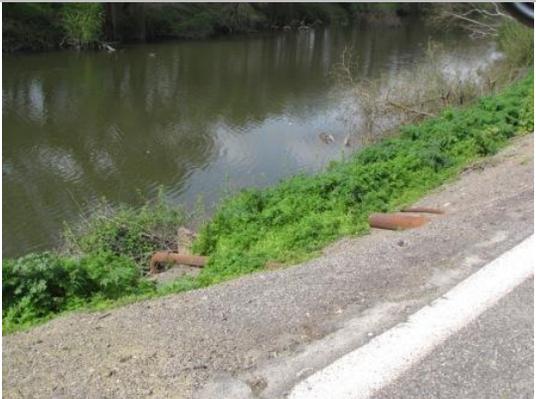
Photo 1 of 1 : FA\_2015\_RD0150\_17\_46\_20150911\_00038.jpg

View of an improperly abandoned pipe through the levee looking upstream.

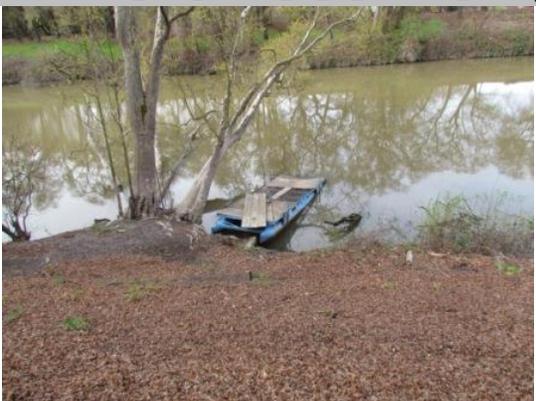
Photo 1 of 1 : FA\_2015\_RD0150\_17\_44\_20150911\_00037.jpg

An abandoned dock was found on the waterside of the levee looking upstream.

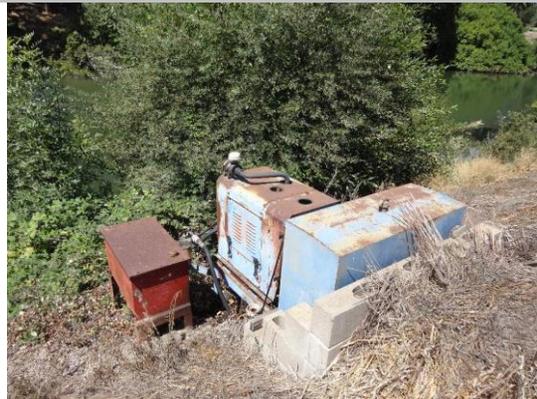
Photo 2 of 3 : UCIP\_FA\_2015\_1691.jpg

WS view: diesel pump on steep levee slope.

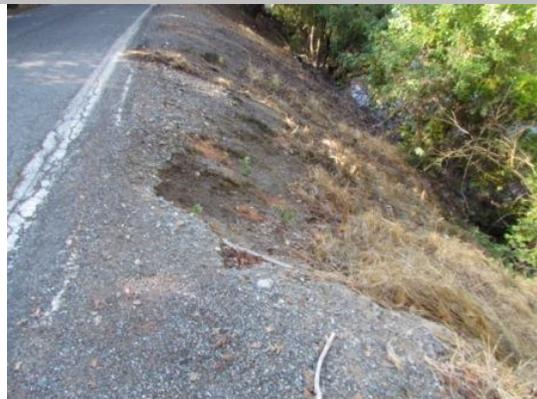
Photo 2 of 2 : FA\_2015\_RD0150\_17\_61\_20150911\_00055.jpg

Erosion was found on the waterside slope of the levee looking downstream. This updated picture was taken during fall 2012 inspection.

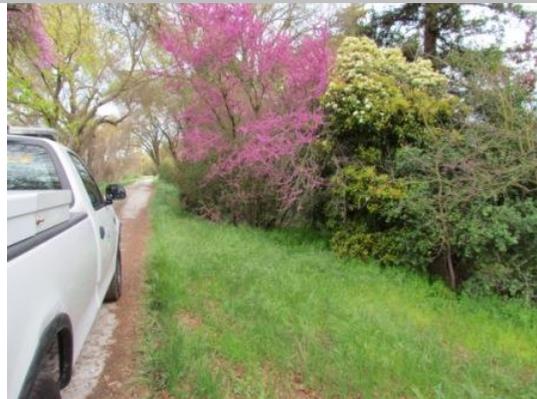
Photo 1 of 2 : FA\_2015\_RD0150\_17\_32\_20150911\_00024.jpg

Vegetation on the landside of the levee looking upstream. This picture was taken during spring 2012 inspection.

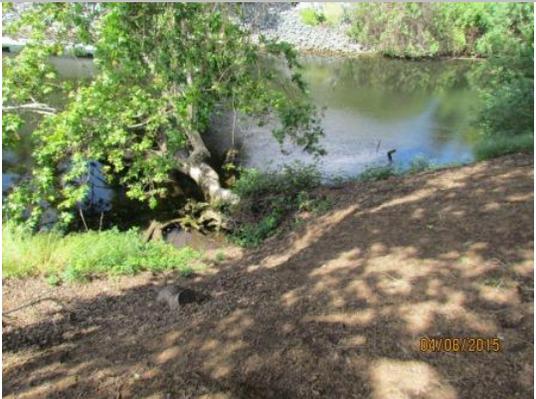
Photo 1 of 1 : FA\_2015\_RD0150\_17\_396\_20150911\_00098.jpg

Slope instability was found on the waterside toe of the levee looking upstream.

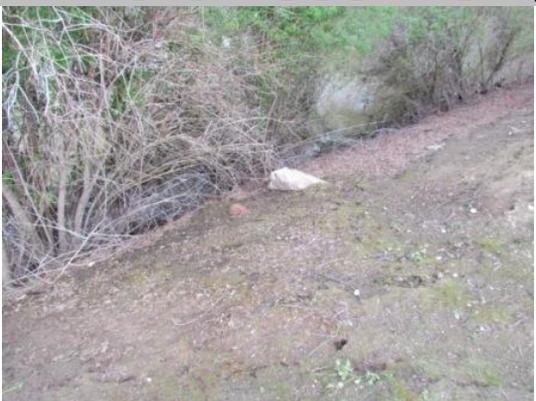
Photo 1 of 1 : FA\_2015\_RD0150\_17\_87\_20150911\_00084.jpg

A concrete block was found on the waterside of the levee looking upstream.

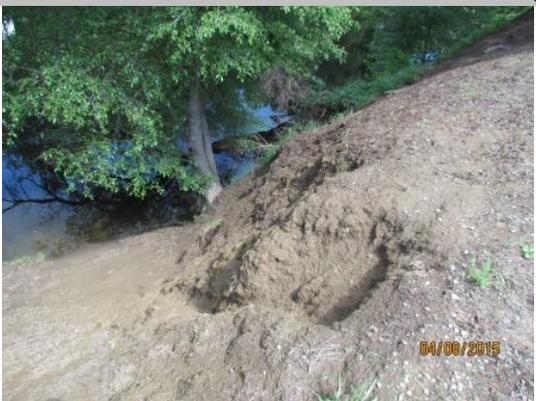
Photo 1 of 2 : FA\_2015\_RD0150\_17\_92\_20150911\_00089.jpg

Updated picture of the slope instability on the waterside of the levee looking upstream during spring 2015 inspection.

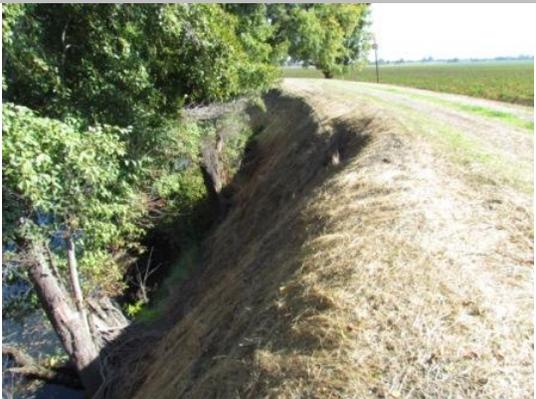
Photo 2 of 2 : FA\_2015\_RD0150\_17\_67\_20150911\_00065.jpg

Erosion was found on the waterside shoulder of the levee looking upstream. This picture was taken during fall 2012 inspection.

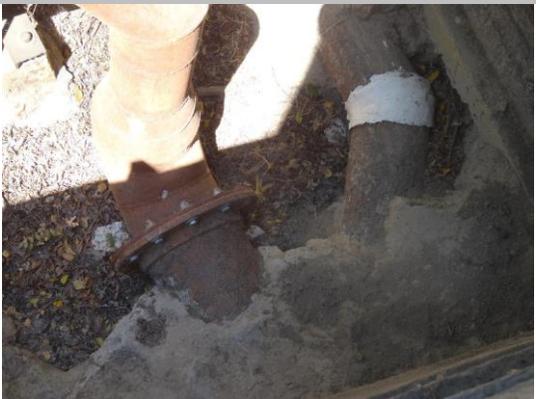
Photo 1 of 3 : UCIP\_FA\_2015\_1995.jpg

WS view: 8-inch steel pipe (right) next to 12" pipe (left). This 8" pipe might have merged with 12" pipe under the levee .
