**Flood Control Project Maintenance
Levee Inspections
LMA District Cover Sheet
Spring 2010 Levee Inspection Results**

Reclamation District No. 0150 Merrit Island

Levee Inspection Report By Mile - Spring 2010

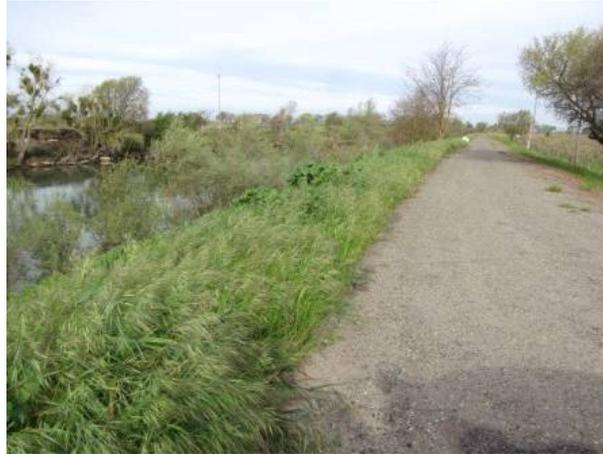
Levee Mile Report Line	1
Start Levee Mile	0.00
End Levee Mile	0.53
Location	Water Side
Category	Earthen Levee
Item	Vegetation
View of the waterward slope with vegetation on it looking west.	
jhirabay_s_20100701_001.jpg

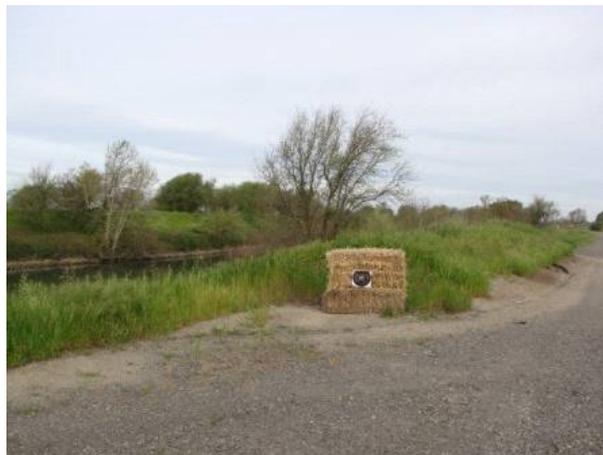
Levee Mile Report Line	3
Start Levee Mile	0.33
End Levee Mile	0.33
Location	Crown
Category	Earthen Levee
Item	Encroachments
View of a hay bale target on the crown of the levee looking west.	
jhirabay_s_20100701_003.jpg

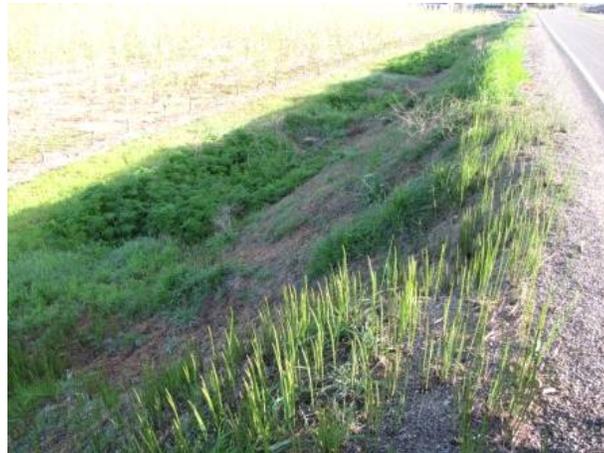
Levee Mile Report Line	3
Start Levee Mile	0.04
End Levee Mile	0.04
Location	Land Side
Category	Earthen Levee
Item	Erosion / Bank Caving
View of erosion on the landward slope looking upstream.	
jhirabay_s_20100701_471.jpg

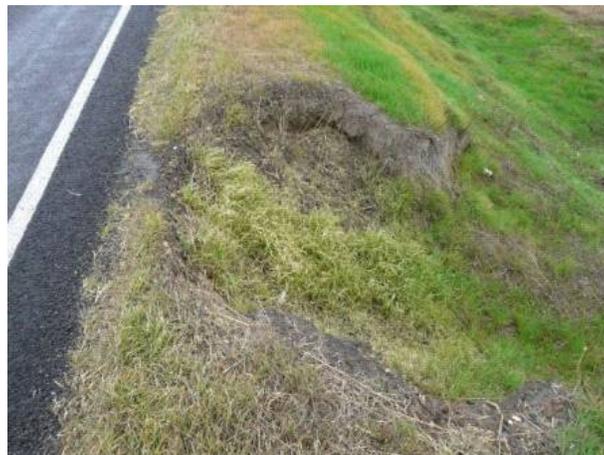
Levee Mile Report Line	4
Start Levee Mile	0.06
End Levee Mile	0.06
Location	Land Side
Category	Earthen Levee
Item	Erosion / Bank Caving
Repair erosion/slumping on landside slope of levee at LM 0.06	
dpesaven_s_20100316_450.JPG

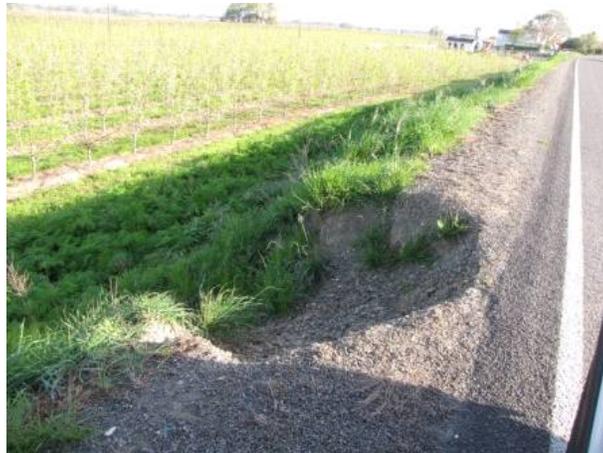
Levee Mile Report Line	4
Start Levee Mile	0.06
End Levee Mile	0.06
Location	Land Side
Category	Earthen Levee
Item	Erosion / Bank Caving
Spring 2010 updated view of erosion on landward slope looking upstream.	
jhirabay_s_20100701_473.jpg

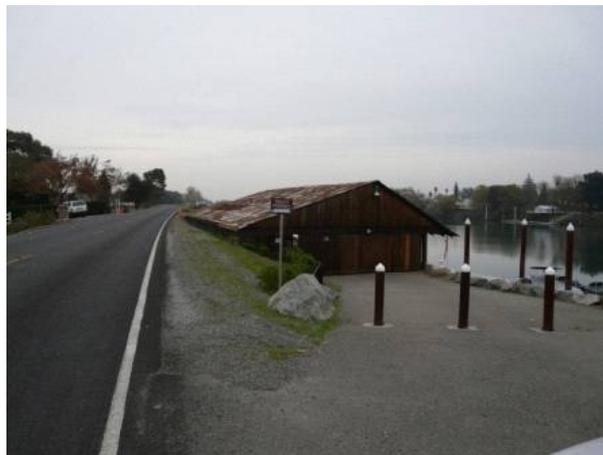
Levee Mile Report Line	5
Start Levee Mile	0.16
End Levee Mile	0.16
Location	Water Side
Category	Earthen Levee
Item	Encroachments
Building located on waterside of levee at LM 0.16	
dpesaven_s_20100316_435.JPG

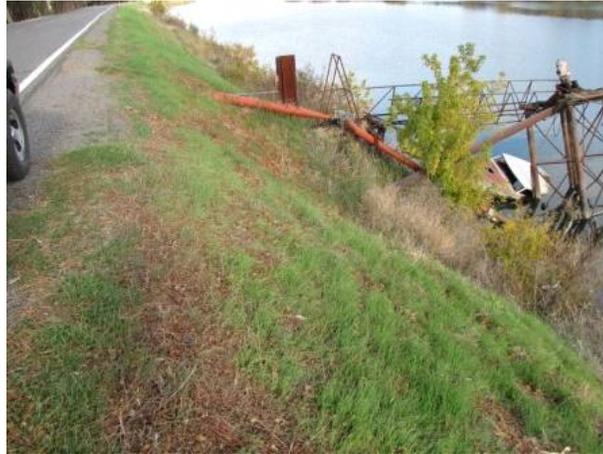
Levee Mile Report Line	44
Start Levee Mile	3.29
End Levee Mile	3.29
Location	Water Side
Category	Earthen Levee
Item	Erosion / Bank Caving
Additional view of erosion on the waterward slope looking upstream. Note the damaged pump support, pump, and pipe just upstream of the site.	
dpesaven_s_20100316_454.jpg

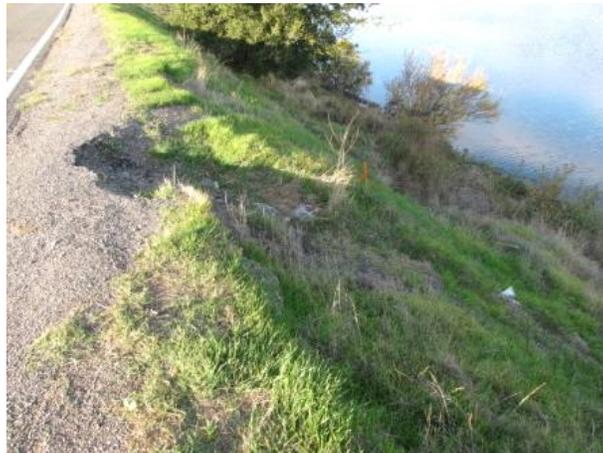
Levee Mile Report Line	107
Start Levee Mile	7.28
End Levee Mile	7.28
Location	Water Side
Category	Earthen Levee
Item	Slope Stability
View of minor erosion along the top portion of the waterward slope likely cause by foot traffic. The erosion has started to encroach into the shoulder of the road.	
dpesaven_s_20100316_460.jpg

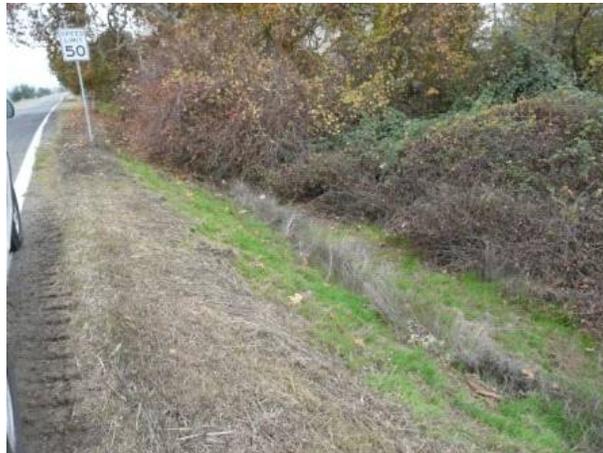
Levee Mile Report Line	112
Start Levee Mile	7.36
End Levee Mile	7.41
Location	Land Side
Category	Earthen Levee
Item	Trim / Thin Trees
Trim/thin trees and brush on landside of levee from LM 7.36 to LM 7.41	
dpesaven_s_20100316_434.JPG

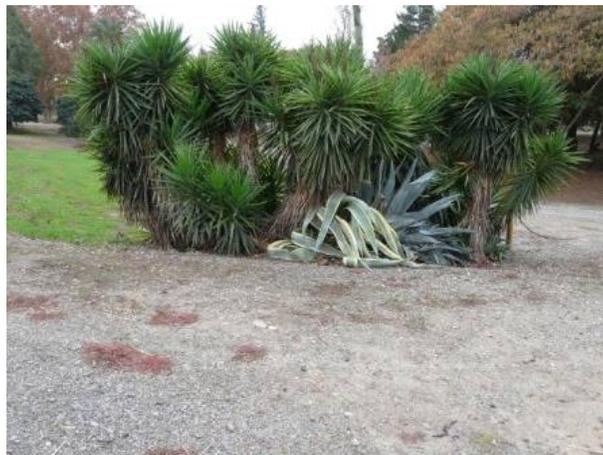
Levee Mile Report Line	114
Start Levee Mile	7.92
End Levee Mile	7.92
Location	Land Side
Category	Earthen Levee
Item	Encroachments
Landscaping on landside of levee at LM 7.92	
dpesaven_s_20100316_438.JPG

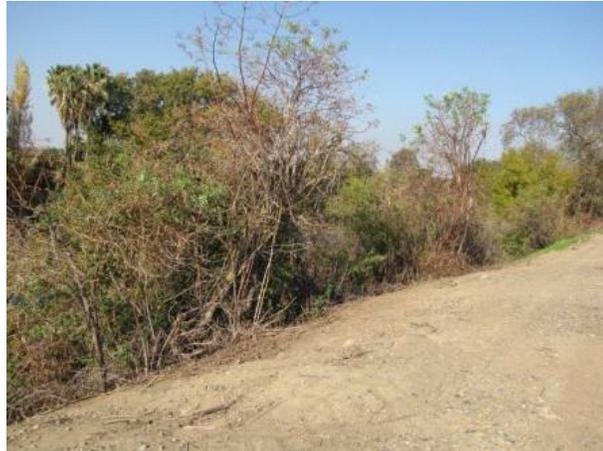
Levee Mile Report Line	3
Start Levee Mile	0.11
End Levee Mile	0.11
Location	Water Side
Category	Earthen Levee
Item	Vegetation
View of elderberry bush within 20 feet of shoulder blocking visibility and access.	
dpesaven_s_20100316_494.jpg

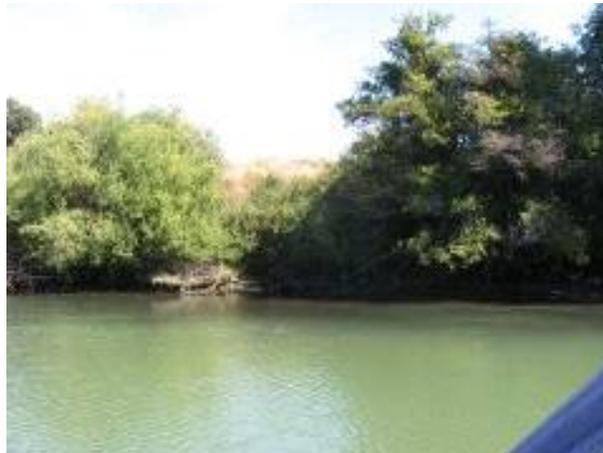
Levee Mile Report Line	4
Start Levee Mile	0.20
End Levee Mile	0.21
Location	Water Side
Category	Supplemental
Item	USACE Erosion Survey
2009: no berm, 1:1 slope, tree hazards, clays and cobbles, 3 ft/s [2009 SiteID:ELK_0-2_L]	
USACE2009_ELK_0-2_L_2009_09_17-D3bP38_small.JPG

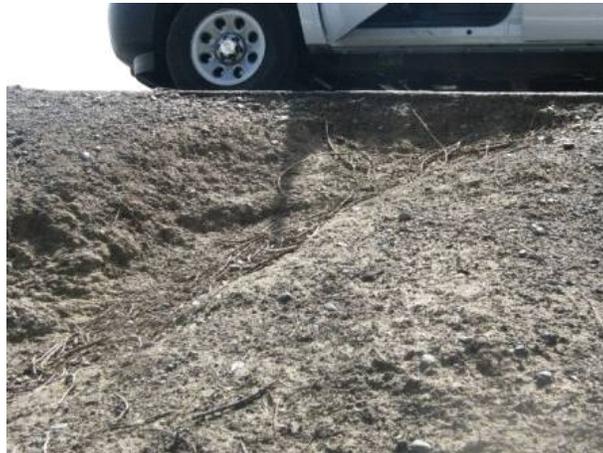
Levee Mile Report Line	15
Start Levee Mile	1.23
End Levee Mile	1.23
Location	Land Side
Category	Earthen Levee
Item	Slope Stability
Damaged slope from foot traffic and rain runoff at LM 1.23	
dpesaven_s_20100316_469.jpg

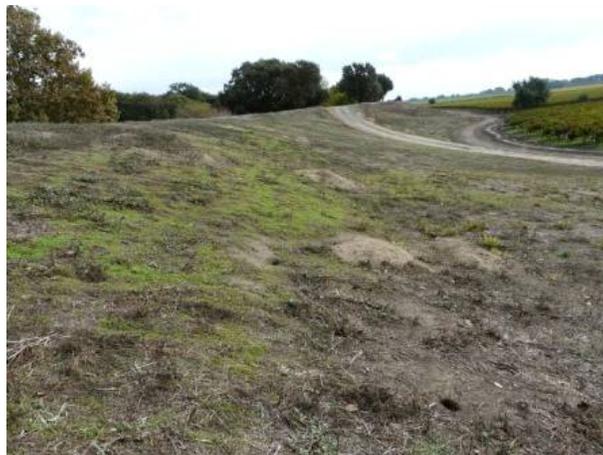
Levee Mile Report Line	18
Start Levee Mile	2.02
End Levee Mile	2.05
Location	Land Side
Category	Earthen Levee
Item	Animal Control
Backfill or grout rodent holes at LM 2.03 to LM 2.06.	
dpesaven_s_20100316_480.JPG

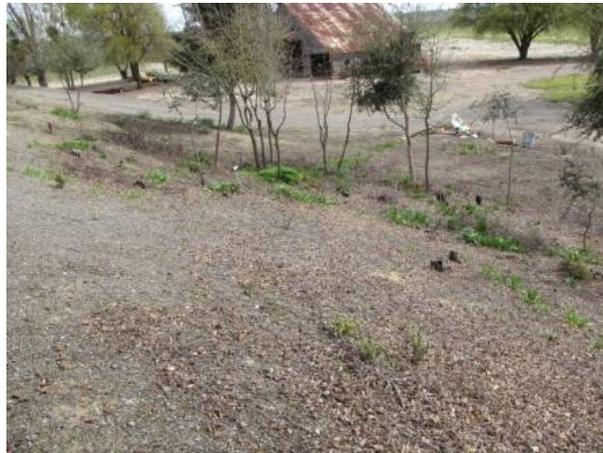
Levee Mile Report Line	20
Start Levee Mile	2.60
End Levee Mile	2.60
Location	Land Side
Category	Earthen Levee
Item	Trim / Thin Trees
View of tree stumps on the landward slope.	
jhirabay_s_20100701_512.jpg

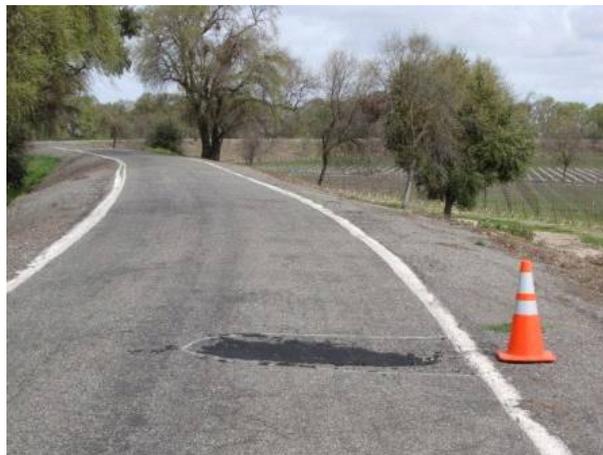
Levee Mile Report Line	22
Start Levee Mile	2.78
End Levee Mile	2.78
Location	Crown
Category	Earthen Levee
Item	Crown Surface / Depressions / Rutting
View of a depression in the crown roadway looking upstream.	
jhirabay_s_20100701_513.jpg

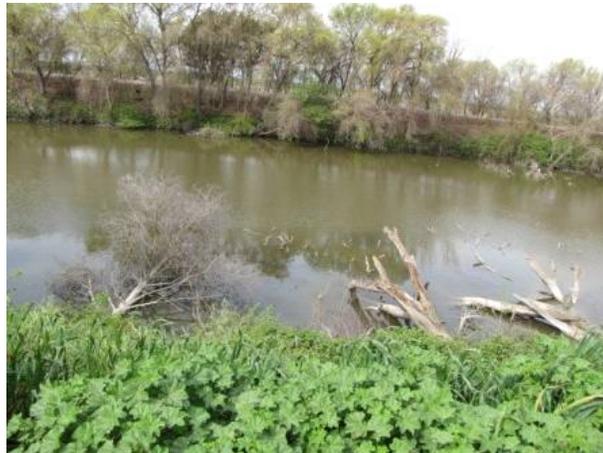
Levee Mile Report Line	24
Start Levee Mile	3.01
End Levee Mile	3.01
Location	Water Side
Category	Earthen Levee
Item	Trim / Thin Trees
View of tree stumps on the waterward slope.	
jhirabay_s_20100701_515.jpg

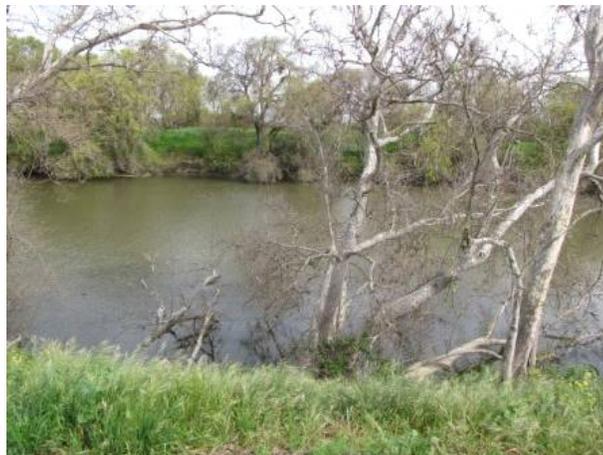
Levee Mile Report Line	25
Start Levee Mile	3.18
End Levee Mile	3.18
Location	Water Side
Category	Earthen Levee
Item	Trim / Thin Trees
View of tree stumps on the waterward slope.	
jhirabay_s_20100701_516.jpg

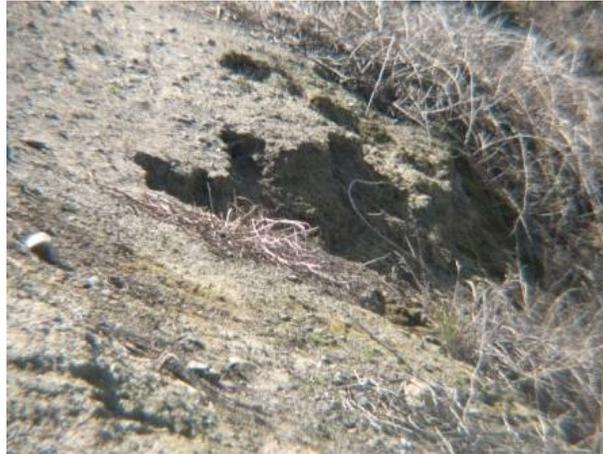
Levee Mile Report Line	30
Start Levee Mile	3.43
End Levee Mile	3.48
Location	Water Side
Category	Earthen Levee
Item	Erosion / Bank Caving
Erosion damage on waterward toe from LM 3.43 to 3.48	
dpesaven_s_20100316_470.jpg

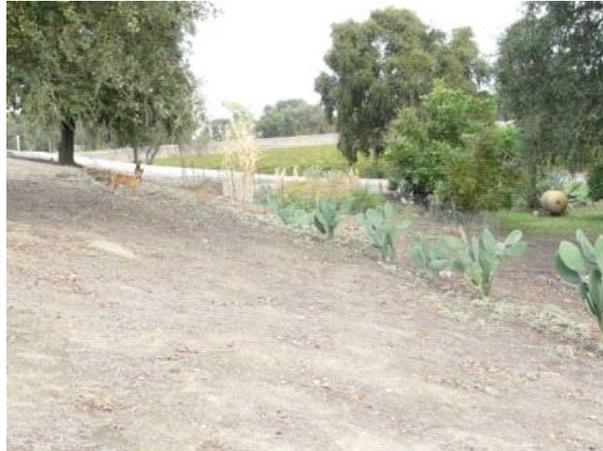
Levee Mile Report Line	31
Start Levee Mile	3.50
End Levee Mile	3.54
Location	Land Side
Category	Earthen Levee
Item	Encroachments
Landscaping & garden on landward slope of levee at LM 3.50 to LM 3.54.	
dpesaven_s_20100316_481.JPG

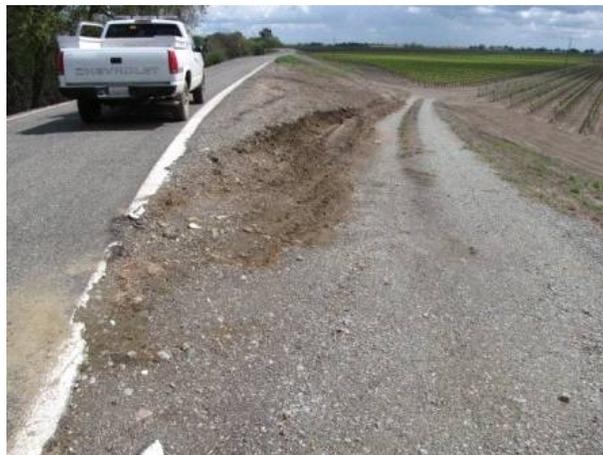
Levee Mile Report Line	32
Start Levee Mile	3.75
End Levee Mile	3.75
Location	Land Side
Category	Earthen Levee
Item	Slope Stability
Repair minor damage to levee slope along landward ramp at LM 3.75.	
dpesaven_s_20100316_493.jpg

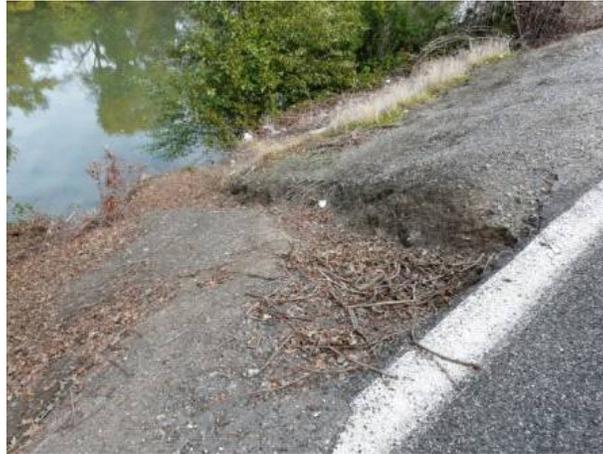
Levee Mile Report Line	33
Start Levee Mile	3.77
End Levee Mile	3.77
Location	Water Side
Category	Earthen Levee
Item	Slope Stability
Repair slope damaged by foot traffic at LM 3.77.	
dpesaven_s_20100316_471.JPG

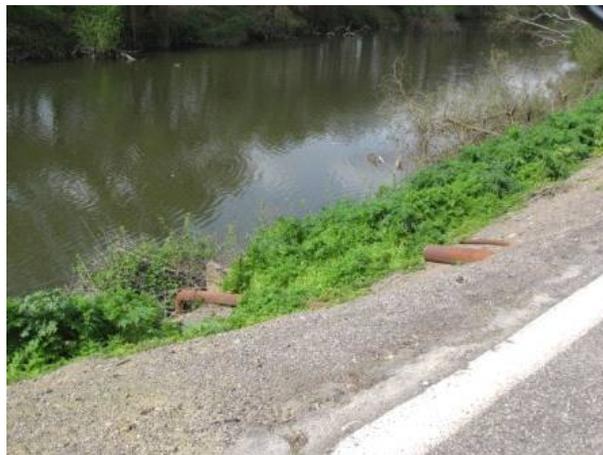
Levee Mile Report Line	61
Start Levee Mile	6.06
End Levee Mile	6.06
Location	Water Side
Category	Earthen Levee
Item	Encroachments
View of an improperly abandoned pipe through the levee looking upstream.	
jhirabay_s_20100701_524.jpg

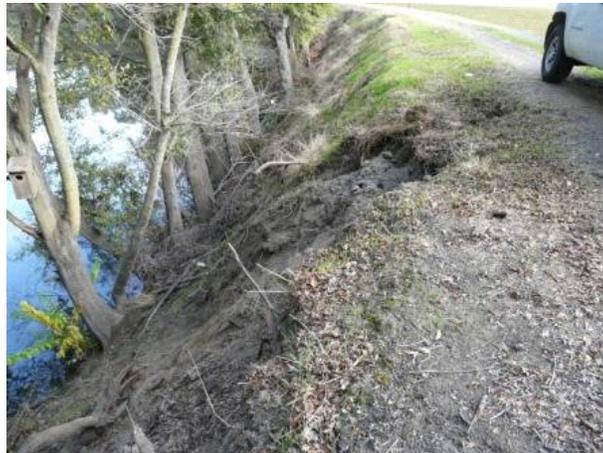
Levee Mile Report Line	90
Start Levee Mile	8.46
End Levee Mile	8.46
Location	Water Side
Category	Earthen Levee
Item	Erosion / Bank Caving
Repair erosion on waterward slope near shoulder at LM 8.46.	
dpesaven_s_20100316_490.JPG

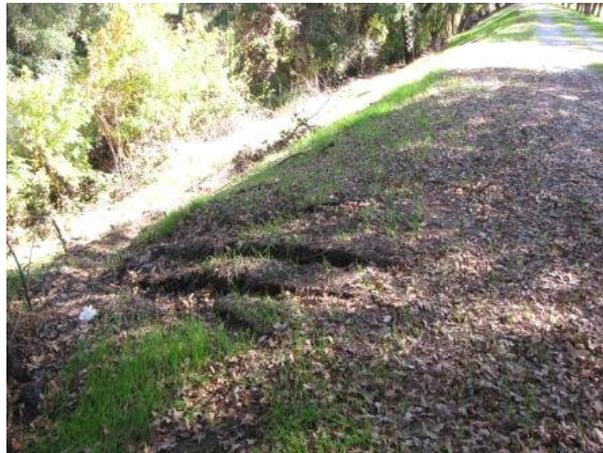
Levee Mile Report Line	97
Start Levee Mile	9.19
End Levee Mile	9.19
Location	Water Side
Category	Earthen Levee
Item	Slope Stability
View of erosion on the landward slope caused by a vehicle driving along it.	
dpesaven_s_20100316_505.jpg
