**Flood Control Project Maintenance
Levee Inspections**
LMA District Cover Sheet
Spring 2015 Levee Inspection Results

Reclamation District No. 0150 Merrit Island

Spring 2015 Levee Inspection Results

Waterway		Bank	Unit Miles
Unit No. 01 Sutter Slough		Left	0.52

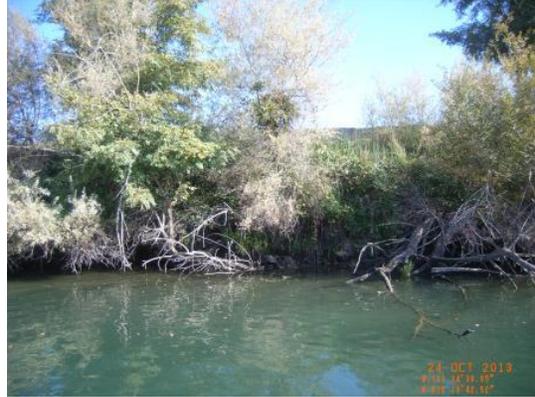
Photo 1 of 2 : SP_2015_RD0150_15_2_20150313_00001.jpg

LM Start	0.44	Rating **	M	Issue No.	2
LM End	0.49	Issue Type +	Ma	Location *	WS
Category	Supplemental			GPS Latitude/Longitude	
				Start	End
Item	USACE Erosion Survey			38.328606 °	38.328091 °
				-121.577472 °	-121.576640 °
DWR ID	DWR_RD0150_01_f_2014_2				
Action/Comments					
Inspector Comments: 2013: Old toe repair unraveling. Bridge at upstream end of site. [2013 Site ID: STR_28-4_R]

USACE 2013 Photo #1

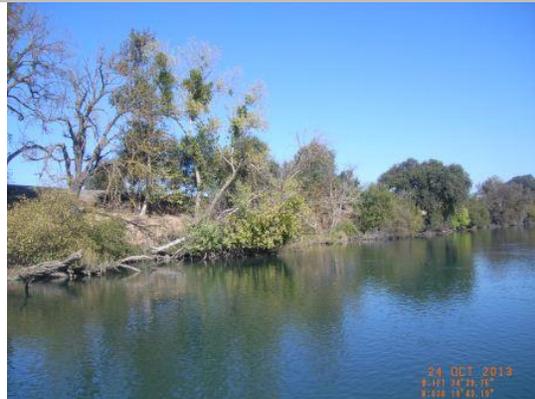
Photo 2 of 2 : SP_2015_RD0150_15_2_20150313_00002.jpg

USACE 2013 Photo #2

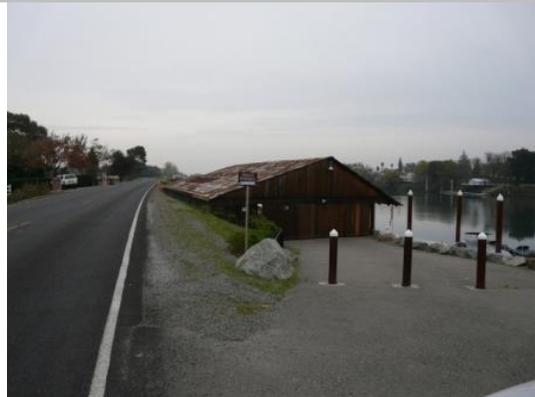
Photo 1 of 1 : SP_2015_RD0150_16_49_20150313_00027.jpg

Building located on waterside of levee at LM 0.16

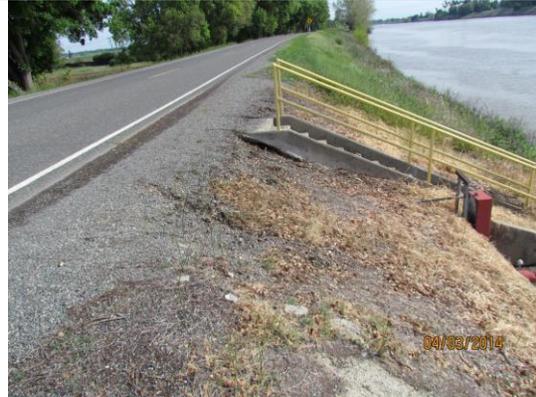
Photo 1 of 2 : SP_2015_RD0150_16_6_20150313_00002.jpg

LM Start	0.39	Rating **	M	Issue No.	6
LM End	0.39	Issue Type +	Ma	Location *	WS
Category	Earthen Levee			GPS Latitude/Longitude	
				Start	End
Item	Slope Stability			38.332717 °	38.332717 °
				-121.572083 °	-121.572083 °
DWR ID	DWR_RD0150_02_s_2012_6				
Action/Comments					
Repair the levee slope damaged by foot traffic and prevent access where possible.

Updated photo of the slope instability on the waterside of the levee looking upstream during spring 2014 inspection.

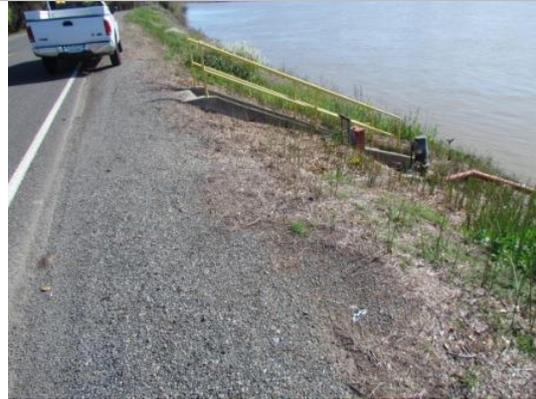
Photo 2 of 2 : SP_2015_RD0150_16_6_20150313_00003.jpg

Slope instability was found on the waterside of the levee looking upstream.

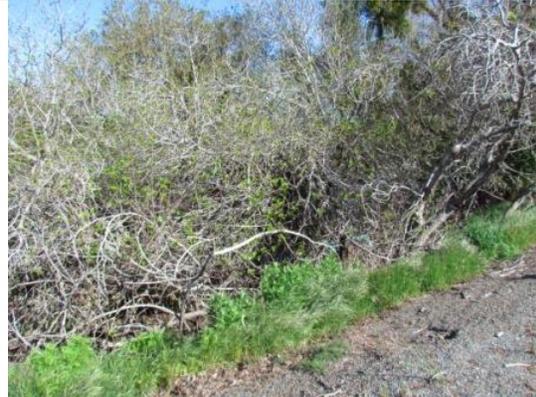
Photo 1 of 1 : SP_2015_RD0150_16_12_20150313_00007.jpg

Overgrown trees were obstructing the landside slope of the levee looking upstream.

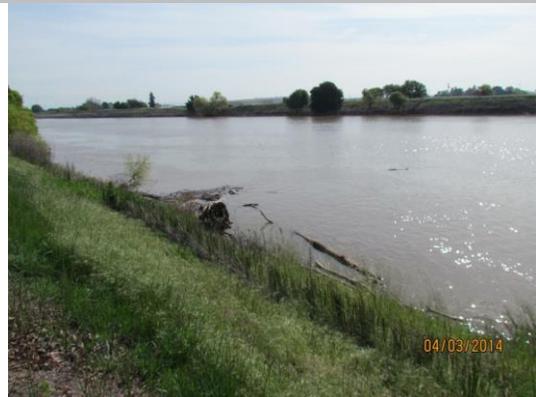
Photo 1 of 2 : SP_2015_RD0150_16_18_20150313_00012.jpg

LM Start	0.99	Rating **	M	Issue No.	18
LM End	0.99	Issue Type +	Ma	Location *	WS
Category	Earthen Levee		GPS Latitude/Longitude		
			Start	End	
Item	Encroachments		38.339268 °	38.339268 °	
			-121.564839 °	-121.564839 °	
DWR ID	DWR_RD0150_02_s_2013_18				
Action/Comments					
Tree or limb					
Inspector Comments: Tree trunk was found on the waterside toe of the levee.

Updated picture of the tree trunk on the waterside toe of the levee looking upstream during spring 2014 inspection.

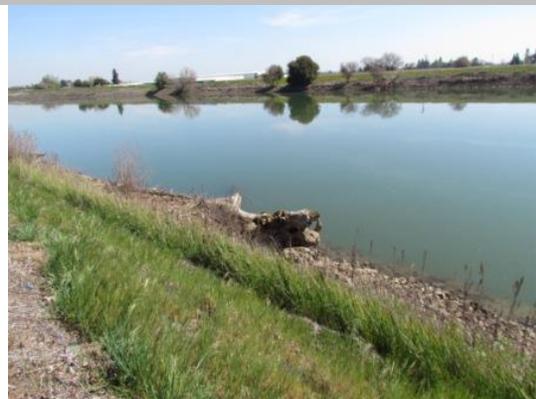
Photo 2 of 2 : SP_2015_RD0150_16_18_20150313_00013.jpg

A tree trunk was found on the waterside toe of the levee looking upstream during spring 2013 inspection.

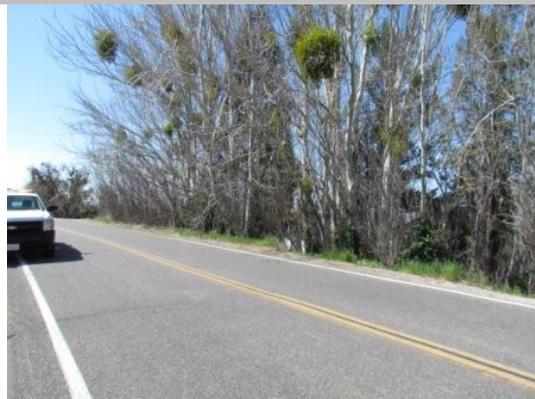
Photo 1 of 2 : SP_2015_RD0150_16_91_20150313_00046.jpg

Landscaping was obstructing the view of the landside slope of the levee looking downstream. This picture was taken during spring 2013 inspection.

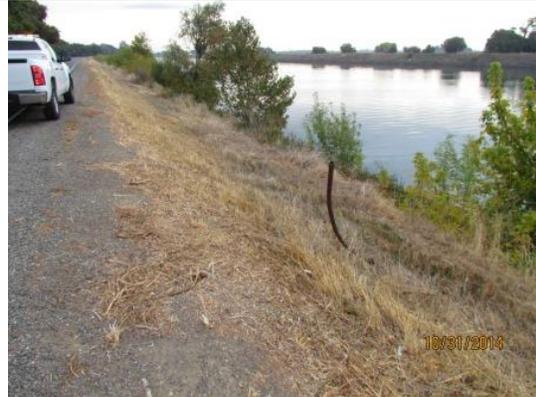
Photo 1 of 1 : SP_2015_RD0150_16_48_20150313_00026.jpg

LM Start	1.73	Rating **	M	Issue No.	48
LM End	1.73	Issue Type +	En	Location *	WS
Category	Earthen Levee		GPS Latitude/Longitude		
			Start	End	
Item	Encroachments		38.345583 °	38.345583 °	
			-121.554507 °	-121.554507 °	
DWR ID	DWR_RD0150_02_f_2014_48				
Action/Comments					
Pole Inspector Comments: A pole was found on the waterside slope of the levee. Most probably is connected to a pump.

A pole/pipe was found on the waterside slope of the levee looking upstream.

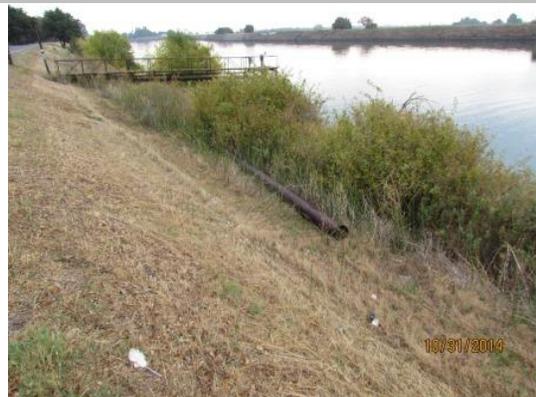
Photo 1 of 1 : SP_2015_RD0150_16_50_20150313_00028.jpg

LM Start	1.89	Rating **	M	Issue No.	50
LM End	1.89	Issue Type +	Ma	Location *	WS
Category	Earthen Levee		GPS Latitude/Longitude		
			Start	End	
Item	Encroachments		38.346323 °	38.346323 °	
			-121.551568 °	-121.551568 °	
DWR ID	DWR_RD0150_02_f_2014_50				
Action/Comments					
Pipe Inspector Comments: An abandoned pipe was found on the waterside of the levee.

A pipe was found on the waterside toe of the levee looking upstream.

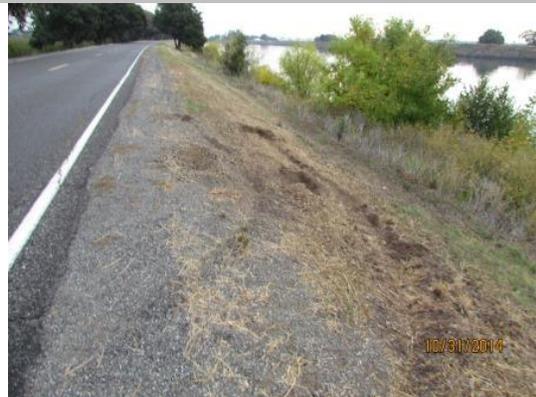
Photo 1 of 1 : SP_2015_RD0150_16_52_20150313_00030.jpg

LM Start	1.93	Rating **	M	Issue No.	52
LM End	1.93	Issue Type +	Ma	Location *	WS
Category	Earthen Levee		GPS Latitude/Longitude		
			Start	End	
Item	Slope Stability		38.346462 °	38.346462 °	
			-121.550978 °	-121.550978 °	
DWR ID	DWR_RD0150_02_f_2014_52				
Action/Comments					
Repair the levee slope damaged by vehicle traffic and prevent access where possible. Inspector Comments: Rutting caused by vehicles.

A slope instability was found on the waterside slope of the levee looking upstream.

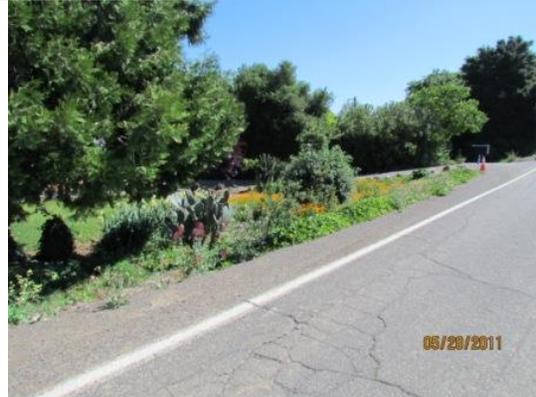
Photo 1 of 1 : SP_2015_RD0150_16_88_20150313_00045.jpg

Landscaping was found on the landside of the levee. The picture was taken from the crown looking upstream.

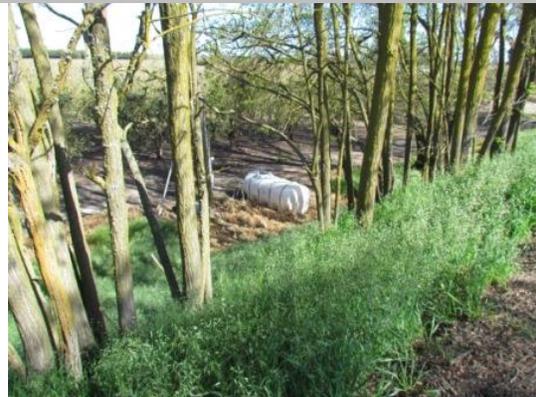
Photo 1 of 1 : SP_2015_RD0150_16_23_20150313_00015.jpg

A tank was found on the landside toe of the levee looking upstream.

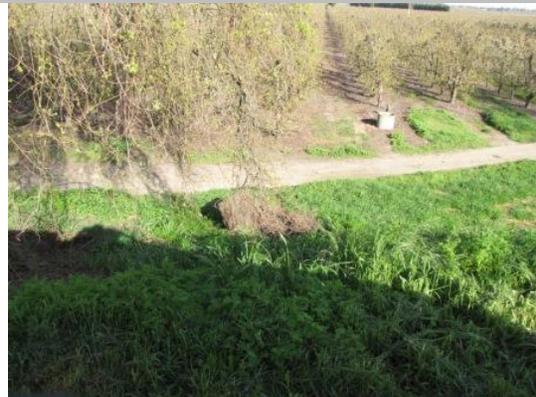
Photo 1 of 1 : SP_2015_RD0150_16_14_20150313_00009.jpg

View of a tree stump on the landward slope.

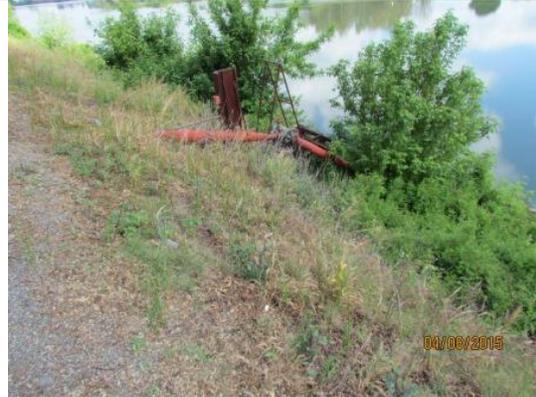
Photo 1 of 5 : SP_2015_RD0150_16_961_20150413_00076.jpg

Updated picture of the erosion on the waterside of the levee during spring 2015 inspection.

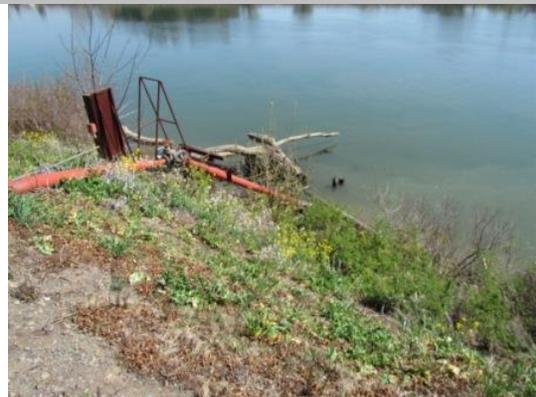
Photo 3 of 5 : SP_2015_RD0150_16_961_20150313_00050.jpg

View of the erosion on the waterside slope of the levee looking upstream during spring 2013 inspection.

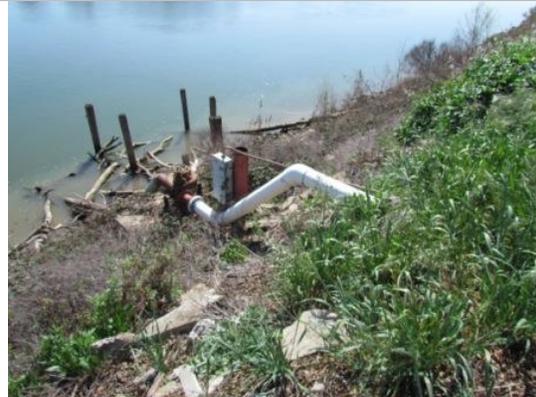
Photo 1 of 2 : SP_2015_RD0150_16_15_20150313_00010.jpg

A PVC pipe was used to pump the water from waterside of the levee. It appeared that the PVC pipe was penetrating through a corroded steel casing through the levee crown. The picture was taken from the crown of the levee looking upstream during spring 2013 inspection.

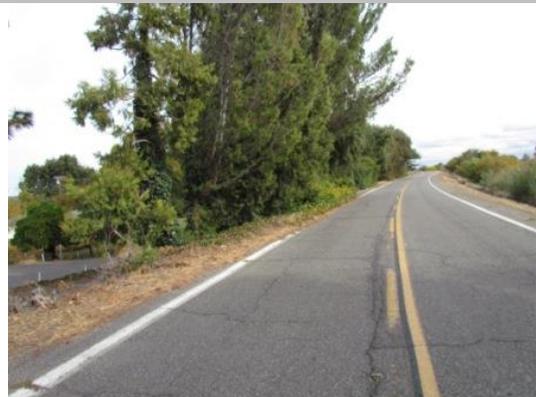
Photo 1 of 1 : SP_2015_RD0150_16_82_20150313_00043.jpg

Landscaping was blocking the visibility on the landside of the levee looking upstream.

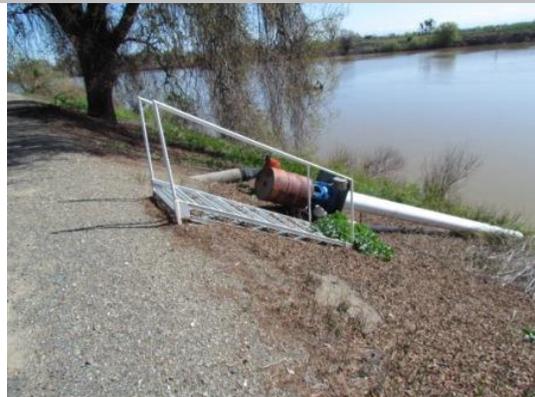
Photo 1 of 1 : SP_2015_RD0150_16_33_20150313_00021.jpg

A stairway was found on the waterside slope of the levee.

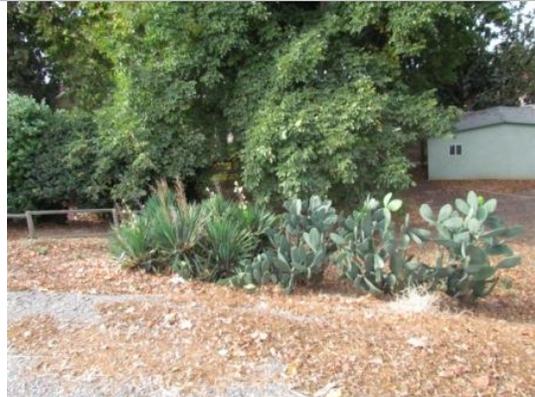
Photo 1 of 1 : SP_2015_RD0150_16_953_20150313_00048.jpg

View of cacti on the landside of the levee looking from the crown.

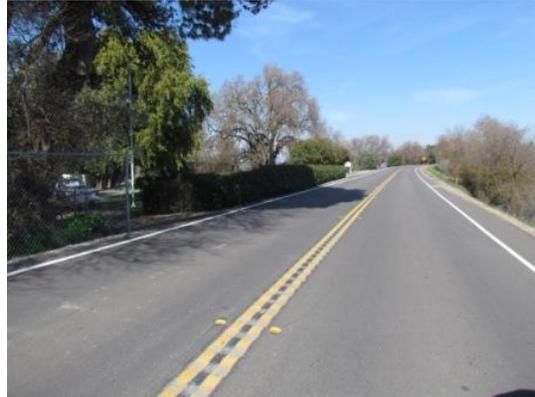
Photo 1 of 1 : SP_2015_RD0150_16_30_20150313_00019.jpg

Landscaping was found on the landside shoulder of the levee looking upstream.

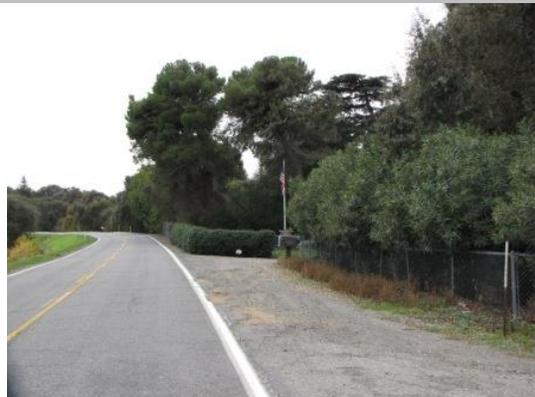
Photo 1 of 1 : SP_2015_RD0150_16_75_20150313_00039.jpg

View of landscaping along the landward shoulder and slope looking downstream.

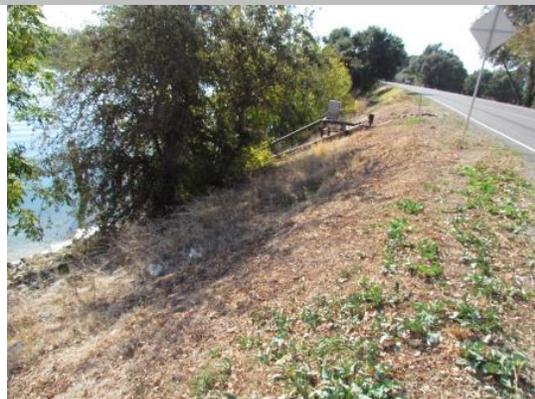
Photo 1 of 2 : SP_2015_RD0150_16_975_20150313_00055.jpg

View of minor slope instability on the waterside slope of the levee looking downstream during fall 2013 inspection.

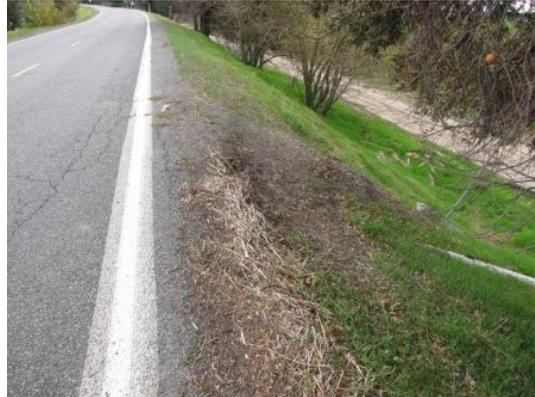
Photo 2 of 2 : SP_2015_RD0150_16_975_20150313_00056.jpg

View of a minor depression along the landward slope of the levee over a pipe penetration looking downstream.

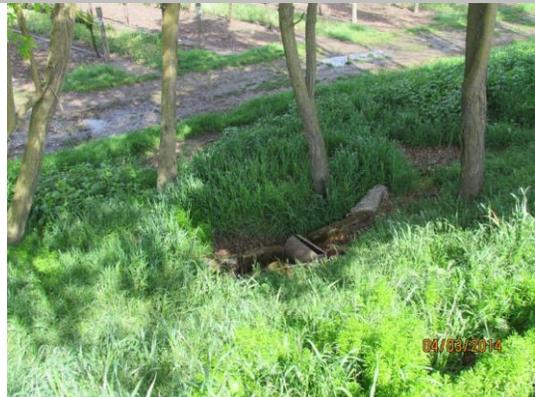
Photo 1 of 1 : SP_2015_RD0150_16_51_20150313_00029.jpg

View of a damaged pipe on the landside toe of the levee looking upstream.

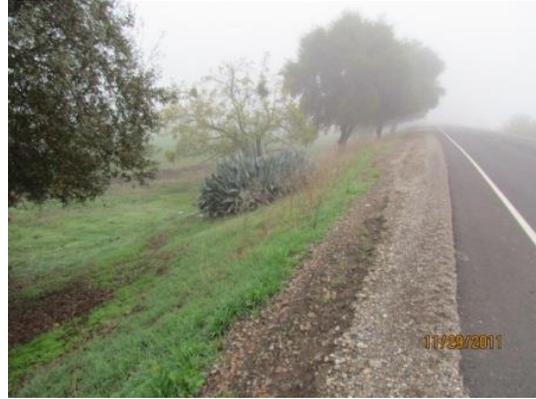
Photo 1 of 1 : SP_2015_RD0150_16_27_20150313_00017.jpg

Century plant was found on the landside of the levee looking upstream.

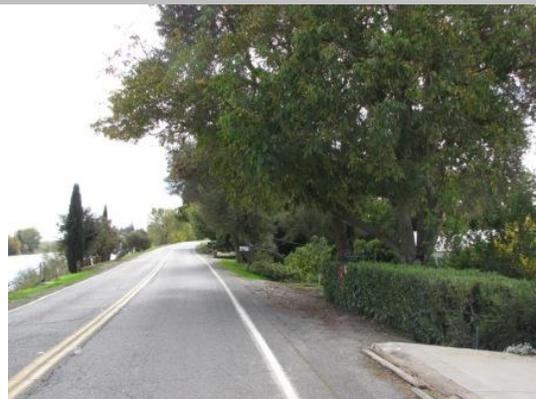
Photo 1 of 1 : SP_2015_RD0150_16_65_20150313_00037.jpg

View of landscaping along the waterward shoulder and slope looking downstream.

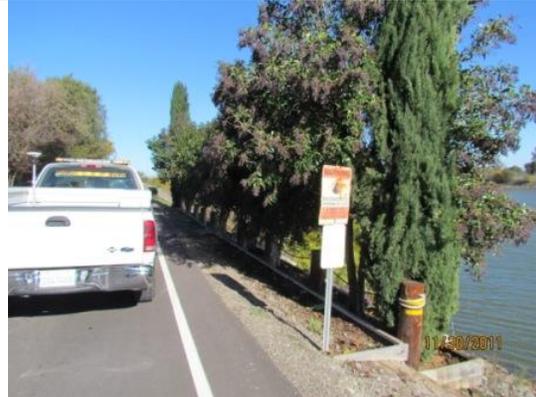
Photo 1 of 1 : SP_2015_RD0150_16_34_20150313_00022.jpg

Landscaping was found on the waterside of the levee looking upstream.

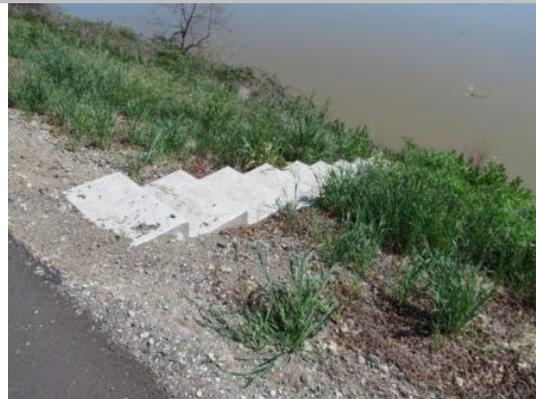
Photo 1 of 1 : SP_2015_RD0150_16_42_20150313_00024.jpg

A stairway was found on the waterside slope of the levee looking upstream.

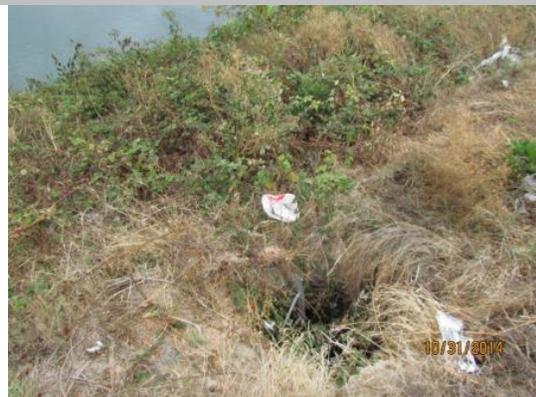
Photo 1 of 1 : SP_2015_RD0150_16_55_20150313_00032.jpg

An open pipe valve was found without a cover on the waterside toe of the levee.

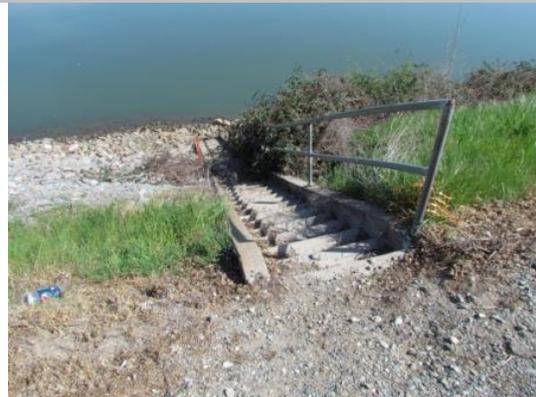
Photo 1 of 1 : SP_2015_RD0150_16_38_20150313_00023.jpg

A stairway was found on the waterside slope of the levee looking upstream during spring 2013 inspection.

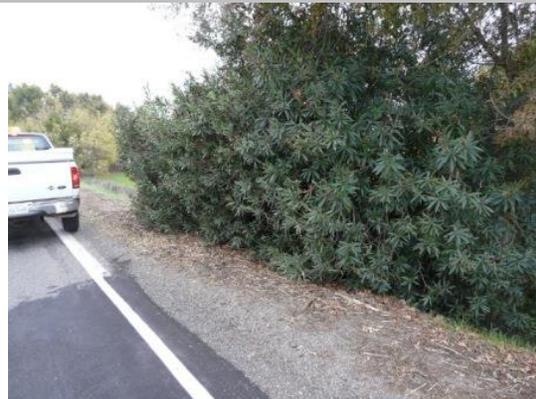
Photo 1 of 1 : SP_2015_RD0150_16_58_20150313_00034.jpg

Landscaping providing a screen for a residence on landside of levee at LM 7.12

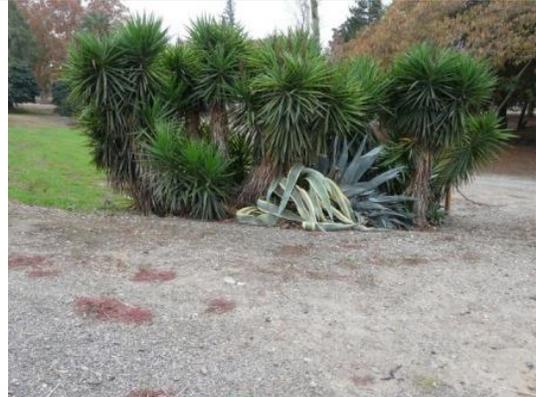
Photo 1 of 1 : SP_2015_RD0150_16_56_20150313_00033.jpg

Landscaping on landside of levee at LM 7.92

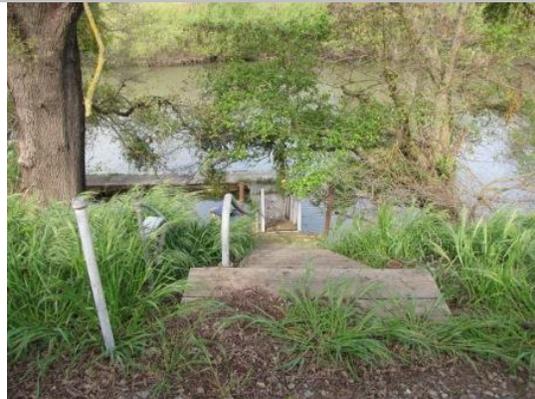
Photo 2 of 2 : SP_2015_RD0150_17_3_20150313_00001.jpg

View of steps, a dock, and associated utilities on the waterward slope.

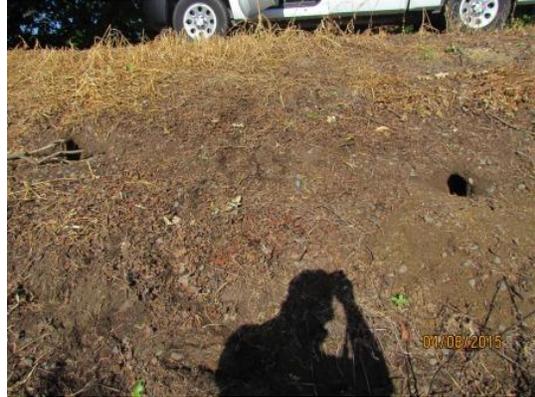
Photo 1 of 1 : SP_2015_RD0150_17_390_20150410_00116.jpg

Rodent holes were found on the landside of the levee looking downstream.

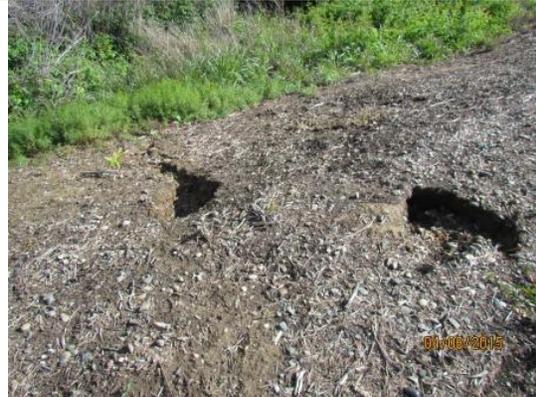
Photo 1 of 1 : SP_2015_RD0150_17_392_20150410_00118.jpg

Slope instability possibly caused by rodent holes were found on the waterside of the levee looking upstream.

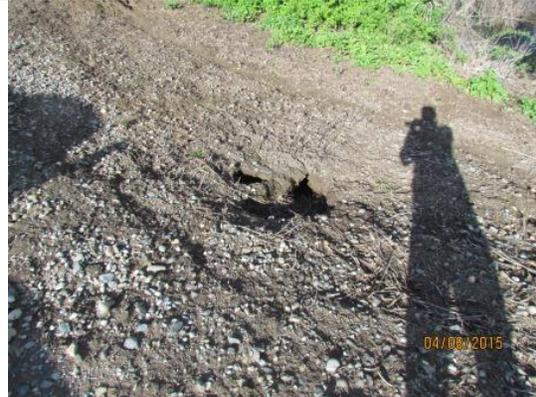
Photo 1 of 1 : SP_2015_RD0150_17_393_20150413_00119.jpg

Rodent holes were found on the waterside of the levee looking downstream.

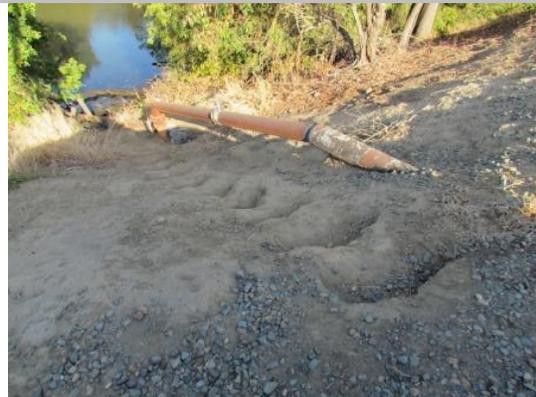
Photo 1 of 2 : SP_2015_RD0150_17_50_20150313_00039.jpg

Steps were dug next to the pipe and also erosion was found near the vicinity of the pipe on the waterside slope of the levee looking upstream during fall 2013 inspection.

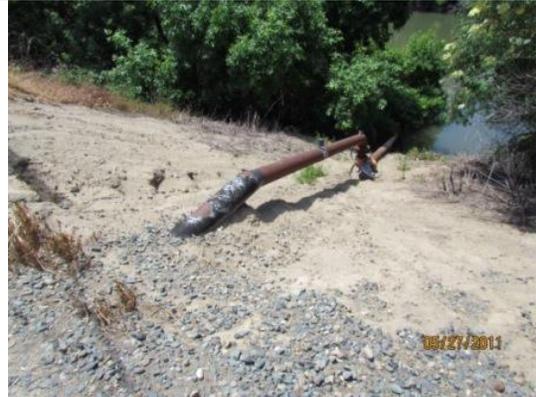
Photo 2 of 2 : SP_2015_RD0150_17_50_20150313_00040.jpg

Erosion was found on the waterside slope of the levee near the vicinity of the pipe. The picture was taken from the crown looking downstream.

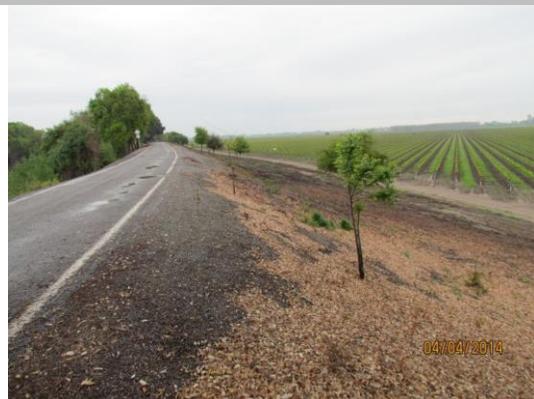
Photo 2 of 5 : SP_2015_RD0150_17_78_20150313_00074.jpg

View of the newly planted tree on the landside slope of the levee during spring 2014 inspection.

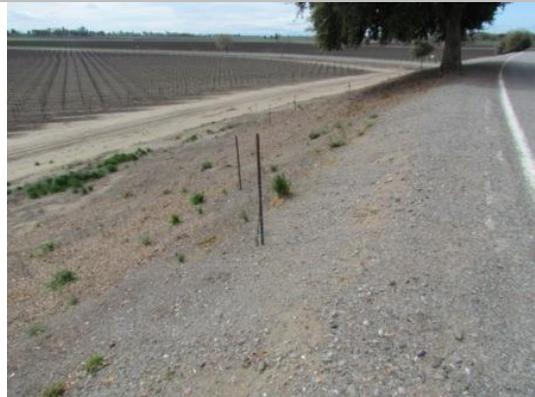
Photo 5 of 5 : SP_2015_RD0150_17_78_20150313_00077.jpg

New tree was planted on the landside of the levee looking downstream.

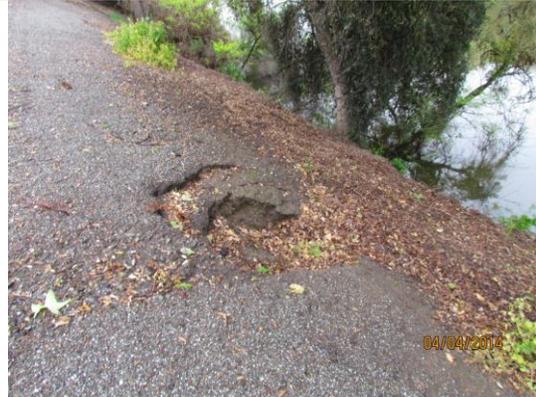
Photo 2 of 3 : SP_2015_RD0150_17_35_20150313_00027.jpg

Updated picture of the erosion on the waterside slope of the levee during spring 2014 inspection.

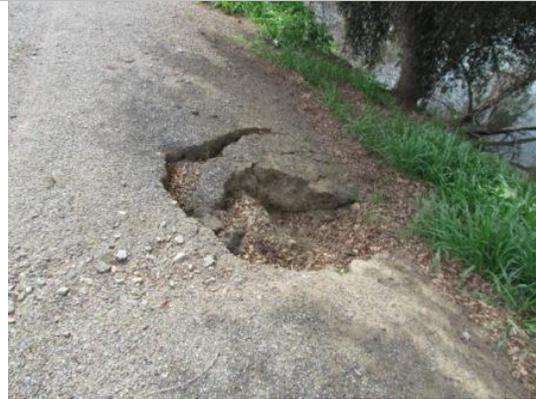
Photo 3 of 3 : SP_2015_RD0150_17_35_20150313_00028.jpg

Erosion was found on the waterside slope of the levee looking downstream during spring 2013 inspection.

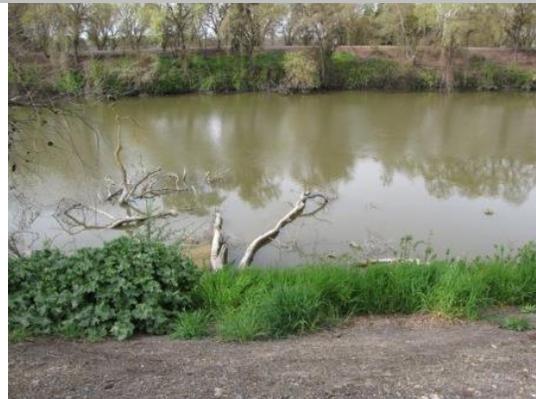
Photo 1 of 1 : SP_2015_RD0150_17_17_20150313_00014.jpg

View of tree stumps on the waterward slope.

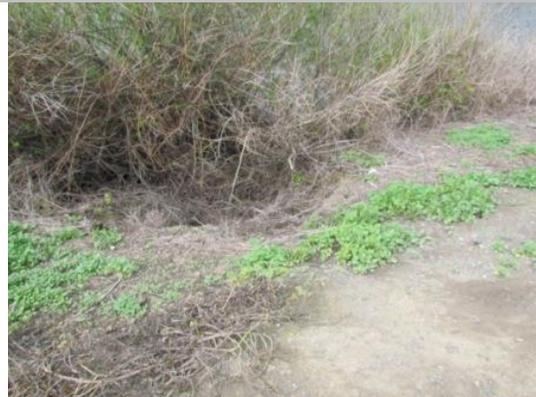
Photo 1 of 2 : SP_2015_RD0150_17_76_20150313_00071.jpg

Erosion was found on the waterside of the levee looking upstream. This picture was taken during spring 2012 inspection.

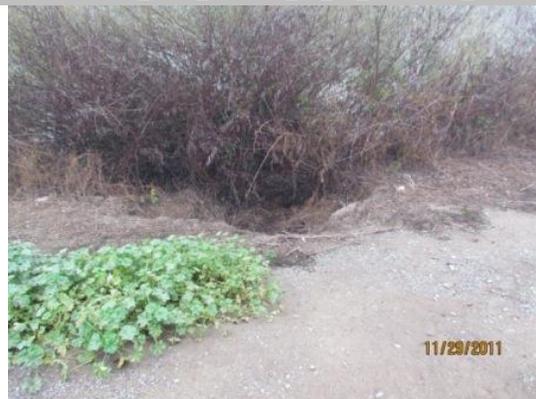
Photo 2 of 2 : SP_2015_RD0150_17_76_20150313_00072.jpg

Slope instability was found on the waterside of the levee. The picture was taken from the crown looking towards the toe of the levee.

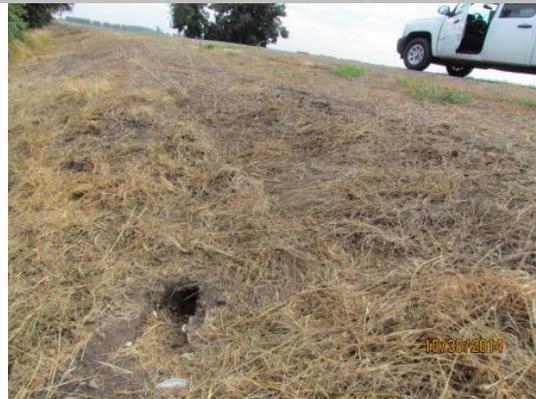
Photo 1 of 1 : SP_2015_RD0150_17_77_20150313_00073.jpg

A rodent hole was found on the waterside of the levee looking upstream.

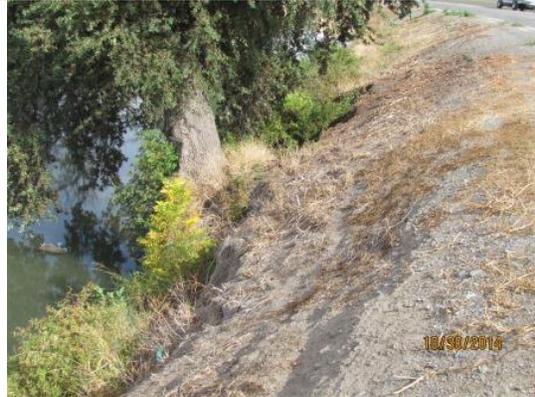
Photo 2 of 3 : SP_2015_RD0150_17_40_20150313_00032.jpg

Updated picture of the erosion on the waterside of the levee looking upstream during fall 2014 inspection.

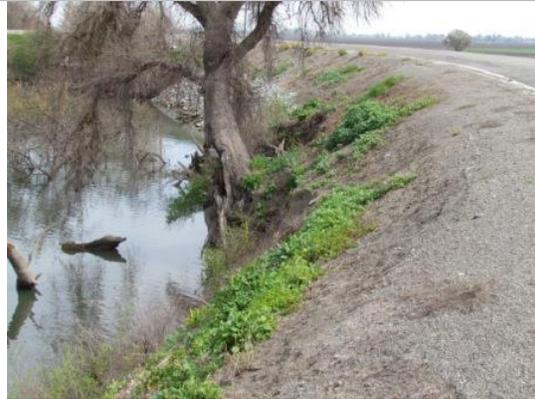
Photo 3 of 3 : SP_2015_RD0150_17_40_20150313_00033.jpg

Erosion was found on the waterside toe of the levee looking upstream during spring 2013 inspection.

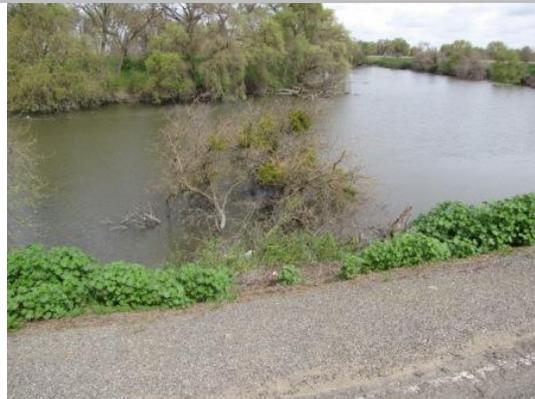
Photo 1 of 1 : SP_2015_RD0150_17_27_20150313_00019.jpg

View of tree stumps on the waterside slope looking upstream.

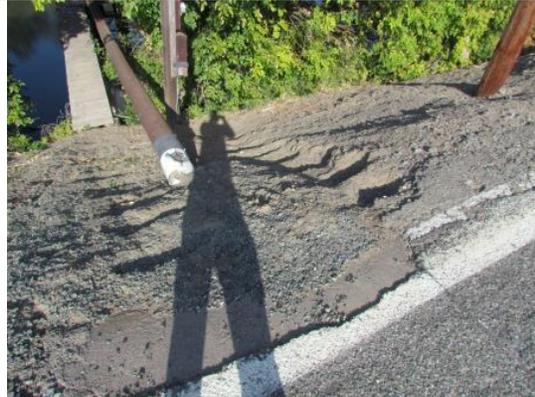
Photo 1 of 1 : SP_2015_RD0150_17_114_20150313_00092.jpg

View of steps that were dug on the waterside slope of the levee looking upstream.

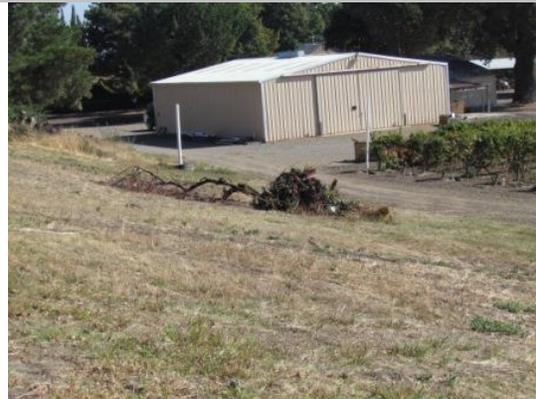
Photo 3 of 4 : SP_2015_RD0150_17_51_20150313_00043.jpg

Prunings were found on the landside of the levee looking upstream. This picture was taken during fall 2012 inspection.

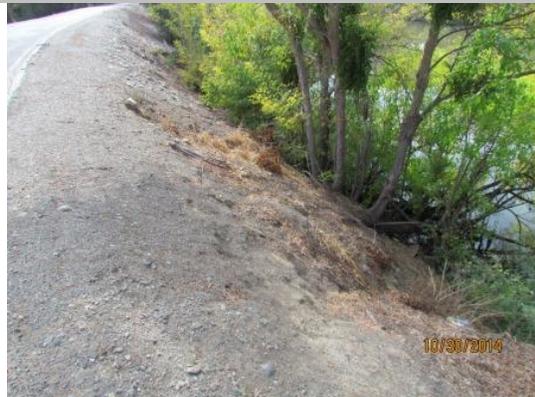
Photo 1 of 1 : SP_2015_RD0150_17_81_20150313_00080.jpg

View of erosion on the waterside of the levee looking downstream.

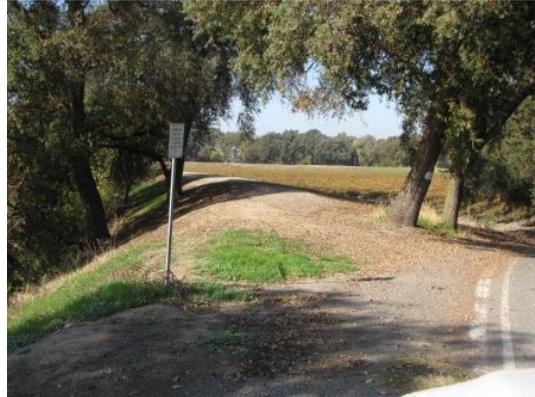
Photo 1 of 1 : SP_2015_RD0150_17_941_20150313_00103.jpg

View of varying elevations in the crown of the levee at the transition from county road to access road.

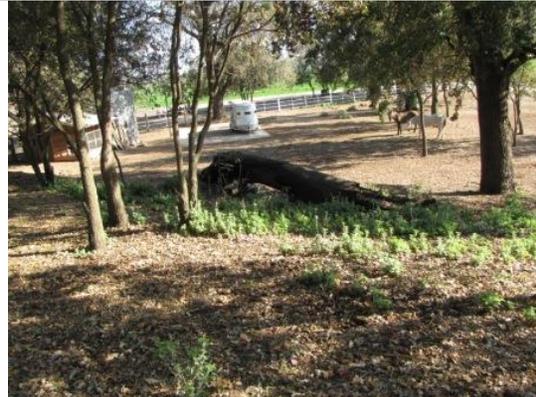
Photo 1 of 1 : SP_2015_RD0150_17_57_20150313_00048.jpg

View of a tree trunk lying on the landward slope blocking visibility.

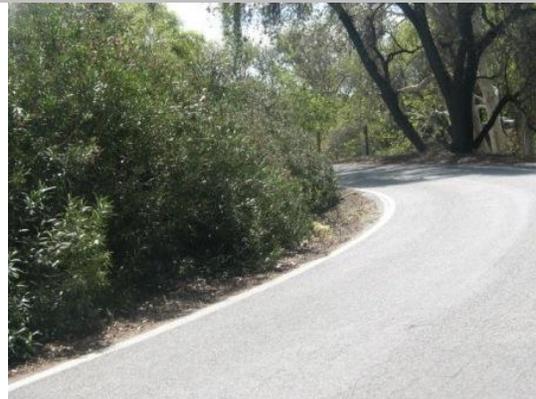
Photo 1 of 1 : SP_2015_RD0150_17_24_20150313_00017.jpg

Oleander on landward slope blocking view of levee from LM 6.24 to 6.32

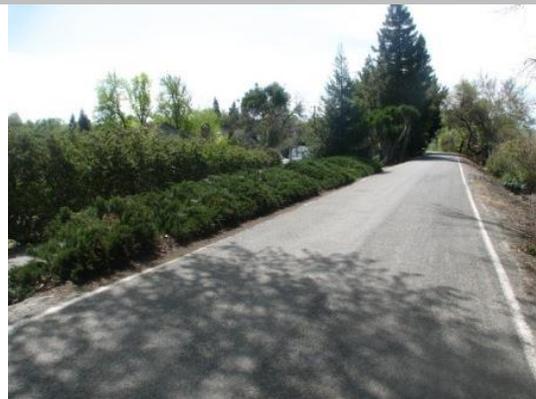
Photo 1 of 1 : SP_2015_RD0150_17_26_20150313_00018.jpg

Landscaping on landward slope blocking view from LM 6.37 to 6.40

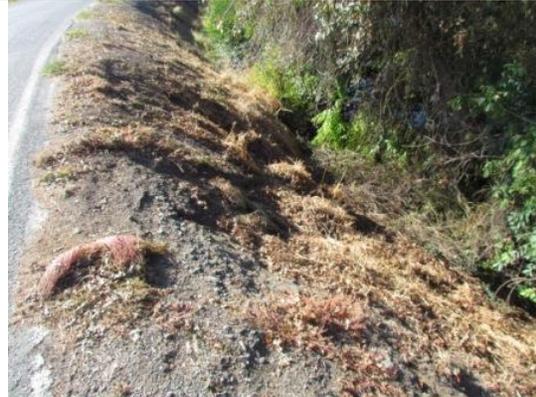
Photo 1 of 1 : SP_2015_RD0150_17_43_20150313_00034.jpg

Slope instability was found on the waterside of the levee looking downstream.

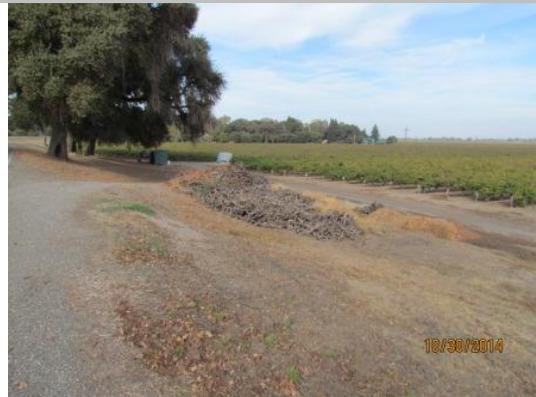
Photo 1 of 1 : SP_2015_RD0150_17_83_20150313_00082.jpg

Prunings were found on the landside toe of the levee looking upstream.

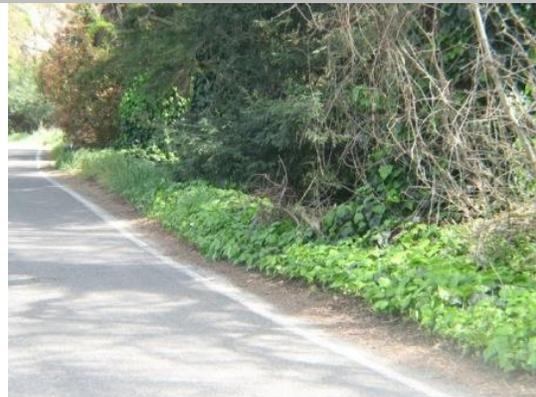
Photo 1 of 1 : SP_2015_RD0150_17_30_20150313_00021.jpg

Landscaping on landward slope blocking view from LM 6.87 to 6.95

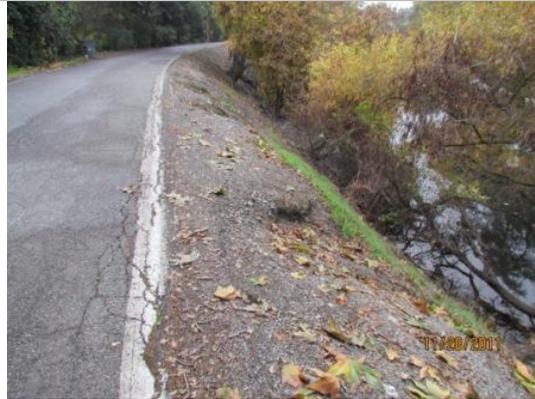
Photo 4 of 4 : SP_2015_RD0150_17_61_20150313_00054.jpg

Erosion was found on the waterside of the levee looking downstream. This picture was taken during fall 2011 inspection.

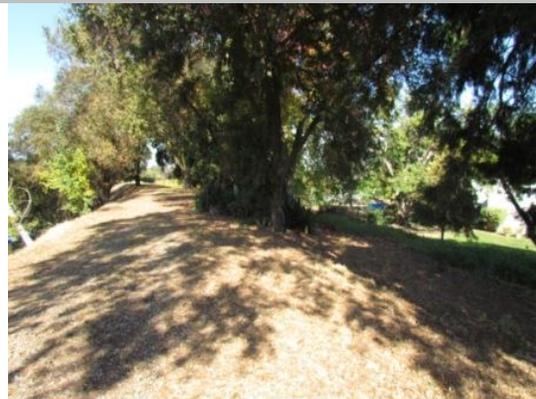
Photo 1 of 1 : SP_2015_RD0150_17_84_20150313_00083.jpg

Landscaping was found on the landside shoulder of the levee looking upstream.

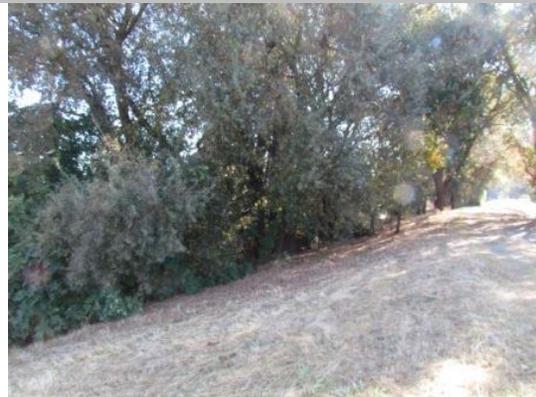
Photo 1 of 1 : SP_2015_RD0150_17_934_20150313_00098.jpg

Landscaping was blocking the visibility on the landside of the levee looking downstream.

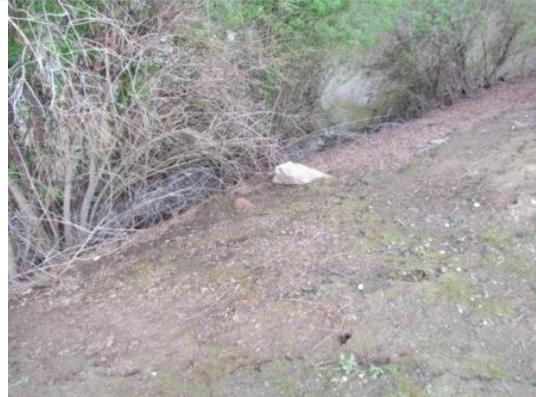
Photo 1 of 1 : SP_2015_RD0150_17_87_20150313_00084.jpg

An abandoned pipe was found on the waterside of the levee looking upstream.

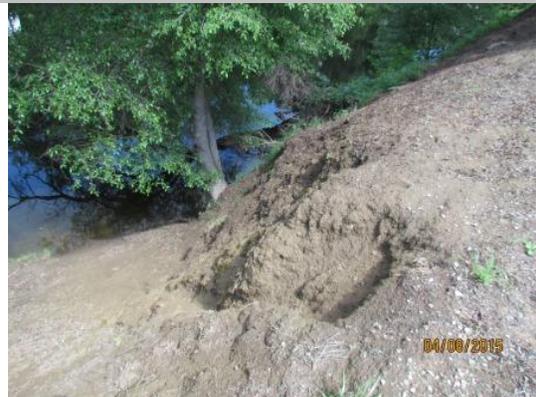
Photo 1 of 2 : SP_2015_RD0150_17_92_20150413_00126.jpg

Updated picture of the slope instability on the waterside of the levee looking upstream during spring 2015 inspection.

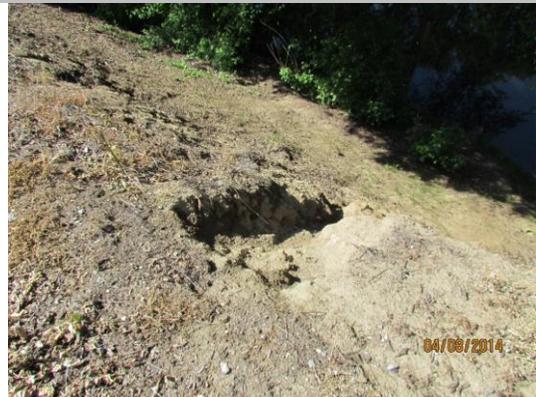
Photo 2 of 2 : SP_2015_RD0150_17_92_20150313_00090.jpg

A slope instability was found on the waterside of the levee looking downstream.

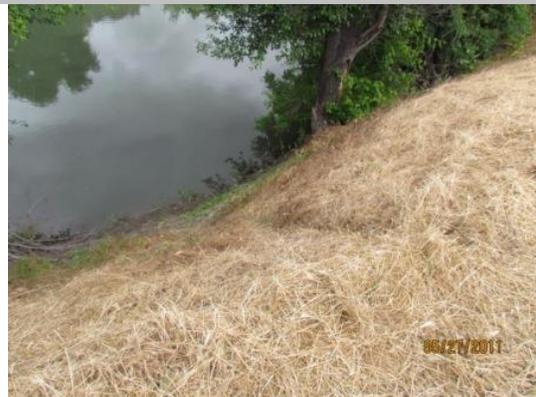
Photo 3 of 3 : SP_2015_RD0150_17_67_20150313_00065.jpg

Slope instability on the waterside slope of the levee. The picture was taken from the crown looking upstream.

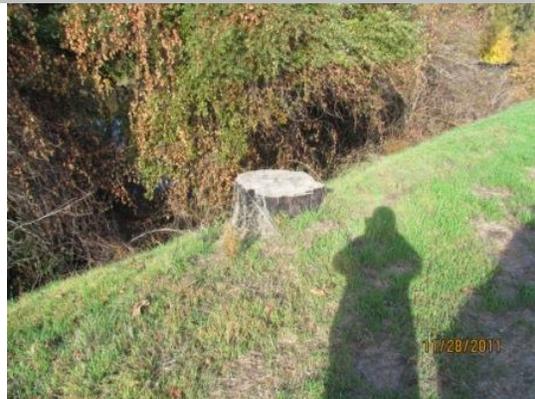
Photo 1 of 1 : SP_2015_RD0150_17_55_20150313_00046.jpg

A tree stump was found on the waterside of the levee looking upstream.
