**Flood Control Project Maintenance
Levee Inspections**

Maintenance Issue Types Only, Levee Inspection Report By Mile - Spring 2015

Reclamation District No. 0150 Merrit Island

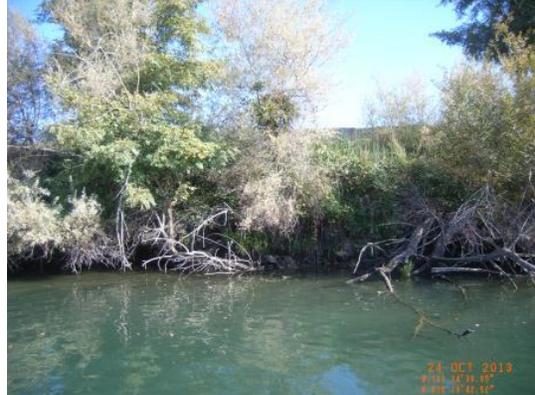
Photo 1 of 2 : SP_2015_RD0150_15_2_20150313_00001.jpg

LM Start	0.44	Rating **	M	Issue No.	2
LM End	0.49	Issue Type +	Ma	Location *	WS
Category	Supplemental		GPS Latitude/Longitude		
			Start	End	
Item	USACE Erosion Survey		38.328606 °	38.328091 °	
			-121.577472 °	-121.576640 °	
DWR ID	DWR_RD0150_01_f_2014_2				
Action/Comments					
Inspector Comments: 2013: Old toe repair unraveling. Bridge at upstream end of site. [2013 Site ID: STR_28-4_R]

USACE 2013 Photo #1

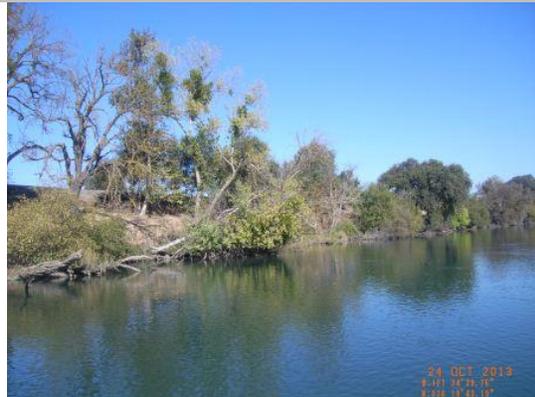
Photo 2 of 2 : SP_2015_RD0150_15_2_20150313_00002.jpg

USACE 2013 Photo #2

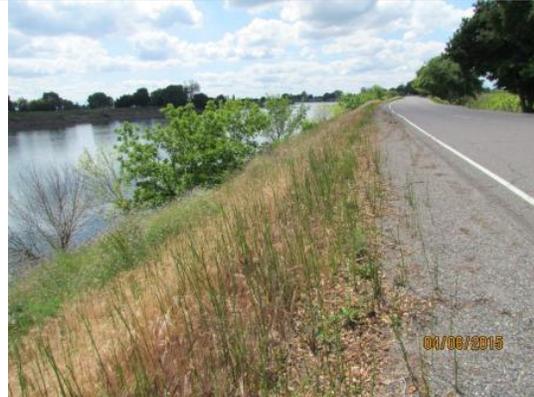
Photo 1 of 1 : SP_2015_RD0150_16_382_20150413_00075.jpg

Vegetation on the waterside of the levee looking downstream.

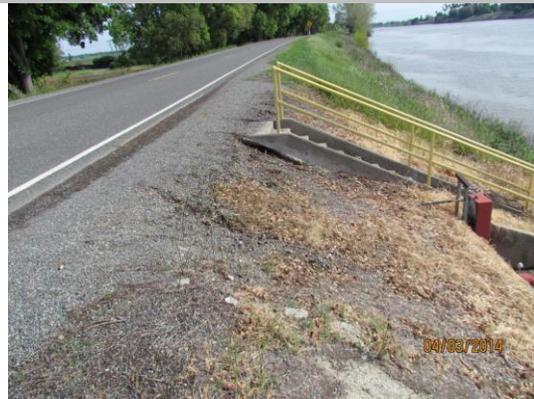
Photo 1 of 2 : SP_2015_RD0150_16_6_20150313_00002.jpg

LM Start	0.39	Rating **	M	Issue No.	6
LM End	0.39	Issue Type +	Ma	Location *	WS
Category	Earthen Levee		GPS Latitude/Longitude		
			Start	End	
Item	Slope Stability		38.332717 °	38.332717 °	
			-121.572083 °	-121.572083 °	
DWR ID	DWR_RD0150_02_s_2012_6				
Action/Comments					
Repair the levee slope damaged by foot traffic and prevent access where possible.

Updated photo of the slope instability on the waterside of the levee looking upstream during spring 2014 inspection.

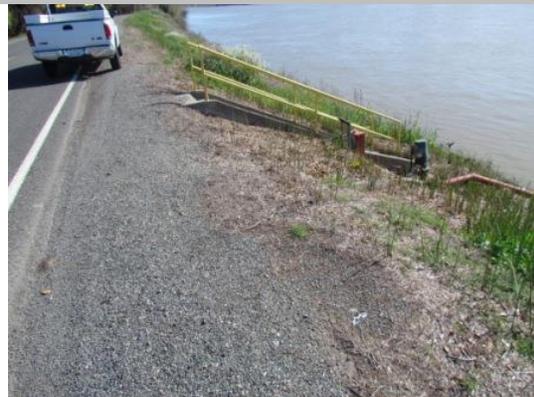
Photo 2 of 2 : SP_2015_RD0150_16_6_20150313_00003.jpg

Slope instability was found on the waterside of the levee looking upstream.

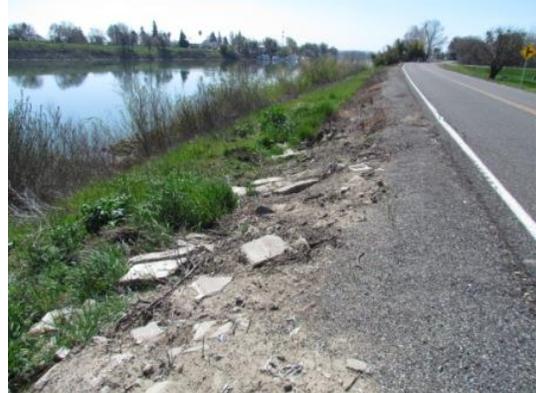
Photo 1 of 1 : SP_2015_RD0150_16_10_20150313_00006.jpg

Debris was found on the waterside slope of the levee looking downstream during Spring 2013 inspection.

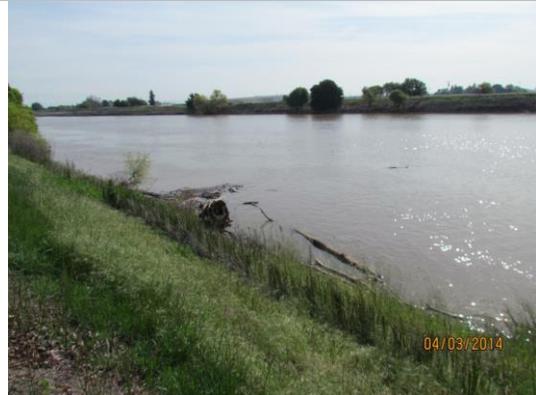
Photo 1 of 2 : SP_2015_RD0150_16_18_20150313_00012.jpg

LM Start	0.99	Rating **	M	Issue No.	18
LM End	0.99	Issue Type +	Ma	Location *	WS
Category	Earthen Levee			GPS Latitude/Longitude	
				Start	End
Item	Encroachments			38.339268 °	38.339268 °
				-121.564839 °	-121.564839 °
DWR ID	DWR_RD0150_02_s_2013_18				
Action/Comments					
Tree or limb Inspector Comments: Tree trunk was found on the waterside toe of the levee.

Updated picture of the tree trunk on the waterside toe of the levee looking upstream during spring 2014 inspection.

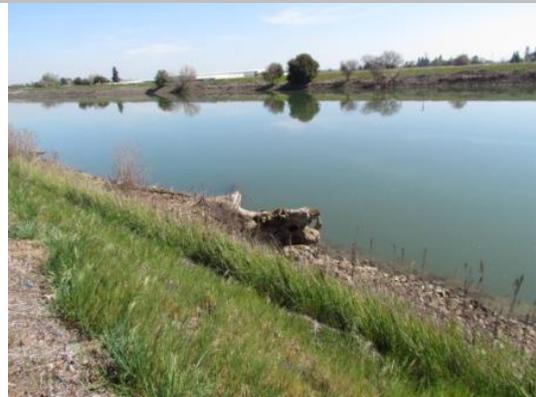
Photo 2 of 2 : SP_2015_RD0150_16_18_20150313_00013.jpg

A tree trunk was found on the waterside toe of the levee looking upstream during spring 2013 inspection.

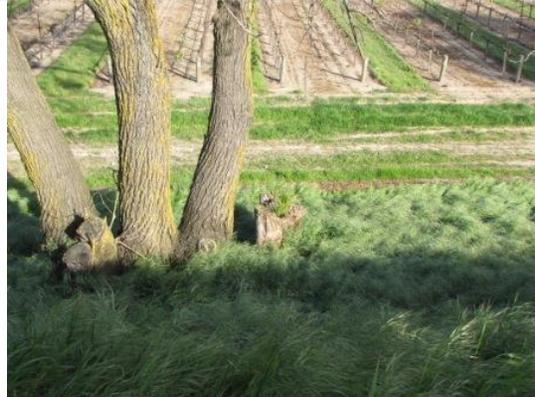
Photo 1 of 1 : SP_2015_RD0150_16_8_20150313_00004.jpg

View of a tree stump on the landward slope.

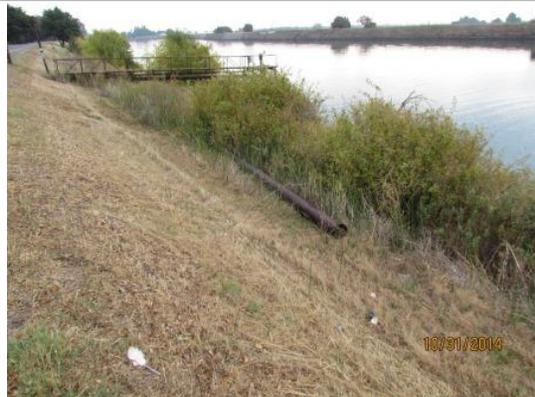
Photo 1 of 1 : SP_2015_RD0150_16_50_20150313_00028.jpg

LM Start	1.89	Rating **	M	Issue No.	50
LM End	1.89	Issue Type +	Ma	Location *	WS
Category	Earthen Levee		GPS Latitude/Longitude		
			Start	End	
Item	Encroachments		38.346323 °	38.346323 °	
			-121.551568 °	-121.551568 °	
DWR ID	DWR_RD0150_02_f_2014_50				
Action/Comments					
Pipe Inspector Comments: An abandoned pipe was found on the waterside of the levee.

A pipe was found on the waterside toe of the levee looking upstream.

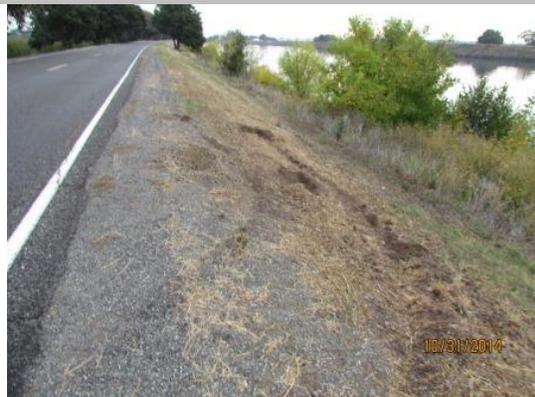
Photo 1 of 1 : SP_2015_RD0150_16_52_20150313_00030.jpg

LM Start	1.93	Rating **	M	Issue No.	52
LM End	1.93	Issue Type +	Ma	Location *	WS
Category	Earthen Levee		GPS Latitude/Longitude		
			Start	End	
Item	Slope Stability		38.346462 °	38.346462 °	
			-121.550978 °	-121.550978 °	
DWR ID	DWR_RD0150_02_f_2014_52				
Action/Comments					
Repair the levee slope damaged by vehicle traffic and prevent access where possible. Inspector Comments: Rutting caused by vehicles.

A slope instability was found on the waterside slope of the levee looking upstream.

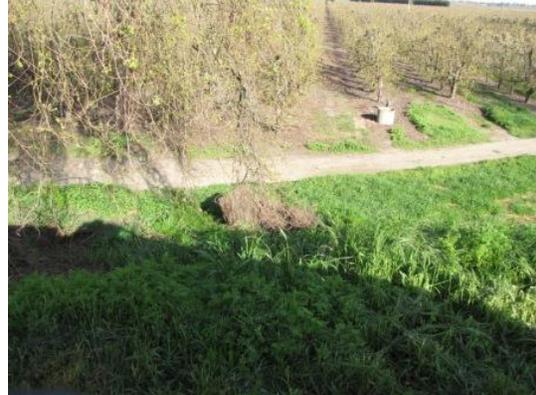
Photo 1 of 1 : SP_2015_RD0150_16_14_20150313_00009.jpg

View of a tree stump on the landward slope.

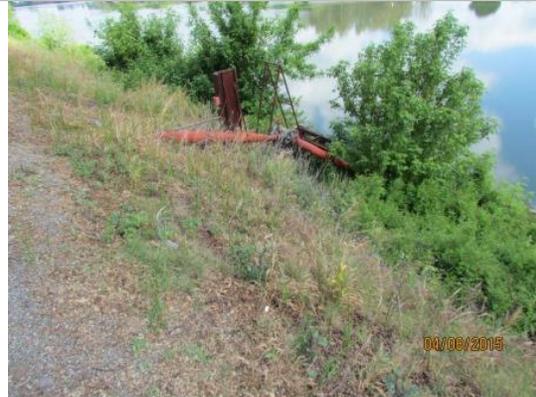
Photo 1 of 5 : SP_2015_RD0150_16_961_20150413_00076.jpg

LM Start	3.24	Rating **	M	Issue No.	961
LM End	3.24	Issue Type +	Ma	Location *	WS
Category	Earthen Levee		GPS Latitude/Longitude		
			Start	End	
Item	Erosion / Bank Caving		38.355321 °	38.355321 °	
			-121.530902 °	-121.530902 °	
DWR ID	DWR_RD0150_02_s_2012_961				
Action/Comments					
Schedule repair of erosion site prior to the next inspection. Inspector Comments: Depressions into the waterward slope can be seen along the waterward slope at this site. Also note the damaged pump support, pump, and pipe just upstream of the site; they may contribute to the erosion in a high water event and should be removed.

Updated picture of the erosion on the waterside of the levee during spring 2015 inspection.

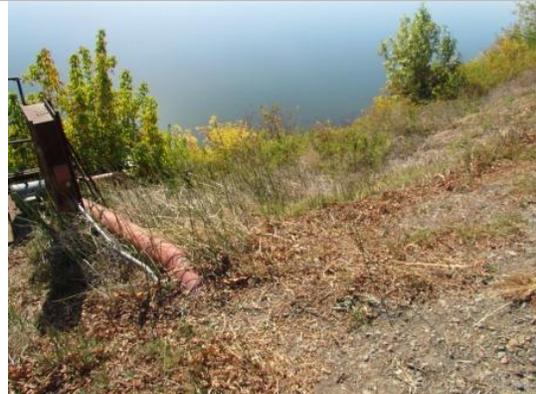
Photo 2 of 5 : SP_2015_RD0150_16_961_20150313_00049.jpg

View of the erosion on the waterside slope of the levee near the pipe looking downstream. This picture was taken during the fall 2013 inspection.

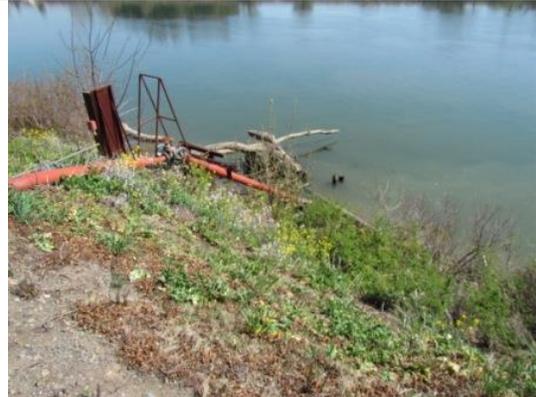
Photo 3 of 5 : SP_2015_RD0150_16_961_20150313_00050.jpg

LM Start	3.24	Rating **	M	Issue No.	961 (cont)
LM End	3.24	Issue Type +	Ma	Location *	WS
Category	Earthen Levee			GPS Latitude/Longitude	
				Start	End
Item	Erosion / Bank Caving			38.355321 °	38.355321 °
				-121.530902 °	-121.530902 °
DWR ID	DWR_RD0150_02_s_2012_961				
Action/Comments					
Schedule repair of erosion site prior to the next inspection. Inspector Comments: Depressions into the waterward slope can be seen along the waterward slope at this site. Also note the damaged pump support, pump, and pipe just upstream of the site; they may contribute to the erosion in a high water event and should be removed.

View of the erosion on the waterside slope of the levee looking upstream during spring 2013 inspection.

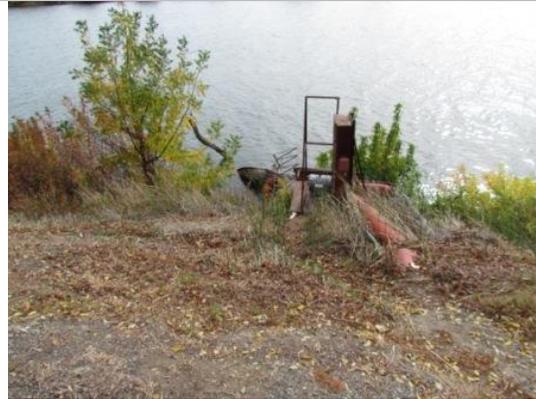
Photo 4 of 5 : SP_2015_RD0150_16_961_20150313_00051.jpg

View of erosion and damaged pipe and abandoned boat on the waterside of the levee looking upstream. This picture was taken during fall 2012 inspection.

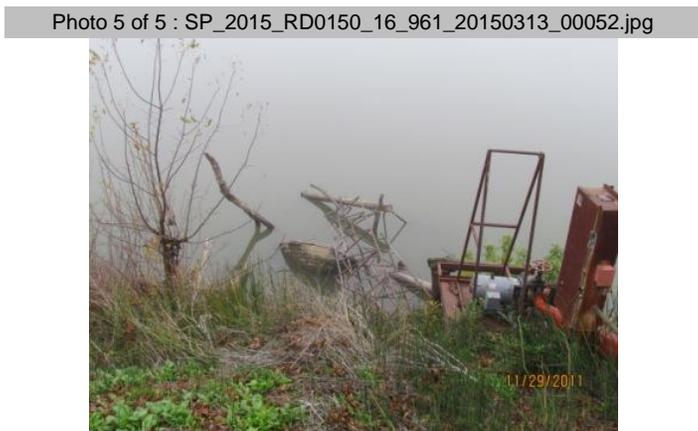
LM Start	3.24	Rating **	M	Issue No.	961 (cont)
LM End	3.24	Issue Type +	Ma	Location *	WS
Category	Earthen Levee		GPS Latitude/Longitude		
			Start	End	
Item	Erosion / Bank Caving		38.355321 °	38.355321 °	
			-121.530902 °	-121.530902 °	
DWR ID	DWR_RD0150_02_s_2012_961				
Action/Comments					
Schedule repair of erosion site prior to the next inspection. Inspector Comments: Depressions into the waterward slope can be seen along the waterward slope at this site. Also note the damaged pump support, pump, and pipe just upstream of the site; they may contribute to the erosion in a high water event and should be removed.

View of the erosion site, and broken pump support along with a boat on the waterside of the levee. The picture was taken from the crown looking towards the toe of the levee during fall 2011 inspection.

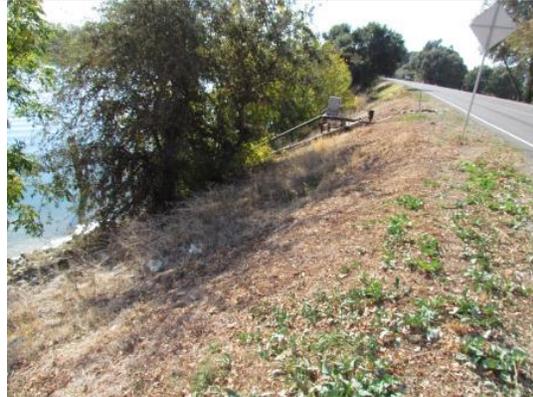
Photo 1 of 2 : SP_2015_RD0150_16_975_20150313_00055.jpg

LM Start	5.24	Rating **	M	Issue No.	975
LM End	5.24	Issue Type +	Ma	Location *	WS
Category	Earthen Levee			GPS Latitude/Longitude	
				Start	End
Item	Slope Stability			38.381126 °	38.381126 °
				-121.524207 °	-121.524207 °
DWR ID	DWR_RD0150_02_s_2013_975				
Action/Comments					
Repair slope instability. Inspector Comments: Depression in the landward slope at the shoulder over an irrigation pipe.

View of minor slope instability on the waterside slope of the levee looking downstream during fall 2013 inspection.

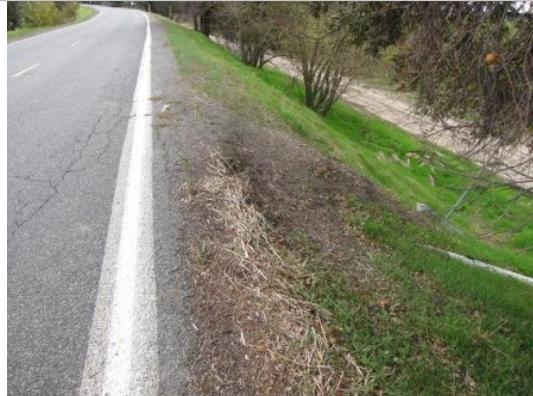
Photo 2 of 2 : SP_2015_RD0150_16_975_20150313_00056.jpg

View of a minor depression along the landward slope of the levee over a pipe penetration looking downstream.

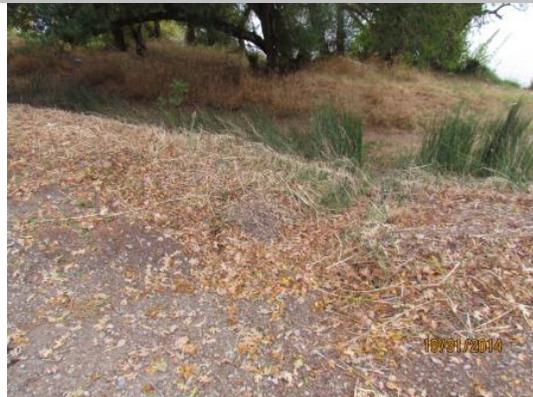
Photo 1 of 1 : SP_2015_RD0150_16_54_20150313_00031.jpg

LM Start	5.33	Rating **	M	Issue No.	54
LM End	5.33	Issue Type +	Ma	Location *	WS
Category	Earthen Levee			GPS Latitude/Longitude	
				Start	End
Item	Slope Stability			38.382072 °	38.382072 °
				-121.523220 °	-121.523220 °
DWR ID	DWR_RD0150_02_f_2014_54				
Action/Comments					
Repair the levee slope damaged by foot traffic and prevent access where possible.

View of a slope instability on the waterside of the levee looking towards the toe.

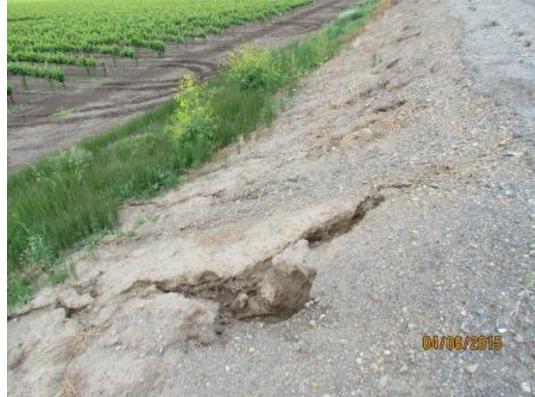
Photo 1 of 1 : SP_2015_RD0150_16_383_20150413_00074.jpg

LM Start	5.89	Rating **	M	Issue No.	383
LM End	5.89	Issue Type +	Ma	Location *	LS
Category	Earthen Levee		GPS Latitude/Longitude		
			Start	End	
Item	Slope Stability		38.387809 °	38.387809 °	
			-121.516030 °	-121.516030 °	
DWR ID	DWR_RD0150_02_s_2015_383				
Action/Comments					
Repair slope instability. Inspector Comments: Runoff.

Slope instability caused by runoff was found on the landside of the levee looking upstream.

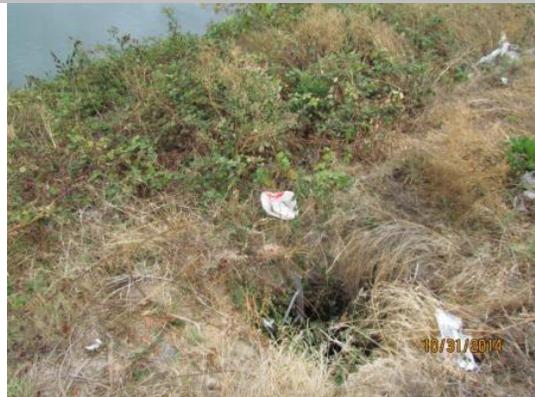
Photo 1 of 1 : SP_2015_RD0150_16_55_20150313_00032.jpg

An open pipe valve was found without a cover on the waterside toe of the levee.

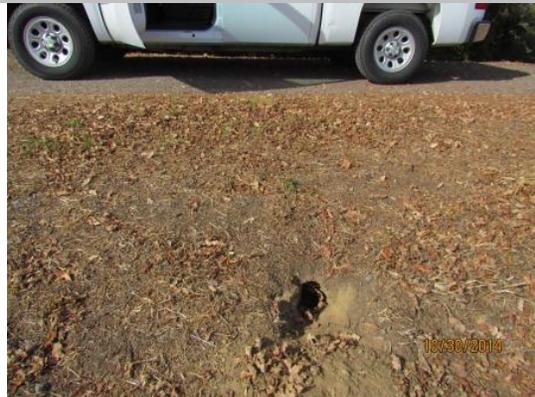
Photo 1 of 1 : SP_2015_RD0150_17_74_20150313_00069.jpg

A rodent hole was found on the landside of the levee looking upstream.

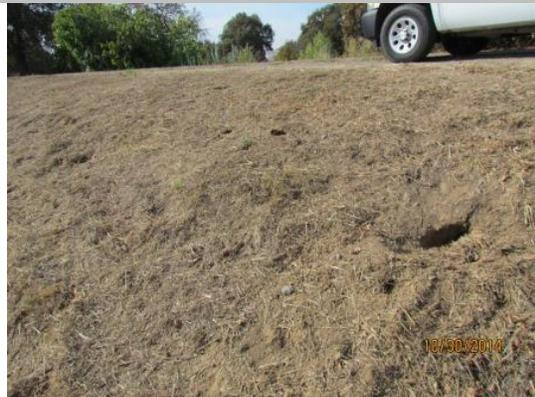
Photo 1 of 1 : SP_2015_RD0150_17_54_20150313_00045.jpg

View of an animal hole on the landside of the levee looking downstream.

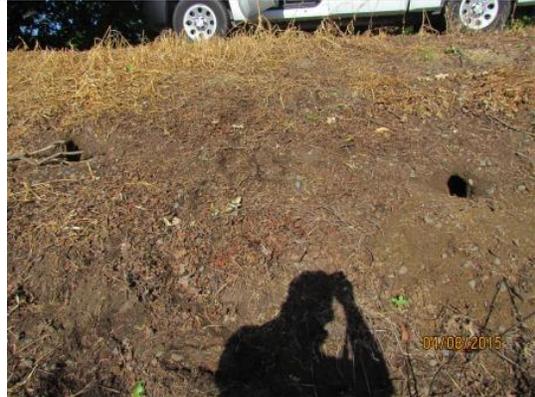
Photo 1 of 1 : SP_2015_RD0150_17_390_20150410_00116.jpg

Rodent holes were found on the landside of the levee looking downstream.

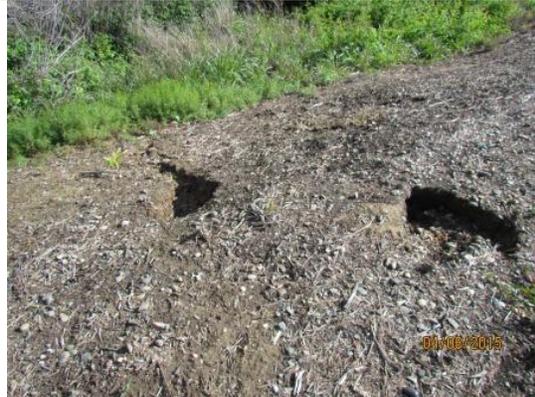
Photo 1 of 1 : SP_2015_RD0150_17_392_20150410_00118.jpg

LM Start	1.26	Rating **	M	Issue No.	392
LM End	1.26	Issue Type +	Ma	Location *	WS
Category	Earthen Levee			GPS Latitude/Longitude	
				Start	End
Item	Slope Stability			38.347466 °	38.347466 °
				-121.574937 °	-121.574937 °
DWR ID	DWR_RD0150_03_s_2015_392				
Action/Comments					
Repair slope instability. Inspector Comments: Runoff possibly caused by animal holes.

Slope instability possibly caused by rodent holes were found on the waterside of the levee looking upstream.

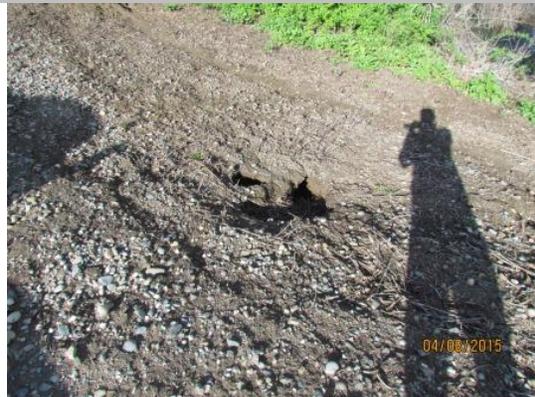
Photo 1 of 1 : SP_2015_RD0150_17_393_20150413_00119.jpg

Rodent holes were found on the waterside of the levee looking downstream.

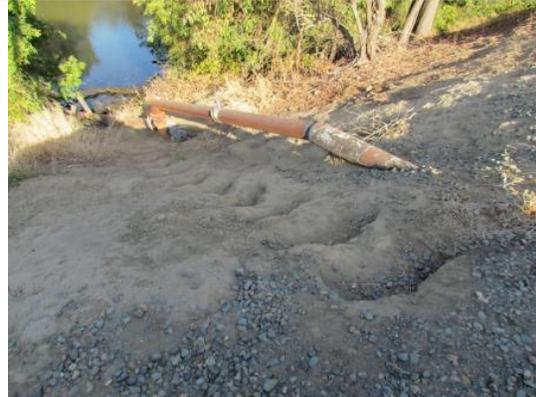
Photo 1 of 2 : SP_2015_RD0150_17_50_20150313_00039.jpg

Steps were dug next to the pipe and also erosion was found near the vicinity of the pipe on the waterside slope of the levee looking upstream during fall 2013 inspection.

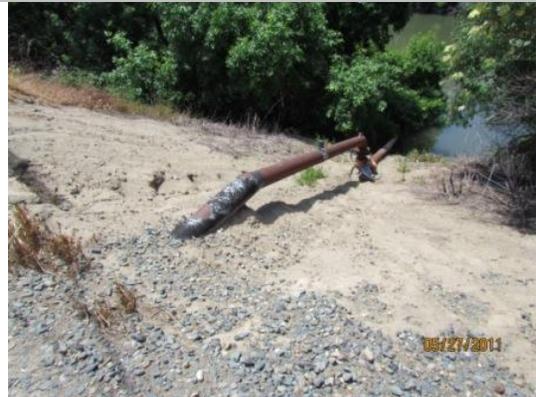
Photo 2 of 2 : SP_2015_RD0150_17_50_20150313_00040.jpg

Erosion was found on the waterside slope of the levee near the vicinity of the pipe. The picture was taken from the crown looking downstream.

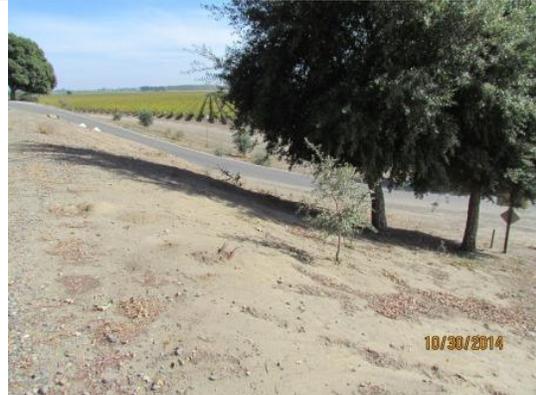
Photo 1 of 1 : SP_2015_RD0150_17_75_20150313_00070.jpg

LM Start	2.24	Rating **	M	Issue No.	75
LM End	2.24	Issue Type +	Ma	Location *	LS
Category	Earthen Levee		GPS Latitude/Longitude		
			Start	End	
Item	Vegetation		38.353811 °	38.353811 °	
			-121.565668 °	-121.565668 °	
DWR ID	DWR_RD0150_03_f_2014_75				
Action/Comments					
Remove the wild growth other than native grasses from the levee slopes. Inspector Comments: Newly planted tree was found on the landside slope of the levee.

View of a few trees that were planted on the landside slope of the levee looking upstream.

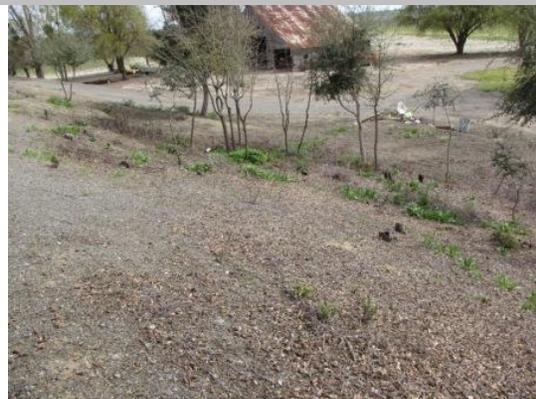
Photo 1 of 1 : SP_2015_RD0150_17_11_20150313_00007.jpg

View of tree stumps on the landward slope.

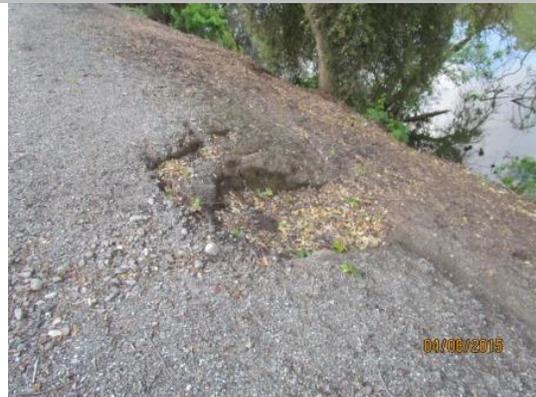
Photo 1 of 3 : SP_2015_RD0150_17_35_20150413_00121.jpg

LM Start	2.80	Rating **	M	Issue No.	35
LM End	2.80	Issue Type +	Ma	Location *	WS
Category	Earthen Levee		GPS Latitude/Longitude		
			Start	End	
Item	Erosion / Bank Caving		38.360432 °	38.360432 °	
			-121.561644 °	-121.561644 °	
DWR ID	DWR_RD0150_03_s_2013_35				
Action/Comments					
Schedule repair of erosion site prior to the next inspection.

Updated picture of the erosion on the waterside of the levee during spring 2015 inspection.

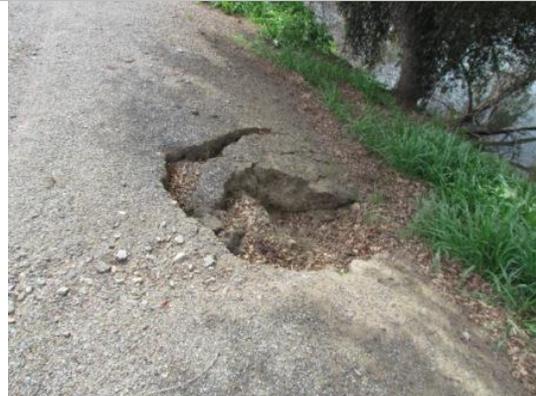
Photo 3 of 3 : SP_2015_RD0150_17_35_20150313_00028.jpg

Erosion was found on the waterside slope of the levee looking downstream during spring 2013 inspection.

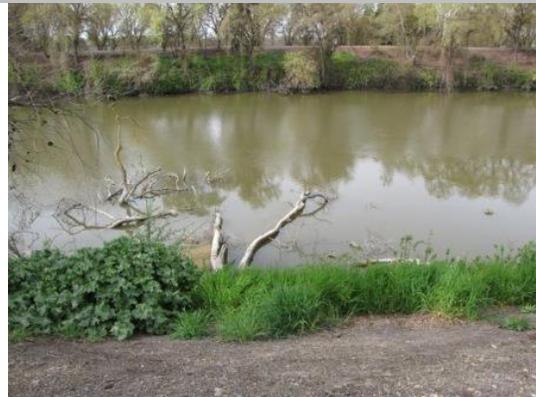
Photo 1 of 1 : SP_2015_RD0150_17_17_20150313_00014.jpg

View of tree stumps on the waterward slope.

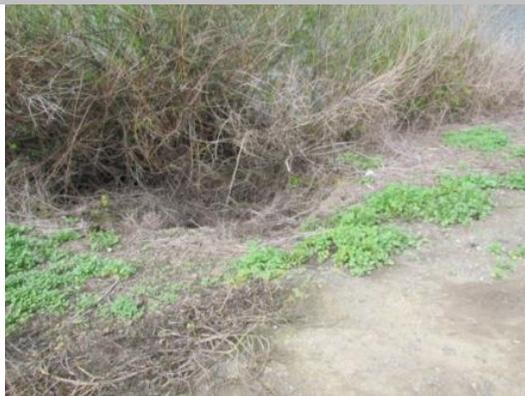
Photo 1 of 2 : SP_2015_RD0150_17_76_20150313_00071.jpg

Erosion was found on the waterside of the levee looking upstream. This picture was taken during spring 2012 inspection.

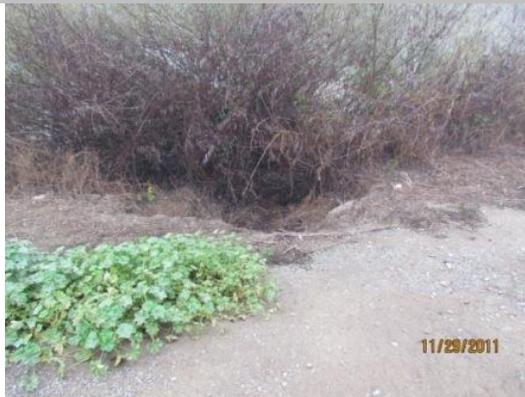
Photo 2 of 2 : SP_2015_RD0150_17_76_20150313_00072.jpg

Slope instability was found on the waterside of the levee. The picture was taken from the crown looking towards the toe of the levee.

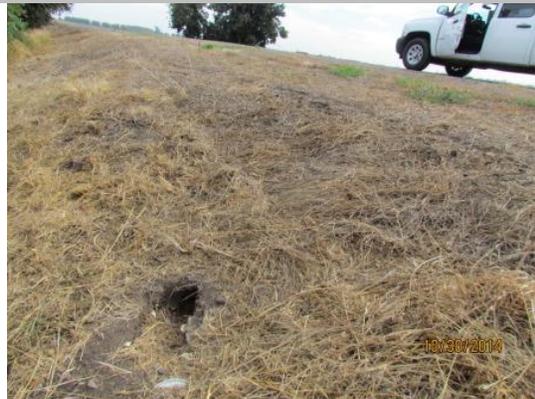
Photo 1 of 1 : SP_2015_RD0150_17_77_20150313_00073.jpg

A rodent hole was found on the waterside of the levee looking upstream.

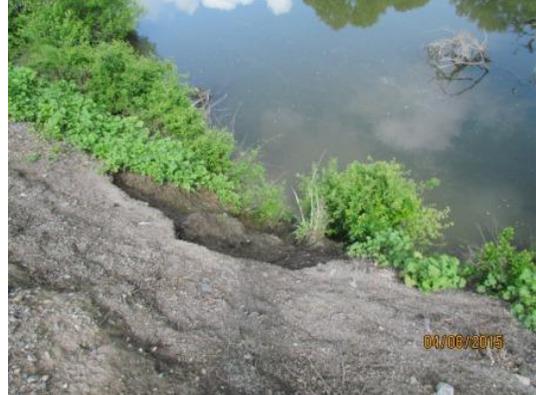
Photo 1 of 3 : SP_2015_RD0150_17_40_20150413_00122.jpg

Updated picture of the erosion on the waterside of the levee during spring 2015 inspection.

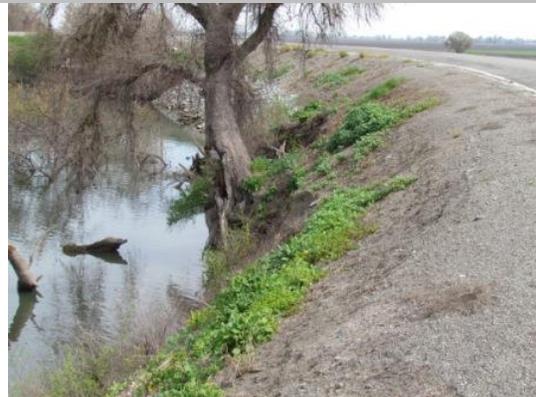
Photo 3 of 3 : SP_2015_RD0150_17_40_20150313_00033.jpg

Erosion was found on the waterside toe of the levee looking upstream during spring 2013 inspection.

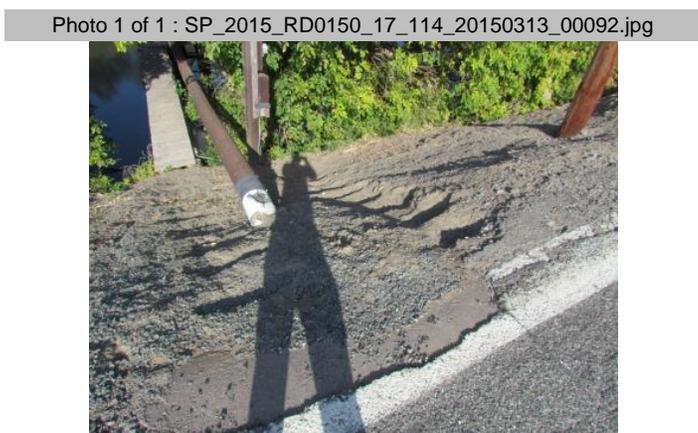
LM Start	3.39	Rating **	M	Issue No.	114
LM End	3.39	Issue Type +	Ma	Location *	WS
Category	Earthen Levee		GPS Latitude/Longitude		
			Start	End	
Item	Encroachments		38.363540 °	38.363540 °	
			-121.555555 °	-121.555555 °	
DWR ID	DWR_RD0150_03_f_2013_114				
Action/Comments					
Stairway

View of steps that were dug on the waterside slope of the levee looking upstream.

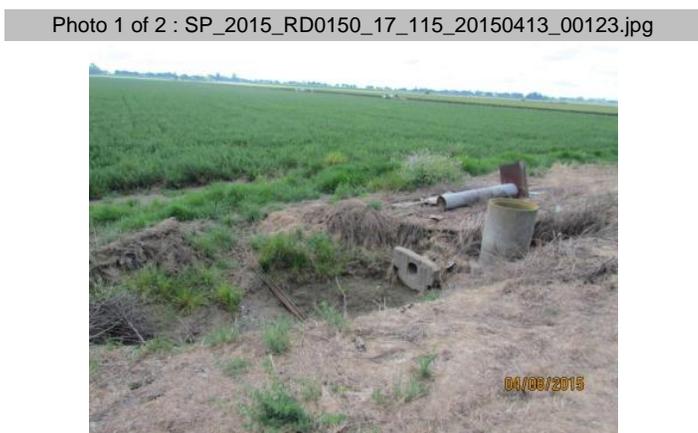
LM Start	3.39	Rating **	U	Issue No.	115
LM End	3.39	Issue Type +	Ma	Location *	LS
Category	Earthen Levee		GPS Latitude/Longitude		
			Start	End	
Item	Erosion / Bank Caving		38.363540 °	38.363540 °	
			-121.555554 °	-121.555554 °	
DWR ID	DWR_RD0150_03_f_2013_115				
Action/Comments					
Schedule repair of erosion site prior to the next inspection. Inspector Comments: Erosion (ditch) was found on the landside toe of the levee.

Updated picture of the ditch on the landside toe of the levee during spring 2015 inspection.

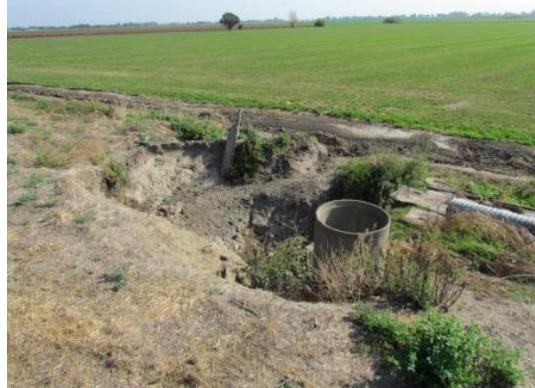
Photo 2 of 2 : SP_2015_RD0150_17_115_20150313_00093.jpg

A drainage ditch with depth of 4 feet and width of 15 feet was found on the landside toe of the levee. The picture was taken from the landside slope looking upstream during the fall 2013 inspection.

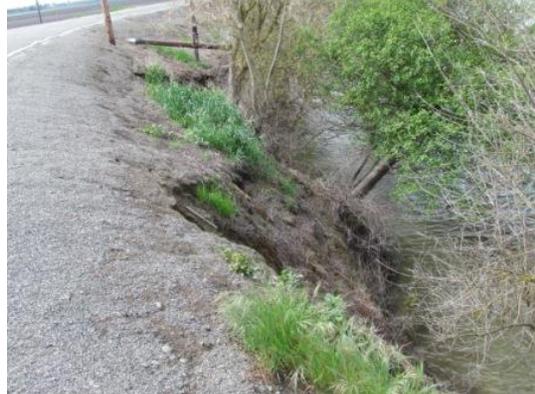
Photo 1 of 1 : SP_2015_RD0150_17_98_20150313_00091.jpg

Erosion was found on the waterside of the levee looking downstream.

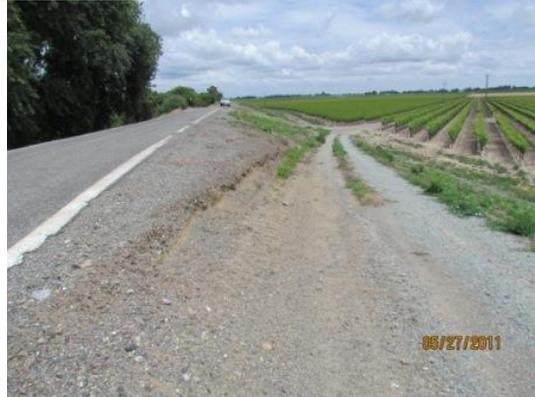
Photo 1 of 2 : SP_2015_RD0150_17_927_20150313_00095.jpg

Slope instability possible due to vehicular traffic on the landside of the levee. The picture was taken from the crown looking upstream during Spring 2011 inspection.

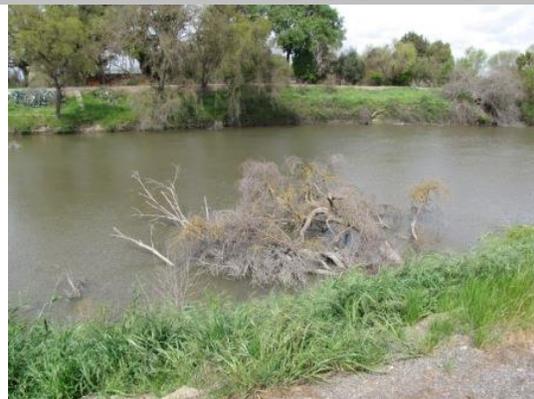
Photo 1 of 1 : SP_2015_RD0150_17_37_20150313_00030.jpg

View of tree stumps on the waterward slope.

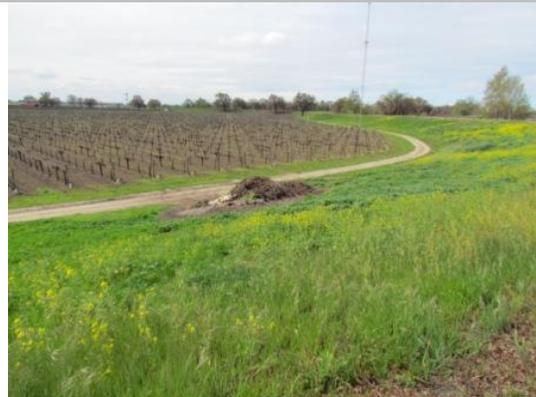
Photo 2 of 4 : SP_2015_RD0150_17_51_20150313_00042.jpg

Prunings were found on the landside of the levee looking downstream.

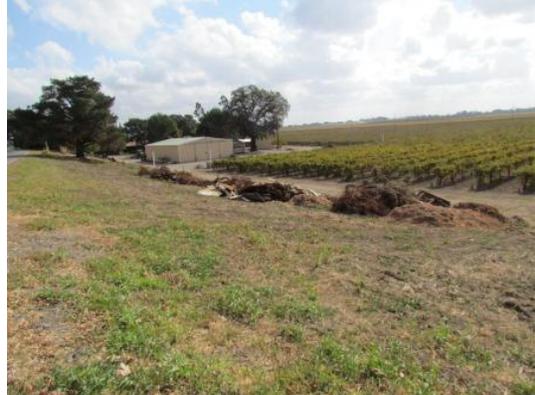
Photo 4 of 4 : SP_2015_RD0150_17_51_20150313_00044.jpg

Updated picture of the pruning pile on the landside of the levee looking upstream during the fall 2013 inspection.

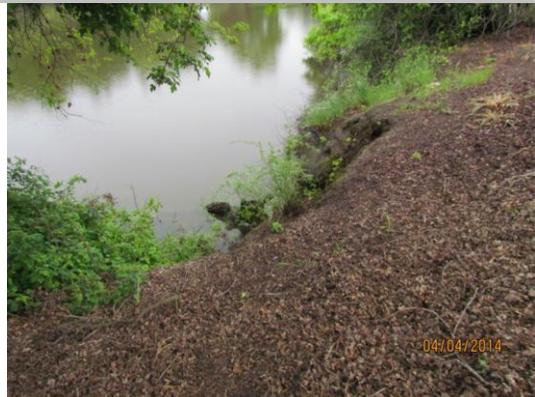
Photo 1 of 1 : SP_2015_RD0150_17_80_20150313_00079.jpg

View of an erosion site on the waterside toe of the levee looking upstream.

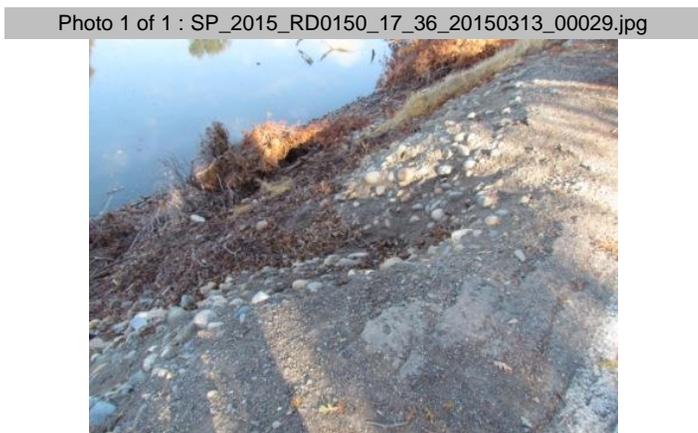
LM Start	4.99	Rating **	M	Issue No.	36
LM End	4.99	Issue Type +	Ma	Location *	WS
Category	Earthen Levee			GPS Latitude/Longitude	
				Start	End
Item	Slope Stability			38.378771 °	38.378771 °
				-121.540538 °	-121.540538 °
DWR ID	DWR_RD0150_03_f_2012_36				
Action/Comments					
Repair slope instability.

Slope instability was found on the waterside of the levee looking upstream.

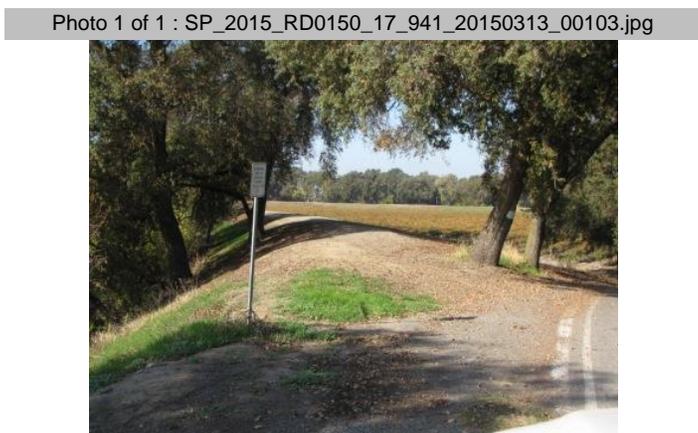
LM Start	5.14	Rating **	M	Issue No.	941
LM End	5.14	Issue Type +	Ma	Location *	CR
Category	Earthen Levee			GPS Latitude/Longitude	
				Start	End
Item	Crown Surface / Depressions / Rutting			38.380779 °	38.380779 °
				-121.540264 °	-121.540264 °
DWR ID	DWR_RD0150_03_s_2012_941				
Action/Comments					
Repair depressions or ruts in the crown or slope. Inspector Comments: There is a significant difference in the crown roadway elevation as it transitions from the paved roadway to the gravel access road.

View of varying elevations in the crown of the levee at the transition from county road to access road.

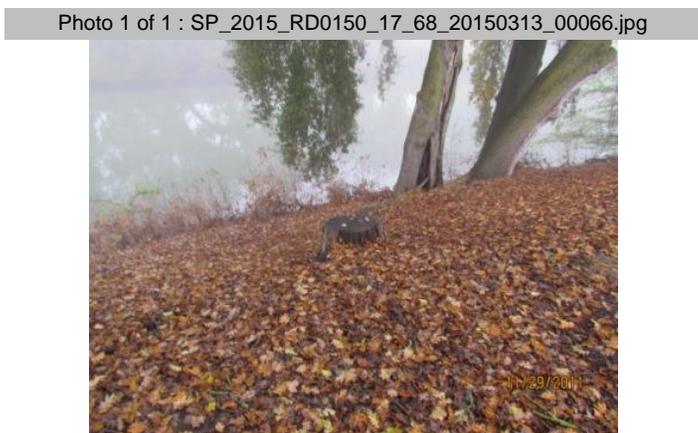
LM Start	5.56	Rating **	N	Issue No.	68
LM End	5.56	Issue Type +	Ma	Location *	WS
Category	Earthen Levee			GPS Latitude/Longitude	
				Start	End
Item	Trim / Thin Trees			38.383697 °	38.383697 °
				-121.545201 °	-121.545201 °
DWR ID	DWR_RD0150_03_s_2012_68				
Action/Comments					
Tree stumps.

Tree stump was found on the waterside of the levee looking upstream.

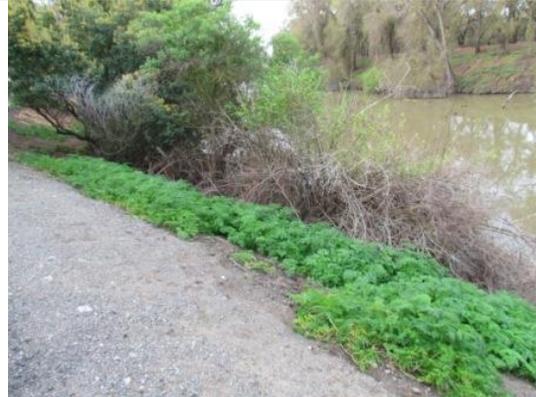
Photo 1 of 1 : SP_2015_RD0150_17_33_20150313_00025.jpg

Tree trunks and vegetation was obstructing the visibility on the waterside slope of the levee looking downstream.

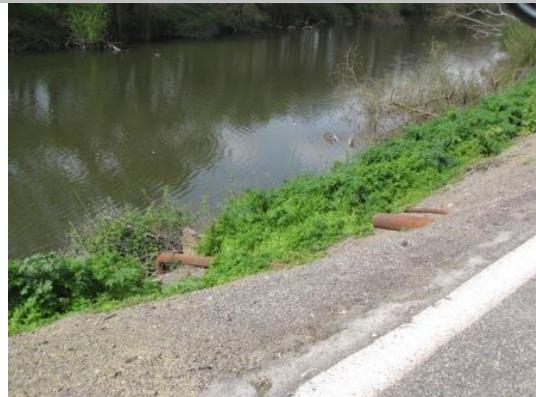
Photo 1 of 1 : SP_2015_RD0150_17_46_20150313_00036.jpg

View of an improperly abandoned pipe through the levee looking upstream.

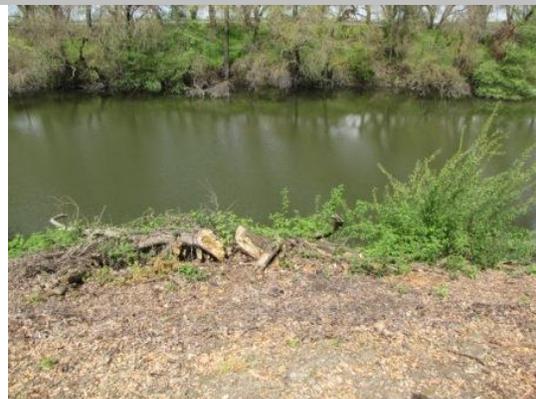
Photo 1 of 1 : SP_2015_RD0150_17_49_20150313_00038.jpg

View of tree stumps on the waterward slope.

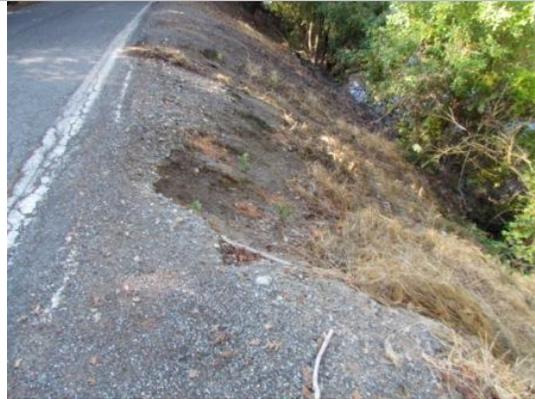
Erosion was found on the waterside slope of the levee looking downstream. This updated picture was taken during fall 2012 inspection.

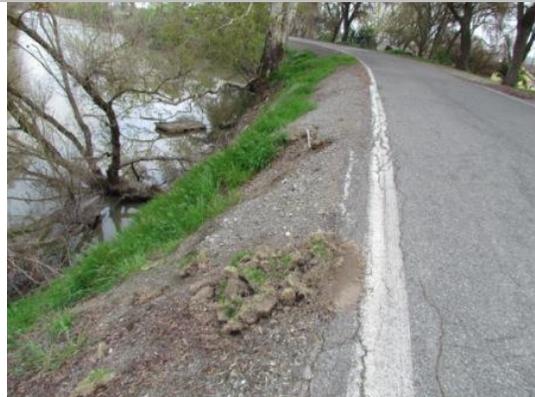
Erosion on the waterside of the levee looking upstream. This picture was taken during spring 2012 inspection.

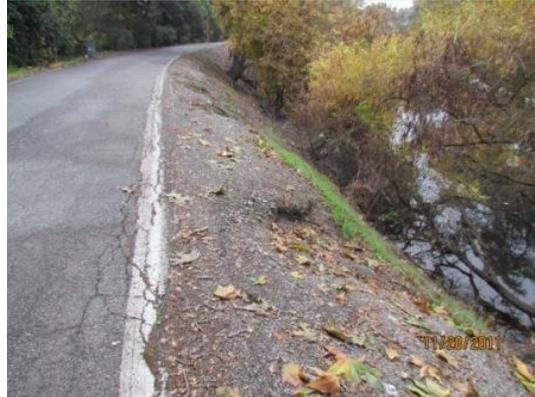
Erosion was found on the waterside of the levee looking downstream. This picture was taken during fall 2011 inspection.

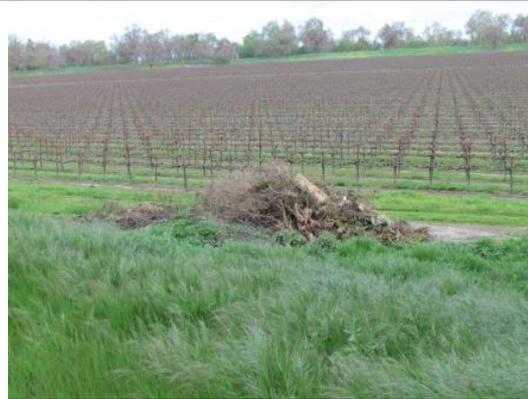
Prunings were found on the landside of the levee looking upstream.

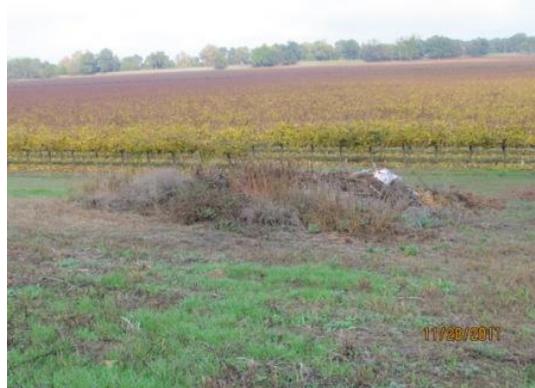
Prunings were found on the landside of the levee looking upstream. This picture was taken during fall 2011 inspection.

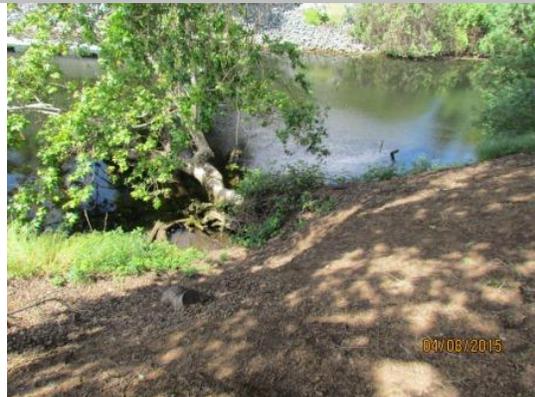
Slope instability was found on the waterside toe of the levee looking upstream.

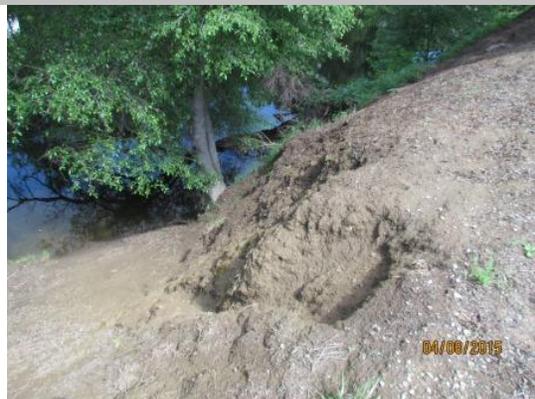
Updated picture of the slope instability on the waterside of the levee looking upstream during spring 2015 inspection.

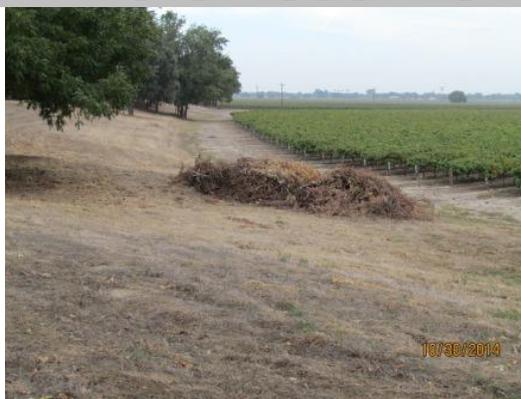
Prunings were found on the landside toe of the levee looking upstream.

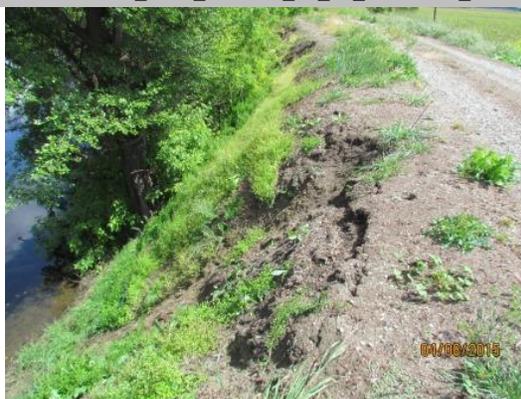
Updated picture of the erosion on the waterside of the levee during spring 2015 inspection.

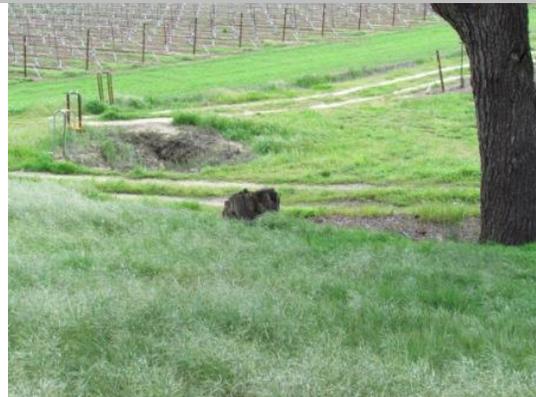
A tree stump was found on the landside of the levee looking upstream.

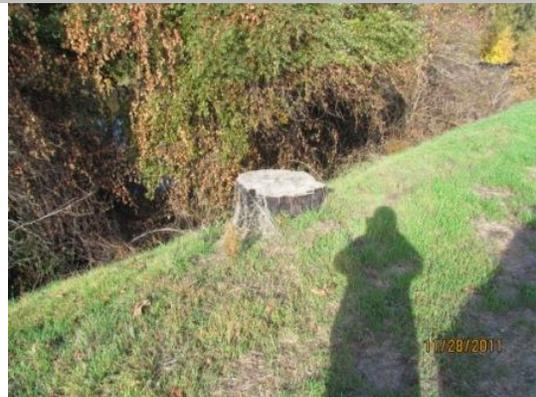
A tree stump was found on the waterside of the levee looking upstream.

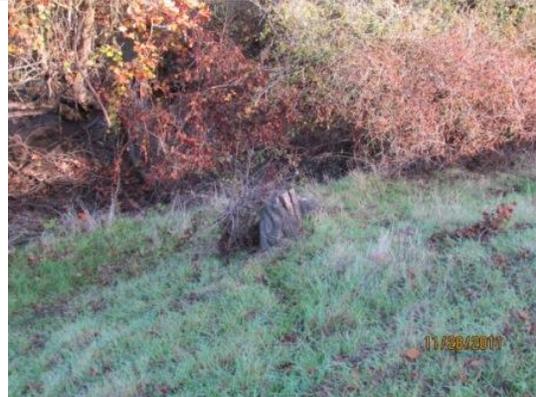
A tree stump was found on the waterside of the levee looking upstream.
