**Flood Control Project Maintenance  
Levee Inspections**  
**LMA District Cover Sheet**  
**Spring 2008 Levee Inspection Results**

**Reclamation District No. 0150**

**Levee Inspection Report By Mile - Spring 2008**

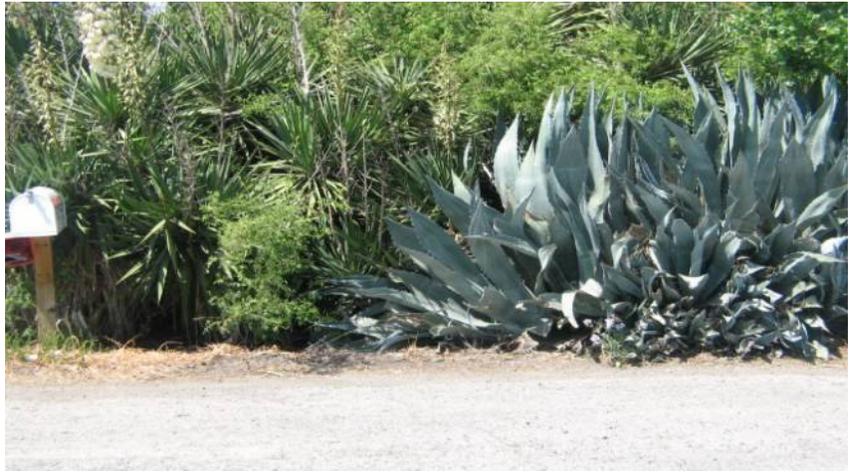
Levee Mile Report Line	4
Start Levee Mile	0.25
End Levee Mile	0.25
Location	
Category	Earthen Levee
Item	Encroachments
Landscaping on landward slope at LM 0.25 blocking view of levee slope.

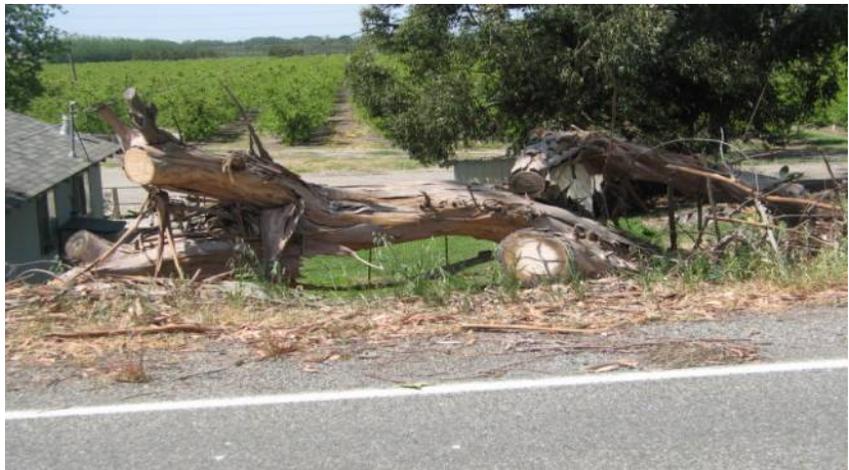
Levee Mile Report Line	15
Start Levee Mile	2.84
End Levee Mile	2.84
Location	
Category	Earthen Levee
Item	Encroachments
Down tree limbs on landward slope at LM 2.84

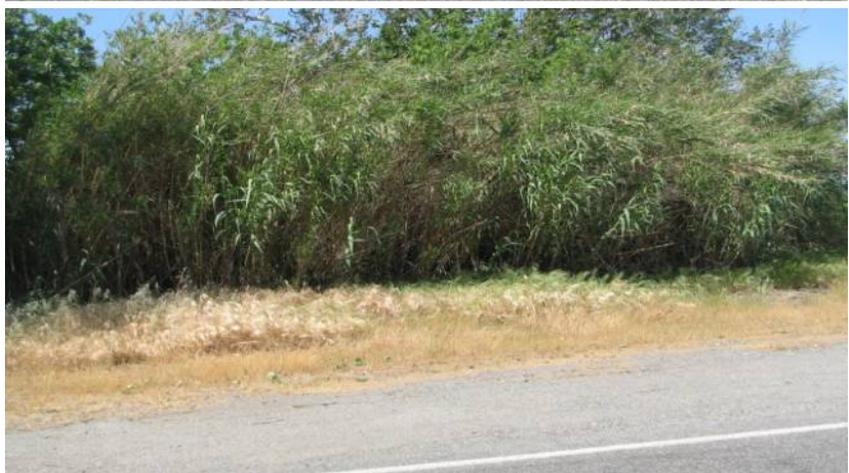
Levee Mile Report Line	16
Start Levee Mile	3.02
End Levee Mile	3.02
Location	
Category	Earthen Levee
Item	Vegetation
Bamboo on landward slope next to ramp at LM 3.02

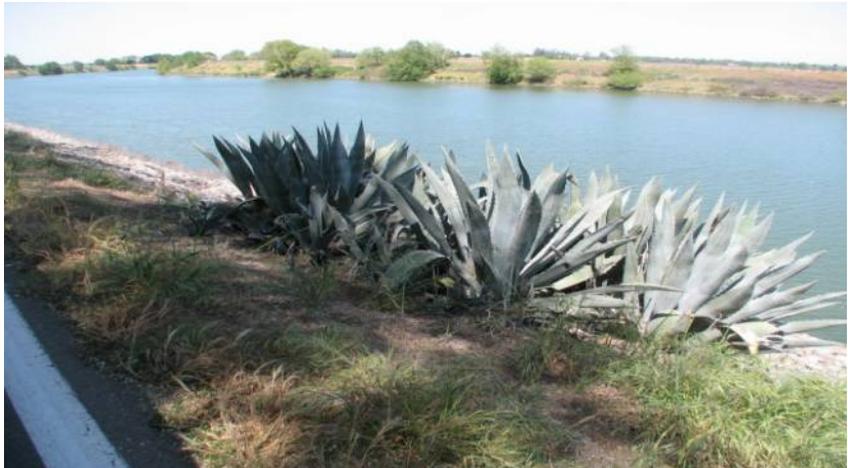
Levee Mile Report Line	28
Start Levee Mile	4.76
End Levee Mile	4.76
Location	
Category	Earthen Levee
Item	Vegetation
Century plant on waterward slope at LM 4.76

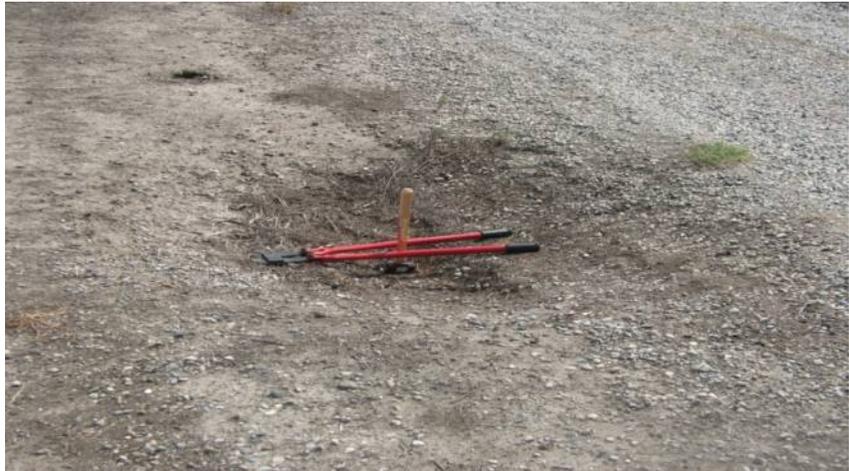
Levee Mile Report Line	9
Start Levee Mile	1.22
End Levee Mile	1.22
Location	
Category	Earthen Levee
Item	Crown Surface / Depressions / Rutting
Minor depression on levee crown at LM 1.22

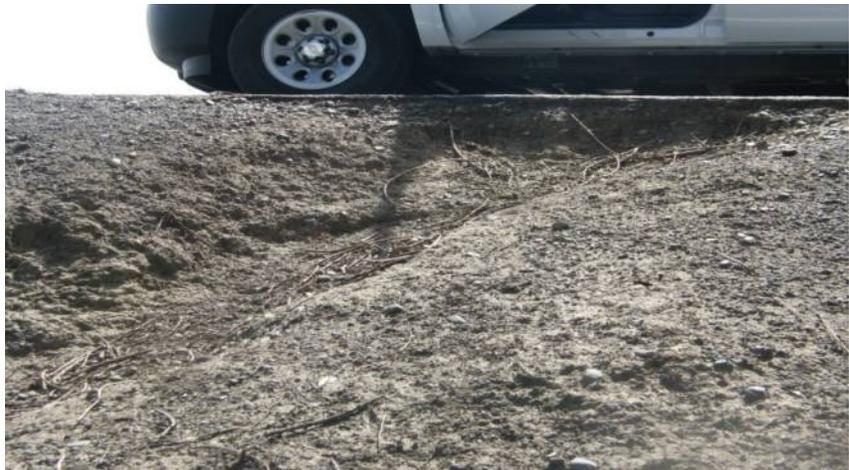
Levee Mile Report Line	10
Start Levee Mile	1.23
End Levee Mile	1.23
Location	
Category	Earthen Levee
Item	Slope Stability
Damage slope from foot traffic and rain runoff at LM 1.23

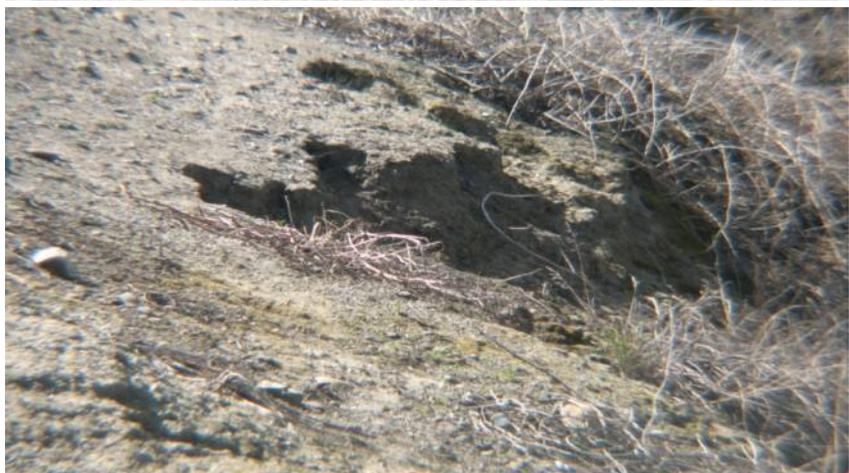
Levee Mile Report Line	14
Start Levee Mile	3.43
End Levee Mile	3.48
Location	
Category	Earthen Levee
Item	Erosion / Bank Caving
Erosion damage on waterward toe from LM 3.43 to 3.48

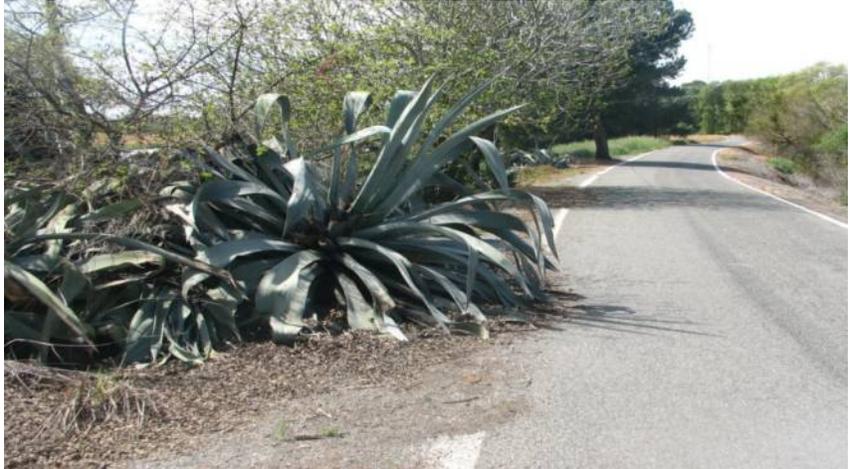
Levee Mile Report Line	16
Start Levee Mile	4.50
End Levee Mile	4.58
Location	
Category	Earthen Levee
Item	Encroachments
Landscaping blocking view of landward slope from 4.50 to 4.58

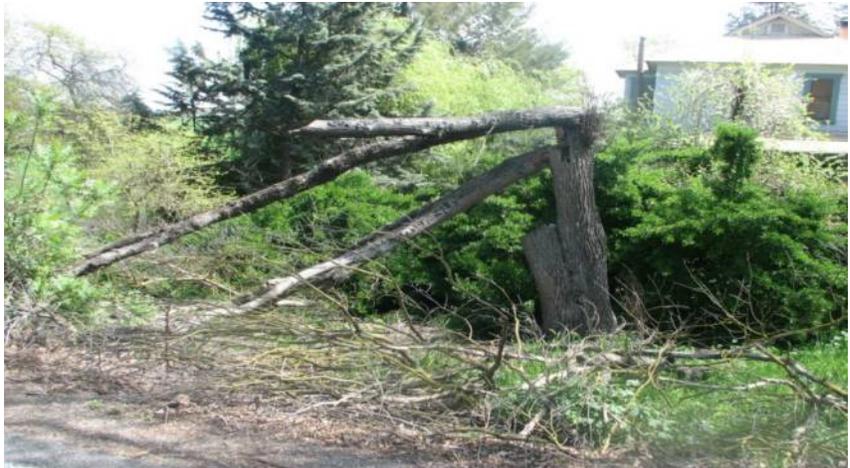
19	5.05	5.05	Earthen Levee	Encroachments	LS	M	Tree or limb	38.378372 ° -121.540863 °	38.378372 ° -121.540863 °	Y	19

Levee Mile Report Line	19
Start Levee Mile	5.05
End Levee Mile	5.05
Location	
Category	Earthen Levee
Item	Encroachments
Broken tree limbs on landward toe at LM 5.05

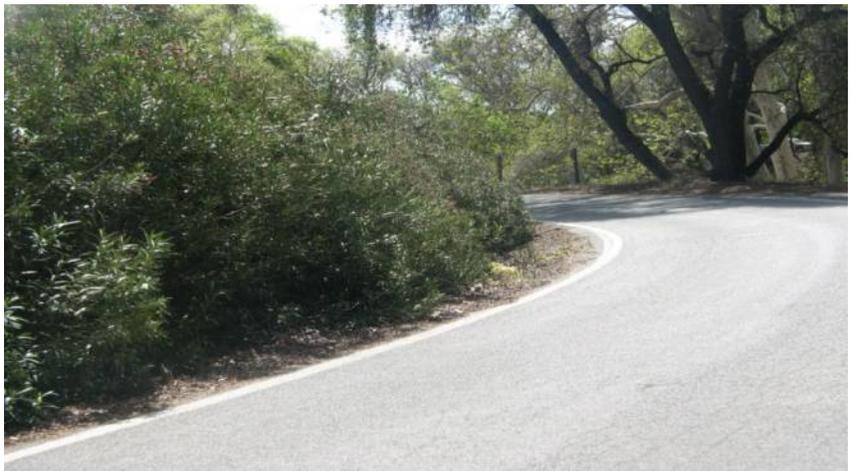
Levee Mile Report Line	24
Start Levee Mile	6.24
End Levee Mile	6.32
Location	
Category	Earthen Levee
Item	Encroachments
Oleander on landward slope blocking view of levee from LM 6.24 to 6.32

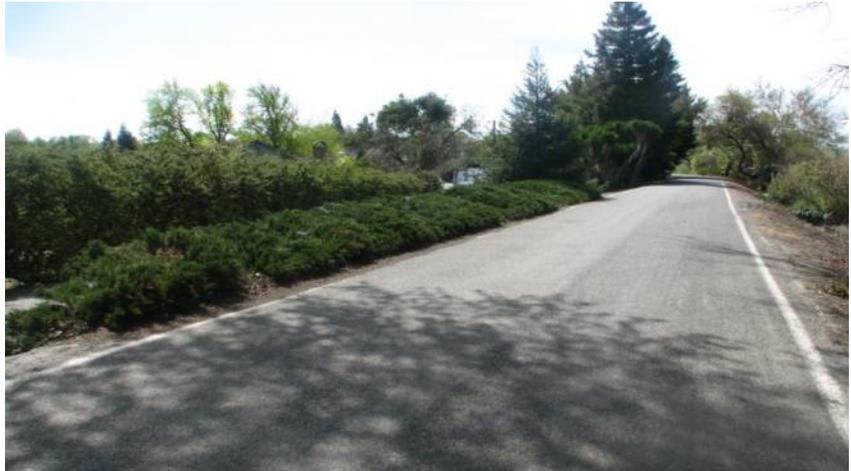
Levee Mile Report Line	26
Start Levee Mile	6.37
End Levee Mile	6.40
Location	
Category	Earthen Levee
Item	Encroachments
Landscaping on landward slope blocking view from LM 6.37 to 6.40

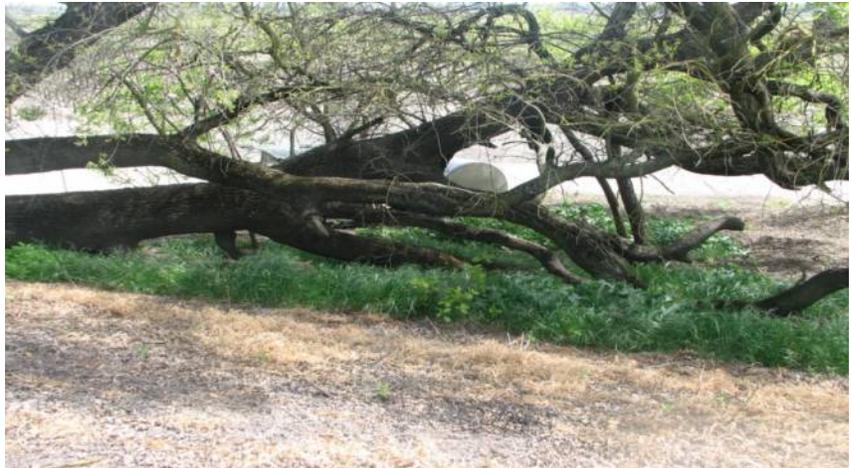
27	6.52	6.52	Earthen Levee	Trim / Thin Trees	LS	M	Trim trees to at least five feet above ground level.	38.391177 ° -121.538953 °	38.391177 ° -121.538953 °	Y	27
28	6.65	6.65	Earthen Levee	Encroachments	LS	M	Prunings	38.392858 ° -121.538085 °	38.392858 ° -121.538085 °		28
29	6.71	6.74	Earthen Levee	Trim / Thin Trees	WS	M	Trim trees to at least five feet above ground level.	38.393687 ° -121.538368 °	38.393985 ° -121.538490 °		29
30	6.87	6.95	Earthen Levee	Encroachments	LS	PO	Landscaping	38.395670 ° -121.537925 °	38.396027 ° -121.536575 °	Y	30
31	7.07	7.09	Earthen Levee	Trim / Thin Trees	LS	M	Trim trees to at least five feet above ground level.	38.397180 ° -121.535140 °	38.397540 ° -121.535183 °		31
32	7.42	7.47	Earthen Levee	Encroachments	LS	PO	Landscaping	38.401738 ° -121.537127 °	38.402308 ° -121.537703 °	Y	32
33	7.51	7.51	Earthen Levee	Encroachments	LS	M	Prunings	38.402735 ° -121.538140 °	38.402735 ° -121.538140 °		33

Levee Mile Report Line	27
Start Levee Mile	6.52
End Levee Mile	6.52
Location	
Category	Earthen Levee
Item	Trim / Thin Trees
Tree at landward slope at LM 6.52

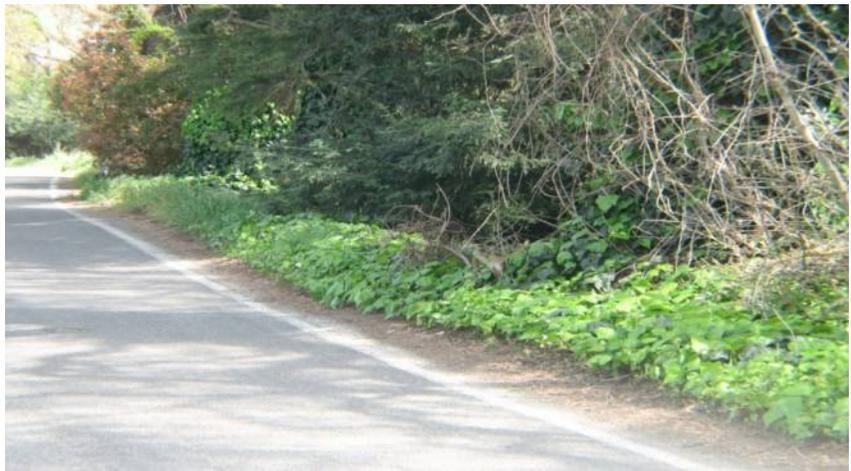
Levee Mile Report Line	30
Start Levee Mile	6.87
End Levee Mile	6.95
Location	
Category	Earthen Levee
Item	Encroachments
Landscaping on landward slope blocking view from LM 6.87 to 6.95

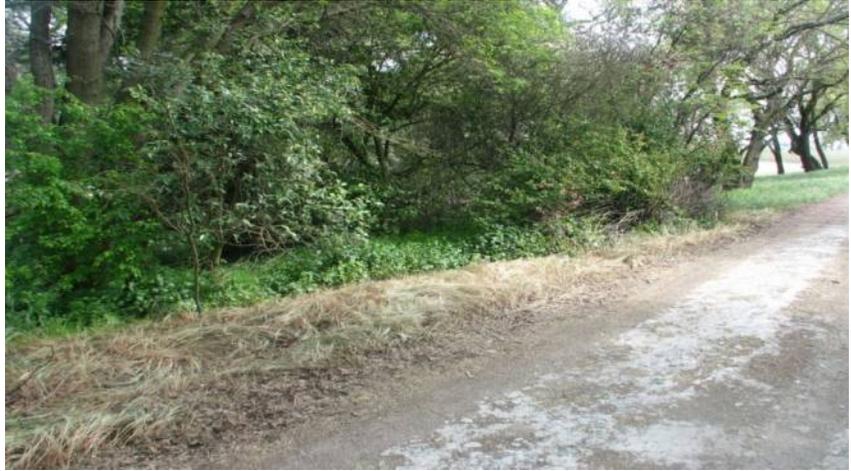
Levee Mile Report Line	32
Start Levee Mile	7.42
End Levee Mile	7.47
Location	
Category	Earthen Levee
Item	Encroachments
Landscaping on landward slope blocking view from LM 7.42 to 7.47

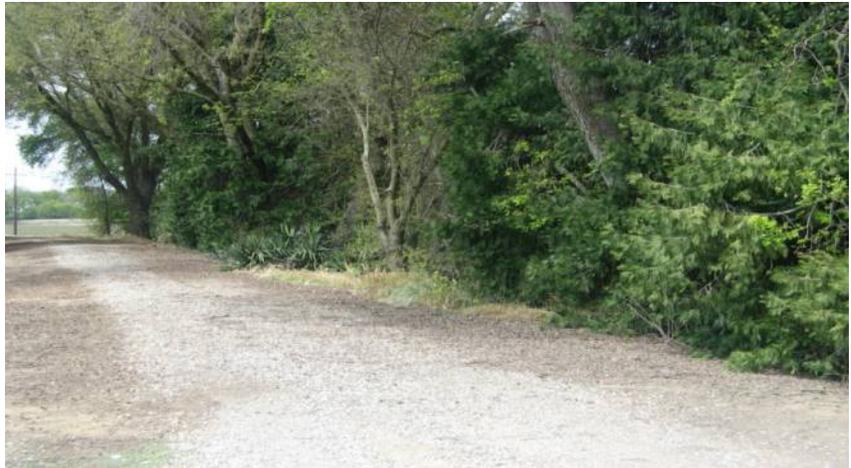
34	7.52	7.58	Earthen Levee	Encroachments	LS	PO	Landscaping	38.402922 ° -121.538277 °	38.403658 ° -121.538957 °	Y	34
35	8.19	8.19	Earthen Levee	Encroachments	LS	M	Prunings	38.409143 ° -121.539447 °	38.409143 ° -121.539447 °		36
36	8.19	8.92	Earthen Levee	Animal Control	WS	M	Exterminate rodents and backfill and compact or grout burrows.	38.409135 ° -121.539490 °	38.412098 ° -121.528853 °		35
37	8.37	9.50	Earthen Levee	Crown Surface / Depressions / Rutting	CR	M	Keep the crown roadway free of vegetation.	38.408453 ° -121.536382 °	38.413052 ° -121.523773 °	Y	37
38	9.18	9.18	Earthen Levee	Trim / Thin Trees	WS	M	Trim trees to at least five feet above ground level.	38.415455 ° -121.528045 °	38.415455 ° -121.528045 °		38

Levee Mile Report Line	34
Start Levee Mile	7.52
End Levee Mile	7.58
Location	
Category	Earthen Levee
Item	Encroachments
Landscaping on landward slope blocking view from LM 7.52 to 7.58

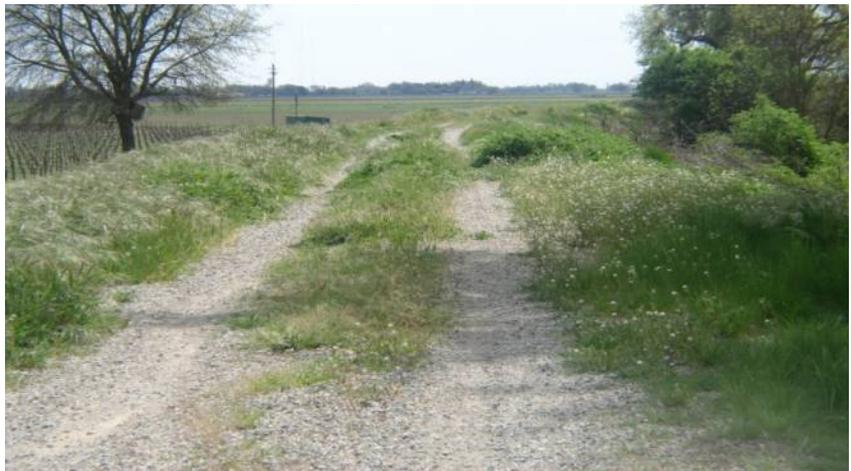
Levee Mile Report Line	37
Start Levee Mile	8.37
End Levee Mile	9.50
Location	
Category	Earthen Levee
Item	Crown Surface / Depressions / Rutting
Levee crown with veg from LM 8.37 to 9.50
