**Flood Control Project Maintenance
Levee Inspections
LMA District Cover Sheet
Spring 2011 Levee Inspection Results**

Reclamation District No. 0150 Merrit Island

Spring 2011 Levee Inspection Results

Waterway	Bank	Unit Miles
Unit No. 01 Sutter Slough	Left	0.54

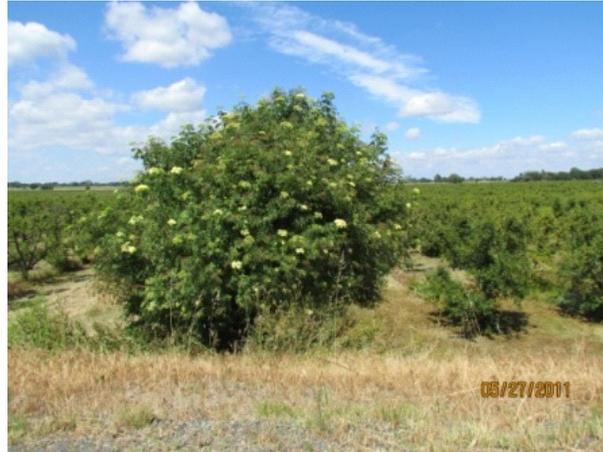
Levee Mile Report Line	1
Start Levee Mile	0.20
End Levee Mile	0.20
Location	Land Side
Category	Earthen Levee
Item	Vegetation
<p>Elderberry tree was found on the landside of the levee. The picture was taken from the crown looking downstream.</p>	
<p>pkazi_s_20110531_694.jpg</p>

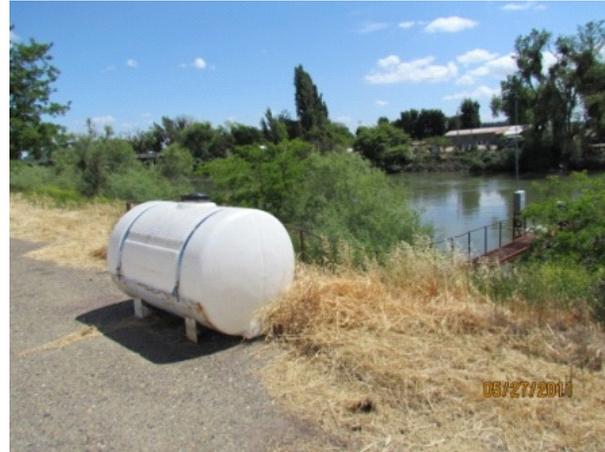
Levee Mile Report Line	4
Start Levee Mile	0.35
End Levee Mile	0.35
Location	Water Side
Category	Earthen Levee
Item	Encroachments
<p>A water tank was found on the waterside of the levee. The picture was taken from the crown looking downstream.</p>	
<p>pkazi_s_20110531_693.jpg</p>

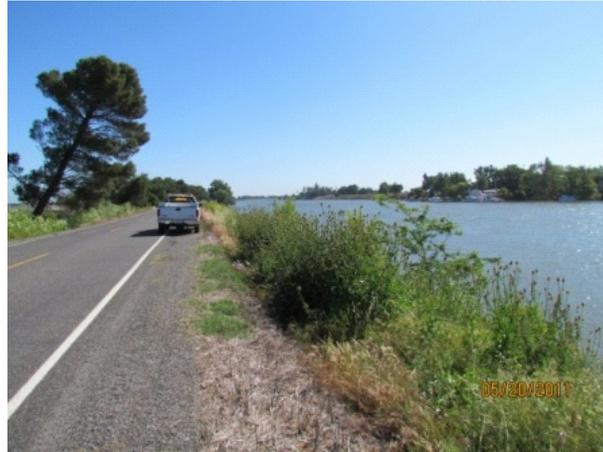
Levee Mile Report Line	5
Start Levee Mile	0.27
End Levee Mile	0.57
Location	Water Side
Category	Earthen Levee
Item	Vegetation
Wild growth vegetation was found on the waterside of the levee looking upstream.	
pkazi_s_20110531_653.jpg

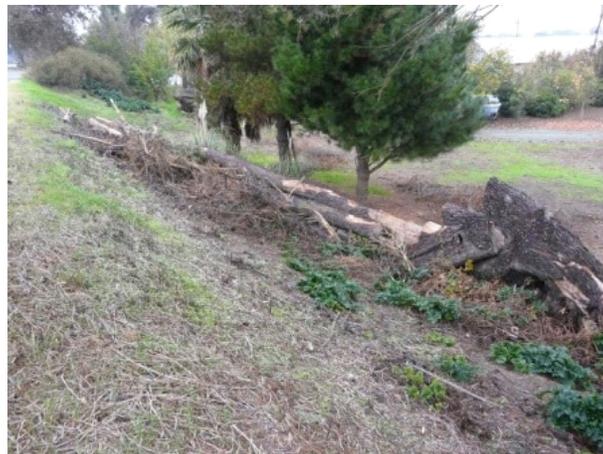
Levee Mile Report Line	6
Start Levee Mile	0.27
End Levee Mile	0.27
Location	Land Side
Category	Earthen Levee
Item	Encroachments
Remove tree branches from landside of levee at LM 0.27	
pkazi_s_20110328_412.JPG

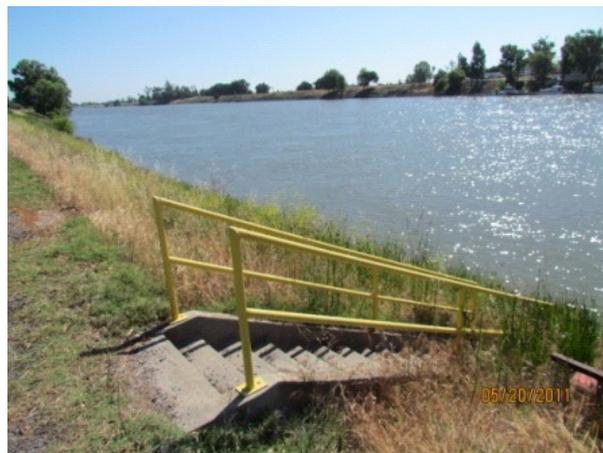
Levee Mile Report Line	7
Start Levee Mile	0.39
End Levee Mile	0.39
Location	Water Side
Category	Earthen Levee
Item	Encroachments
A stairway was found on the waterside of the levee. The picture was taken from the crown looking upstream.	
pkazi_s_20110531_654.jpg

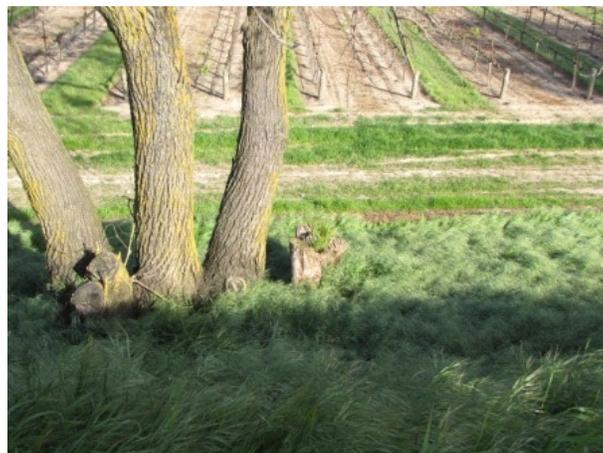
Levee Mile Report Line	16
Start Levee Mile	1.16
End Levee Mile	1.16
Location	Land Side
Category	Earthen Levee
Item	Trim / Thin Trees
View of a tree stump on the landward slope.	
pkazi_s_20110328_387.jpg

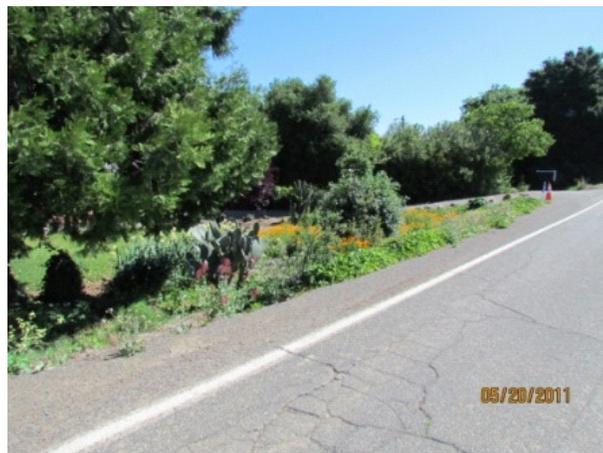
Levee Mile Report Line	29
Start Levee Mile	2.31
End Levee Mile	2.33
Location	Land Side
Category	Earthen Levee
Item	Encroachments
Landscaping was found on the landside of the levee. The picture was taken from the crown looking upstream.	
pkazi_s_20110531_656.jpg

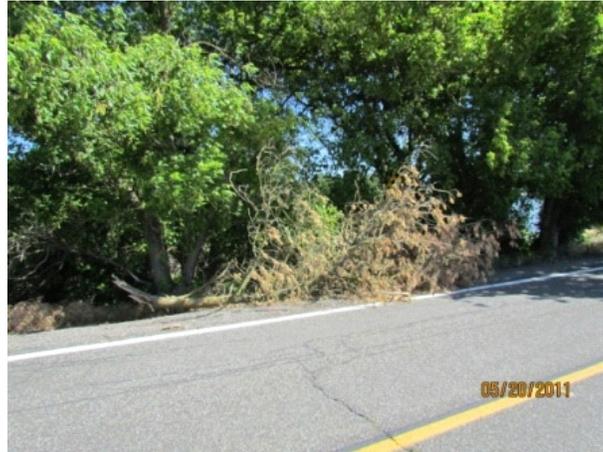
Levee Mile Report Line	30
Start Levee Mile	2.35
End Levee Mile	2.35
Location	Water Side
Category	Earthen Levee
Item	Encroachments
<p>Tree limbs were found on the waterside of the levee, even though debris on the toe couldn't be seen due to vegetation. The picture was taken from the crown looking downstream.</p>	
<p>pkazi_s_20110531_657.jpg</p>

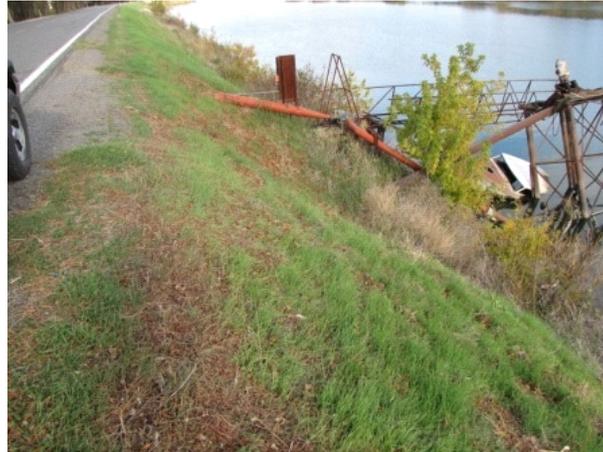
Levee Mile Report Line	40
Start Levee Mile	3.29
End Levee Mile	3.29
Location	Water Side
Category	Earthen Levee
Item	Erosion / Bank Caving
Additional view of erosion on the waterward slope looking upstream. Note the damaged pump support, pump, and pipe just upstream of the site.	
pkazi_s_20110328_415.jpg

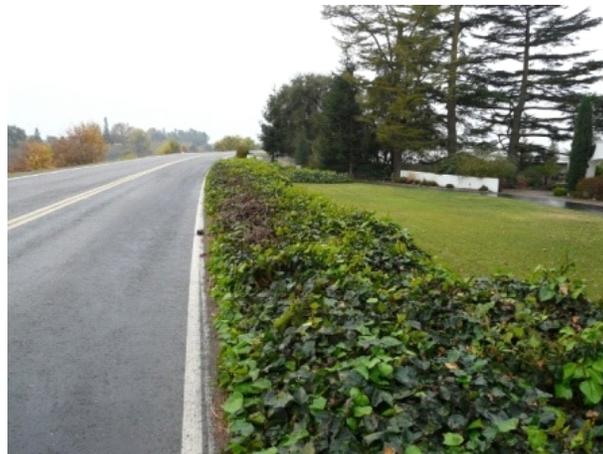
Levee Mile Report Line	48
Start Levee Mile	3.90
End Levee Mile	3.93
Location	Land Side
Category	Earthen Levee
Item	Encroachments
Landscaping in front of a residence on landside of levee from LM 3.90 to LM 3.93. The levee in this location is greater than 100' wide.	
pkazi_s_20110328_410.JPG

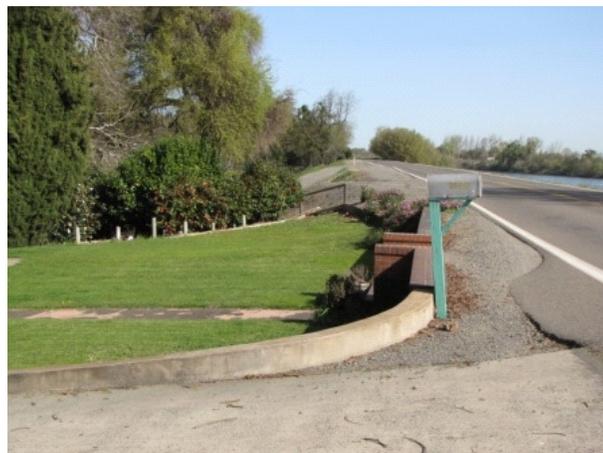
Levee Mile Report Line	49
Start Levee Mile	4.15
End Levee Mile	4.16
Location	Land Side
Category	Earthen Levee
Item	Encroachments
View of a retaining wall on the landward slope looking upstream.	
pkazi_s_20110328_390.jpg

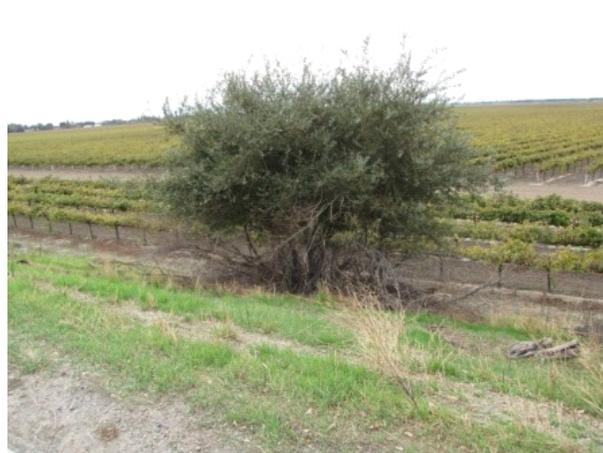
Levee Mile Report Line	56
Start Levee Mile	4.68
End Levee Mile	4.68
Location	Land Side
Category	Earthen Levee
Item	Trim / Thin Trees
View of a tree on the landward slope with lower branches blocking visibility and access. Most of these branches appear to already be dead and should be removed.	
pkazi_s_20110328_421.jpg

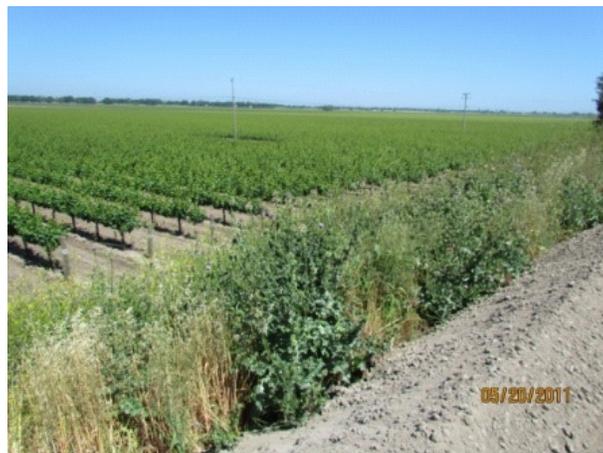
Levee Mile Report Line	63
Start Levee Mile	5.27
End Levee Mile	5.32
Location	Land Side
Category	Earthen Levee
Item	Vegetation
Wild growth vegetation was found on the landside of the levee. The picture was taken from the crown looking upstream.	
pkazi_s_20110531_659.jpg

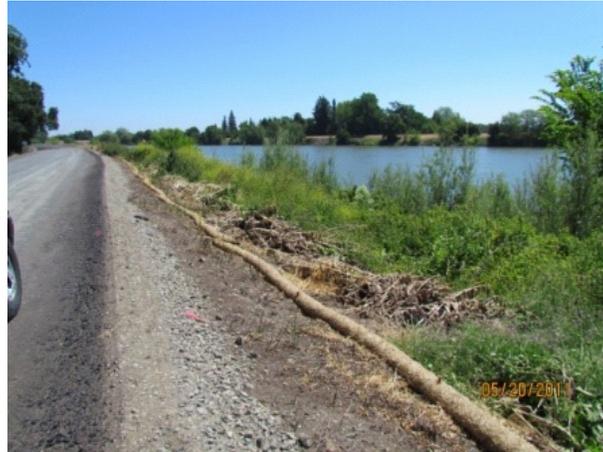
Levee Mile Report Line	72
Start Levee Mile	5.75
End Levee Mile	5.75
Location	Water Side
Category	Earthen Levee
Item	Encroachments
<p>Debris were found on the waterside slope of the levee. The picture was taken from the crown looking upstream.</p>	
<p>pkazi_s_20110531_661.jpg</p>

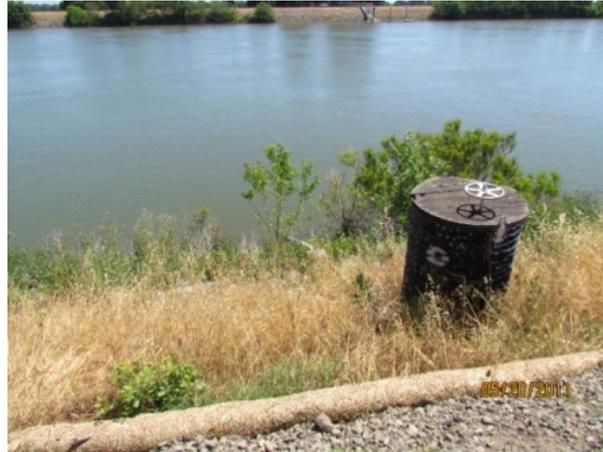
Levee Mile Report Line	89
Start Levee Mile	7.12
End Levee Mile	7.12
Location	Water Side
Category	Earthen Levee
Item	Encroachments
<p>No debris was found near the gate where debris was found during last inspection. The picture was taken from the crown looking waterside of the levee.</p>	
<p>pkazi_s_20110531_662.jpg</p>

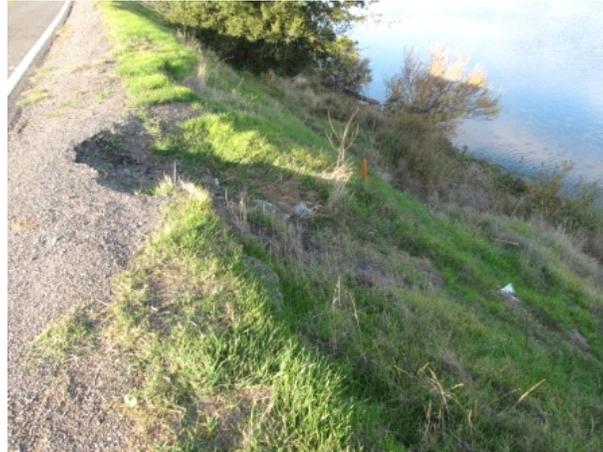
View of minor erosion along the top portion of the waterward slope likely cause by foot traffic. The erosion has started to encroach into the shoulder of the road.

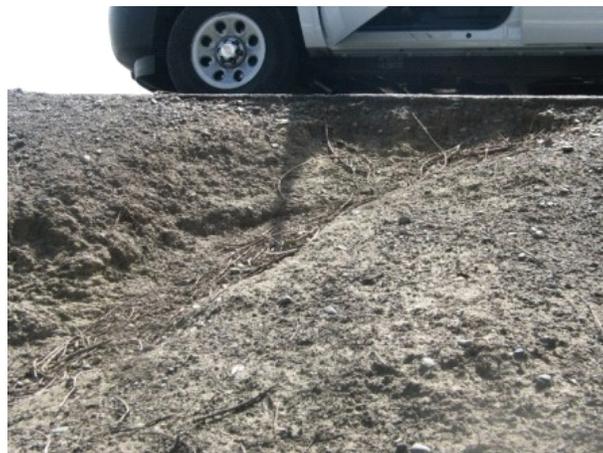
Levee Mile Report Line	7
Start Levee Mile	1.23
End Levee Mile	1.23
Location	Land Side
Category	Earthen Levee
Item	Slope Stability
Damaged slope from foot traffic and rain runoff at LM 1.23	
pkazi_s_20110328_425.jpg

6	0.92	0.95	Earthen Levee	Vegetation	LS	M	Elderberries are blocking visibility and flood fight capability.	38.345293 ° -121.579769 °	38.345634 ° -121.579574 °	5 Y
7	1.23	1.23	Earthen Levee	Slope Stability	LS	M	Repair the levee slope damaged by vehicle traffic and prevent access where possible.	38.347607 ° -121.576130 °	38.347607 ° -121.576130 °	10 Y
8	1.34	1.56	Earthen Levee	Vegetation	LS	M	Control annual grass and weeds on the levee slopes and easements.	38.347393 ° -121.573900 °	38.349840 ° -121.572639 °	59
9	1.82	1.82	Earthen Levee	Erosion / Bank Caving	WS	M	Note and monitor erosion site. Inspector Comments: Erosion appeared under the pipe.	38.353249 ° -121.572848 °	38.353249 ° -121.572848 °	50 Y
10	1.82	2.06	Earthen Levee	Vegetation	LS	M	Remove the wild growth other than native grasses from the levee slopes.	38.353251 ° -121.572848 °	38.354665 ° -121.569340 °	44
11	2.02	2.02	Earthen Levee	Vegetation	WS	M	Remove the wild growth other than native grasses from the levee slopes.	38.354796 ° -121.570004 °	38.354796 ° -121.570004 °	45 Y

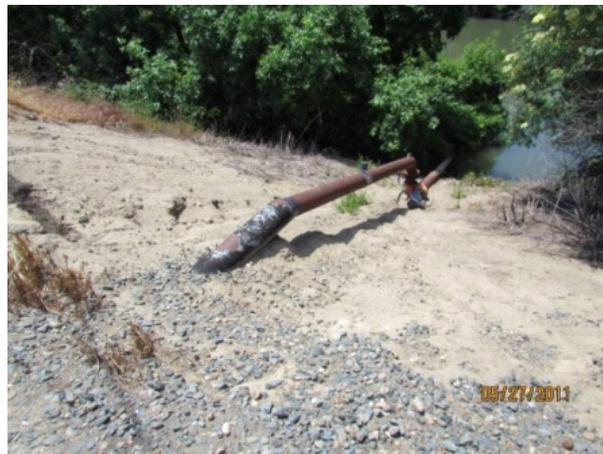
Levee Mile Report Line	9
Start Levee Mile	1.82
End Levee Mile	1.82
Location	Water Side
Category	Earthen Levee
Item	Erosion / Bank Caving
Erosion was found on the waterside slope of the levee near the vicinity of the pipe. The picture was taken from the crown looking downstream.	
pkazi_s_20110531_690.jpg

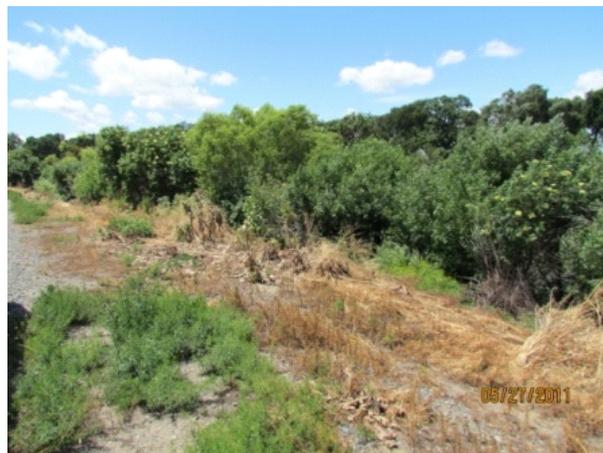
Levee Mile Report Line	11
Start Levee Mile	2.02
End Levee Mile	2.02
Location	Water Side
Category	Earthen Levee
Item	Vegetation
Overgrown vegetation was blocking the visibility of waterside of the levee looking downstream.	
pkazi_s_20110531_689.jpg

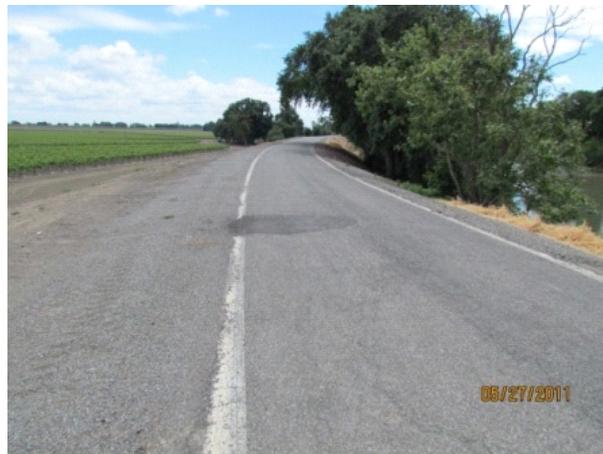
Levee Mile Report Line	13
Start Levee Mile	2.77
End Levee Mile	2.77
Location	Crown
Category	Earthen Levee
Item	Crown Surface / Depressions / Rutting
The crown was repaired by the LMA. The picture was taken from the crown looking downstream.	
pkazi_s_20110531_688.jpg

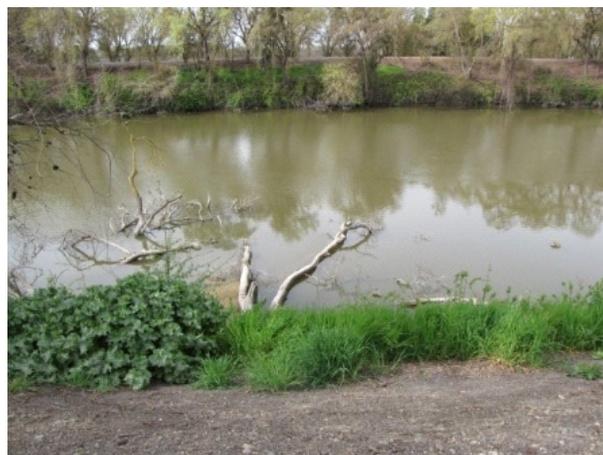
Levee Mile Report Line	15
Start Levee Mile	2.87
End Levee Mile	2.87
Location	Water Side
Category	Earthen Levee
Item	Trim / Thin Trees
View of tree stumps on the waterward slope.	
pkazi_s_20110328_432.jpg

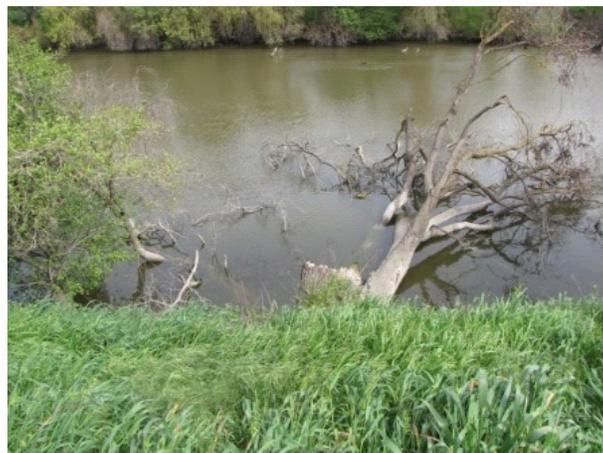
Levee Mile Report Line	18
Start Levee Mile	3.21
End Levee Mile	3.21
Location	Water Side
Category	Earthen Levee
Item	Trim / Thin Trees
View of tree stumps on the waterward slope.	
pkazi_s_20110328_435.jpg

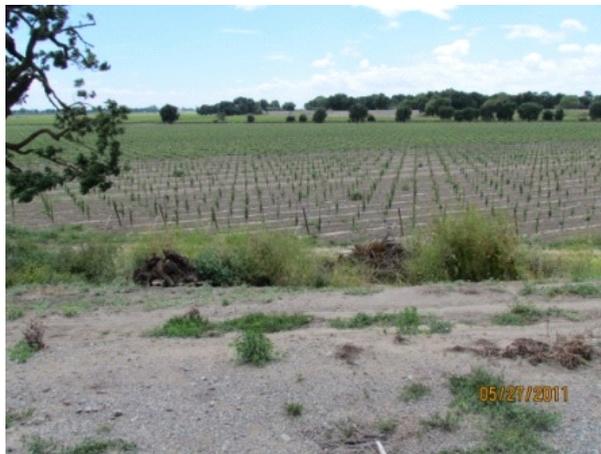
Levee Mile Report Line	20
Start Levee Mile	3.30
End Levee Mile	3.30
Location	Land Side
Category	Earthen Levee
Item	Encroachments
Debris were found on the landside of the levee. The picture was taken from the crown looking landside.	
pkazi_s_20110531_687.jpg

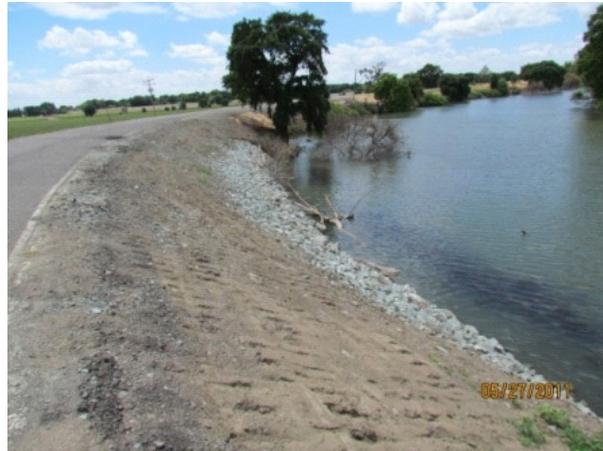
Levee Mile Report Line	24
Start Levee Mile	3.43
End Levee Mile	3.48
Location	Water Side
Category	Earthen Levee
Item	Erosion / Bank Caving
The erosion site has been repaired by LMA. The picture was taken from the crown looking downstream.	
pkazi_s_20110531_685.jpg

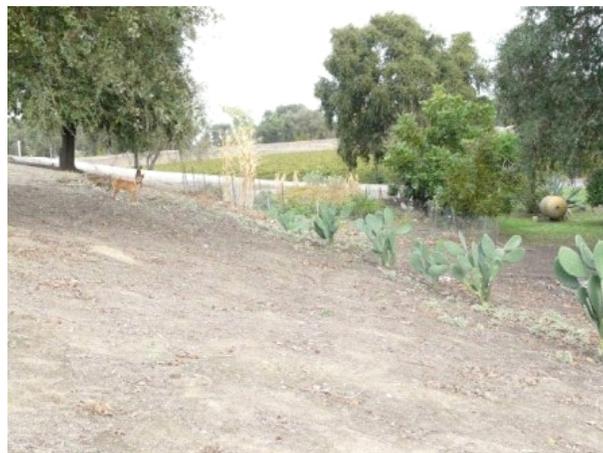
Levee Mile Report Line	25
Start Levee Mile	3.50
End Levee Mile	3.54
Location	Land Side
Category	Earthen Levee
Item	Encroachments
Landscaping & garden on landward slope of levee at LM 3.50 to LM 3.54.	
pkazi_s_20110328_448.JPG

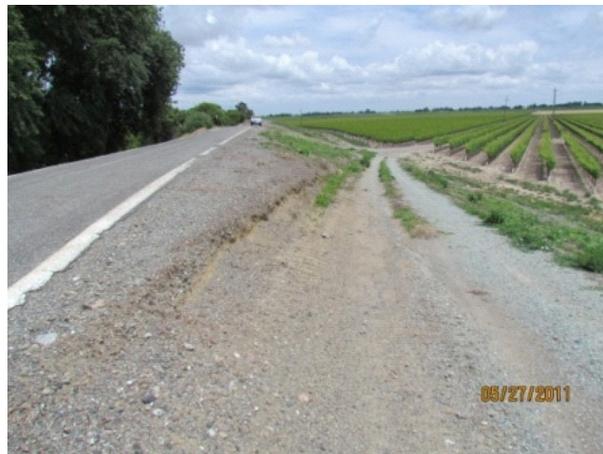
Levee Mile Report Line	26
Start Levee Mile	3.75
End Levee Mile	3.75
Location	Land Side
Category	Earthen Levee
Item	Slope Stability
Slope instability possible due to vehicular traffic on the landside of the levee. The picture was taken from the crown looking upstream during Spring 2011 inspection.	
pkazi_s_20110531_684.jpg

25	3.50	3.54	Earthen Levee	Encroachments	LS	PO	Landscaping	38.364251 ° -121.555321 °	38.364772 ° -121.555343 °	47 Y
26	3.75	3.75	Earthen Levee	Slope Stability	LS	M	Repair the levee slope damaged by vehicle traffic and prevent access where possible.	38.367305 ° -121.554984 °	38.367305 ° -121.554984 °	927 Y
27	3.77	3.77	Earthen Levee	Slope Stability	WS	M	Repair the levee slope damaged by foot traffic and prevent access where possible.	38.367393 ° -121.554528 °	38.367393 ° -121.554528 °	15 Y
28	3.79	3.79	Earthen Levee	Animal Control	WS	M	Exterminate rodents and backfill and compact or grout burrows.	38.367373 ° -121.554085 °	38.367373 ° -121.554085 °	36 Y
29	3.95	3.95	Earthen Levee	Encroachments	LS	M	Debris	38.368118 ° -121.551509 °	38.368118 ° -121.551509 °	48 Y
30	4.02	4.02	Earthen Levee	Slope Stability	WS	M	Repair slope instability.	38.369182 ° -121.551477 °	38.369182 ° -121.551477 °	33 Y
31	4.06	4.06	Earthen Levee	Crown Surface / Depressions / Rutting	CR	M	Regrade the crown roadway for proper drainage.	38.369686 ° -121.551744 °	38.369686 ° -121.551744 °	35 Y

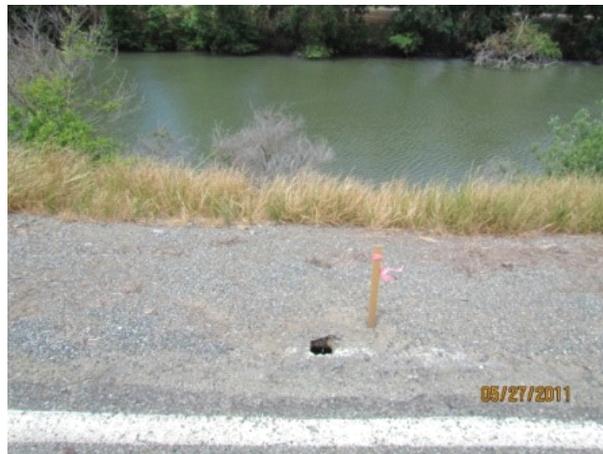
Levee Mile Report Line	28
Start Levee Mile	3.79
End Levee Mile	3.79
Location	Water Side
Category	Earthen Levee
Item	Animal Control
A rodent hole was found on the shoulder of waterside of the levee. The picture was taken from the crown looking toward the slough.	
pkazi_s_20110531_682.jpg

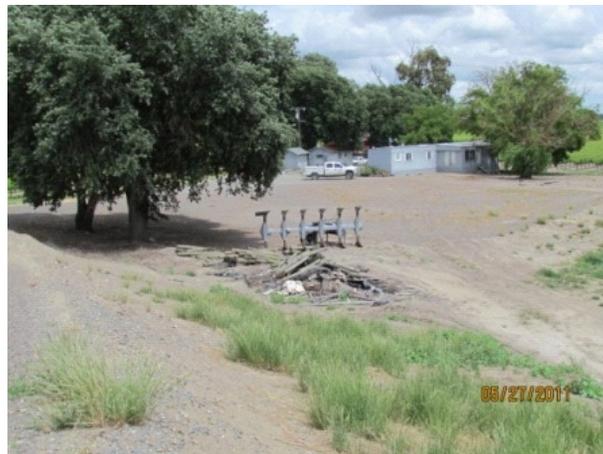
Levee Mile Report Line	29
Start Levee Mile	3.95
End Levee Mile	3.95
Location	Land Side
Category	Earthen Levee
Item	Encroachments
Debris found on the landside of the levee during Spring 2011 inspection. The picture was taken from the crown looking upstream.	
pkazi_s_20110531_681.jpg

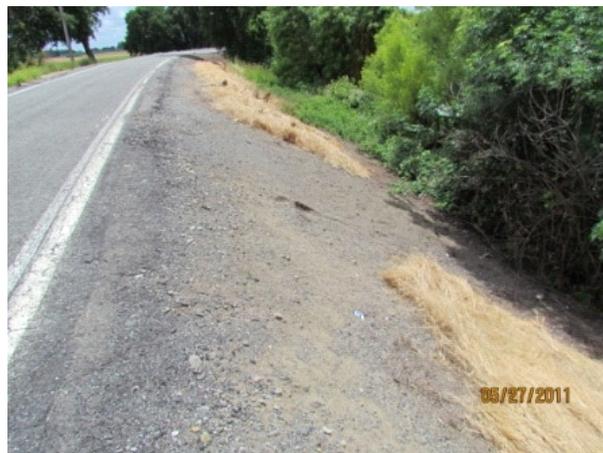
Levee Mile Report Line	30
Start Levee Mile	4.02
End Levee Mile	4.02
Location	Water Side
Category	Earthen Levee
Item	Slope Stability
Erosion was found on the waterside slope of the levee. The picture was taken from the crown looking downstream.	
pkazi_s_20110531_680.jpg

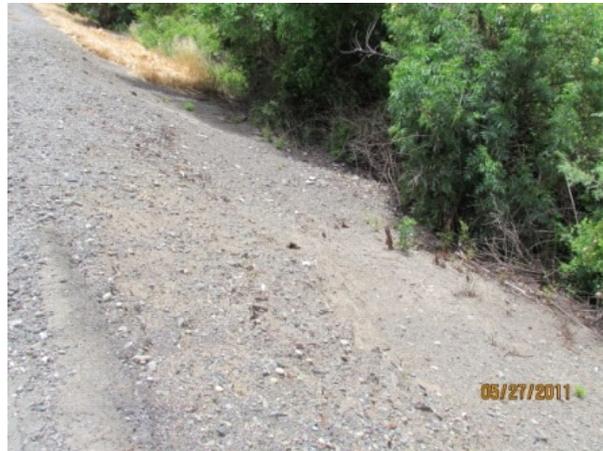
Levee Mile Report Line	32
Start Levee Mile	4.10
End Levee Mile	4.10
Location	Water Side
Category	Earthen Levee
Item	Animal Control
A rodent hole was found on the waterside slope of the levee. The picture was taken from the crown looking downstream.	
pkazi_s_20110531_678.jpg

32	4.10	4.10	Earthen Levee	Animal Control	WS	M	No rodents visible, but rodent burrows visible; need to backfill and compact or grout burrows.	38.370113 ° -121.552009 °	38.370113 ° -121.552009 °	29 Y
33	4.10	4.10	Earthen Levee	Slope Stability	WS	M	Repair slope instability.	38.370113 ° -121.552011 °	38.370113 ° -121.552011 °	28 Y
34	4.35	4.35	Earthen Levee	Trim / Thin Trees	WS	N	Tree stumps.	38.373319 ° -121.550836 °	38.373319 ° -121.550836 °	37 Y
35	4.39	4.39	Earthen Levee	Crown Surface / Depressions / Rutting	CR	M	Regrade the crown roadway for proper drainage.	38.373741 ° -121.550481 °	38.373741 ° -121.550481 °	38 Y

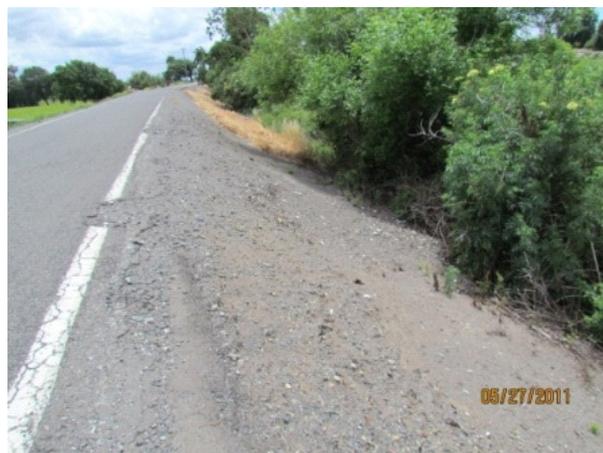
Levee Mile Report Line	33
Start Levee Mile	4.10
End Levee Mile	4.10
Location	Water Side
Category	Earthen Levee
Item	Slope Stability
Erosion was found on the waterside slope of the levee. The picture was taken from the crown looking downstream.	
pkazi_s_20110531_679.jpg

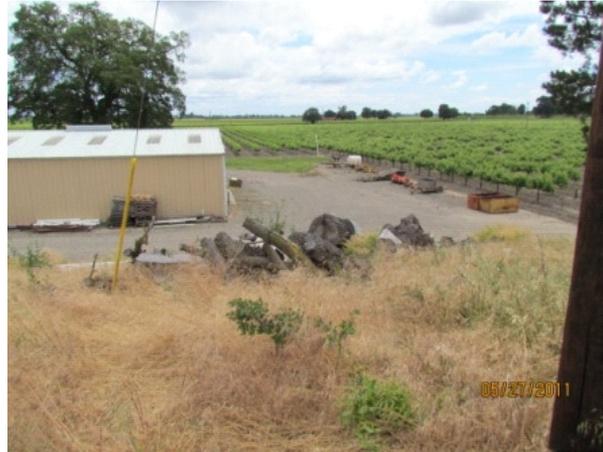
Levee Mile Report Line	37
Start Levee Mile	4.51
End Levee Mile	4.51
Location	Land Side
Category	Earthen Levee
Item	Encroachments
<p>Tree branches were found on the toe of landside of the levee. The picture was taken from the crown looking downstream.</p>	
<p>pkazi_s_20110531_677.jpg</p>

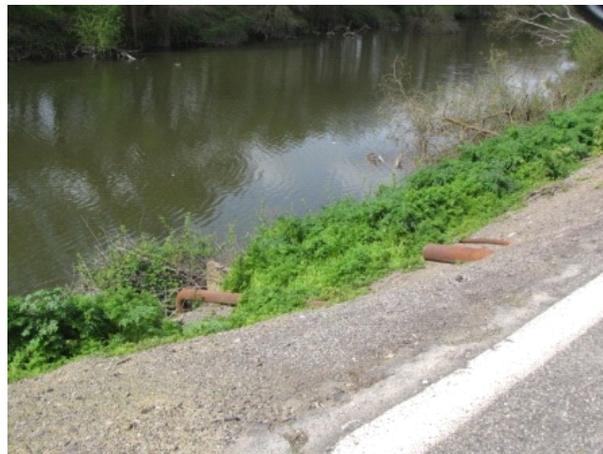
Levee Mile Report Line	52
Start Levee Mile	6.06
End Levee Mile	6.06
Location	Water Side
Category	Earthen Levee
Item	Encroachments
View of an improperly abandoned pipe through the levee looking upstream.	
pkazi_s_20110328_447.jpg

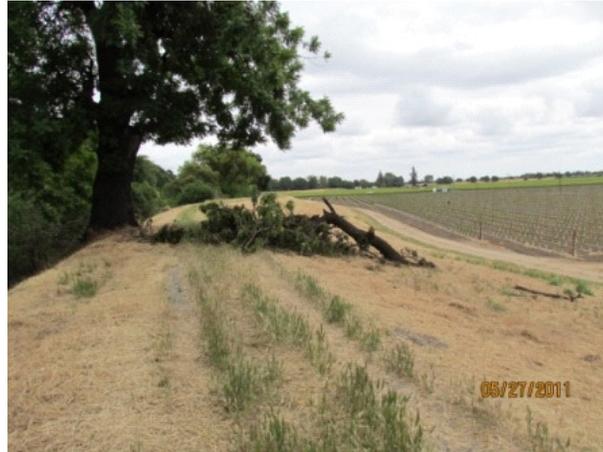
Levee Mile Report Line	76
Start Levee Mile	8.62
End Levee Mile	8.62
Location	Crown
Category	Earthen Levee
Item	Encroachments
<p>Tree limbs were found on the crown of the levee. The picture was taken from the crown looking upstream.</p>	
<p>pkazi_s_20110531_666.jpg</p>

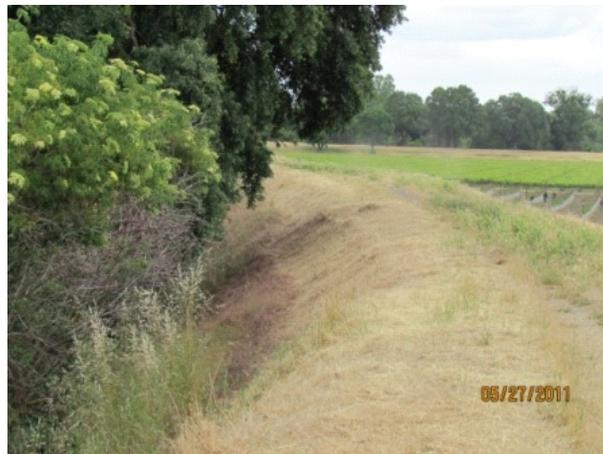
Levee Mile Report Line	77
Start Levee Mile	8.69
End Levee Mile	8.69
Location	Water Side
Category	Earthen Levee
Item	Erosion / Bank Caving
<p>Erosion was found on the waterside slope of the levee. The picture was taken from the crown looking downstream.</p>	
<p>pkazi_s_20110531_667.jpg</p>
