**Flood Control Project Maintenance
Levee Inspections**

Fall 2008 Levee Maintenance Deficiency Summary Report

Reclamation District No. 0307

Waterway		Bank	Unit Miles
Unit No. 01 Sacramento River		Right	6.70

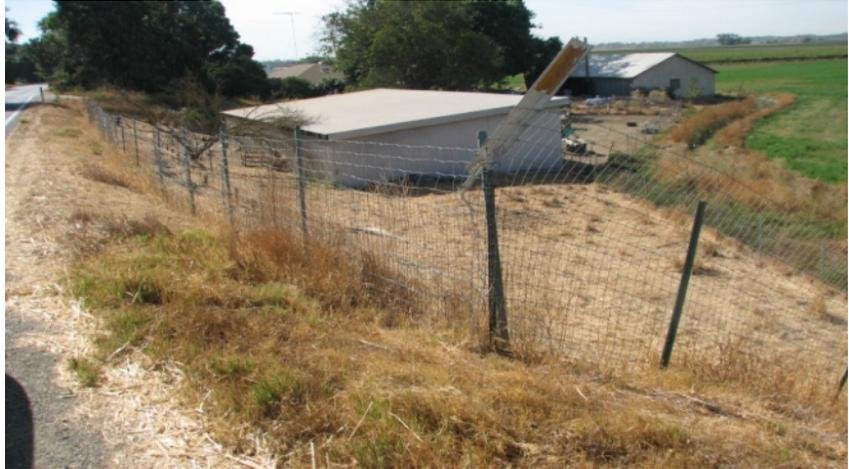
Levee Mile Report Line	28
Start Levee Mile	2.99
End Levee Mile	3.03
Location	
Category	Earthen Levee
Item	Encroachments
unauthorized fence located landward in RD 307.

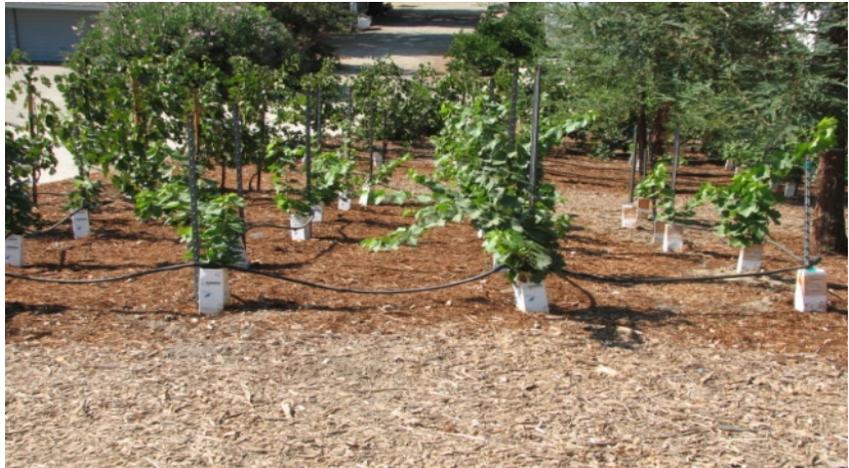
Levee Mile Report Line	44
Start Levee Mile	4.43
End Levee Mile	4.44
Location	
Category	Earthen Levee
Item	Encroachments
Unauthorized grapes vinyard with driplines placed within levee shouldr and slope Levee mile 4.5038.443822-121.503262
