**Flood Control Project Maintenance  
Levee Inspections**

**Fall 2013 Levee Maintenance Deficiency Summary Report**

**Reclamation District No. 0307 Lisbon**

Waterway		Bank	Unit Miles
Unit No. 01 Sacramento River		Right	6.65
	Spring (March - May)	Summer (June - August)	(September - November) Fall Winter (December - February)
Unit Maintenance Rating (Fall Only)			<b>U</b>
Date of Inspection	03/07/2013 - 03/07/2013		10/02/2013 - 10/02/2013
DWR Inspector	Herman Phillips		Herman Phillips
Accompanied By	Pete Dweyer RD 307

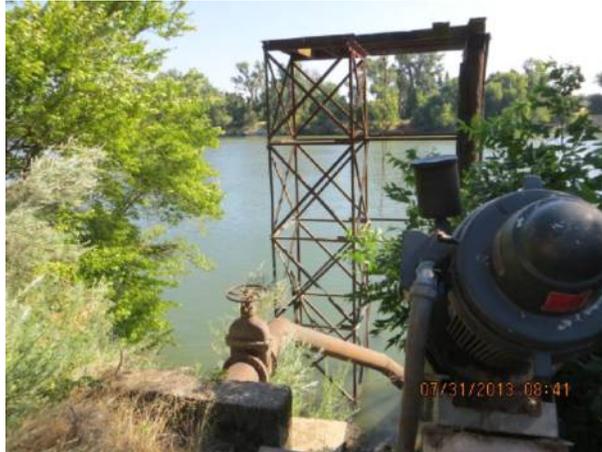
8	0.45	0.45	Supplemental	DWR UCIP Field Study	LS	U En	Inspector Comments: FS_ID:16745 EP_NO: N/A Repair Type: Urgent Crossing Status: Found UCIP Comments: Pipe heavily corroded and will likely need replacement if 15-inch pipe sleeved through it needs replacement. Annular space not grouted between two pipes. FIELD_STRUCT_DESC: 20-inch steel irrigation pipe through the levee 16.7 feet below the crown. 15-inch pipe sleeved through this pipe. Pump missing from abandoned steel pier on WS toe. Walkway from shoulder to pier missing or abandoned. Originally included in the 1959 O&M manual. FS Date: 7/31/2013	38.475542 ° -121.543566 °	38.475542 ° -121.543566 °	14
DWR ID: DWR_RD0307_01_f_2013_14

Levee Mile Report Line	9
Start Levee Mile	0.45
End Levee Mile	0.45
Location	Water Side
Category	Supplemental
Item	DWR UCIP Field Study
Pipe, gate valve, pump, and abandoned metal pier on WS slope.	
UCIP_9715.jpg

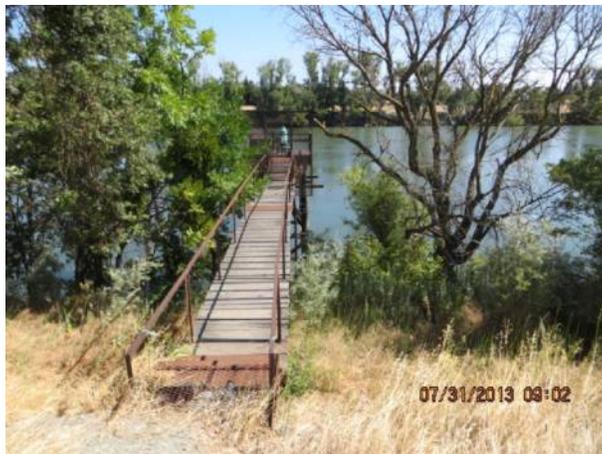
12	0.94	0.94	Supplemental	DWR UCIP Field Study	LS	M En	Inspector Comments: FS_ID:17103 EP_NO: 18229 Repair Type: Non-Urgent Crossing Status: Found UCIP Comments: Pipe open on both ends. Need to install caps. FIELD_STRUCT_DESC: 2 of 2: 2-inch galvanized iron pipe through the levee 2.0 feet below the crown (Permit No. 18229, 2007). FS Date: 7/31/2013	38.472872 ° -121.535542 °	38.472872 ° -121.535542 °	16 Y
DWR ID: DWR_RD0307_01_f_2013_16

Levee Mile Report Line	12
Start Levee Mile	0.94
End Levee Mile	0.94
Location	Water Side
Category	Supplemental
Item	DWR UCIP Field Study
Conduit visible under first step of walkway to pump on WS shoulder.	
UCIP_9843.jpg

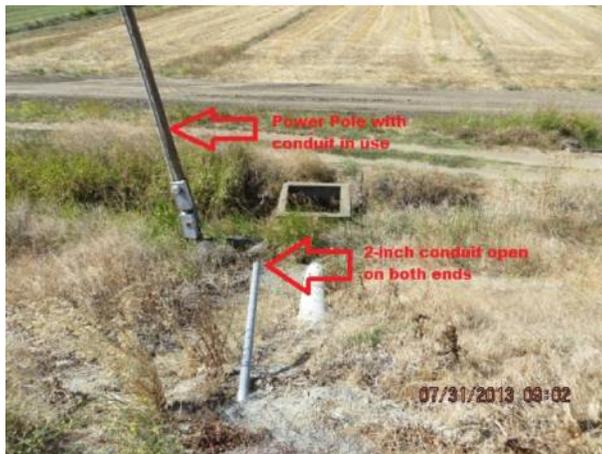
Levee Mile Report Line	12
Start Levee Mile	0.94
End Levee Mile	0.94
Location	Water Side
Category	Supplemental
Item	DWR UCIP Field Study
Conduit visible 2-feet below the crown on the LS shoulder.	
UCIP_9844.jpg

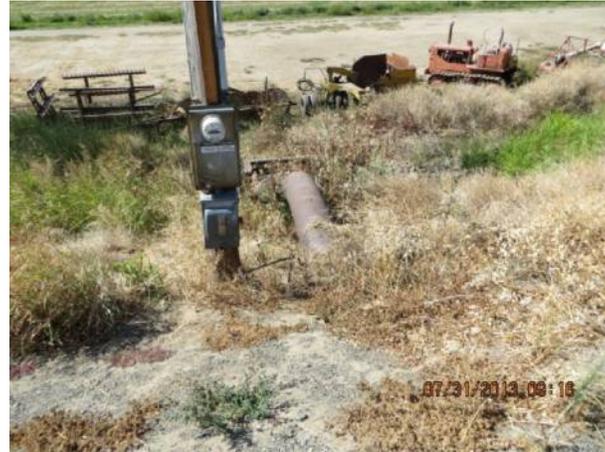
Levee Mile Report Line	15
Start Levee Mile	1.09
End Levee Mile	1.09
Location	Water Side
Category	Supplemental
Item	DWR UCIP Field Study
Pipe and JP/meter on LS slope.	
UCIP_9731.jpg

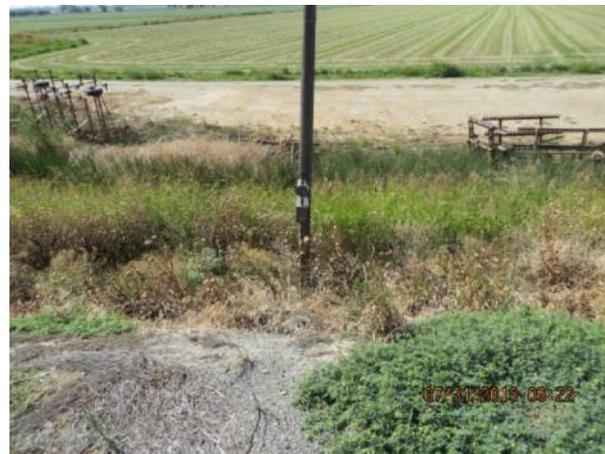
DWR ID: DWR_RD0307_01_f_2013_22		
16	1.10	1.10	Supplemental	DWR UCIP Field Study	WS	M En	Inspector Comments: FS_ID:16766 EP_NO: 3324 Repair Type: Non-Urgent Crossing Status: Found UCIP Comments: Walkway completely obscured by vegetation on WS slope. FIELD_STRUCT_DESC: 1.25-inch electrical conduit through the levee 10.0 feet below the crown. Corrugated metal stage recorder house and walkway on the waterward slope. Service pole on the landward slope (Permit No. 3324, 1960). FS Date: 7/31/2013	38.472874 ° -121.532611 °	38.472874 ° -121.532611 °	24 Y
								DWR ID: DWR_RD0307_01_f_2013_24		
17	1.10	1.10	Supplemental	DWR UCIP Field Study	WS	M En	Inspector Comments: FS_ID:16763 EP_NO: 3324 Repair Type: Non-Urgent Crossing Status: Found UCIP Comments: Walkway completely obscured by vegetation on WS slope. FIELD_STRUCT_DESC: 1.25-inch electrical conduit through the levee 10.0 feet below the crown. Corrugated metal stage recorder house and walkway on the waterward slope. Service pole on the landward slope (Permit No. 3324, 1960). FS Date: 7/31/2013	38.472874 ° -121.532611 °	38.472874 ° -121.532611 °	26

Levee Mile Report Line	16
Start Levee Mile	1.10
End Levee Mile	1.10
Location	Water Side
Category	Supplemental
Item	DWR UCIP Field Study
Conduit visible at base of JP on LS toe.	
UCIP_9736.jpg

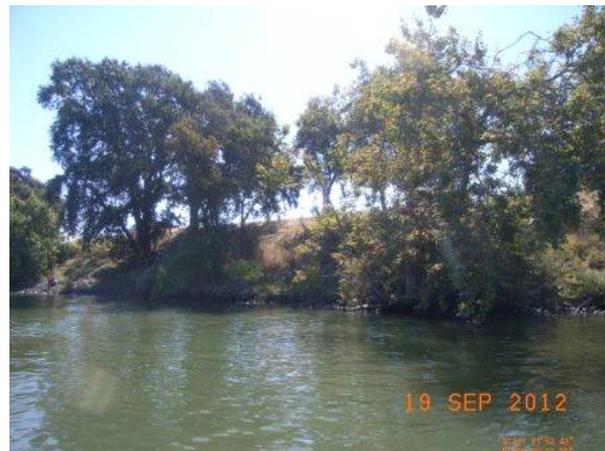
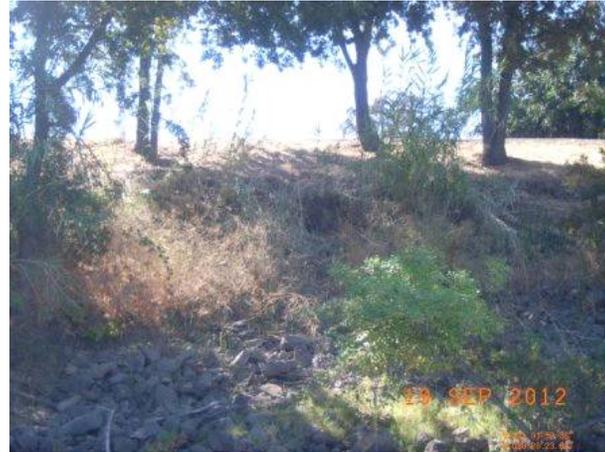
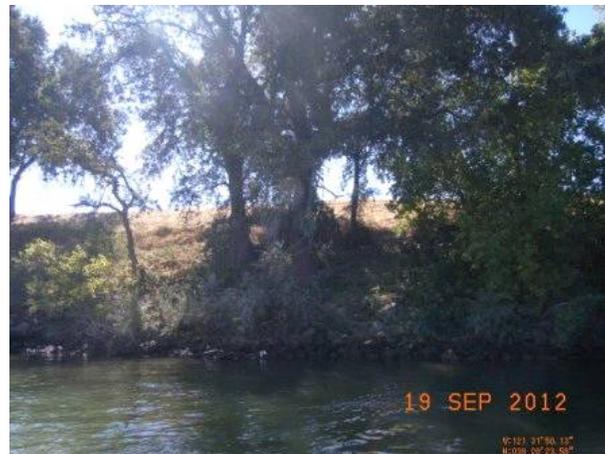
Levee Mile Report Line	21
Start Levee Mile	1.20
End Levee Mile	1.31
Location	Water Side
Category	Supplemental
Item	USACE Erosion Survey
USACE 2012 Photo #1	
USACE2013_SAC_48-6_R_1.jpg

Levee Mile Report Line	21
Start Levee Mile	1.20
End Levee Mile	1.31
Location	Water Side
Category	Supplemental
Item	USACE Erosion Survey
USACE 2012 Photo #2	
USACE2013_SAC_48-6_R_2.jpg

Levee Mile Report Line	21
Start Levee Mile	1.20
End Levee Mile	1.31
Location	Water Side
Category	Supplemental
Item	USACE Erosion Survey
USACE 2012 Photo #3	
USACE2013_SAC_48-6_R_3.jpg

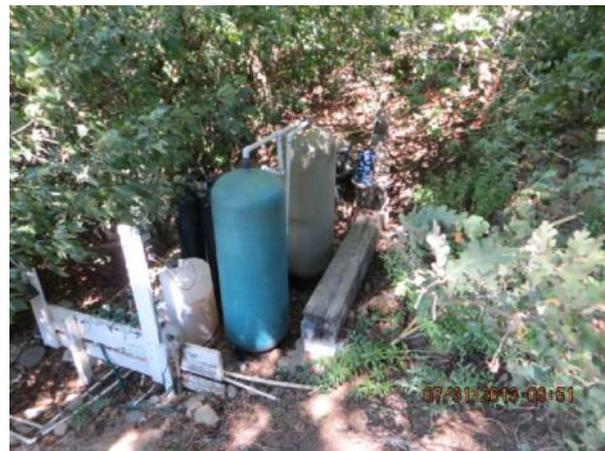
23	1.32	1.32	Earthen Levee	Encroachments	WS	M Ma	TR : Tree or limb	38.472872 ° -121.528601 °	38.472872 ° -121.528600 °	53
DWR ID: DWR_RD0307_01_f_2012_53										
24	1.64	1.64	Supplemental	DWR UCIP Field Study	WS	M En	Inspector Comments: FS_ID:17106 EP_NO: N/A Repair Type: Non-Urgent Crossing Status: Found UCIP Comments: No permit identified for this crossing. FIELD_STRUCT_DESC: 1 of 2: 1.5-inch PVC pipe through the levee 2-feet below the crown. Metal walkway/pier on WS slope. Possible pump, Filter, and tanks on LS slope. FS Date: 7/31/2013	38.473129 ° -121.522717 °	38.473129 ° -121.522717 °	28 Y
DWR ID: DWR_RD0307_01_f_2013_28										
25	1.64	1.64	Supplemental	DWR UCIP Field Study	WS	M En	Inspector Comments: FS_ID:17105 EP_NO: N/A Repair Type: Non-Urgent Crossing Status: Found UCIP Comments: No permit identified for crossing or boat dock/steel ramp. FIELD_STRUCT_DESC: 2 of 2: 1.5-inch PVC pipe through the levee 2-feet below the crown. Metal walkway/pier on WS slope. Possible pump on LS slope with filter tanks. FS Date: 7/31/2013	38.473129 ° -121.522717 °	38.473129 ° -121.522717 °	29

Levee Mile Report Line	24
Start Levee Mile	1.64
End Levee Mile	1.64
Location	Water Side
Category	Supplemental
Item	DWR UCIP Field Study
Possible pump and filter plant on LS slope.	
UCIP_9850.jpg

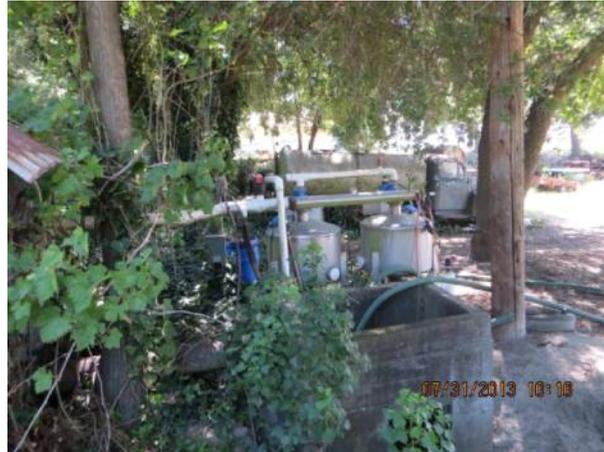
28	1.84	1.84	Supplemental	DWR UCIP Field Study	WS	M En	Inspector Comments: FS_ID:16803 EP_NO: 8016 Repair Type: Non-Urgent Crossing Status: Found UCIP Comments: Needs to be abandoned properly. FIELD_STRUCT_DESC: *Abandoned* 8-inch iron pipe through the levee 15.7 feet below the crown. No connection in pump house on the LS toe, but 8-inch outlet pipe remains at connection from pumphouse to concrete standpipe. (Permit No. 8016, 1972). Pipe capped at both ends according to Permit No. 18209 for replacement pipe. Originally included in the 1959 O&M manual. FS Date: 7/31/2013	38.473249 ° -121.519095 °	38.473249 ° -121.519095 °	33 Y
----	------	------	--------------	----------------------	----	---------	---	------------------------------	------------------------------	---------

Levee Mile Report Line	28
Start Levee Mile	1.84
End Levee Mile	1.84
Location	Water Side
Category	Supplemental
Item	DWR UCIP Field Study
Concrete distribution box at LS toe.	
UCIP_9737.jpg

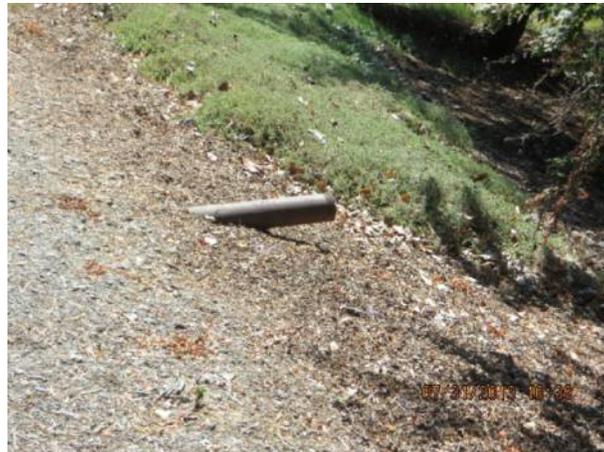
29	2.23	2.23	Supplemental	DWR UCIP Field Study	WS	M En	Inspector Comments: FS_ID:16807 EP_NO: N/A Repair Type: Non-Urgent Crossing Status: Found UCIP Comments: Pipe abandoned and should be done so properly. FIELD_STRUCT_DESC: 5-inch steel irrigation pipe through the levee 2.5 feet below the crown. Pipe open on both ends. Originally included in the 1959 O&M manual. FS Date: 7/31/2013	38.472281 ° -121.512217 °	38.472281 ° -121.512217 °	35 Y
----	------	------	--------------	----------------------	----	---------	--	------------------------------	------------------------------	---------

Levee Mile Report Line	29
Start Levee Mile	2.23
End Levee Mile	2.23
Location	Water Side
Category	Supplemental
Item	DWR UCIP Field Study
Pipe visible on LS shoulder.	
UCIP_9743.jpg

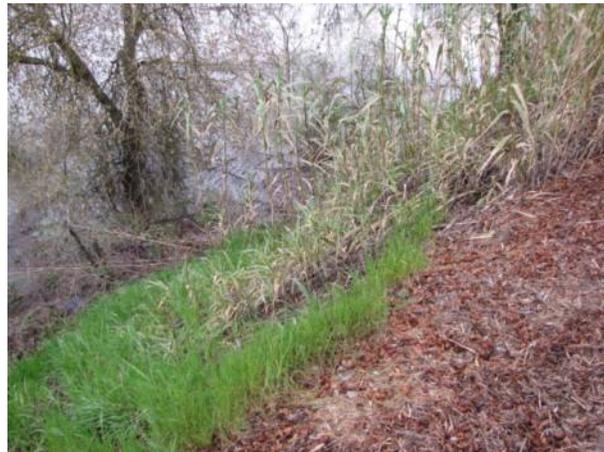
LMIR No.	Levee Mile		Category	Item	Location	Rating	Action/Comment	GPS Latitude/Longitude		Issue No. Photo
	Start	End						Start	End	
31	2.43	2.45	Earthen Levee	Erosion / Bank Caving	WS	U Ma	E1 : Note and monitor erosion site.	38.471032 ° -121.508317 °	38.470855 ° -121.508026 °	4 Y
DWR ID: DWR_RD0307_01_s_2012_4										
32	2.45	2.45	Supplemental	DWR UCIP Field Study	WS	M En	Inspector Comments: FS_ID:16810 EP_NO: N/A Repair Type: Non-Urgent Crossing Status: Found UCIP Comments: FIELD_STRUCT_DESC: 6-inch steel irrigation pipe through the levee 3.0 feet below the crown. Pump and gate valve on the waterward slope. 36-inch concrete standpipe on LS toe. Originally included in the 1959 O&M manual. FS Date: 7/31/2013	38.471093 ° -121.508429 °	38.471093 ° -121.508429 °	42 Y
DWR ID: DWR_RD0307_01_f_2013_42										
33	2.76	2.76	Supplemental	DWR UCIP Field Study	WS	M En	Inspector Comments: FS_ID:16815 EP_NO: 8023 Repair Type: Non-Urgent Crossing Status: Found UCIP Comments: Appears abandoned and should be done so properly. FIELD_STRUCT_DESC: 8-inch steel irrigation pipe through the levee 13.7 feet below the crown. Pump and gate valve in pump house on the landward toe. 4'X2.5' concrete distribution box off LS toe. Service pole and anchor on the landward slope (Permit No. 8023, 1972). Included in the 1959 O&M manual. FS Date: 7/31/2013	38.467404 ° -121.505681 °	38.467404 ° -121.505681 °	43 Y

Levee Mile Report Line	31
Start Levee Mile	2.43
End Levee Mile	2.45
Location	Water Side
Category	Earthen Levee
Item	Erosion / Bank Caving
Looking downstream from waterside levee mile 2.43 at erosion on bank, you can't see the erosion very well because of the overgrown bamboo. Photo taken 3-18-2011. This site was discovered by the land owner Mr. Borges.	
phillips_f_20130925_829.jpg

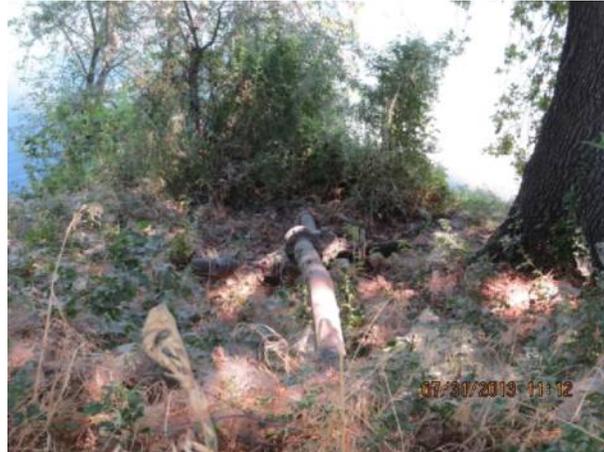
Levee Mile Report Line	32
Start Levee Mile	2.45
End Levee Mile	2.45
Location	Water Side
Category	Supplemental
Item	DWR UCIP Field Study
Pump and gate valve on WS slope.	
UCIP_9749.jpg

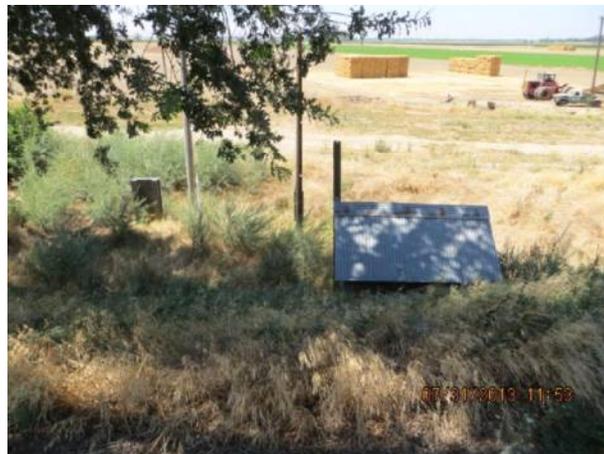
Levee Mile Report Line	33
Start Levee Mile	2.76
End Levee Mile	2.76
Location	Water Side
Category	Supplemental
Item	DWR UCIP Field Study
Pumphouse on LS toe.	
UCIP_9751.jpg

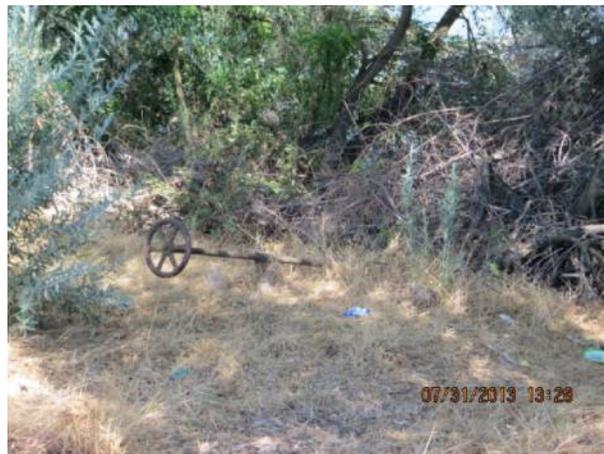
Levee Mile Report Line	41
Start Levee Mile	3.65
End Levee Mile	3.65
Location	Water Side
Category	Supplemental
Item	DWR UCIP Field Study
Gate valve actuator on WS slope.	
UCIP_9791.jpg

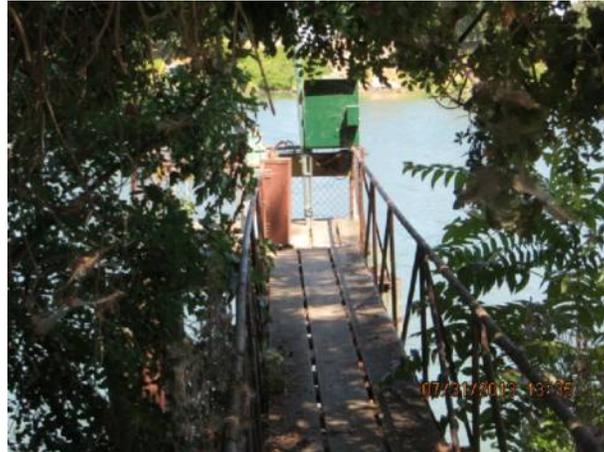
42	3.70	3.70	Supplemental	DWR UCIP Field Study	LS	M En	Inspector Comments: FS_ID:16924 EP_NO: 8030 Repair Type: Non-Urgent Crossing Status: Found UCIP Comments: Pipe not visible on LS slope or toe due to excessive vegetation. Vegetation should be cleared from pipe. FIELD_STRUCT_DESC: 1 of 2: 12-inch steel irrigation pipe through the levee 6-feet below the crown. Walkway on WS slope to a pump on a pile structure in the stream. JP and meter on LS toe. Pipe appears to cross levee at an angle. (Permit No. 8030, 1972). Included in the 1959 O&M manual. FS Date: 7/31/2013	38.454154 ° -121.502939 °	38.454154 ° -121.502939 °	46 Y
DWR ID: DWR_RD0307_01_f_2013_46

Levee Mile Report Line	42
Start Levee Mile	3.70
End Levee Mile	3.70
Location	Land Side
Category	Supplemental
Item	DWR UCIP Field Study
Pump and electrical controls on Pier at WS slope.	
UCIP_9794.jpg

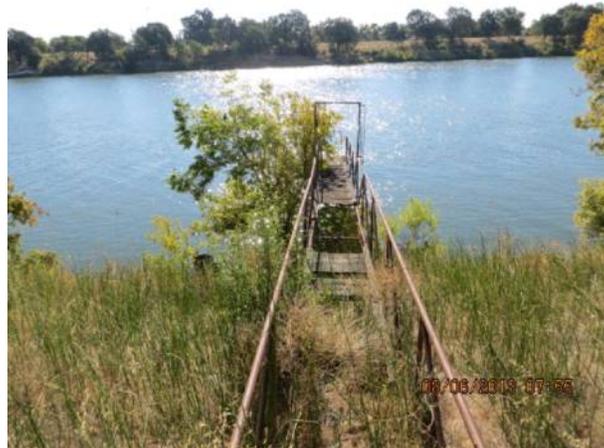
LMR No.	Levee Mile		Category	Item	Location	Rating	Action/Comment	GPS Latitude/Longitude		Issue No. Photo
	Start	End						Start	End	
47	3.95	3.95	Supplemental	DWR UCIP Field Study	LS	U En	Inspector Comments: FS_ID:16983 EP_NO: 8034 Repair Type: Urgent Crossing Status: Found UCIP Comments: Appears abandoned and should be done so properly. Walkway to pier is falling apart and is an attractive nuisance. Pipe rusted through at riser on LS toe. FIELD_STRUCT_DESC: 1 of 2: 14-inch steel irrigation pipe through the levee 13.0 feet below the crown. Pump on pile structure with walkway on WS slope. Gate valve at the waterward toe and a 48-inch concrete standpipe on the LS toe. Sheet pile wall around base of metal pier at WS toe (Permit No. 8034, 1972). Included in the 1959 O&M manual. FS Date: 8/6/2013 3:32:15 PM	38.450575 ° -121.502580 °	38.450575 ° -121.502580 °	55 Y
DWR ID: DWR_RD0307_01_f_2013_55

Levee Mile Report Line	47
Start Levee Mile	3.95
End Levee Mile	3.95
Location	Land Side
Category	Supplemental
Item	DWR UCIP Field Study
Metal walkway to pump on pier and gate valve actuator on WS slope.	
UCIP_9802.jpg

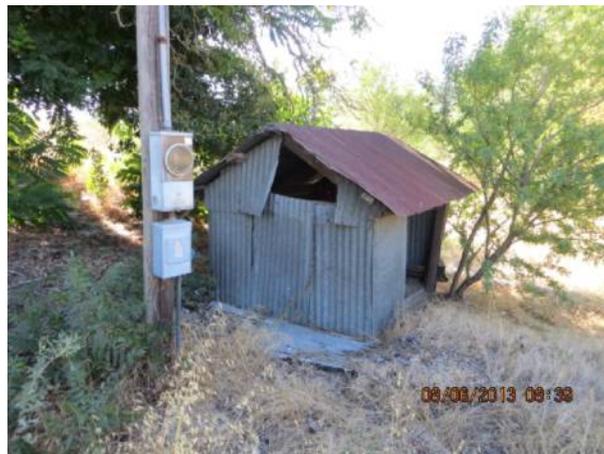
LMR No.	Levee Mile		Category	Item	Location	Rating	Action/Comment	GPS Latitude/Longitude		Issue No. Photo
	Start	End						Start	End	
52	4.12	4.12	Supplemental	DWR UCIP Field Study	LS	U En	Inspector Comments: FS_ID:17128 EP_NO: 8038 Repair Type: Urgent Crossing Status: Found UCIP Comments: Wooden lid on 5-foot Diam. CMP riser rotten and could collapse. This could create a hazard for the public and should be replaced. Pipe appears abandoned and should be done so properly. FIELD_STRUCT_DESC: 6-inch steel irrigation pipe through the levee 13.5 feet below the crown. Gate valve in 5-foot diameter corrugated metal pipe riser on the waterward slope. Power pole and meter at LS toe (Permit No. 8038, 1972). Included in the 1959 O&M manual. FS Date: 7/31/2013	38.448191 ° -121.502653 °	38.448191 ° -121.502653 °	63 Y
DWR ID: DWR_RD0307_01_f_2013_63										
53	4.14	4.15	Earthen Levee	Vegetation	WS	C Ma	V2 : Remove the wild growth other than native grasses from the levee slopes. Inspector Comments: Bamboo on waterside slope need to be removed.	38.447197 ° -121.502713 °	38.447053 ° -121.502721 °	60

Levee Mile Report Line	52
Start Levee Mile	4.12
End Levee Mile	4.12
Location	Land Side
Category	Supplemental
Item	DWR UCIP Field Study
Power Pole, meter, and pumphouse on LS toe.	
UCIP_9857.jpg

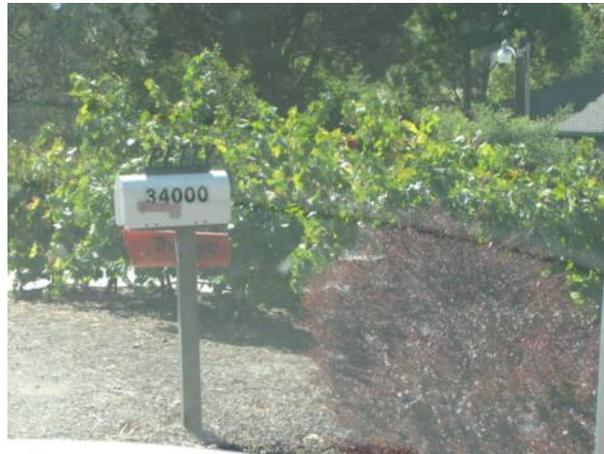
Levee Mile Report Line	60
Start Levee Mile	4.43
End Levee Mile	4.44
Location	Land Side
Category	Earthen Levee
Item	Encroachments

RD 307 Unauthorized encroachment at levee mile 4.43 land side levee slope and shoulder. Photo taken 10-02-2013.

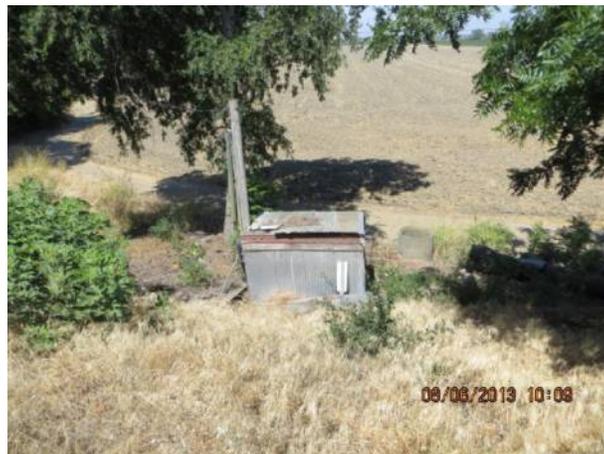
Levee Mile Report Line	61
Start Levee Mile	4.52
End Levee Mile	4.52
Location	Land Side
Category	Supplemental
Item	DWR UCIP Field Study

Pumphouse for 6-inch pipe at LS toe.

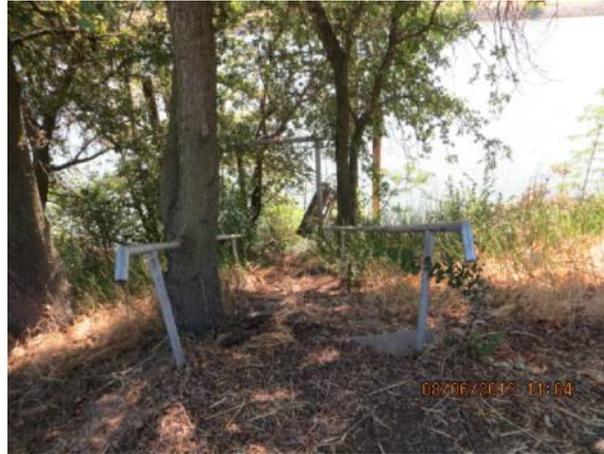
Pipe and gate valve on WS slope just downstream from stairs.

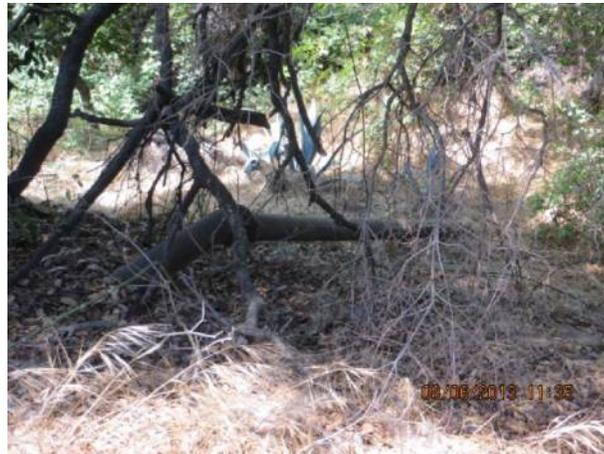
Levee Mile Report Line	66
Start Levee Mile	4.88
End Levee Mile	4.88
Location	Land Side
Category	Supplemental
Item	DWR UCIP Field Study

Pipe visible on LS slope.

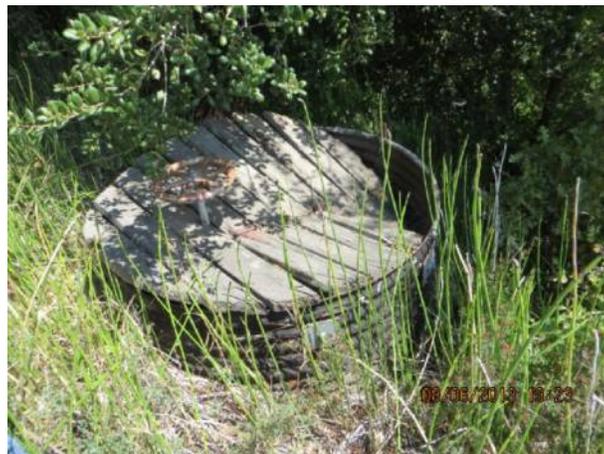
Levee Mile Report Line	69
Start Levee Mile	5.30
End Levee Mile	5.30
Location	Land Side
Category	Supplemental
Item	DWR UCIP Field Study

Gate valve in 5-foot diameter CMP riser on WS slope.

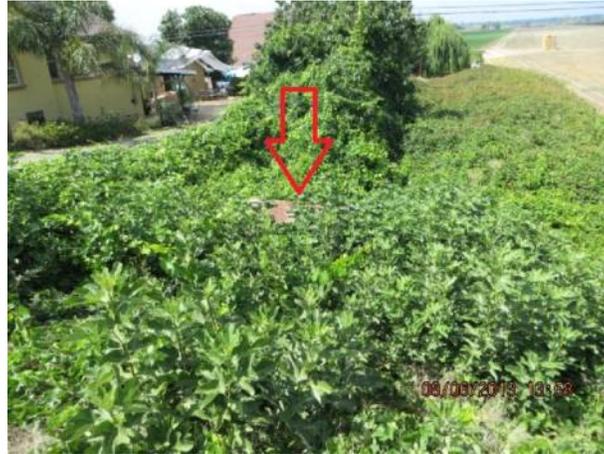
Levee Mile Report Line	72
Start Levee Mile	5.45
End Levee Mile	5.45
Location	Land Side
Category	Supplemental
Item	DWR UCIP Field Study
Pumphouse on LS toe.	
UCIP_9891.jpg

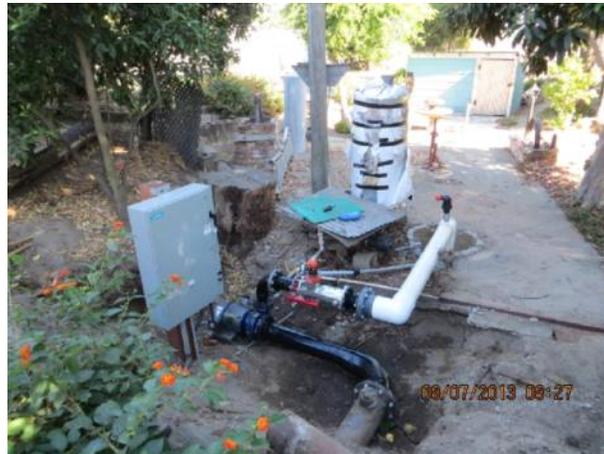
Levee Mile Report Line	74
Start Levee Mile	5.55
End Levee Mile	5.55
Location	Land Side
Category	Supplemental
Item	DWR UCIP Field Study
Pump, electrical panel, Concrete riser, and vent on LS toe.	
UCIP_9894.jpg

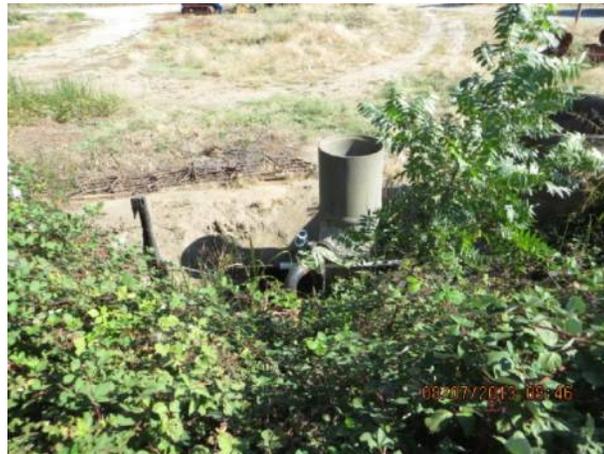
Levee Mile Report Line	76
Start Levee Mile	5.76
End Levee Mile	5.76
Location	Land Side
Category	Supplemental
Item	DWR UCIP Field Study
Pump, butterfly valve, vent, and concrete standpipe on LS toe.	
UCIP_9897.jpg

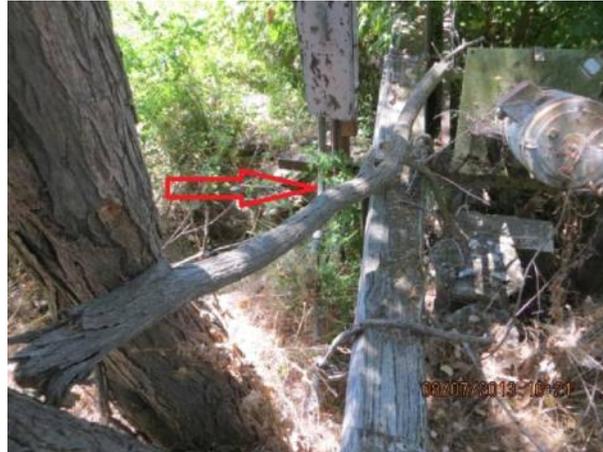
Levee Mile Report Line	77
Start Levee Mile	6.05
End Levee Mile	6.05
Location	Water Side
Category	Supplemental
Item	DWR UCIP Field Study
Electrical conduit visible at panel next to slant pump on WS slope.	
UCIP_9904.jpg

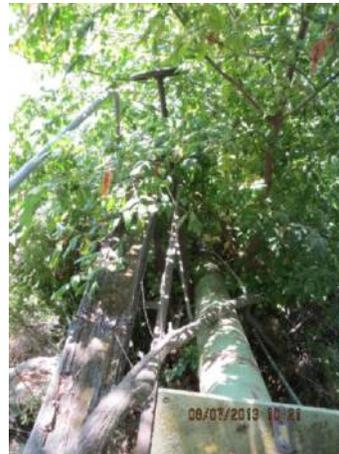
Levee Mile Report Line	78
Start Levee Mile	6.07
End Levee Mile	6.07
Location	Water Side
Category	Supplemental
Item	DWR UCIP Field Study
Gate valve at slant pump on WS slope.	
UCIP_9902.jpg

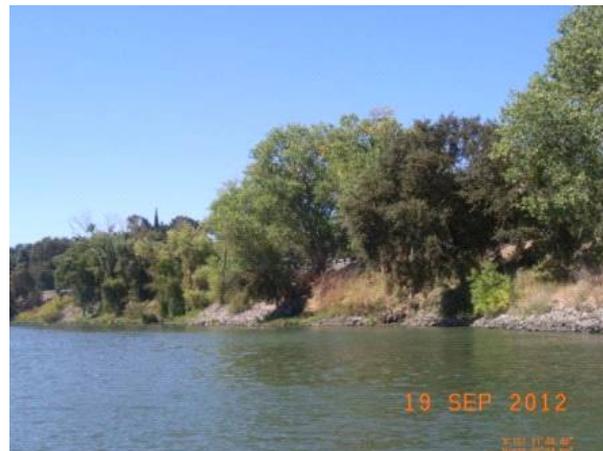
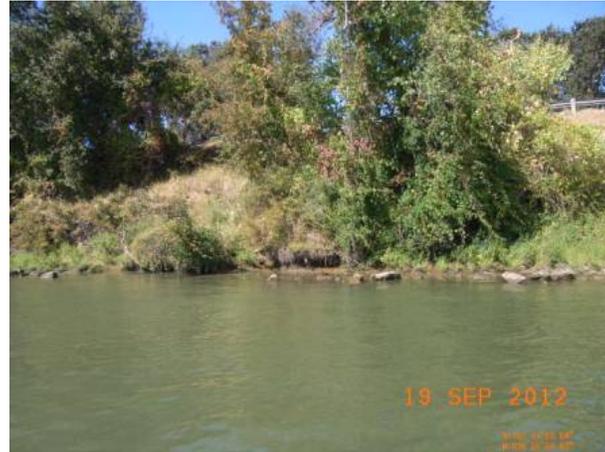
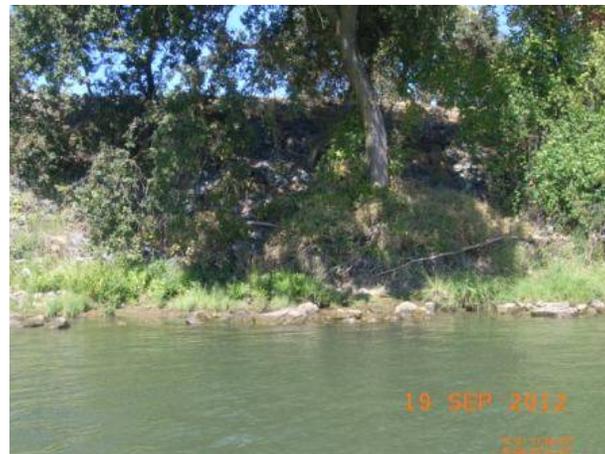
Levee Mile Report Line	79
Start Levee Mile	6.19
End Levee Mile	6.39
Location	Water Side
Category	Supplemental
Item	USACE Erosion Survey
USACE 2012 Photo #1	
USACE2013_SAC_43-2_R_1.jpg

Levee Mile Report Line	79
Start Levee Mile	6.19
End Levee Mile	6.39
Location	Water Side
Category	Supplemental
Item	USACE Erosion Survey
USACE 2012 Photo #2	
USACE2013_SAC_43-2_R_2.jpg

Levee Mile Report Line	79
Start Levee Mile	6.19
End Levee Mile	6.39
Location	Water Side
Category	Supplemental
Item	USACE Erosion Survey
USACE 2012 Photo #3	
USACE2013_SAC_43-2_R_3.jpg

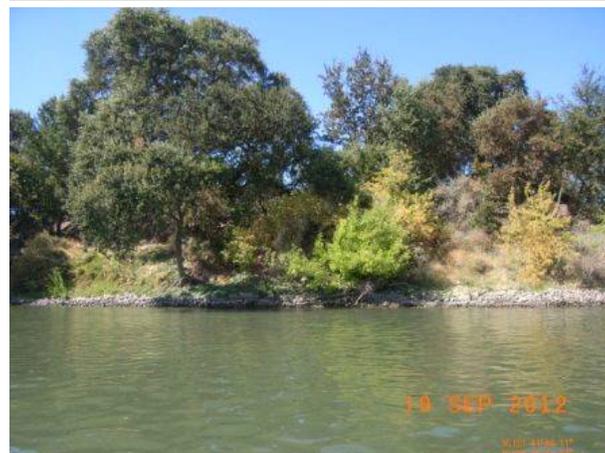
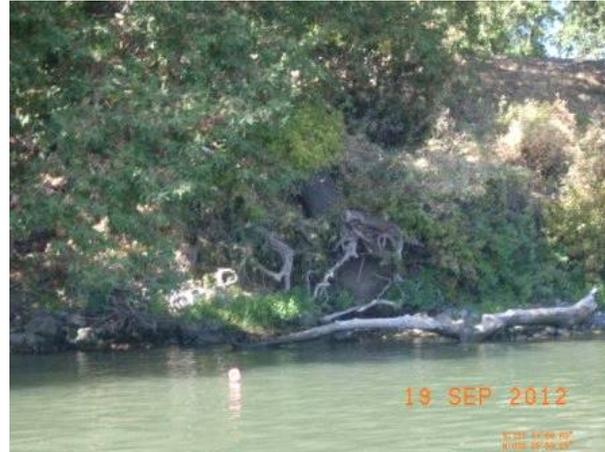
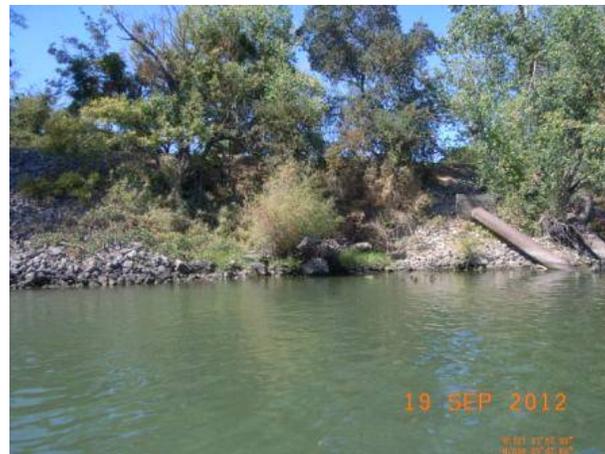
Levee Mile Report Line	80
Start Levee Mile	6.43
End Levee Mile	6.56
Location	Water Side
Category	Supplemental
Item	USACE Erosion Survey
USACE 2012 Photo #1	
USACE2013_SAC_43-1_R_1.jpg

Levee Mile Report Line	80
Start Levee Mile	6.43
End Levee Mile	6.56
Location	Water Side
Category	Supplemental
Item	USACE Erosion Survey
USACE 2012 Photo #2	
USACE2013_SAC_43-1_R_2.jpg

Levee Mile Report Line	80
Start Levee Mile	6.43
End Levee Mile	6.56
Location	Water Side
Category	Supplemental
Item	USACE Erosion Survey
USACE 2012 Photo #3	
USACE2013_SAC_43-1_R_3.jpg

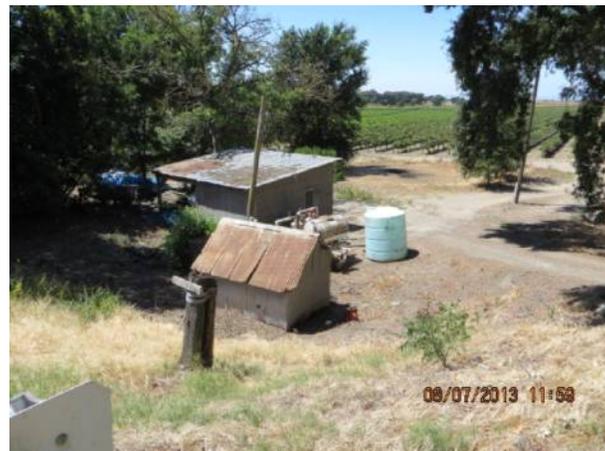
Levee Mile Report Line	81
Start Levee Mile	6.49
End Levee Mile	6.49
Location	Water Side
Category	Supplemental
Item	DWR UCIP Field Study
Pump and gate valve inside pumphouse on LS toe.	
UCIP_9908.jpg

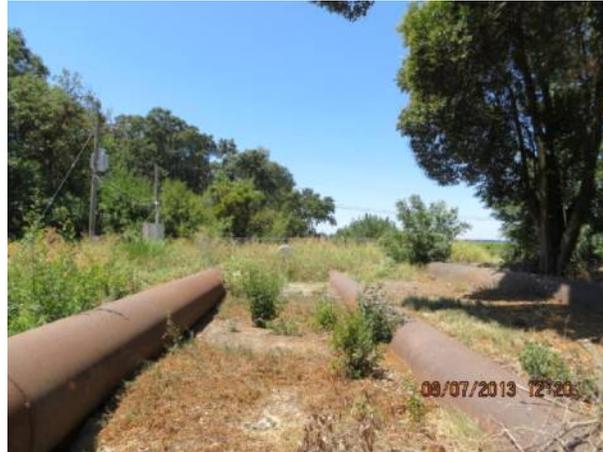
Levee Mile Report Line	82
Start Levee Mile	6.62
End Levee Mile	6.62
Location	Water Side
Category	Supplemental
Item	DWR UCIP Field Study
Pipe visible on LS toe to pumping plant 200-feet off LS toe.	
UCIP_9911.jpg
