**Flood Control Project Maintenance
Levee Inspections**

Fall 2014 Levee Maintenance Deficiency Summary Report

Reclamation District No. 0307 Lisbon

Levee Inspection Report By Mile - Fall 2014

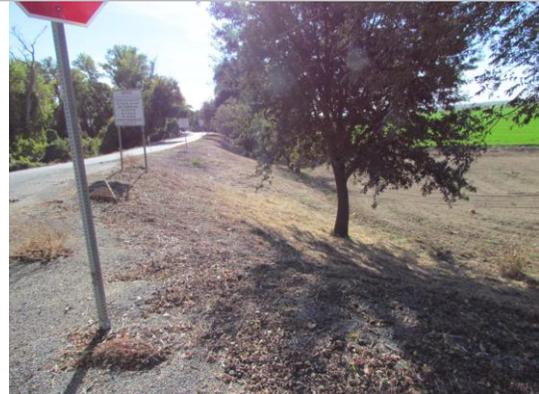
Photo 1 of 1 : FA_2014_RD0307_166_1_20141103_00003.jpg

LM Start	0.01	Rating **	A	Issue No.	1
LM End	1.65	Issue Type +	Ma	Location *	N/A
Category	Earthen Levee		GPS Latitude/Longitude		
			Start	End	
Item	Vegetation		38.480037 °	38.473162 °	
			-121.549550 °	-121.322640 °	
DWR ID	DWR_RD0307_01_f_2014_1				
Action/Comments					
Control annual grass and weeds on the levee slopes and easements. Inspector Comments: District has done a great job of removing unwanted vegetation from levee section, landward.

Looking downstream from levee mile 0.01 landside to levee mile 1.65.

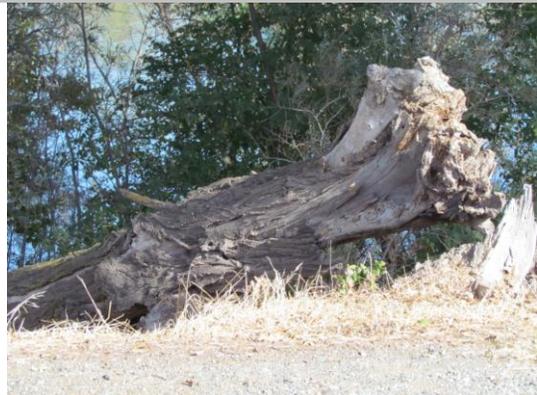
Photo 1 of 1 : FA_2014_RD0307_166_9_20141103_00001.jpg

LM Start	1.31	Rating **	U	Issue No.	9
LM End	1.31	Issue Type +	En	Location *	WS
Category	Earthen Levee		GPS Latitude/Longitude		
			Start	End	
Item	Encroachments		38.472827 °	38.472827 °	
			-121.528785 °	-121.528785 °	
DWR ID	DWR_RD0307_01_f_2014_9				
Action/Comments					
Tree or limb

This tree needs to be removed from the waterside slope.

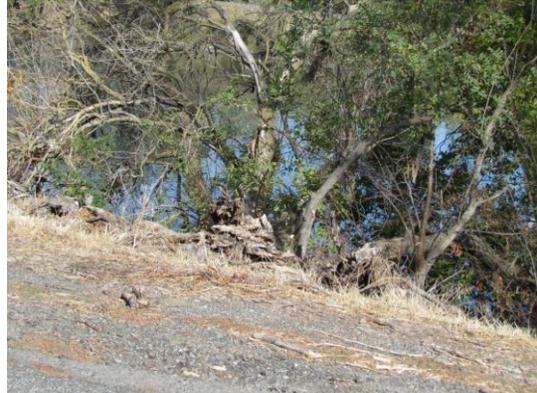
Photo 1 of 1 : FA_2014_RD0307_166_10_20141103_00002.jpg

LM Start	1.37	Rating **	U	Issue No.	10
LM End	1.37	Issue Type +	En	Location *	WS
Category	Earthen Levee		GPS Latitude/Longitude		
			Start	End	
Item	Encroachments		38.472880 °	38.472880 °	
			-121.527733 °	-121.527733 °	
DWR ID	DWR_RD0307_01_f_2014_10				
Action/Comments					
Tree or limb

Remove unwanted trees from waterside slope. These trees are dead and are resting on the slope.

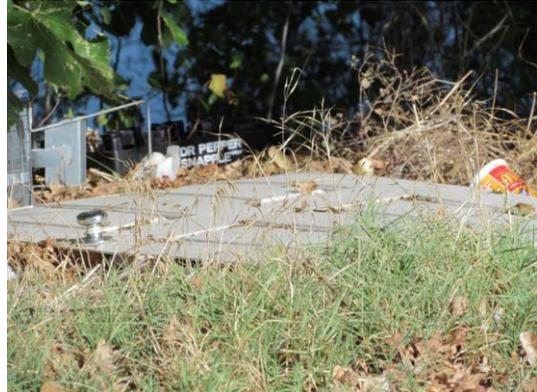
Photo 1 of 1 : FA_2014_RD0307_166_14_20141103_00004.jpg

LM Start	1.71	Rating **	U	Issue No.	14
LM End	1.82	Issue Type +	En	Location *	WS
Category	Earthen Levee		GPS Latitude/Longitude		
			Start	End	
Item	Encroachments		38.473243 °	38.473277 °	
			-121.521460 °	-121.519537 °	
DWR ID	DWR_RD0307_01_f_2014_14				
Action/Comments					
Garbage Inspector Comments: Remove encroachments from levee section waterward slope.

Garbage and debris dumped on waterside levee slope.

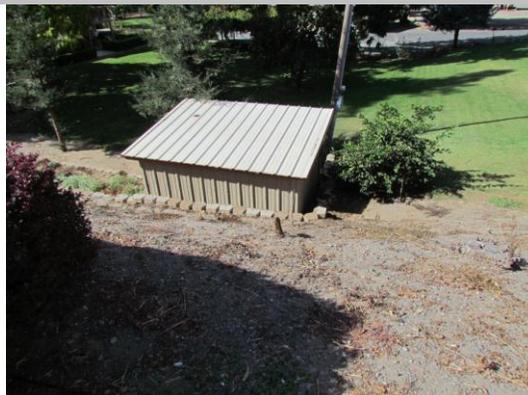
Photo 1 of 1 : FA_2014_RD0307_166_26_20141103_00005.jpg

LM Start	4.37	Rating **	U	Issue No.	26
LM End	4.37	Issue Type +	En	Location *	N/A
Category	Earthen Levee		GPS Latitude/Longitude		
			Start	End	
Item	Encroachments		38.444612 °	38.444612 °	
			-121.503100 °	-121.503100 °	
DWR ID	DWR_RD0307_01_f_2014_26				
Action/Comments					
Building Inspector Comments: This pumphouse was built without a permit, the district is aware of the encroachment.

This pump house was built without CVFPB Permit.

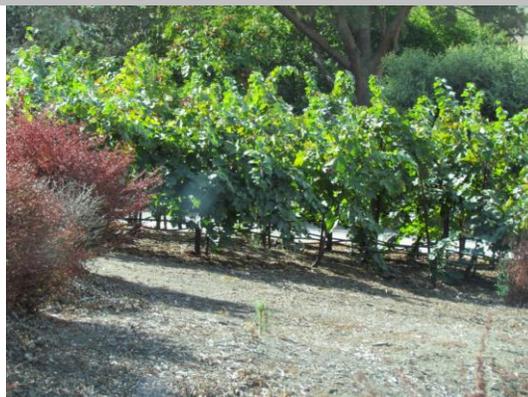
Photo 1 of 1 : FA_2014_RD0307_166_27_20141103_00006.jpg

LM Start	4.45	Rating **	U	Issue No.	27
LM End	4.45	Issue Type +	En	Location *	N/A
Category	Earthen Levee		GPS Latitude/Longitude		
			Start	End	
Item	Encroachments		38.443517 °	38.443517 °	
			-121.503338 °	-121.503338 °	
DWR ID	DWR_RD0307_01_f_2014_27				
Action/Comments					
Crops Inspector Comments: There are grapes planted on the levee slope landside without permit from the CVFPB. This issue has been reported and recorded in previous inspections.

Unwanted grapes placed on levee slope, these grapes has been reported to both district and CVFPB. No permit.

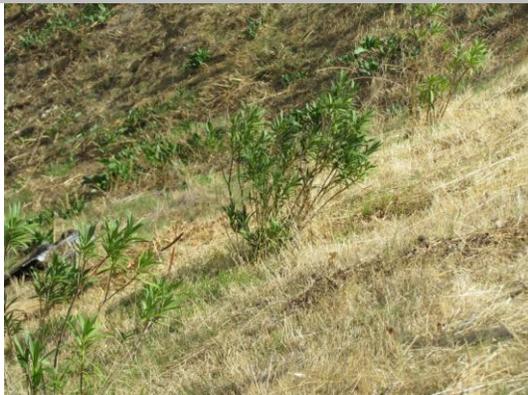
Photo 1 of 2 : FA_2014_RD0307_166_28_20141103_00007.jpg

LM Start	5.40	Rating **	U	Issue No.	28
LM End	5.44	Issue Type +	En	Location *	N/A
Category	Earthen Levee		GPS Latitude/Longitude		
			Start	End	
Item	Encroachments		38.435728 °	38.435662 °	
			-121.516023 °	-121.516735 °	
DWR ID	DWR_RD0307_01_f_2014_28				
Action/Comments					
Tree or limb Inspector Comments: Unauthorized planting of small oleander trees on the levee slope landside, no permit for this encroachment. 15 trees at this location.

15 Oleander trees planted on the landside levee slope, no permit. Looking upstream from levee mile 5.40.

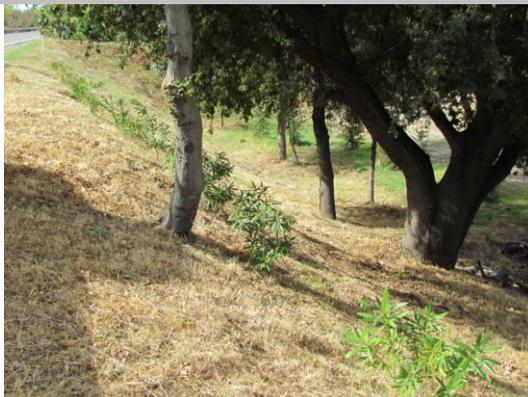
Photo 2 of 2 : FA_2014_RD0307_166_28_20141103_00008.jpg

Looking downstream from levee mile 5.40 landward at small trees planted on the levee section.
