**Flood Control Project Maintenance
Levee Inspections**
LMA District Cover Sheet
Spring 2014 Levee Inspection Results

Reclamation District No. 0307 Lisbon

Spring 2014 Levee Inspection Results

Waterway	Bank	Unit Miles
Unit No. 01 Sacramento River	Right	6.65

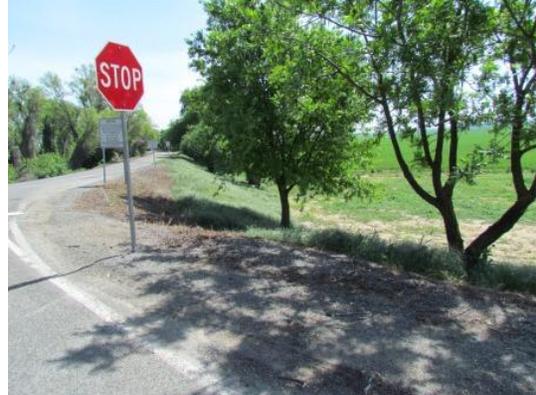
Photo 1 of 1 : phillips_s_20140421_792.jpg

Looking downstream from levee mile 0.00 RD 307 landside slope.
Photo taken 4-08-2014.

LM Start	0.12	Rating **	M	Issue No.	9
LM End	1.98	Issue Type +	Ma	Location *	LS
Category	Earthen Levee		GPS Latitude/Longitude		
			Start	End	
Item	Animal Control		38.478802 °	38.473036 °	
			-121.548116 °	-121.516650 °	
DWR ID	DWR_RD0307_01_f_2012_9				
Action/Comments					
Exterminate rodents and backfill and compact or grout burrows.

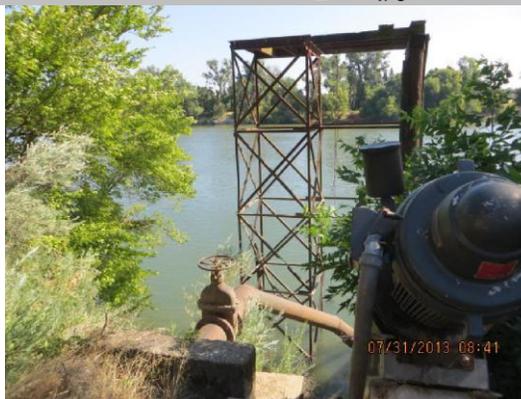
Photo 1 of 1 : UCIP_1505.jpg

LM Start	0.45	Rating **	M	Issue No.	3
LM End	0.45	Issue Type +	En	Location *	WS
Category	Supplemental		GPS Latitude/Longitude		
			Start	End	
Item	DWR UCIP Field Study		38.475542 °	38.475542 °	
			-121.543565 °	-121.543565 °	
DWR ID	DWR_RD0307_01_s_2014_3				
Action/Comments					
Inspector Comments: FS_ID:16743 EP_NO: N/A Repair Type: Crossing Status: UCIP Comments: Pipe heavily corroded at outlet on LS toe. Holes on bottom of pipe at outlet and internal circumference shows heavy exfoliation. Pipe failing internally. Recommend replacement or video inspection before continuing use. FIELD_STRUCT_DESC: 1 of 2: 15-inch steel irrigation pipe sleeved through 21-inch steel conduit, through the levee 16.7 feet below crown. Slant pump, gate valve, concrete headwall, electrical control pane, and abandoned pier on WS slope. Concrete U-shaped outlet with flap gate on LS toe. Service pole on the landward slope with anchor. FS Date: 7/31/2013 9:44:32 AM

Pipe, gate valve, pump, and abandoned metal pier on WS slope.

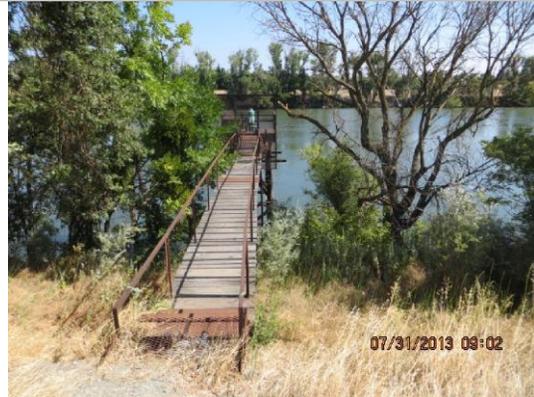
Photo 1 of 1 : UCIP_1553.jpg

LM Start	0.94	Rating **	M	Issue No.	8
LM End	0.94	Issue Type +	En	Location *	LS
Category	Supplemental			GPS Latitude/Longitude	
				Start	End
Item	DWR UCIP Field Study			38.472872 °	38.472872 °
				-121.535542 °	-121.535542 °
DWR ID	DWR_RD0307_01_s_2014_8				
Action/Comments					
Inspector Comments: FS_ID:17103 EP_NO: 18229 Repair Type: Crossing Status: UCIP Comments: Pipe open on both ends. Need to install caps. FIELD_STRUCT_DESC: 2 of 2: 2-inch galvanized iron pipe through the levee 2.0 feet below the crown (Permit No. 18229, 2007). FS Date: 7/31/2013

Conduit visible under first step of walkway to pump on WS shoulder.

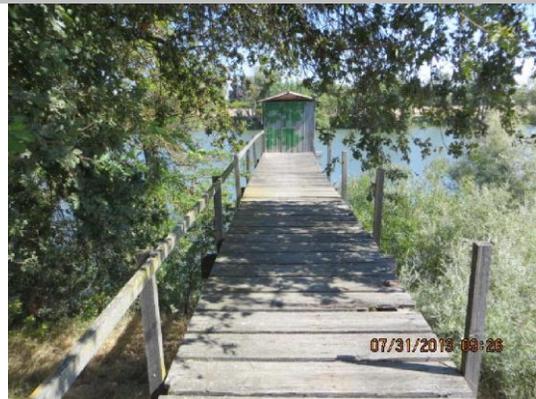
Photo 1 of 1 : UCIP_1516.jpg

LM Start	1.09	Rating **	M	Issue No.	10
LM End	1.09	Issue Type +	En	Location *	WS
Category	Supplemental		GPS Latitude/Longitude		
			Start	End	
Item	DWR UCIP Field Study		38.472870 °	38.472870 °	
			-121.532750 °	-121.532750 °	
DWR ID	DWR_RD0307_01_s_2014_10				
Action/Comments					
Inspector Comments: FS_ID:16764 EP_NO: 8012 Repair Type: Crossing Status: UCIP Comments: Pipe rusted through at outlet on LS of shutoff valve. This may be good indicator or corrosion throughout pipe. This is a good candidate for video inspection. FIELD_STRUCT_DESC: 1 of 2: 20-inch steel pipe through levee 7.4 feet below crown. Walkway from the waterward shoulder to pump on pile structure in stream. Distribution box and gate valve at toe of landward slope. Service pole on the landward side (Permit No. 8012, 1972). Originally included in the 1959 O&M manual. FS Date: 7/31/2013

Pump on pier at end of walkway on WS shoulder.

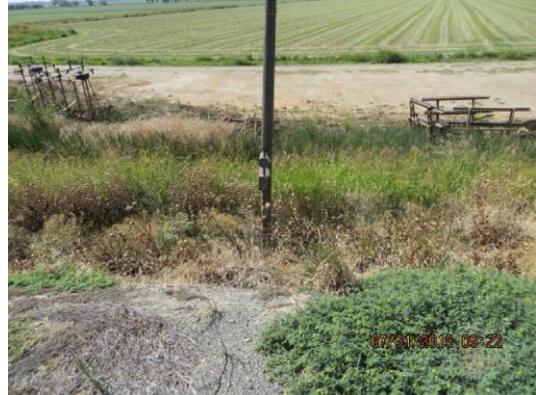
Photo 1 of 1 : UCIP_1519.jpg

LM Start	1.10	Rating **	M	Issue No.	11
LM End	1.10	Issue Type +	En	Location *	WS
Category	Supplemental			GPS Latitude/Longitude	
				Start	End
Item	DWR UCIP Field Study			38.472874 °	38.472874 °
				-121.532611 °	-121.532611 °
DWR ID	DWR_RD0307_01_s_2014_11				
Action/Comments					
Inspector Comments: FS_ID:16766 EP_NO: 3324 Repair Type: Crossing Status: UCIP Comments: Walkway completely obscured by vegetation on WS slope. FIELD_STRUCT_DESC: 1.25-inch electrical conduit through the levee 10.0 feet below the crown. Corrugated metal stage recorder house and walkway on the waterward slope. Service pole on the landward slope (Permit No. 3324, 1960). FS Date: 7/31/2013

Conduit visible at base of JP on LS toe.

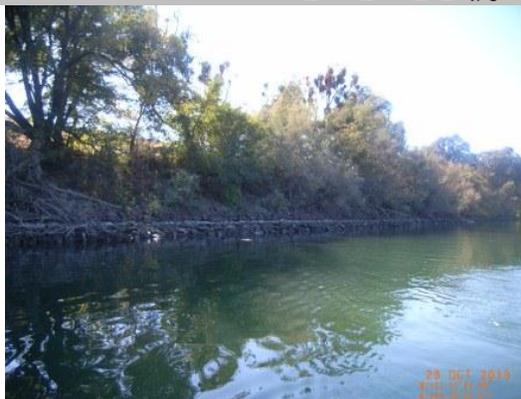
Photo 1 of 1 : USACE2013A_SAC_48-6_R_4.jpg

LM Start	1.24	Rating **	M	Issue No.	62
LM End	1.33	Issue Type +	Ma	Location *	WS
Category	Supplemental			GPS Latitude/Longitude	
				Start	End
Item	USACE Erosion Survey			38.473059 °	38.473082 °
				-121.530988 °	-121.528437 °
DWR ID					
Action/Comments					
Inspector Comments: 2012 - Bank is slowly eroding, old rock protection starting to unravel. 2013: No observed changes. [2013 Site ID: SAC_48-6_R]

USACE 2013 Photo #1

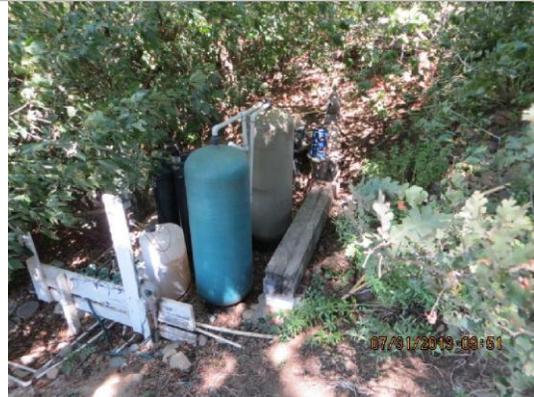
Photo 1 of 1 : UCIP_1557.jpg

LM Start	1.64	Rating **	M	Issue No.	12
LM End	1.64	Issue Type +	En	Location *	WS
Category	Supplemental			GPS Latitude/Longitude	
				Start	End
Item	DWR UCIP Field Study			38.473129 °	38.473129 °
				-121.522717 °	-121.522717 °
DWR ID	DWR_RD0307_01_s_2014_12				
Action/Comments					
Inspector Comments: FS_ID:17105 EP_NO: N/A Repair Type: Crossing Status: UCIP Comments: No permit identified for crossing or boat dock/steel ramp. FIELD_STRUCT_DESC: 2 of 2: 1.5-inch PVC pipe through the levee 2-feet below the crown. Metal walkway/pier on WS slope. Possible pump on LS slope with filter tanks. FS Date: 7/31/2013

Possible pump and filter station on LS slope.

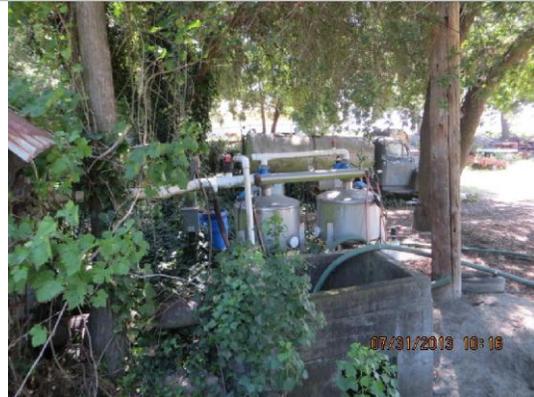
Photo 1 of 1 : UCIP_1520.jpg

LM Start	1.84	Rating **	M	Issue No.	14
LM End	1.84	Issue Type +	En	Location *	WS
Category	Supplemental		GPS Latitude/Longitude		
			Start	End	
Item	DWR UCIP Field Study		38.473249 °	38.473249 °	
			-121.519095 °	-121.519095 °	
DWR ID	DWR_RD0307_01_s_2014_14				
Action/Comments					
Inspector Comments: FS_ID:16805 EP_NO: 8016 Repair Type: Crossing Status: UCIP Comments: Needs to be abandoned properly. FIELD_STRUCT_DESC: *Abandoned* 8-inch iron pipe through the levee 15.7 feet below the crown. No connection in pump house on the LS toe, but 8-inch outlet pipe remains at connection from pumphouse to concrete standpipe. (Permit No. 8016, 1972). Pipe capped at both ends according to Permit No. 18209 for replacement pipe. Originally included in the 1959 O&M manual. FS Date: 7/31/2013

Concrete distribution box at LS toe.

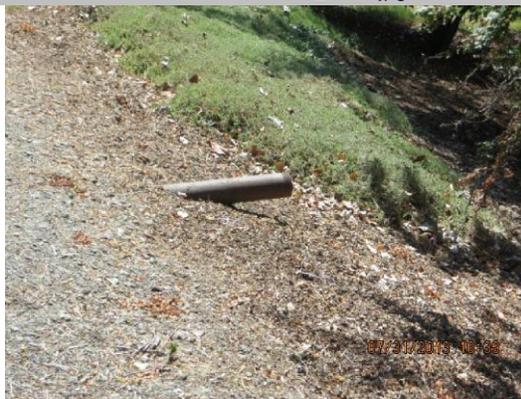
Photo 1 of 1 : UCIP_3031.jpg

LM Start	2.24	Rating **	M	Issue No.	15
LM End	2.24	Issue Type +	En	Location *	LS
Category	Supplemental			GPS Latitude/Longitude	
				Start	End
Item	DWR UCIP Field Study			38.472237 °	38.472237 °
				-121.512031 °	-121.512031 °
DWR ID	DWR_RD0307_01_s_2014_15				
Action/Comments					
Inspector Comments: FS_ID:22709 EP_NO: N/A Repair Type: Crossing Status: UCIP Comments: Pipe abandoned and should be done so properly. FIELD_STRUCT_DESC: 5-inch steel irrigation pipe through the levee 2.0-feet below the crown. Pipe open on both ends. Originally included in the 1959 O&M manual. FS Date: 7/31/2013

Pipe visible on LS shoulder.

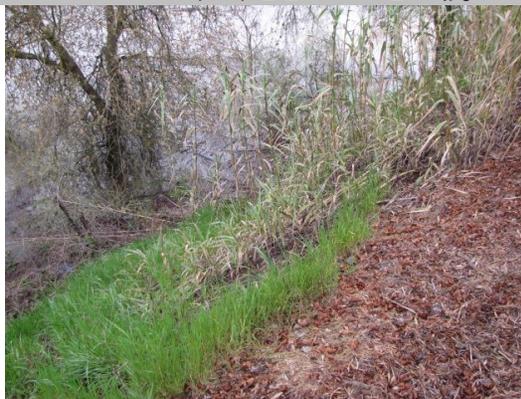
Photo 1 of 1 : phillips_s_20140408_632.jpg

LM Start	2.43	Rating **	U	Issue No.	4
LM End	2.45	Issue Type +	Ma	Location *	WS
Category	Earthen Levee			GPS Latitude/Longitude	
				Start	End
Item	Erosion / Bank Caving			38.471032 °	38.470855 °
				-121.508317 °	-121.508026 °
DWR ID	DWR_RD0307_01_s_2012_4				
Action/Comments					
Note and monitor erosion site.

Looking downstream from waterside levee mile 2.43 at erosion on bank, you can't see the erosion very well because of the overgrown bamboo. Photo taken 3-18-2011. This site was discovered by the land owner Mr. Borges.

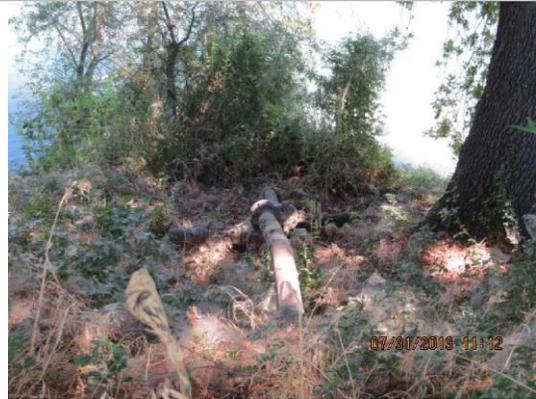
Photo 1 of 1 : UCIP_1524.jpg

LM Start	2.45	Rating **	M	Issue No.	16
LM End	2.45	Issue Type +	En	Location *	WS
Category	Supplemental			GPS Latitude/Longitude	
				Start	End
Item	DWR UCIP Field Study			38.471093 °	38.471093 °
				-121.508429 °	-121.508429 °
DWR ID	DWR_RD0307_01_s_2014_16				
Action/Comments					
Inspector Comments: FS_ID:16810 EP_NO: N/A Repair Type: Crossing Status: UCIP Comments: FIELD_STRUCT_DESC: 6-inch steel irrigation pipe through the levee 3.0 feet below the crown. Pump and gate valve on the waterward slope. 36-inch concrete standpipe on LS toe. Originally included in the 1959 O&M manual. FS Date: 7/31/2013

Pump and gate valve on WS slope.

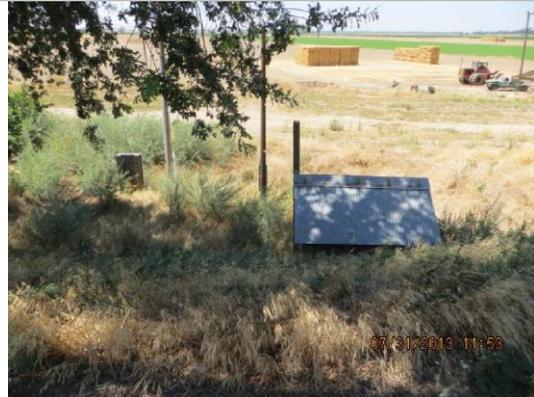
Photo 1 of 1 : UCIP_1526.jpg

LM Start	2.76	Rating **	M	Issue No.	22
LM End	2.76	Issue Type +	En	Location *	WS
Category	Supplemental			GPS Latitude/Longitude	
				Start	End
Item	DWR UCIP Field Study			38.467404 °	38.467404 °
				-121.505681 °	-121.505681 °
DWR ID	DWR_RD0307_01_s_2014_22				
Action/Comments					
Inspector Comments: FS_ID:16815 EP_NO: 8023 Repair Type: Crossing Status: UCIP Comments: Appears abandoned and should be done so properly. FIELD_STRUCT_DESC: 8-inch steel irrigation pipe through the levee 13.7 feet below the crown. Pump and gate valve in pump house on the landward toe. 4'X2.5' concrete distribution box off LS toe. Service pole and anchor on the landward slope (Permit No. 8023, 1972). Included in the 1959 O&M manual. FS Date: 7/31/2013

Pumphouse on LS toe.

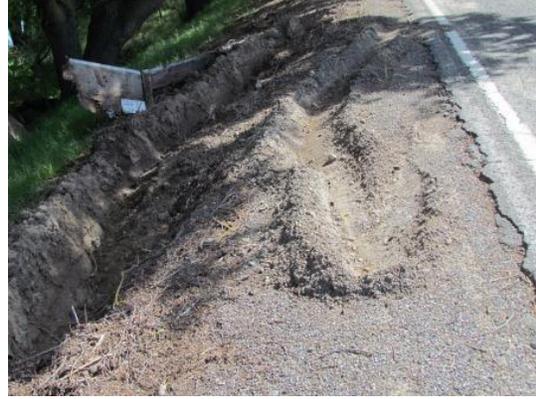
Photo 1 of 1 : phillips_s_20140421_793.jpg

LM Start	3.14	Rating **	U	Issue No.	64
LM End	3.14	Issue Type +	Ma	Location *	WS
Category	Earthen Levee		GPS Latitude/Longitude		
			Start	End	
Item	Slope Stability		38.462098 °	38.462098 °	
			-121.504999 °	-121.504999 °	
DWR ID	DWR_RD0307_01_s_2014_64				
Action/Comments					
Repair slope instability. Inspector Comments: This damage was caused because a vehicle got stuck after the rain. The shoulder was too wet couldn't support the weight.

Looking downstream waterside shoulder damage to shoulder (vehicle).
Photo taken 4-08-2014.

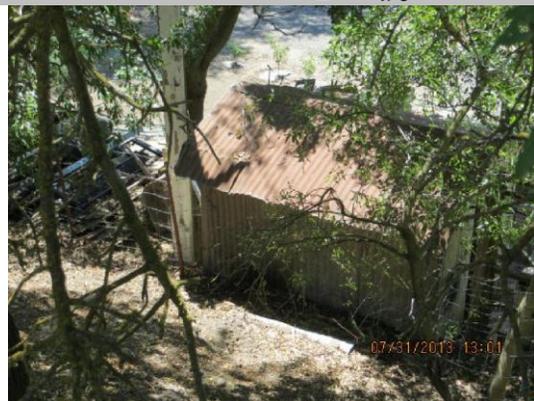
Photo 1 of 1 : UCIP_1528.jpg

LM Start	3.49	Rating **	M	Issue No.	24
LM End	3.49	Issue Type +	En	Location *	LS
Category	Supplemental			GPS Latitude/Longitude	
				Start	End
Item	DWR UCIP Field Study			38.457182 °	38.457182 °
				-121.503847 °	-121.503847 °
DWR ID	DWR_RD0307_01_s_2014_24				
Action/Comments					
Inspector Comments: FS_ID:16843 EP_NO: N/A Repair Type: Crossing Status: UCIP Comments: No access to pumphouse as fence is within 10-feet of toe. FIELD_STRUCT_DESC: 8-inch steel irrigation pipe through the levee 11.8 feet below the crown. Pump house on the landward toe. 48-inch diameter concrete standpipe just off LS toe. Originally included in the 1959 O&M manual. FS Date: 7/31/2013

Pumphouse on LS toe. No access due to fence along toe.

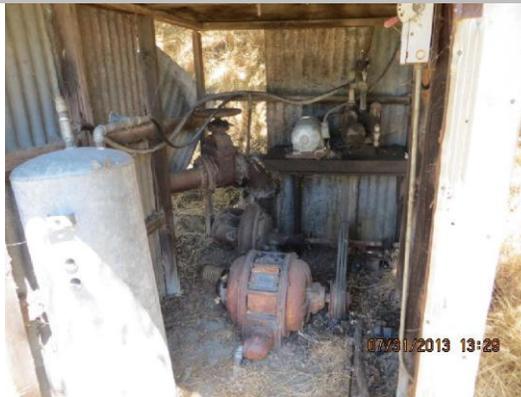
Photo 1 of 1 : UCIP_1529.jpg

LM Start	3.65	Rating **	M	Issue No.	25
LM End	3.65	Issue Type +	En	Location *	LS
Category	Supplemental			GPS Latitude/Longitude	
				Start	End
Item	DWR UCIP Field Study			38.454939 °	38.454939 °
				-121.503146 °	-121.503146 °
DWR ID	DWR_RD0307_01_s_2014_25				
Action/Comments					
Inspector Comments: FS_ID:16923 EP_NO: N/A Repair Type: Crossing Status: UCIP Comments: Gate valve does not function on WS slope. Pipe and pump appear to be abandoned and should be done so properly. FIELD_STRUCT_DESC: 7-inch steel irrigation pipe through the levee 14.7 feet below the crown. Pump in pumphouse on LS toe. Gate valve on the WS slope and at pumphouse on the LS toe. Air vent on pipe at WS toe near waterline. Originally included in the 1959 O&M manual. FS Date: 7/31/2013

Gate valve and pump in pumphouse on LS toe.

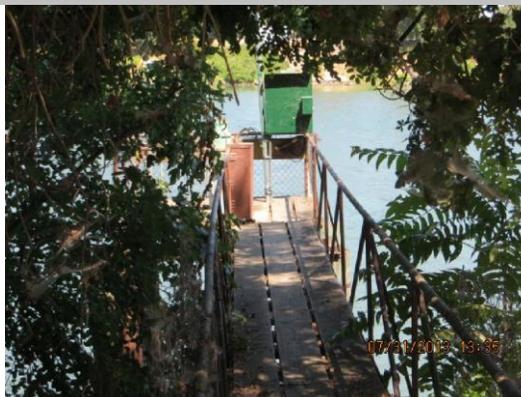
Photo 1 of 1 : UCIP_1534.jpg

LM Start	3.70	Rating **	M	Issue No.	26
LM End	3.70	Issue Type +	En	Location *	LS
Category	Supplemental			GPS Latitude/Longitude	
				Start	End
Item	DWR UCIP Field Study			38.454154 °	38.454154 °
				-121.502939 °	-121.502939 °
DWR ID	DWR_RD0307_01_s_2014_26				
Action/Comments					
Inspector Comments: FS_ID:16924 EP_NO: 8030 Repair Type: Crossing Status: UCIP Comments: Pipe not visible on LS slope or toe due to excessive vegetation. Vegetation should be cleared from pipe. FIELD_STRUCT_DESC: 1 of 2: 12-inch steel irrigation pipe through the levee 6-feet below the crown. Walkway on WS slope to a pump on a pile structure in the stream. JP and meter on LS toe. Pipe appears to cross levee at an angle. (Permit No. 8030, 1972). Included in the 1959 O&M manual. FS Date: 7/31/2013

Pump and electrical controls on Pier at WS slope.

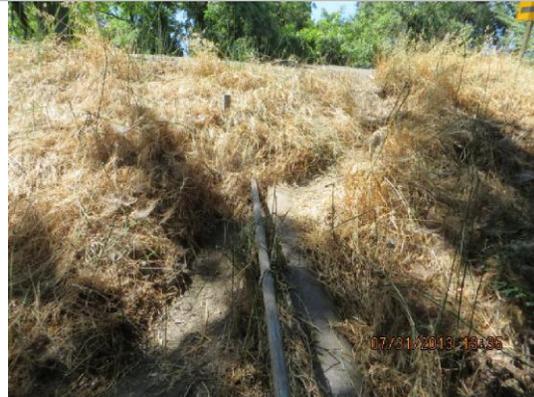
Photo 1 of 1 : UCIP_1537.jpg

LM Start	3.70	Rating **	M	Issue No.	27
LM End	3.70	Issue Type +	En	Location *	LS
Category	Supplemental			GPS Latitude/Longitude	
				Start	End
Item	DWR UCIP Field Study			38.454154 °	38.454154 °
				-121.502939 °	-121.502939 °
DWR ID	DWR_RD0307_01_s_2014_27				
Action/Comments					
Inspector Comments: FS_ID:16925 EP_NO: 8030 Repair Type: Crossing Status: UCIP Comments: Excessive vegetation should be cleared from conduit and JP on LS toe. FIELD_STRUCT_DESC: 2 of 2: 1.5-inch conduit through levee 6.0 feet below crown. Walkway on WS slope to pump on a pile structure. Meter on JP at LS toe (Permit No. 8030, 1972) FS Date: 7/31/2013

Conduit visible on WS slope.

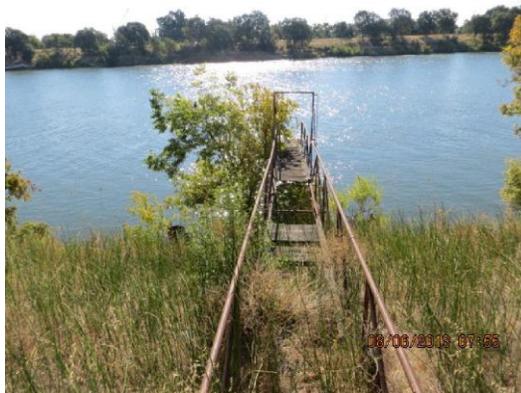
Photo 1 of 1 : UCIP_1540.jpg

LM Start	3.95	Rating **	M	Issue No.	29
LM End	3.95	Issue Type +	En	Location *	LS
Category	Supplemental			GPS Latitude/Longitude	
				Start	End
Item	DWR UCIP Field Study			38.450575 °	38.450575 °
				-121.502580 °	-121.502580 °
DWR ID	DWR_RD0307_01_s_2014_29				
Action/Comments					
Inspector Comments: FS_ID:16983 EP_NO: 8034 Repair Type: Crossing Status: UCIP Comments: Appears abandoned and should be done so properly. Walkway to pier is falling apart and is an attractive nuisance. Pipe rusted through at riser on LS toe. FIELD_STRUCT_DESC: 1 of 2: 14-inch steel irrigation pipe through the levee 13.0 feet below the crown. Pump on pile structure with walkway on WS slope. Gate valve at the waterward toe and a 48-inch concrete standpipe on the LS toe. Sheet pile wall around base of metal pier at WS toe (Permit No. 8034, 1972). Included in the 1959 O&M manual. FS Date: 8/6/2013 3:32:15 PM

Metal walkway to pump on pier and gate valve actuator on WS slope.

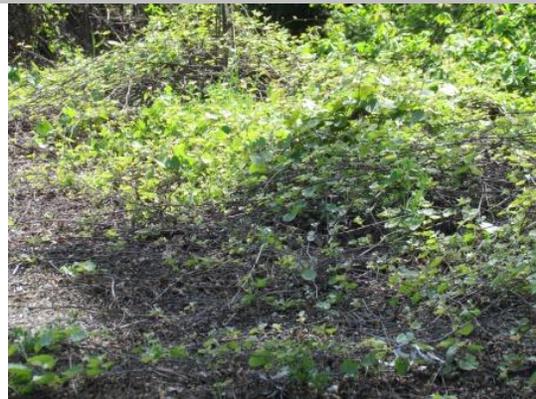
Photo 1 of 1 : phillips_s_20140421_795.jpg

Looking downstream from landside slope the shoulder, slope and toe over taken with wild berries. Unable to stage a Flood Fight here. Photo taken 4-08-2014.

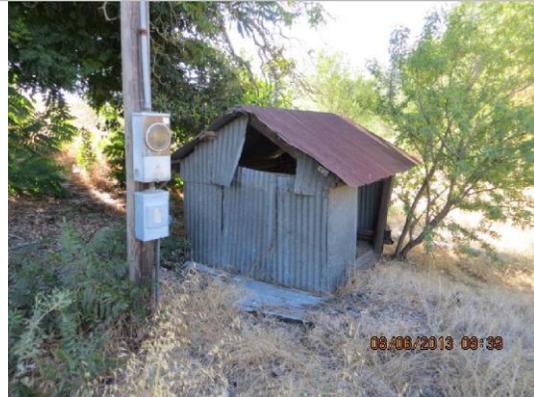
Photo 1 of 1 : UCIP_1567.jpg

LM Start	4.12	Rating **	M	Issue No.	32
LM End	4.12	Issue Type +	En	Location *	LS
Category	Supplemental		GPS Latitude/Longitude		
			Start	End	
Item	DWR UCIP Field Study		38.448190 °	38.448190 °	
			-121.502653 °	-121.502653 °	
DWR ID	DWR_RD0307_01_s_2014_32				
Action/Comments					
Inspector Comments: FS_ID:17128 EP_NO: 8038 Repair Type: Crossing Status: UCIP Comments: Wooden lid on 5-foot Diam. CMP riser rotten and could collapse. This could create a hazard for the public and should be replaced. Pipe appears abandoned and should be done so properly. FIELD_STRUCT_DESC: 6-inch steel irrigation pipe through the levee 13.5 feet below the crown. Gate valve in 5-foot diameter corrugated metal pipe riser on the waterward slope. Power pole and meter at LS toe (Permit No. 8038, 1972). Included in the 1959 O&M manual. FS Date: 7/31/2013

Power Pole, meter, and pumphouse on LS toe.

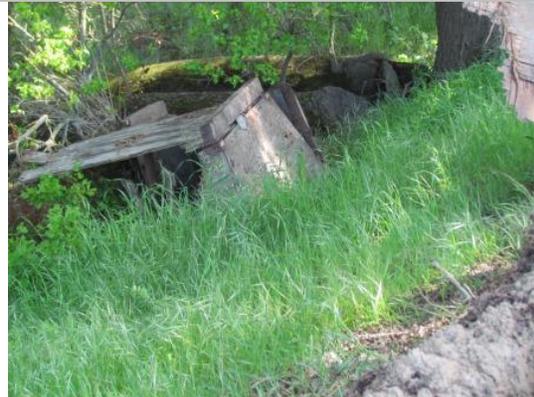
Photo 1 of 1 : phillips_s_20140421_794.jpg

LM Start	4.15	Rating **	U	Issue No.	67
LM End	4.15	Issue Type +	En	Location *	WS
Category	Earthen Levee		GPS Latitude/Longitude		
			Start	End	
Item	Encroachments		38.461894 °	38.461894 °	
			-121.504959 °	-121.504959 °	
DWR ID	DWR_RD0307_01_s_2014_67				
Action/Comments					
Debris

Wooden ben dumped on water side slope. Photo taken 4-08-2014.

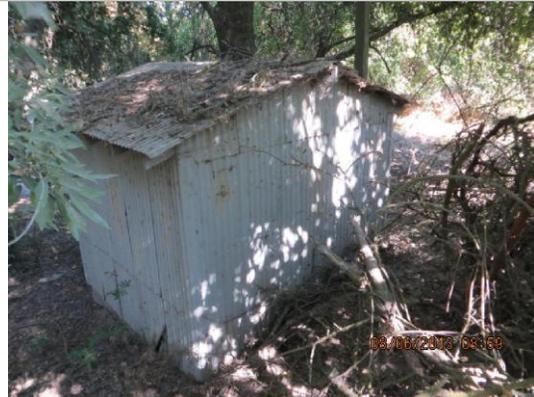
Photo 1 of 1 : UCIP_3020.jpg

Pumphouse on LS toe.

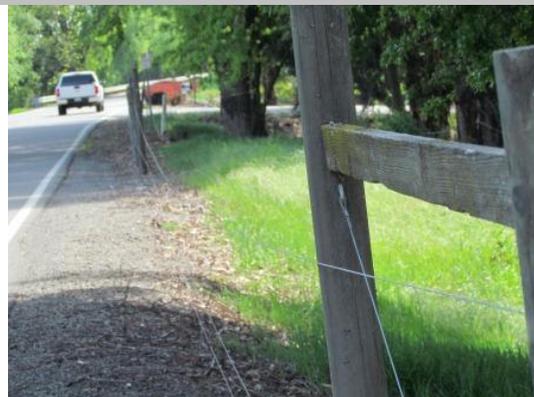
Photo 1 of 2 : phillips_s_20140421_796.jpg

LM Start	4.27	Rating **	U	Issue No.	31
LM End	4.36	Issue Type +	En	Location *	LS
Category	Earthen Levee		GPS Latitude/Longitude		
			Start	End	
Item	Encroachments		38.446041 °	38.445720 °	
			-121.502816 °	-121.503014 °	
DWR ID	DWR_RD0307_01_s_2012_31				
Action/Comments					
Fence

Levee mile 4.27 to 4.36 this wire fence should be removed from the levee section. No permit on file. Photo taken 4-08-2014.

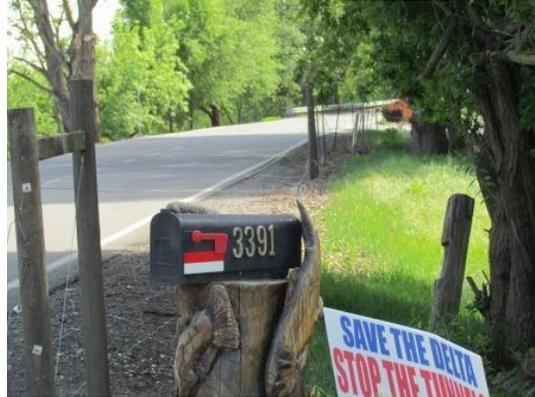
Photo 2 of 2 : phillips_s_20140421_797.jpg

Looking downstream at the unauthorized electric wire fence and fence post landside shoulder.

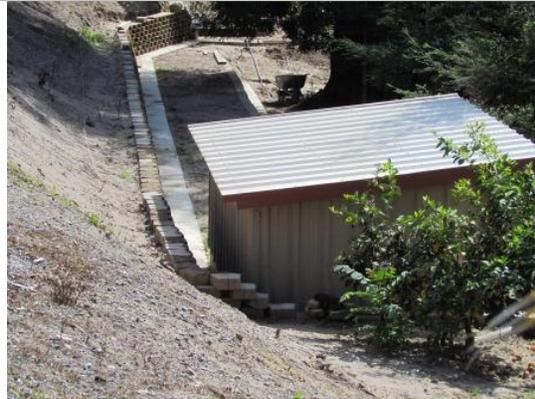
Photo 1 of 2 : phillips_s_20140421_799.jpg

LM Start	4.36	Rating **	U	Issue No.	19
LM End	4.36	Issue Type +	En	Location *	LS
Category	Earthen Levee		GPS Latitude/Longitude		
			Start	End	
Item	Encroachments		38.440289 °	38.440289 °	
			-121.503127 °	-121.503127 °	
DWR ID	DWR_RD0307_01_s_2013_19				
Action/Comments					
Retaining Wall					
Inspector Comments: This retaining wall was in place prior to the spring inspection 2013. No CVFPB permit on file. No new picture taken of encroachment.

This pump house was built 2013 without a CVFPB Permit. Photo taken 4-08-2014.

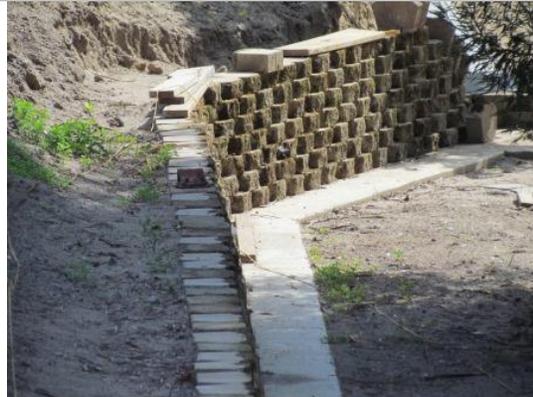
Photo 2 of 2 : phillips_s_20140421_798.jpg

This retaining has no CVFPB Permit on file. Photo taken 4-08-2014.

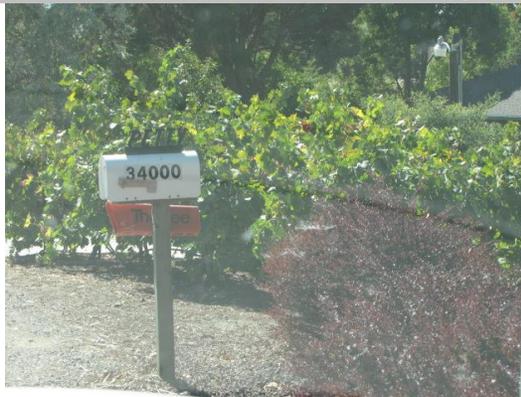
Photo 1 of 1 : phillips_s_20140408_643.jpg

RD 307 Unauthorized encroachment at levee mile 4.43 land side levee slope and shoulder. Photo taken 10-02-2013.

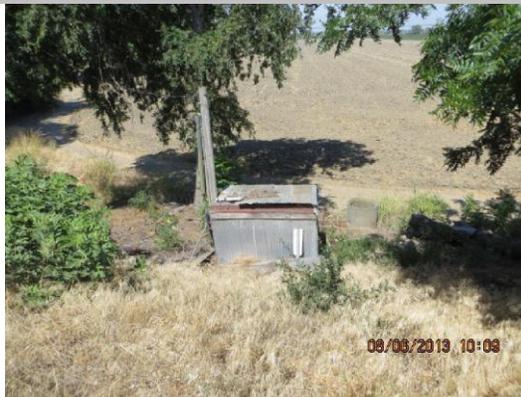
Photo 1 of 1 : UCIP_1583.jpg

LM Start	4.52	Rating **	M	Issue No.	35
LM End	4.52	Issue Type +	En	Location *	LS
Category	Supplemental		GPS Latitude/Longitude		
			Start	End	
Item	DWR UCIP Field Study		38.442515 °	38.442515 °	
			-121.503620 °	-121.503620 °	
DWR ID	DWR_RD0307_01_s_2014_35				
Action/Comments					
Inspector Comments: FS_ID:17183 EP_NO: 8041 Repair Type: Crossing Status: UCIP Comments: Pipe appears abandoned and should be done so properly. Gate valve has been removed from pipe on LS toe. FIELD_STRUCT_DESC: 6-inch steel irrigation pipe through the levee 13.5 feet below the crown. Pump and-gate valve in pump house on the landward slope. Gate valve on WS slope. Service pole and anchor on the landward slope (Permit No. 8041, 1972). Included in the 1959 O&M manual. FS Date: 8/6/2013

Pumphouse for 6-inch pipe at LS toe.

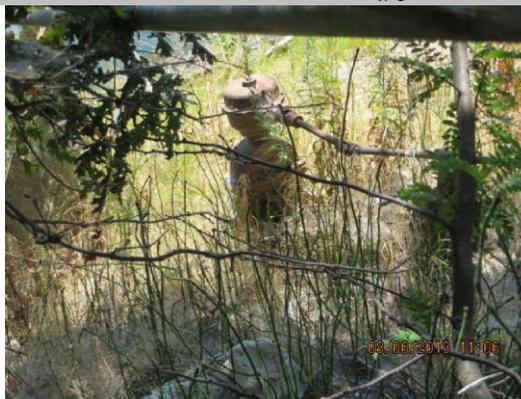
Photo 1 of 1 : UCIP_1587.jpg

Gate valve on WS slope.

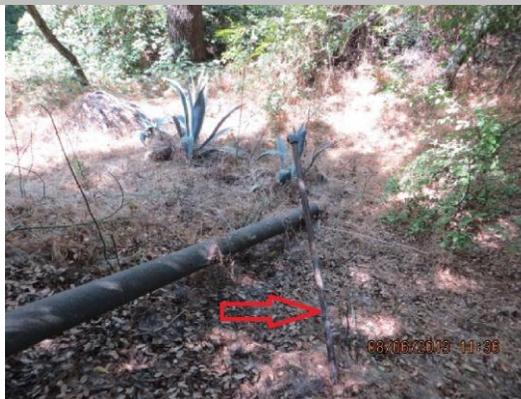
Photo 1 of 1 : UCIP_3023.jpg

LM Start	4.88	Rating **	M	Issue No.	37
LM End	4.88	Issue Type +	En	Location *	LS
Category	Supplemental		GPS Latitude/Longitude		
			Start	End	
Item	DWR UCIP Field Study		38.438390 °	38.438390 °	
			-121.507323 °	-121.507323 °	
DWR ID	DWR_RD0307_01_s_2014_37				
Action/Comments					
Inspector Comments: FS_ID:22672 EP_NO: N/A Repair Type: Crossing Status: UCIP Comments: Pipe abandoned and should be done so properly. FIELD_STRUCT_DESC: 2 of 2: 1-inch conduit through levee 1.5 feet below crown. FS Date: 8/6/2013

Abandoned electrical conduit next to pipe on LS slope.

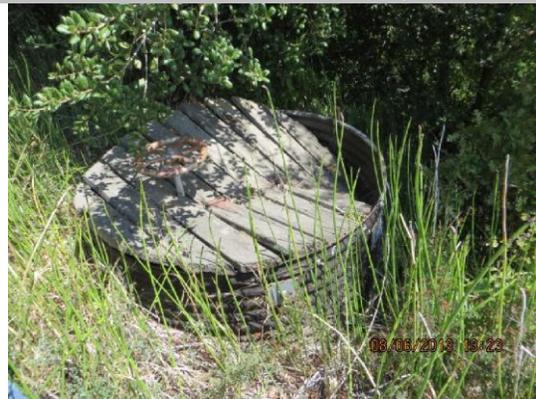
Photo 1 of 1 : UCIP_3034.jpg

Gate valve in 5-foot diameter CMP riser on WS slope.

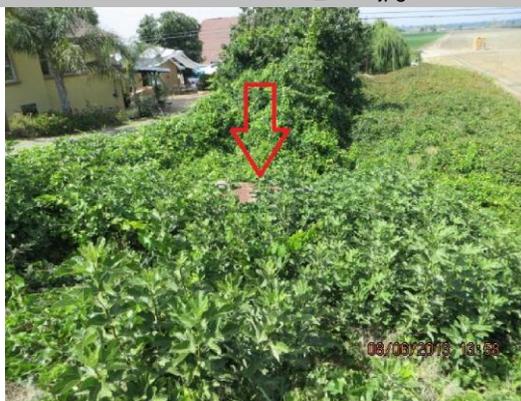
Photo 1 of 1 : UCIP_1591.jpg

Pumphouse on LS toe.

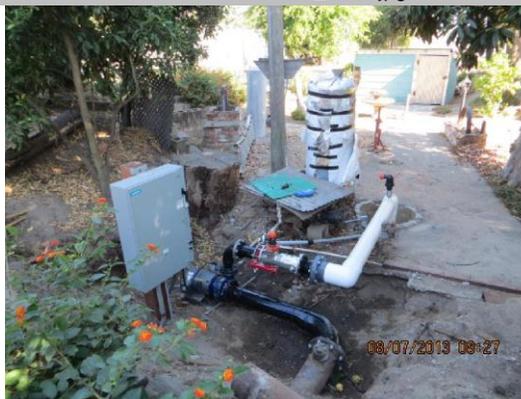
Photo 1 of 1 : UCIP_1594.jpg

Pump, electrical panel, Concrete riser, and vent on LS toe.

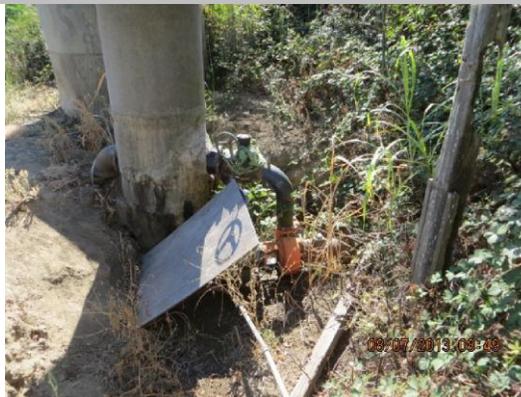
Photo 1 of 1 : UCIP_1596.jpg

Pump, butterfly valve, vent, and concrete standpipe on LS toe. foto 3 description or comment here.

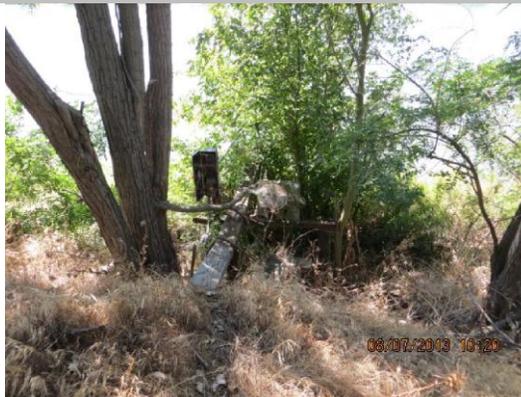
Photo 1 of 1 : UCIP_3043.jpg

Slant pump on WS slope.

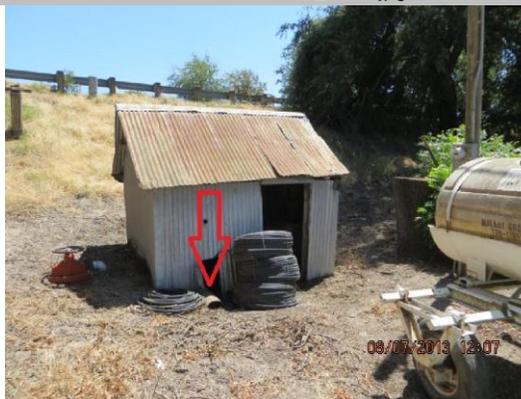
Photo 1 of 1 : UCIP_1599.jpg

Pipe cut and open on LS of pumphouse.

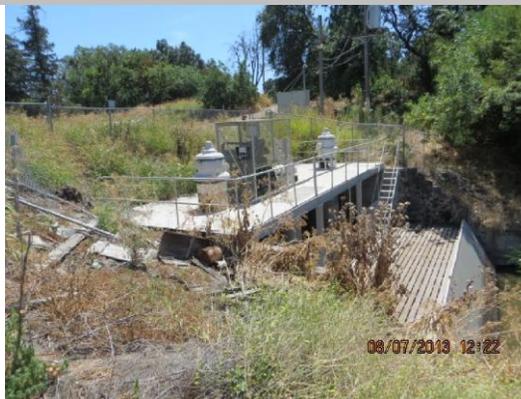
Photo 1 of 1 : UCIP_1602.jpg

Pumping plant and trash rack off LS toe.
