**Flood Control Project Maintenance
Levee Inspections**
LMA District Cover Sheet
Spring 2015 Levee Inspection Results

Reclamation District No. 0307 Lisbon

Spring 2015 Levee Inspection Results

Waterway		Bank	Unit Miles
Unit No. 01 Sacramento River		Right	6.56

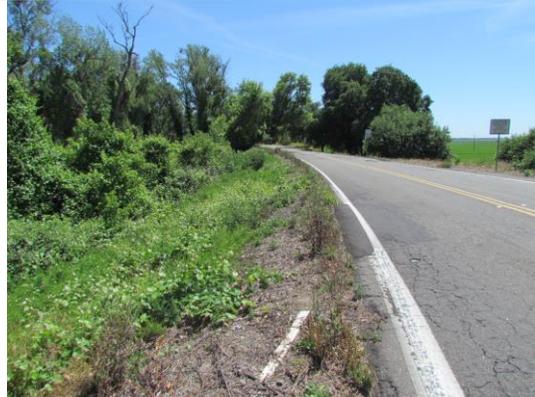
Photo 1 of 1 : SP_2015_RD0307_166_64_20150518_00032.jpg

LM Start	0.01	Rating **	U	Issue No.	64
LM End	0.18	Issue Type +	Ma	Location *	WS
Category	Earthen Levee		GPS Latitude/Longitude		
			Start	End	
Item	Vegetation		38.479968 °	38.478210 °	
			-121.549372 °	-121.547085 °	
DWR ID	DWR_RD0307_01_s_2015_64				
Action/Comments					
Remove the wild growth other than native grasses from the levee slopes. Inspector Comments: There is wild berries and other wild growth on the waterside that blocks the view of the levee slope.

Unacceptable wild growth on the waterside of the levee slope and shoulder.

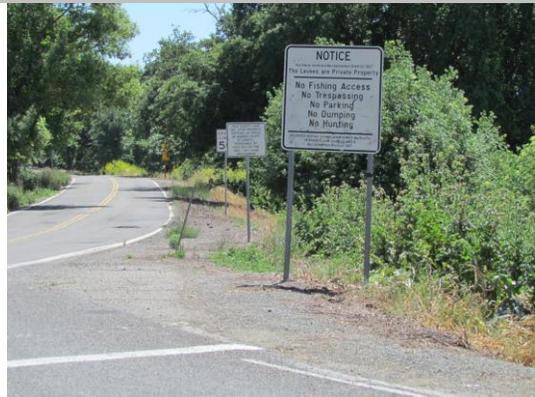
Photo 1 of 1 : SP_2015_RD0307_166_63_20150518_00033.jpg

LM Start	0.01	Rating **	U	Issue No.	63
LM End	0.22	Issue Type +	Ma	Location *	LS
Category	Earthen Levee		GPS Latitude/Longitude		
			Start	End	
Item	Vegetation		38.479968 °	38.477782 °	
			-121.549372 °	-121.546607 °	
DWR ID	DWR_RD0307_01_s_2015_63				
Action/Comments					
Remove the wild growth other than native grasses from the levee slopes. Inspector Comments: Unwanted thistle 5-6 foot tall, milkweeds and wild mustards on landward slope.

Looking downstream at tall thistle, milkweeds, and other wild growth covering the landside slope.

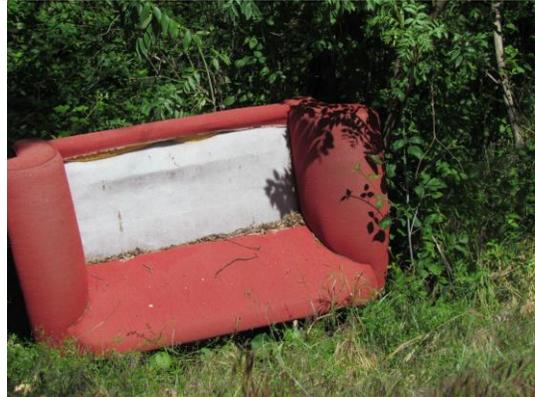
Photo 1 of 1 : SP_2015_RD0307_166_67_20150518_00036.jpg

LM Start	0.15	Rating **	M	Issue No.	67
LM End	0.15	Issue Type +	En	Location *	WS
Category	Earthen Levee		GPS Latitude/Longitude		
			Start	End	
Item	Encroachments		38.478473 °	38.478473 °	
			-121.547612 °	-121.547612 °	
DWR ID	DWR_RD0307_01_s_2015_67				
Action/Comments					
Debris Inspector Comments: Discarded couch on the waterside slope.

Discarded furniture and other garbage on the waterside levee slope.

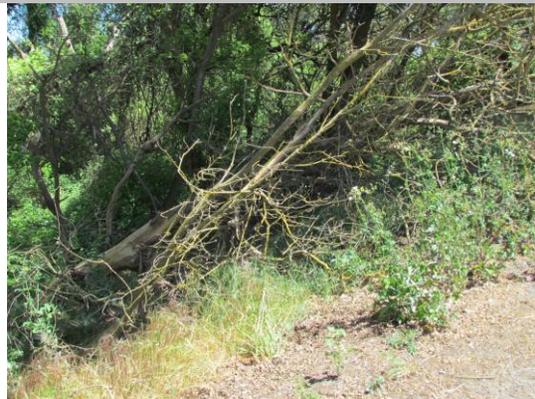
Photo 1 of 1 : SP_2015_RD0307_166_68_20150518_00034.jpg

LM Start	0.15	Rating **	U	Issue No.	68
LM End	0.15	Issue Type +	En	Location *	WS
Category	Earthen Levee		GPS Latitude/Longitude		
			Start	End	
Item	Encroachments		38.478473 °	38.478473 °	
			-121.547612 °	-121.547612 °	
DWR ID	DWR_RD0307_01_s_2015_68				
Action/Comments					
Tree or limb Inspector Comments: Dead fallen tree on the waterside slope and shoulder.

Dead tree on the waterside slope need to be cut up and removed from the levee section.

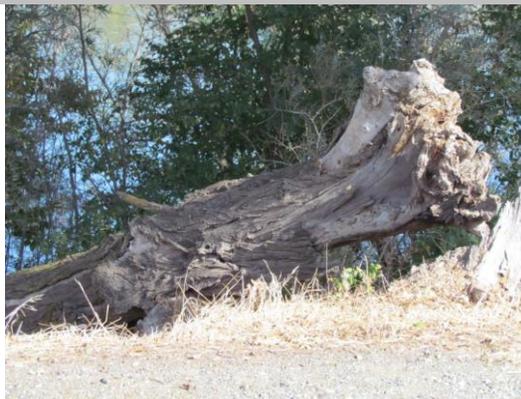
Photo 1 of 1 : SP_2015_RD0307_166_9_20150312_00001.jpg

LM Start	1.29	Rating **	U	Issue No.	9
LM End	1.29	Issue Type +	En	Location *	WS
Category	Earthen Levee			GPS Latitude/Longitude	
				Start	End
Item	Encroachments			38.472827 °	38.472827 °
				-121.528785 °	-121.528785 °
DWR ID	DWR_RD0307_01_f_2014_9				
Action/Comments					
Tree or limb

This tree needs to be removed from the waterside slope. No new photo taken of this issue Spring 2015.

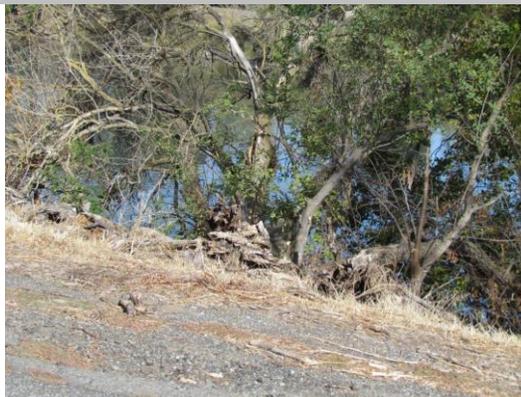
Photo 1 of 1 : SP_2015_RD0307_166_10_20150312_00002.jpg

LM Start	1.35	Rating **	U	Issue No.	10
LM End	1.35	Issue Type +	En	Location *	WS
Category	Earthen Levee			GPS Latitude/Longitude	
				Start	End
Item	Encroachments			38.472880 °	38.472880 °
				-121.527733 °	-121.527733 °
DWR ID	DWR_RD0307_01_f_2014_10				
Action/Comments					
Tree or limb

Remove unwanted trees from waterside slope. These trees are dead and are resting on the slope.

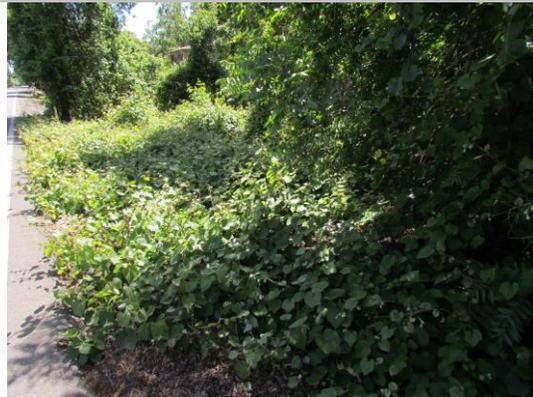
Photo 1 of 1 : SP_2015_RD0307_166_100_20150519_00042.jpg

LM Start	4.11	Rating **	U	Issue No.	100
LM End	4.13	Issue Type +	Ma	Location *	LS
Category	Earthen Levee			GPS Latitude/Longitude	
				Start	End
Item	Vegetation			38.447530 °	38.447215 °
				-121.502705 °	-121.502665 °
DWR ID	DWR_RD0307_01_s_2015_100				
Action/Comments					
Remove the wild growth other than native grasses from the levee slopes. Inspector Comments: Unwanted wild grapes and berries on the landside slope, shoulder and toe.

Wild grapes and berries have completely blocked view of the landside shoulder, slope and toe.

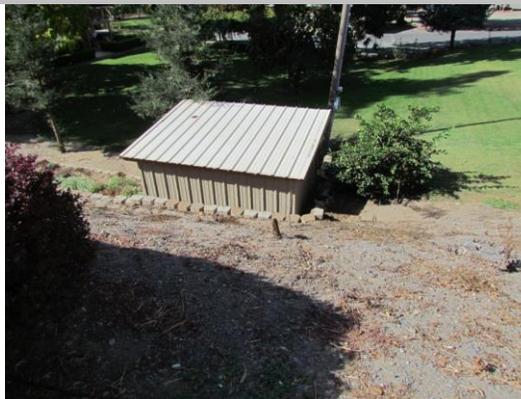
Photo 1 of 1 : SP_2015_RD0307_166_26_20150312_00004.jpg

LM Start	4.31	Rating **	U	Issue No.	26
LM End	4.31	Issue Type +	En	Location *	N/A
Category	Earthen Levee		GPS Latitude/Longitude		
			Start	End	
Item	Encroachments		38.444612 °	38.444612 °	
			-121.503100 °	-121.503100 °	
DWR ID	DWR_RD0307_01_f_2014_26				
Action/Comments					
Building Inspector Comments: This pumphouse was built without a permit, the District is aware of the encroachment. No new photo taken.

This pump house was built without CVFPB Permit.

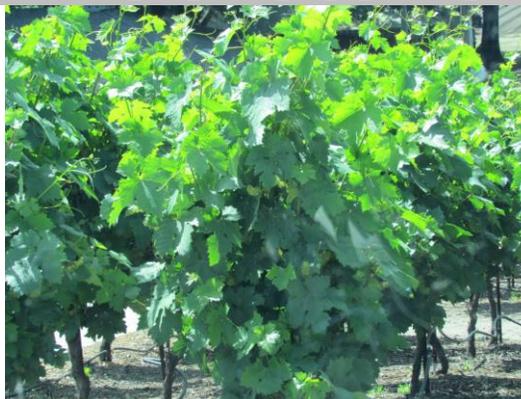
Photo 1 of 1 : SP_2015_RD0307_166_27_20150519_00043.jpg

LM Start	4.39	Rating **	U	Issue No.	27
LM End	4.39	Issue Type +	En	Location *	LS
Category	Earthen Levee		GPS Latitude/Longitude		
			Start	End	
Item	Encroachments		38.443517 °	38.443517 °	
			-121.503338 °	-121.503338 °	
DWR ID	DWR_RD0307_01_f_2014_27				
Action/Comments					
Crops Inspector Comments: There are grapes planted on the levee slope landside without permit from the CVFPB. This issue has been reported and recorded in previous inspections.

Grapes planted on the landside levee shoulder and slope with a permit.

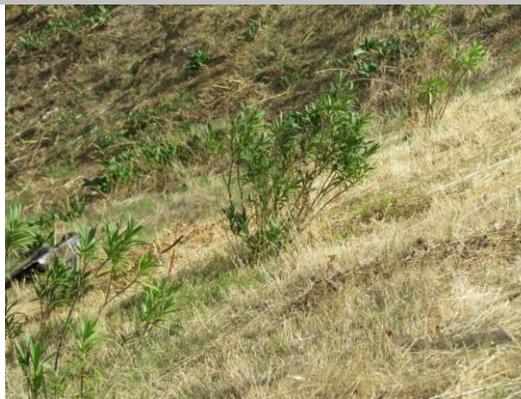
Photo 1 of 1 : SP_2015_RD0307_166_28_20150312_00007.jpg

LM Start	5.33	Rating **	U	Issue No.	28
LM End	5.37	Issue Type +	En	Location *	LS
Category	Earthen Levee			GPS Latitude/Longitude	
				Start	End
Item	Encroachments			38.435728 °	38.435662 °
				-121.516023 °	-121.516735 °
DWR ID	DWR_RD0307_01_f_2014_28				
Action/Comments					
Tree or limb Inspector Comments: Unauthorized planting of small oleander trees on the levee slope landside, no permit for this encroachment. 15 trees at this location.

This issue was reported last year, unauthorized planting of small oleander trees.

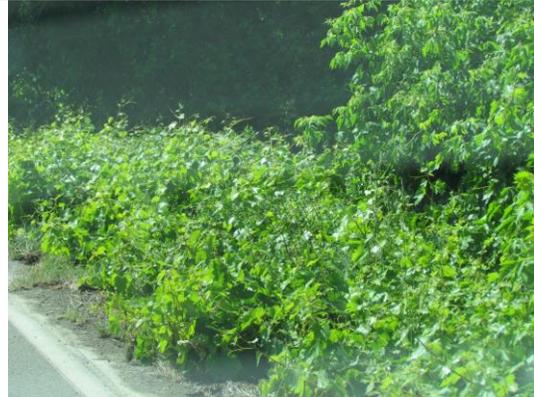
Photo 1 of 1 : SP_2015_RD0307_166_102_20150519_00044.jpg

LM Start	5.39	Rating **	U	Issue No.	102
LM End	5.46	Issue Type +	Ma	Location *	LS
Category	Earthen Levee			GPS Latitude/Longitude	
				Start	End
Item	Vegetation			38.435658 °	38.435680 °
				-121.517243 °	-121.518360 °
DWR ID	DWR_RD0307_01_s_2015_102				
Action/Comments					
Remove the wild growth other than native grasses from the levee slopes. Inspector Comments: The wild grapes need to be removed from the landside levee section so the levees slope can be seen.

Wild grapes has completely blocked the view of the landside shoulder and slope.

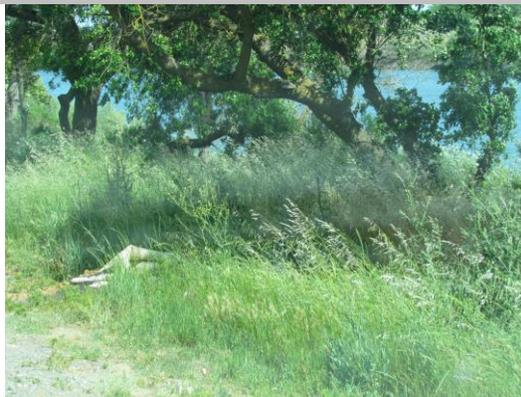
Photo 1 of 1 : SP_2015_RD0307_166_104_20150519_00045.jpg

LM Start	5.71	Rating **	U	Issue No.	104
LM End	5.91	Issue Type +	Ma	Location *	WS
Category	Earthen Levee			GPS Latitude/Longitude	
				Start	End
Item	Vegetation			38.435885 °	38.436118 °
				-121.523072 °	-121.526695 °
DWR ID	DWR_RD0307_01_s_2015_104				
Action/Comments					
Remove the wild growth other than native grasses from the levee slopes.

Unwanted tall weeds growing on the waterside of the levee section and toe.
